Struan Community Development Struan, Isle of Skye Archaeological Walkover Survey Report

Struan Community Development, Isle of Skye Archaeological Walkover Survey Report

On Behalf of:	Struan Community Development Committee
National Grid Reference (NGR):	NG 34077 38425
AOC Project No:	70306
Prepared by:	L. Fraser
Illustrations by:	L. Teufel
Date of Fieldwork:	15 th and 16 th May 2019
Date of Report:	May 2019
OASIS No.:	aocarcha1-354146

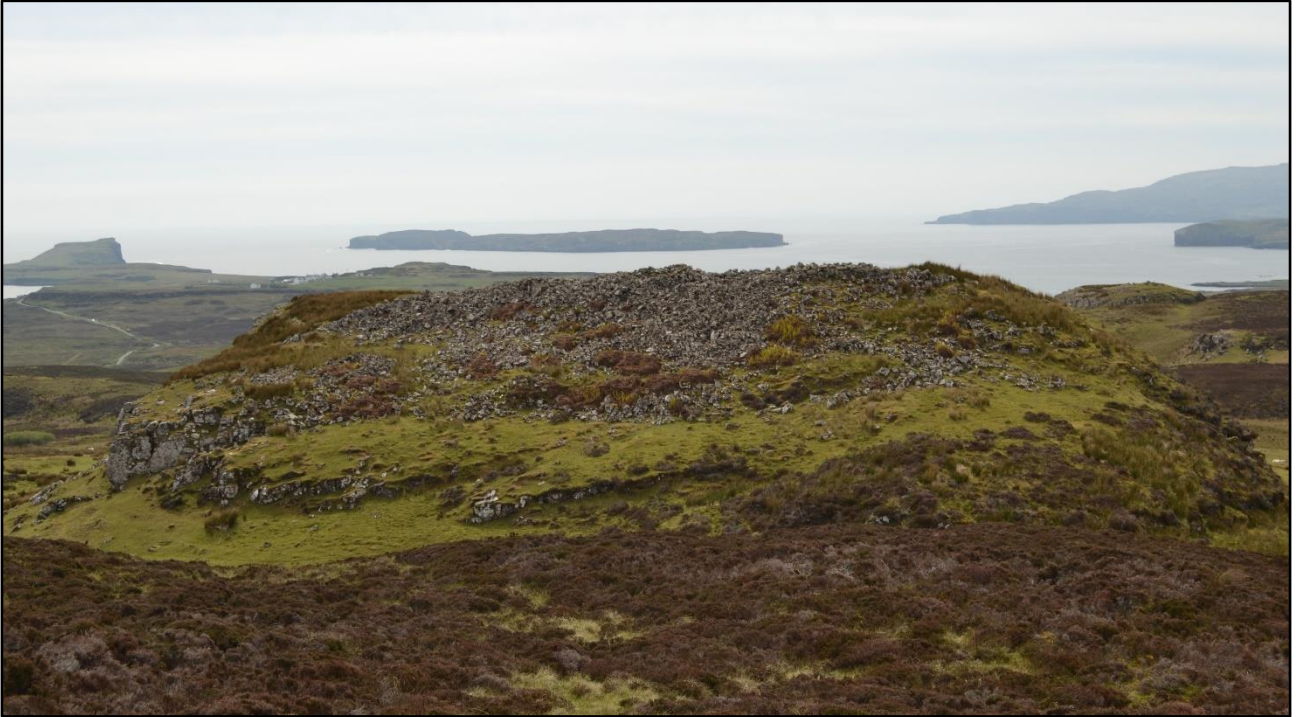
Plate 1: Dun Mor, Site 15, facing SW.

- 7.4 Whilst close to Dun Beag, Dun Mor is clearly not a well-visited site, if at all. It has the potential to be highlighted to visitors as it provides a short, extended walk from Dun Beag; a purpose-built footpath would assist in visitors navigating to the fort and help protect the surrounding landscape from numerous desire paths forming. At present, the site is not easily understood by the casual visitor and interpretation would have to be provided, perhaps both in the exhibition and on site. To aid with the production of meaningful interpretation, it is recommended that some limited excavation and tidying by professional archaeologists take place at specific points along the upstanding wall on the fort's east side. Such 'keyhole' excavation is designed to assess archaeological potential and recover information to a pre-determined plan; it can provide valuable information and usefully increase the current corpus of knowledge on such structures. This type of work would fit within the goal of the Scottish Archaeological Research Framework (2012) to increase the understanding of the context of enclosed places, with a particular issue being the lack of dating evidence. The work would aid conservation of the monument's wall as well as providing valuable data that would fit into wider research on forts that is currently taking place across Scotland.

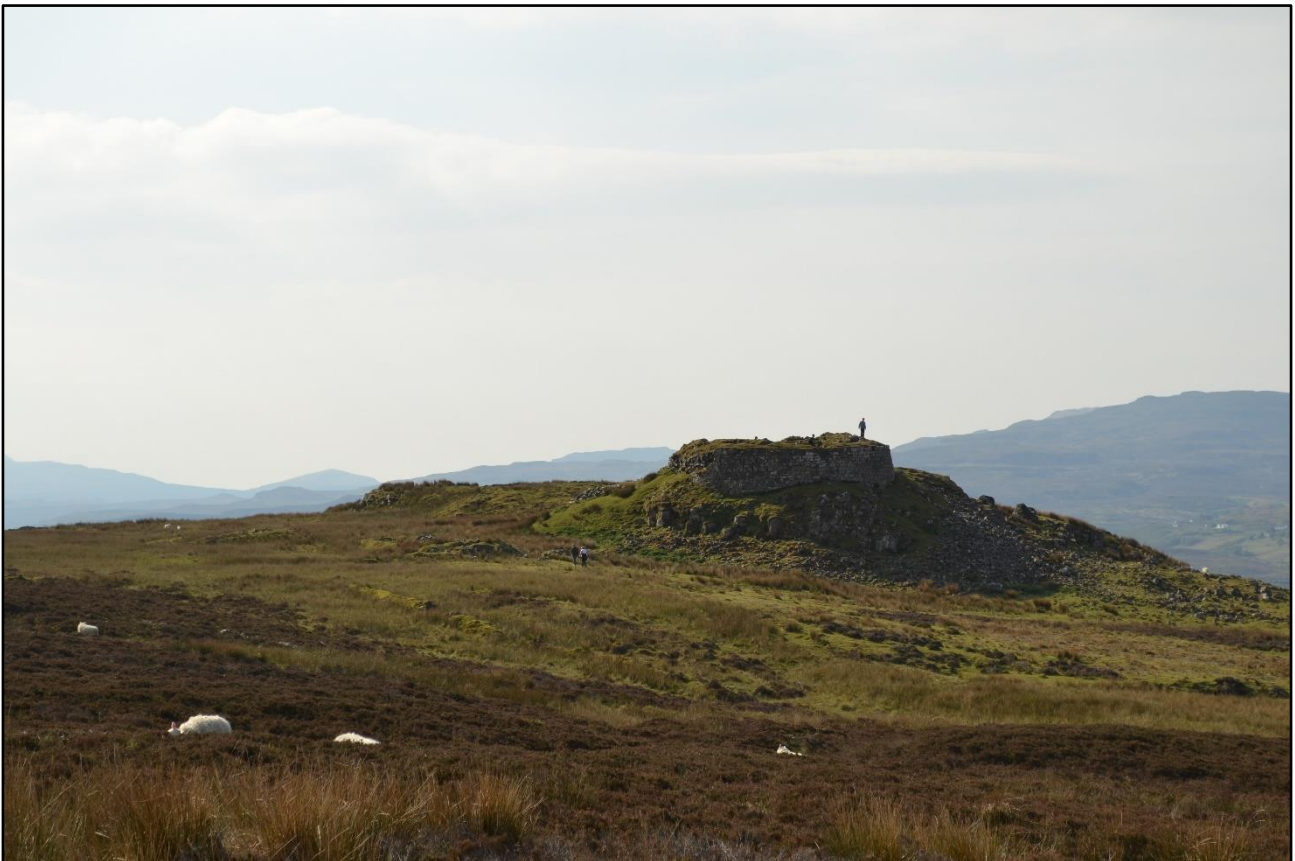
Plate 2: Dun Beag, Site 36, facing SSE.

- 7.3 Dun Beag is currently a well-visited site. The surveyors observed numerous people visiting over the course of two days whilst undertaking the survey. Its popularity is no doubt due to the fact that there is a parking area adjacent to the road, albeit small, and a well-worn path to the broch, which is visible from the road. The visitor numbers are taking a toll on the monument and erosion on the walls and wall-head is clearly visible. This will only be exacerbated by increased foot flow. It is recommended that the community work in conjunction with Historic Environment Scotland to stabilise the erosion before the situation worsens and put in place a strategy for the continued maintenance of the broch. This may take the form of providing formalised routes in and out of the broch as well as appropriate signage. Further car parking space should be considered, particularly to cater for the larger buses.

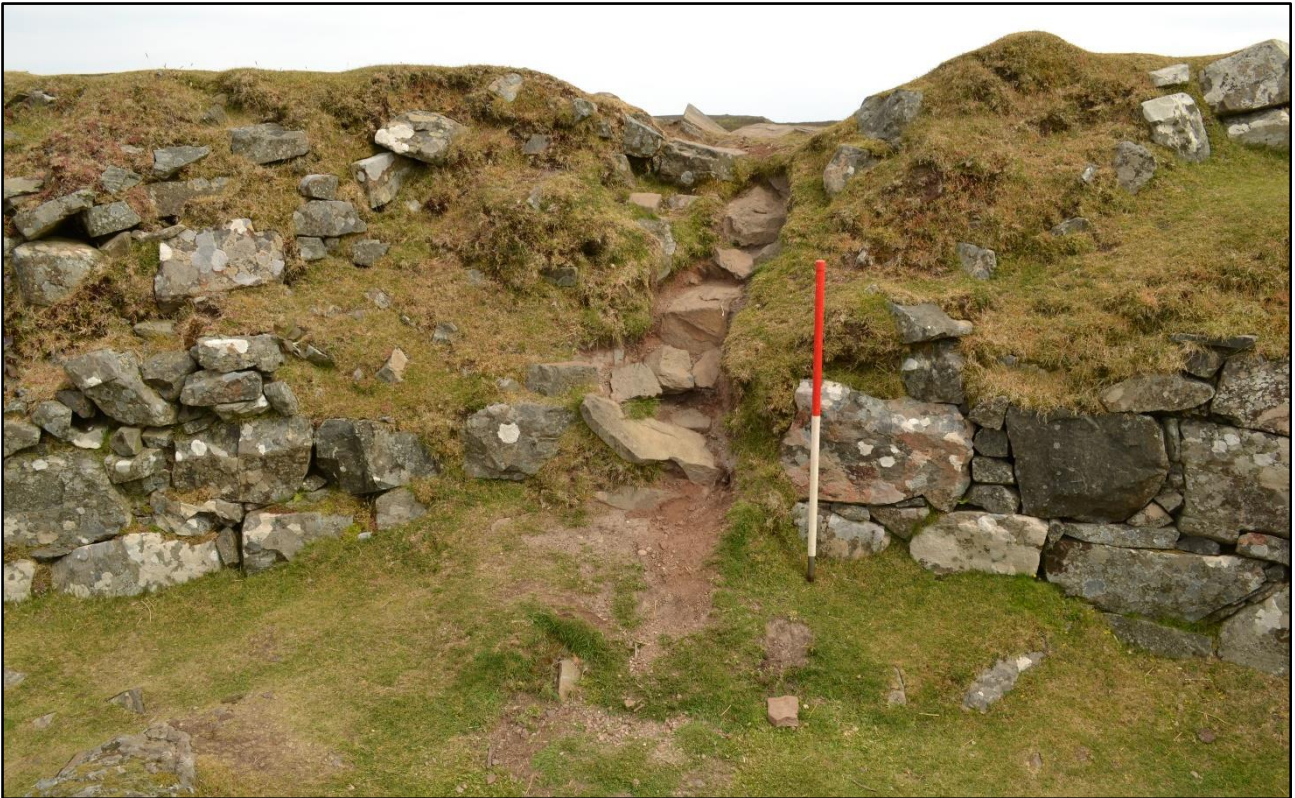
Plate 3: Erosion on inner broch wall, Site 36, facing NE.

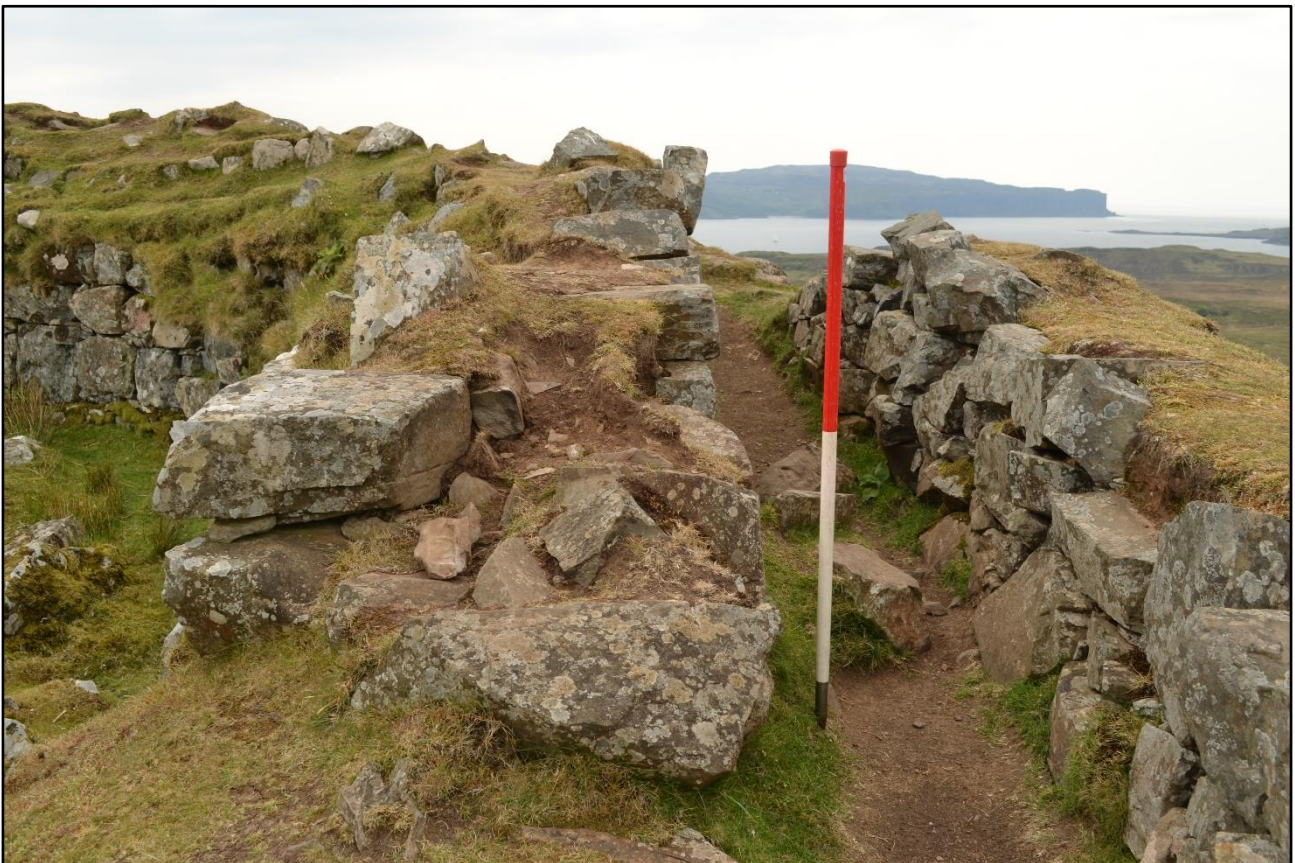
Plate 4: Erosion on the broch wall head, Site 36, facing SSE.

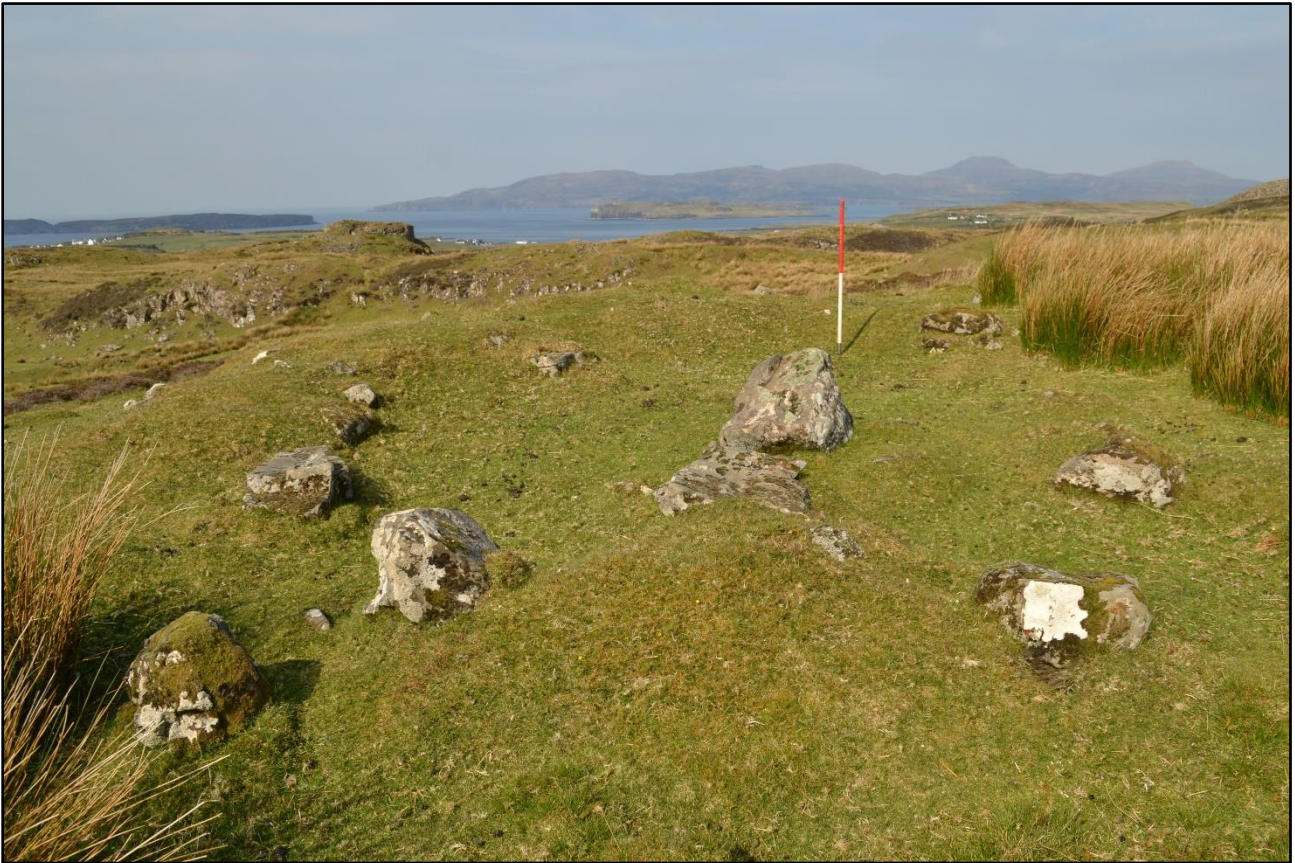
Plate 7: Hut circle, Site 34, overlooking Dun Beag, Site 36, facing W.

- 7.6 The degraded hut circle, **Site 34**, would be a suitable site for a community excavation for volunteers led by professional archaeologists. Hut circles or roundhouses, often with an attendant 'field system', are one of the most abundant prehistoric monument types throughout the Highlands and Islands of Scotland. The ubiquity and uniformity of the designation conceals the potential for a range of interpretations; they have a date range that spans from the Bronze Age to the 19th century (McCullagh 1993). It is only with excavation that a definitive

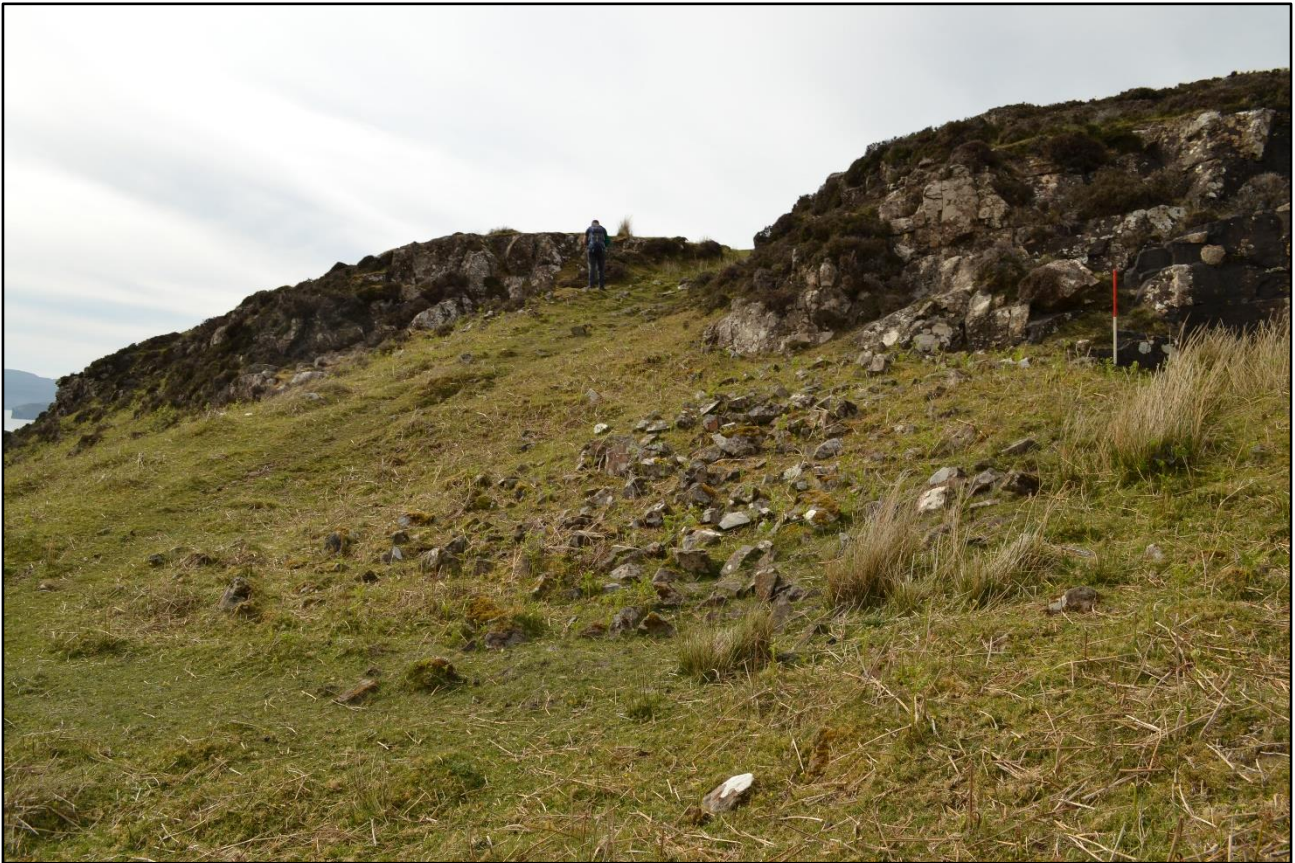
Plate 9: Prehistoric quarries, Sites 31a (right) and 31b with possible haul road between them, facing NW.

31b	Quarry	Degraded	Prehistoric	Quarrying is apparent on the rockface with steps into the face. It is well eroded so possibly prehistoric. There is a small spoil heap spreading downslope. There is a possible haul road between Sites 31a and b.	133948	838498
32	Dyke	Degraded	Post-medieval	A turf-covered dyke spread up to 2m wide at the base and standing up to 0.75m high. It is double-faced with stone when it passes rocky outcrops.	133866	838814
32	Dyke	Degraded	Post-medieval	A turf-covered dyke spread up to 2m wide at the base and standing up to 0.75m high. It is double-faced with stone when it passes rocky outcrops.	133815	838683
32	Dyke	Degraded	Post-medieval	A turf-covered dyke spread up to 2m wide at the base and standing up to 0.75m high. It is double-faced with stone when it passes rocky outcrops.	133797	838632
32	Dyke	Degraded	Post-medieval	A turf-covered dyke spread up to 2m wide at the base and standing up to 0.75m high. It is double-faced with stone when it passes rocky outcrops.	133776	838584

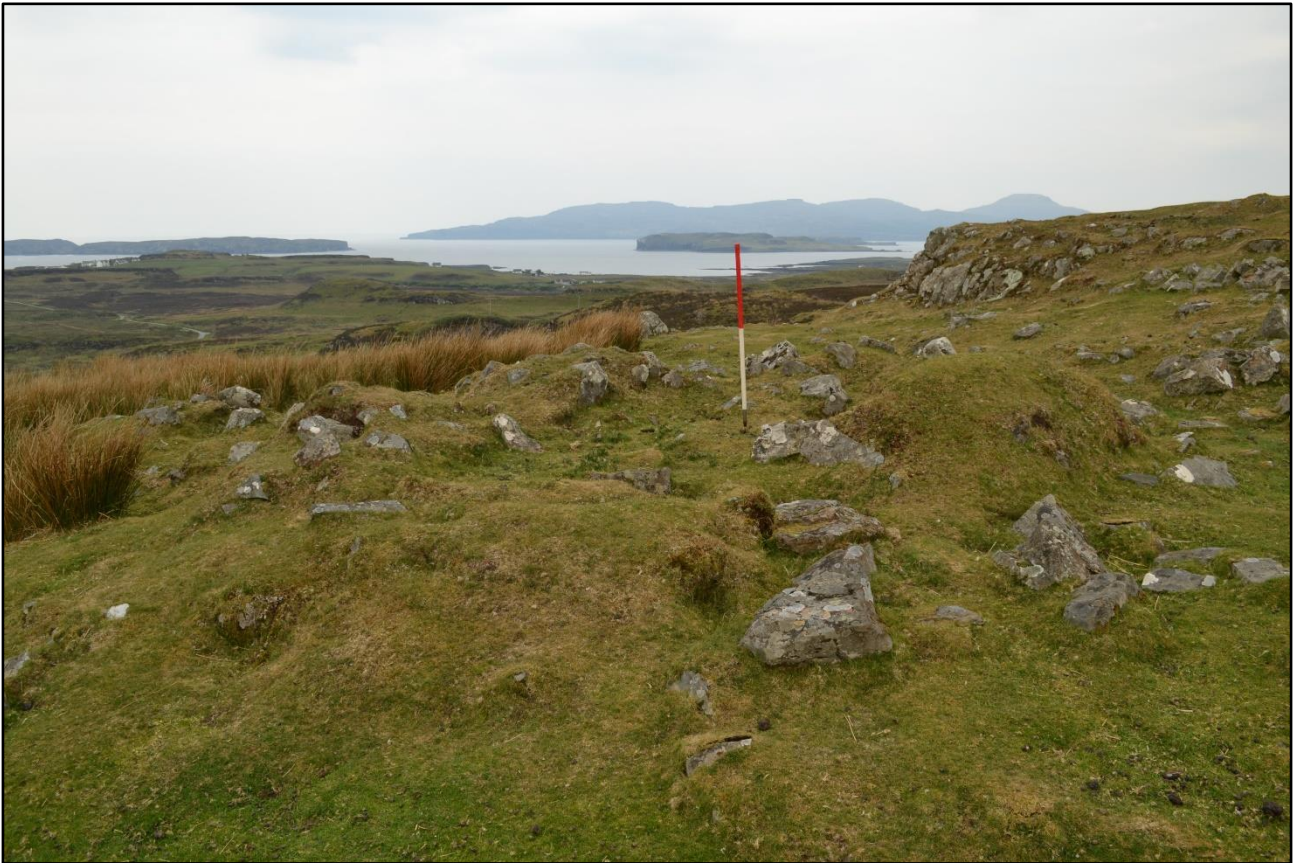
5.3.3 A small number of settlement structures was recorded. **Site 7 (Plate 21)** is an isolated, rectangular stone and turf structure attached to the south side of the dyke, **Site 4**, to the west of Dun Mor. Similarly, **Site 20b** is a much-degraded boulder structure attached to a dyke, **Site 20a**, forming a D-shape (**Plate 22**). In contrast, **Site 36a-g** is a small cluster of structures around Dun Beag (**Figure 8**). **Site 36a (Plate 23)** consists of an L-shaped building with a small kaleyard (**Site 36b**) attached on the southeast. The southwest end of the building has a curved inner wall face which suggests that it may have been a kiln barn. **Site 36d (Plate 24)** also has what appears to be a bowl within its southwest end; this structure also has a platform attached to the south side that may have been a kaleyard or structure. **Sites 36e-g** are all small turf-covered oval structures (**Plate 25**), the use of which could not be determined.

Plate 25: Post-medieval stone and turf structure, Site 36f, facing W.

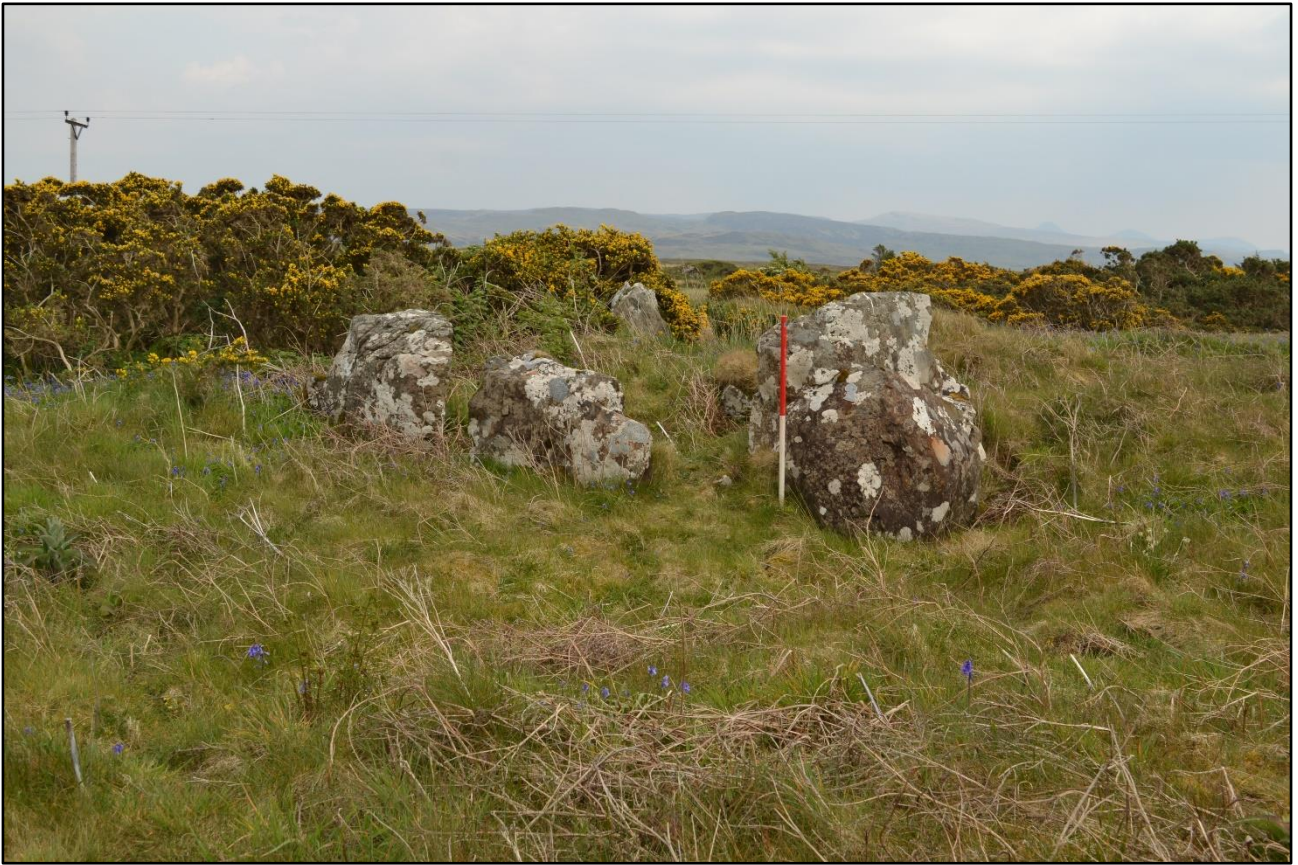
This is a much-robbed Hebridean-type chambered cairn with a pear-shaped chamber of massive split blocks (**Plate 27**). It is very close to the road but obscured from sight by gorse. There is a small parking area with a picnic bench close-by and an easy walk into the cairn through a gate. A path has been worn in the vegetation that goes alongside and beyond the cairn. Scenic views are visible all round. The site would benefit from vegetation clearance to make it more visible from the road and once on site. An information panel would improve the visitor experience.

Plate 27: Ullinish Lodge Chambered Cairn, facing E.

- 7.5 To enhance the visitor experience at several sites, including Ullinish Lodge Chambered Cairn, would benefit from limited vegetation clearance. The gravestones at St Assinds Chapel could be cleaned (following appropriate conservation guidance) to make them more visible. Several sites have informal paths or worn tracks leading to them. Enhancement or formalisation of access routes to the sites could help mitigate against visitor impact.

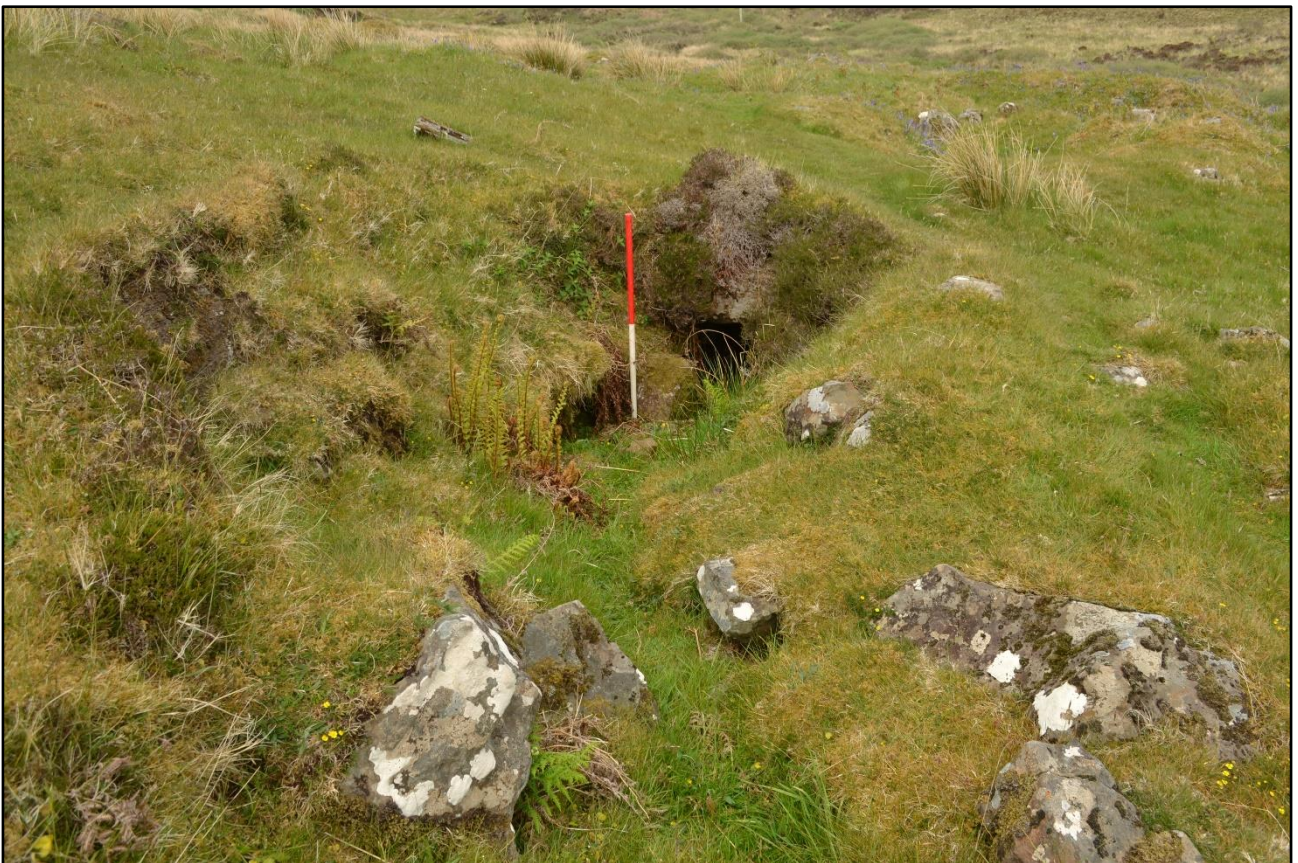
The souterrain is located on rough, rocky moorland about 400m W of the junction where the road to Ullinish Lodge branches off from the Dunvegan and Struanmore Road. It is in a much-degraded state with areas of collapse and it is only possible to access a small portion of it (**Plate 28**). Parking and navigation to the souterrain are an issue. Without any form of

Plate 28: Knock Ullinish Souterrain, facing NNE.

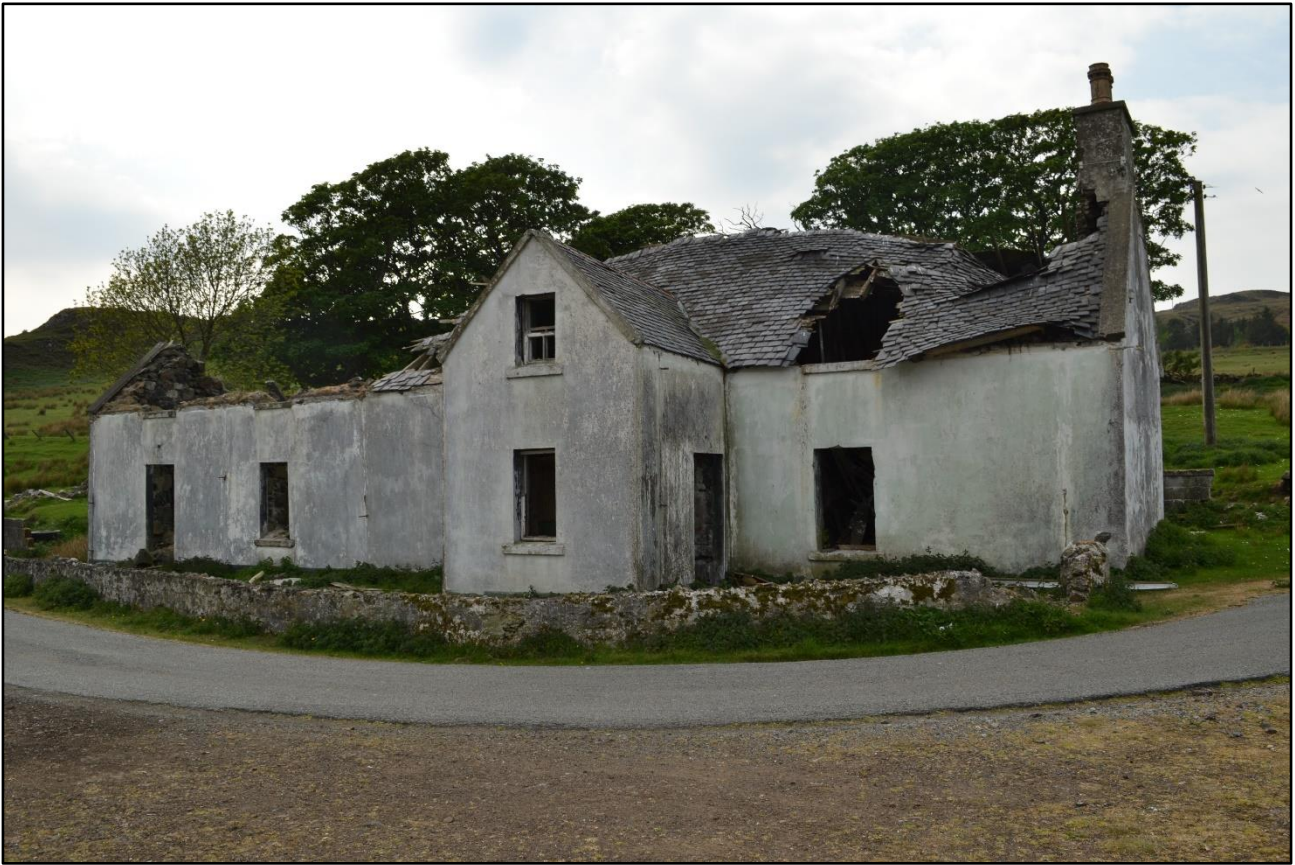
This building is depicted and marked as 'Struan Inn' on both 1st and 2nd edition Ordnance Survey mapping. It is now in a derelict state, and on the Buildings at Risk Register. First noted in poor condition in March 1996, a site visit in September 2010 recorded that the building was no longer weatherproof, and that ceilings had collapsed. A 19th century date is suggested by its present appearance, and it is said to have been built as an inn as it is located close to the shore and fronting roadway leading to a nearby pier. It is not all one build; it is a single storey cottage type building, with attic dormers. This site is a C Listed building.

Plate 29: Struan Inn, facing W.

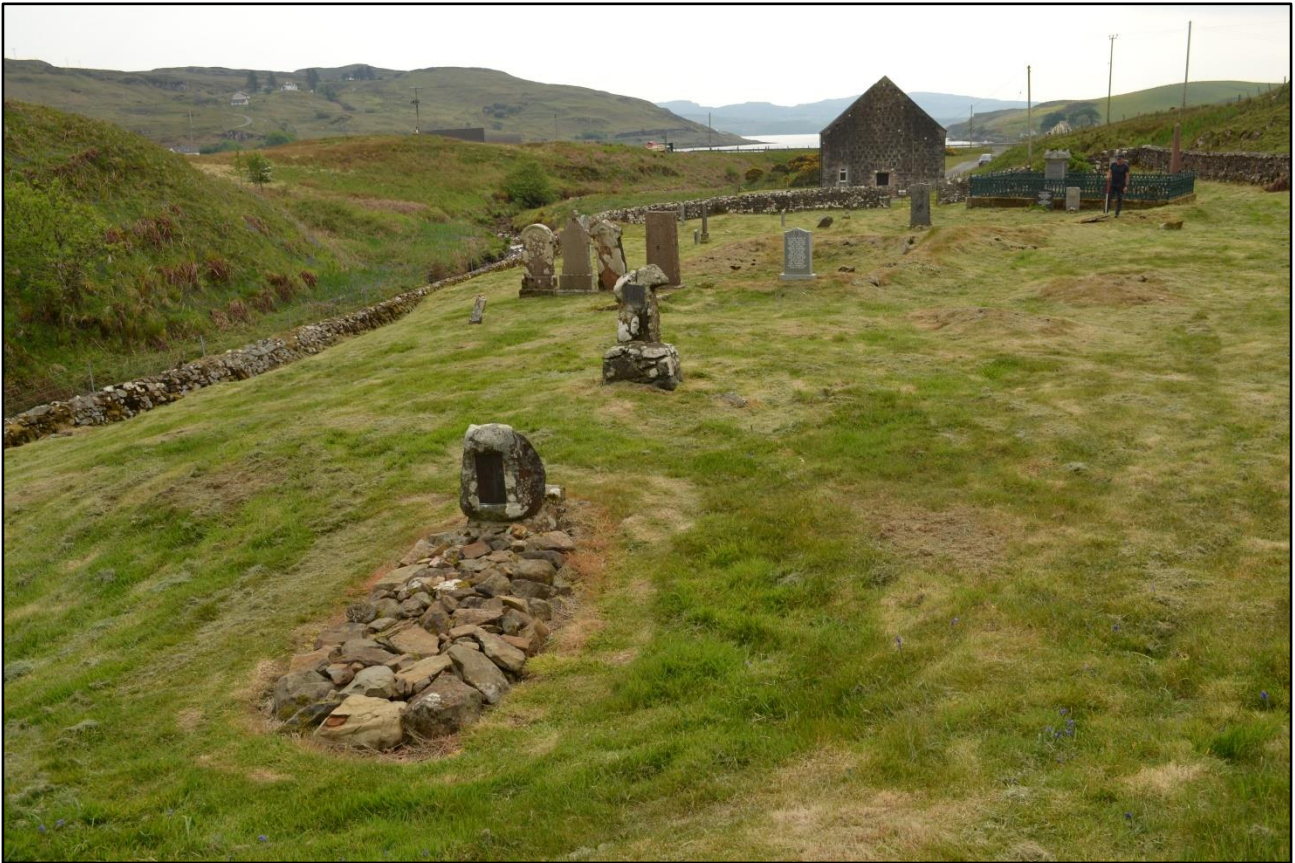
Bracadale Church is still in use but in the old graveyard to the NE, abutting on the side of a small private burial enclosure, there are the remains of turf-covered foundations. The building has been extensively mutilated by graves which now lie both inside and on top of the walling, but its general appearance, plan and orientation suggest that it is almost certainly St. Assind's Chapel. These foundations are easily visible but would require interpretation to enhance the visitor experience. The two grave slabs with a claymore and foliaceous designs carved on them noted in section 3.3.4 could not be seen. The stone that bears in high relief the effigy of a warrior clad in a surcoat was located but it is almost entirely obscured by moss and not easily seen. The gravestones of John Norman Collie and John MacKenzie, both early mountaineers and Cuillin guides, were noted (**Plate 31**). There is potential here for a limited programme of work to better understand the graveyard, including potential to clean some of the gravestones to conserve and record them (using written records and photogrammetry) and potentially relocate the known stones from the area that are not currently visible. This could tie in with work already presented on the website Skye Gravestones (www.skyegravestones.co.uk).

Plate 31: Bracadale graveyard with St Assind's Chapel in the mid-ground, facing SW.
