## Cairnurenan, Mulbuie, Muir of Ord

### Archaeological Watching Brief 2021

### Data Structure Report (DSR)

### Archaeological Watching Brief Project 2021

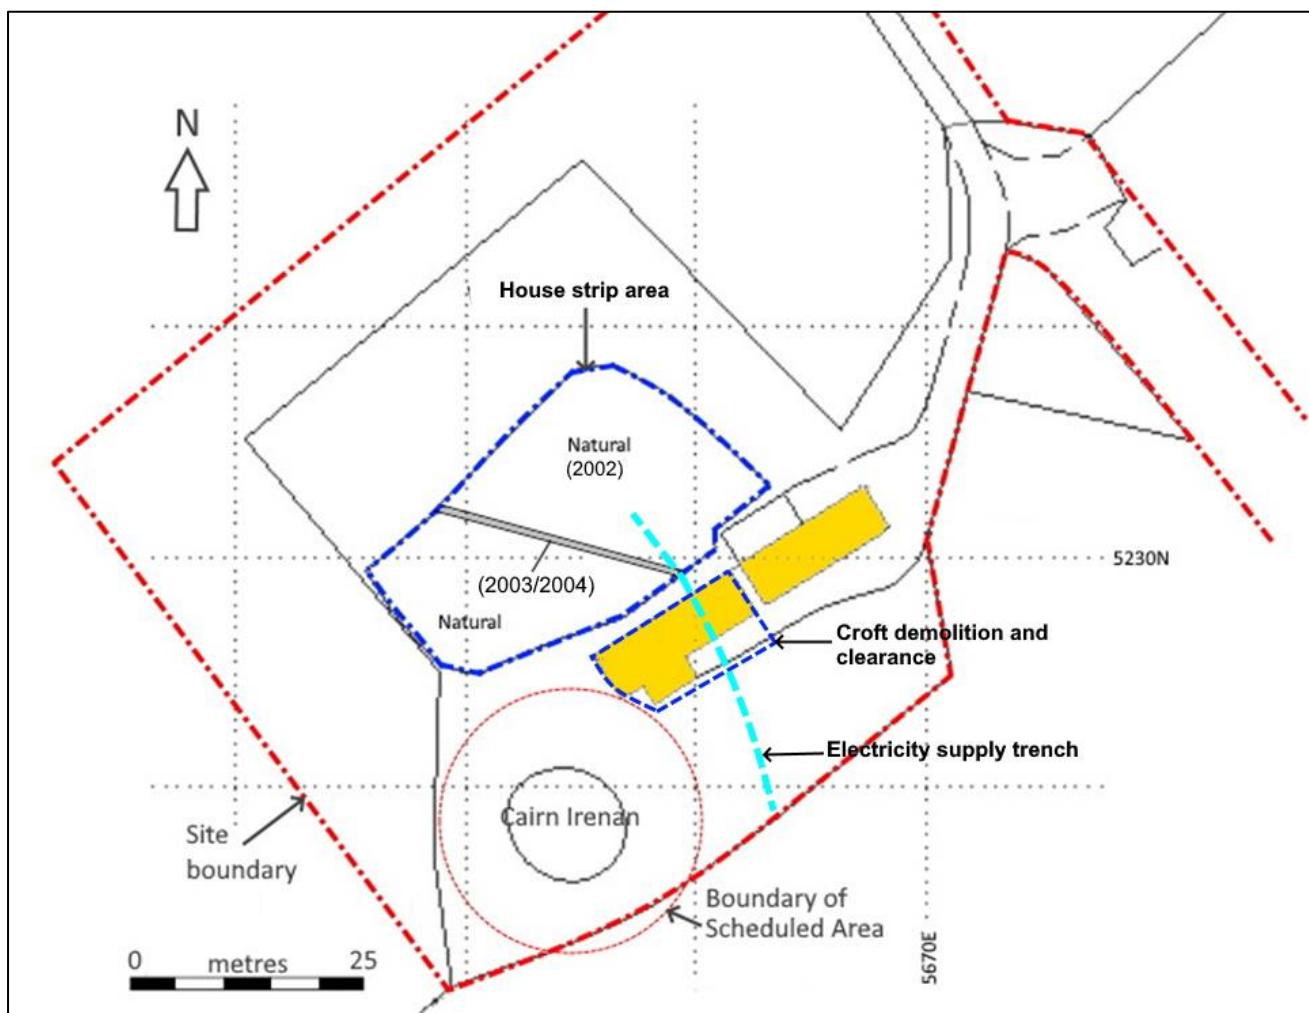
Figure 4 - Site plan showing watching brief areas at Cairnurenan. Scale shown

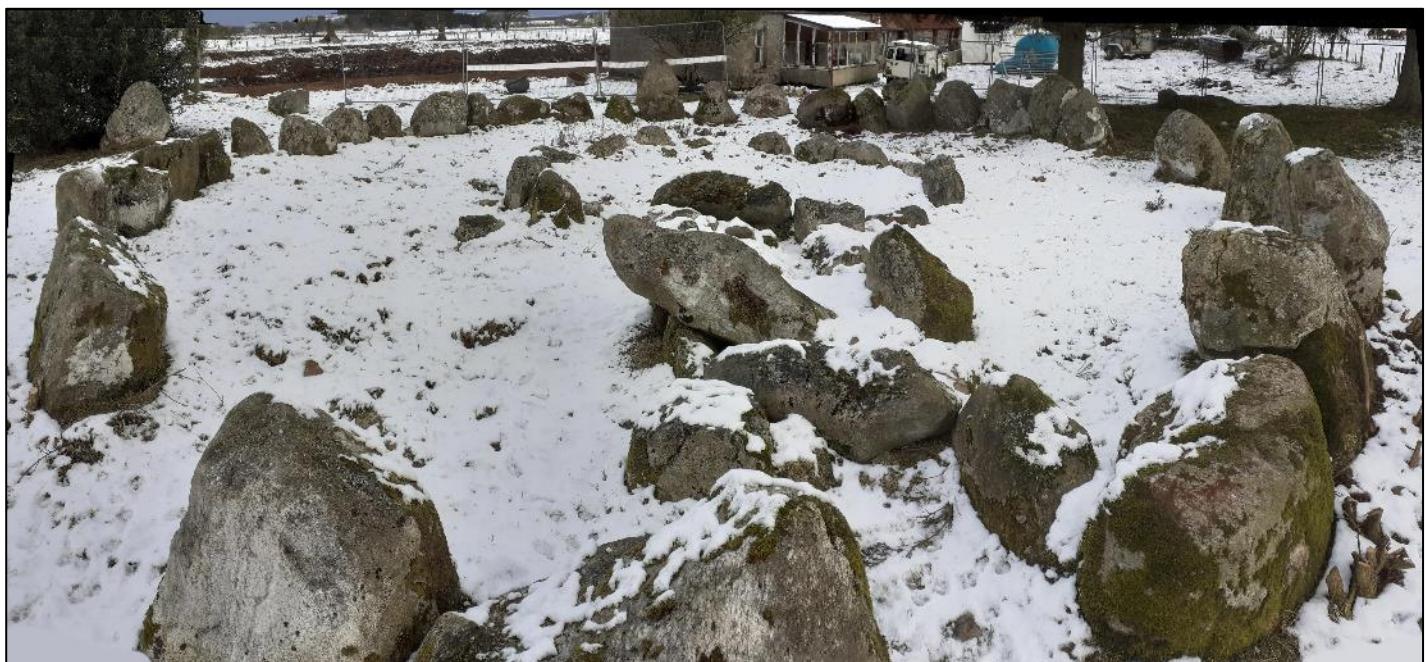
In January 2021, at the time of the watching brief, the Cairn Irenan Scheduled Monument had been cleared of gorse bushes and vegetation with the agreement of Historic Environment Scotland (HES).

The clearance work has allowed a far more complete and coherent view of the megalithic monument (see Figure 5 below).

Figure 5 - Cairn Irenan viewed from the S in January 2021 after the clearance of vegetation, showing the stones of the inner and outer kerbs and the kerb of the passage-chamber entrance. Wide angle image facing N

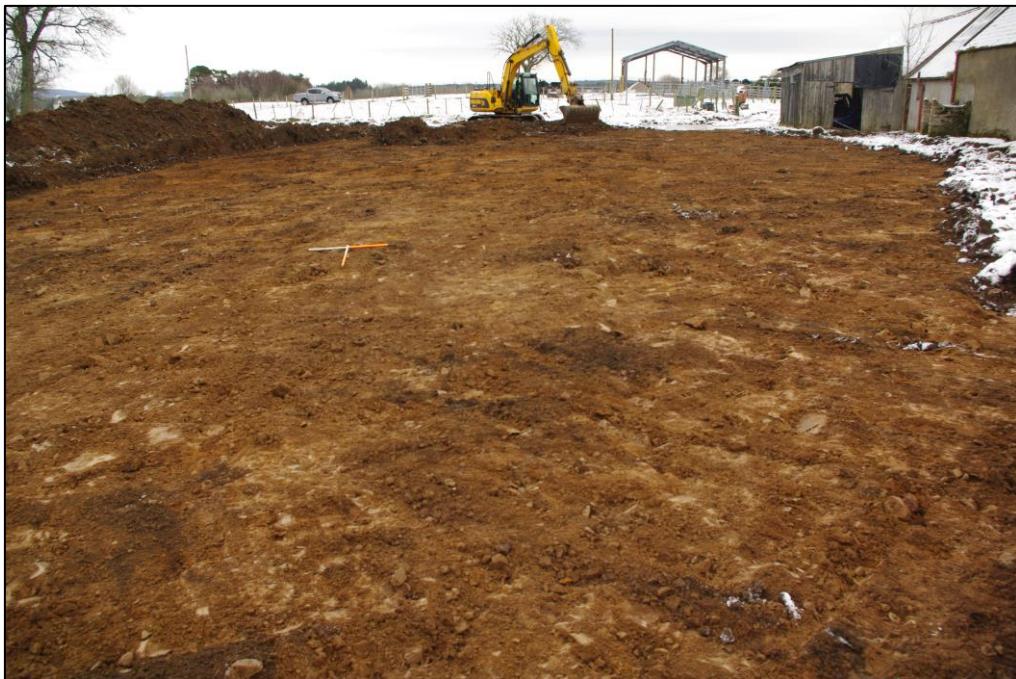
Topsoil stripping was undertaken using a toothless grading bucket across the area of the new house (Figure 4), a part of the site that was previously evaluated by Trenches 8, 9 and 11.

Figure 6 - The area of the new building after topsoil stripping. Facing NE. Scales 1m

Topsoil stripping across the area of the new house failed to reveal any significant archaeological deposits, features or finds of any type.

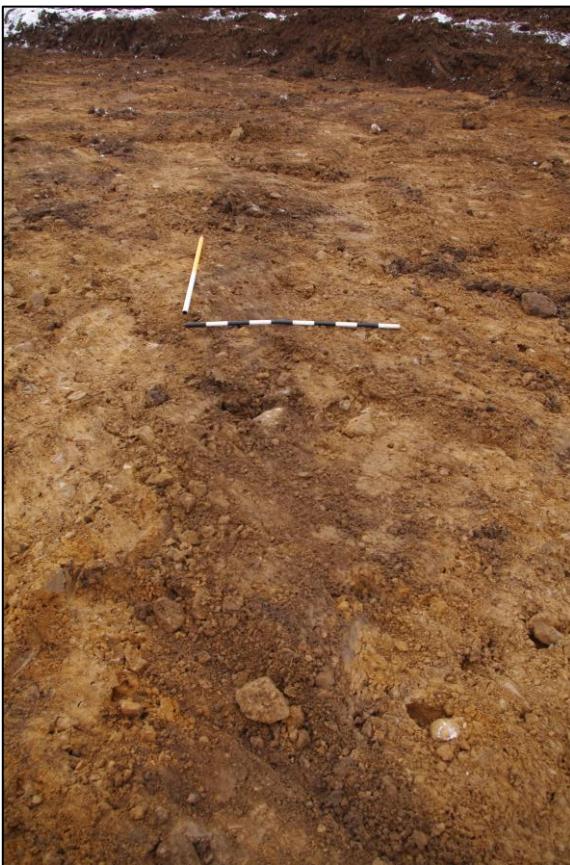
The clearance (Figure 7) revealed a uniform sequence of deposits restricted to mixed topsoil (2001) that directly overlay the natural gravelly substrate (2002). The topsoil varied in depth between 250mm and 450mm and overlay a single narrow cut linear soil feature (Figure 8: contexts 2003/2004) orientated NW to SE. The feature was recognised as the outfall pipe for Croft's septic tank, which was recorded during the preceding evaluation trenching stage as feature (803). The feature (2003/2004) was linear, up to 600 mm wide and contained occasional fragments of modern ceramic roof tile, brick and fragments of plastic.

Figure 7 – The modern septic tank pipe trench and fill (2003/2004) as revealed. Facing NW. Scales 1m

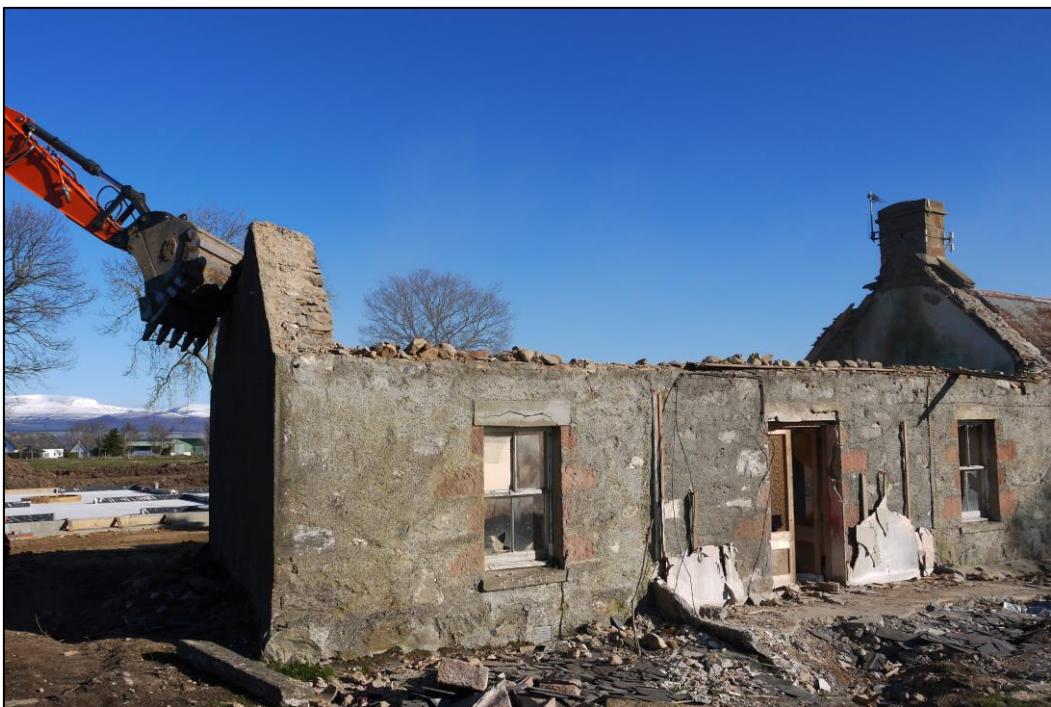
Removal of the roof structure by machine left the shell walls of the building as an unstable structure (Figure 9). These were then reduced to ground level by machine during which it was noted that the fabric of each of the four walls, in places up to 700mm wide, was bonded with an extremely friable and loose sandy silt soil that contained sparse fragments of lime-based mortar.

Figure 8 – Demolition of the croft building after removal of the roof structure. Facing N

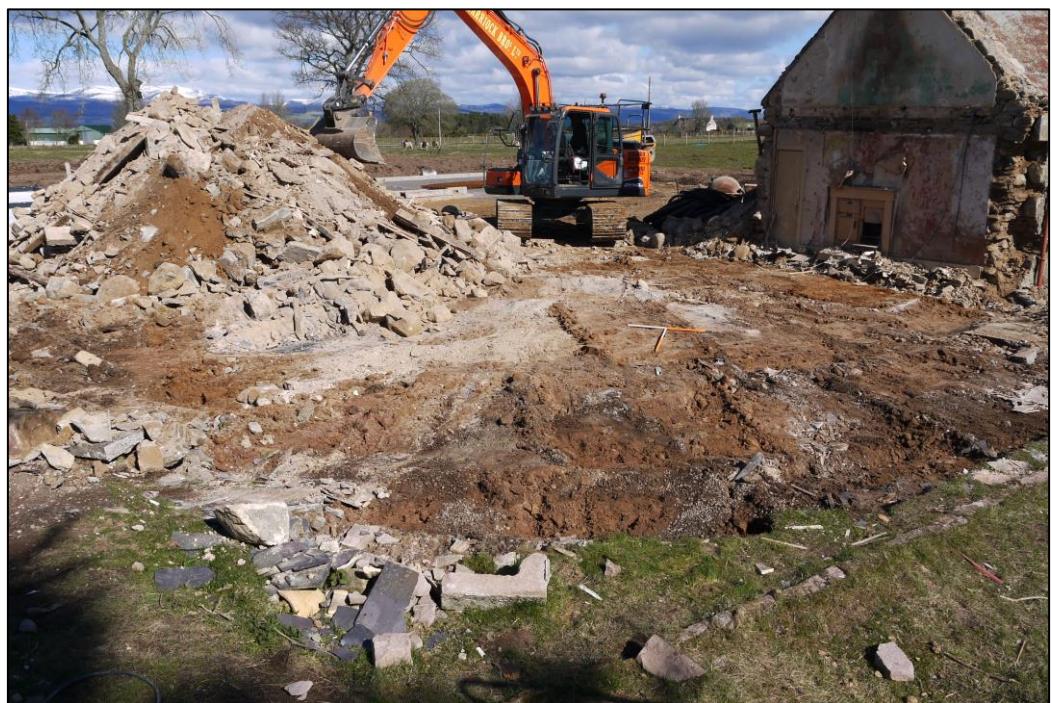
The final clearance of the building footprint at ground level was undertaken using a toothless grading bucket during which particular care was taken to ensure that any soil features or larger boulders built into the foundations were inspected. In the event no soil features or substantial boulders were present and throughout the footprint of the building the remnant stone that formed the walls and the remains of a suspended internal wooden floor overlay patches of weathered Marl bedrock and sandy silt gravel substrate (205), all of which was natural. Each of the croft walls had been built directly over the natural substrate and no excavated footings were present.

No archaeologically significant deposits, features or finds were revealed during the course of the demolition and clearance work.

Figure 9 – Final ground level clearance of the croft building in progress. Facing N. Scales 1m

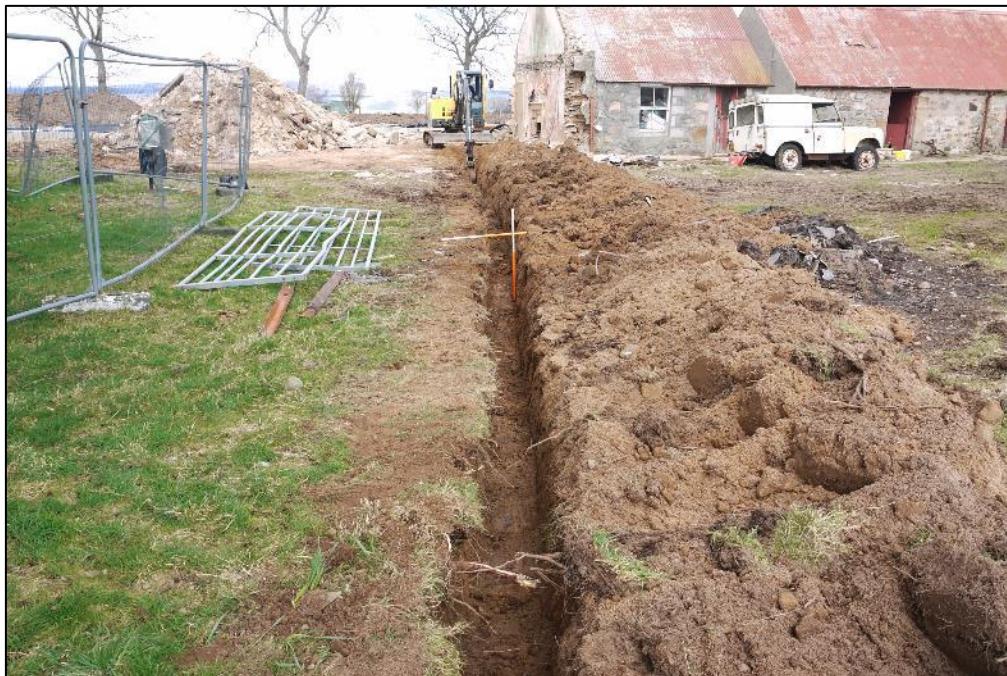
The trench was excavated by machine from the site boundary to join the position of the new house (Figure 4). The cutting was up to 600mm wide and between 750mm and 900mm deep and crossed the footprint of the former croft building after it had been demolished and cleared (Figure 10).

The trench revealed a uniform sequence of deposit consisting of up to 350mm of sandy silt topsoil (2006) that overlay up to 450mm of gravelly sandy silt (2007), which in turn overlay weathered marl bedrock (2008) in the base of the trench.

The cutting did not reveal any significant buried archaeological deposits, features or finds.

Figure 10 – The electricity supply trench during excavation. Facing N. Scales 1m
