Modified Transmission Infrastructure for  
Telford, Stevenson and MacColl Wind Farms

## Technical Appendix 3.2 A

Hydrology, Geology and  
Hydrogeology

This document was produced by Arup on behalf of Moray Offshore Renewables Ltd

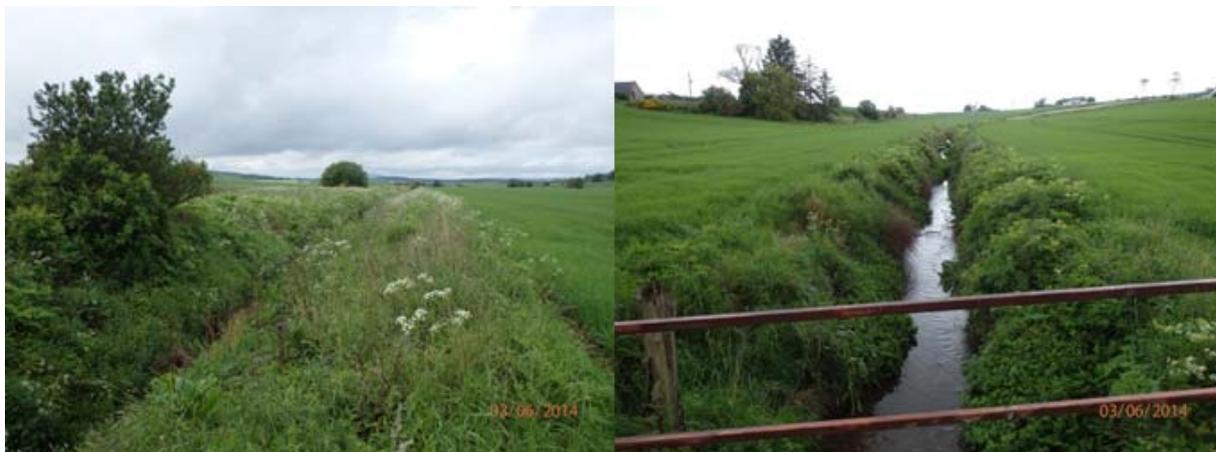
Based on the site inspection, the majority of the watercourses –especially the smaller ones– have some degree of channelisation. Since the land is mainly dedicated to crop production and grazing the channels are commonly straightened and productive land pushed to the edge of the banks. Raised embankments commonly bound the channels, which are generally incised. There is evidence of bank toe undercutting in numerous locations and many watercourses have very steep banks, which were covered in dense vegetation (high grass and bush) at the time of the visit (June 2014) (Photo 1).

**Photograph 1 – Examples of channelised watercourses. Left: Boyndie Burn next to Mill of Blairshinnoch. Right: Burn of Fortrie at Milltack.**

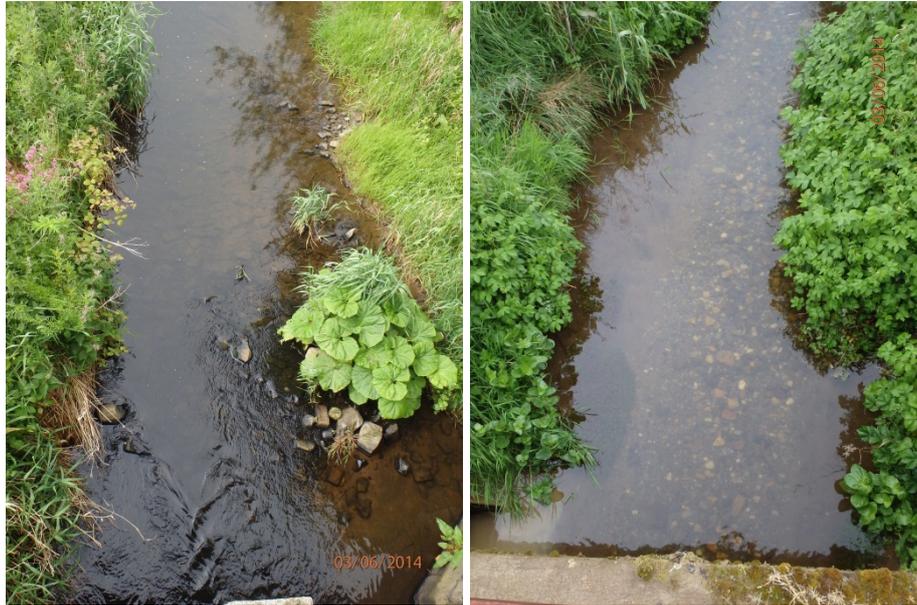
The river bed material is generally gravel (Photo 2), often covered by fine particles, most common in smaller watercourses and drains (Photo 2 Left). These fines are also found attached to macrophytes (e.g. algae) on the bed, colouring the bed a brown tone (Photo 3).

Photograph 2 – Examples of river bed material. Left: Boyndie Burn at Boyndie Bridge, shortly before Boyndie Bay. Right: Burn of Fortie north-east of King Edward. Note the gravel bed covered with fines.

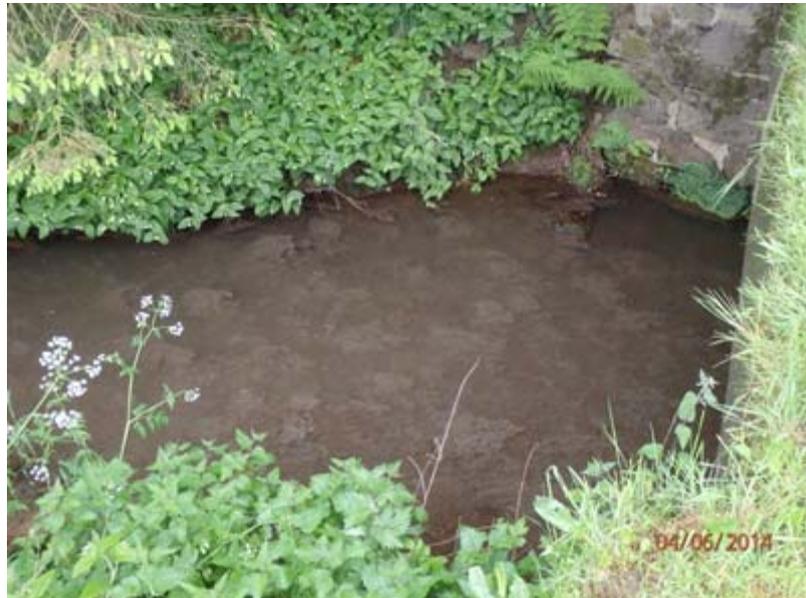
Photograph 3 – Craigston Burn approximately 1km downstream of Craigston Castle. Note the very fine particles attached to the macrophytes.

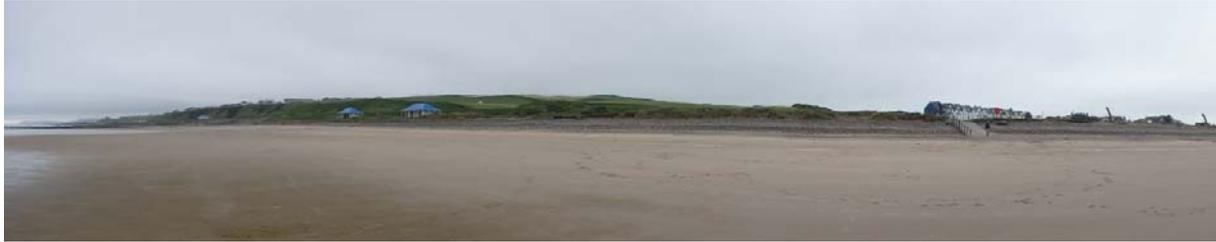
The landfall point at Boyndie Bay has a sandy beach, with the Boyndie Burn cutting through it. High vegetated sand dunes are found at the back of the beach (Photo 4).

**Photograph 4 – Boyndie Beach. Boyndie Burn discharges to the right of the image. Note the dunes in the background.**

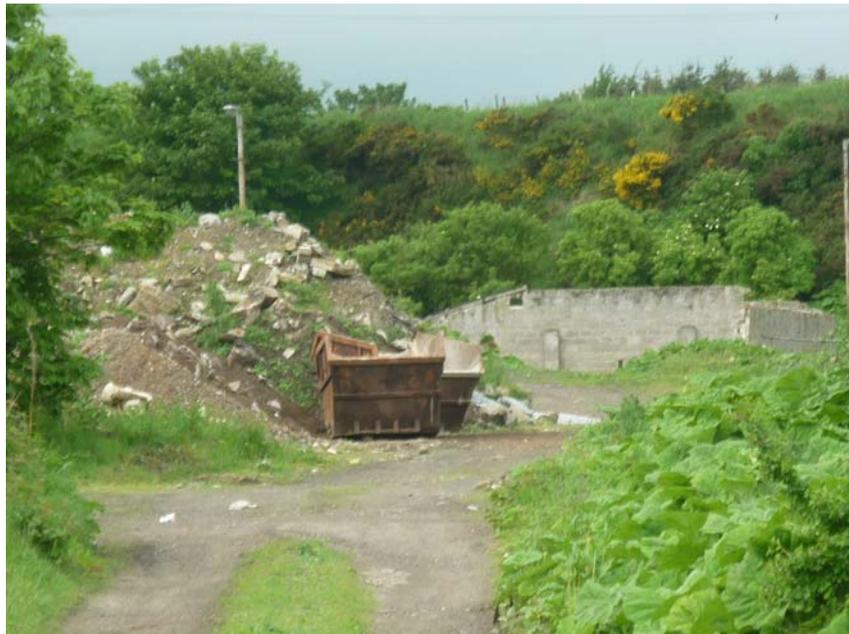
Photograph 5: Demolition rubble at Inverboyndie

- Possible contaminated land site at Inverboyndie, demolished buildings, made ground/ possible inert rubble;
- Southern end of route is a disused quarry at Swanford Farm, with evidence of rubble and scrap metal;
- Burnside Farm, disused farmyard;
- Hill of Cotburn, motorcross track and caravan site , evidence of fuel containers;
- A large quarry to the west of South of Gorrachie; and
- Paddocklaw Farm, pig farm.

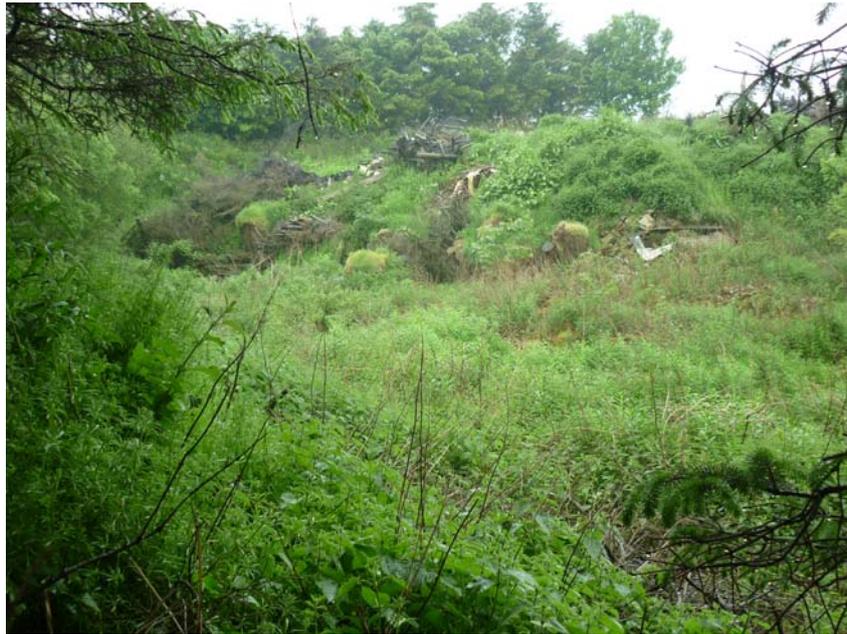
Photograph 6: Swanford Farm, with evidence of made ground / rubble and scrap metal

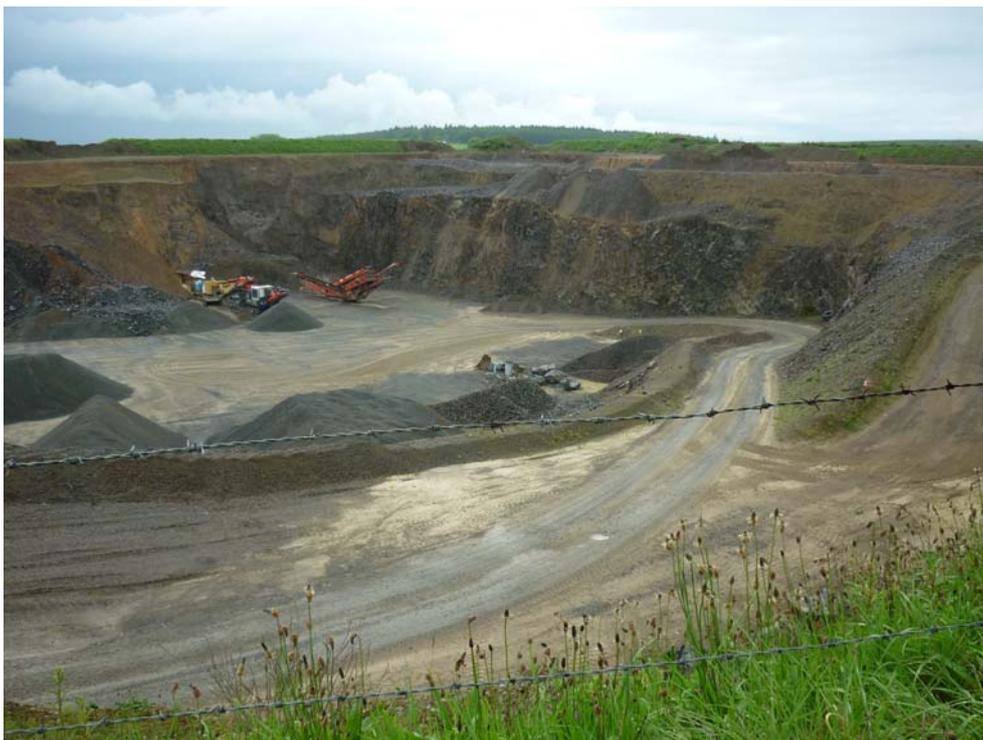
Photograph 7: Quarry near South Gorrachie
