## **Project Experience**

**Project:** Bollards in lock Zandkreeksluis.

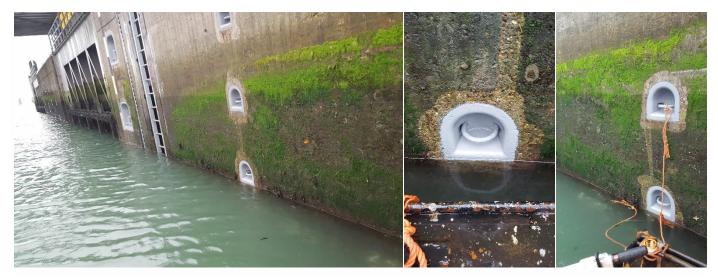
Cast iron bollards at the Dutch lock Zandkreeksluis needed maintenance due to the corrosion generated which damaged the areas between the concrete and the iron. One of the bigger restrictions is the moment for the coating application: only one door could be closed and thus only in between tidal zones could be painted. For the bollards located at the upper rows was not a problem as they had enough time to dry before immersion. But the 2 lowest rows are subject to immersion within 1 hour. To apply the full system on these lowest rows they had to paint the first layers, let the tide immerse the fresh paint and next low tide the next layers could be applied.

After a year later the coating and bollards are in perfect condition and this is a big success taking in consideration that cast iron is very porous, there only could be a minimal surface preparation and not to avoid is that in the deep pitting and porosity in there is oil form the mooring ships that floats on the water and with every tide during the years penetrated in this porosity.

SSPC SP12 Low pressure water cleaning maximal 70 Bar. SSPC SP2 and SP3 Hand and Power Tool cleaning.

MCU-ALUPRIME 30 μm DFT (penetration)

MCU-ZINC 100 μm DFT
MCU-MIOMASTIC 75 μm DFT
MCU-MIOTOPCOAT 75 μm DFT

Abrasive blast was impossible due to the risk of weakened steel and the content of alcohol. A mild surface prep was executed to avoid risks. Due to the minimal preparation with residues of fixed corrosion, deep pitting and some mil scale, as also the humidity of the water preparation.

MCU Coatings was the only safe choice to obtain best results long term. Our MCU primers penetrates deep in the porosity and glue all corrosion. Beside of this, our coatings will react with the water, trapped in the porosity of the surface, corrosion and pitting, resulting in absence of moisture in the porosity and avoiding thus further corrosion.
