**Norton Bury Farm – Excavations for the Time
Team Big Dig 28/29 June 2003**

Report compiled for Mrs Ruth Baker by Neil Rushton

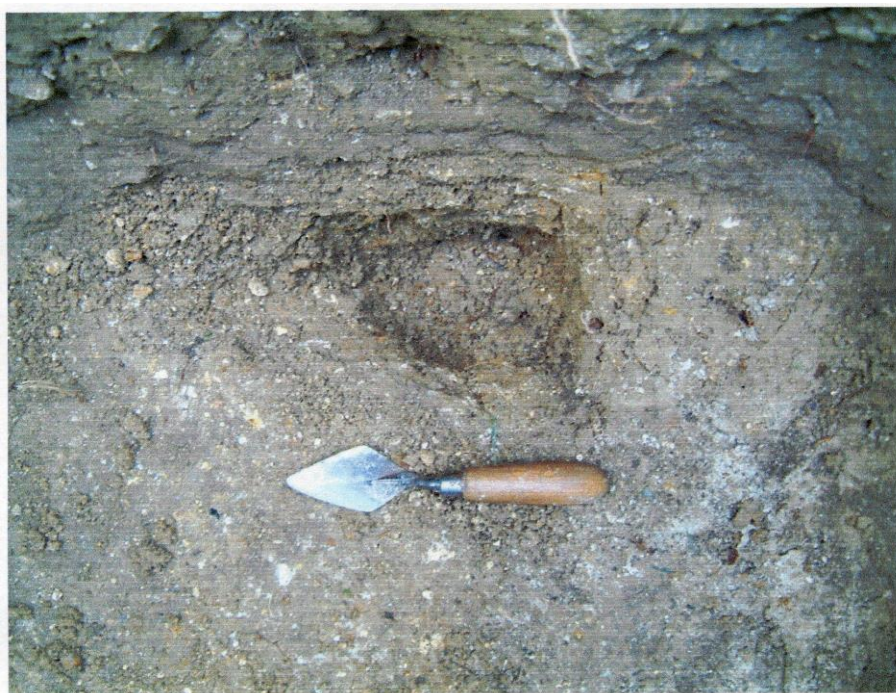
Plate 3: Post Hole in Trench 1, close up

Trench 1 (figure 4 and plates 2-4): The main features of trench 1 were a demolished tile floor and a post hole. The tile floor was located between 25cm and 30cm into the trench. It consisted of an abundance of broken unpatterned, red-clay floor tiles with a thin seam of mortar underneath. The tiles spread over the whole N-side of the trench but were less prominent on the S-side. All tiles were severely damaged but were significantly different than the broken roof tiles found at a depth between 10cm and 20cm. Below this level there was disturbed clay with more broken tiles with some brick and pottery. At a depth of 64cm was a post hole cut into the natural chalk on the W-side of the trench, partly obscured by the baulk. This was roughly circular, had a diameter of about 23cm and consisted of a yellow/orange clay material with abundant stones. This post hole was excavated and found to be of a

depth of 18cm. Unfortunately there were no finds from the excavated post hole. The post hole showed up well in the plan photographs and the broken tile floor can be seen in the S-facing section.

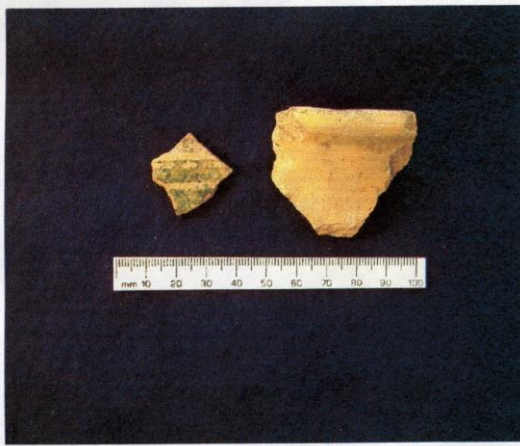
Plate 10: medieval pottery

The floor tiles and roof tiles from both trenches are not precisely datable, but the two pieces of late medieval green-glazed ware found in context 3 of trench 1 were directly underneath the demolished floor and so suggest a date of the late fifteenth century or the sixteenth century for the floor's final use. Trench 2 contained much nineteenth-century pottery in context 1 and also one piece of eighteenth-century brown-glazed ware. The charcoal fragments and oyster shells from trench 1 also suggest occupation of the site. (Plates 6-11 show a selection of the finds from trenches 1 and 2).

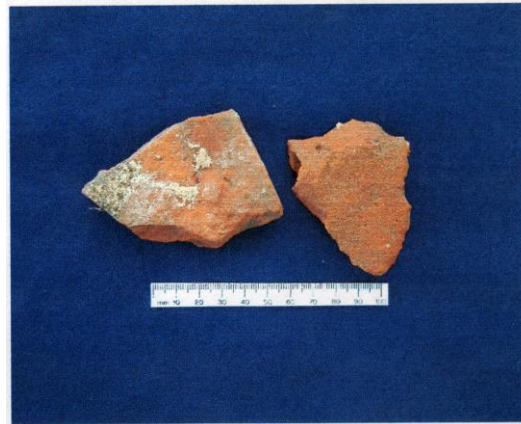
Plate 11: floor tile
