Procedures and Problems of Highway Soils Engineering on Loessial Terrain in Alaska

L. L. MORRISON, Engineering Geologist, Alaska Department of Highways

This paper describes current procedures used in performing soils investigations and developing design recommendations for highways on loessial terrain. It explains investigation procedures from the reconnaissance phase through the most detailed study and discusses the occurrence and character of Alaskan loess relative to surface transportation routes. Design practices are outlined and their relative success is described using examples from the Fairbanks area.

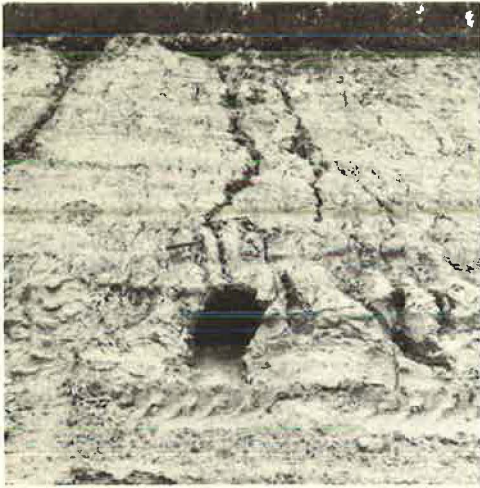
Figure 3. Moderate gullying.

Some degree of gulying was found on all slopes of 1963 and 1964 vintage. When the top of the backslope was nearly at the crest of a ridge, gulying was minor as the amount of runoff was then limited. Moderate gulying developed in areas where an expanse of hillside above the backslope allowed accumulation of a significant amount of runoff. Severe gulying developed only at those locations where runoff was concentrated above the backslope. This occurred at natural drainage paths and at places where the backslope intercepted old access roads or other cleared areas. Gullies,

pitlike in profile, up to 12 ft deep were observed in 1963 vintage slopes at these points. Illustrations of moderate and severe gullying are shown in Figures 3 and 4.

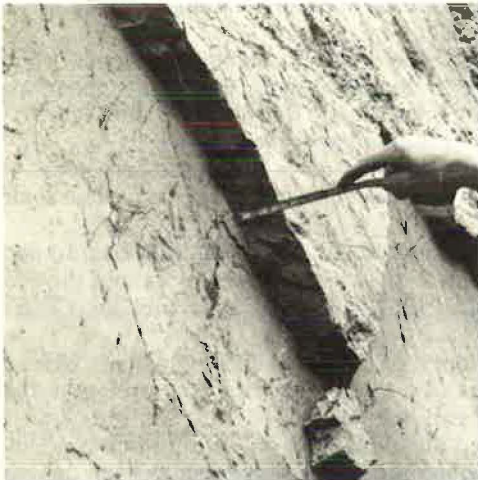
Figure 5. Slabbing of vertical loess backslope.

In loess where the top of the slope was protected the steep slopes have performed very well. In all but the driest areas, however, slabs from about 1 to 4 in. thick separated from the face of the slope (see Fig. 5). This "slabbing" was observed to be more severe in damper material and on the south-facing slopes. It is thought to be a result of the development of planes of weakness due to concentration of moisture by cyclic freezing and thawing. In some places irregular chunks of material have fallen out of the backslope (see Fig. 6). The occurrence of these features could not be correlated with moisture content, slope exposure or material variation. They are apparently caused by the intersection of joints (probably contraction cracks) a short distance behind the face of the slope.

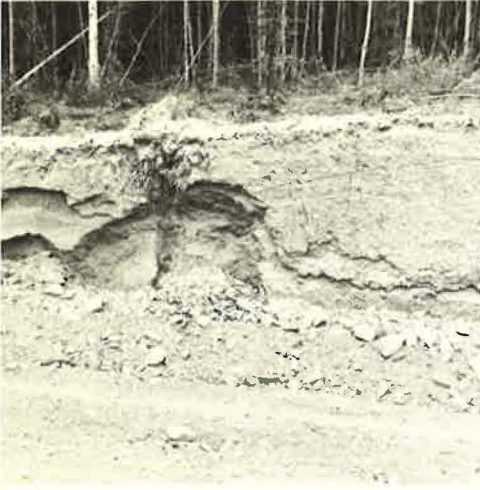
Figure 7. Erosion of vertical loess backslope due to runoff concentration.

slope or where runoff was concentrated to some degree. Figure 7 shows a case where a small berm oriented approximately transverse to the roadway concentrated water and forced it over the face of the slope. Retransported silt occurs only in swales (where drainage could concentrate); so it was always eroded. In general, the erosion seemed to stop when a projecting "roof" of organic material had formed.
