COLLUVIUM AND TALUS

1. INTRODUCTION

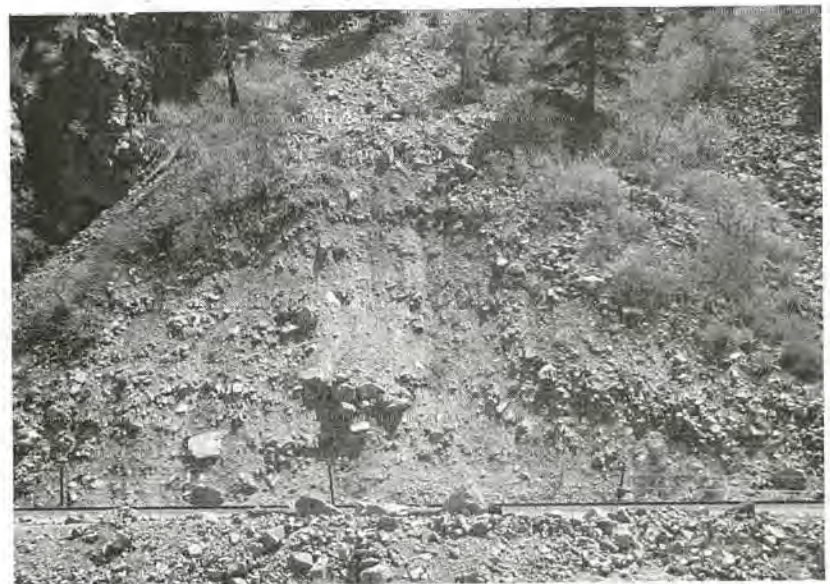
FIGURE 20-1
Colluvial slope along
Denver and Rio
Grande Western
Railroad, Glenwood
Canyon, Colorado.
J.D. HIGGINS, COLORADO
SCHOOL OF MINES, GOLDEN,
COLORADO

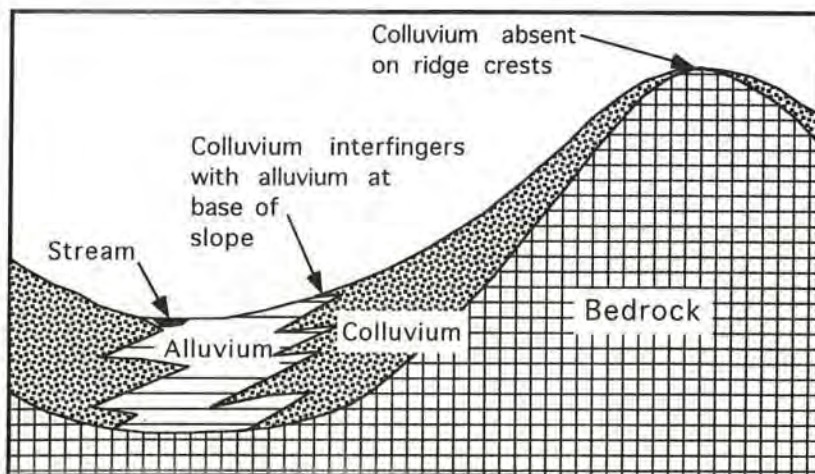
FIGURE 20-2
Idealized cross
section of colluvial
deposit.

Typically, colluvium is a poorly sorted mixture of angular rock fragments and fine-grained materials. These deposits rarely are more than 8 to 10 m thick, and they usually are thinnest near the crest and thickest near the toe of each slope (Figure 20-2).

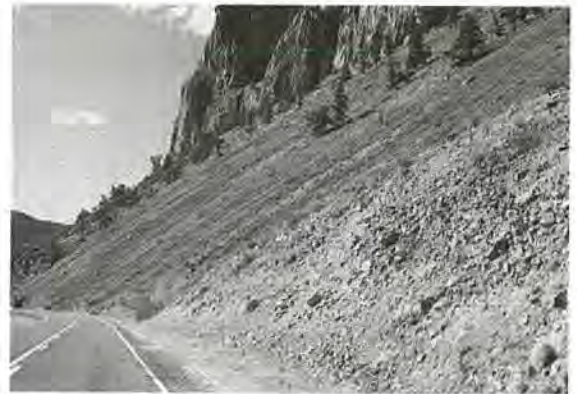
FIGURE 20-3

Talus slope in western Colorado.

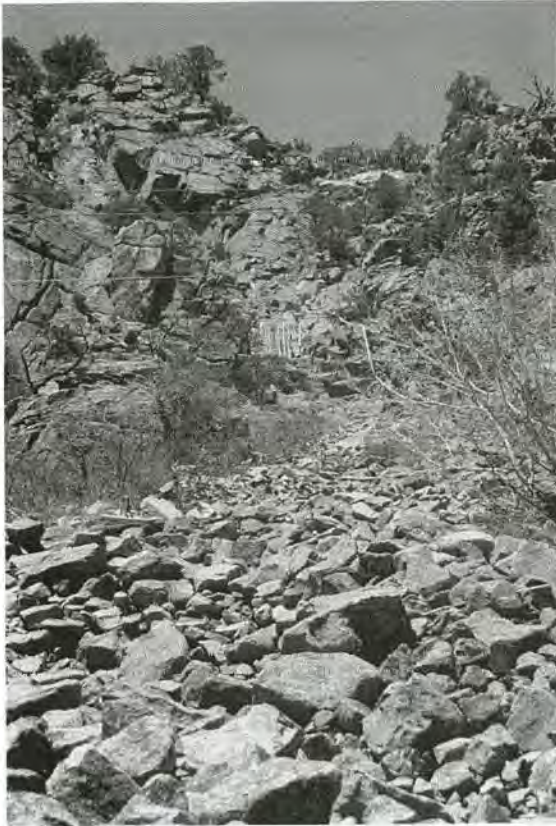
FIGURE 20-4
Rock chute as source of talus, Glenwood Canyon,
Colorado.

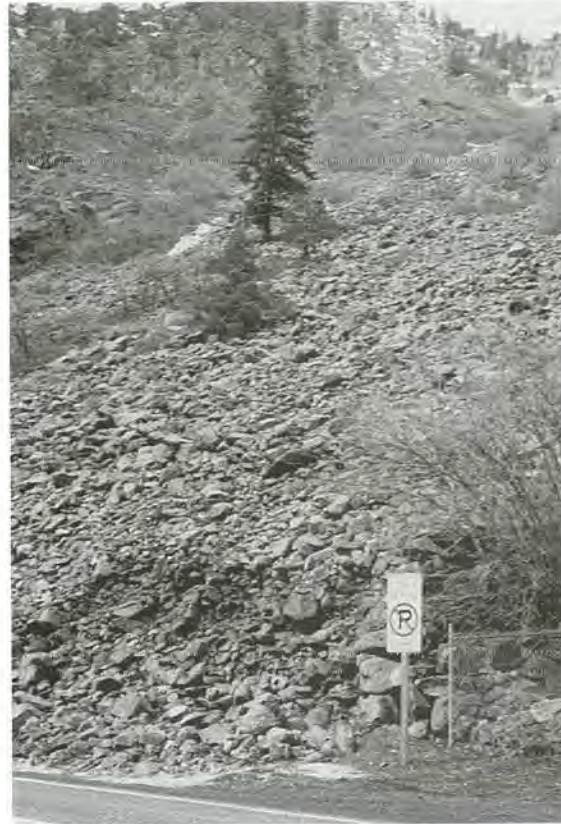
FIGURE 20-5
Talus cone, Glenwood Canyon, Colorado.

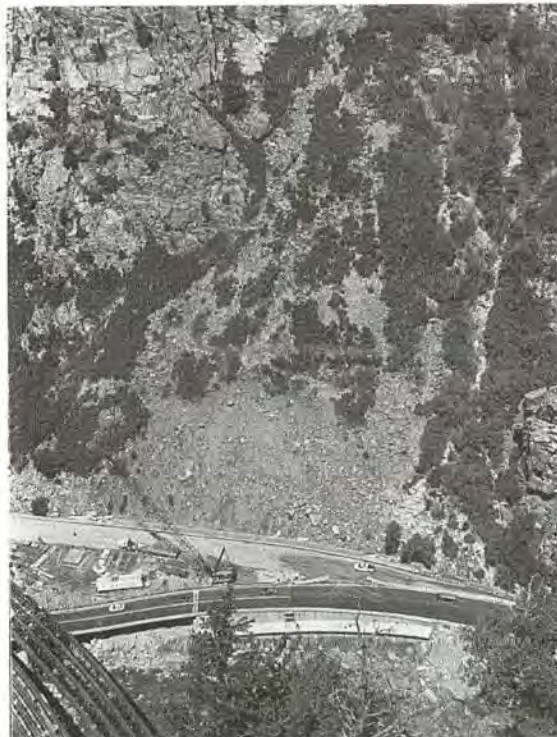
FIGURE 20-6
Multiple overlapping
talus cones forming
complex talus
deposit, Glenwood
Canyon, Colorado.
Construction of
Interstate-70 is
under way at base
of this deposit.

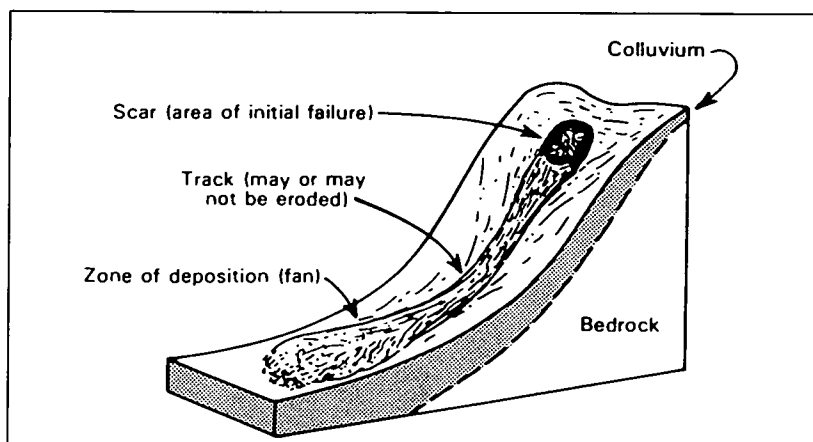
FIGURE 20-7
Principal features of
a soil slide–debris
flow (modified from
Smith 1988).

at the location of the initial slide, a long narrow track leading directly down the hillside formed by the flowage of the liquefied soil and debris, and a zone of deposition in the minor drainage channel at the base of the slope (Figure 20-7). Numerous individual such slides provide large volumes of debris that clog stream channels. Liquefaction of this material causes it to remobilize and produce large and rapidly moving debris flows that destroy lives and property downstream.

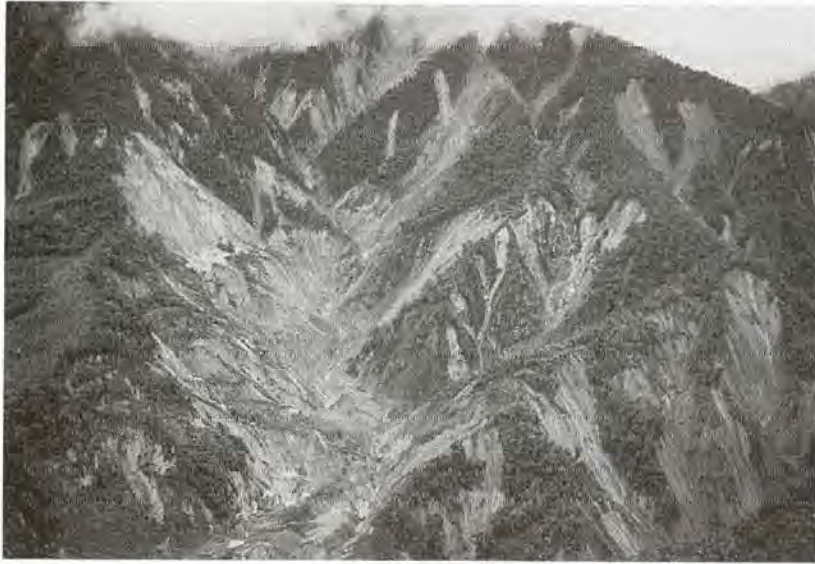
FIGURE 20-8
Thin landslides and debris flows on steep slopes of saturated residual soils at headwaters of San Vicente River, southwestern Colombia, triggered by 1994 Paez earthquake.
R. L. SCHUSTER, U.S. GEOLOGICAL SURVEY

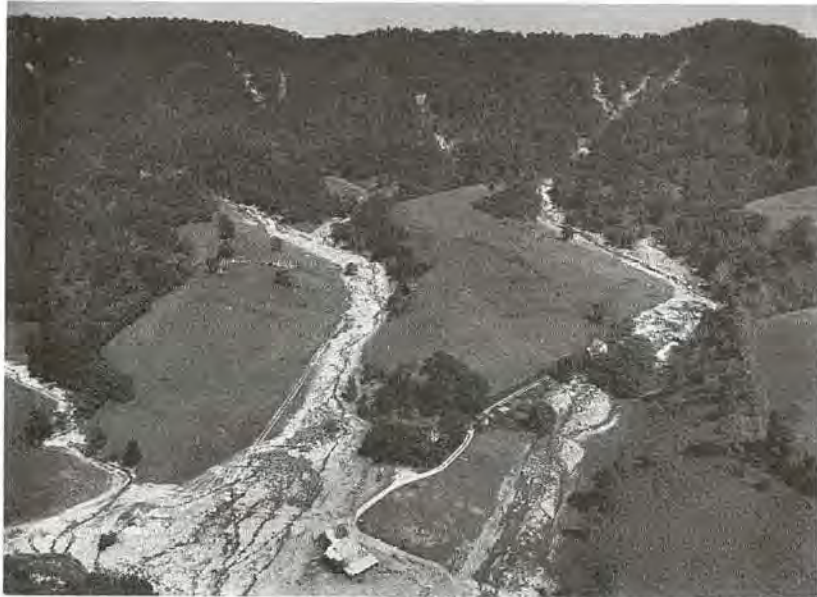
FIGURE 20-9
Debris flows along East Branch of Hat Creek, Virginia, caused by Hurricane Camille in 1969 (Williams and Guy 1973, Figure 14a).

forested natural slopes (Figure 20-9). Most of the 150 people killed by this storm were overwhelmed by these rapidly moving debris flows (Costa and Baker 1981).

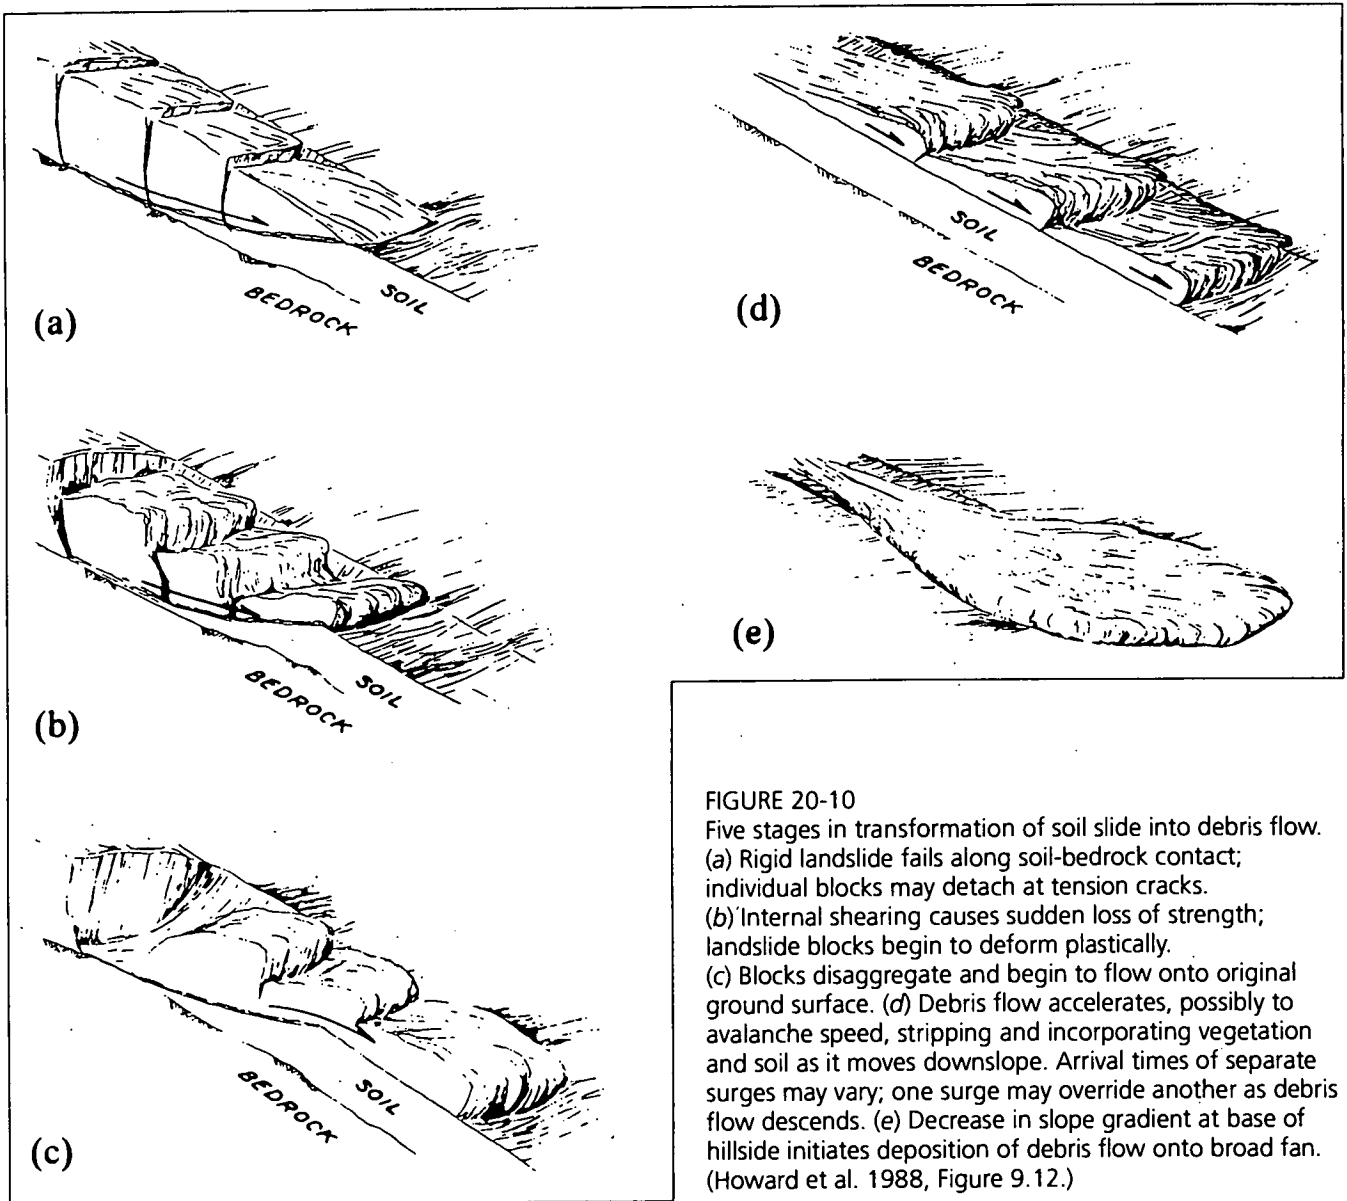
FIGURE 20-10

Five stages in transformation of soil slide into debris flow. (a) Rigid landslide fails along soil-bedrock contact; individual blocks may detach at tension cracks. (b) Internal shearing causes sudden loss of strength; landslide blocks begin to deform plastically. (c) Blocks disaggregate and begin to flow onto original ground surface. (d) Debris flow accelerates, possibly to avalanche speed, stripping and incorporating vegetation and soil as it moves downslope. Arrival times of separate surges may vary; one surge may override another as debris flow descends. (e) Decrease in slope gradient at base of hillside initiates deposition of debris flow onto broad fan. (Howard et al. 1988, Figure 9.12.)

Howard et al. (1988) defined the transformation of an initially rigid sliding soil mass into a debris flow as consisting of five stages (Figure 20-10). The first stage [Figure 20-10(a)] occurs as the colluvium slides along, or just above, the soil-bedrock contact. The sliding process is controlled by tension cracks in the colluvium and by high pore-water pressures caused by a permeability contrast between soil and bedrock. With continued movement, the second stage [Figure 20-10(b)] evolves as internal shearing causes a reduction in strength

of the colluvium. Increasing levels of plastic deformation result (Johnson and Rahn 1970; Campbell 1975). Shearing causes dilation of the soil mass. Water from tension cracks is drawn into the dilating mass, further weakening and disaggregating the soil material. In stage three, the soil material begins to flow over the ground surface [Figure 20-10(c)]. As the initial mass continues to flow down the slope, it commonly accelerates and incorporates soils and debris, forming, in stage four, a debris flow [Figure 20-10(d)]. At the base of the slope, the decreased gradient causes deposition of the debris in stage five [Figure 20-10(e)].

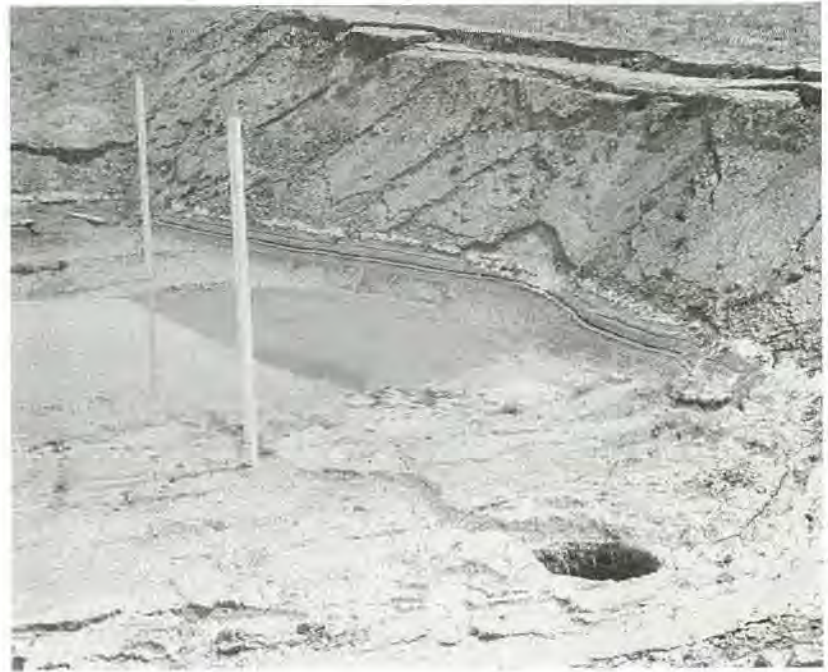
FIGURE 20-13 Results of saturation test on hydrocompactible colluvial soils in western Colorado; land surface has collapsed about 1 m.

rapidly by evaporation and infiltration. The resulting deposits often exhibit a very flocculated or loose soil structure that is stable only as long as it remains dry. Wetting of these soils, such as may be caused by diversion of water from a paved highway surface, will cause the flocculated structure to collapse to a much smaller volume. This collapse may further lead to temporary liquefaction of the soils and their rapid erosion by flowage. These arid colluvial soils are said to be subject to *hydrocompaction*. Hydrocompaction may lower the ground surface by as much as 1 m (Figure 20-13).

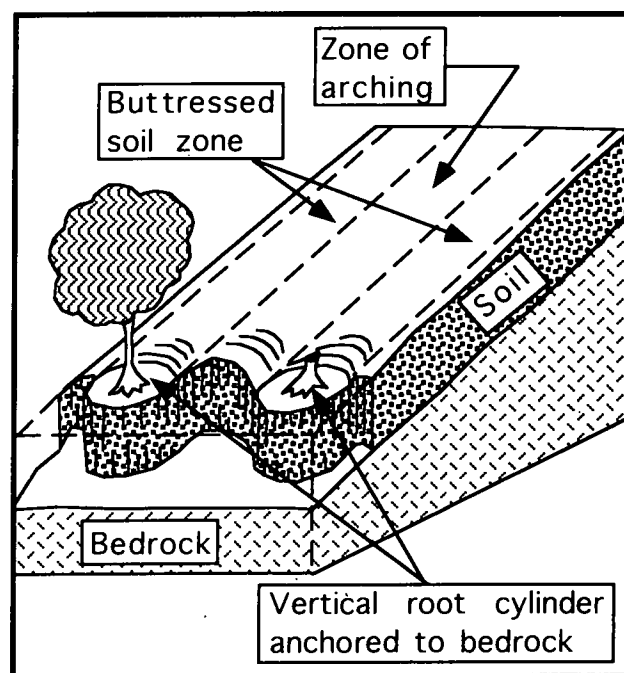
FIGURE 20-16
Schematic diagram showing soil anchoring, buttressing, and arching by trees on colluvial slope (modified from Greenway 1987, Figure 6.23).
REPRINTED WITH PERMISSION OF JOHN WILEY & SONS, LTD.

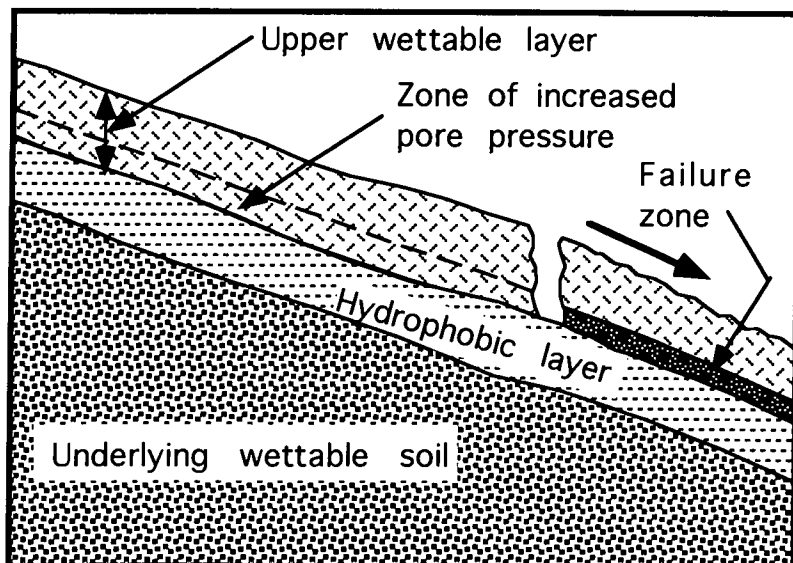
FIGURE 20-17
Schematic diagram of postfire colluvial soil slope, showing effects of hydrophobic soil layer.

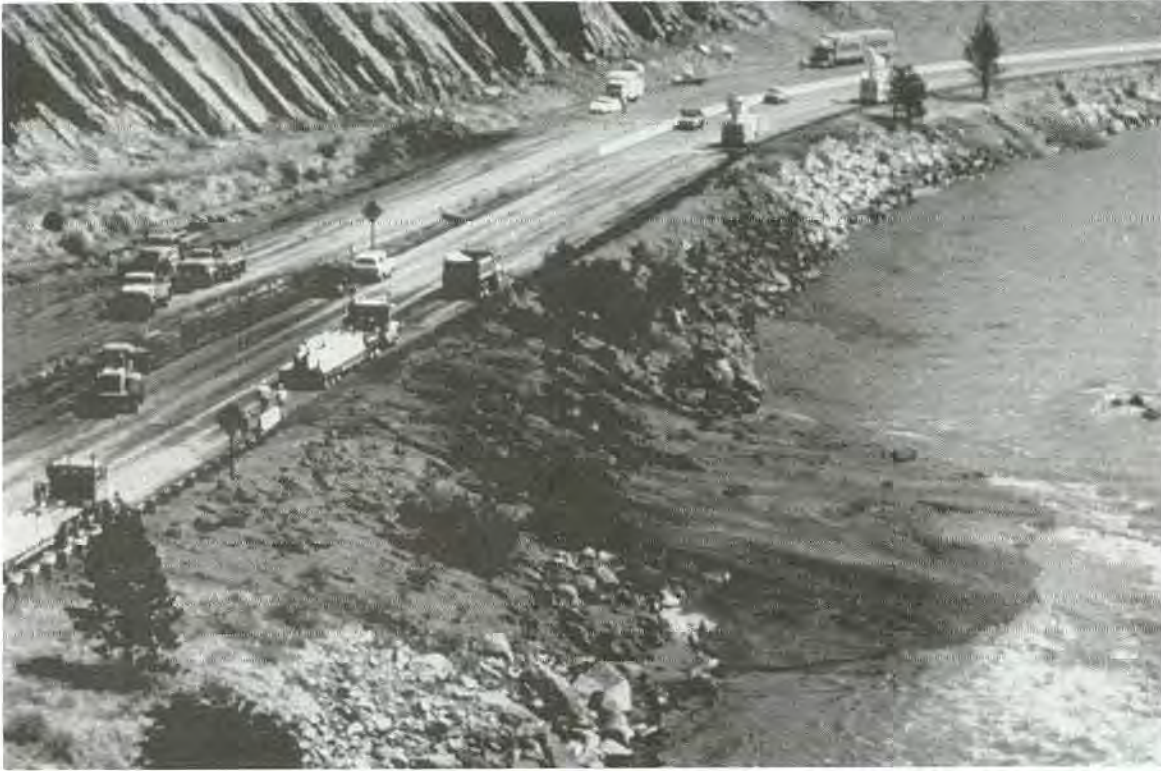
FIGURE 20-18
Cleanup activities
after debris flows
blocked Interstate-70
west of Glenwood
Springs, Colorado.
These debris flows
occurred with first
heavy rains after
large forest fire had
affected slopes
above roadway.
BOB ELDERKIN, BUREAU OF
LAND MANAGEMENT

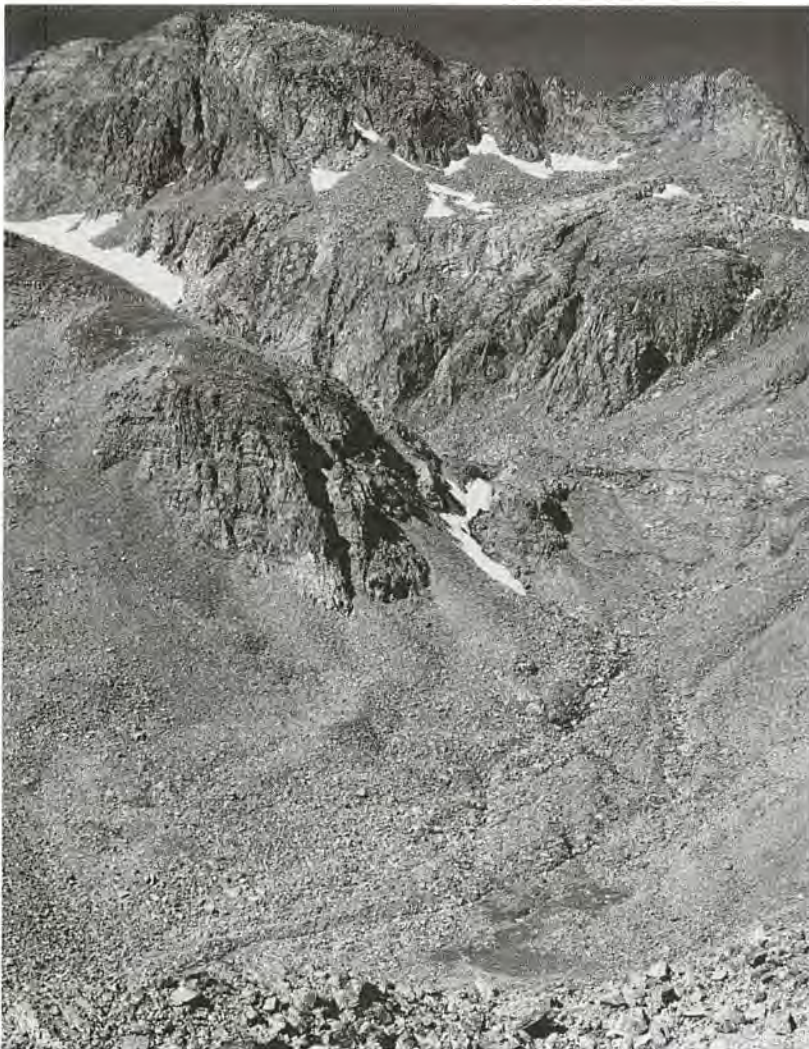
FIGURE 20-19
Extensive and active
talus deposits in
mountainous
region.

Classic examples of massive talus deposits are common in high mountainous regions, where steep slopes, durable bedrock, lack of vegetation, and harsh climate combine to produce abundant rock fragments (Figure 20-19). In these regions movements of talus fragments are frequent and rock-fall hazards are considerable. Fortunately, transportation facilities rarely cross such regions and thus these unstable and hazardous conditions affect them infrequently. However, in regions of relatively high relief, transportation facilities commonly must pass through valleys and canyons in order to find acceptable routes at lower elevations. Talus deposits are commonly encountered along such valley and canyon routes (Figures 20-20 and 20-21).

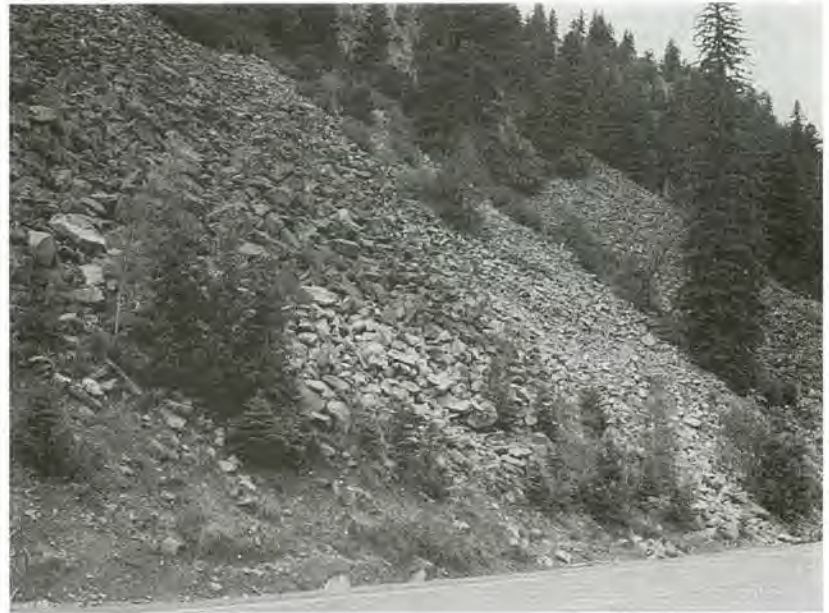
FIGURE 20-20
Typical talus deposit along road in valley.
R.D. ANDREW, COLORADO DEPARTMENT OF TRANSPORTATION

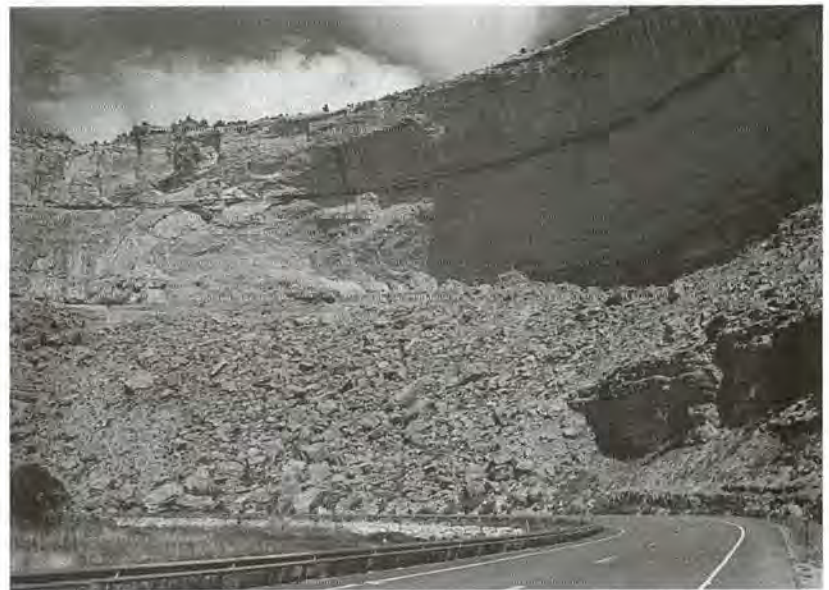
FIGURE 20-21
Talus deposit in canyon setting, western Colorado.
R.D. ANDREW, COLORADO DEPARTMENT OF TRANSPORTATION

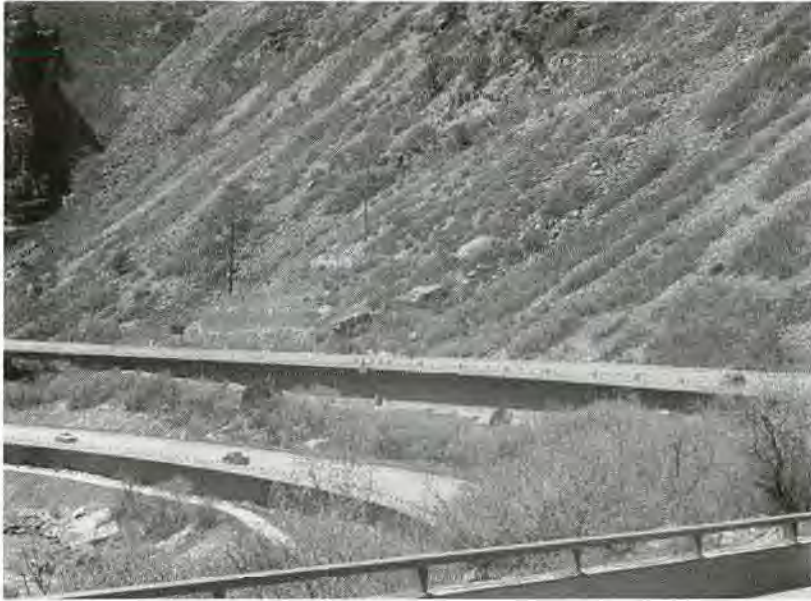
FIGURE 20-22 Completed Interstate-70 crossing extensive talus, Glenwood Canyon, Colorado.

The recent construction of Interstate-70 (I-70) through Glenwood Canyon in the state of Colorado encountered extensive talus deposits, and the experiences gained there have considerably enhanced the knowledge of geotechnical characteristics of talus and appropriate construction procedures where talus is encountered. Glenwood Canyon was eroded through a series of sedimentary and igneous rocks by the Colorado River. It reaches a depth of more than 1000 m and is characterized by steep slopes and cliffs, with extensive colluvium and talus deposits at their bases. The canyon provides an important low-gradient east-west route through an otherwise rugged plateau region. A railroad and an existing highway shared the narrow canyon bottom with the Colorado River. The scenic nature of the canyon raised environmental concerns that required the new four-lane Interstate highway to be constructed in such a way as to minimize impacts on canyon features. As a consequence, major roadway structures traverse and are founded on extensive talus slopes (Figure 20-22).

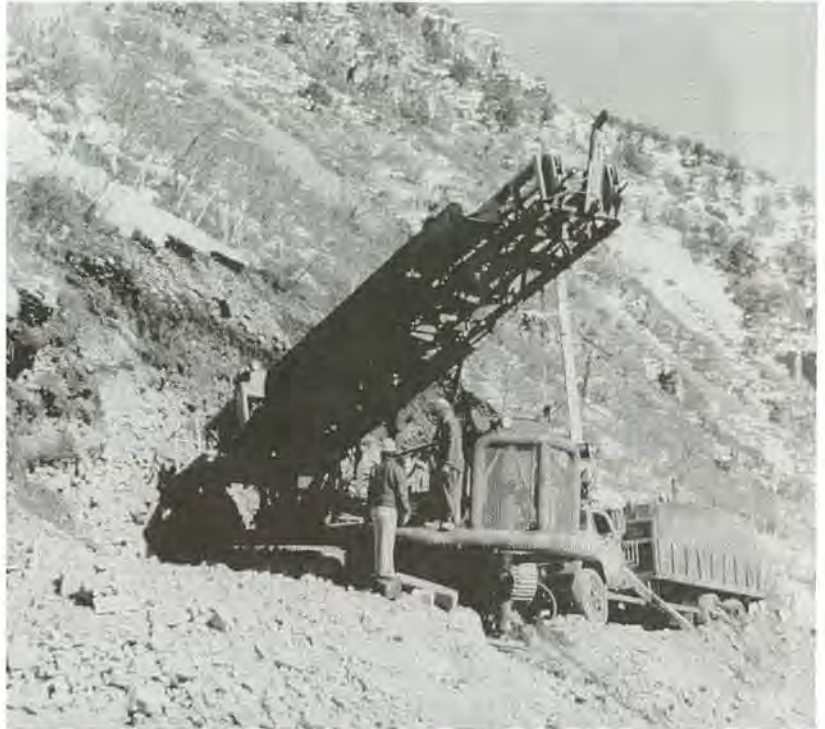
FIGURE 20-25
Large specialized rig drilling horizontal ground anchor holes in talus, Glenwood Canyon, Colorado.
COLORADO DEPARTMENT OF TRANSPORTATION

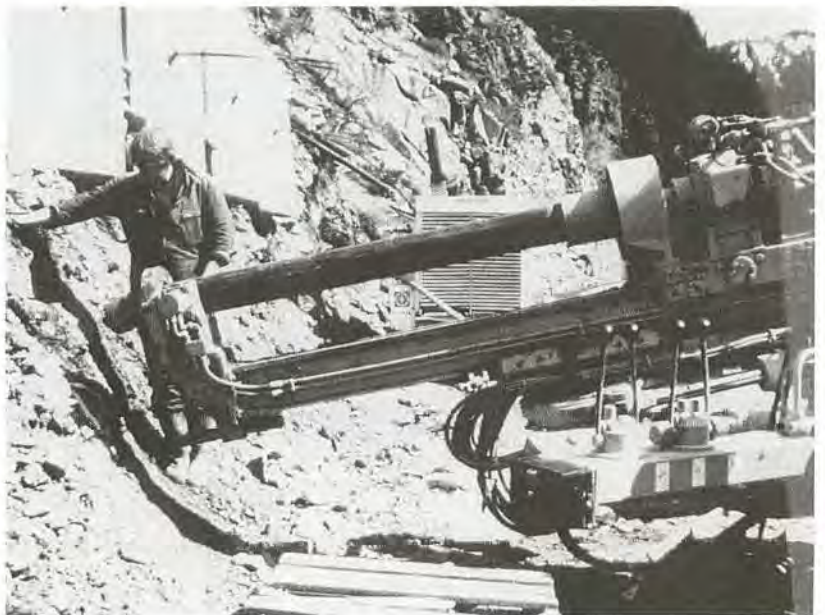
FIGURE 20-26
Smaller rig drilling ground anchor holes in talus for temporary slope-retention devices (*square concrete pads, upper part of photograph*), Glenwood Canyon, Colorado.
COLORADO DEPARTMENT OF TRANSPORTATION

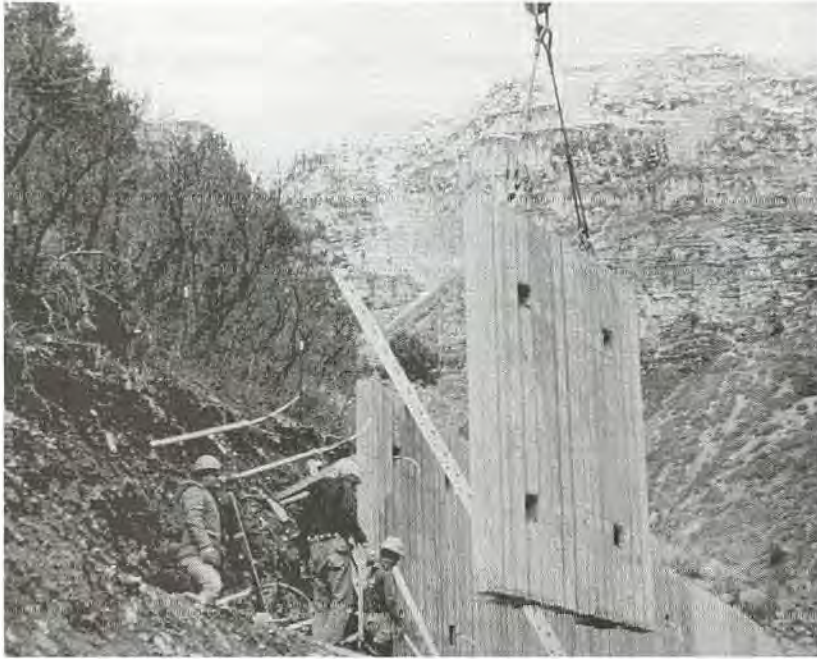
FIGURE 20-27
Installation of permanent retaining walls that utilize tiebacks into talus,
Glenwood Canyon, Colorado.
COLORADO DEPARTMENT OF TRANSPORTATION

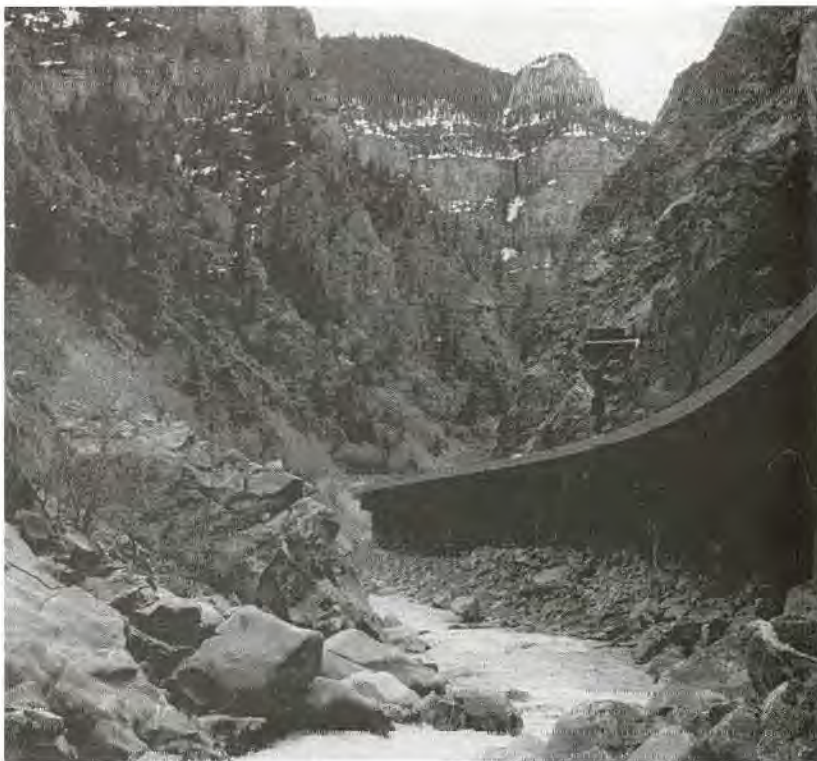
FIGURE 20-28
Interstate-70 viaduct founded on talus, Glenwood Canyon, Colorado.
J.D. HIGGINS, COLORADO SCHOOL OF MINES, GOLDEN, COLORADO

In Glenwood Canyon, the foundations for an extensive viaduct had to be placed on a talus deposit (Figure 20-28). Preblasting techniques were developed by CDOT and successfully used to allow the driving of large-diameter piles through this talus. The method involved predrilling a small-diameter hole at the location of each steel pile using wire-line drilling. The hole was cased with polyvinylchloride (PVC) pipe and backfilled with drill cuttings. Gelatin dynamite was attached

to reinforced detonator cords and lowered into the hole, which was then stemmed. Detonation of the charges fractured any large talus fragments so the piling could be driven through the small broken fragments. The process was repeated as necessary until the pile had been driven to the desired tip elevation. This procedure obviously added to the cost for installation of these steel piles. However, when compared with other alternatives, it was a feasible and cost-effective solution.

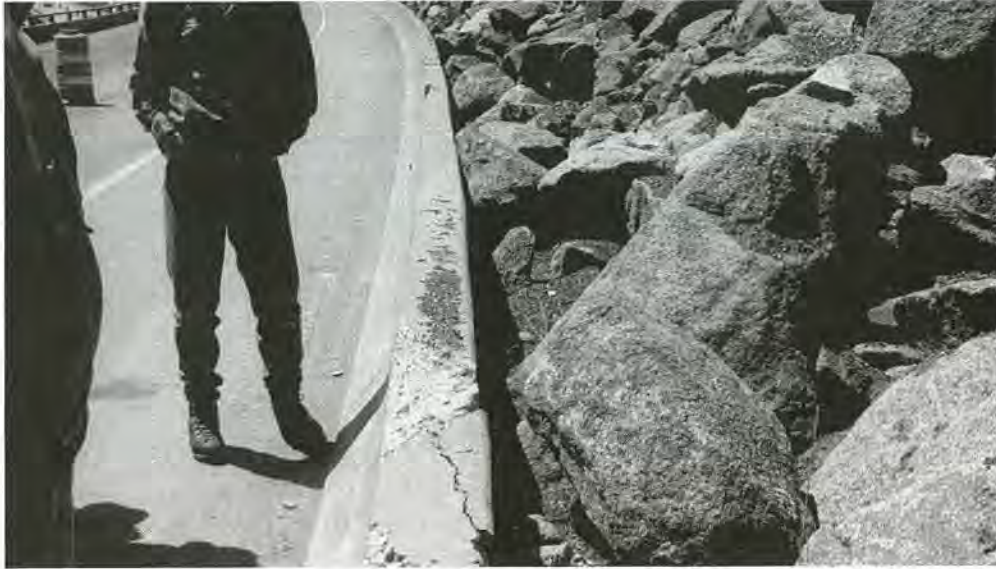
FIGURE 20-29
Minor rock-fall
damage at base of
talus slope,
Interstate-70,
Glenwood Canyon,
Colorado.
