Physical Properties of Southeastern Washington Loess Related to Cut Slope Design

LAWRENCE D. BEARD, JERRY D. HIGGINS, RICHARD J. FRAGASZY,
ALAN P. KILIAN, AND ARTHUR J. PETERS

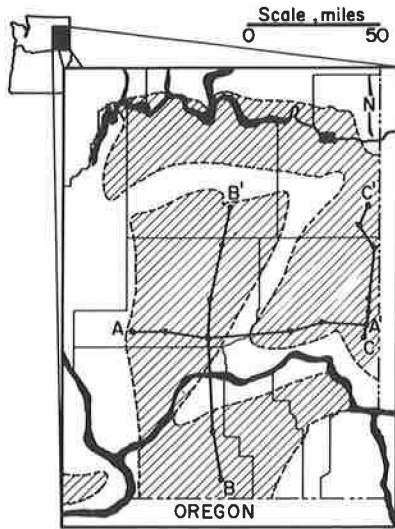
FIGURE 6 Location map for cross section A-A', B-B', and C-C'.

trends within the deposit that should be very helpful to engineering geologists and geotechnical engineers. Figure 6 shows the locations of three cross sections constructed through the deposits, one trending east-west and the other two north-south. In Figure 7, the east-west cross section A-A', a general increase in clay size content and a decrease in sand to the east are

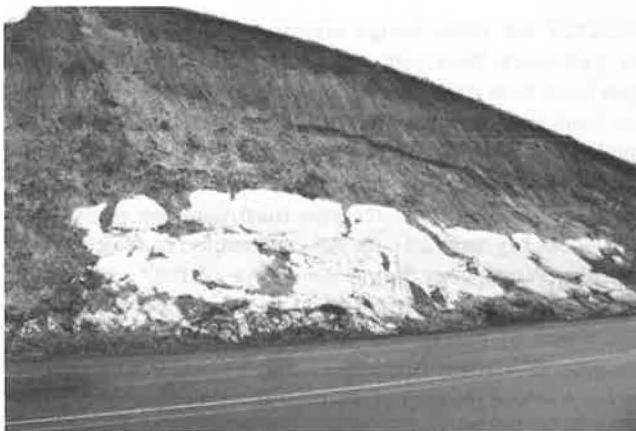
FIGURE 15 Shallow failure of road cut in loessial soils under melting snowdrift.

larger scale, involving the entire cut (Figure 15). In most cases the initial failure was followed by increased erosion due to the loss of vegetative cover with severe gully erosion a common result. A number of the cut slopes examined in the eastern part of the deposit have experienced this type of failure in the past, and as a result erosion gullies ranging up to 2 ft deep have formed on the cuts. Clearly, cuts of 2:1 in clayey loess are too steep to maintain a vegetative cover.
