Excavations at the Oashore Whaling Station

(M37/162)

Ian Smith and Nigel Prickett

Otago Archaeological Laboratory Report: Number 3

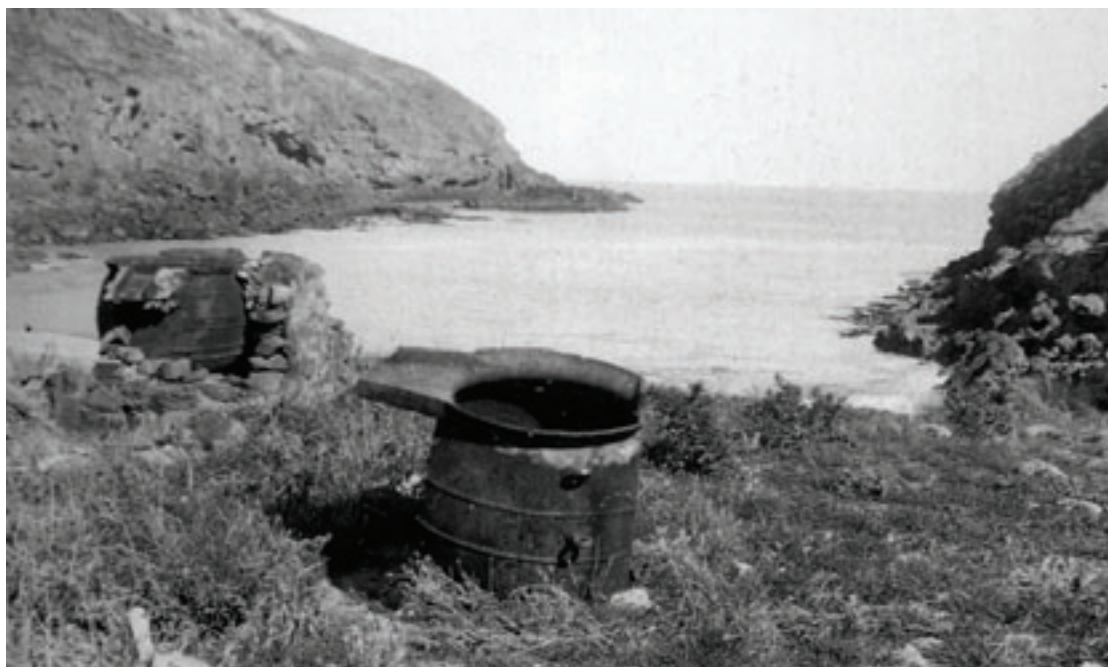
Figure 5 Remnants of the tryworks at Oashore, 1924. W.A. Taylor photograph
(Canterbury Museum 4473/1/2)

Whaling operations were conducted by Kaituna station hands during their winter off-season for several years. This appears to have ceased by the mid-1850s, at which time Thomas Kennedy’s family were living at Oashore while he worked at Kaituna¹. When the Rhodes Brothers’ partnership was dissolved in 1875 the Oashore block was purchased first by James Bell and Edmond Ensor, then in 1879 by the Buchanans who added it to their Kinloch station. Soon after this a road was constructed down the western slopes of Oashore valley (Figure 4), traces of which are still visible today. When Kinloch was broken up for closer settlement in 1906 a fence line separating blocks 14 and 15 was placed along the valley floor, dividing the former whaling station in two. During the early decades of the 20th century at least two makeshift fishing huts were constructed just above the beach (Taylor 1937:, Ogilvie 1994: 217) while visible remnants of the station included parts of the tryworks structure (Figure 5) and the capstan (Ogilvie 1994:217).

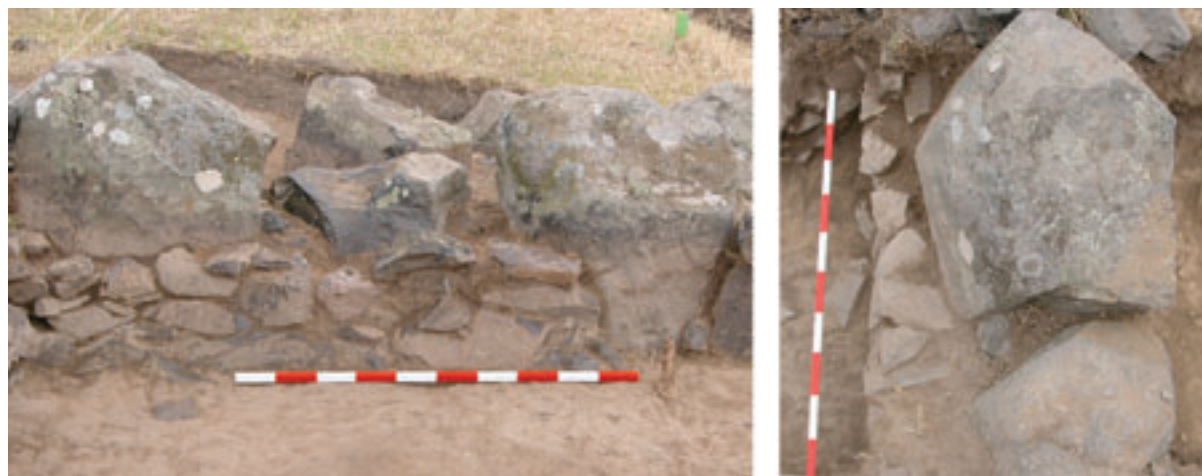
Figure 9 Part of north wall of Area 1 house, viewed from inside (left) and above (right)

The structure in Area 1 was a substantial house. The surviving lower courses of its walls averaged 0.6 m (two feet) in thickness and had been constructed from very large boulders that would have required more than one man to manoeuvre into place, along with carefully laid and clay-mortared small stones (Figure 9). Exactly how high these originally stood can only be guessed at: we suspect that they may have reached 1.5 – 2.0 m. The ground surface within the walls had been flattened by filling the southern side with soil and clay (*layer 3d*) cut from the slightly higher northern side. Many of the larger wall stones were roughly dressed during construction, producing a thin scatter of stone chips over the interior

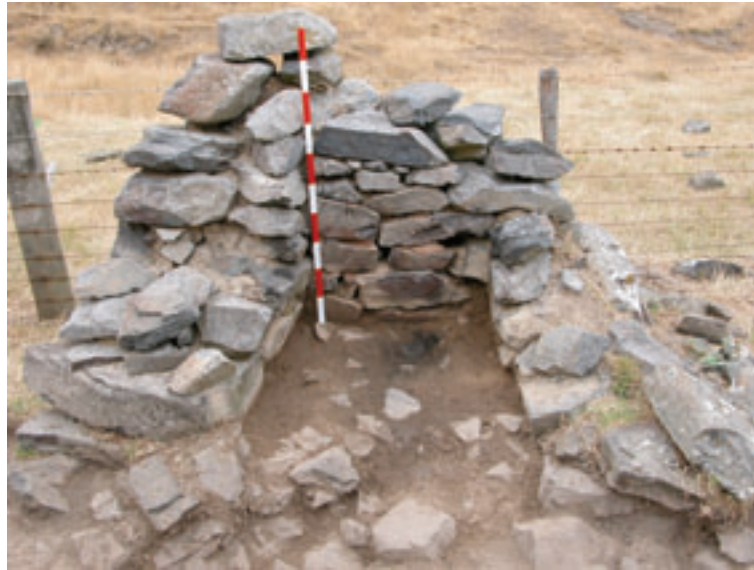
Figure 12 Chimney base, Area 2. Loose stones and soil have been removed, revealing charcoal from recent fires. The original fireplace was 35 cm below this level

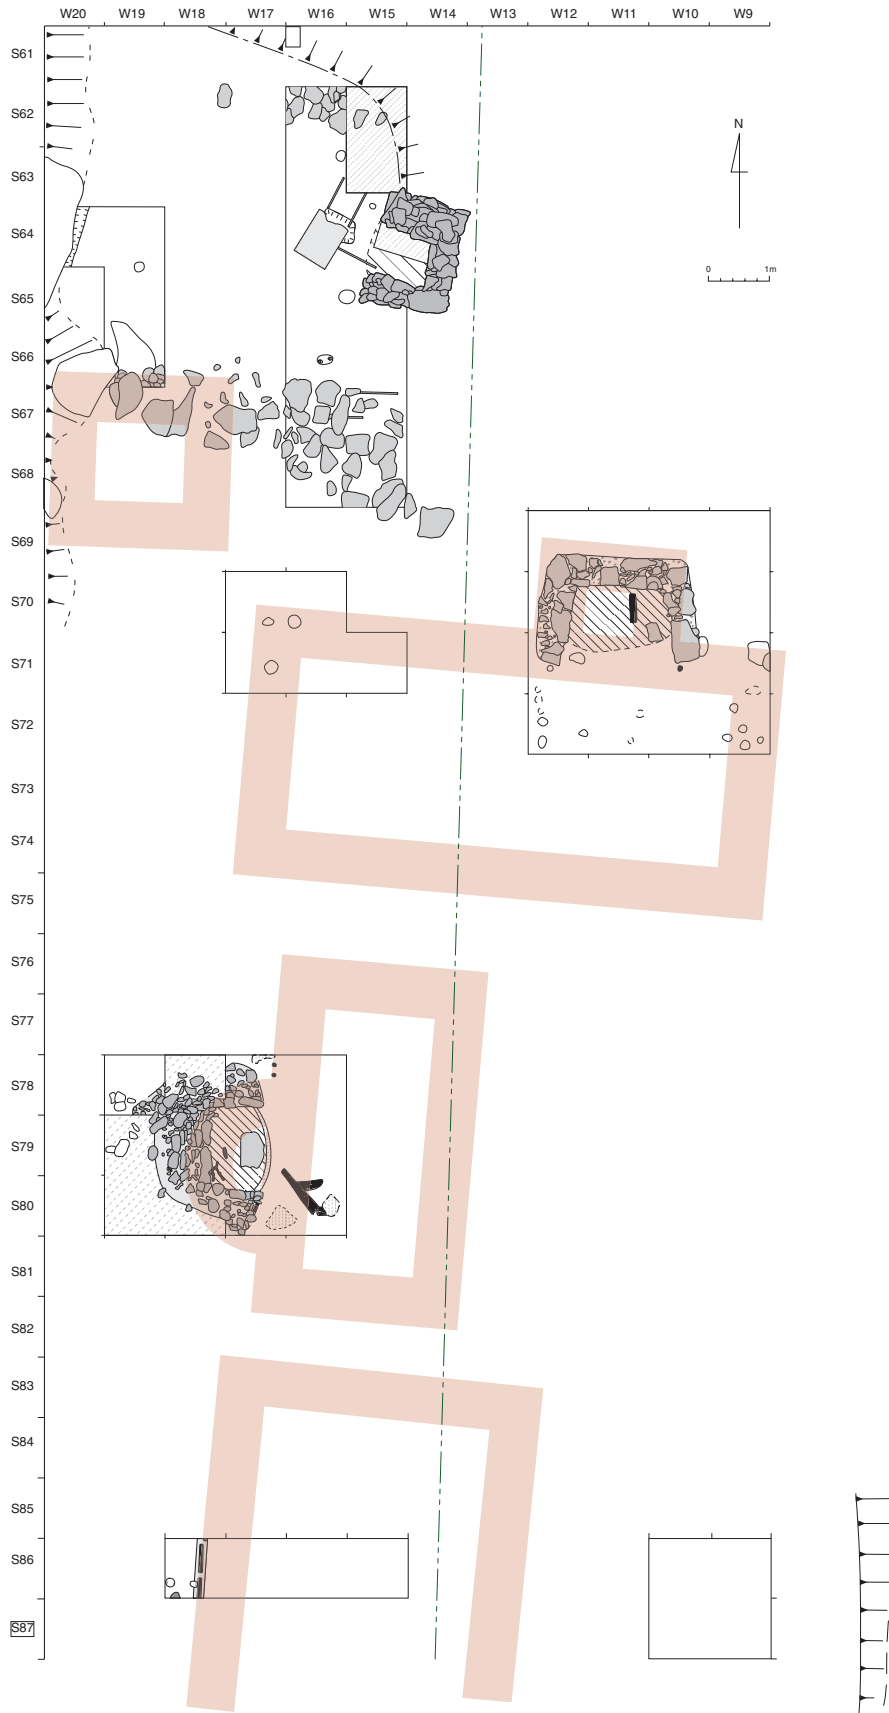
Figure 20 Outlines of structures from Carrington's plan overlaid on archaeological features in Areas 2, 4, 5 and 7

Detailed comparison of our site plan with that made by Carrington demonstrates that the latter is not an entirely accurate representation of the layout of the whaling station. The most obvious feature in common is the large stone house in Area 1, and when the 1849 depiction is enlarged to the same scale and overlaid on our plan it matches this building closely in width, but over-represents its length by about 35%. Conversely, it shows the stone walled enclosure as only about 60% of the length apparent on the ground, and the coastline about 25 m inland and rotated westward of its true position. There is, however, a good match between the two plans with respect to the buildings in Areas 4, 5 and 7. Rescaling and rotating the plan slightly, protrusions from two of the buildings can be overlaid on the chimneys excavated in Areas 4 and 5 (Figure 20). This places walls of those buildings directly over postholes excavated in Areas 4 and 5, and one of the walls of the boat shed over the timber slabs in Area 7. If this part of Carrington's plan can be relied upon for accuracy, it suggests the presence of another small rectangular structure at the foot of the slope immediately northwest of Area 4. As long as this is not a misplaced depiction of the Area 2 chimney, it may be inferred from the absence of anything in the latter area that there was no longer a house standing there by 1849.
