# Condition and Management Survey of the Archaeological Resource in Northern Ireland

## CAMSAR Report

**AUTHORS:** Sarah Gormley, Colm Donnelly, Barrie Hartwell, Janet Bell

A report commissioned by the Northern Ireland Environment Agency  
(formerly Environment and Heritage Service)

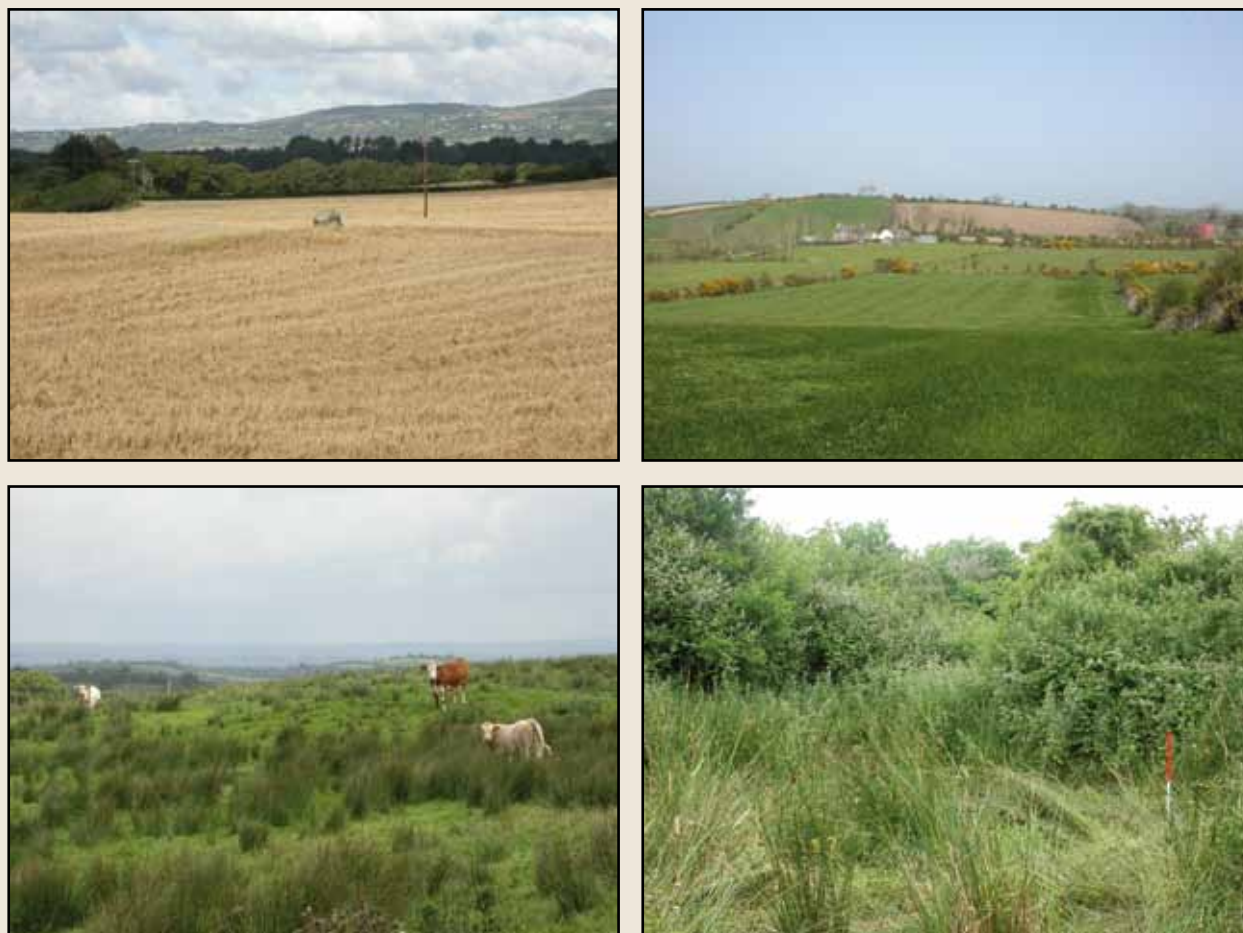
**Plate 1 Examples of land use.**  
**Clockwise from top left - arable, improved grassland, scrub, and rough grazing.**
