# Condition and Management Survey of the Archaeological Resource in Northern Ireland

## CAMSAR Report

**AUTHORS:** Sarah Gormley, Colm Donnelly, Barrie Hartwell, Janet Bell

A report commissioned by the Northern Ireland Environment Agency  
(formerly Environment and Heritage Service)

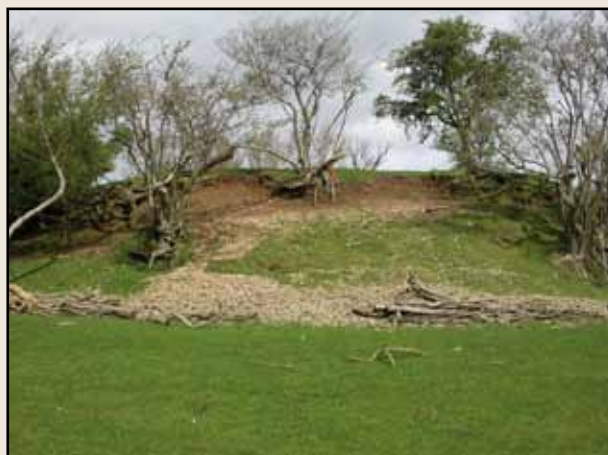
**Plate 7 (left) Clonlum court tomb (ARM 029:004) is in a poor condition due to scrub growth and severe livestock trampling. (right) The possible raised rath at Fofannyreagh (DOW 042 038) is in poor condition due to a combination of livestock erosion and burrowing animals.**
