Condition and Management Survey of the Archaeological Resource in Northern Ireland

CAMSAR Report

A report commissioned by the Northern Ireland Environment Agency
(formerly Environment and Heritage Service)

CAMSAR: A Condition and Management Survey of the
Archaeological Resource in Northern Ireland

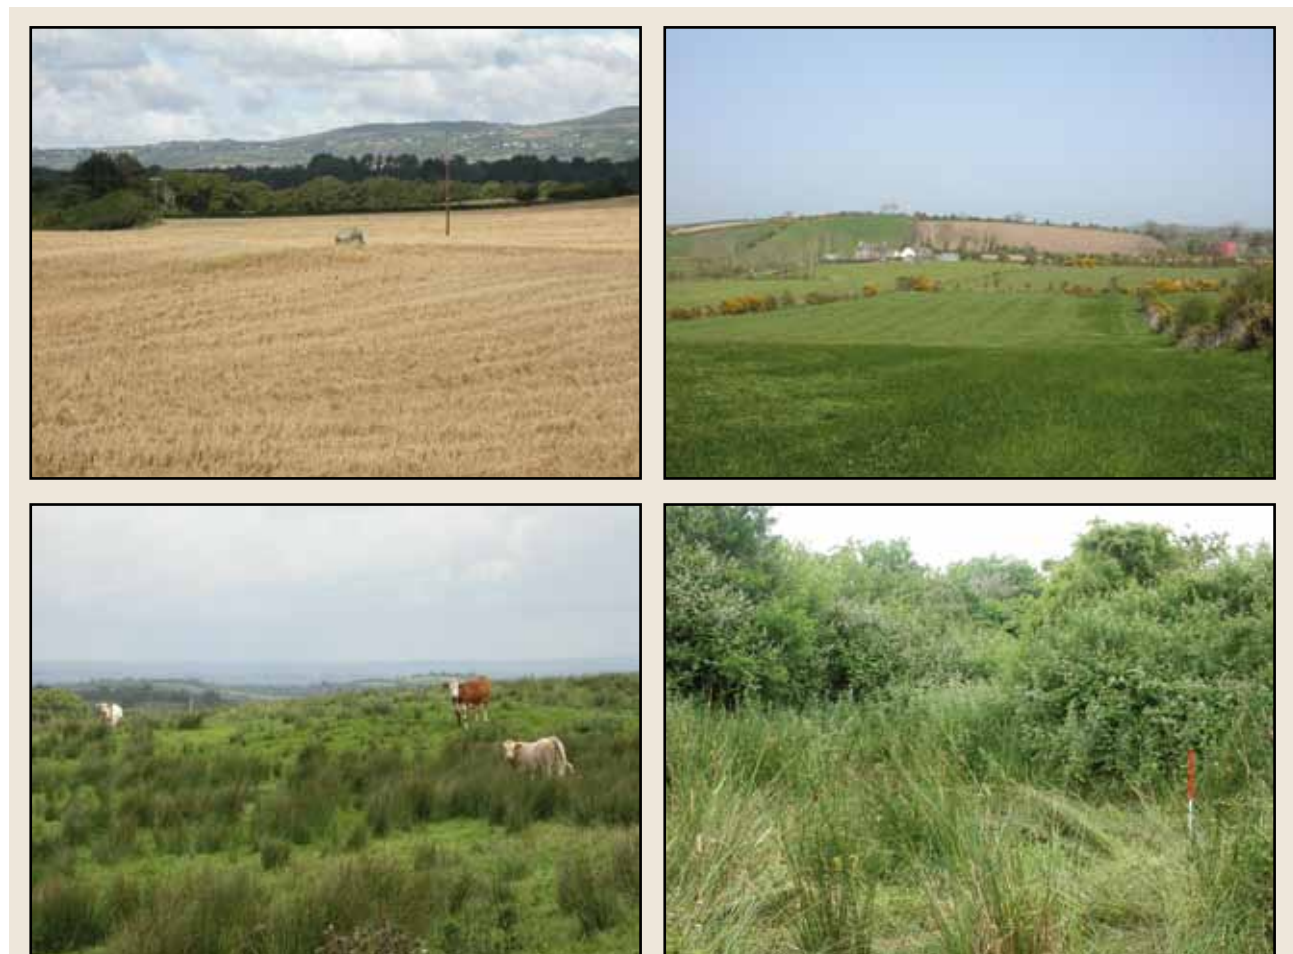
Plate 1 Examples of land use.
Clockwise from top left - arable, improved grassland, scrub, and rough grazing.

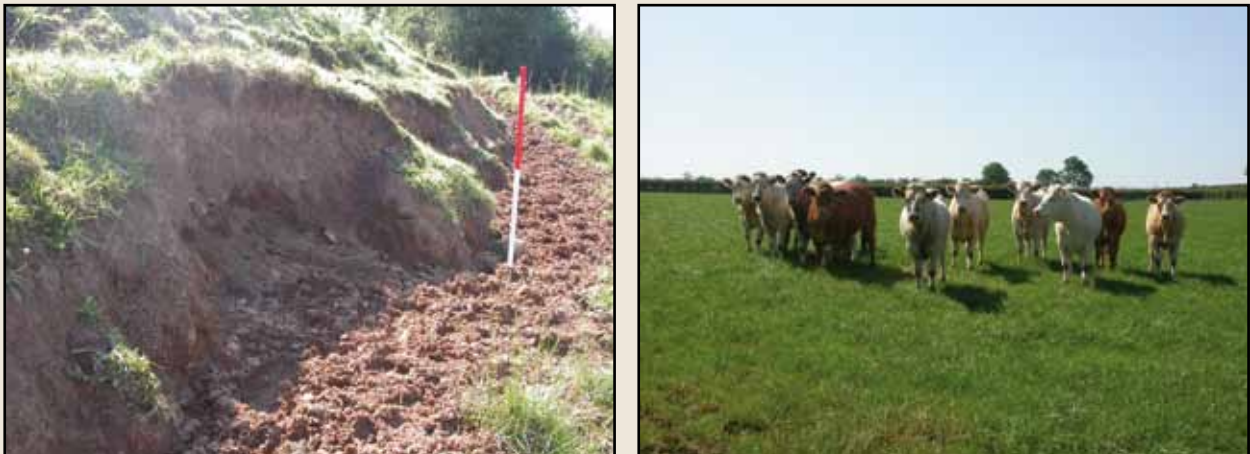
Plate 10 Mount Hamilton large enclosure (ANT 023:016) has been damaged by livestock recently.
