**Federal Railroad
Administration**

Crash Energy Management Coupling Test between a Coach Car and a Passenger Locomotive

13. ABSTRACT Transportation Technology Center, Inc. conducted impact tests with a Budd M1 passenger car and an F40 locomotive to evaluate the performance of both vehicles under dynamic conditions. The locomotive was retrofitted with crash energy management components, including a push-back coupler (PBC) and crushable anti-climbers. A series of impact tests were performed October 3 and 4, 2017, at the Transportation Technology Center in Pueblo, Colorado. The M1 passenger car was impacted by the locomotive at 1.8 mph, 3.74 mph, 5.66 mph, 6.84 mph, 7.63 mph, and 8.85 mph. The most substantial damage was inflicted upon the M1 passenger car, with the F40 locomotive sustaining no noticeable damage. The most significant damage was the buckling of the M1 traction rod that occurred during the third test. The traction rod was replaced and buckled again during the fourth test, and was not replaced. The PBC activated during the last test at 8.85 mph.

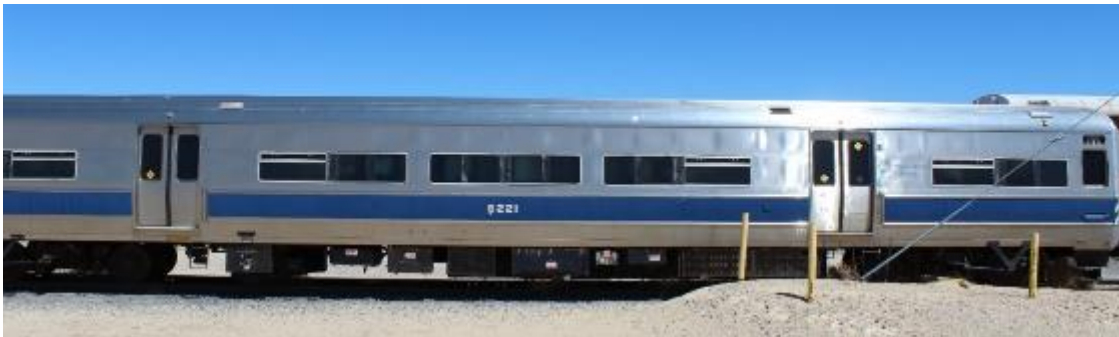
The M1 passenger car is a type of electric multiple unit vehicle, built by the Budd Company for the Long Island Railroad. This test used M1 passenger car 8221, weighing 89,700 lbs, to serve as the stationary passenger car ([Figure 1](#)).

Figure 1. M1 Passenger Car 8221

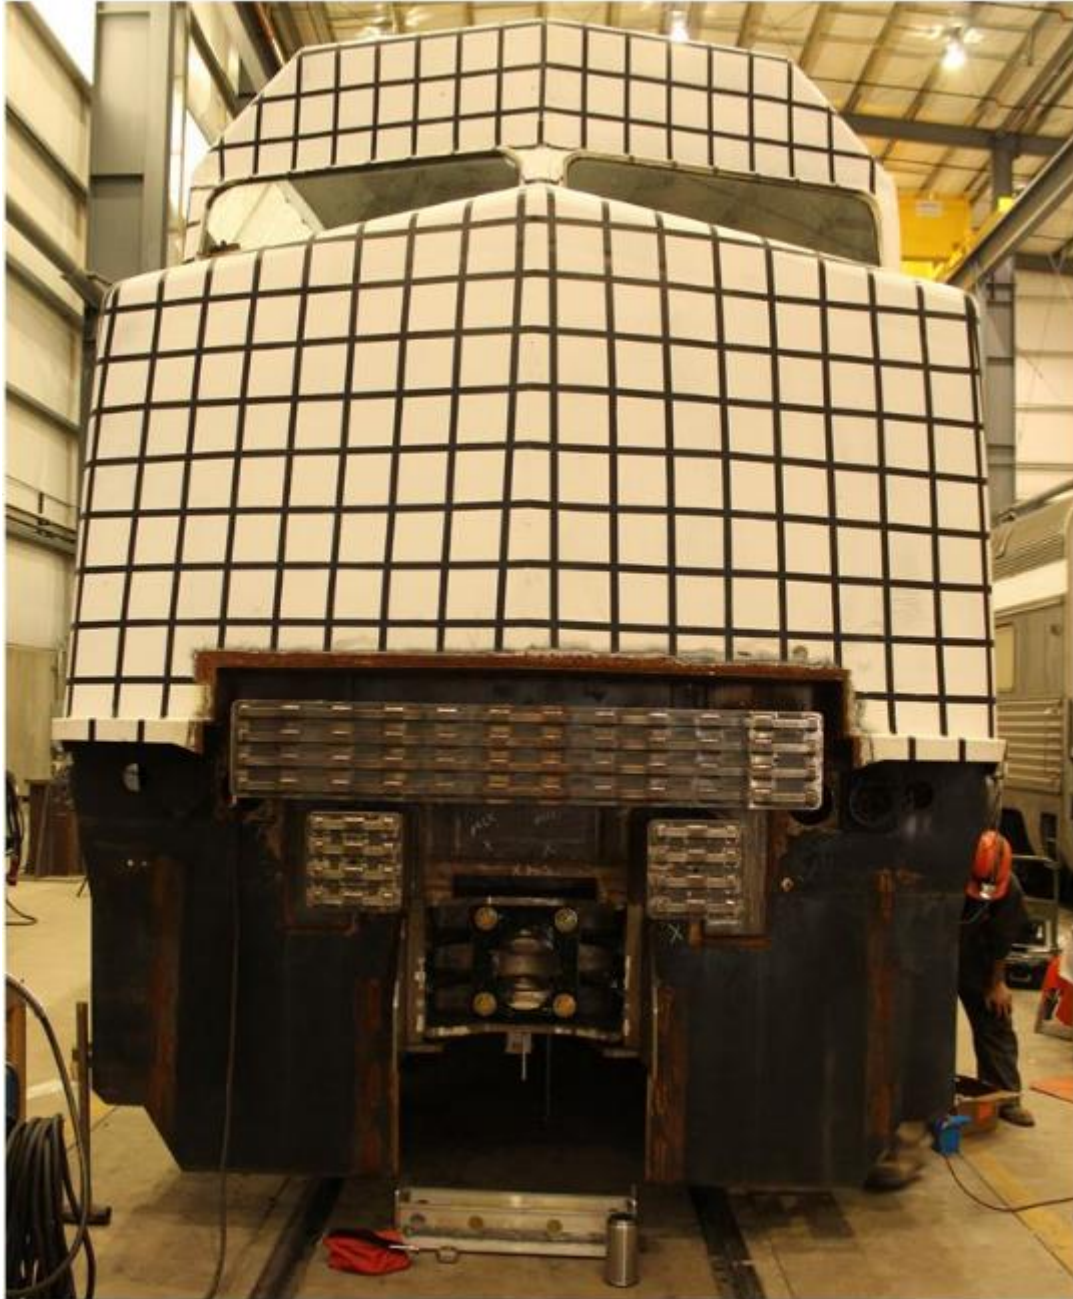
Figure 2. F40 Locomotive

The F40 locomotive is a four-axle diesel electric locomotive intended for use in passenger service. This test used F40 Locomotive 234, weighing 232,600 lbs, as the impacting vehicle ([Figure 2](#)).

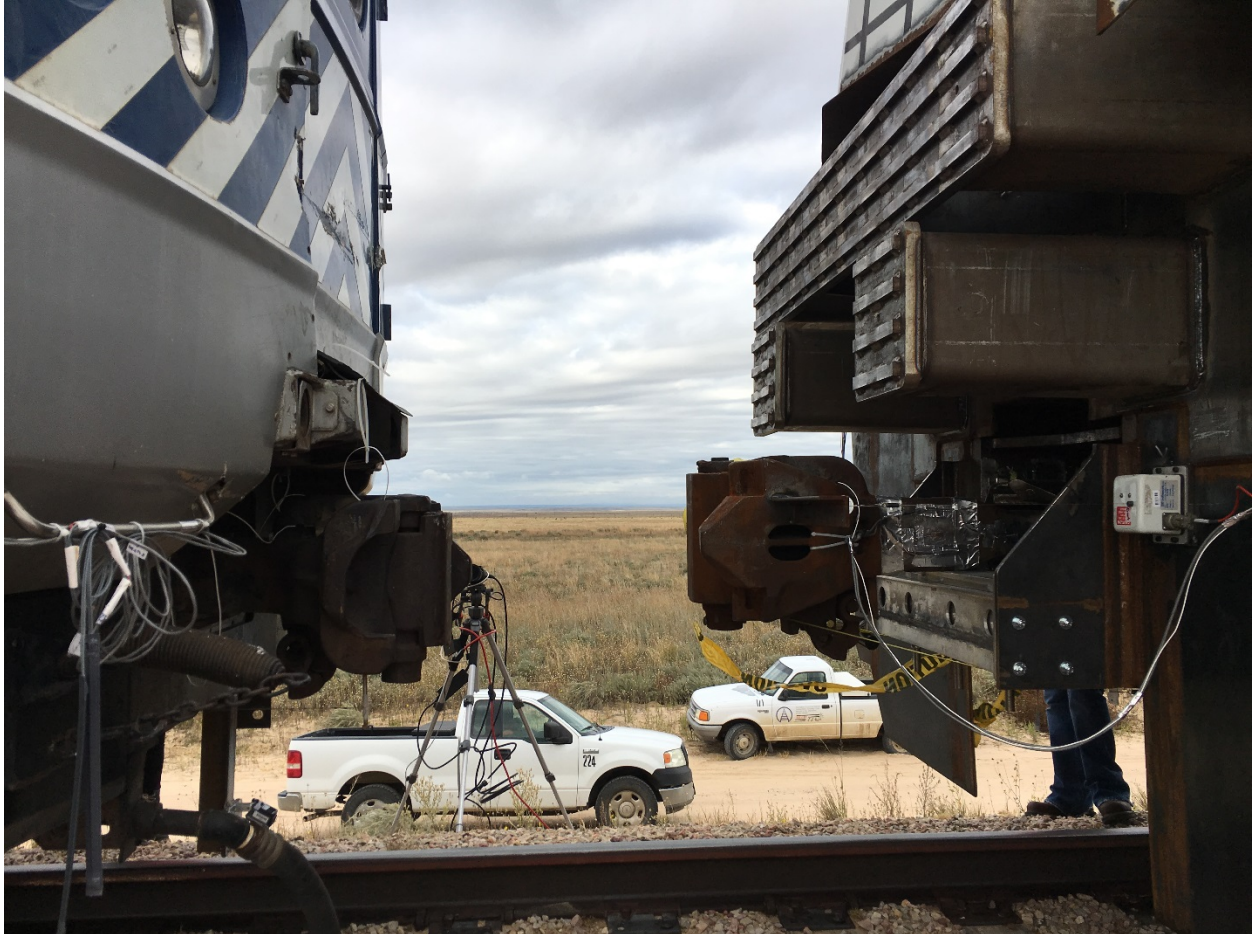
Figure 3. Initial Coupler Misalignment

TTCI performed the CEM coupling testing on October 3 and 4, 2017, at the TTC in Pueblo, Colorado. The testing was performed by positioning the F40 uphill from the stationary M1 passenger car and allowing the locomotive to roll into the car. The release positions of the locomotive were determined through speed trials and adjusted shortly before the release to achieve the desired impact speeds. The couplers were initially misaligned by more than 3 inches, as shown in [Figure 3](#). The M1 coupler was shimmed to compensate, making the coupler height difference between 1 and 2 inches for the first five tests. For the last (9 mph) test, the F40

coupler carrier was lowered to reduce the misalignment to less than 1 inch. The couplers of the locomotive and M1 passenger car were opened and aligned to allow the M1 and locomotive to couple upon impact. [Figure 4](#) shows the retrofitted locomotive coupler carrier and [Figure 5](#) shows coupler shims on the M1 car.

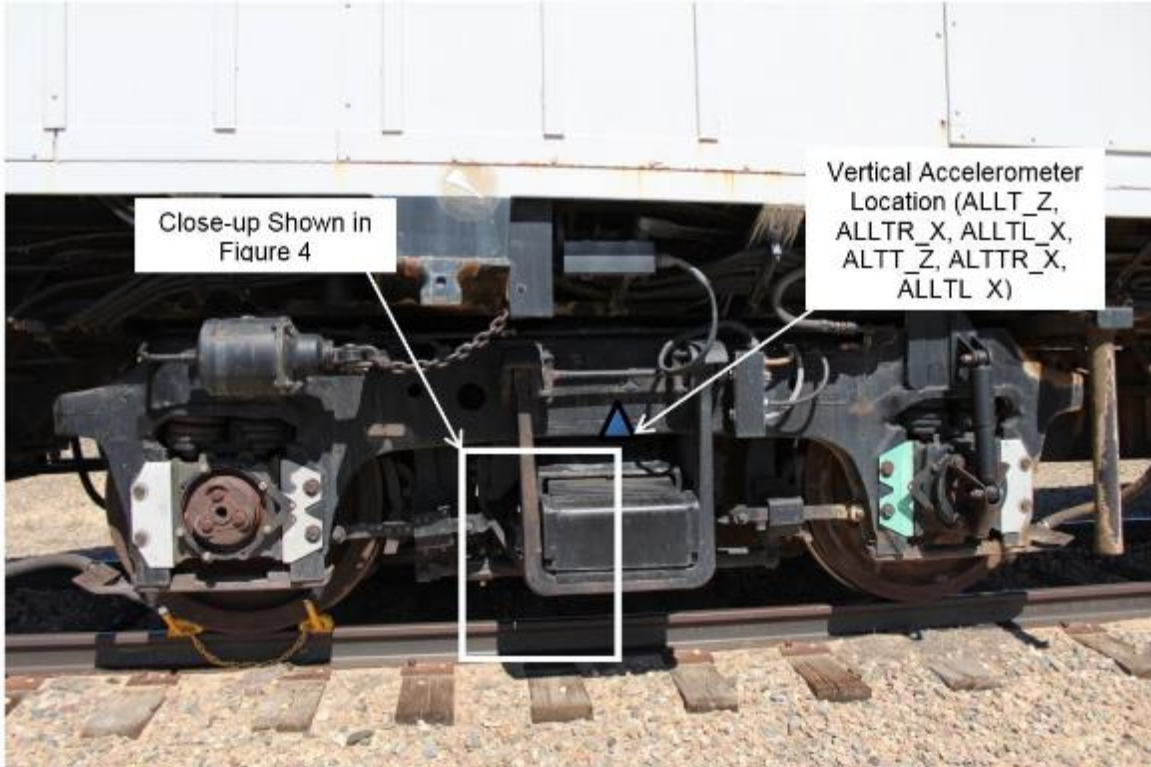
Figure 8. Locations of Accelerometers on F40 Locomotive Truck

In addition to accelerometers, the locomotive was instrumented with string potentiometers across each truck's secondary suspension. Two string potentiometers were also fitted to the coupler of the locomotive to measure the longitudinal displacement. Two more string potentiometers were fitted to the front of the locomotive underframe to measure longitudinal displacements. [Table 3](#) summarizes all string potentiometers on the locomotive. [Figure 8](#) through [Figure 13](#) show locations of the string potentiometers.

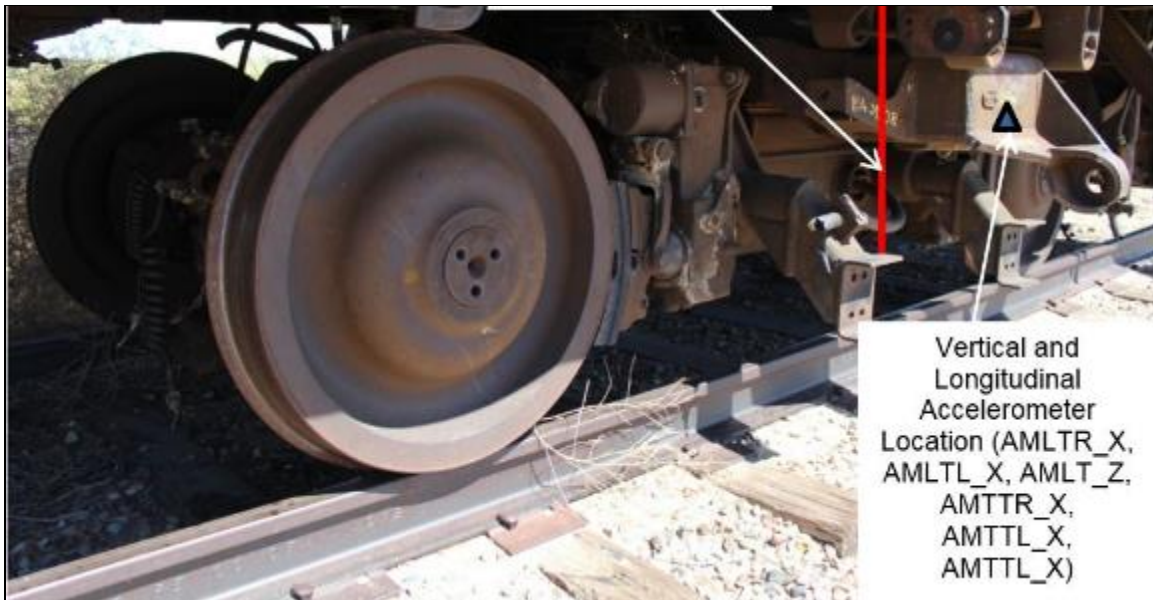
In addition to these accelerometers, the M1 passenger car was fitted with string potentiometers across each truck's secondary suspension. The underframe of the car was also fitted with two string potentiometers near the coupler to measure longitudinal displacement. Table 6 summarizes all string potentiometers on the M1 passenger car, shown in Figure 19 to Figure 22.

Figure 19. String Potentiometer and Accelerometer on M1 Passenger Car Truck

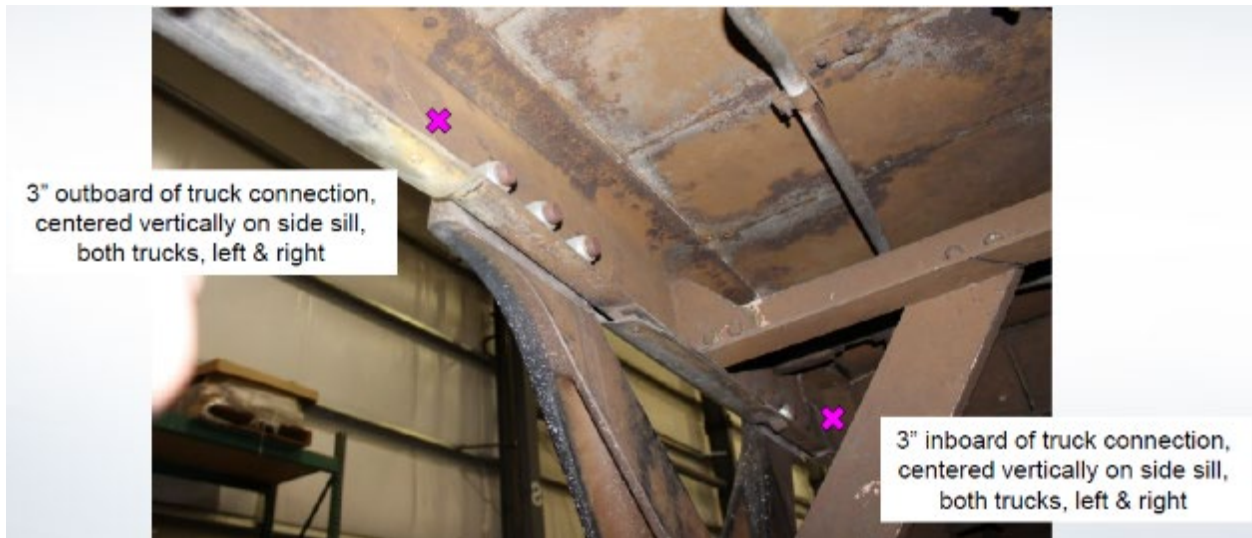
The M1 passenger car was also fitted with 20 strain gages. [Table 7](#) summarizes all strain gages on the M1. [Figure 23](#) and [Figure 24](#) show locations of the gages.

Figure 24. Strain Gage Locations on M1 Passenger Car

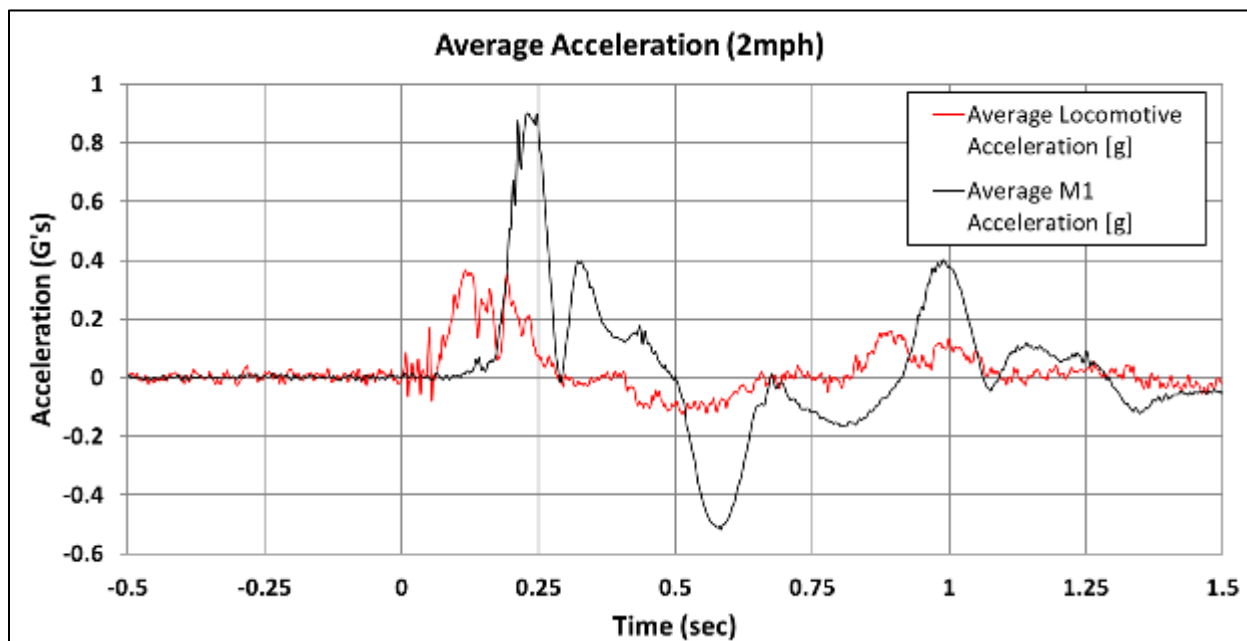
Figure 27. Longitudinal Average Acceleration at 2 mph Impact

The average longitudinal acceleration time history from the locomotive accelerometers is shown in [Figure 27](#) to [Figure 32](#). Impact accelerations are shown as positive in these graphs; however, during an impact the locomotive was accelerated in the negative X direction based on the established coordinate system. During the 6, 7, 8, and 9 mph test runs, the locomotive and the passenger car failed to couple.

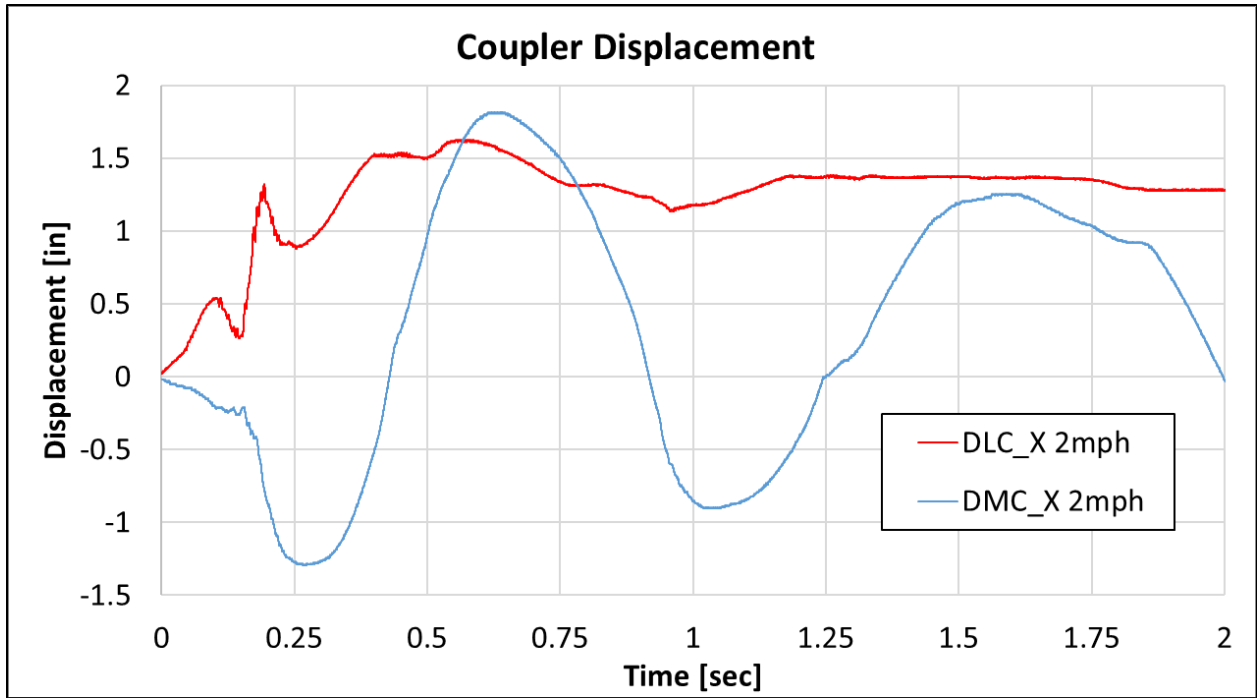
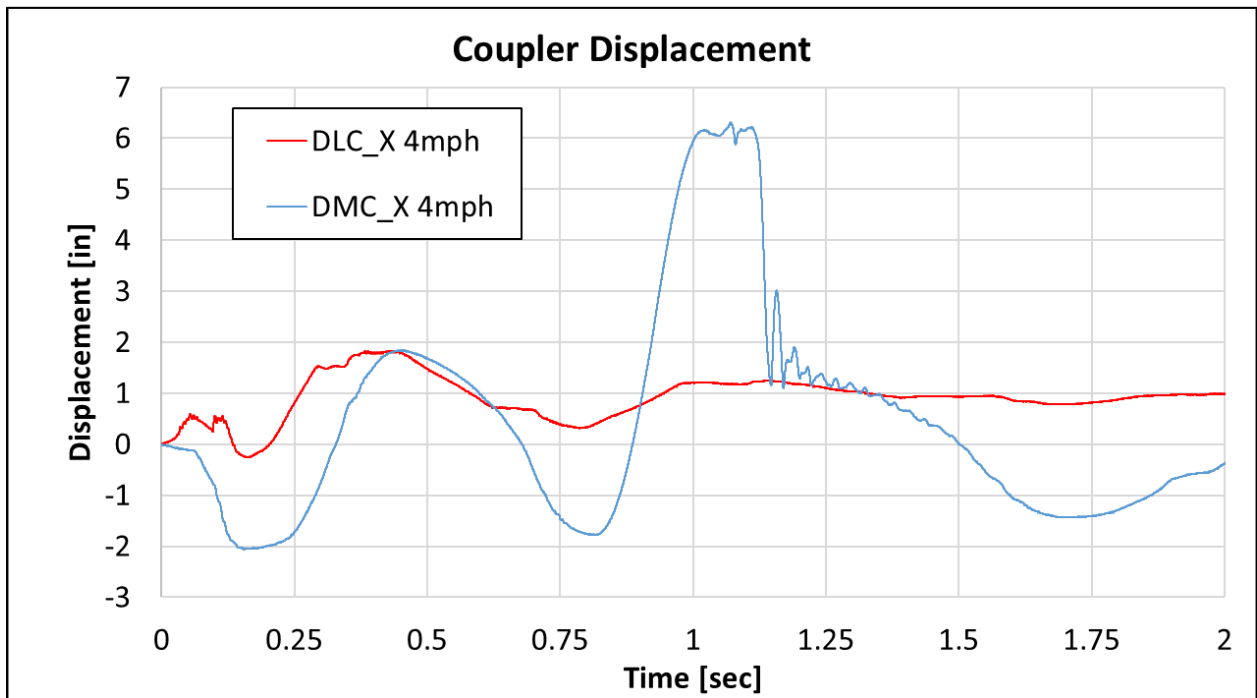
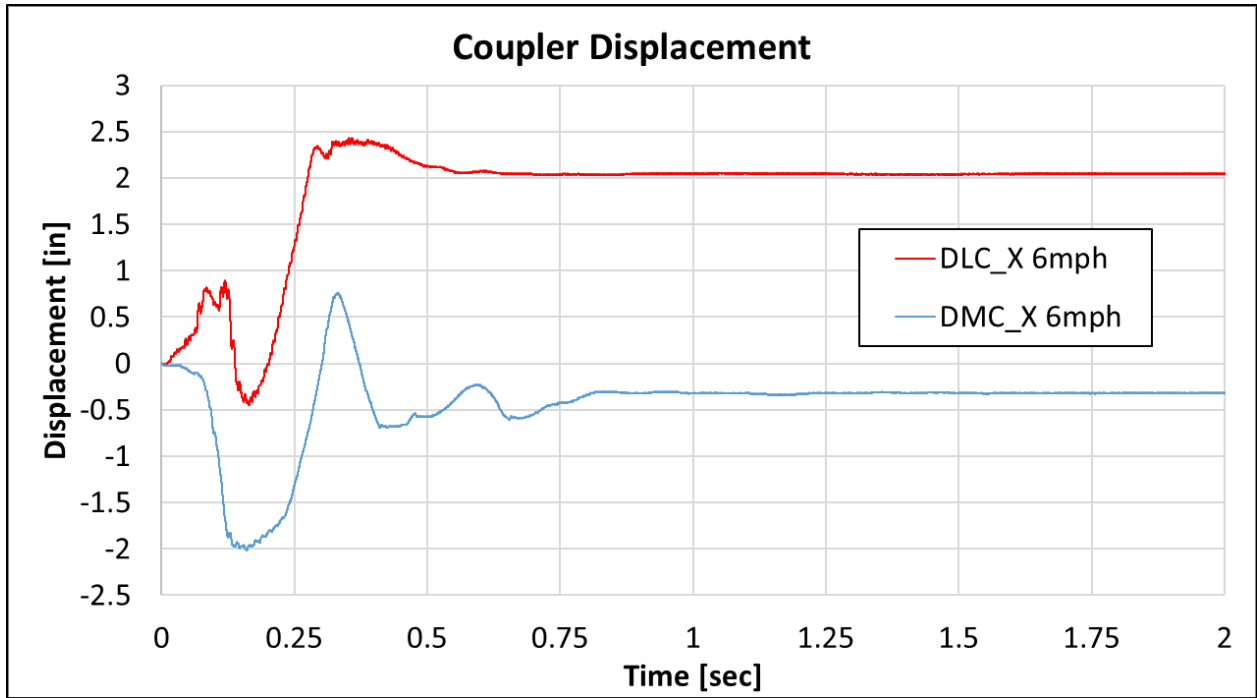
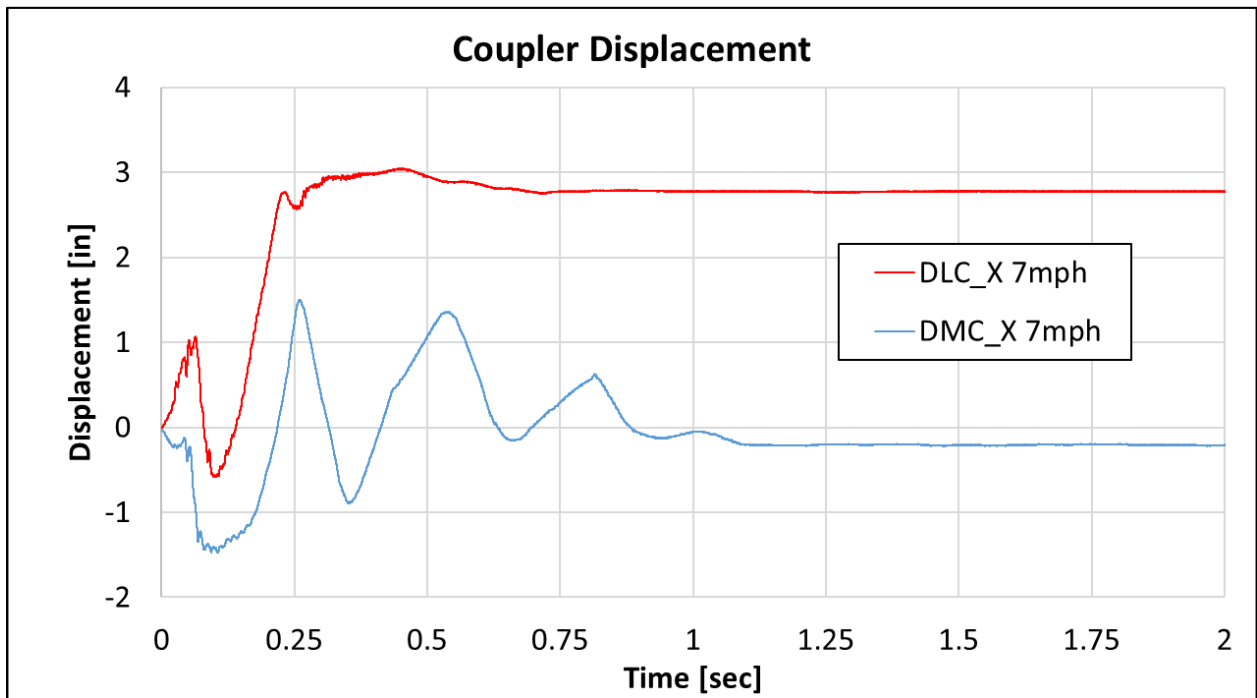
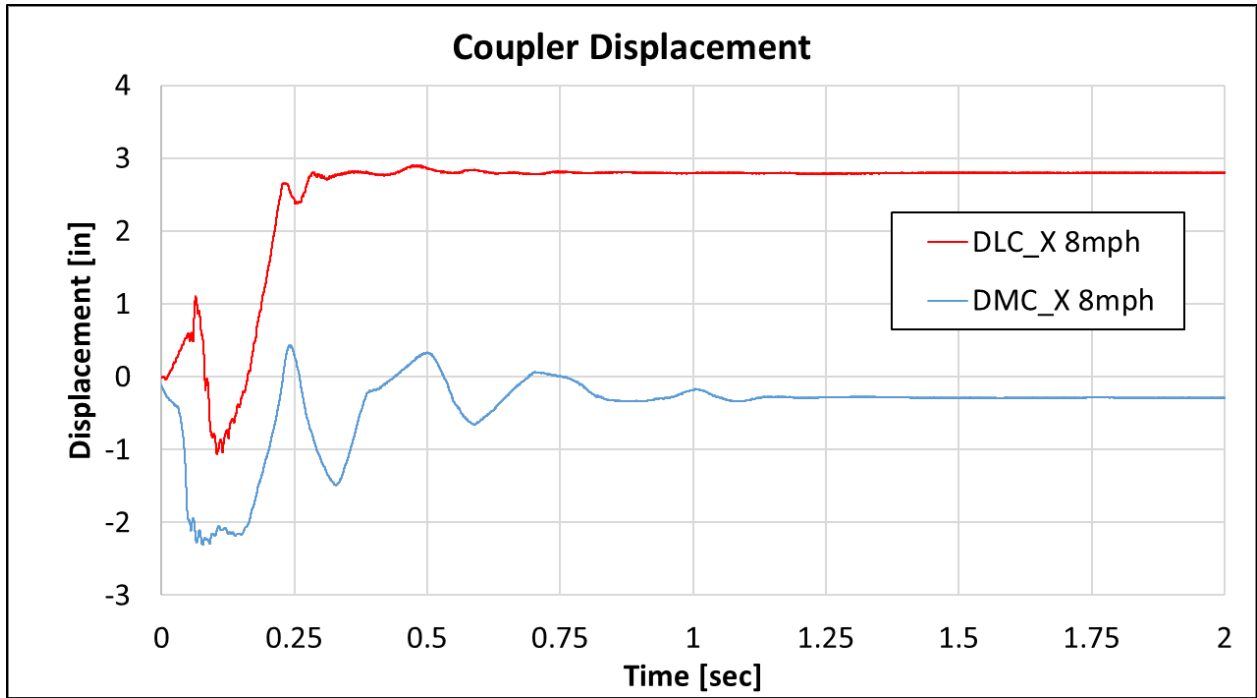
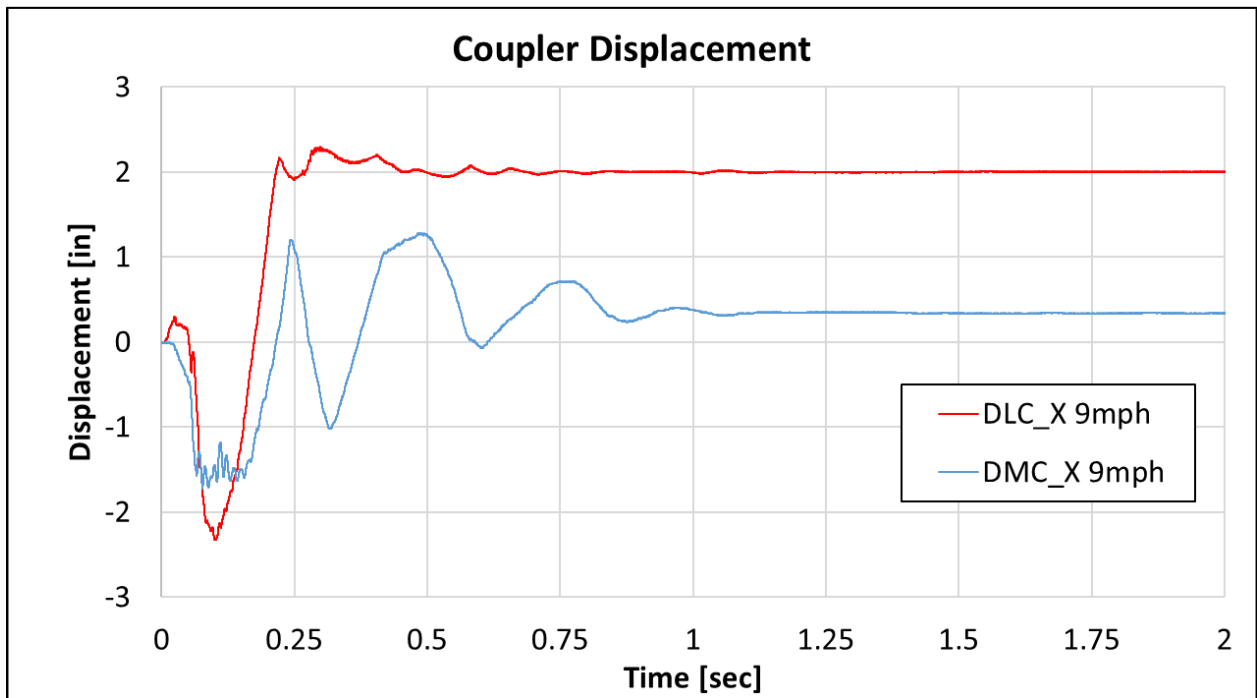
The displacement of the couplers is shown in [Figure 33](#) to [Figure 38](#) for each impact speed. The DMC_X curves represent the response of the M1 coupler; the DLC_X curves represent that of the locomotive coupler. According to the coordinate system, the coupler moving into the draft pocket was reported as a positive displacement for the F40 locomotive, and negative for the M1 passenger car. During the first two tests (2 mph and 4 mph), the two vehicles coupled. Similar to acceleration, the locomotive coupler displacement curve was offset in time for the first impact. The time offset was corrected during data post-processing to match the data recording starting time on both vehicles. The tests in which the cars did not couple should have shown a displacement on both couplers approaching the initial position. The difference between the initial position of the coupler measured by the string potentiometers and its position after the initial impact was due to the coupler's lateral shift.

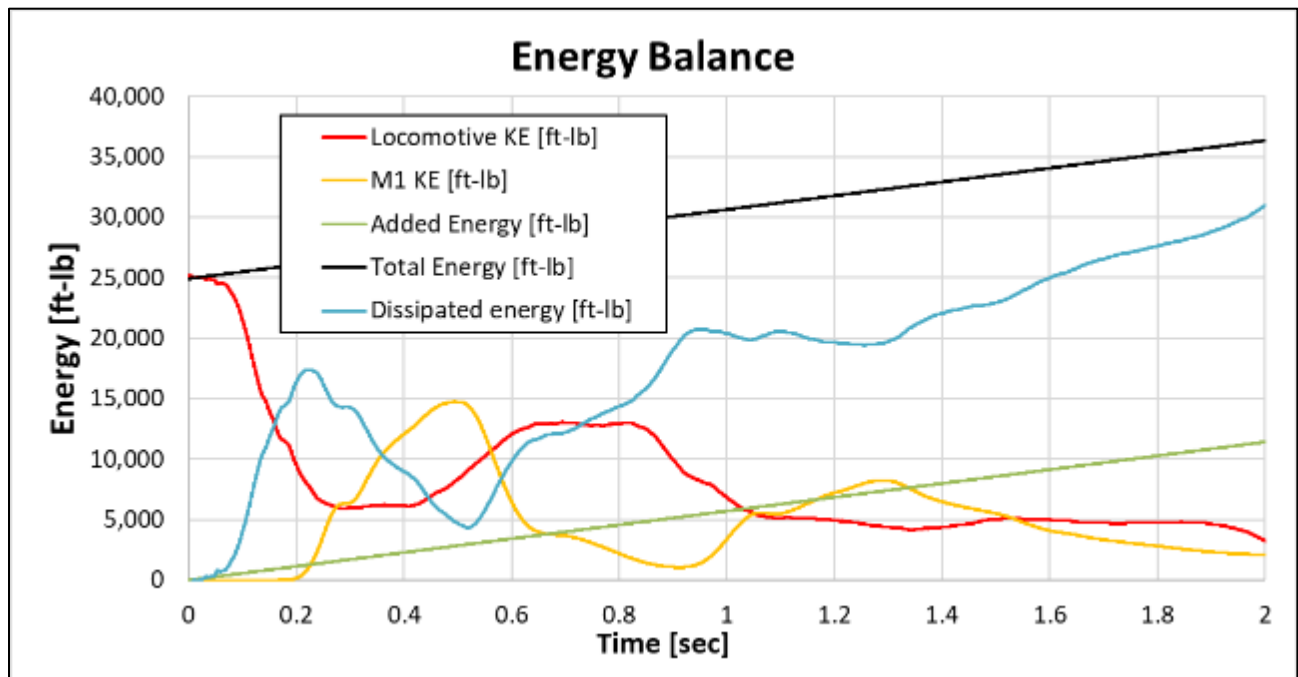
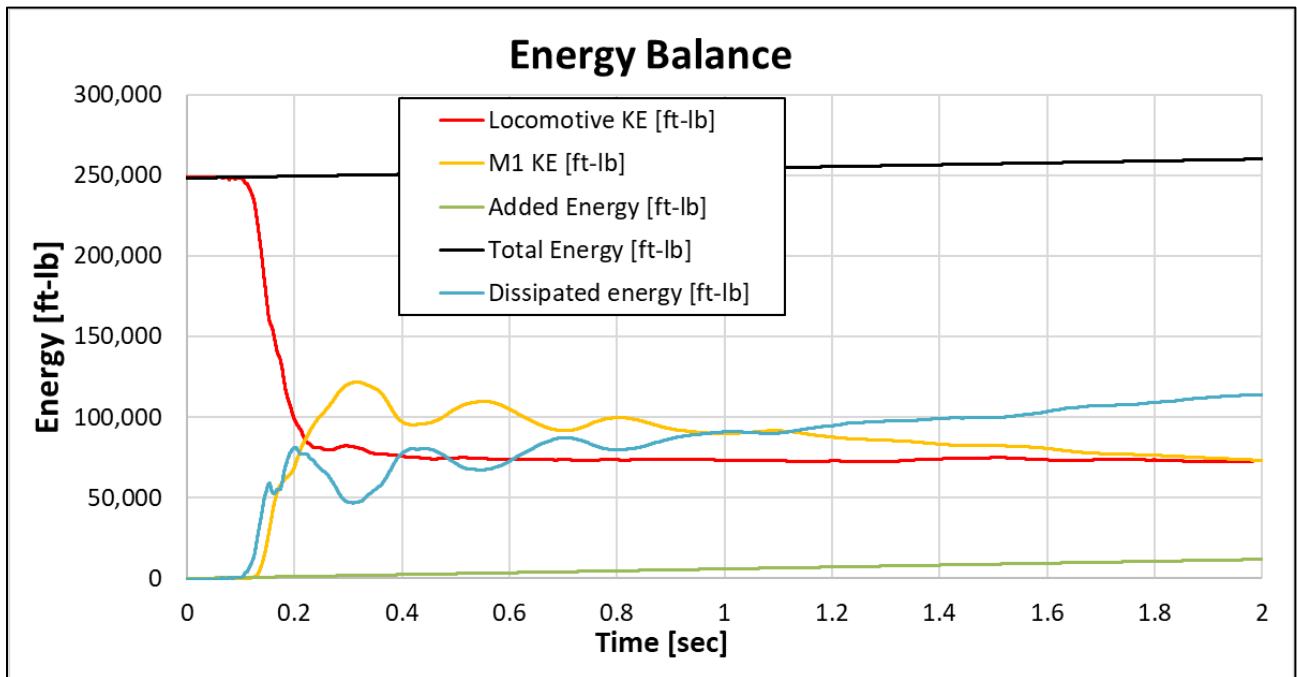
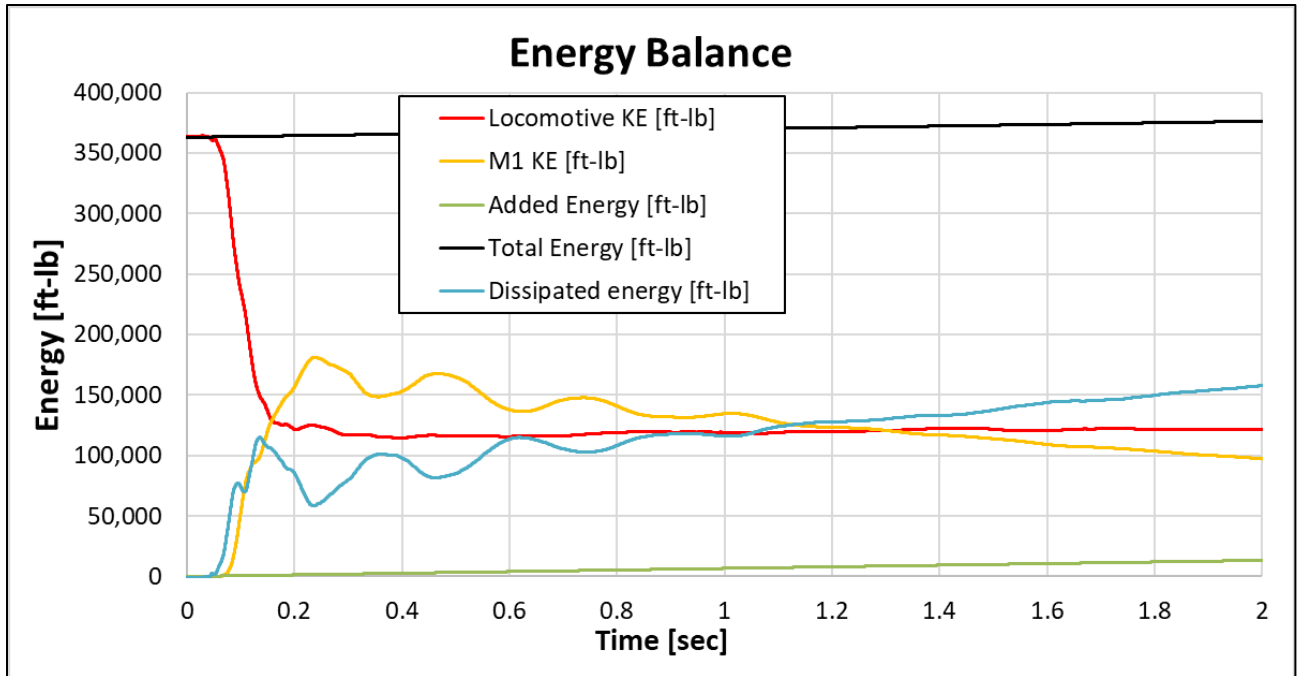
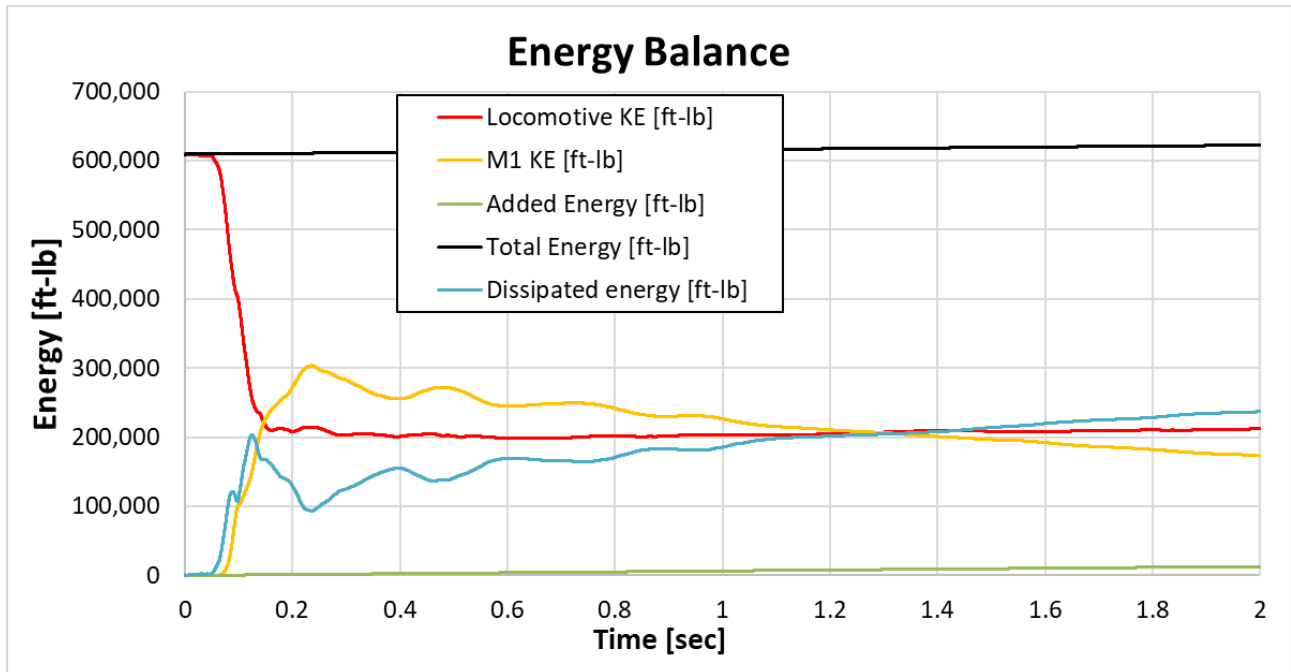
Energy balance is the summary of the energy evolution during the impact. The total energy at the beginning of the impact is equal to the kinetic energy of the locomotive. After the first impact, the F40 locomotive and the M1 passenger car moved forward on the track until they stopped. Energy due to the track grade after the impact was accounted for as “added energy” to the system, and linearly increased from the impact point to the point where both the F40 and the M1 stopped. The other energies in the energy balance were the kinetic energy of both vehicles and the dissipated energy that accounted for deformation, braking, and other energy losses. Because the energies should balance, the dissipated energy was obtained by subtracting the kinetic energies from the total energy. Figure 93 to Figure 98 show the energy balance for each impact speed.

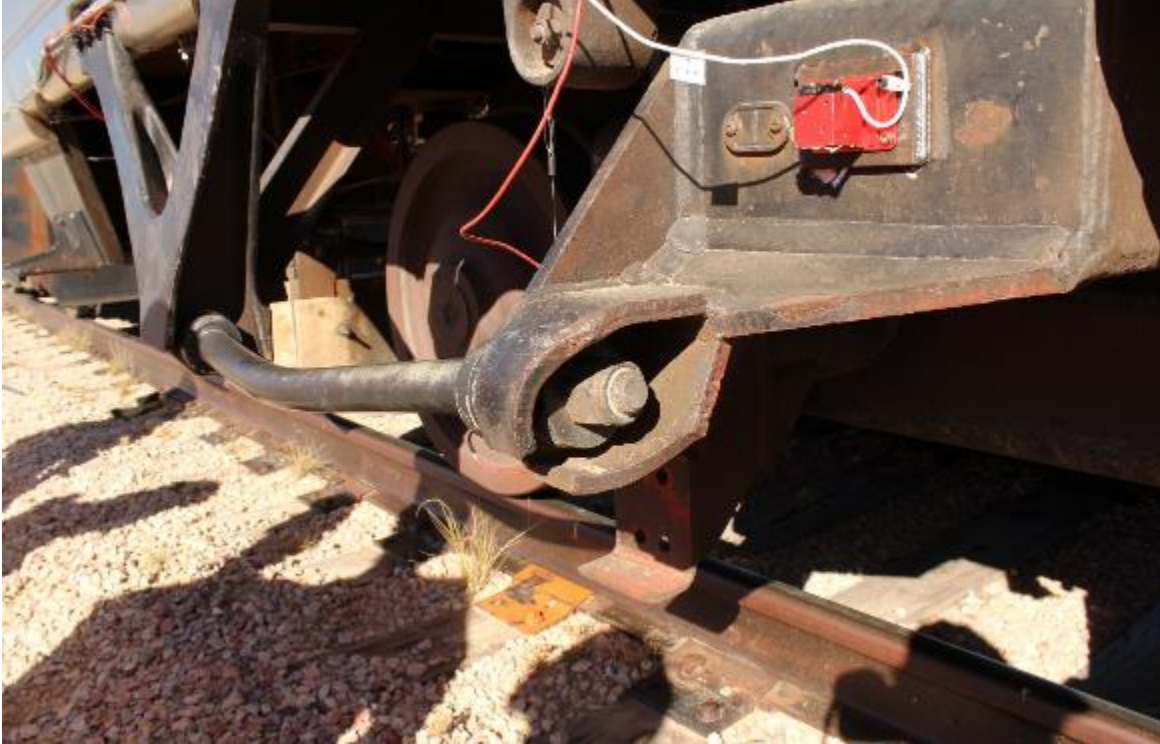
Figure 99. Bent Traction Rod after Third Test

One of the M1 passenger car traction rods buckled after the third test (Figure 99) at 5.7 mph, and it was replaced with an original traction rod taken from a different M1 passenger car. During the fourth test at 6.8 mph, the traction rod buckled again (Figure 100) and was not replaced. During the last two tests, the traction rod deformation continued to increase. Pictures of the traction rod after the fifth and sixth tests are shown in Figure 101 and Figure 102.

The most substantial damage that occurred during each test was inflicted upon the M1 passenger car. After the second test, the traction rod buckled and was replaced for the next test. During the third test, the traction rod buckled again and was not replaced for subsequent tests.

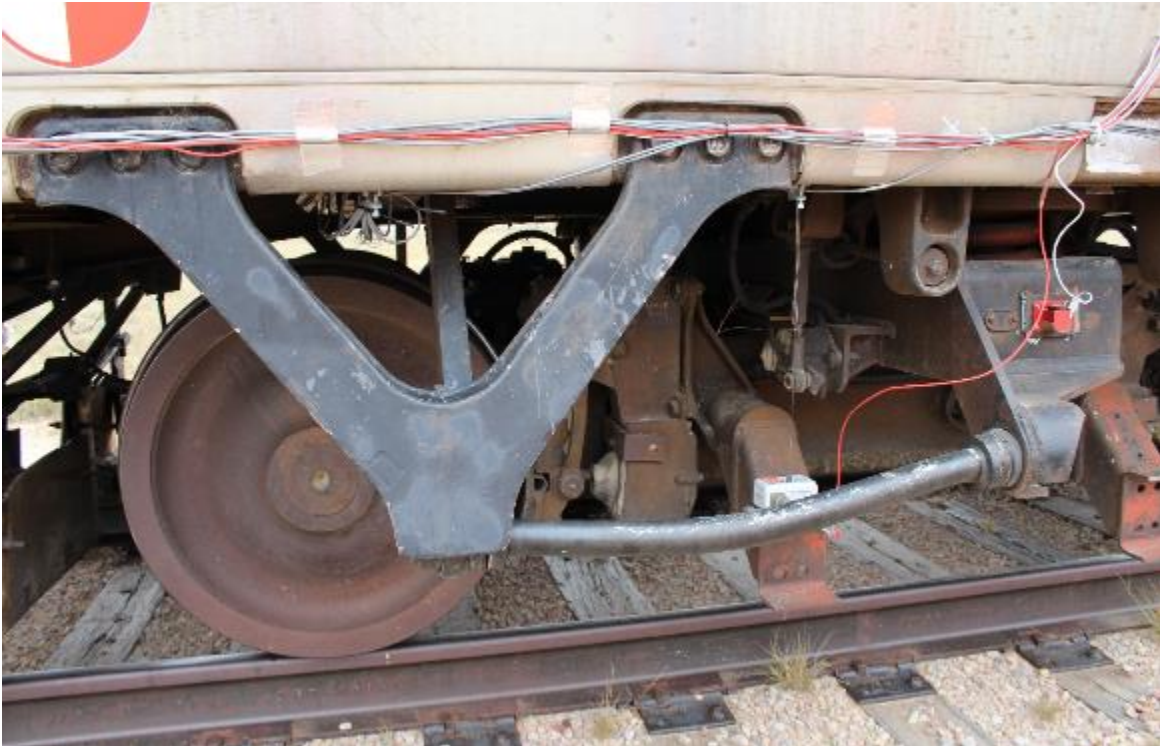
Figure 100. Bent Traction Rod after Fourth Test

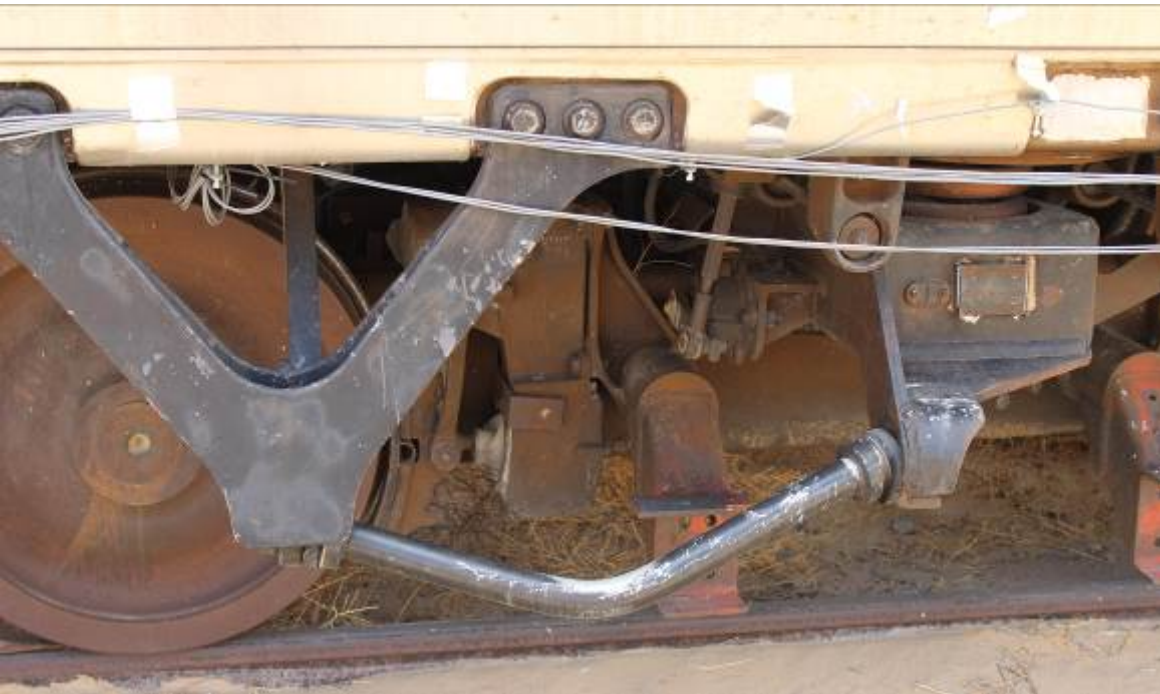
Figure 102. Bent Traction Rod after Sixth Test
