Emerald Sky Dairy Manure Spill Report**December 23, 2019 2019**

Inspection date: November 21, 2019

Operation Name: Emerald Sky Dairy

**Summary of Investigation:**

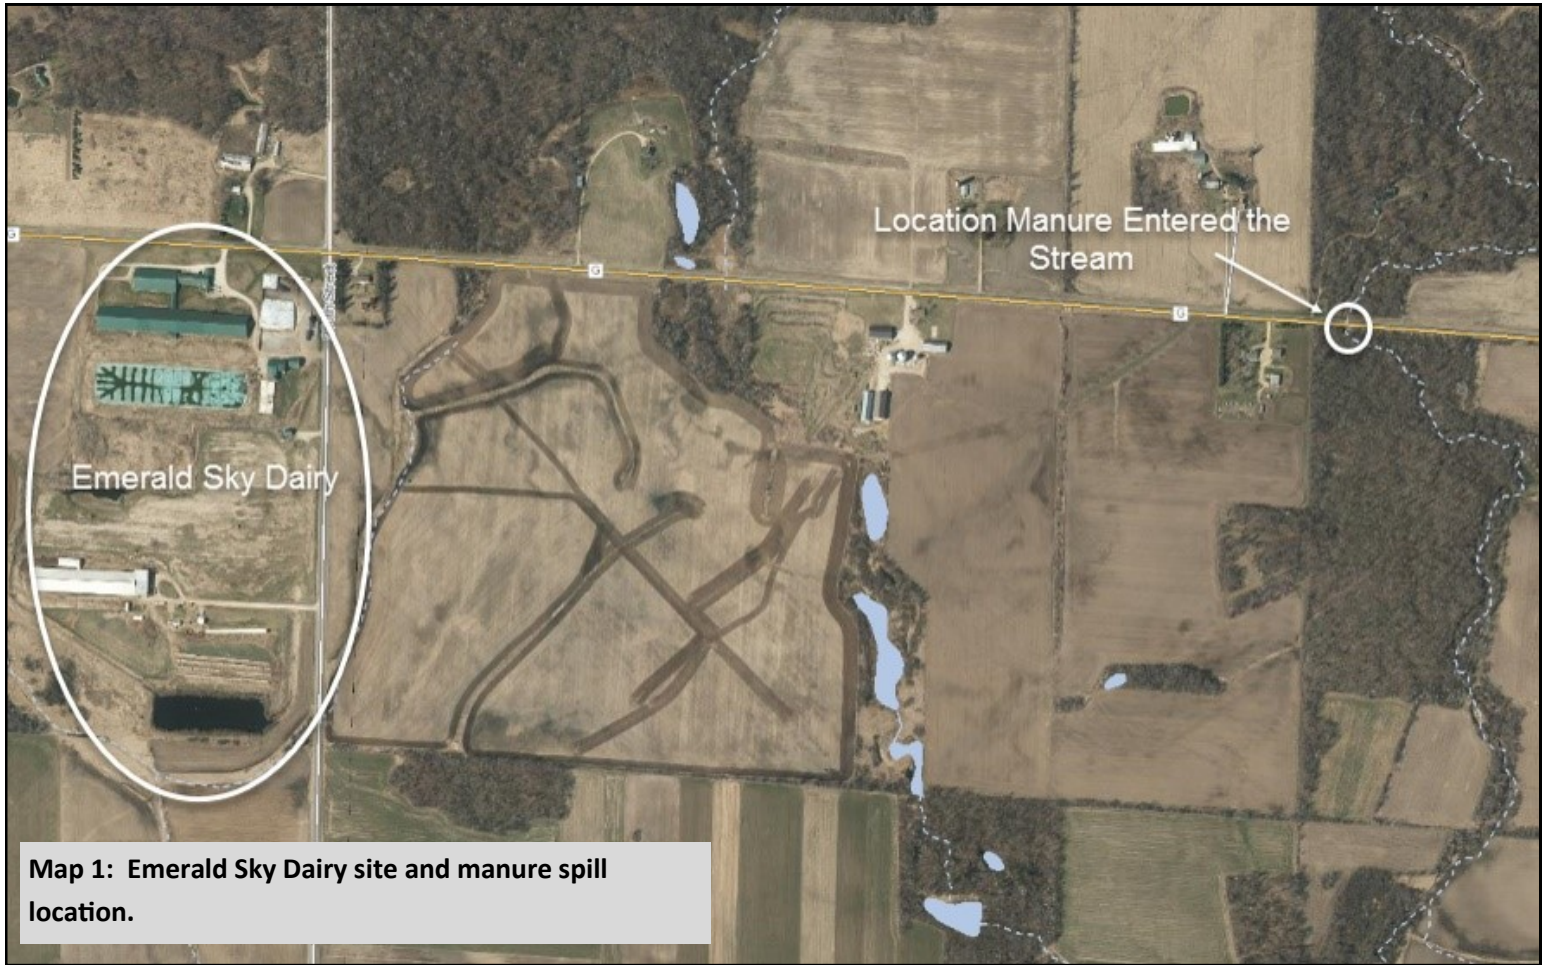
Map 1: Emerald Sky Dairy site and manure spill location.

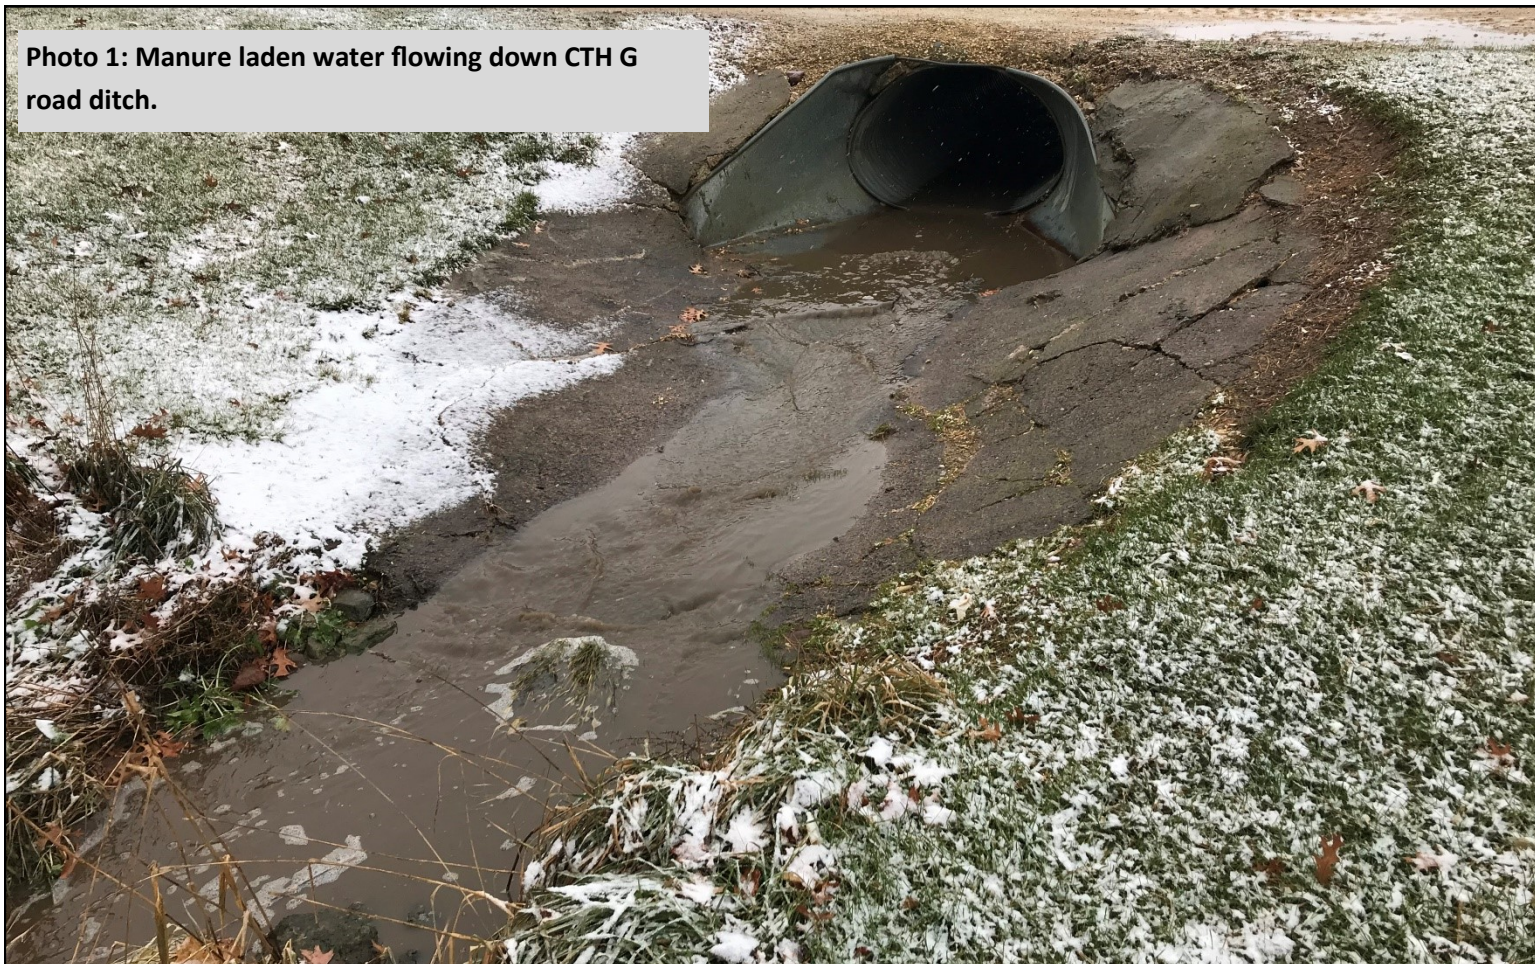
Photo 1: Manure laden water flowing down CTH G road ditch.

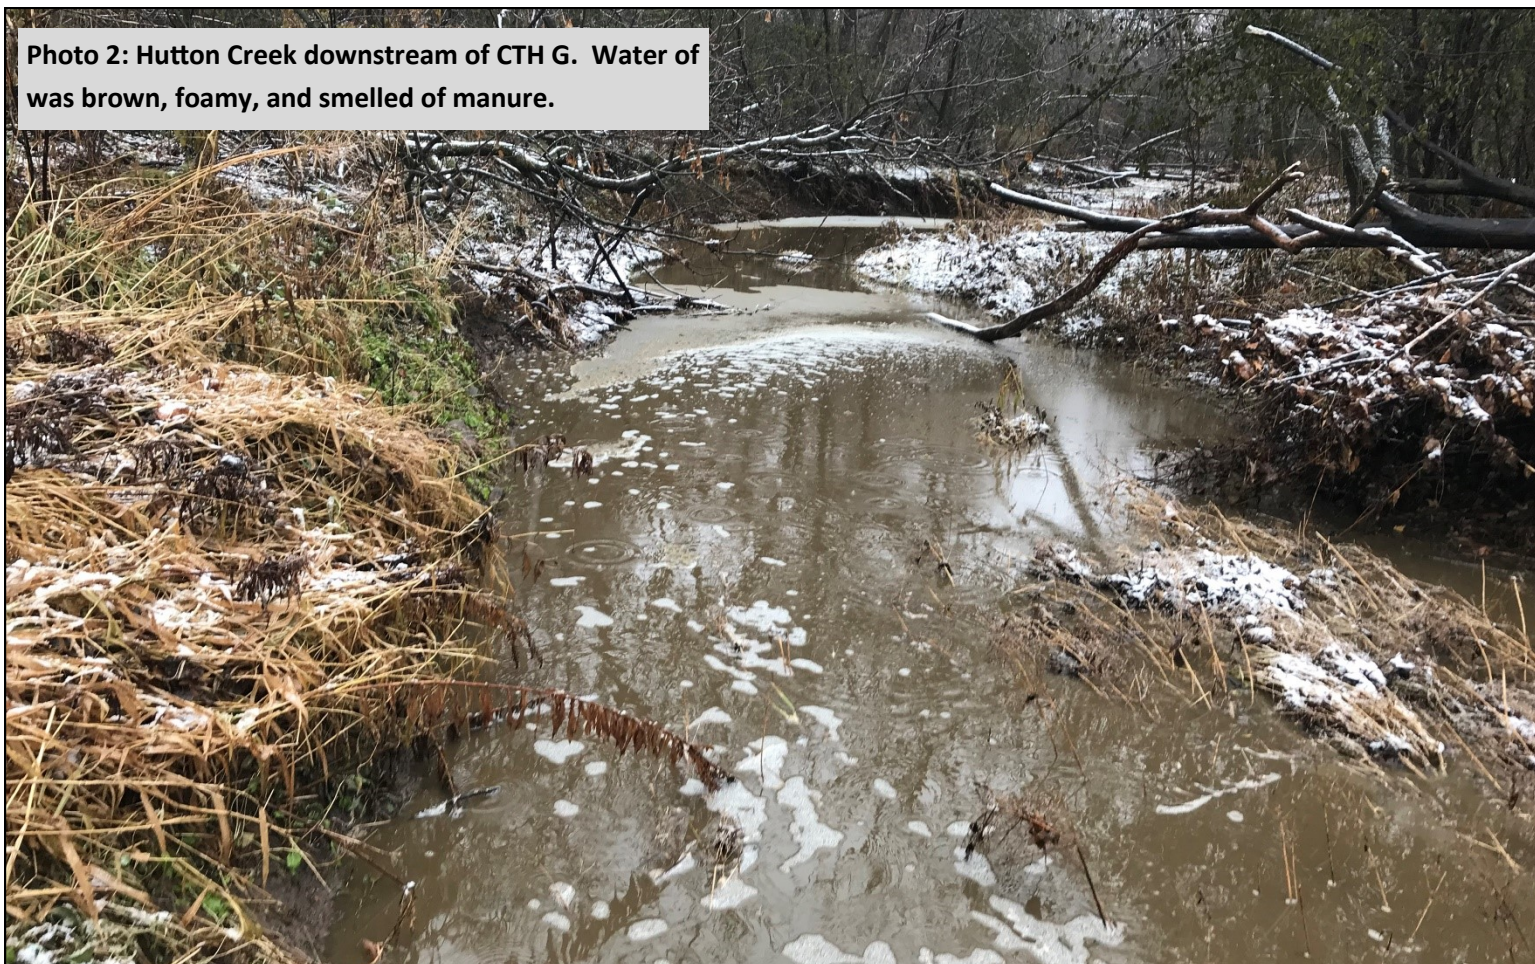
the confluence with the road ditch channel had low stream flow and was mostly covered with ice. The low stream flow allowed contaminated water to back-up, moving upstream approximately 30-40 meters. Water in Hutton Creek below the CTH G bridge had good flow due to additional inputs from the road ditch. Higher flows caused much of the manure water to flow over the top of existing ice sheets.

Photo 2: Hutton Creek downstream of CTH G. Water of was brown, foamy, and smelled of manure.

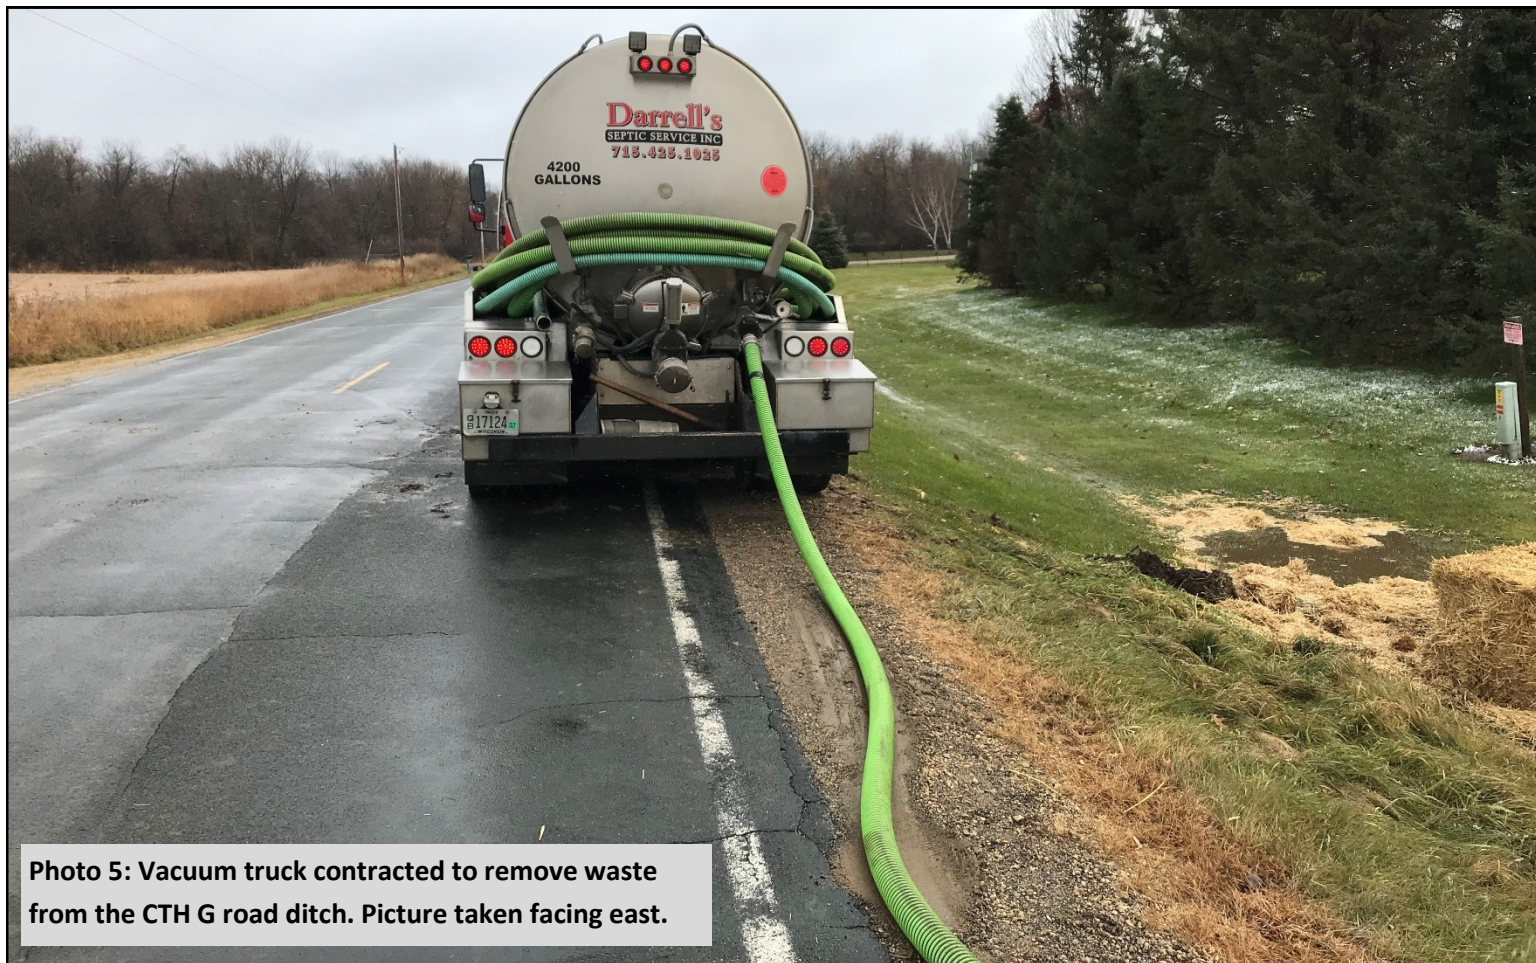
Photo 5: Vacuum truck contracted to remove waste from the CTH G road ditch. Picture taken facing east.

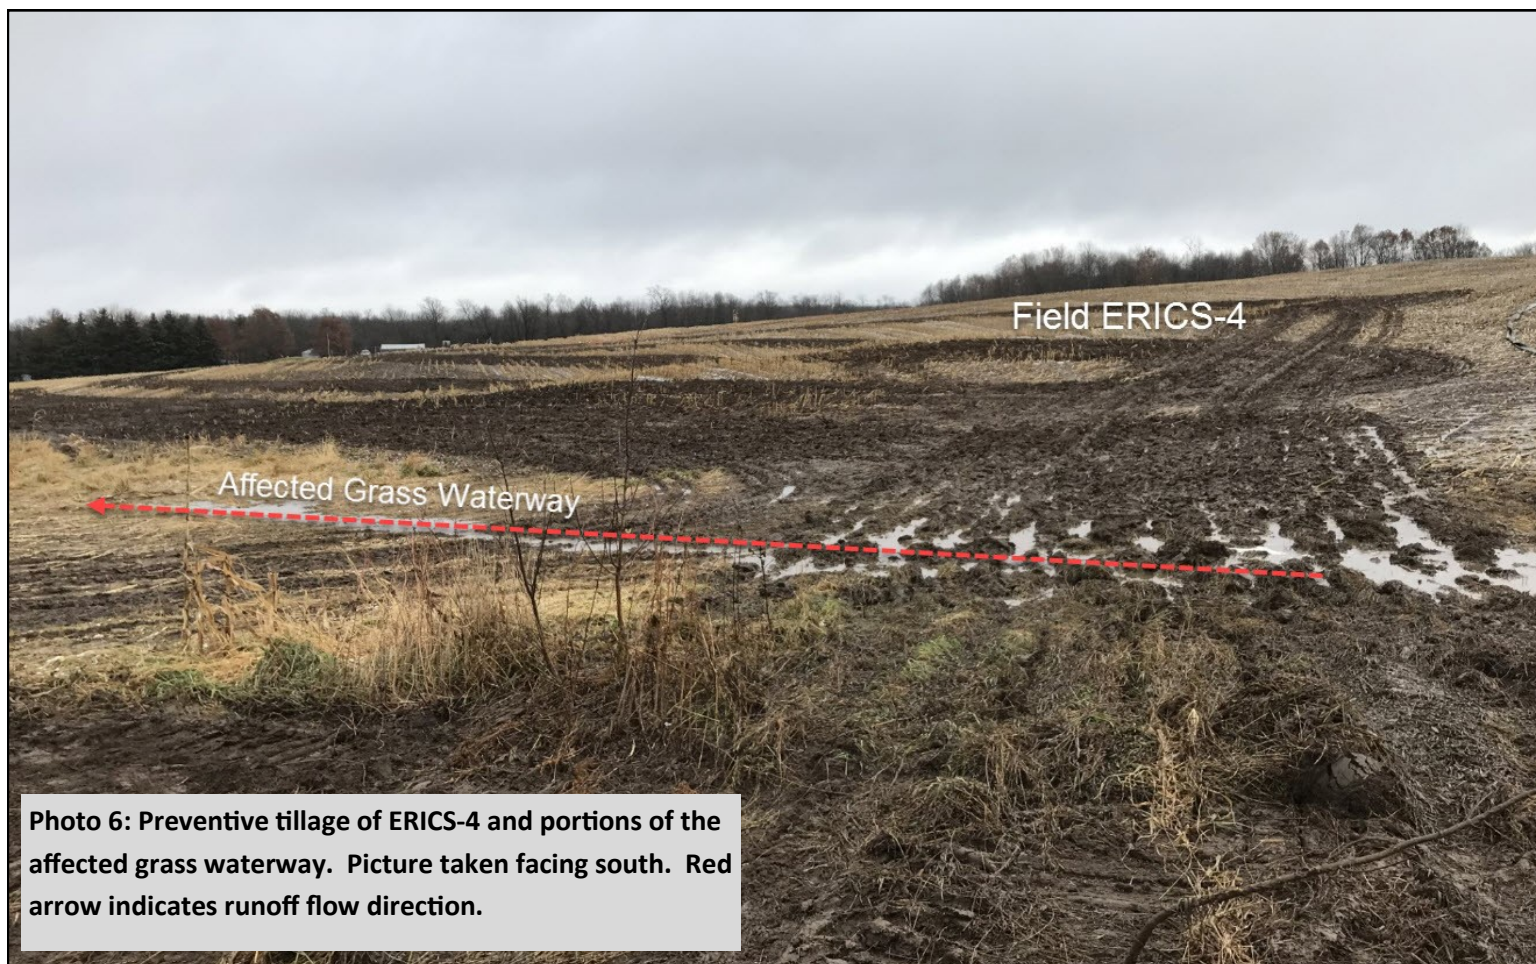
Photo 6: Preventive tillage of ERICS-4 and portions of the affected grass waterway. Picture taken facing south. Red arrow indicates runoff flow direction.

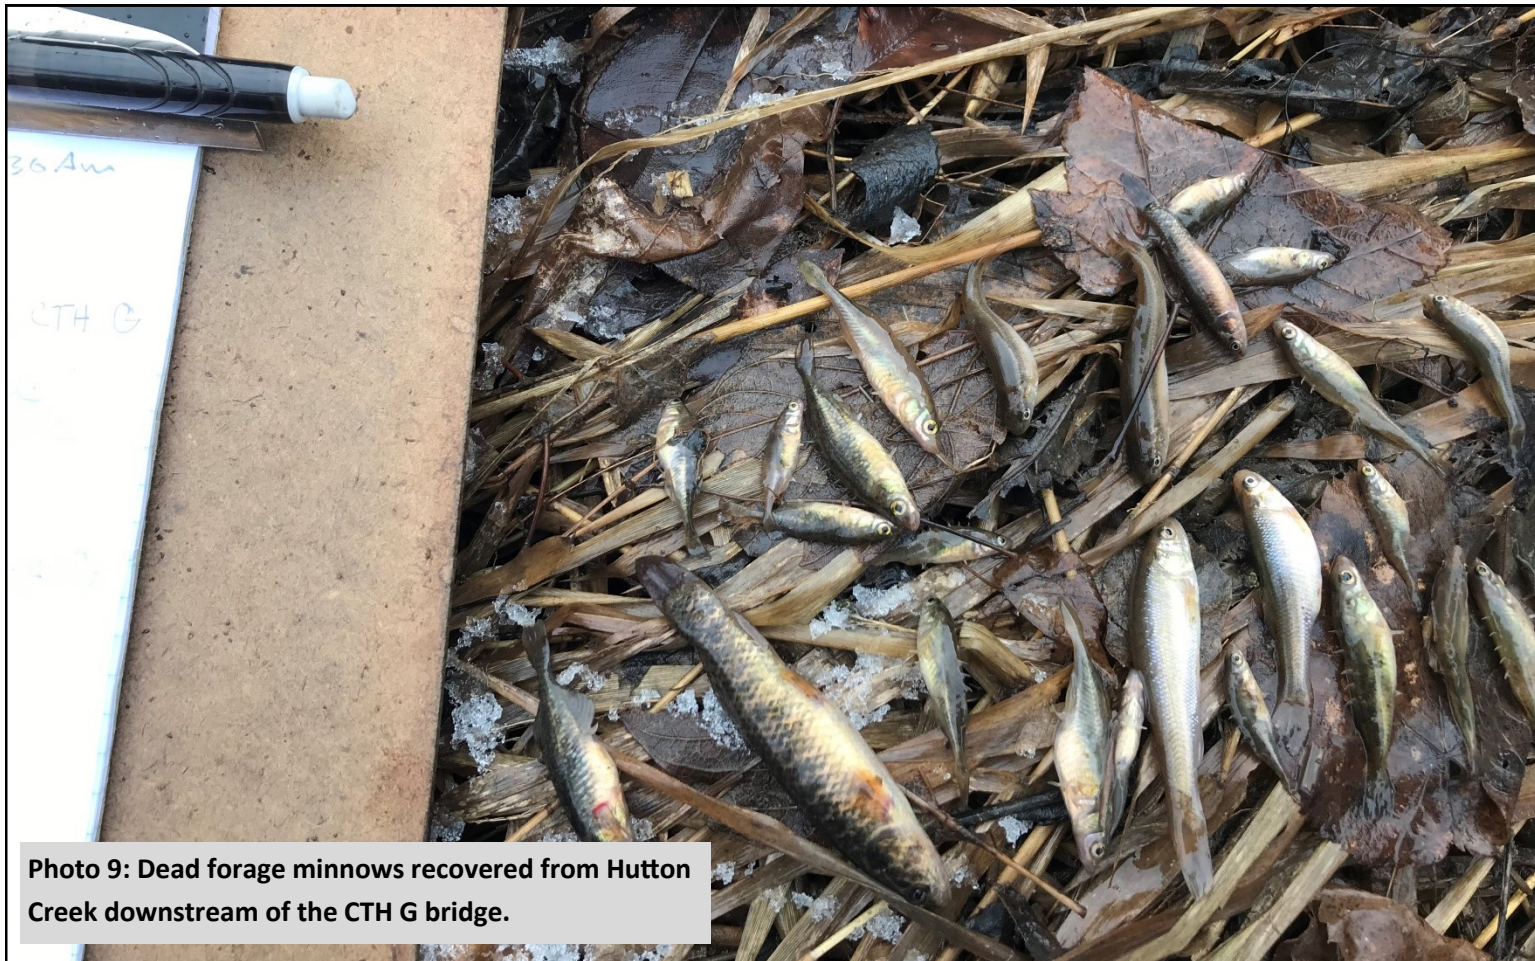
After further investigation of Hutton Creek downstream of CTH G, dead forage minnow species were observed within a shallow riffle approximately 10 meters downstream of CTH G bridge crossing. Approximately 24 dead minnows were discovered in this area. Minnow species included central mud minnow, fathead minnow, creek chub, and brook stickleback (photo 9-10).

Photo 9: Dead forage minnows recovered from Hutton Creek downstream of the CTH G bridge.

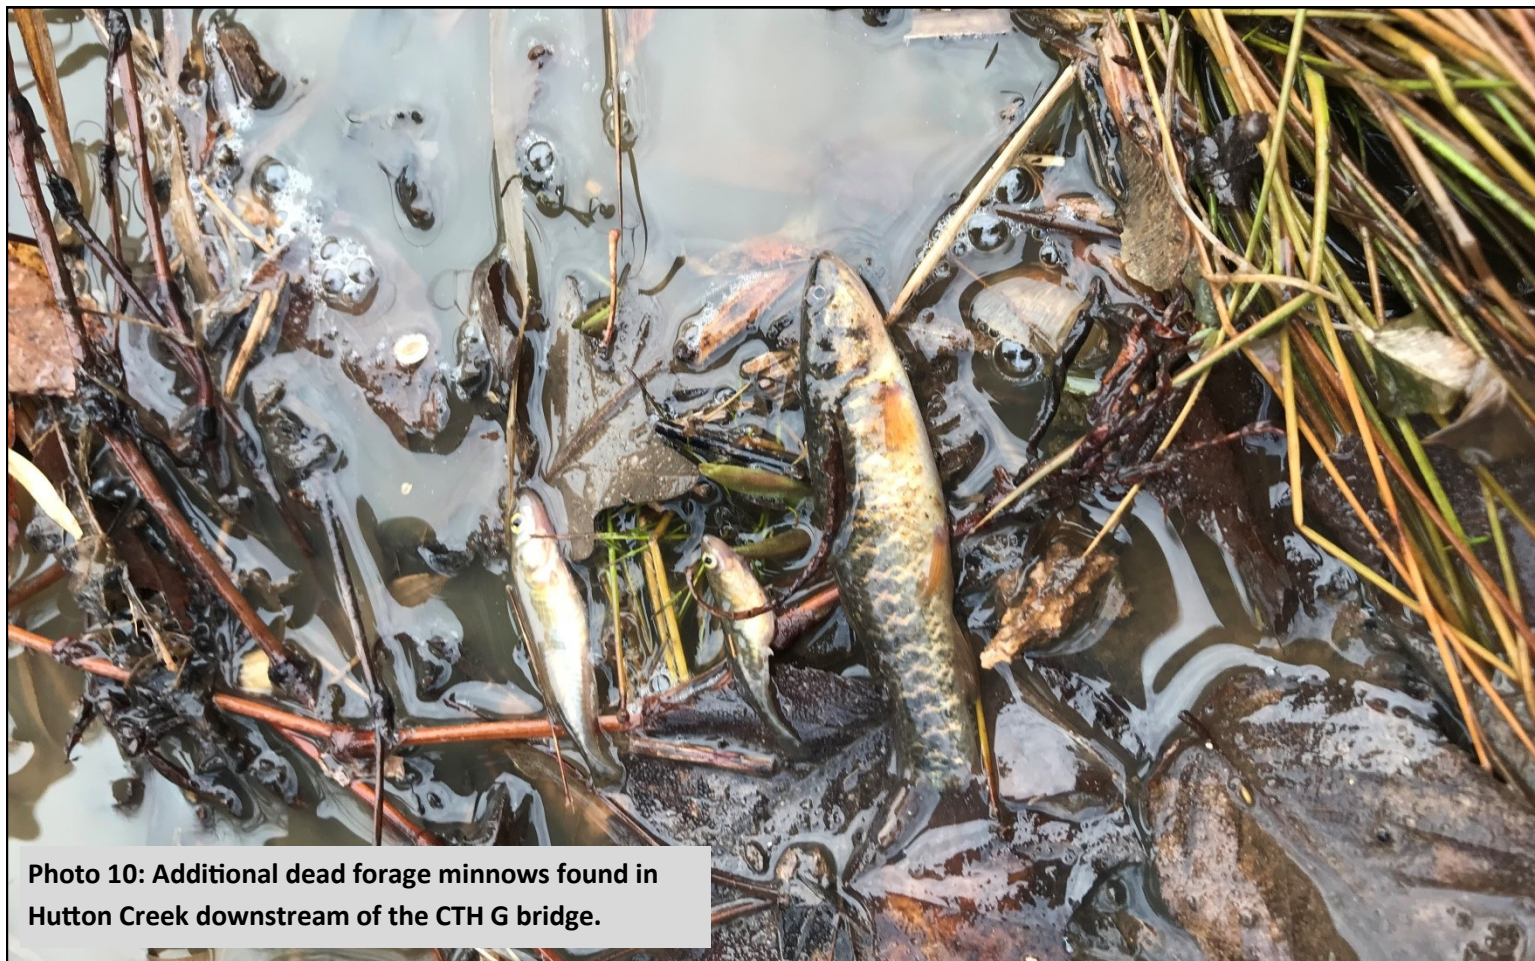
Photo 10: Additional dead forage minnows found in Hutton Creek downstream of the CTH G bridge.

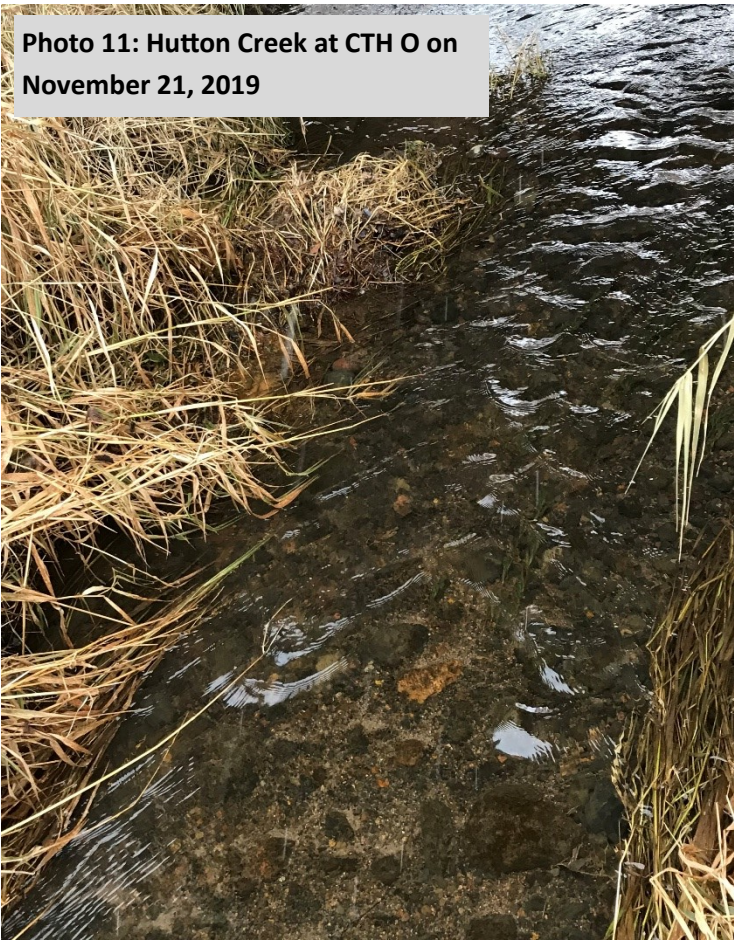
Photo 11: Hutton Creek at CTH O on November 21, 2019

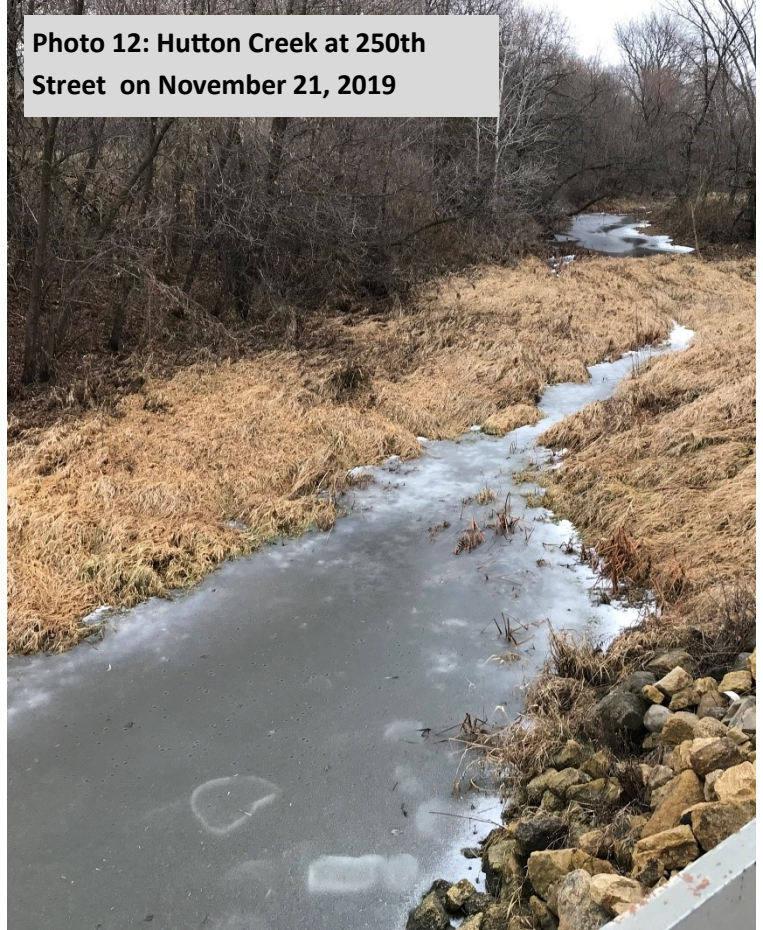
Photo 12: Hutton Creek at 250th Street on November 21, 2019

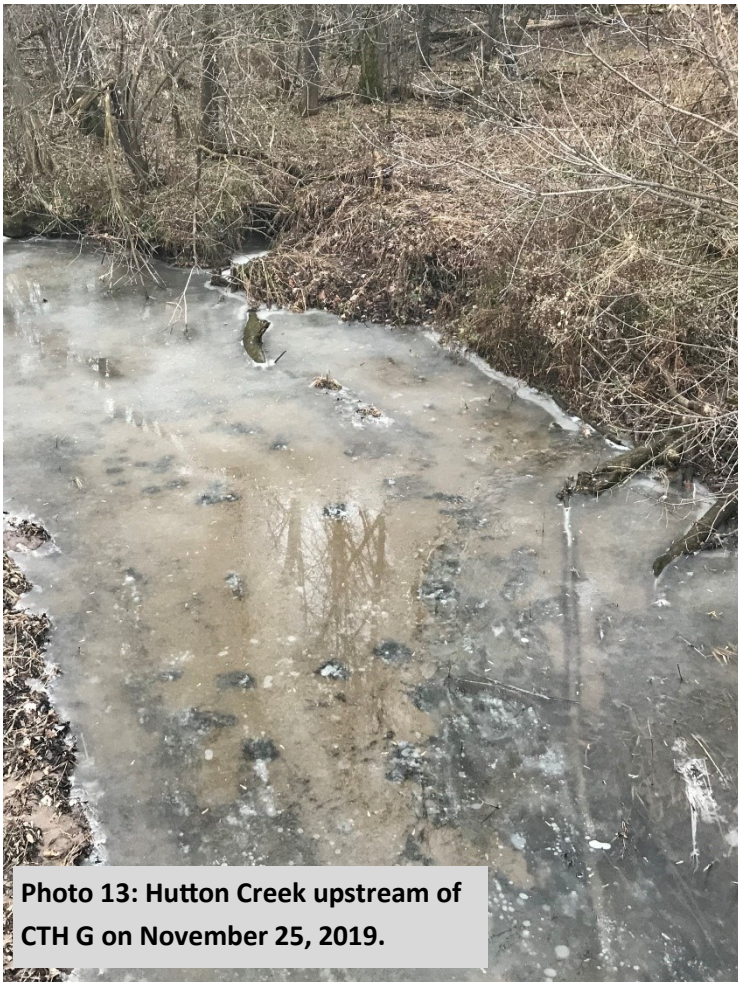
Photo 13: Hutton Creek upstream of CTH G on November 25, 2019.

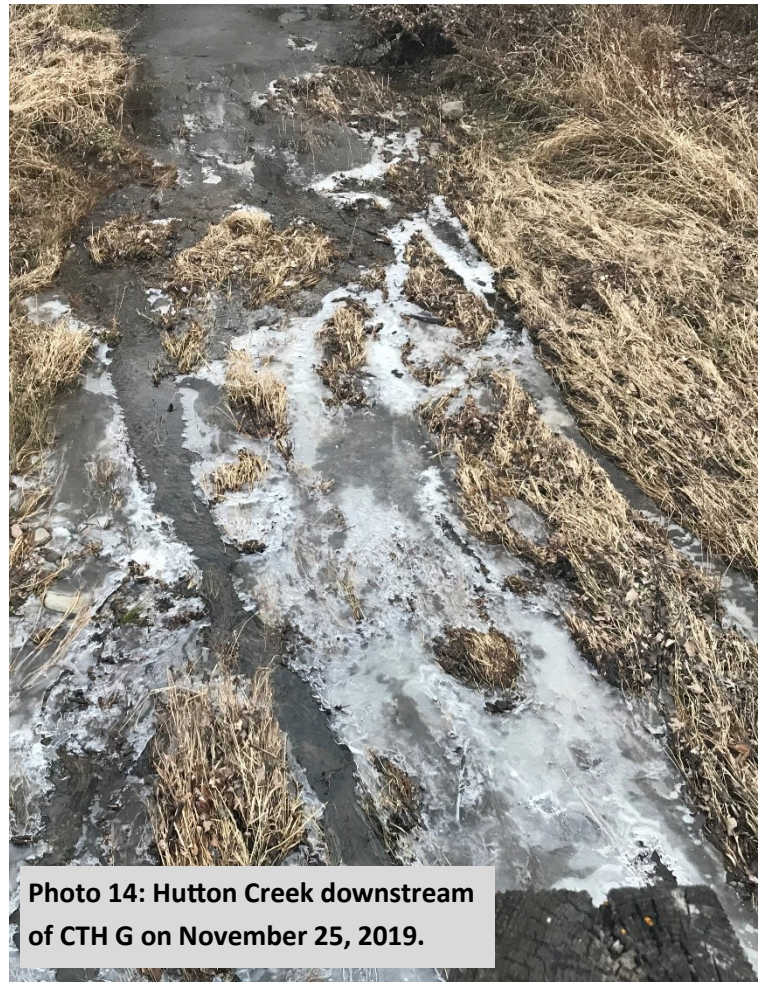
Photo 14: Hutton Creek downstream of CTH G on November 25, 2019.

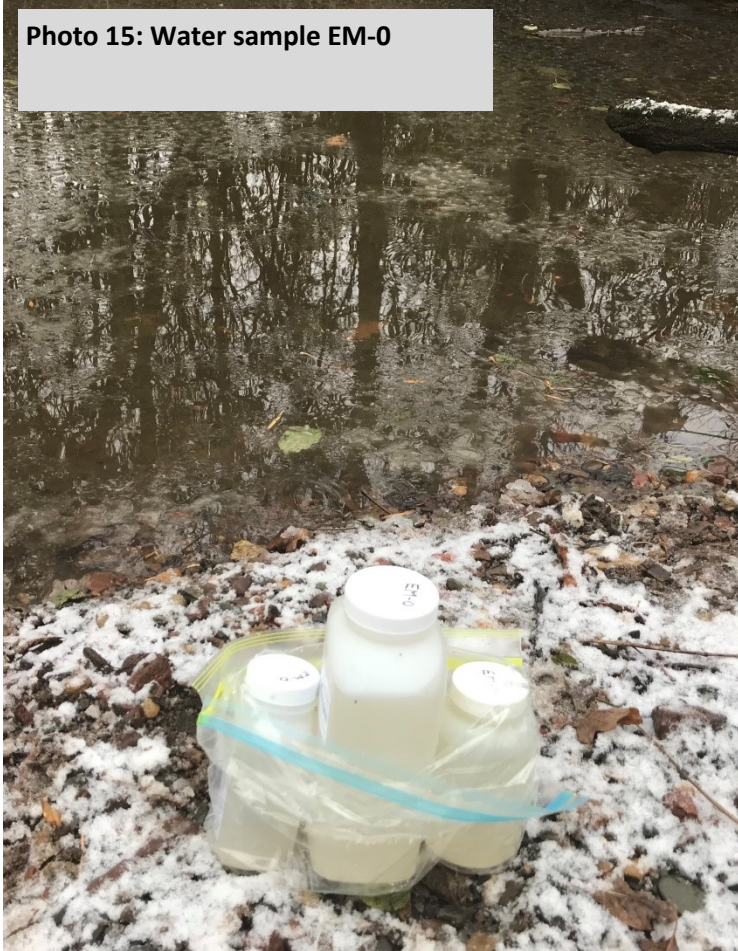
Photo 15: Water sample EM-0

- EM-0: sample taken on Hutton Creek approximately 60 meters upstream of CTH G bridge crossing. Water in this area appeared clear, with little stream flow. This sample served as a baseline water sample of the stream (photo 15)
- EM-1: sample taken from the CTH G road ditch flow channel approximately one meter upstream of the channel's confluence with Hutton Creek. Water was brown and smelled of manure (photo 16)
- EM-2: sample taken on Hutton Creek approximately 12 meters downstream of CTH G bridge crossing (photo 17)
- EM-3: sample taken on Hutton Creek approximately five meters upstream of the 170th Avenue bridge. Hutton Creek was clear, with good stream flow.

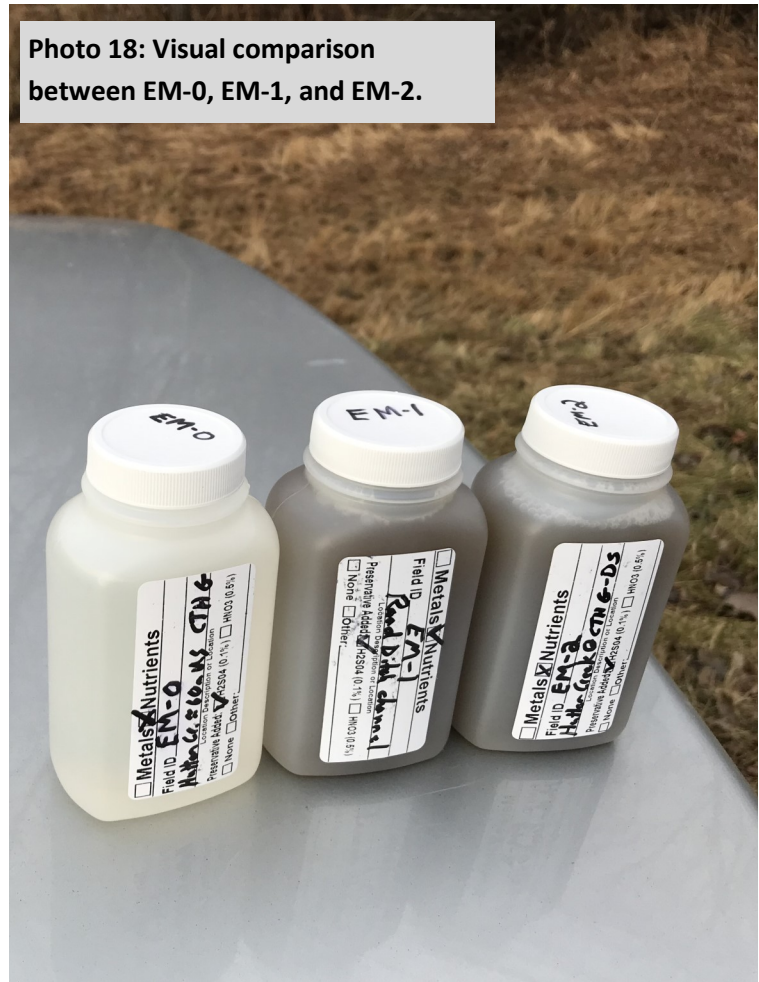
There are a significant difference in water clarity between EM-0, EM1, and EM-2 (photo 18). Water sample results at EM-1 and EM-2 exhibited high levels of bacteria, indicating the presence of waste. Nutrient analysis results for EM-0, EM-1, and EM-2 indicate levels which exceed surface water quality standards (see Appendix 3 for complete water sample results). It is possible waste had backed up to water sample location EM-0. While the water at this location appeared clear, results indicated higher than expected levels of bacteria and nutrients present.

Photo 18: Visual comparison between EM-0, EM-1, and EM-2.

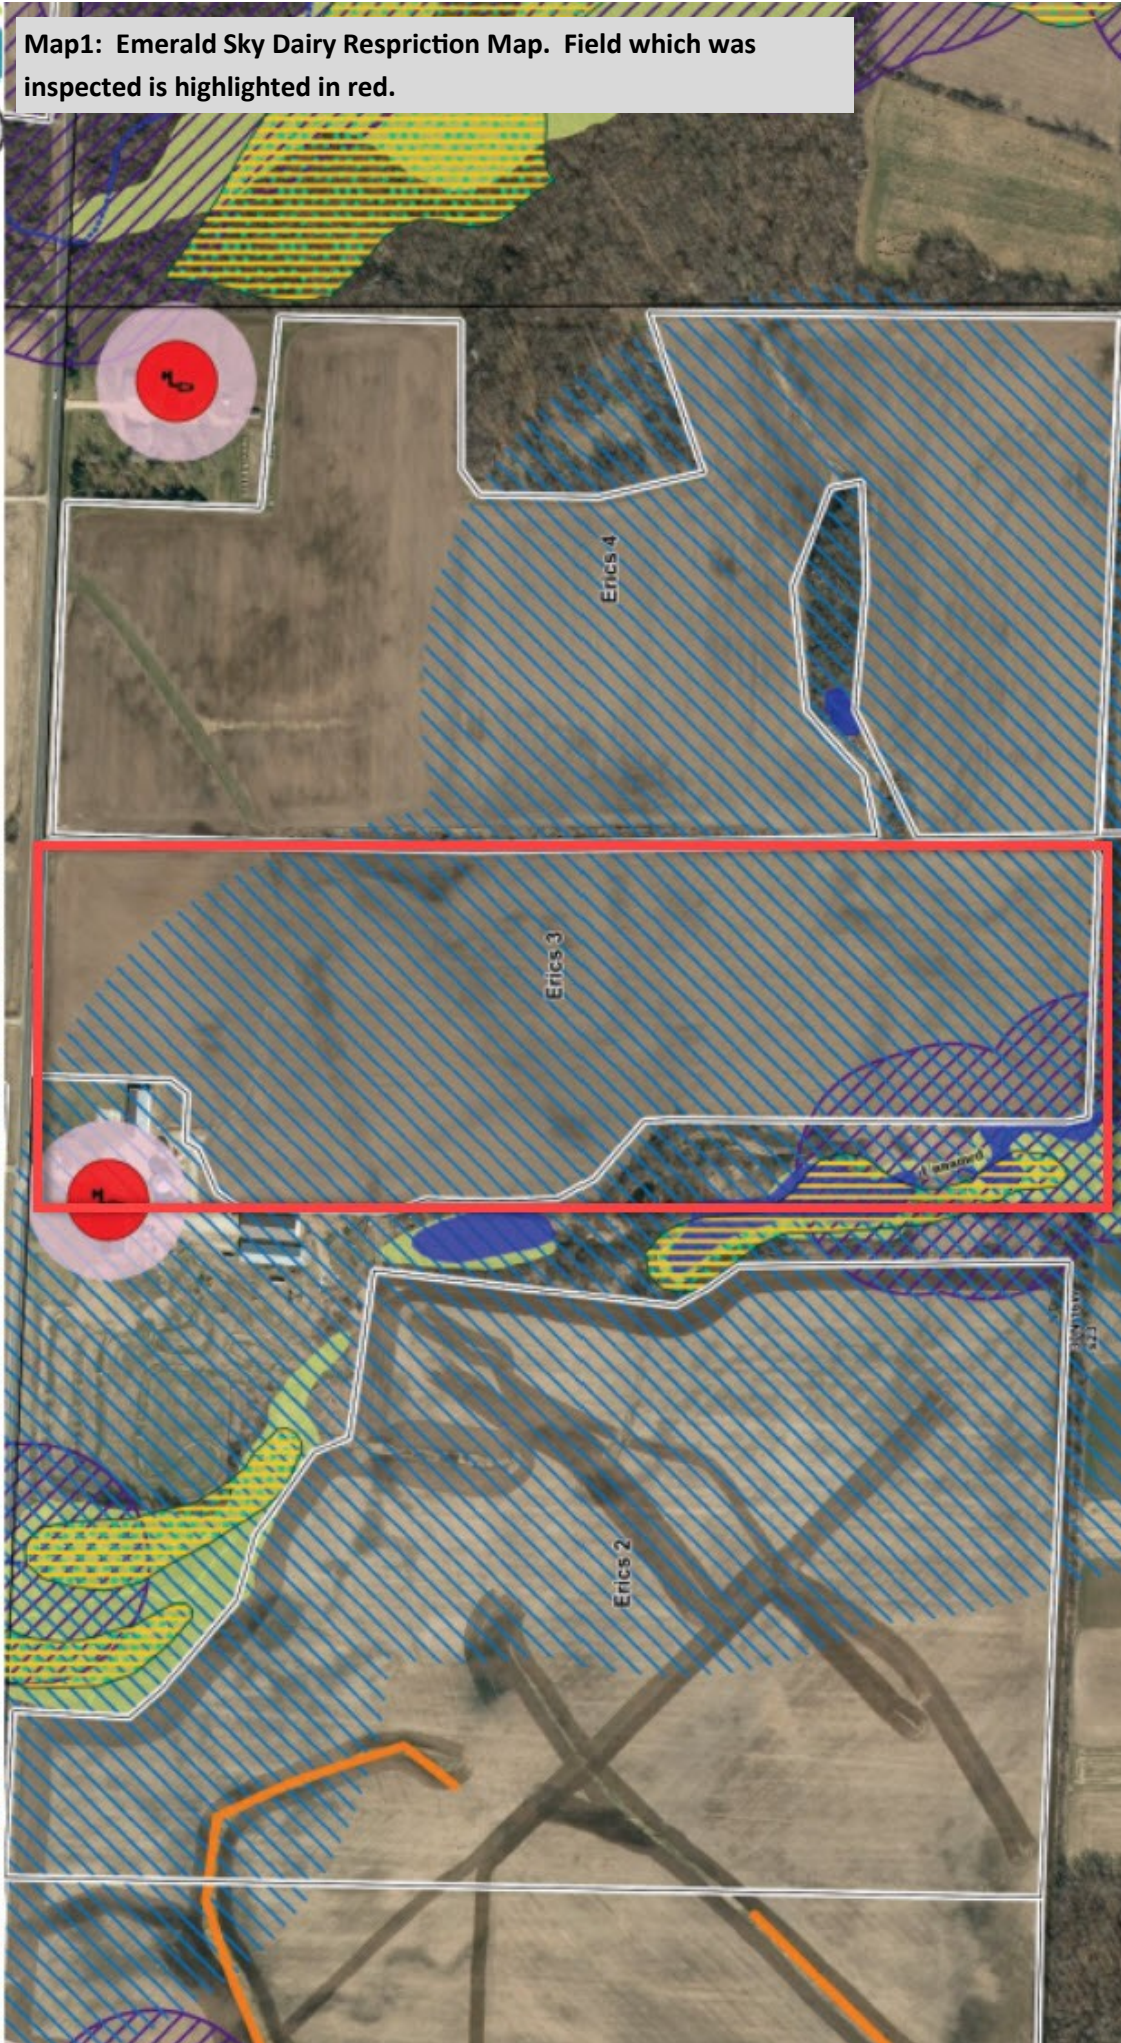
Map1: Emerald Sky Dairy Respriction Map. Field which was inspected is highlighted in red.

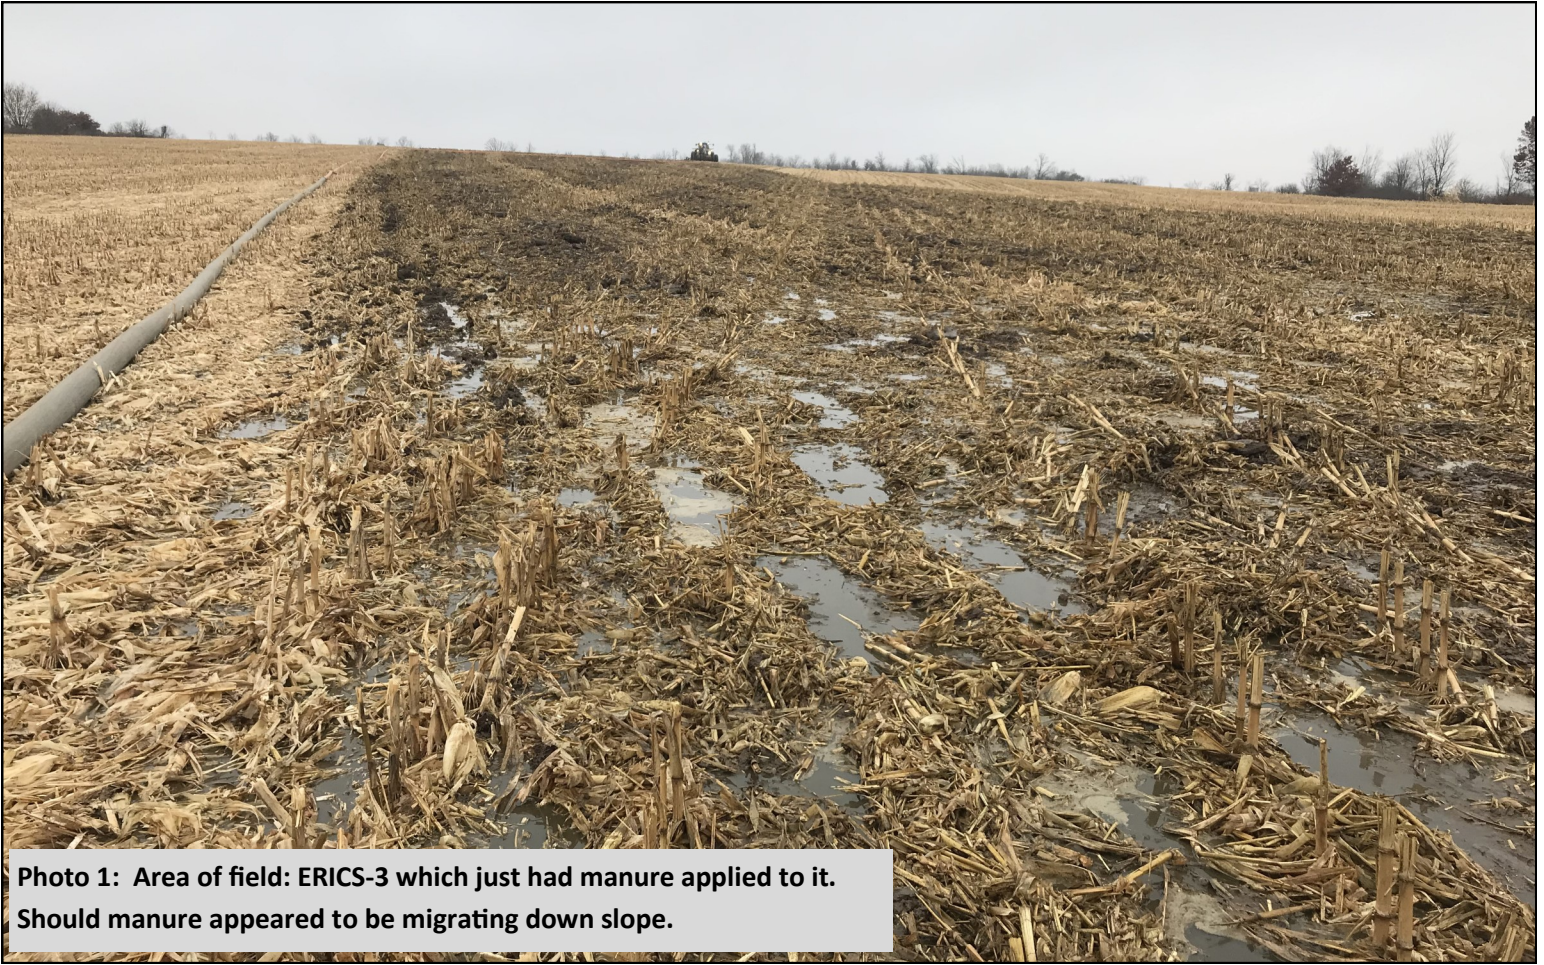
- Liquid manure was being spread at a rate of approximately 11,000—13,000 gallons per acre
- Some manure appeared to be migrating down gradient after been applied
- Soil was damp and somewhat stiff but did not appear frozen
- No noticeable soil erosion was observed within the field boundary
- The previous crop was corn for grain; field edges were harvested for corn silage
- Mooney reviewed the Dairy's manure application protocols with the manure hauler.
- The area was forecasted for precipitation within the next 24 hours

Photo 1: Area of field: ERICS-3 which just had manure applied to it. Should manure appeared to be migrating down slope.

Due to manure movement in the field after application, Jackson requested the dairy reduce application rates and conduct additional tillage along the field boundary and low-lying area . The dairy agreed to the request and immediately reduced application rates; Jackson left the site shortly after.

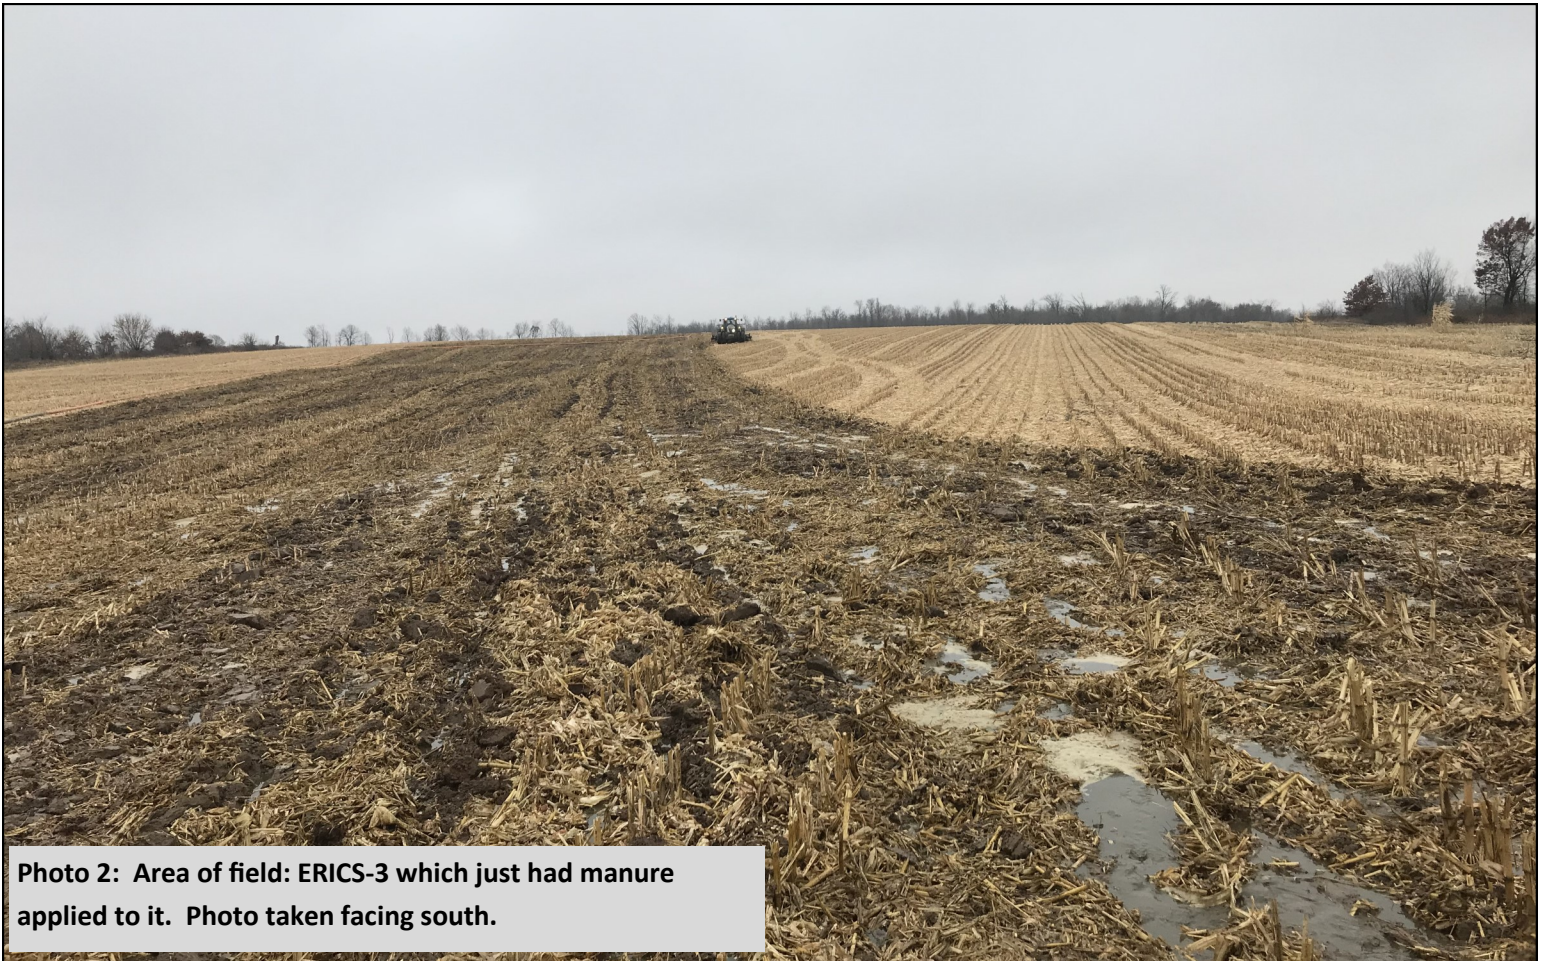
Photo 2: Area of field: ERICS-3 which just had manure applied to it. Photo taken facing south.
