# Use of Maps, Aerial Photographs, and other Remote Sensor Data for Practical Evaluations of Hazardous Waste Sites

John Grimson Lyon

Department of Civil Engineering, The Ohio State University, Columbus, OH 43210

**ABSTRACT:** Aerial photographs and remote sensor data were used to identify and inventory hydrologic, soil, and vegetative conditions indicative of hazardous waste sites. Several papers and their results demonstrate the utility of these data and techniques for engineering applications. A combination of aerial photos, remote sensing, maps, and advanced evaluation techniques provided more information than traditional engineering techniques alone.

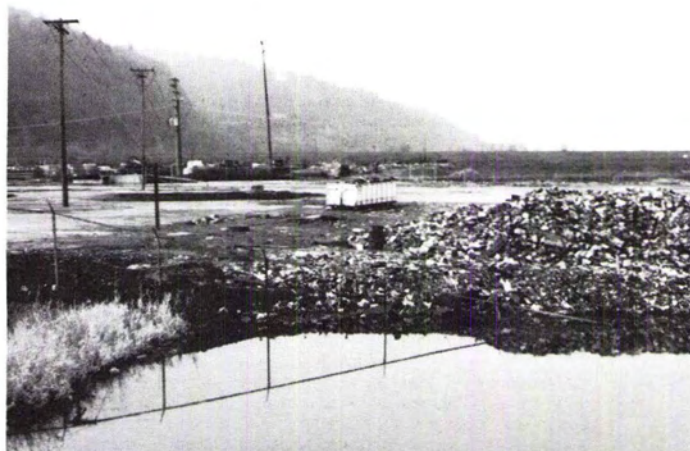
FIG. 1. Piles of car batteries over-fill areas of Doane Lake, Oregon. The December 1983 View looks to the west.

The Doane Lake "super-fund" hazardous waste site of industrial northwest Portland, Oregon provided an example of the value of historical maps and photos for evaluation of landfills. Wastes were buried in the lake or marsh for more than 40 years, and now only an asphalt-covered surface is evident from the ground (Figure 1). Contributions to the lake included chemicals and waste from production of the herbicide 2,4-D, and creosote and chlorine. Sampling of surface and ground water adjacent to the site has indicated the presence of phenols, 2,4-D, lead, and other contaminants, including spent casings and pieces of lead cathodes from car batteries (Figure 1).

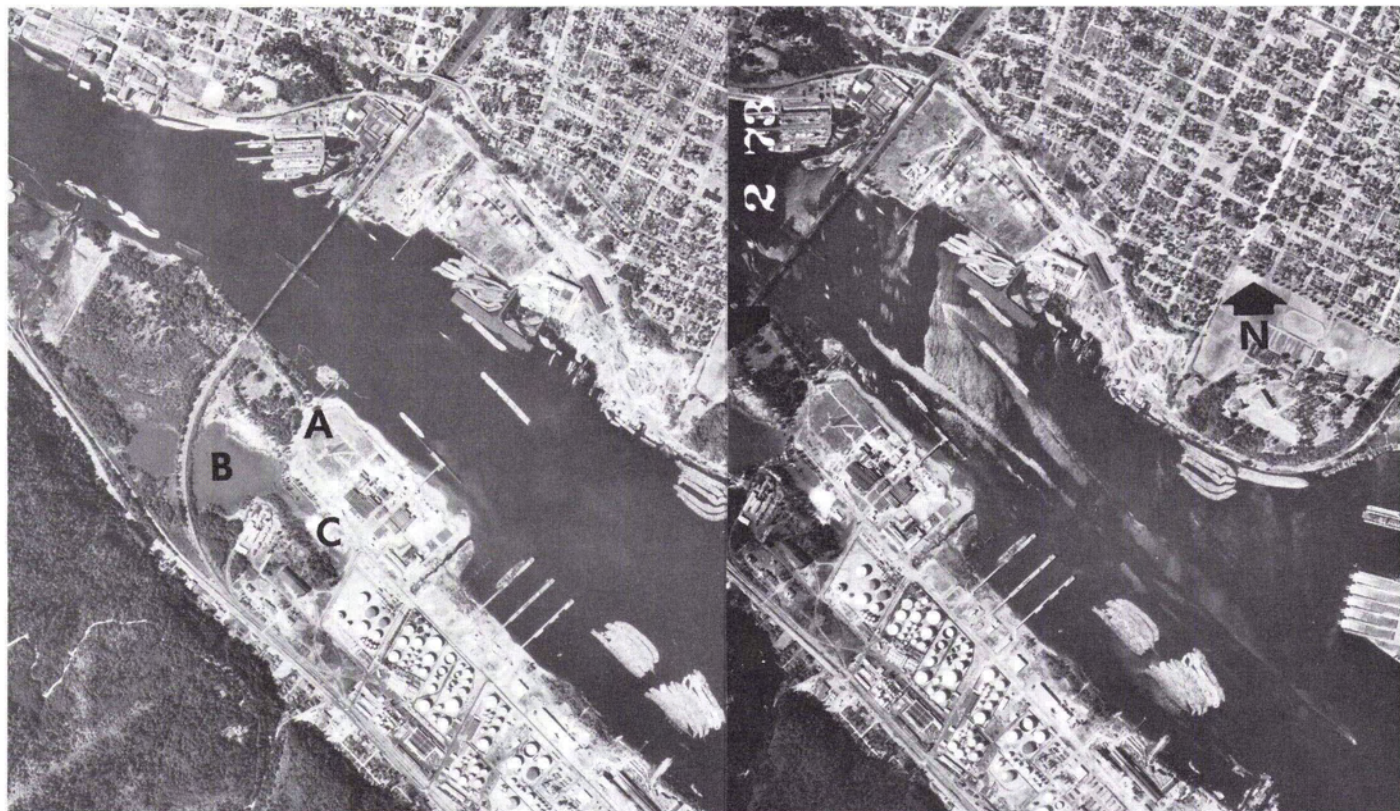
FIG. 2. 1951 aerial photograph of Doane Lake (original scale was 1:20,000). Note presence of drainage connecting the lake to the Willamette River (A), the lake east of the railroad bridge (B), and the bare area at the east end of the lake (C).

Analysis of an orthophoto map from 1975 (1:24,000 scale) and field visits from 1982 to 1985 provided few indicators of a large fill (Figure 3). 1:24,000 scale maps and historical aerial photos for 1951 (July 26) and 1970 (July 5) show the change in area of soil and vegetative cover on the site (Figures 2 and 3).

approximately 8.7 Ha before 1951, with the filling beginning at the east end (Figure 2). In 1970 a map and photo showed additional fill and a diminished surface area measuring approximately 4.8 Ha (Fig. 3). By 1970, 55 percent of the lake east of the railroad bridge had been largely filled.

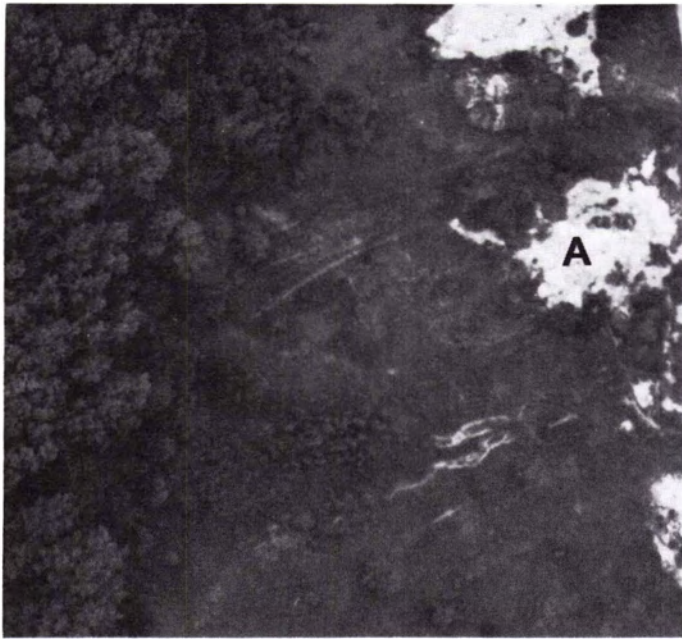
FIG. 4. Low altitude aerial photos of a closed landfill in Ohio (September 1984, original scale, ~ 1:1,000). White toned areas are bare of vegetation and are locations of surface runoff.

Barren areas devoid of vegetation appear lighter in tone, indicating mineral soil. This tone is also characteristic of disturbed soil which can indicate a path for surface runoff. Figure 4 shows an abandoned landfill in Ohio where light tones indicate the path of surface runoff. Also, note the dark tone of plants as compared to areas without any plant cover (A).

A relatively low cost approach is to employ 35-mm or video cameras to photograph waste sites from a rented aircraft. Another cost-efficient method is to obtain a camera mount to acquire vertical or oblique coverage (Figures 4 and 5). These 35-mm or video systems are valuable, low cost, and quantitative approaches for acquisition of data (McCarthy *et al.*, 1982; Lyon and Drobney, 1984). In addition, these systems can be rapidly deployed to photograph sites as required.

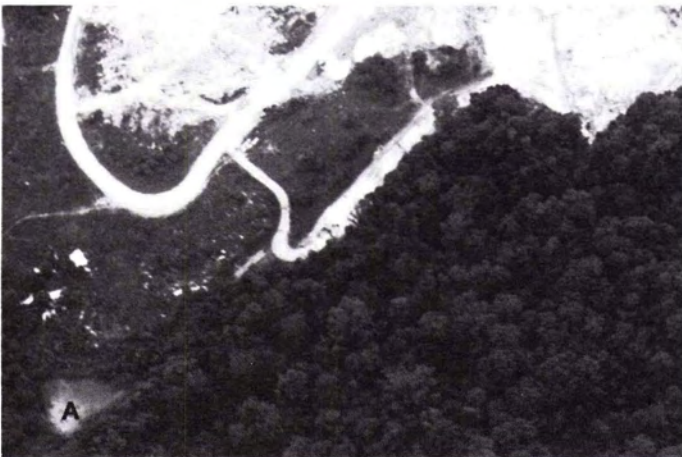
FIG. 5. Low altitude aerial photo of an open landfill in Ohio (September 1984, original scale, ~ 1:1,500). Note location of a pond formed of runoff from the pit (A).

Figure 5 shows a pond of leachate that was not evident from ground inspection (A). Conditions indicative of the movement of leachate included the pond, and low density of vegetation on the berm surrounding the landfill. Identification of these conditions was facilitated by the aerial view, revealing features which initially went unnoticed during field inspection.

Departures from the local sequence of vegetation succession and the resulting absence of vegetation or lower relative abundance of plants on a given site are suspect. An abandoned site which is currently and historically in "weedy or barren" cover has not experienced the sequence of weed, shrub, and forest cover. Commonly, a human-induced problem interrupts the progression and creates an anomalous vegetative condition (Figure 5). These sites can be identified from aerial photos and later evaluated by on-site inspection.
