## INTRODUCTION

- 12.1 This Chapter of the Environmental Impact Assessment Report (EIAR), commissioned by SLR Consulting Ireland on behalf of Kilsaran Concrete addresses the impacts on the archaeological, architectural and cultural heritage of the application site and the surrounding area of a proposal to backfill the existing quarry void at Ballinclare, near Kilbride, Co. Wicklow by importing and landfilling inert soil and stone waste and to restore the backfilled lands thereafter to long-term heathland / grassland habitat, similar to that which existed prior to quarrying. The company also proposes to establish and operate a construction and demolition (C&D) waste recovery facility and a soil washing plant at the same location to produce recycled (or secondary) aggregate. The application site and study area are shown in Figure 12-1.

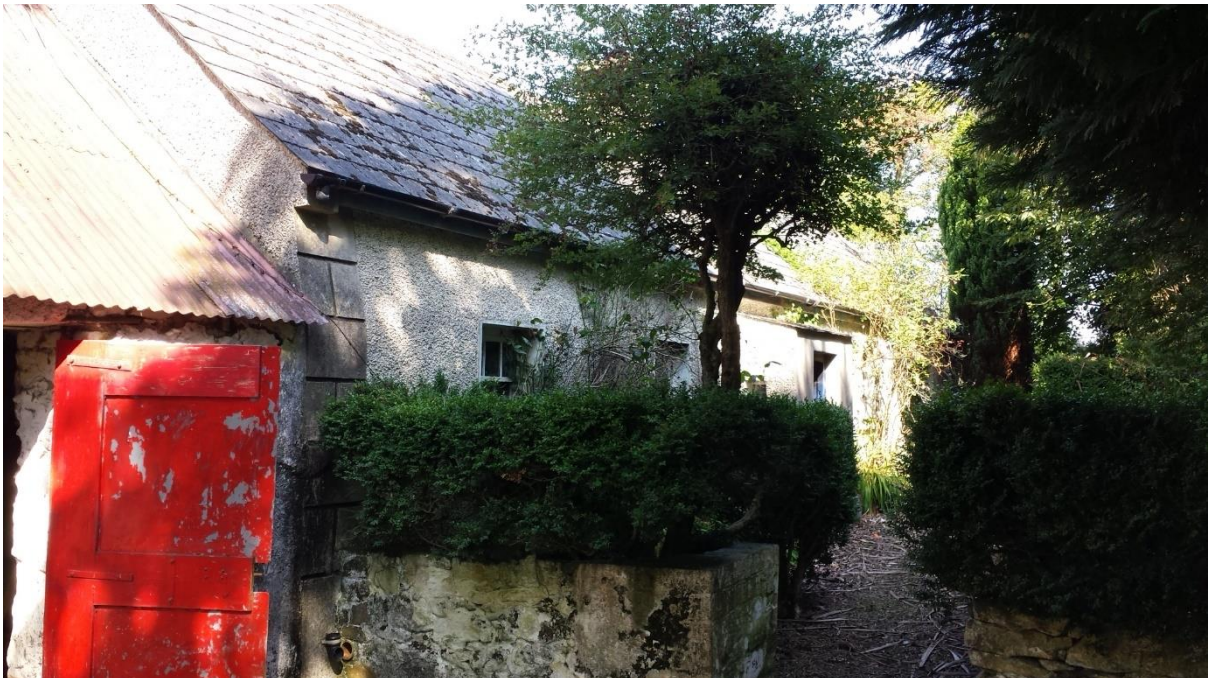
**Plate 12-2**  
**View of Structure 2 looking north**

Type of impact:	None
Significance/quality of impact	None
Description	Six-bay single storey cottage with corrugated roof and single chimney. All original windows replaced with uPVC. Cottage and single outbuilding are visible on the OS 1st edition map.
Mitigation proposal	No mitigation required
Photos:	See Plate 12-1
No.	2
Structure type	Cottage
Townland	Carrigmore
Designation	None
Data source	1910 edition of the six-inch Ordnance Survey mapping
Perceived Significance:	None
Type of impact:	None
Significance/quality of impact	None
Description	Four-bay single storey cottage with slate roof and concrete porch surround. Building is indicated on the OS 1st edition map.
Mitigation proposal	No mitigation required
Photos:	See Plate 12-2

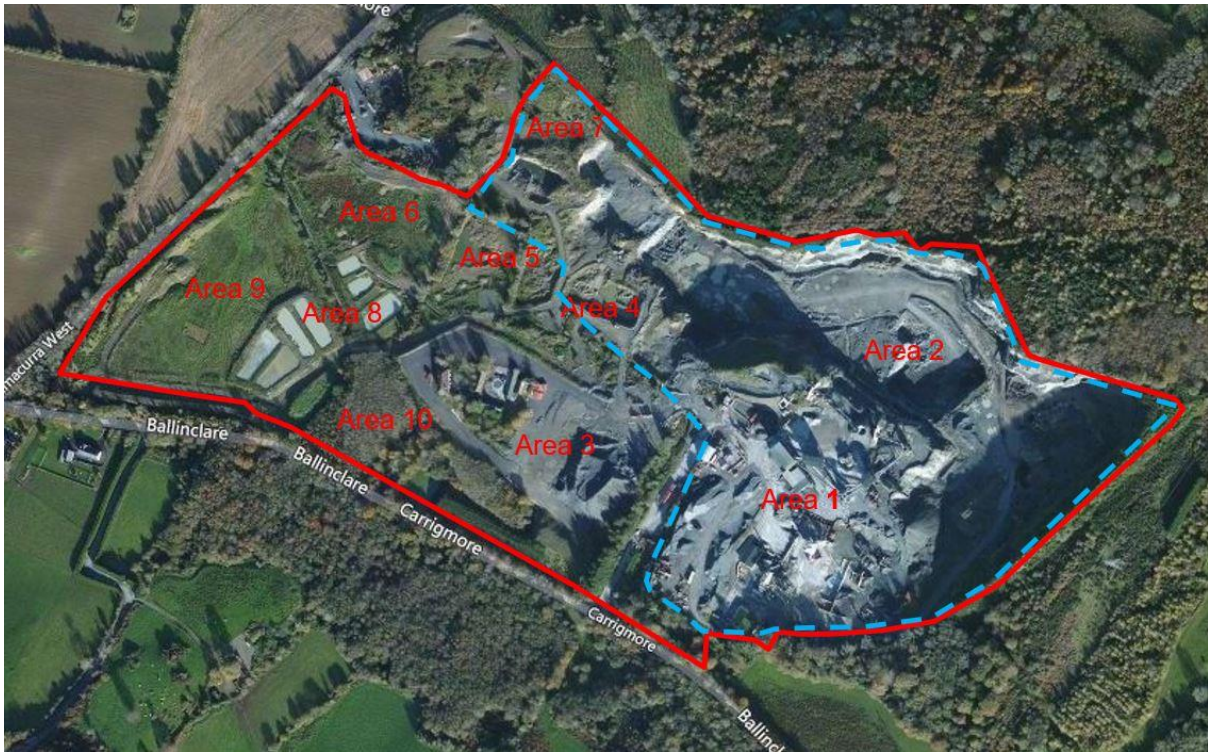
**Plate 12-3**  
**Application site (Red) and Numbered Fieldwork Areas**

12.42 On the 11<sup>th</sup> of September 2014 fieldwork was previously carried out to identify any additional non-designated structures in the vicinity of the application site. This involved assessing all upstanding structures that are marked on the 1910 edition of the six-inch Ordnance Survey mapping within 100m of the application site (refer to Figure 12-1). There are two upstanding structures in this area.

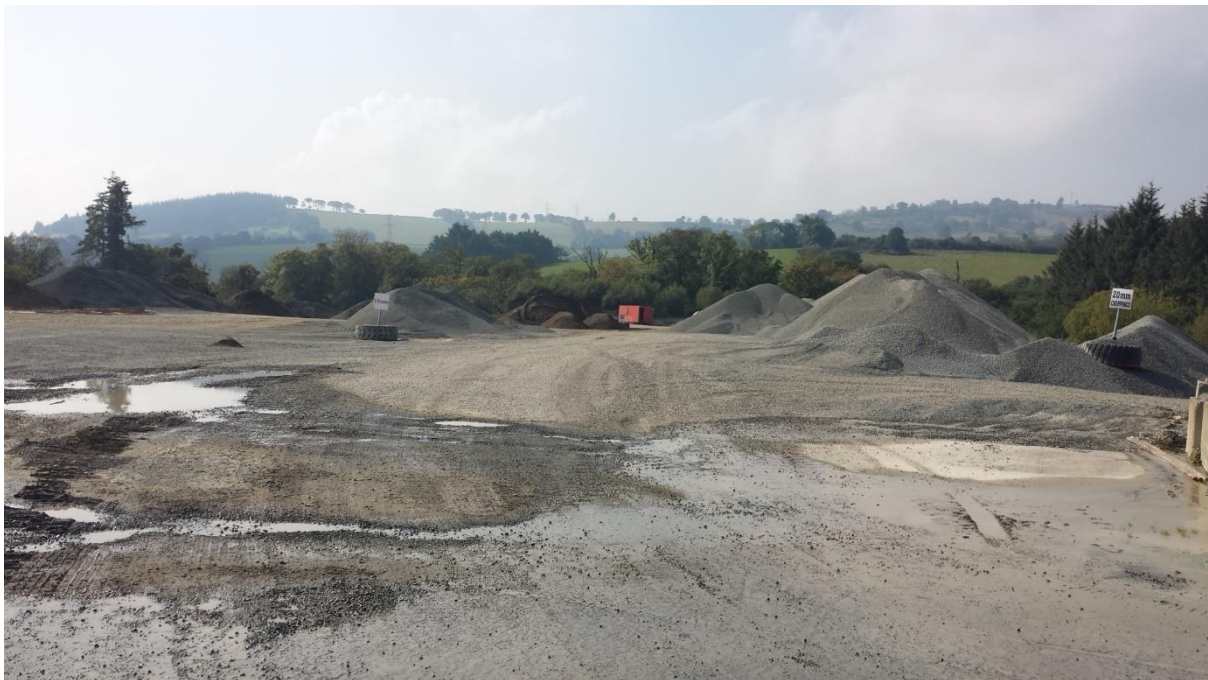
12.58 A field inspection was previously undertaken on the 11<sup>th</sup> of September 2014. This involved an inspection of all the lands within the application site. The location of the fieldwork areas referenced below are numbered on Plate 12-3.

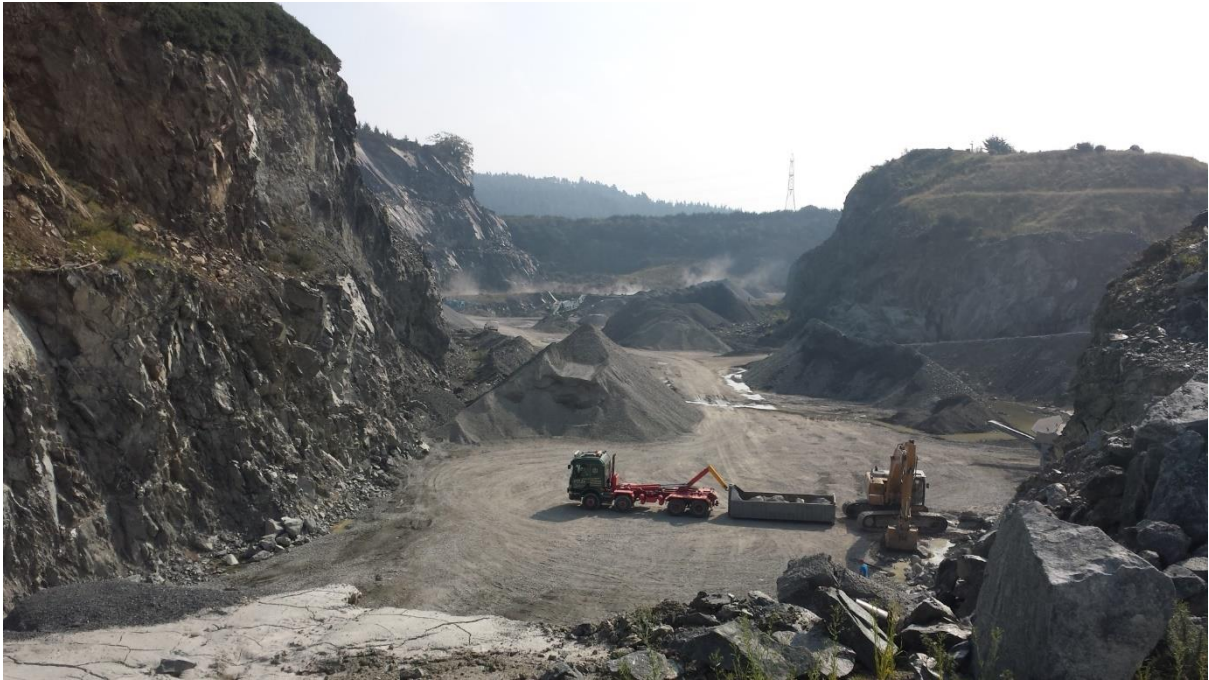
**Plate 12-4**  
**View of Area 1 looking east**

- 12.59 Area 1 is the former aggregate processing / production area (and location of proposed soil washing plant) from which all topsoil has been removed. There was no visible indication of any cultural heritage material (Plate 12-4).

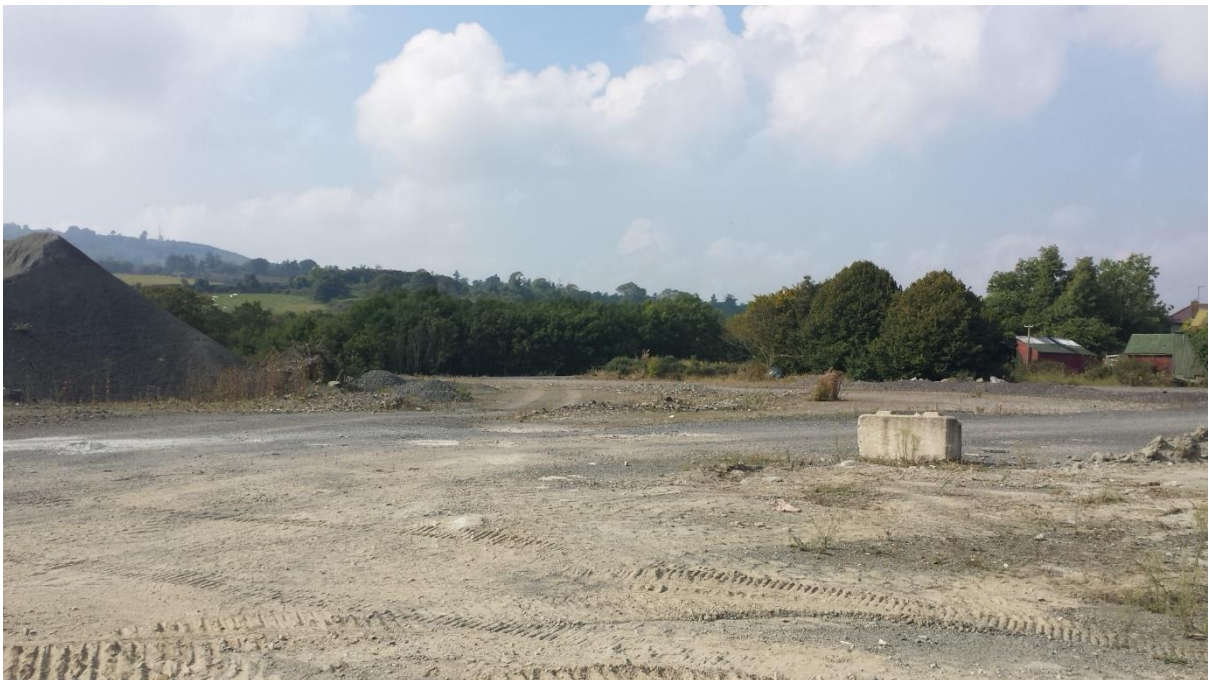
**Plate 12-5**  
**View of Area 2 looking north-east**

- 12.60 Area 2 is the area of rock extraction from which all the topsoil has been removed. There was no visible indication of any cultural heritage material (Plate 12-5).

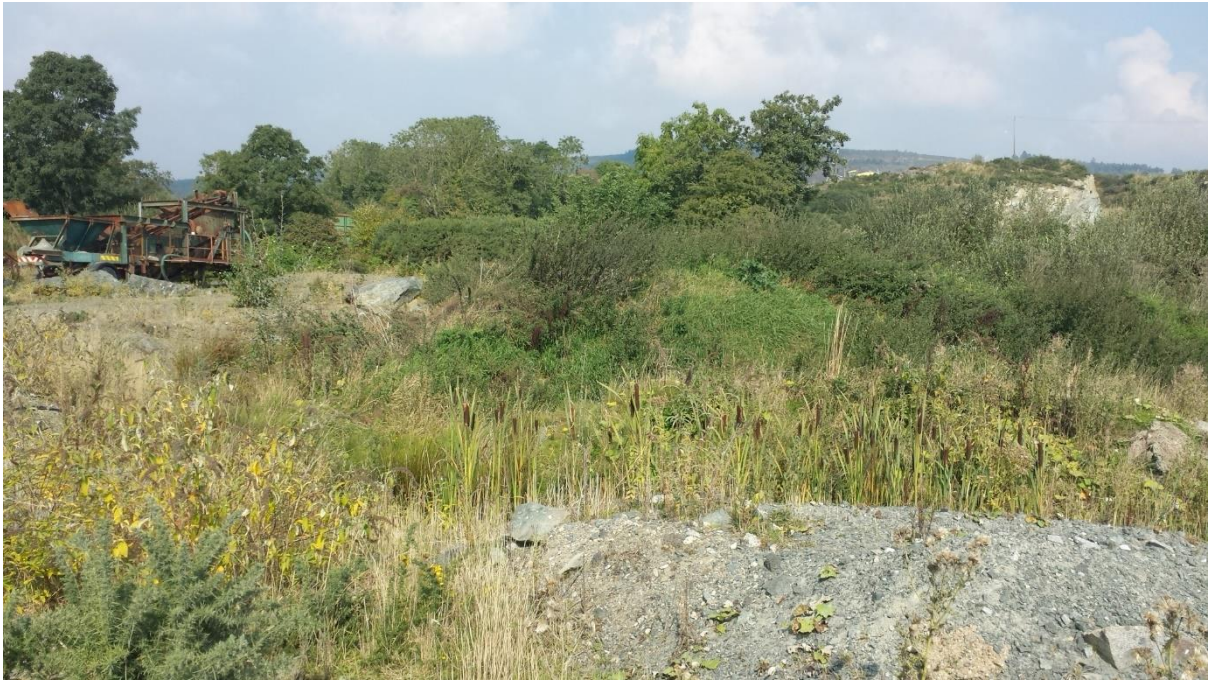
**Plate 12-6**  
**View of Area 3 looking south-west**

- 12.61 Area 3 is a sub-rectangular hardstanding area (and location of proposed C&D waste recycling facility) from which all topsoil has been removed. There was no visible indication of any cultural heritage material (Plate 12-6).

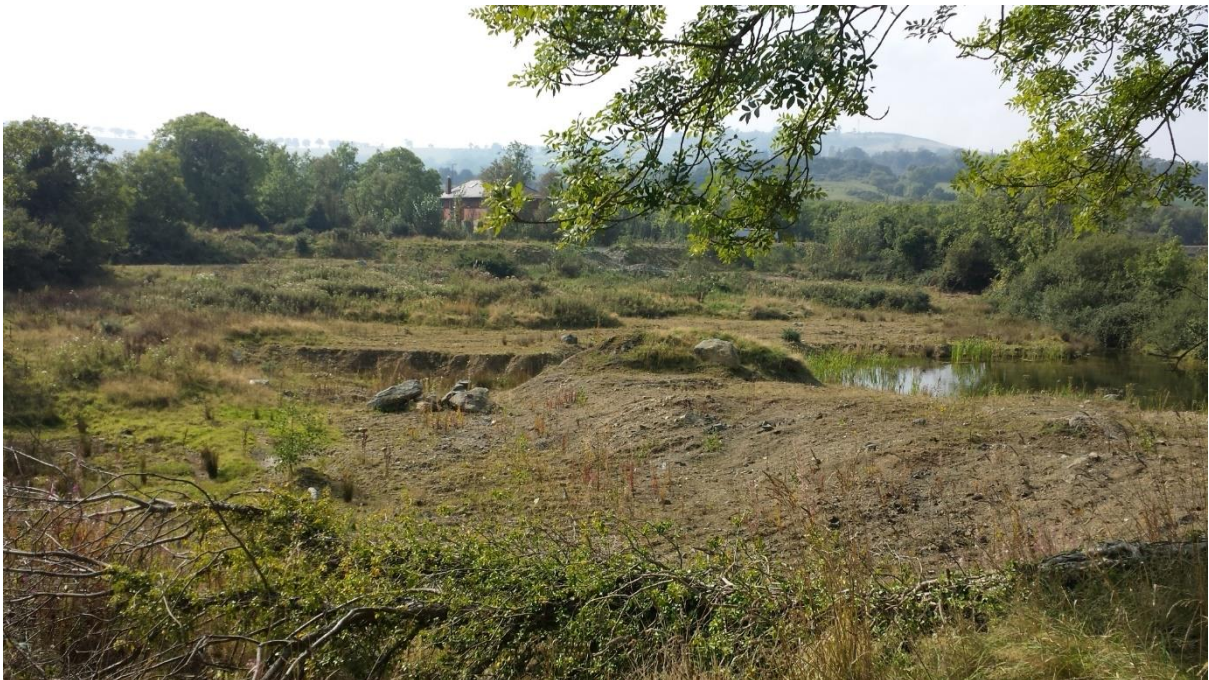
**Plate 12-7**  
**View of Area 4 looking north-west**

- 12.62 Area 4 is an area of overburden storage which has become overgrown. There was no visible indication of any cultural heritage material (Plate 12-7).

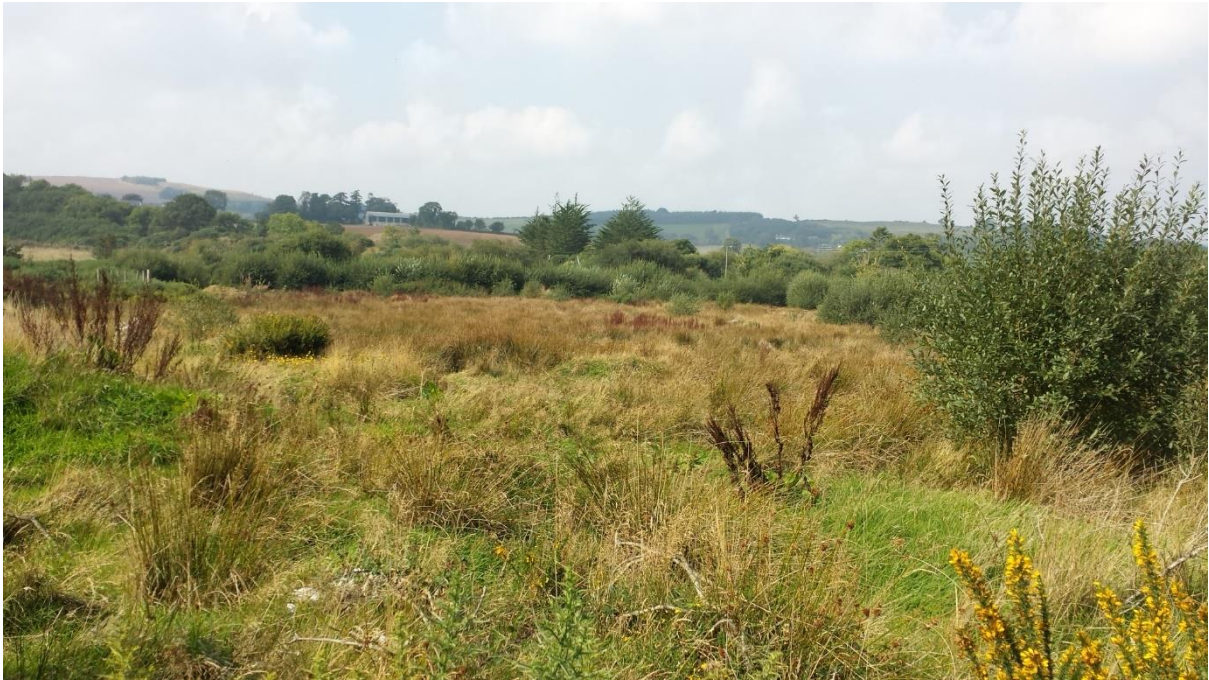
**Plate 12-8**  
**View of Area 5 looking south-west**

- 12.63 Area 5 is a subrectangular field from which all the topsoil has been removed. There is a lagoon and the area is partly overgrown. There was no visible indication of any cultural heritage material (Plate 12-8).

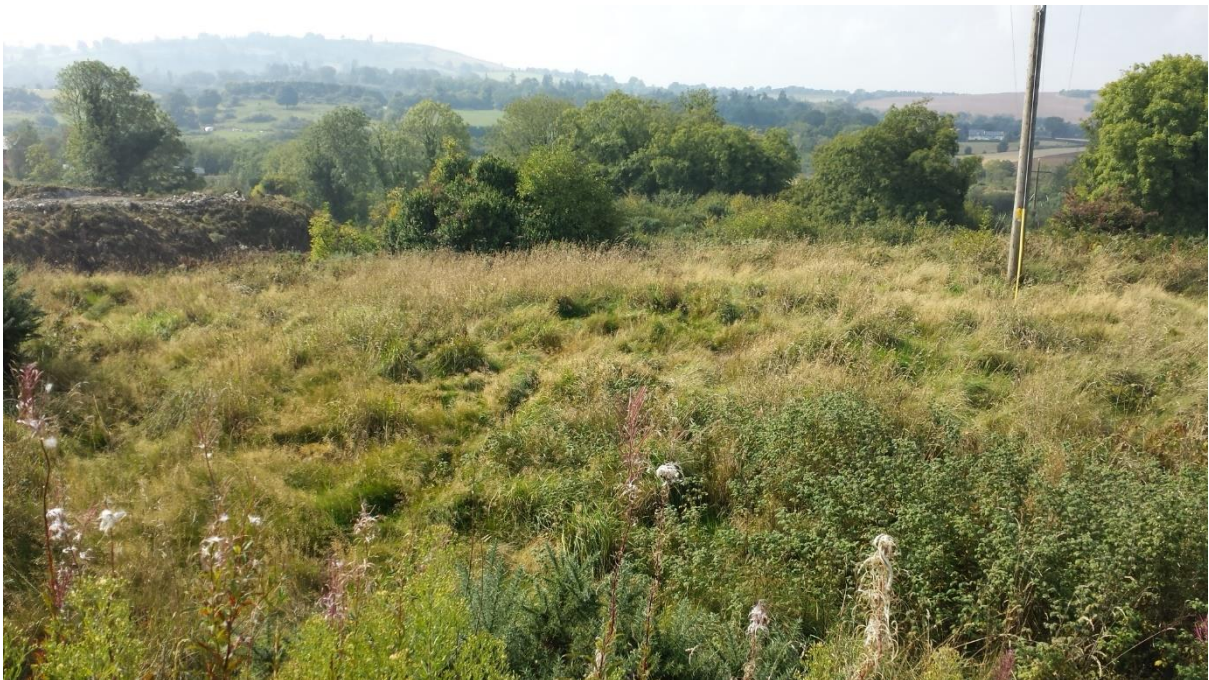
**Plate 12-9**  
**View of Area 6 looking west**

- 12.64 Area 6 is a trapezoidal-shaped field of poor-quality damp pasture. There was no visible indication of any cultural heritage material (Plate 12-9).

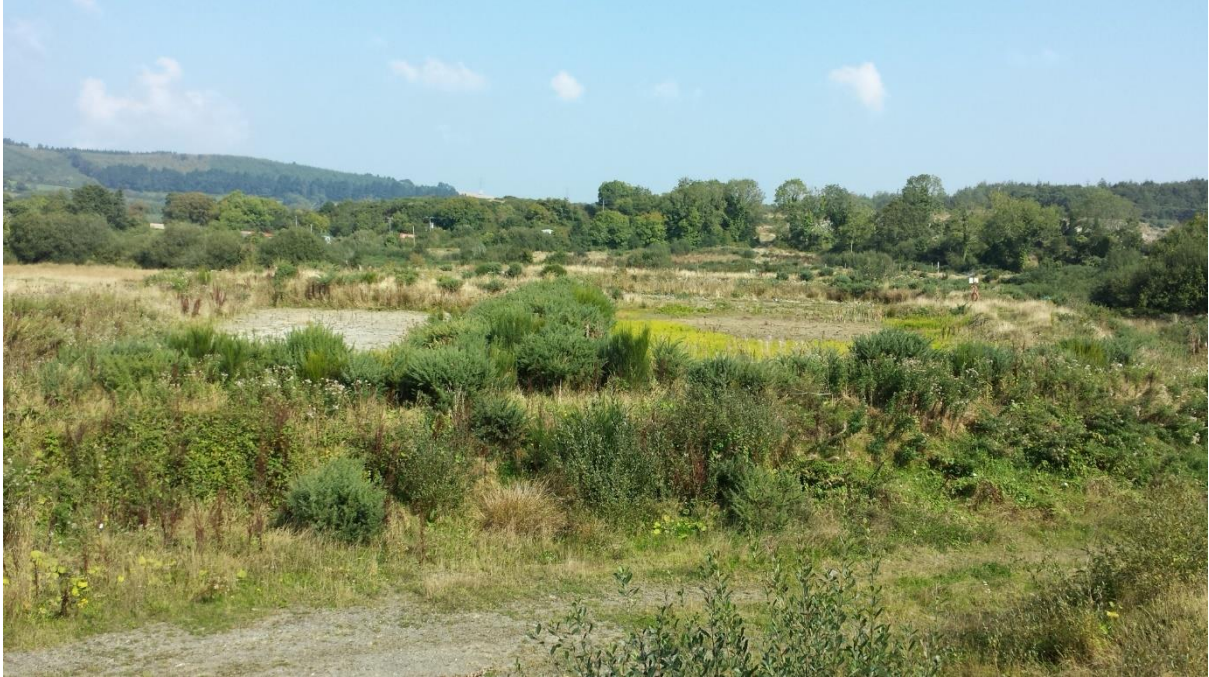
**Plate 12-10**  
**View of Area 7 looking west**

- 12.65 Area 7 is a part of a triangular-shaped field of pasture. There was no visible indication of any cultural heritage material (Plate 12-10).
- 12.66 Area 8 contains the existing surface water settlement lagoons (and the location of the proposed wetland treatment system). There was no visible indication of any cultural heritage material (Plate 12-11).

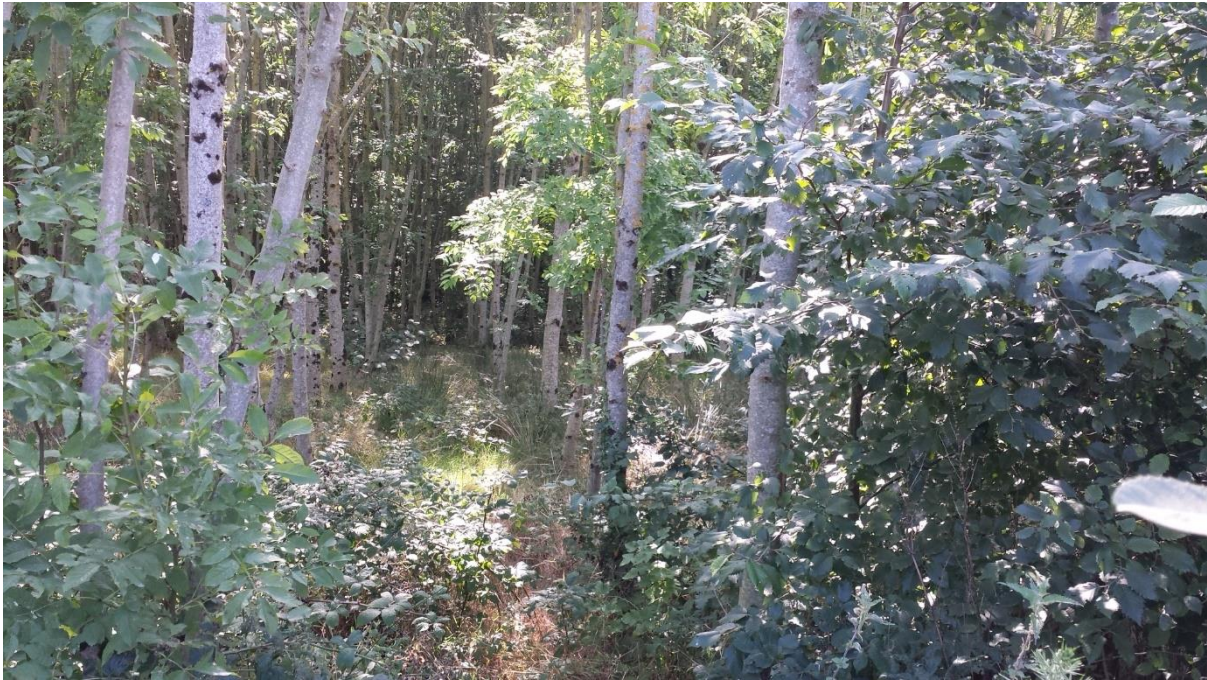
**Plate 12-12**  
**View of Area 9 looking north-east**

- 12.67 Area 9 is a trapezoidal-shaped field of pasture (and the location of the proposed wetland treatment system). There was no visible indication of any cultural heritage material (Plate 12-12).
