Alluvial Gully Prevention and Rehabilitation Options for Reducing Sediment Loads in the Normanby Catchment and Northern Australia

Jeffrey G. Shellberg and Andrew P. Brooks
Griffith University, Australian Rivers Institute

Final Report

December 2013

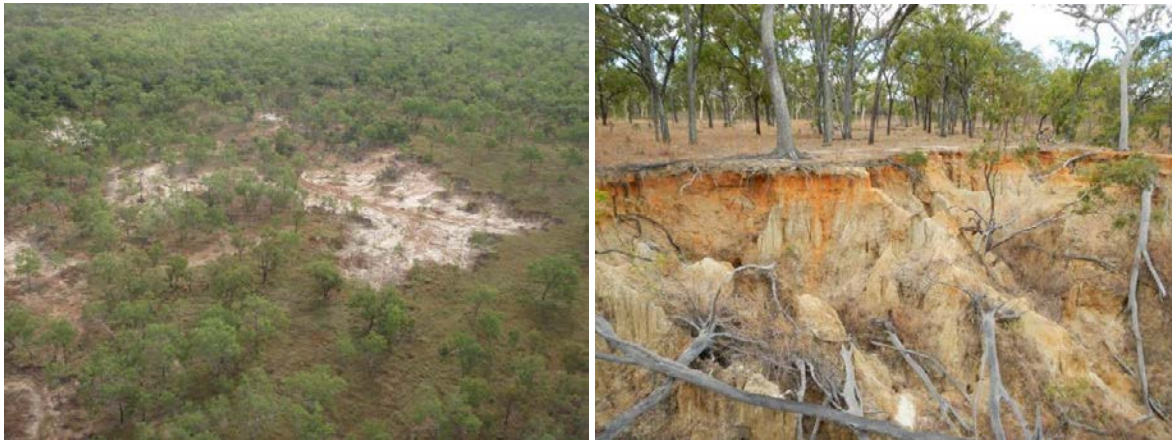
Plate 1 Examples of alluvial gullies in the Normanby catchment.

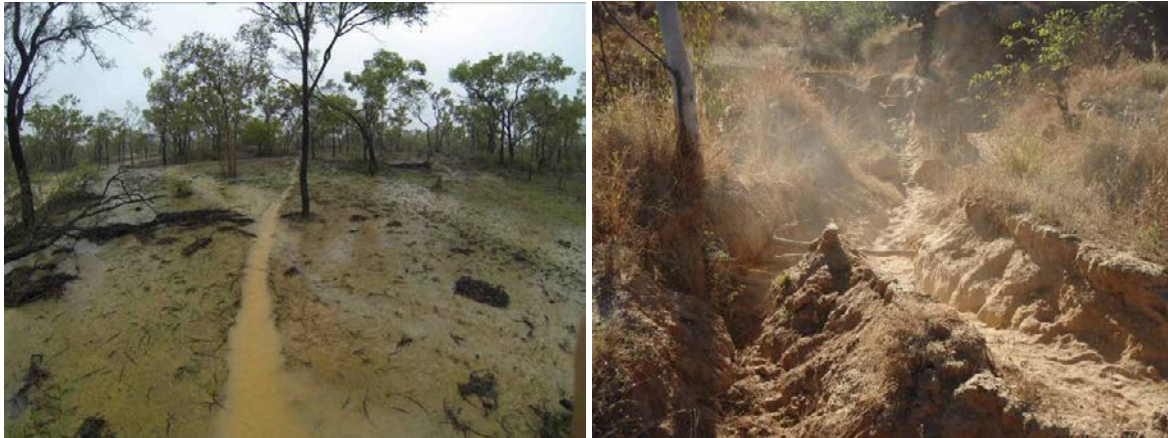
Plate 4 Examples of over-grazed riparian frontage with cattle tracks (pads) funnelling water down to gully heads, as well as cattle tracks cut into steep river bank hollows.

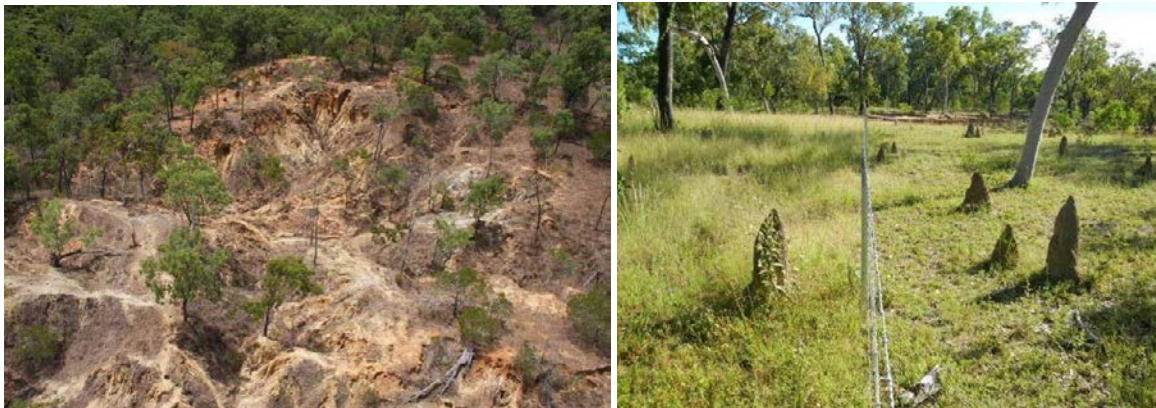
Plate 6 An alluvial gully recently fenced off from cattle grazing, and changes in grass cover on a river terrace above a gully head inside and outside the fence after one wet season. Short-term vegetation improvements within the gully were minor after fencing.

To document the effectiveness of cattle exclusion for vegetation recovery and soil erosion reduction, cattle exclusion experiments have been initiated around alluvial gullies in the upper Laura-Normanby catchment (Plate 6). Four (4) cattle exclusion areas (3-5 ha) were fenced in 2012 to start a long-term monitoring program (5 to 10+ years). A before-after, control-impact study design was used with vegetation and erosion plots and detailed repeat topographic surveys (LiDAR). Funding is needed for long-term monitoring.

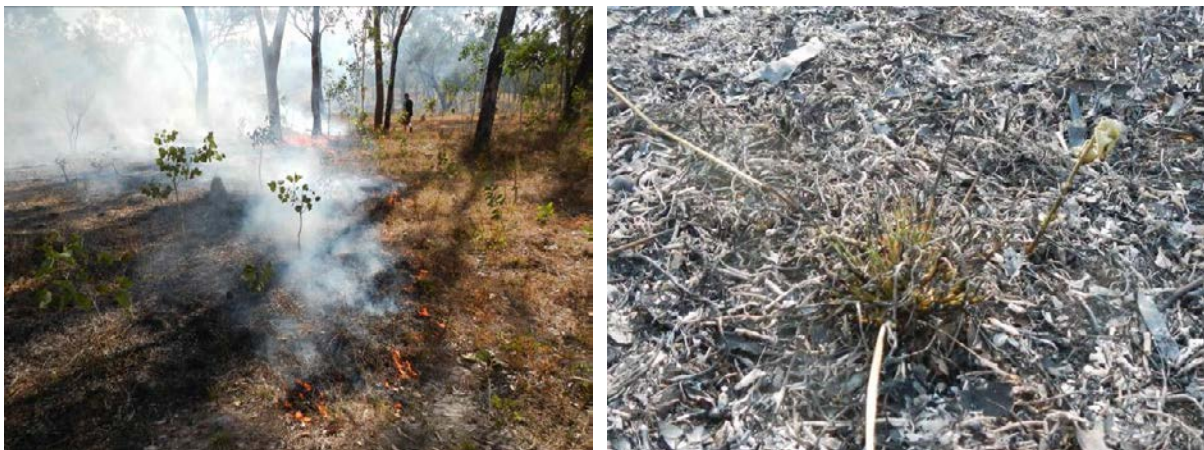
Plate 7 Low intensity early-dry season burn in a colluvial hollow and perennial grass tussock and incompletely burnt organic mulch cover remaining after the low intensity burn.

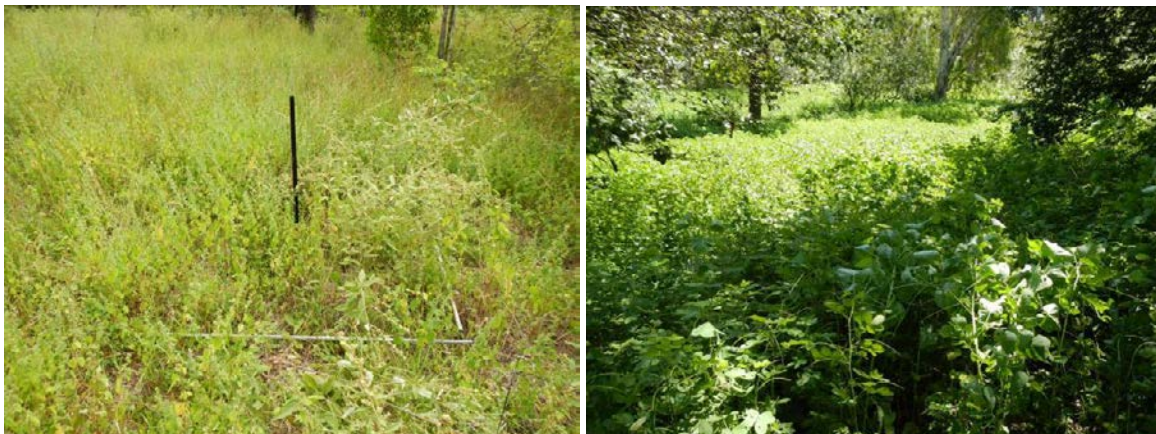
Plate 8 Invasion of annual weeds onto terraces (Hyptis, Hairy Sida, Grader Grass) and river benches (Sicklepod) in Normanby river frontage.

The invasion of exotic weeds into river frontage country and riparian zones has become ubiquitous in the Normanby catchment (Plate 8). Many annual weeds compete with preferred native perennial grasses, provide little ground cover at the beginning of the wet season, have low root density and soil cohesion, and change the infiltration potential of soils. Most weeds have been introduced or increased in river frontage from upstream land use, local disturbance such as over-grazing, altered competition dynamics between grass and weeds, intense late-dry season fires, roads and fences. More scientific experimentation is needed on how to control weeds (fire, chemical, mechanical, biological) along river frontage terraces and elevated floodplains with sodic soils to promote perennial grass health, reduce water runoff and minimise gully erosion.

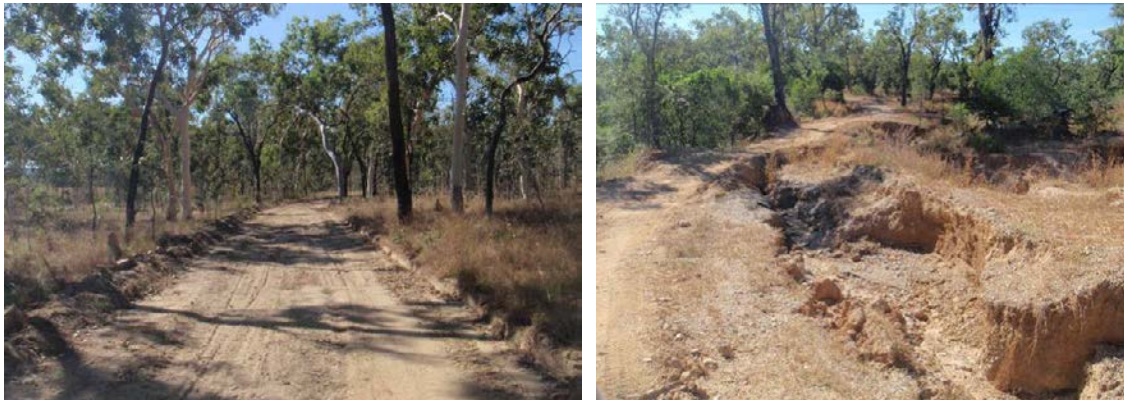
Plate 9 Roads graded repetitively on river frontage with sodic soils can lead concentrated water flow and deep gully erosion.

The best long-term solution to road and fence stability is to not locate this infrastructure on dispersive or sodic soils and river frontage areas (Plate 9; Plate 17). Once dispersive or sodic soils are disturbed, erosion is difficult to prevent. Roads and fences should be placed on stable soils and geology, such as on subtle ridge and spur crests between drainage catchments. Maps of soil/geology, topography (including LiDAR), erosion hazards, and aerial photographs (+Google Earth) can be useful for locating infrastructure during property planning and to minimise the number of crossings of existing gullies, unchannelled hollows, creeks, and rivers. This will reduce long-term road maintenance costs and rill and gully erosion. Where roads and fences must be located through erodible river frontage, frequent water diversion structures (whoa boys) should be installed and capped with locally imported soil/gravel, in addition to armouring the approaches to creek crossings to minimise gully erosion. Vegetation clearing should also be minimised, especially on steep banks.

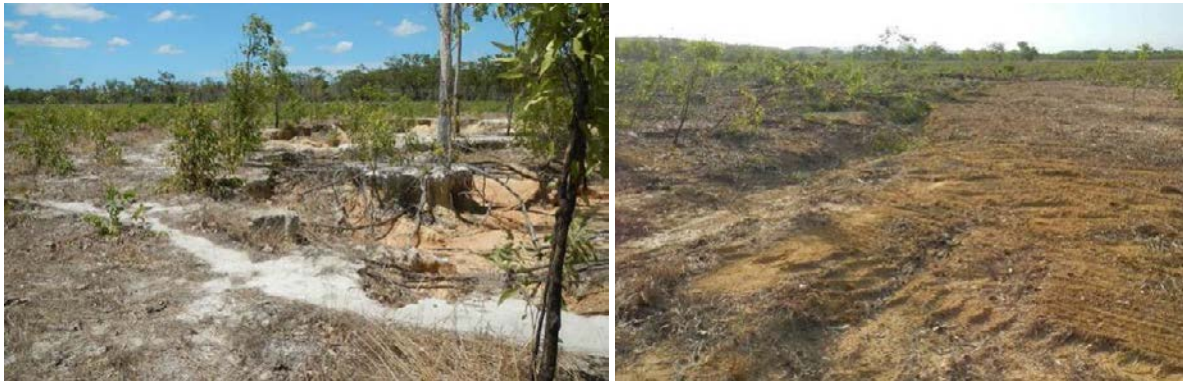
Plate 10 Clearing tree vegetation along river frontage can disturb dispersive soils and initiate or accelerate alluvial gully erosion.

Tree clearing along river frontage can initiate or accelerate alluvial gully erosion by disturbing soil and vegetation from bulldozing, chaining, and stick raking vegetation, as well as changing the water balance by reducing water transpiration by trees, raising water tables, increasing sub-surface water seepage, and accelerate surface water runoff (Plate 10). Generally, clearing trees from dispersive soils on river terraces and floodplains of river frontage should be avoided. Where this has already occurred, mitigation measures can be instated to reduce the continuing or future erosion of alluvial gullies.

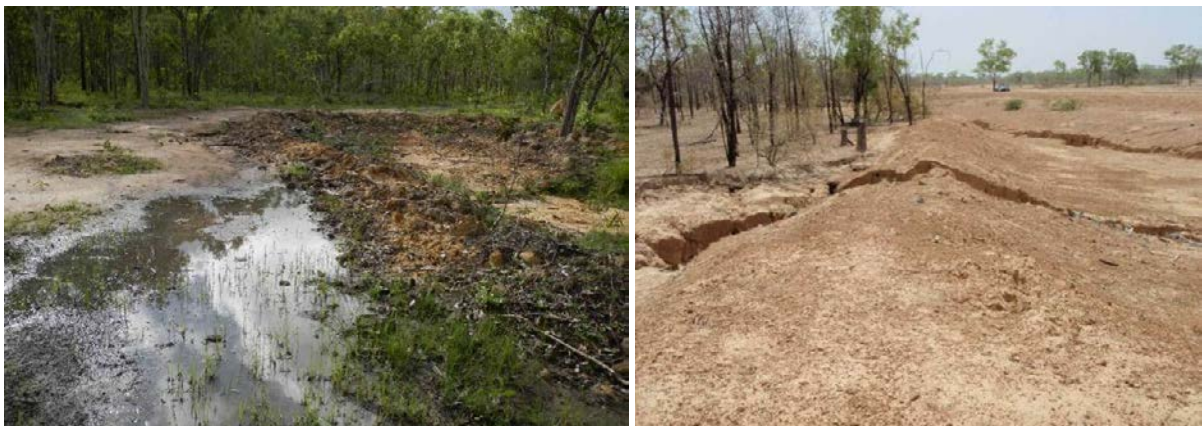
Plate 11 Water diversion banks above alluvial gullies can reduce erosion but also are prone to failure.

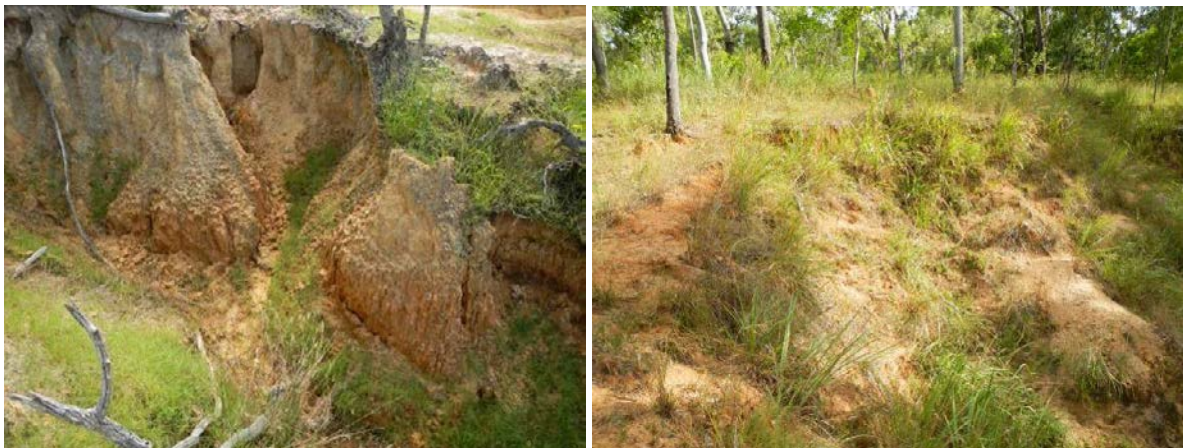
Plate 12 Revegetation of gully scarps with hydromulch can result in modest but not complete cover improvements, while natural recolonisation can be successful with native grasses such as blady grass.

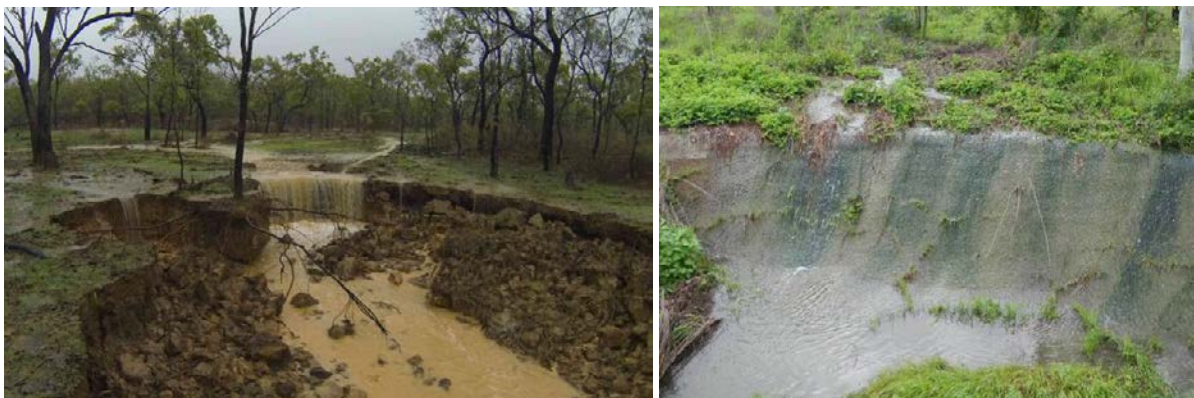
Plate 14 Young, rapidly advancing headcuts of alluvial gullies need to be stabilised with drop structures or rock grade control so that they do not develop into larger gullies and head scarps (Plate 1).

Grade control and drop structures are applicable to narrow semi-confined gullies where overland flow dominates, but only some sections of unconfined alluvial gullies such as finger headcuts. Grade control structures (check dams) can prevent incision, reduce slope, dissipate energy, and trap sediment. Drop structures (weirs, chutes, flumes, etc.) installed at headcuts (scarps) can safely pass water runoff over the scarp edge and stop the gully headcut from advancing. These grade and drop structures can be made out of rock, gabion, concrete, sand bags, steel sheets or mesh, treated lumber, large woody debris (LWD), woven brush and/or live vegetation. Proper attention to engineering design, structure frequency, geomorphic processes, the stage or time of intervention, and long-term maintenance are essential for minimizing failure. Structures should be embedded into the underlying bed and adjacent banks to avoid undermining or outflanking, especially in dispersive soils. In the Normanby catchment, the placement of drop and grade structures is required at many young, very active headcuts advancing up floodplain hollows in river frontage areas in order to prevent major future erosion (Plate 14).

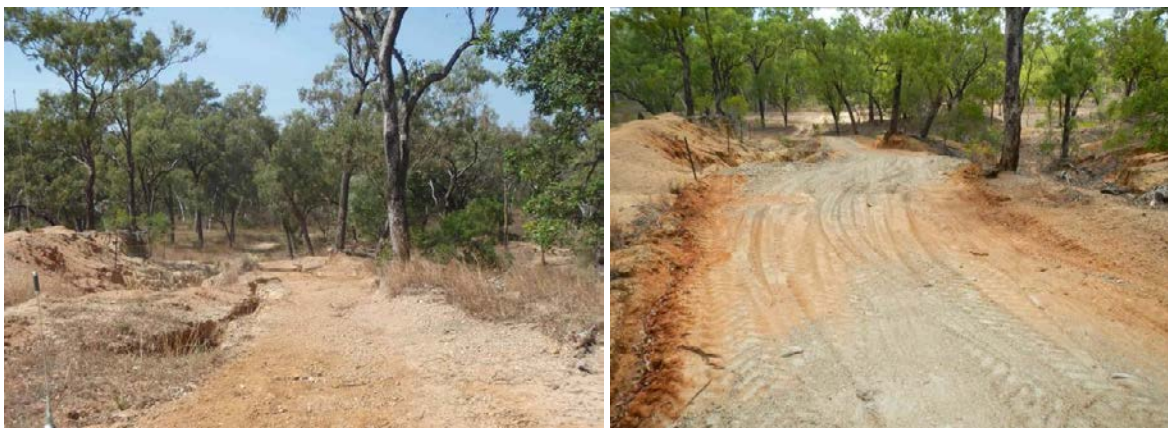
Plate 15 Erosion on station roads over steep river banks in sodic soils can be reduced by installing frequent water diversion banks (whoa boys) and capping them with imported coarse rock.

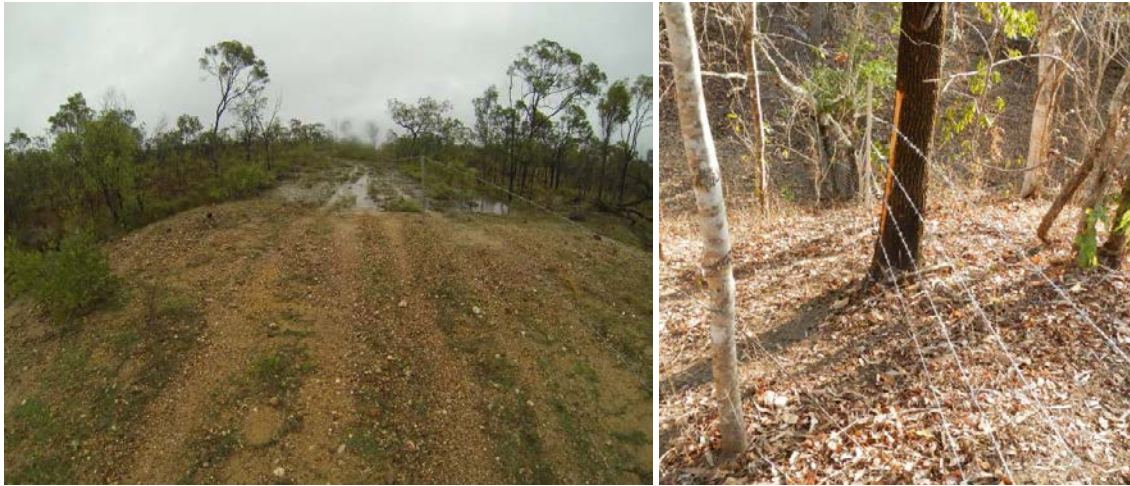
Plate 16 Installing frequent water diversion structures (whoa boys) along fences, and fencing tree-to-tree over steep banks with sodic soils, can reduce gully erosion along fences.

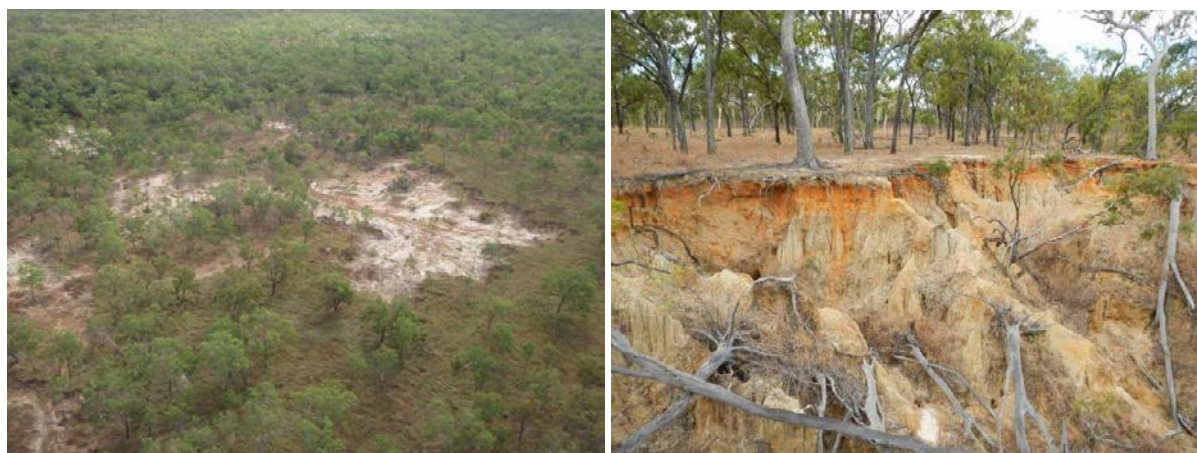
Figure 1 Typical alluvial gully “breakaways” in the Normanby catchment migrating away from a river channel and consuming the floodplain/terrace savanna landscape of the river frontage.

Gully erosion is the process by which running water cuts new unstable channels into erodible soil and weathered rock. In northern Australia there is widespread alluvial gully erosion (*sensu* Brooks et al. 2009; Figure 1) into unconfined alluvial deposits on elevated floodplains and terraces (relict floodplains) adjacent to rivers and creeks with highly dispersive or sodic soils (Table 1; Figure 5). Alluvial gully erosion scarps are locally known as “breakaways” by pastoralists (Figure 1).

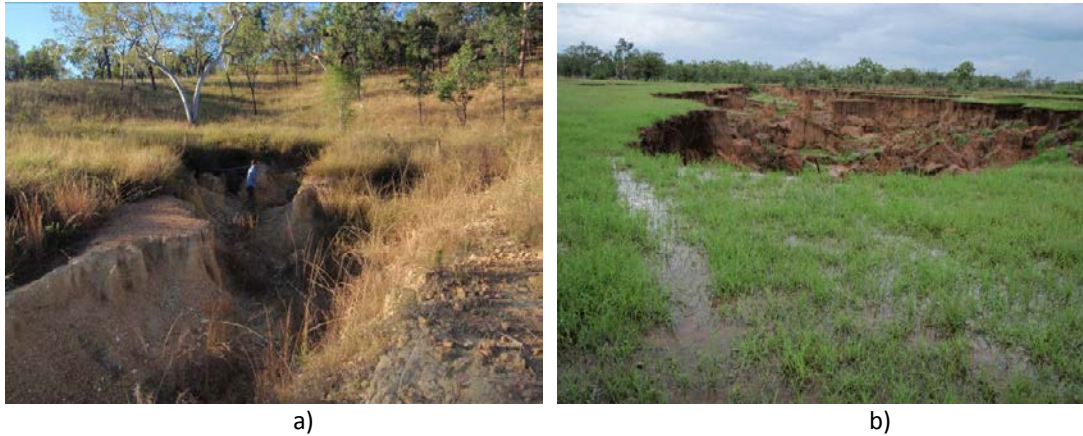
Figure 3 Examples of a) a tropical hillslope/colluvial gully that is elongate and eroding into relatively coarse colluvial material in the lower part of a hillslope, and b) a tropical alluvial gully eroding into deep alluvial deposits that is expanding laterally as well as longitudinally.

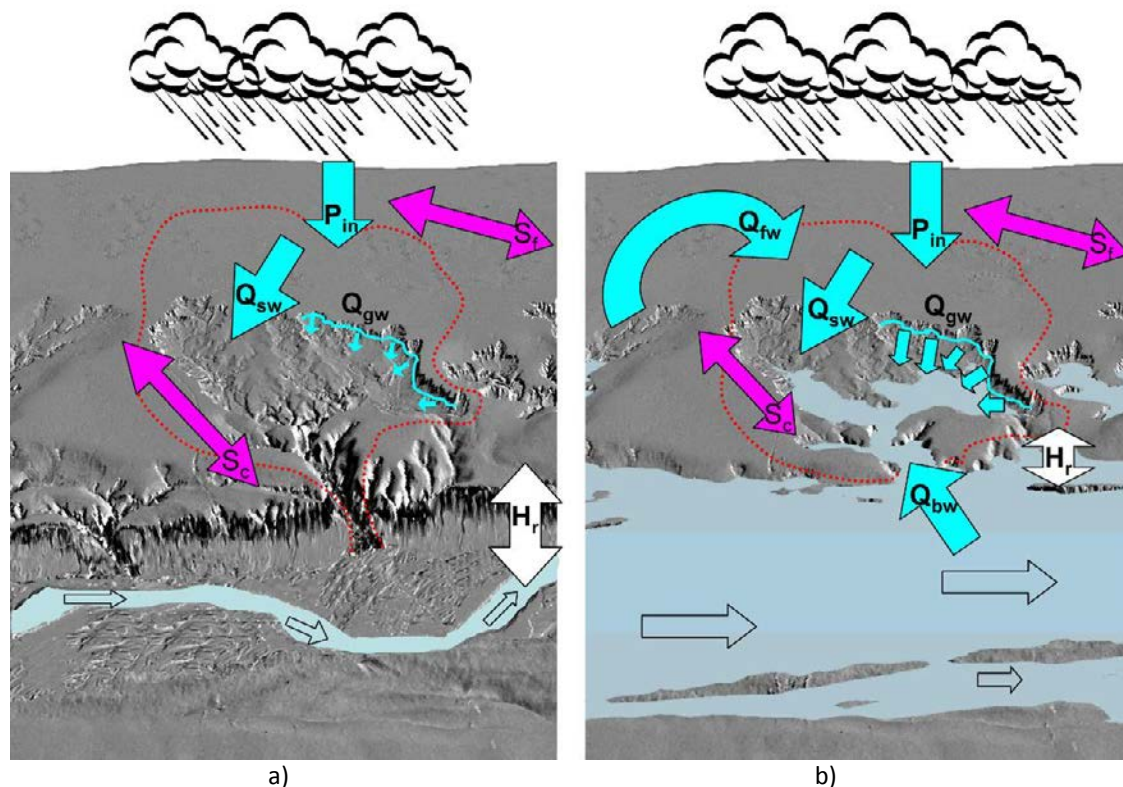
Figure 6 Conceptual model of erosional-drivers of alluvial gully erosion with approximate catchment area in red: a) low river water and high relative relief (H_r) when water sources are dominated by direct precipitation (P_{in}), surface water from overland flow off the floodplain (Q_{sw}), and emergent soil moisture (or groundwater) at breaks in slope (Q_{sm}); and b) high river water and low relative relief (H_r) when water sources additionally include river backwater (Q_{bw}) during common floods and overbank floodplain water (Q_{fw}) during larger magnitude floods. Potential energy factors include relative relief (H_r), the alluvial gully channel slope (S_c), and the often smaller floodplain slope (S_f) (Shellberg et al. 2013a).

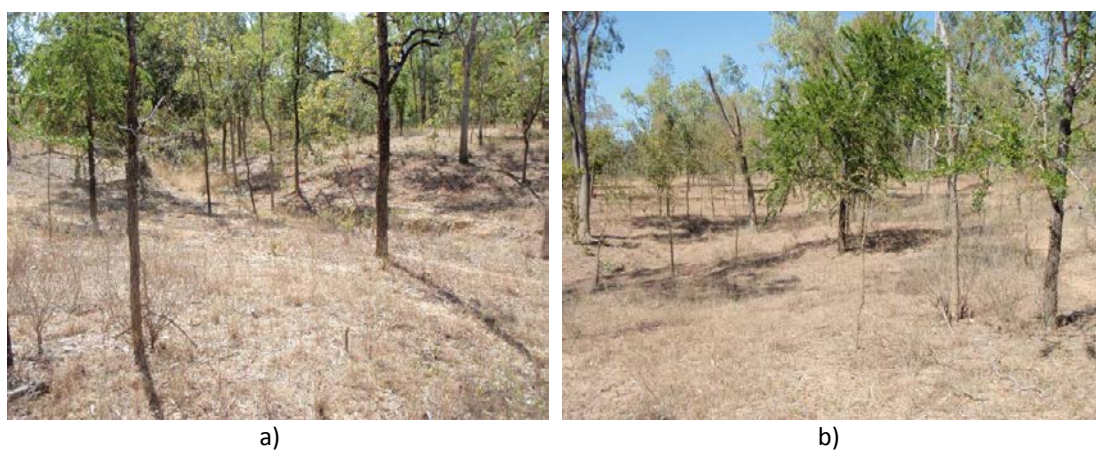
Figure 10 Examples of a) a small alluvial gully on a river bank eroding into b) an un-channelled floodplain hollow immediately upstream, that will eventually develop into a large alluvial gully similar to Figure 3b and Figure 4c.

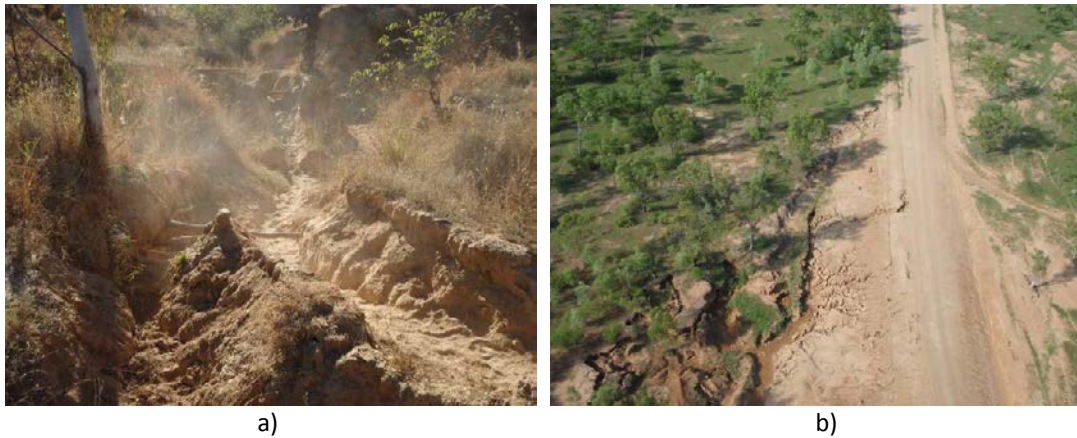
Figure 12 Examples of a) a cattle track (pad) cut down a steep river bank that is rapidly being transformed into an alluvial gully, and b) an alluvial gully initiated by a poorly designed road crossing a river.

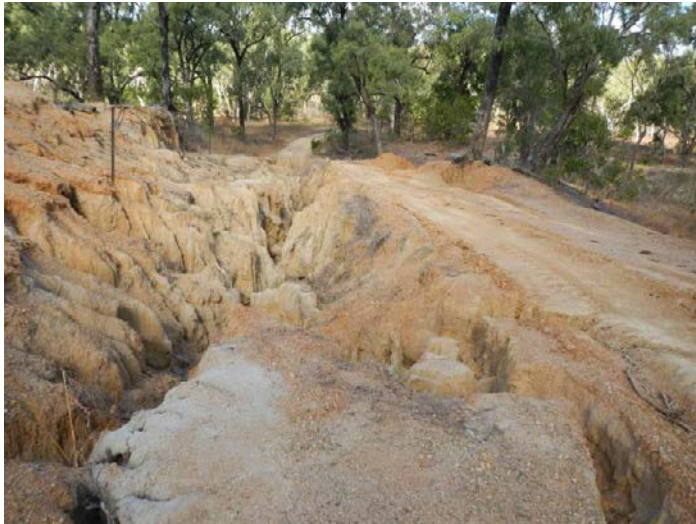
Figure 20 A fence line (left) and road (right) threatened by alluvial gully erosion in the Normanby catchment.

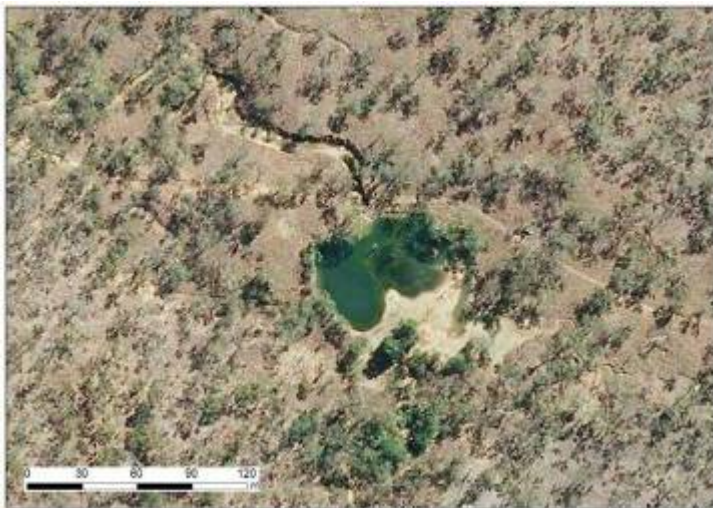
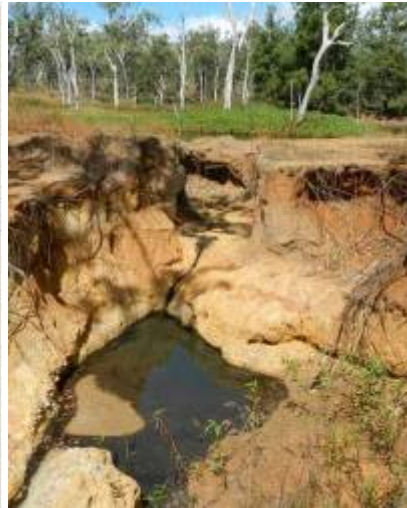
Figure 21 A stock water dam from the a) air and b) ground in the Normanby catchment threatened by gully erosion.

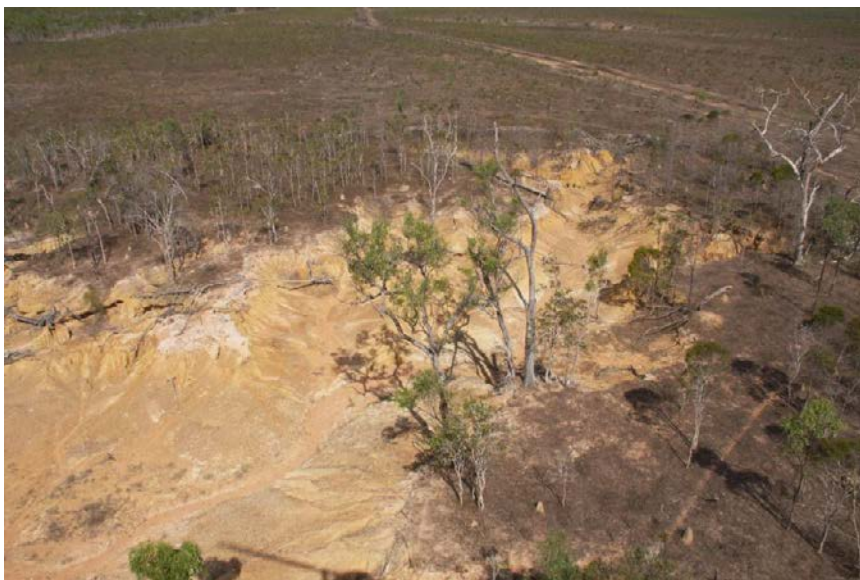
Figure 22 Cleared pasture land threatened by alluvial gully erosion in the Normanby catchment.

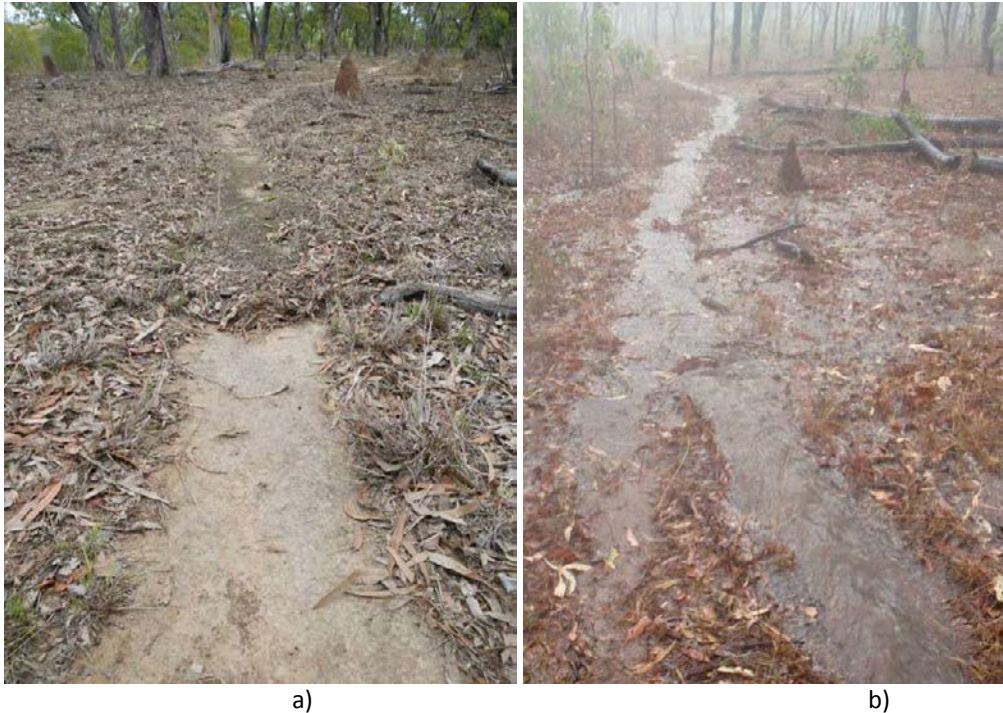
Figure 23 Cattle tracks (pads) funnelling water, sediment and debris off floodplain landscapes toward gully heads.

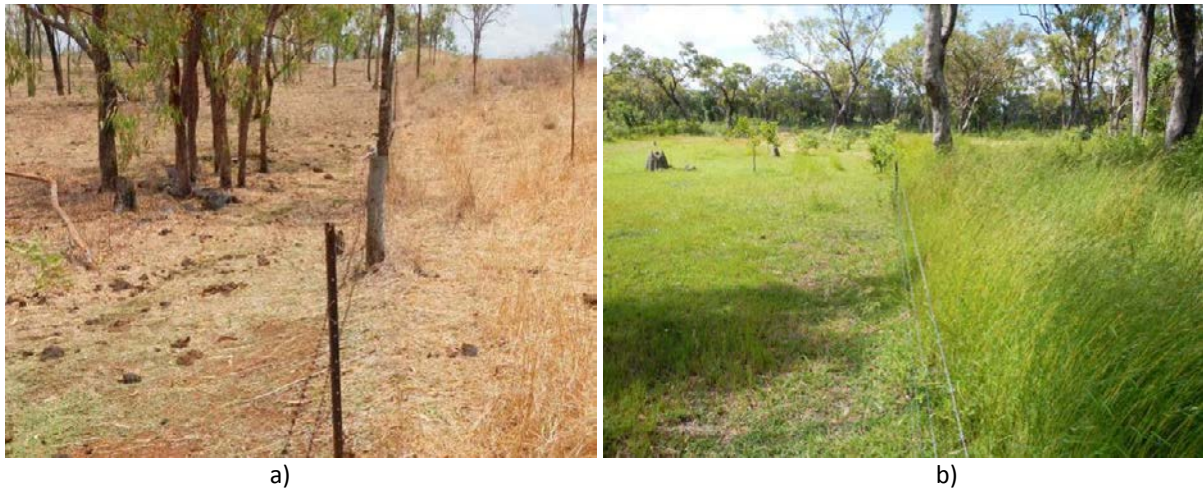
Figure 25 Differences in grass cover on a) the over-grazed (left) and partially grazed (right) sides of a fence in the dry season and b) the grazed (left) and un-grazed (right) sides of a fence in the wet season.

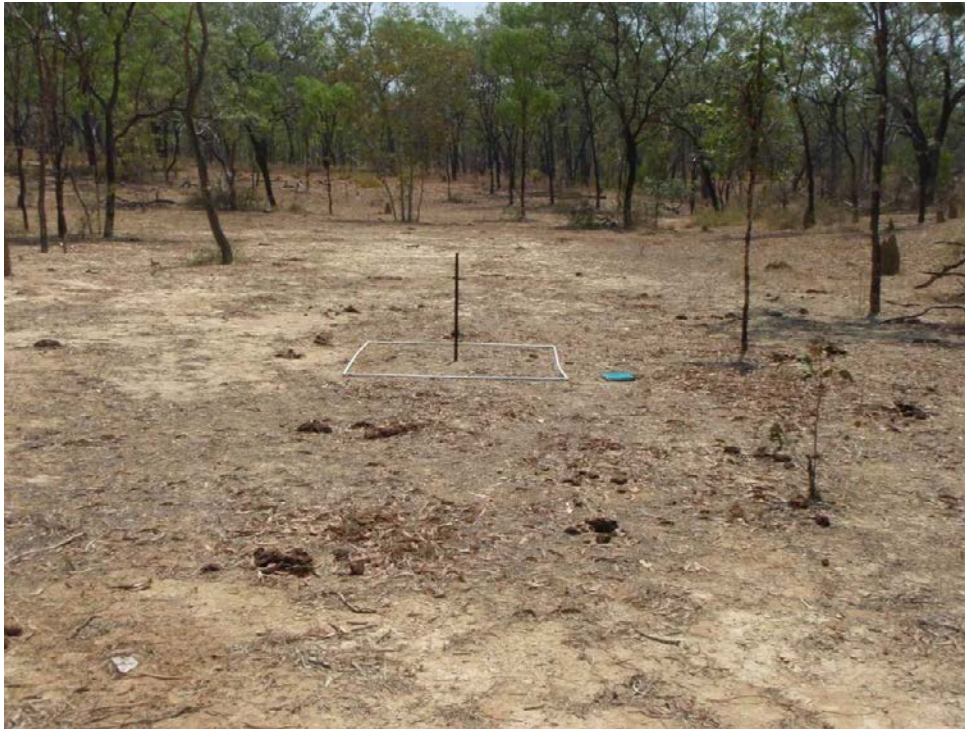
Figure 26 An over-grazed river frontage hollow after a drought (long extended dry season and below average wet season) in the Normanby Catchment. This hollow flows directly into a downstream gully (Figure 81a).

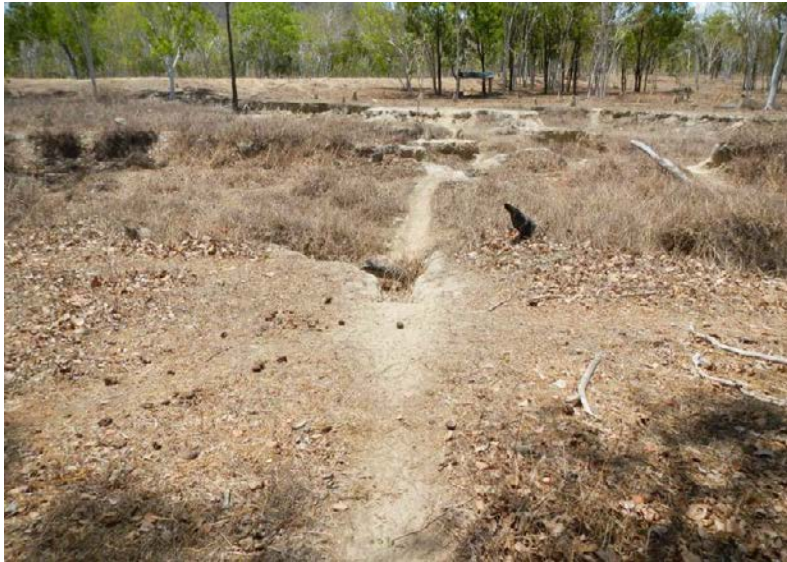
Figure 28 The poor placement of an off-stream water point (dam in background) in terms of erosion control due to high cattle impacts on sodic floodplain soils of an ephemeral creek and incising gully system.

In many situations on terraces and elevated floodplains with sodic soils, surface water runoff from both sides of a shallow alluvial ridge (levee or subtle divide) promotes the potential for gully erosion. In extreme situations, these shallow alluvial ridges can be attacked by gully erosion from both the proximal and distal sides of the ridge (e.g., Figure 54; Brooks et al. 2009; 2012). Surface water runoff and gully erosion that drains distally away from the main river into smaller floodplain tributaries can still deliver large amounts of sediment to the river drainage network. Therefore, caution is needed when placing artificial water points and fences to ensure that these developments do not initiate or accelerate water runoff and gully erosion in distal portions of the floodplain or terrace (i.e., Figure 54; Section 7.5.2.4). In these situations, artificial water points and cattle exclusion fences should be placed well outside land types with dispersive sodic soils (terraces and elevated floodplains) to avoid erosion prone areas.

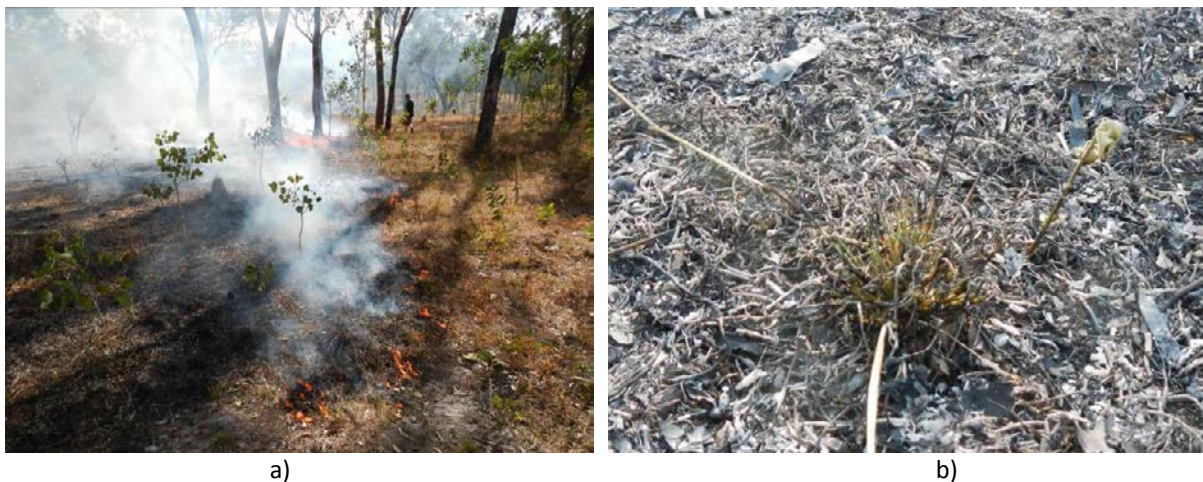
Figure 30 Examples of a) low intensity early-dry season burn in a colluvial hollow, and b) a perennial grass tussock and incompletely burnt mulch cover remaining after the low intensity burn.

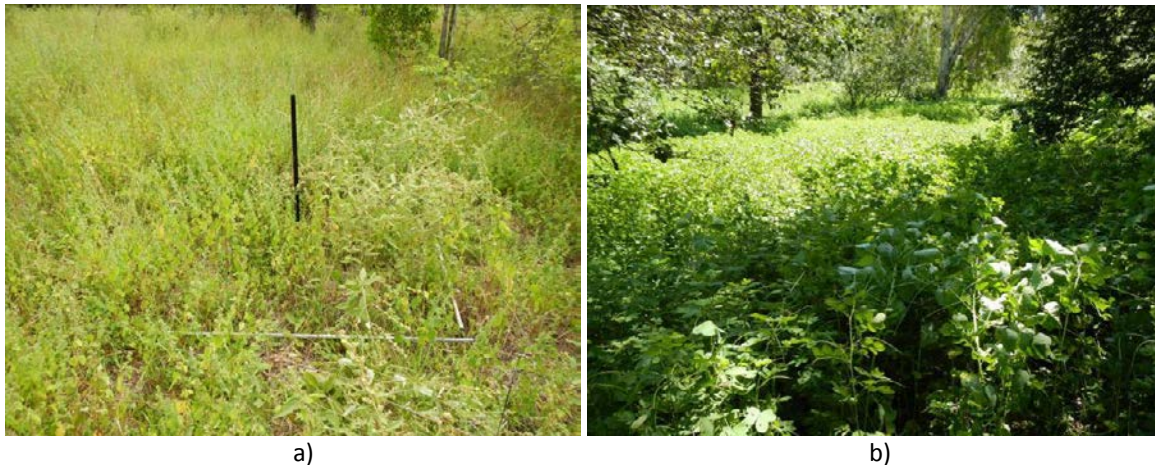
Figure 31 Invasion of annual weeds into river frontage and riparian zones in the Normanby catchment a) dominance of annual herbs (*Hyptis suaveolens* and *Sida trichopoda*) and grasses (*Themeda quadrivalvis*) on river terraces, and b) dominance of sicklepod (*Senna obtusifolia*) on river benches.

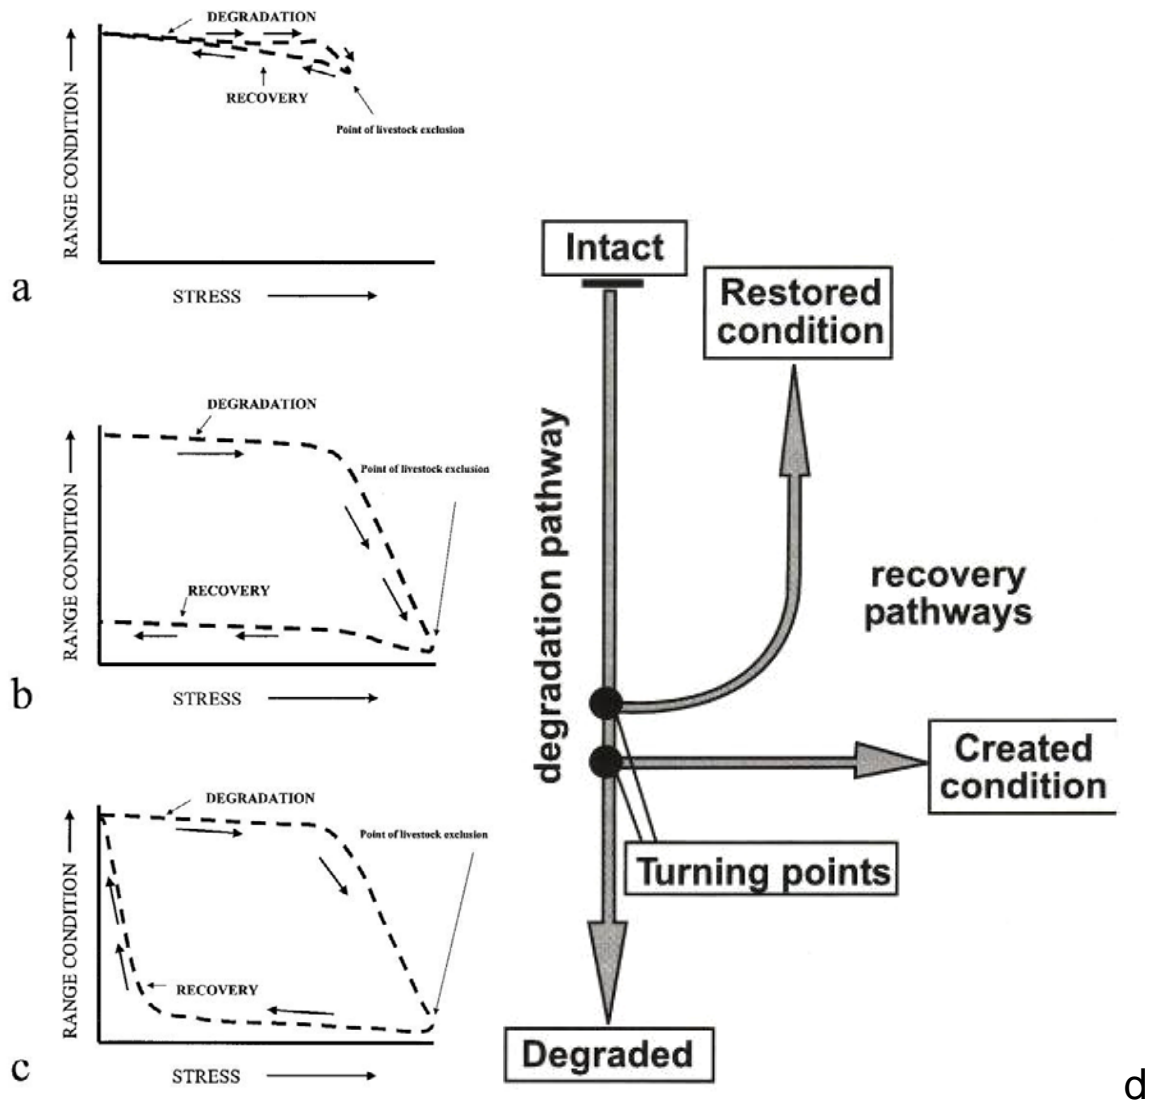
Figure 32 Different degradation and recovery pathways following different stress and rangeland conditions including a) the rubber band model, b) the humpty dumpty model, c) the broken leg model (from Saar 2002), and d) turning points along a degradation pathway where land management intervention could recover restored or created conditions (from Brierley and Fryirs 2005).

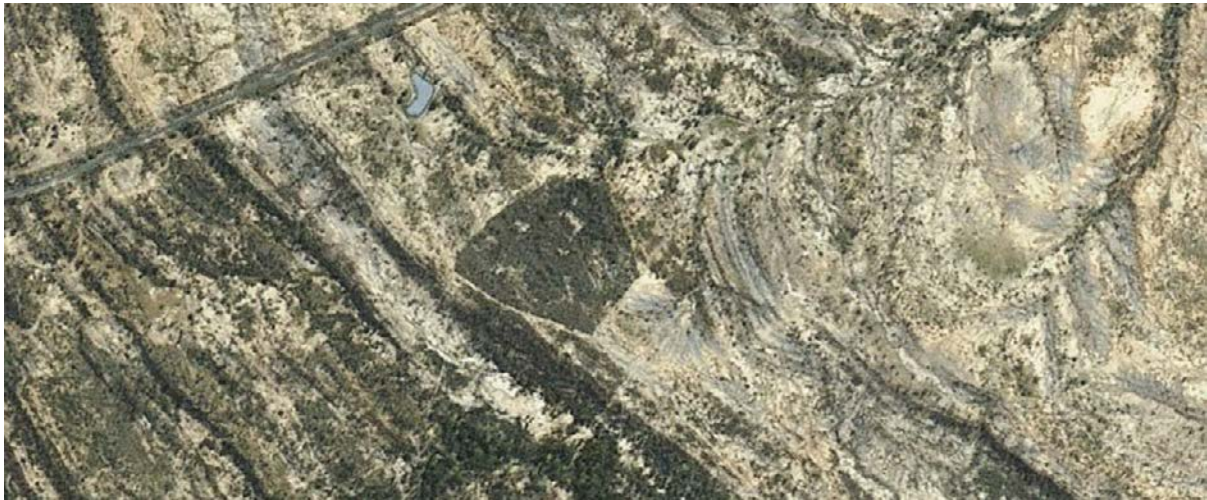
Figure 34 A cattle exclusion area (centre photo) on the extremely degraded “Springvale Station” in the Nogoa River catchment (Fitzroy River catchment, Qld) where dramatic vegetation recovery and erosion reduction has occurred over the last two decades (-23.693012°, 147.456605°).

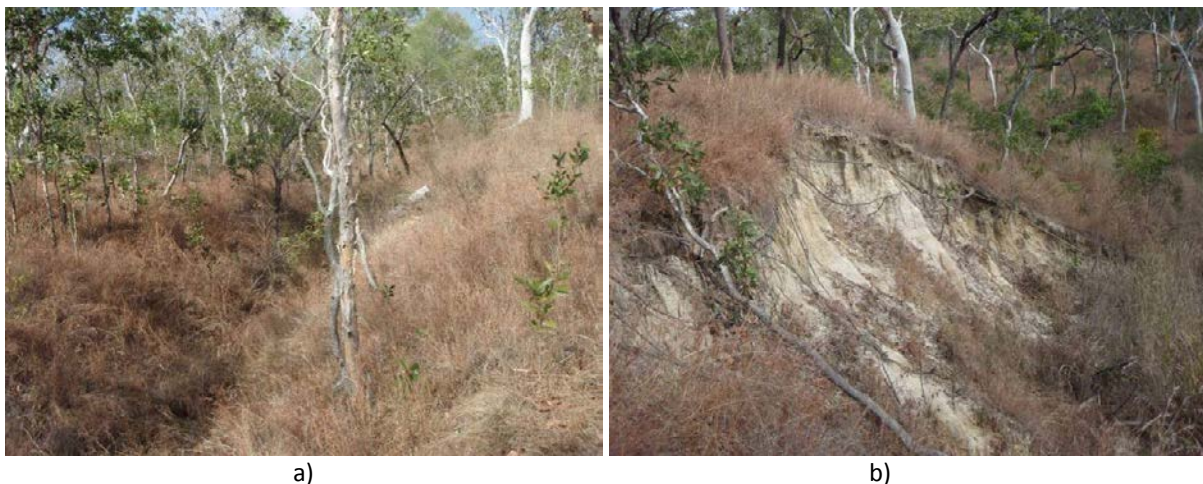
Figure 35 Examples of improved cover of native kangaroo grass (*Themeda triandra*) following 5+ years of cattle exclusion on a) rounded gully slopes, and b) a gully scarp with only modest cover improvements compared to surrounding uneroded soils (middle Annan River).

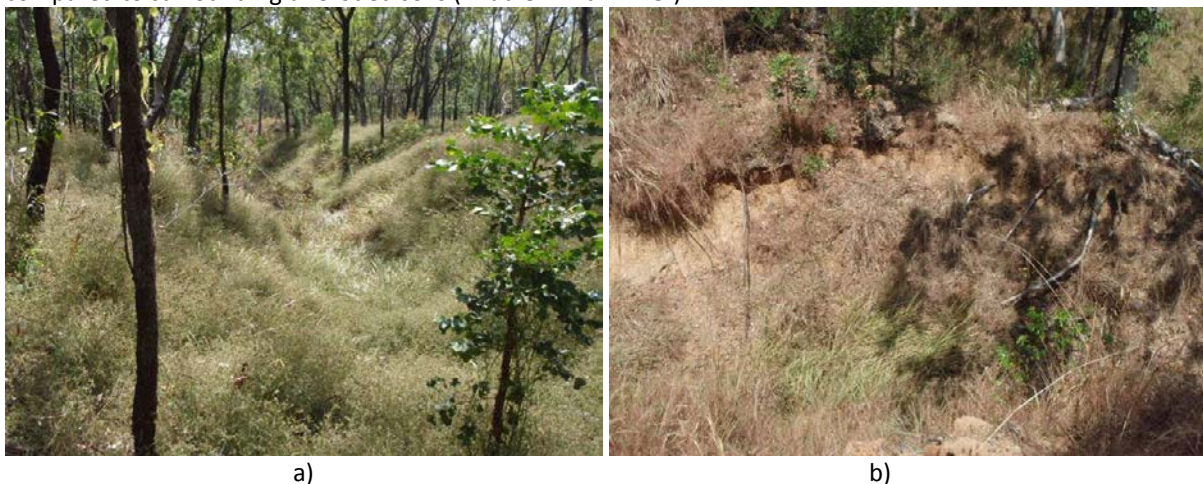
Figure 36 Examples of improved vegetation cover in gullies at a) a rounded gully where cattle and fire have been excluded for 5+ years, dominated by exotic stylo (*Stylosanthes spp.*) and native blady grass (*Imperata cylindrica*), and b) the same gully with some active gully scarps despite dense vegetation (middle Annan River).

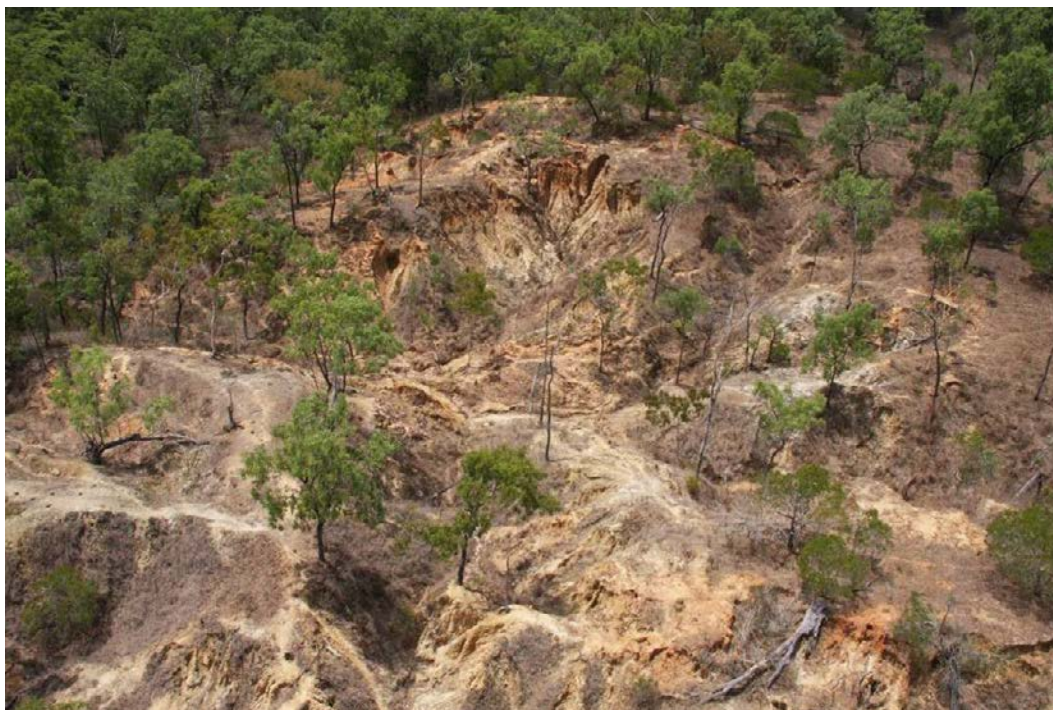
Figure 39 Aerial view (Nov-2011) of the West Normanby gully complex where cattle have been excluded. Note network of cattle trails on gully ridges and valleys.

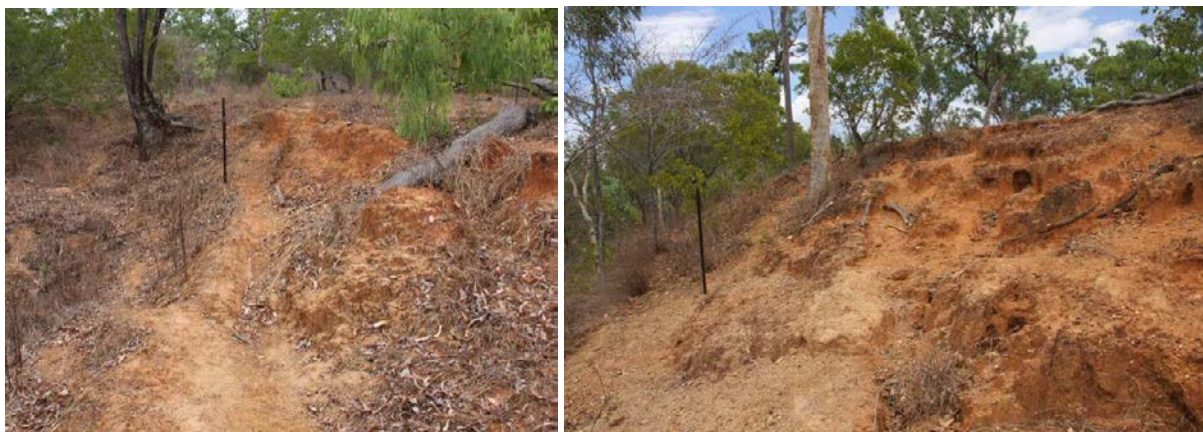
Figure 43 a) b)
Cattle track (pad) erosion examples from the east bank of the West Normanby River.

Detailed photographs were also taken from vertical and oblique angles of each point (e.g., Figure 43). Differentiating wallaby pads from cattle tracks (pads) was difficult in some cases. Cattle tracks were often clear migration paths toward water that were roughly perpendicular to the river, often cut deeply into the alluvial soil. In contrast, wallaby pads were more erratic and discontinuous features, often shallower in depth. However, more subtle cattle tracks also were present as off-shoots of main tracks as cattle grazed along migration paths to the river. Changes over time from cattle exclusion should highlight differences between cattle and wallaby tracks (pads). Tracks should be surveyed into the future in association with vegetation plot surveys.

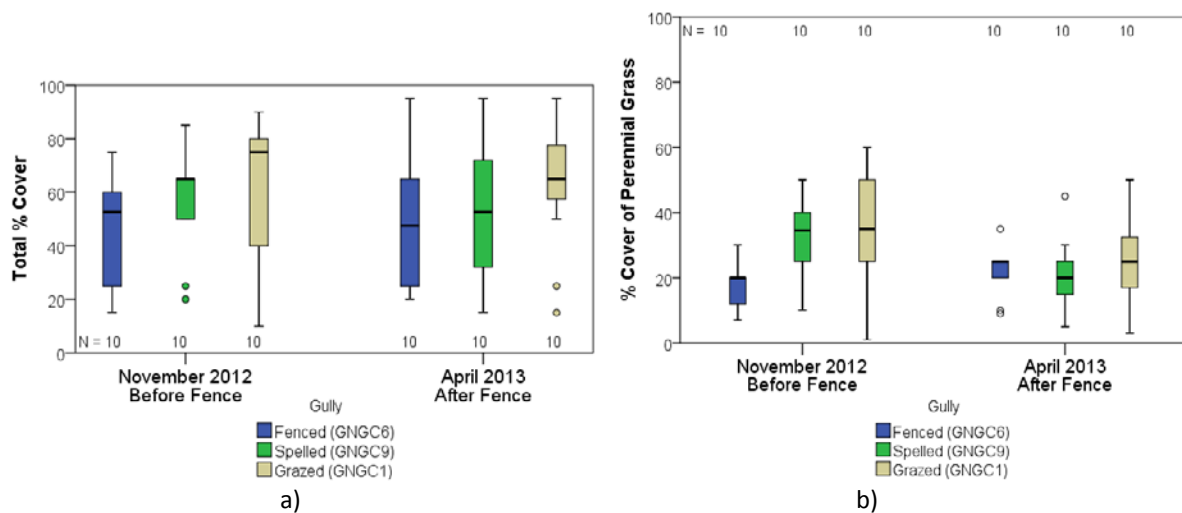
Figure 51 Preliminary changes in cover inside and outside the Granite Normanby cattle exclosure site from 2012 to 2013 showing a) total % organic cover (grass, weeds, leaves, sticks, mulch) and b) % grass cover (standing perennial or annual grass).
