Alluvial Gully Prevention and Rehabilitation Options for Reducing Sediment Loads in the Normanby Catchment and Northern Australia

Jeffrey G. Shellberg and Andrew P. Brooks
Griffith University, Australian Rivers Institute

Final Report

December 2013

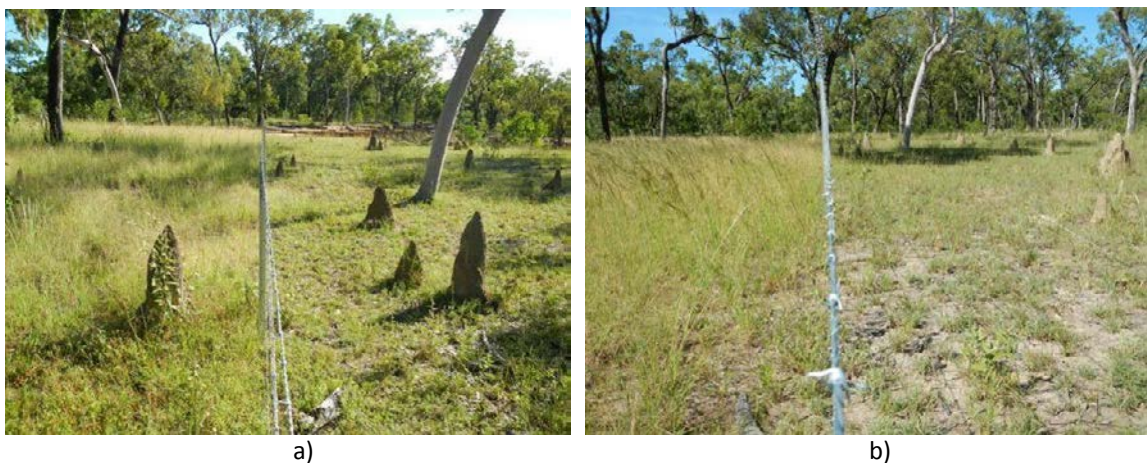
Figure 53 Differences in grass cover and biomass between the fenced gully (Left, GNGC6) and the 'spelled' area (Right, GNGC9) on the high terrace of the Granite Normanby. Note the high stems and seed heads of native black spear grass (*Heteropogon contortus*) on the left of b).

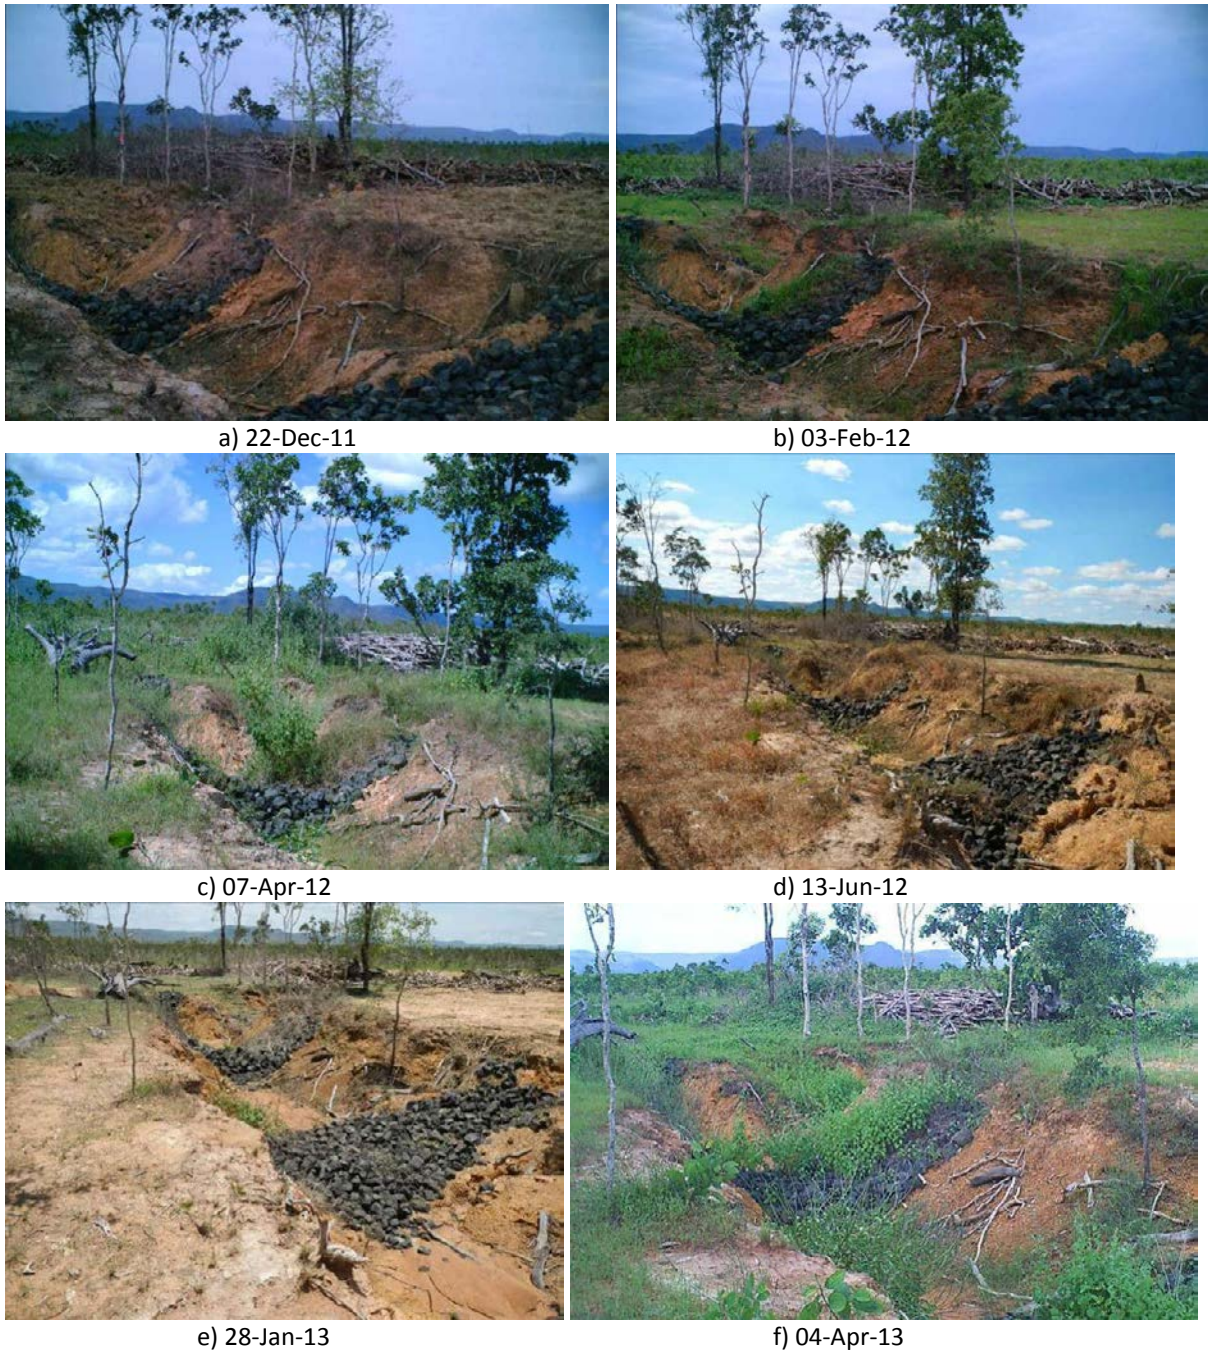
Figure 55 A gully that has been hand sown with grass seed (~50 kg/ha *Urochloa mosambicensis* and *Bothriochloa pertusa*) following installation of grade control structures during a) 22-Dec-11 immediately after seeding and mulch application, b) 03-Feb-12 during wet season growth, c) 07-Apr-12 during wet season growth, d) 13-Jun-12 during the early dry season, e) 28-Jan-13 during the early-wet season and following 400mm of rainfall, and f) 04-Apr-13 after the wet season.

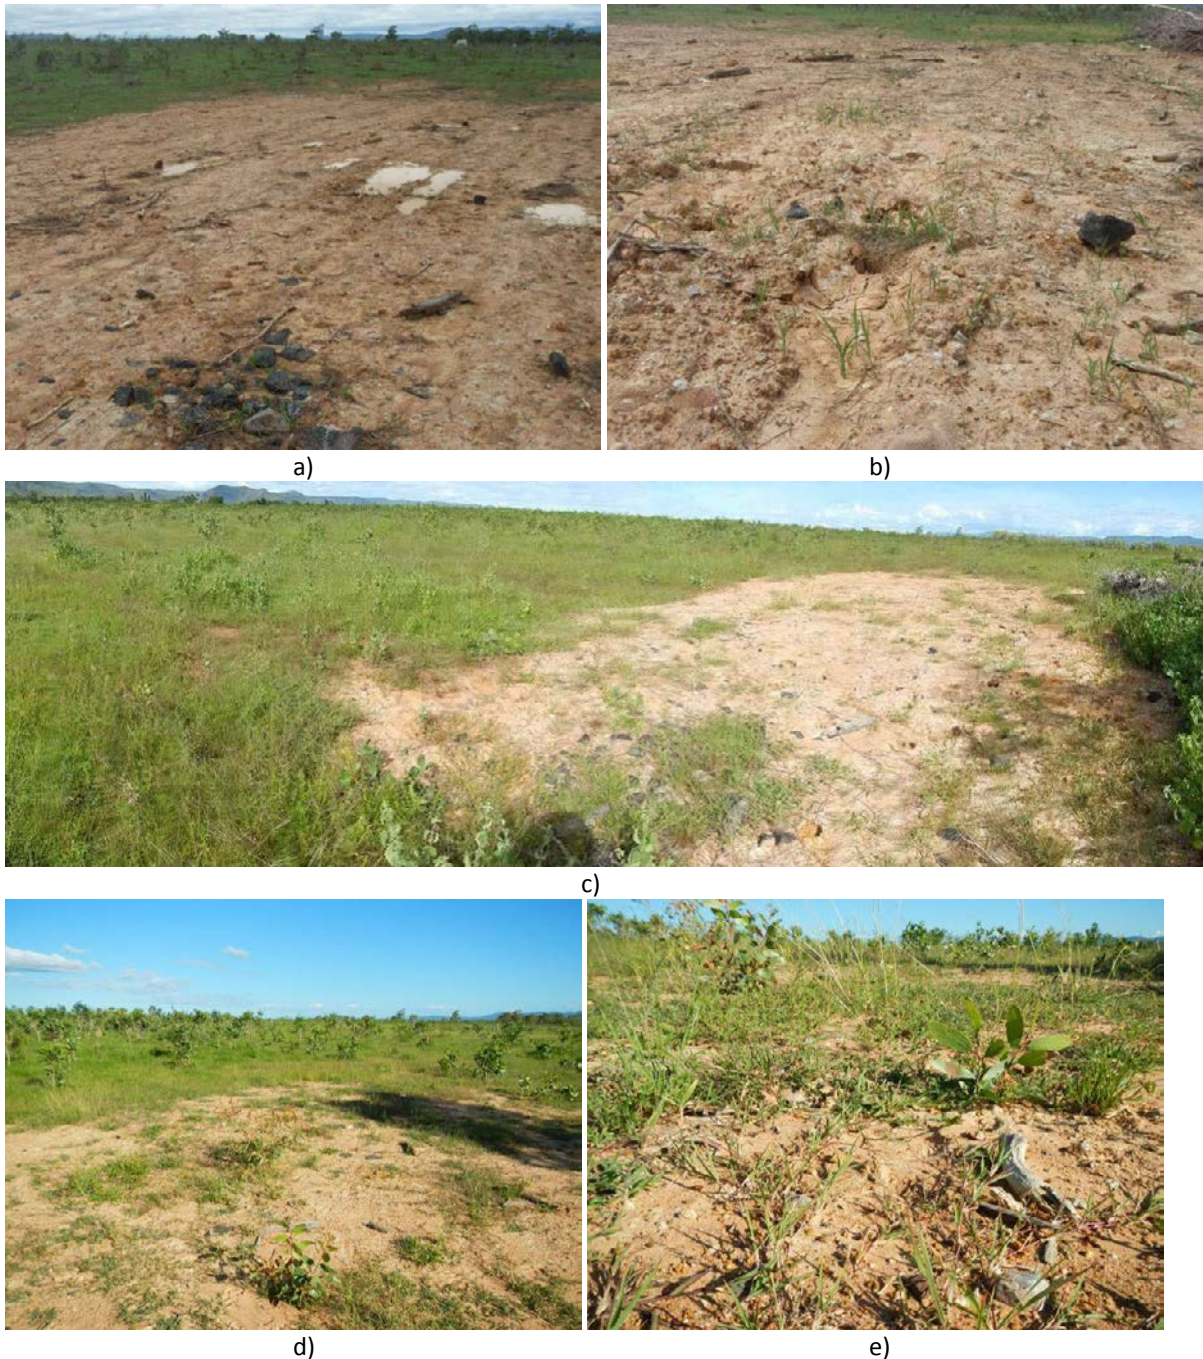
Figure 56 A site example where grass (~50 kg/ha *Urochloa mosambicensis* and *Bothriochloa pertusa*) was hand sown on a) gully sub-soils remaining after gully rehabilitation, b) sparse germination success after the first few rains, c) continuing bare cover at the end of the first wet season, d) continued sparse cover after the end of the second wet season, and e) close-up of low density grass cover after two years.

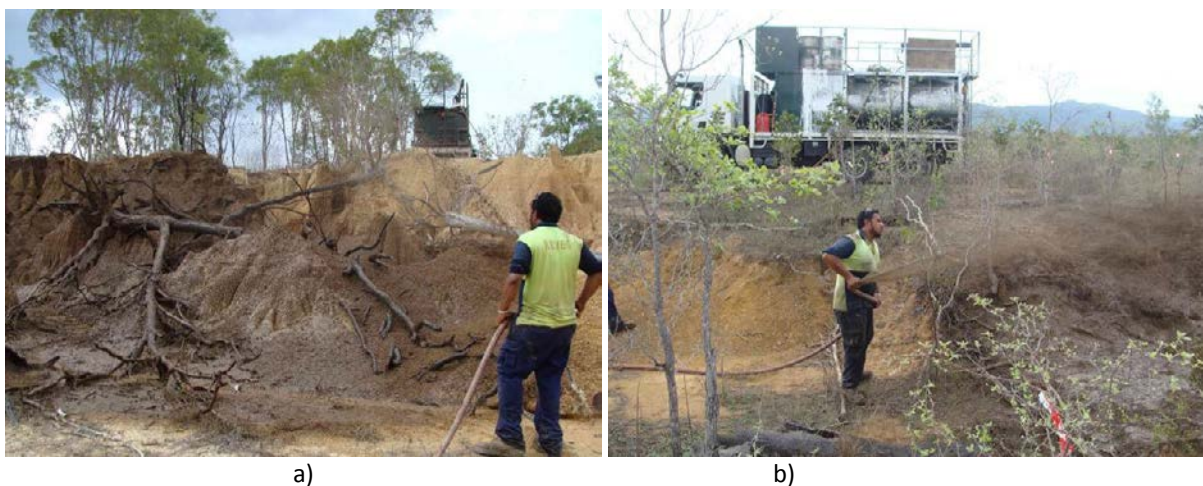
Figure 57 Spraying on hydromulch mix (Table 5) to a) raw eroded gully slopes at CRGC1-28, Dec 2011, and b) scalded gully slopes at CRGC62 with lags of ferricrete pebbles. Note hydromulch truck and tank in background, and application hose.

On Crocodile Station in Dec-2011, raw eroded slopes of gully headcuts, side walls and scalded areas were hydromulched as an initial test of the use of vegetation to stabilise gully slopes without the need to regrade or disturb the slopes. The seed/amendment/water mixture (Table 5) was sprayed directly on raw eroded slopes using hoses (Figure 57). In some extreme cases, the complex and crenulated surface area of the gully walls prevented 100% coverage due to extreme shadowing and angling effects, but coverage generally exceeded 80% from multiple angles, which was sufficient for initial testing.

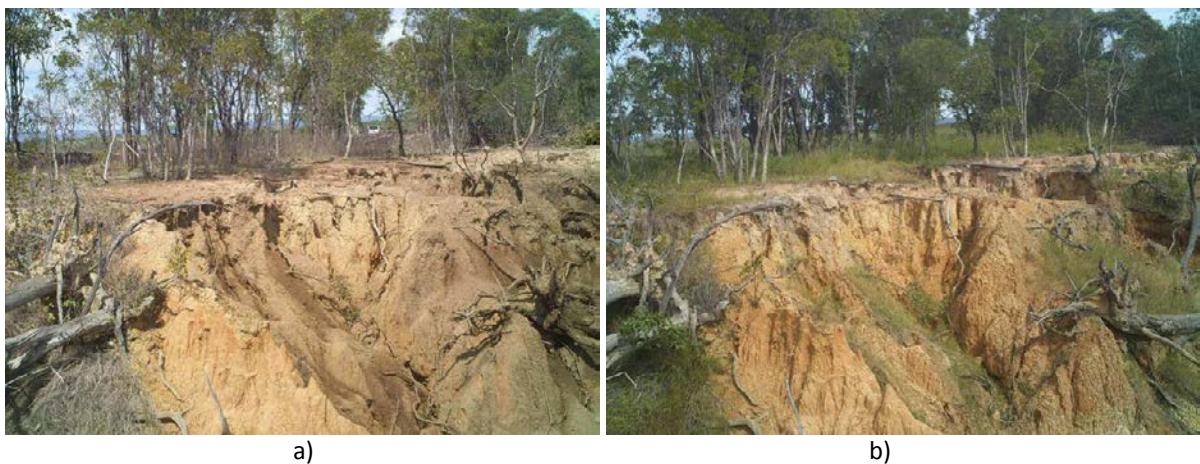
Figure 58 Hydromulch coverage at CRGC1-28 a) just after application in Dec 2011 and b) following germination and wet season growth in April 2012.

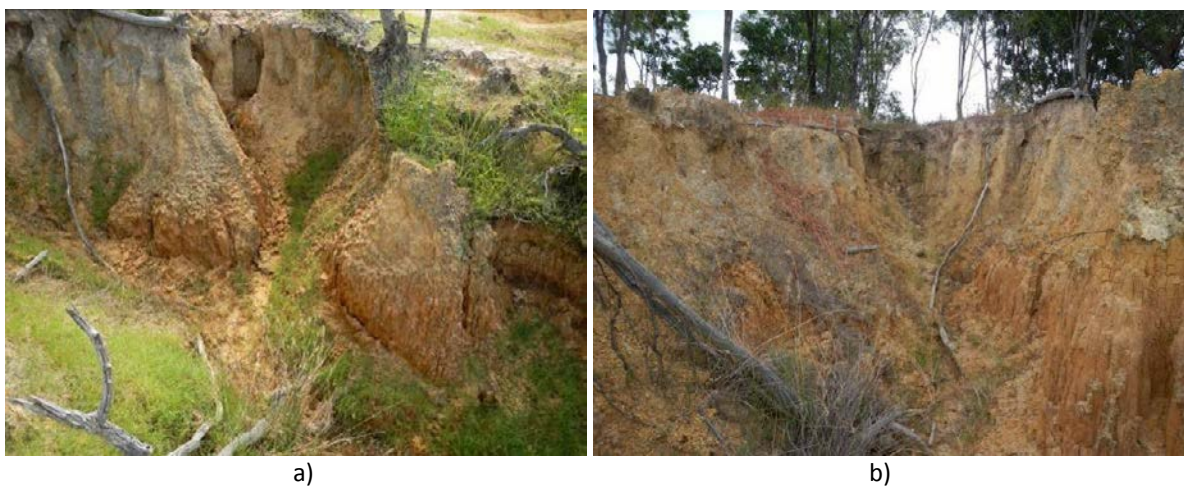
Figure 59 Hydromulch grass establishment at CRGC1-28 by a) April 2012 and b) April 2013. Note the germination success in hollows and concave slopes, but not in active channels or convex slopes with little moisture. Gray areas represent hydromulch mix that did not germinate due to desiccation on these surfaces.

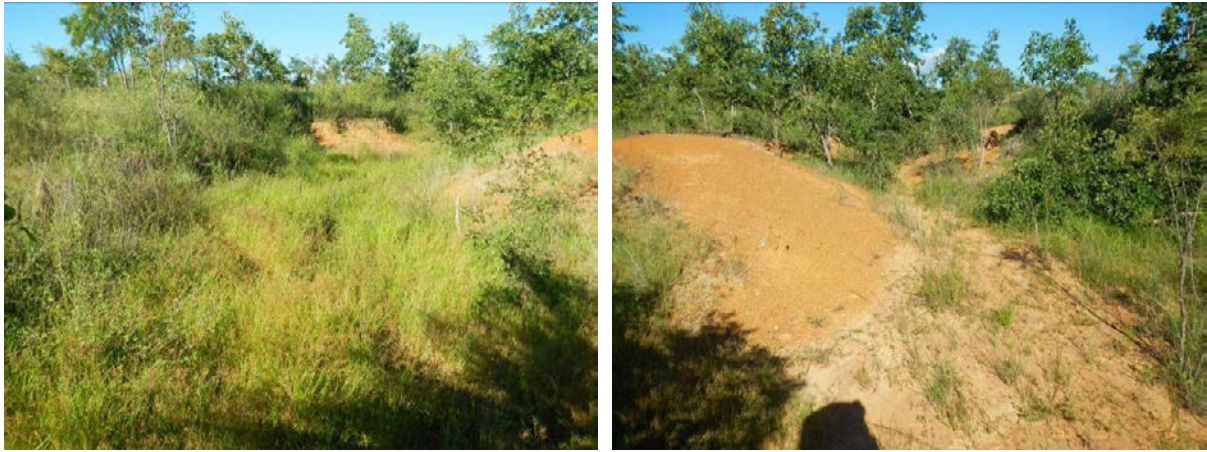
Figure 60 Before and after photos of a) CRGC62a (Plot 507) gully before hydromulch treatment in Dec 2011, b) neighbouring CRGC62b (Plot 511) control gully in Dec 2011, c) CRGC62a (Plot 507) gully after hydromulch treatment in April 2012, d) neighbouring CRGC62b (Plot 511) control gully in April 2012, e) CRGC62a (Plot 507) gully after hydromulch treatment in April 2013, f) neighbouring CRGC62b (Plot 511) control gully in April 2013.

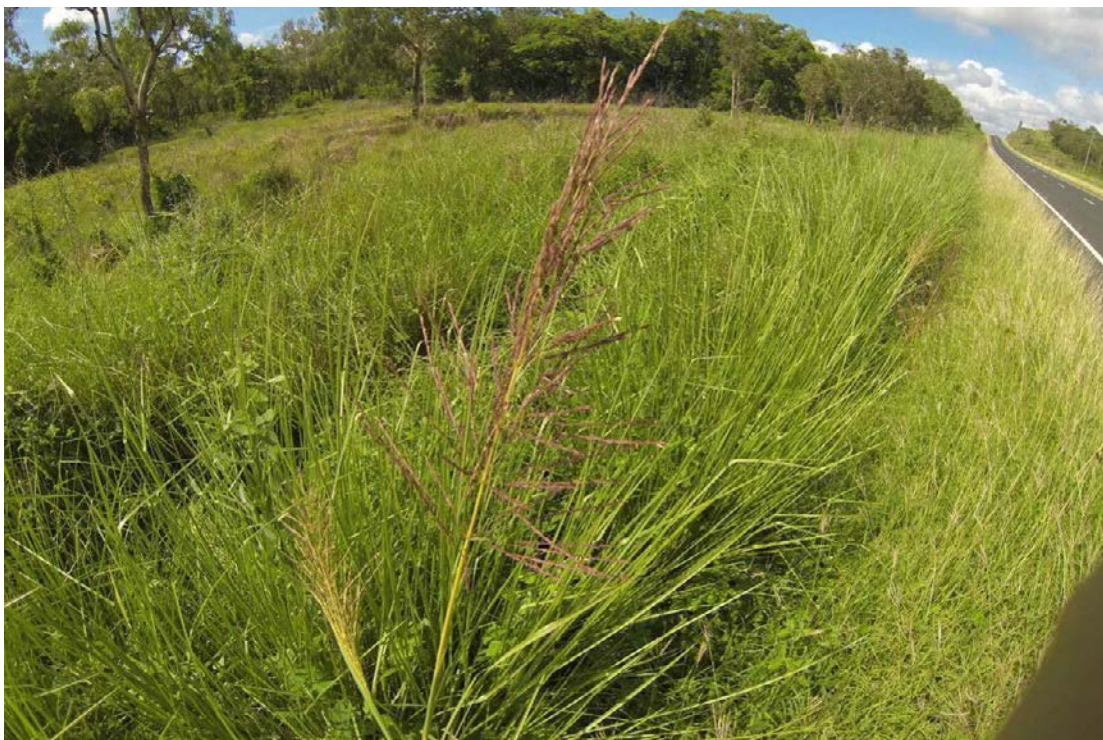
Figure 64 Vetiver grass (*Chrysopogon zizanioides*) hedge rows and seed head growing along the Cooktown Highway that was planted for erosion control by the Queensland Department of Main Roads.

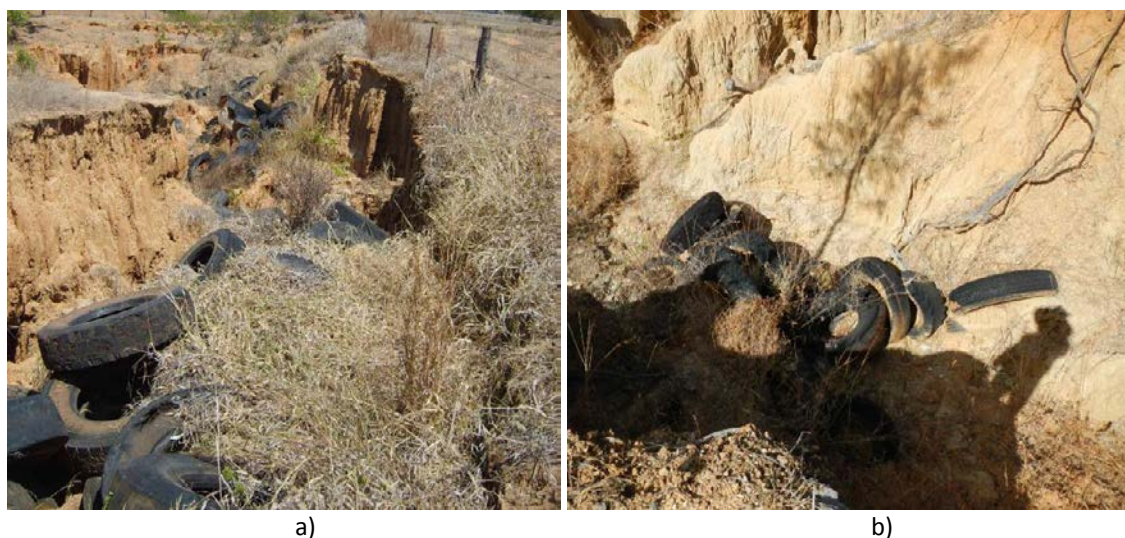
Figure 65 Old tyres are not an effective measure to reduce gully erosion, can accelerate erosion from water turbulence around tyres, and can add toxic material to soils and waterways from the photo-chemical breakdown of the tyres over time.

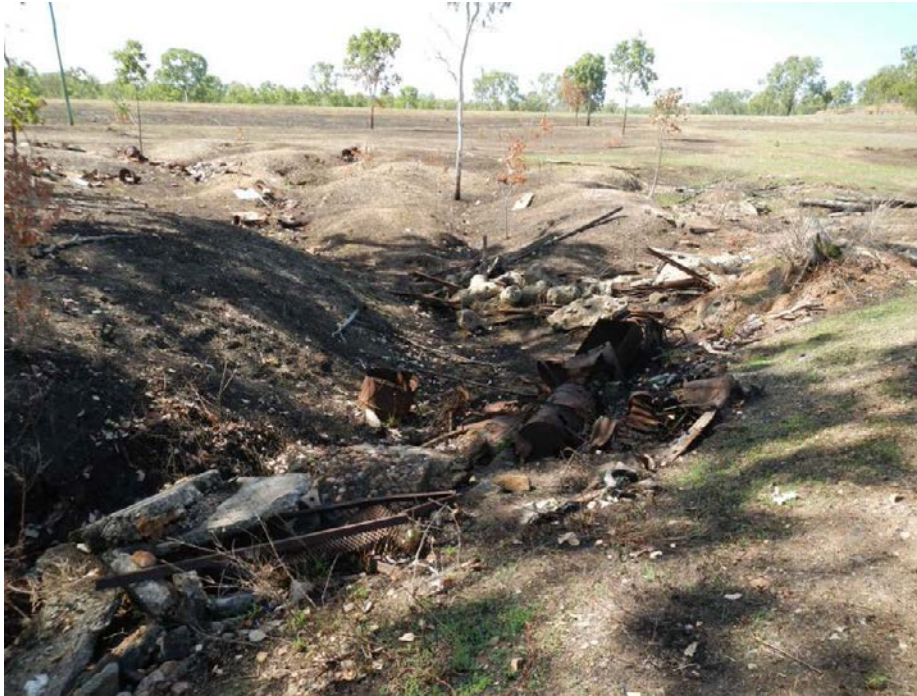
Figure 66 Filling gullies in with debris and trash does not reduce erosion and pollutes waterways.

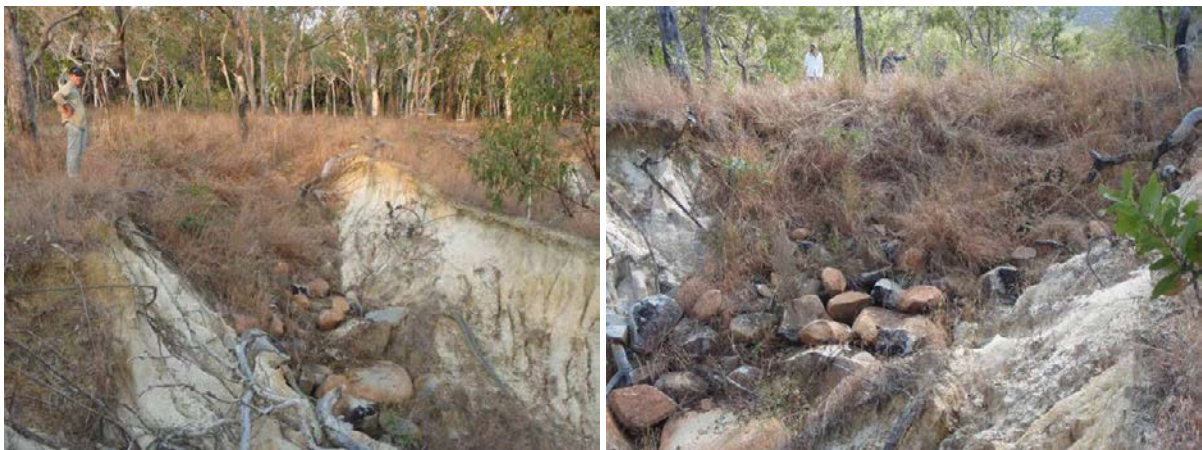
Figure 67 Angular rock armouring and soil backfill at a gully headcut. Note good kangaroo grass (*Themeda triandra*) and black spear grass (*Heteropogon contortus*) establishment on the soil backfill.

As the next step up in the intensity of intervention, angular rock (rip-rap) is often used to armour gully headcuts and scarps. Designs vary from simple dumping of rock and occasionally backfilling (Figure 67) to intricately engineered structures using a combination of rock, gabion baskets, concrete and vegetation for slope stabilization (Gray and Sotir 1996). However, in silt/clay soils with high levels of exchangeable sodium driving dispersion, large angular rock can be ineffective at holding headcuts and soil in place due to soil dispersion and sediment suspensions moving around or through the rock pores, especially when subject to water runoff from upslope (Figure 68). For hillslope gullies in semi-confined valleys, excavation down to bedrock or more stable soil and backfilling with rock can be effective. In dispersive soils, water cut-off trenches might need to be installed at depth to prevent outflanking of any structural control.

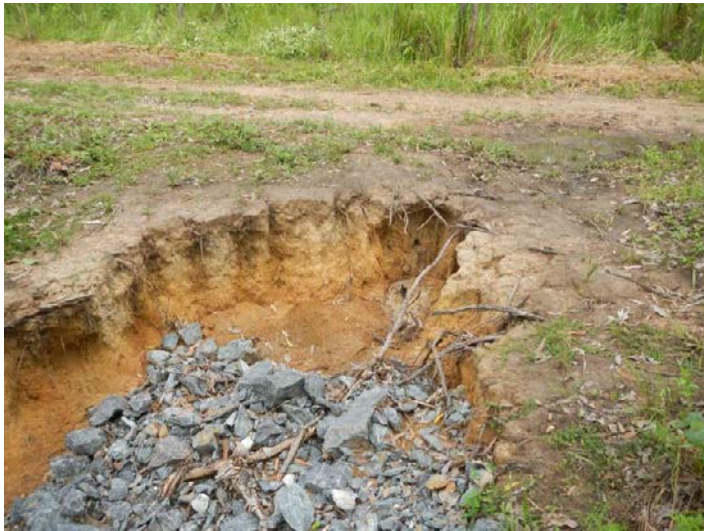
Figure 68 Example of an alluvial gully headcut armoured with angular rock, where seepage and overland flow in dispersive soil has eroded around the rock and continued to propagate upstream, leaving a pile of rock behind as a semi-functional grade control structure.

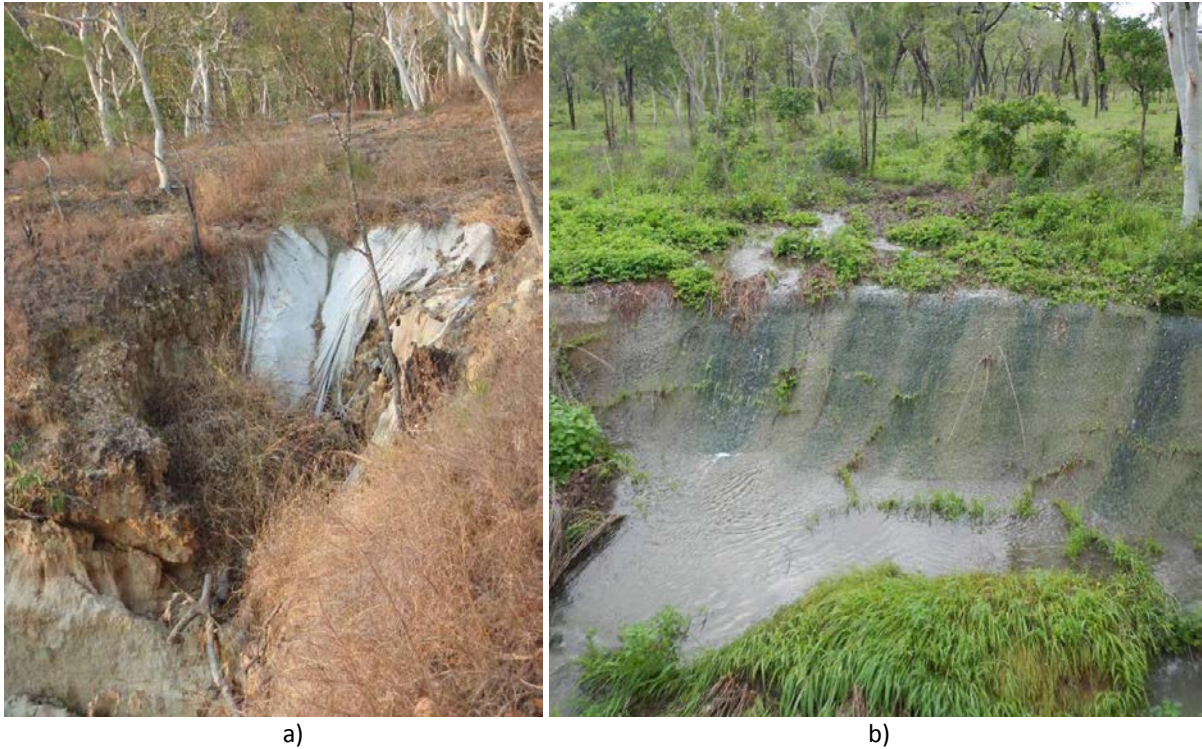
Figure 70 Drop structure examples in the Normanby catchment using a) geo-textile blankets installed at a gully headcut in a failed attempt to protect the soil surface and funnel overland runoff over the headcut, and b) a concrete drop structure and stilling basin at a gully headcut upstream of a road culvert.

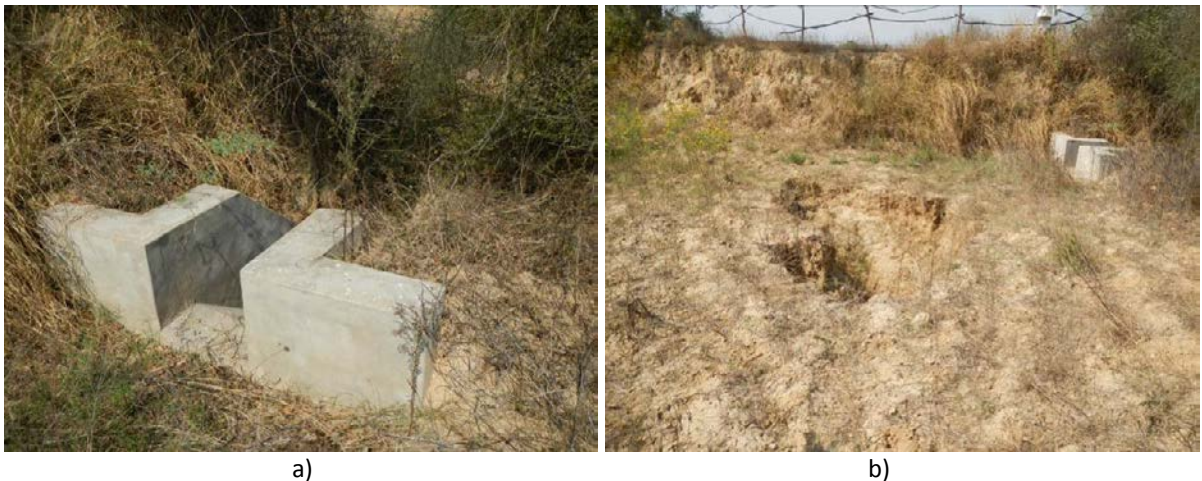
Figure 71 a) A prefabricated drop structure (*sensu* Yadav and Bhushan 1994) placed at an alluvial gully headcut in India, and b) water bypassing of the drop structure due to piping and tunnel erosion through the dispersive alluvial soils upslope.

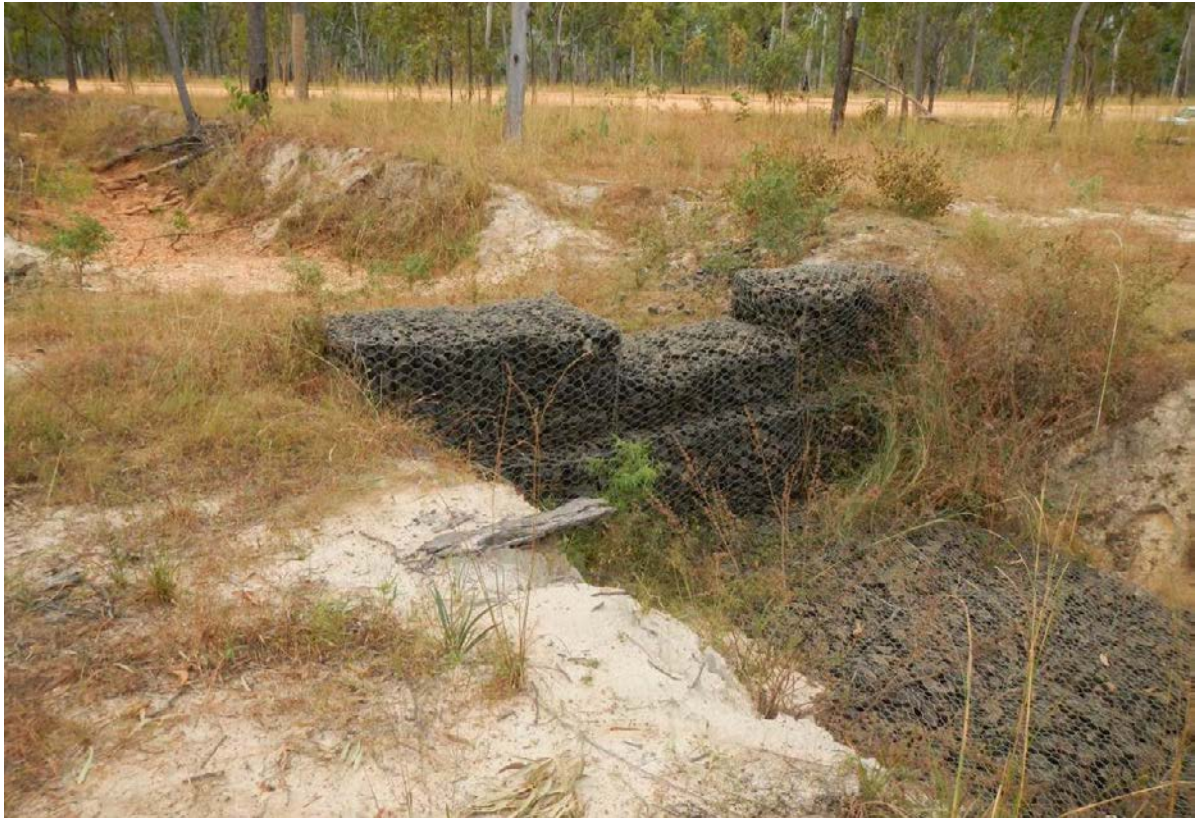
Figure 72 A rock gabion drop structure at a linear gully headcut below a road drain in the Normanby catchment. Note that the structure is not well embedded into the banks of the gully headcut.

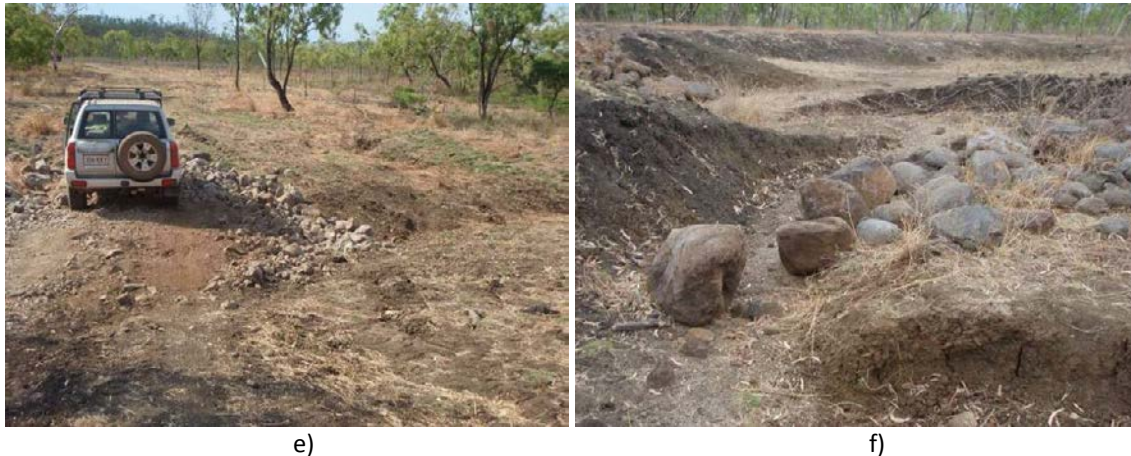
Figure 73 Gully grade control structures in red Ferrosols in the Normanby catchment showing a) small effective boulder check dam in a narrow gully during the dry season, b) loose boulder check dam after the wet season, c) cattle preferentially consuming Floren bluegrass (*Dicanthium aristatum*) planted to stabilise a gully, d) improved grass cover but remaining exposed soils after the wet season due to ‘soil pugging’ by cattle hooves, e) an earthen/rock dam (gully plug) across a gully along a fence-line road, and f) an outflanked loose boulder check dam in a larger gully during the dry season (boulders were not keyed into the bed and banks of the gully).

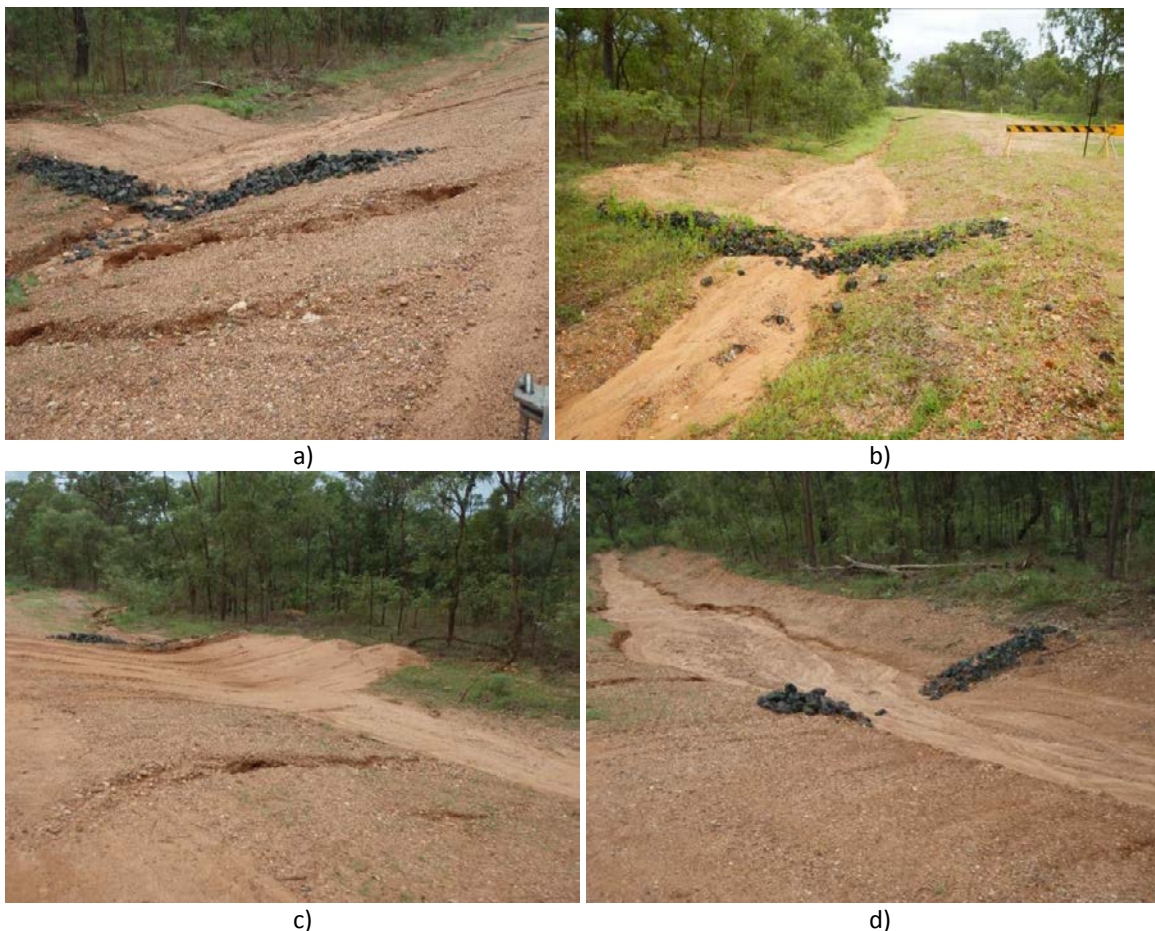
Figure 74 Grade control structures along the Peninsula Development Road: a) sheet and rill erosion off the road and trapping behind a rock structure, b) sediment wedge upstream of a structure, c) maintenance excavation of trapped sediment accumulation, and d) breaching of a structure due to excess water runoff and channel incision along a steep V-drain.

Qualitative observations through several wet seasons indicated that these rock grade control structures had mixed results in terms of road ditch stabilization and sediment retention. Due to the nature of the road base, high traffic and intense rainfall, large amounts of water and fine and coarse sediment are transported off these road surfaces (1029 mg/L mean suspended sediment concentration; 15 to 25mm/yr of surface gravel erosion; Gleeson 2012). Sheet and rill erosion are common place (Figure 74a), as is the potential for gully erosion at most sites (Figure 74b; Gleeson 2012). Many grade control structures are effective at trapping coarse sediment eroding from the road (Figure 74a), but often become buried by upstream sediment deposition (Figure 74b), and frequently require re-excavation to retain their sediment trapping function (Figure 74c). When not maintained or overwhelmed with water and sediment, these structures often fail through breaching or burial (Figure 74d). They also can become completely outflanked by sediment deposition or lack of keying rock into the ditch banks.

These examples highlight the importance of 1) the frequency of road ditch water diversion structures to minimise water stream power and sediment delivery to any one location (Table 7; Johansen et al. 1997; Jolley 2009; NSW OEH 2012), 2) the frequency of grade control structures to match sediment trapping capacity to catchment area, and 3) the height, volume, rock size and abutment design of structures to minimise breaching, outflanking or complete burial, 4) the potential for headcut incision up steep V-drains to undermine structures, 5) the need for regular long-term maintenance, and 6) the limited capacity of grade control structures to mitigate the impact of upstream erosion not addressed through more direct actions (more resistant road base, better water drainage, improved road location and design).

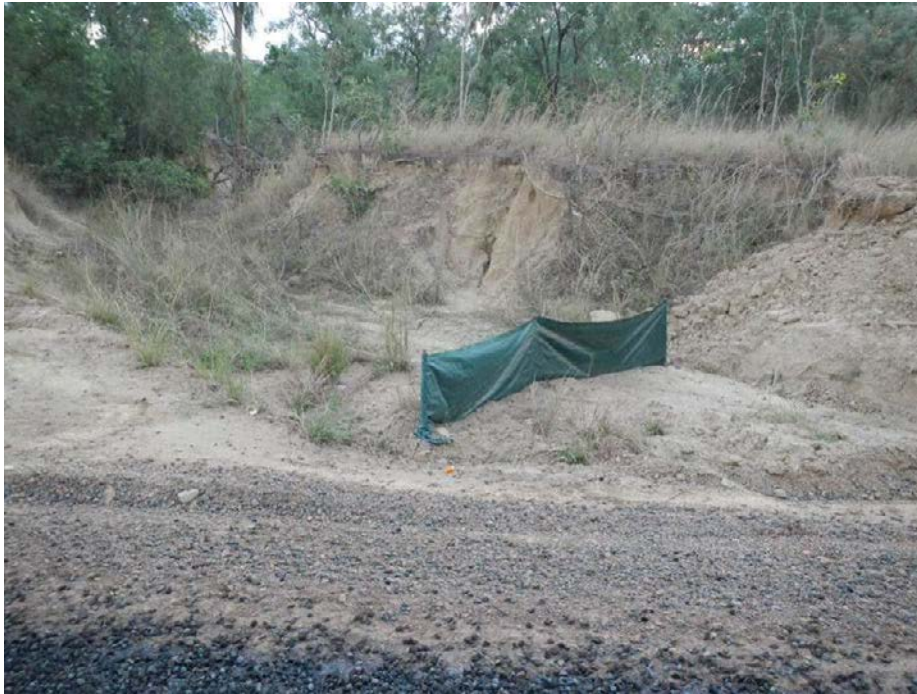
Figure 75 A inadequate silt fence for erosion control that did not follow BMP guidelines (Wetheridge 2009; 2012), was not embedded into gully banks, and is being overwhelmed by road sediment due to overzealous clearing and improperly designed road drainage.

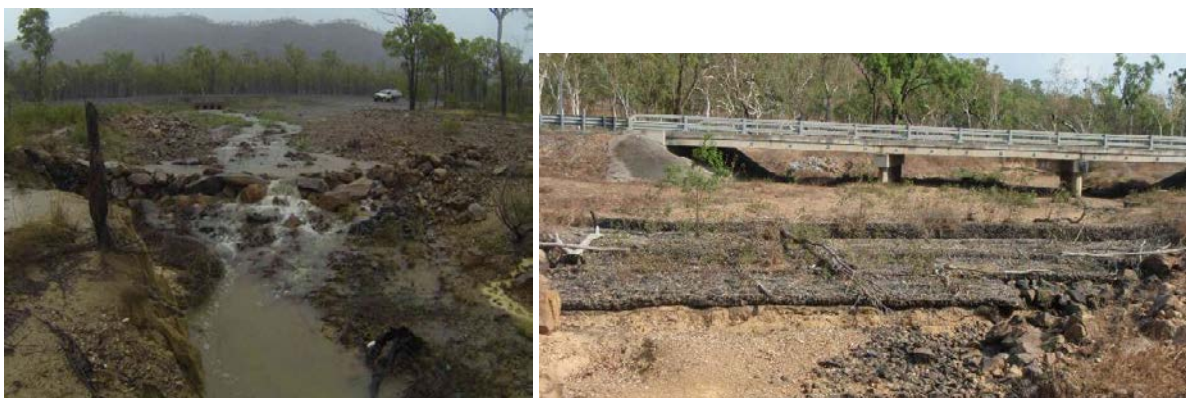
Figure 76 Examples of large grade control structures on Normanby main roads: a) an alluvial headcut that has been partially stabilised by a large rock grade control structure and rock apron downstream of new road culverts, and b) gabion basket (rock filled) grade control structure below a highway bridge.

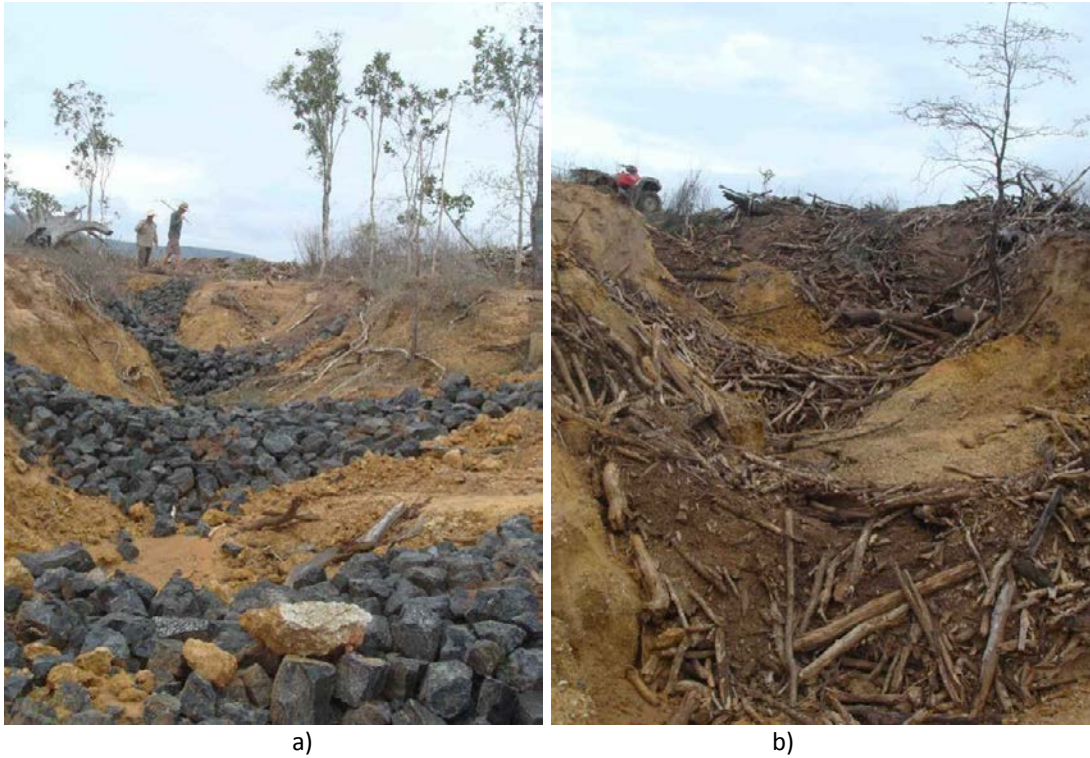
Figure 77 Examples of grade control structures used at a) CRGC1-34 utilizing sequential rock weir keyed into the bed and bank, and b) CRGC1-33 utilizing sequential small-wood weirs keyed into the bed and banks.

Gully Headcut Site #	Treatment	Terrestrial Laser Scanning (TLS)	Latitude / Longitude	Number of Structures	Estimated Total Cost (\$)	Photo Examples
CRGC1-32	Control, No Treatment	Yes	-15.709462 / 144.676439	0	0	not shown
CRGC1-33	LWD Grade Control	Yes	-15.709405 / 144.676869	5	\$ 1000	Figure 77 Figure 78b
CRGC1-34	Rock Grade Control (25t)	Yes	-15.709131 / 144.676814	5	\$ 1800	not shown
CRGC1-40	Regrade slopes, gypsum, hydromulch, LWD grade control	Yes	-15.708456 / 144.676943	6	\$ 6000	Figure 97 Figure 98
CRGC57	Control, No Treatment	Yes	-15.704618 / 144.687048	0	0	not shown
CRGC58	Rock Grade Control (20t)	Yes	-15.7043 / 144.687096	5	\$ 1500	Figure 78a
CRGC59	LWD Grade Control	Yes	-15.703956 / 144.687154	5	\$ 1000	not shown
CRGC61	Control, No Treatment	No	-15.709441 / 144.679948	0	0	not shown
CRGC60	LWD Grade Control	No	-15.709216 / 144.679601	8	\$ 1000	Figure 80

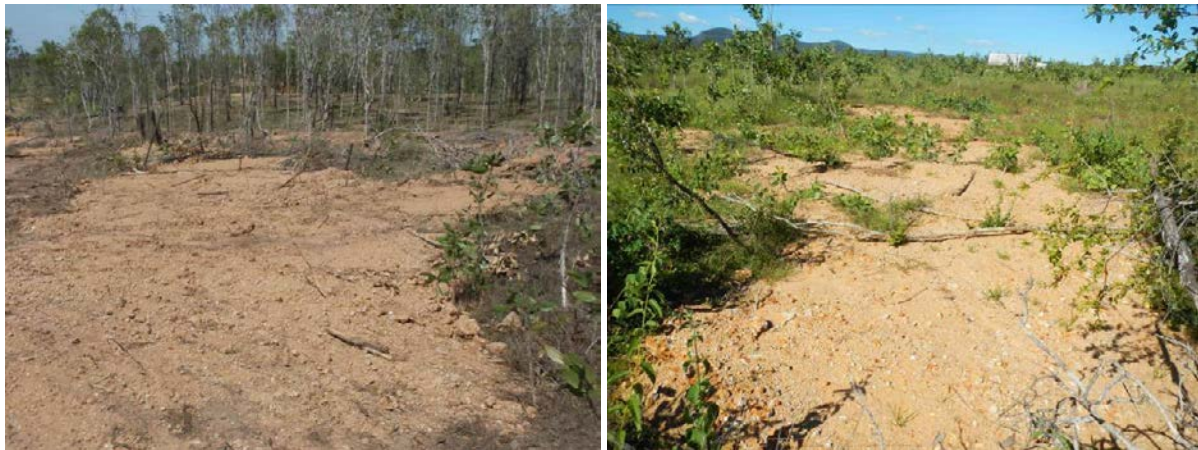
Figure 79 Examples of a) soils disturbed by an excavator during grade control structure installation at CRGC58, and b) poor revegetation success following grass seeding.

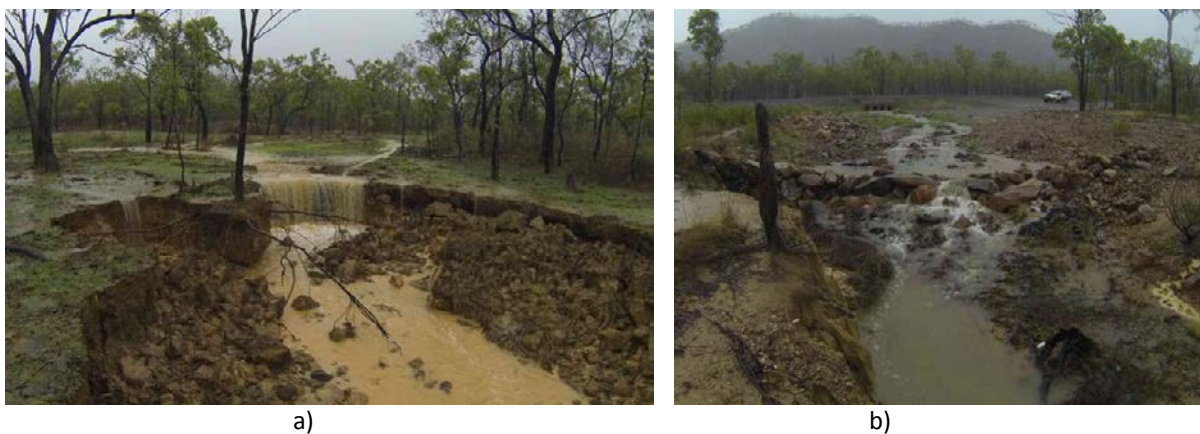
Figure 81 Examples of a) large alluvial gully headcut eroding into a floodplain hollow (CGGC6; Figure 83), and b) an alluvial headcut that has been partially stabilised by a large rock grade control structure downstream of culverts on the Peninsula Development Road near Crocodile Gap.

Currently these gullies are at a critical stage of intervention, and if stopped now early in the cycle of gully evolution, large amounts of sediment could be prevented from eroding into the Laura River. It is proposed to trial large gully headcut stabilization techniques (drop structures and grade control structures; Sections 7.10 and 7.11) at a few of these headcuts (CGGC4-8), while keeping many as an erosion ‘control’ (CGGC1-3). These types of structural interventions could be appropriate and cost-effective per unit sediment yield reduction at this location. Examples of possibly appropriate structures have been installed at nearby gully headcuts eroding into the Peninsula Development Road at Crocodile Gap (Figure 81b).

Preliminary results from November 2012 surveys indicated that % total cover levels were low for head scarps and moderate for hillslopes, hollows, and gully bed/banks (Figure 84). Total cover was dominated by the mulch of dead annual grass (mostly *Themeda quadrivalvis*). The % cover of perennial grass was low in contrast at all sites (Figure 84). These low perennial grass cover conditions can promote the acceleration of water runoff during rainfall events (Figure 82) that can fuel the retreat of headcuts into these floodplain hollows (Figure 81).

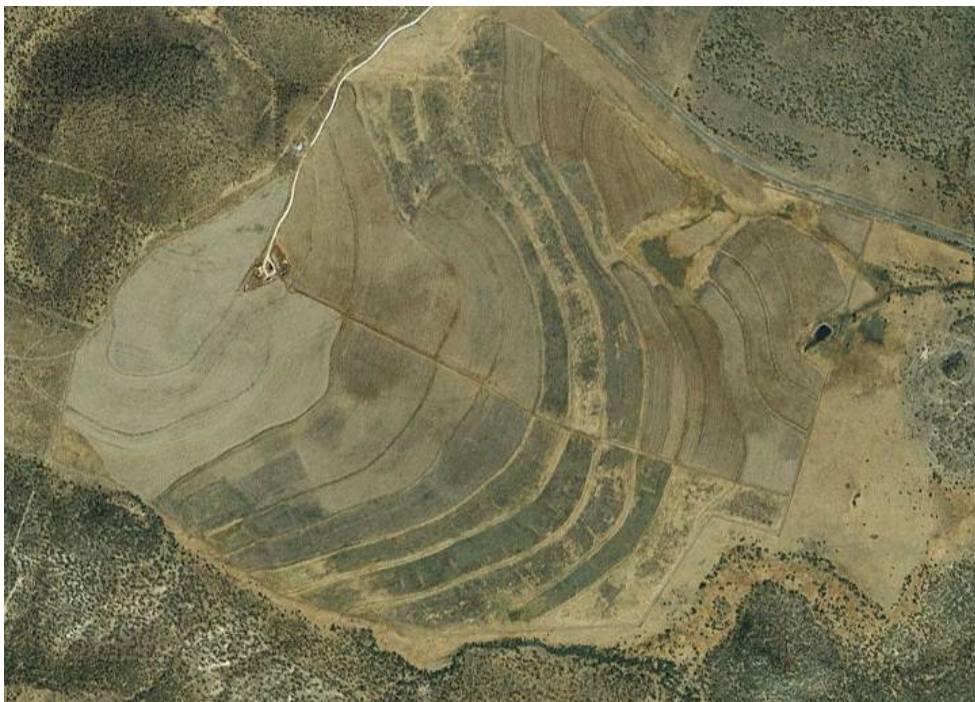
Figure 85 An example of contour banks (berms) installed in a cleared pasture (slope from left to right) in the Lakeland area of the Normanby catchment to control shallow hillslope runoff, promote infiltration, spread water, retain soil in-situ, and reduce water and sediment runoff to adjacent creeks. Note that this treatment is only applicable to already cleared paddocks.

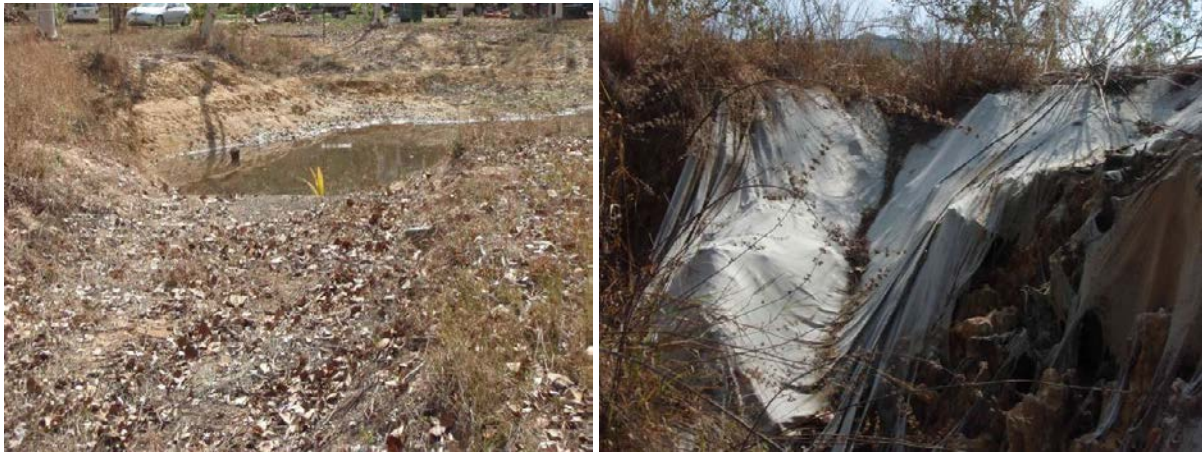
Figure 86 Example of a) a small farm dam installed above a gully head to retain and dissipate overland runoff before reaching the gully head, and b) the gully headcut below the dam still eroding from excess storm runoff out of the dam and insufficient armouring of the headcut.

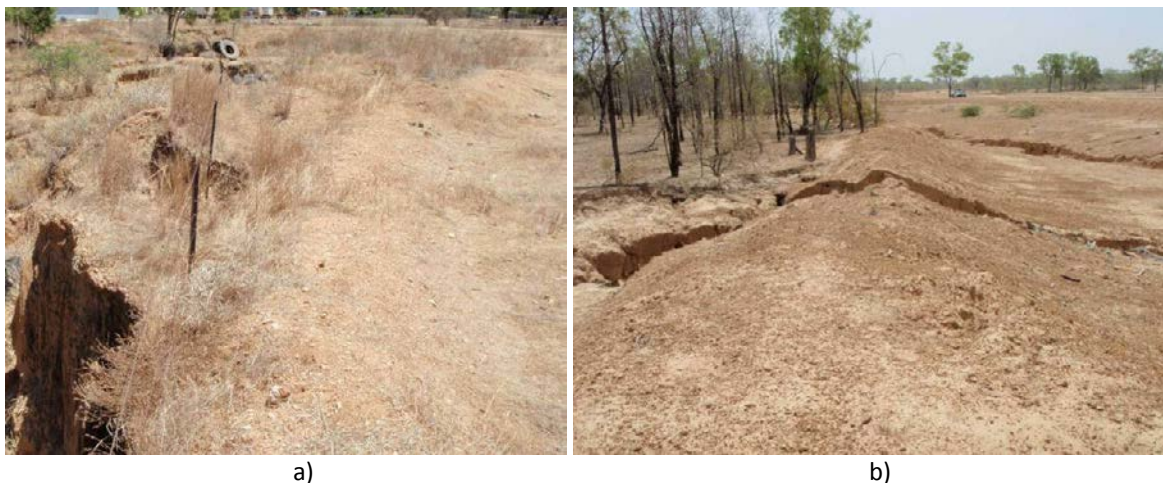
Figure 87 Mitchell catchment examples of earthen banks (berm or bunds) around the heads of gullies used to slow or divert water flowing into gully headcuts: a) earthen bank above an alluvial gully headcut on river frontage, b) an earthen bank around a road induced gully that has been breached by water seepage and piping through sodic soils.

Along long scarp fronts of alluvial gullies, earth banks have been constructed to reduce diffuse runoff from flowing or seeping over scarps (Section 7.12; Figure 87a). Anecdotal information suggests they are successful at ponding shallow runoff and reducing headcut retreat rates. To maximise paddock utilization, they are often placed close to the scarp. However, direct rainfall erosion on the gully scarp (Shellberg et al. 2013a) and continued water seepage through the bank can continue headcut retreat. Ongoing scarp retreat can threaten the integrity of banks if they are situated too close to the scarp without appreciating future scarp retreat rates (Figure 87a).

Using dispersive or sodic soils to construct earthen banks can be problematic due to the high potential for soil piping to undermine or breach the bank (Figure 87b). This is especially true when overland runoff rates are high from upslope catchment areas and additional diversion/retention banks are not installed upslope to manage water (Figure 89). Piping and failure of earthen banks around gully scarps can be especially common when the slope of

the bank(s) and subtle contours are not taken into account. Excess runoff can be diverted along the bank until a preferential flow or weak point in the bank is found, leading to piping and collapse (Figure 87b). Annual or periodic maintenance of earthen banks is needed to ensure their functionality over time (Figure 88b).

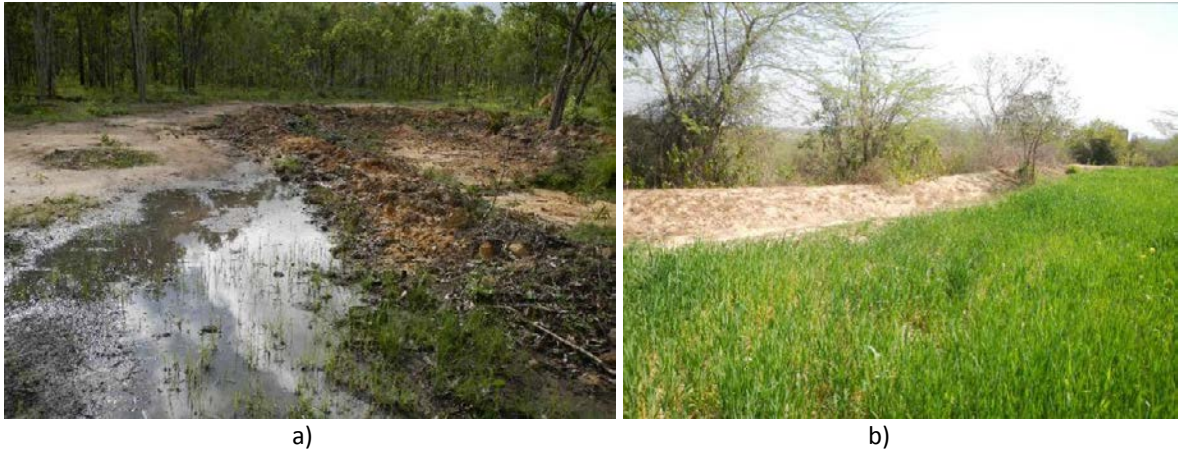
Figure 88 Functional examples of earthen banks (berm or bunds) around the heads of gullies to slow or divert water flowing into gully headcuts: a) a horseshoe earthen bank constructed along the perimeter of a gully headcut to divert road runoff, and b) a well maintained earthen bund in India above an alluvial gully headcut used to retain water runoff from an adjacent field.

When earthen banks are used to divert rather than detain overland runoff, the discharge location needs to be carefully identified and protected from erosion (Geyik 1986). Otherwise diverted water can initiate new gullies and just transfer the erosion problem from one location to another (e.g., Figure 88a; Figure 89). High resolution topographic mapping using LiDAR (e.g., Figure 40; Figure 83; Figure 99), in conjunction with field reconnaissance and surveys, will be useful in identifying appropriate locations, slopes, water flow paths and water discharge points. This will ensure that earthen banks actually reduce water runoff and erosion above gully heads, rather than locally accelerate it.
