Alluvial Gully Prevention and Rehabilitation Options for Reducing Sediment Loads in the Normanby Catchment and Northern Australia

Jeffrey G. Shellberg and Andrew P. Brooks
Griffith University, Australian Rivers Institute

Final Report

December 2013

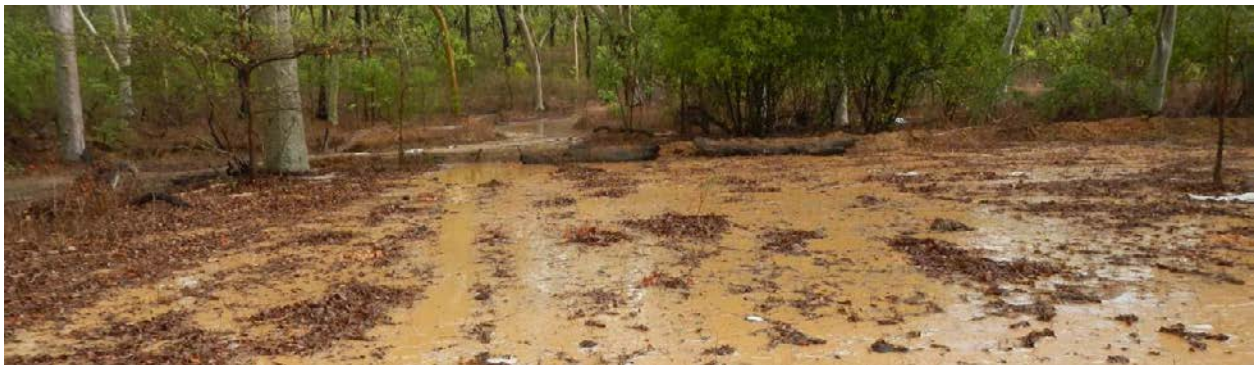
Figure 89 A small earth bank (background) used to divert shallow overland runoff away from a headcut in the distance towards a safe disposal area and sedimentation pond to the left.

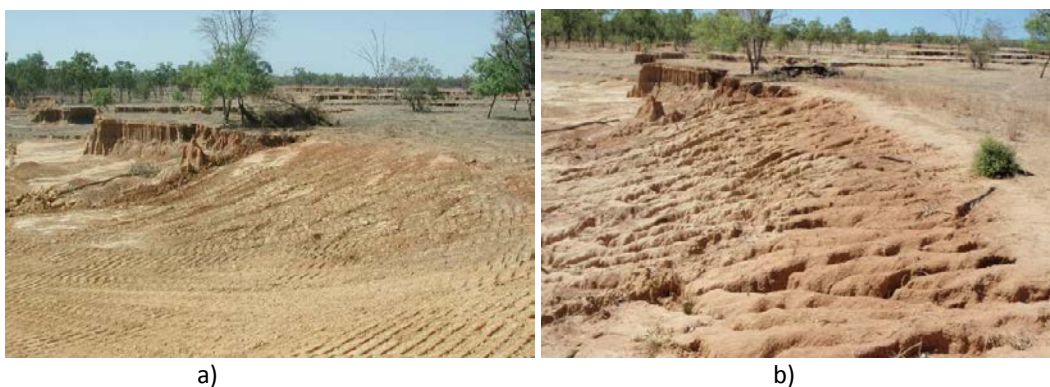
Figure 90 Changes in gully head scarp morphology a) in 2007 following bulldozer regrading, and b) in 2009 after two wet seasons. Note the original head scarp in the background (before condition), the deep rills reforming gully channels in the foreground in 2009, and little vegetation cover on the slope surface.

The lower Mitchell River and associated floodplains are a major area affected by alluvial gully erosion in northern Australia (Brooks et al. 2009; Shellberg 2011). In situations where large alluvial gully scarps have migrated over time towards road prisms, road crews have developed the practice of completely regrading gully head scarps with bulldozers, in the hope of stalling their advancement into roads. To date, these regrading efforts have not been conducted in association with any revegetation efforts, mulch or fertiliser application, chemical amelioration, or cattle exclusion. In most cases, newly shaped surfaces begin re-eroding via sheet flow and rilling almost immediately during the first wet season rains. After two wet seasons, deep rills often cut through the slope and new dendritic gully channels reform into the slope (Figure 90). Thus benefits to slope stabilization and sediment yield reduction remain highly unclear without other rehabilitation measures.

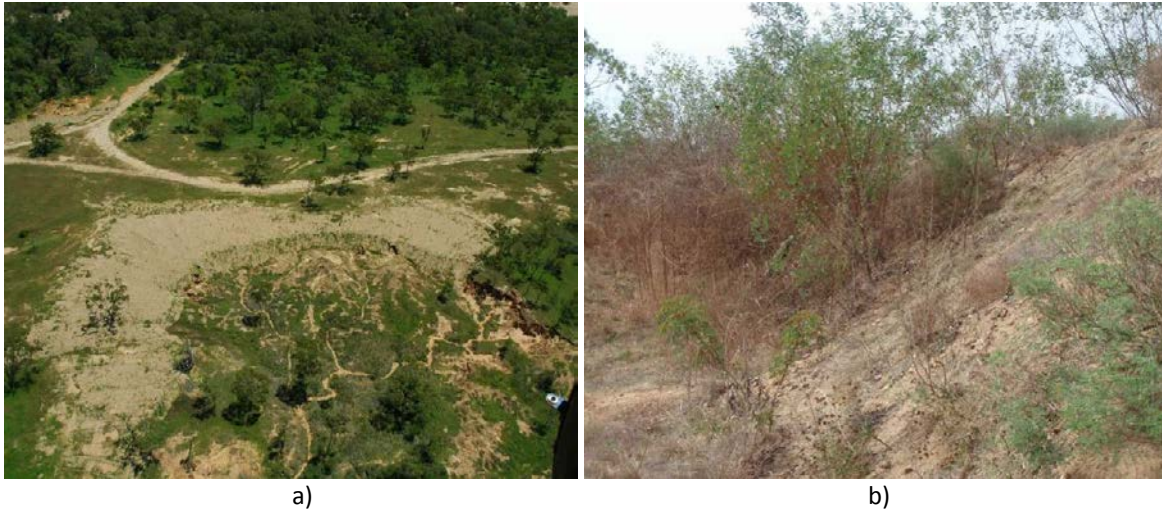
Figure 92 a) Oblique aerial view of a gully head scarp at Mount Mulgrave that has been backfilled with local river sand in an attempt to slow erosion into the road in the background. Note the original scarp front remains intact in the right side of the photo. b) Colonization of the river sand by native *Acacia* spp. and exotic weeds like sicklepod (*Senna obtusifolia*).

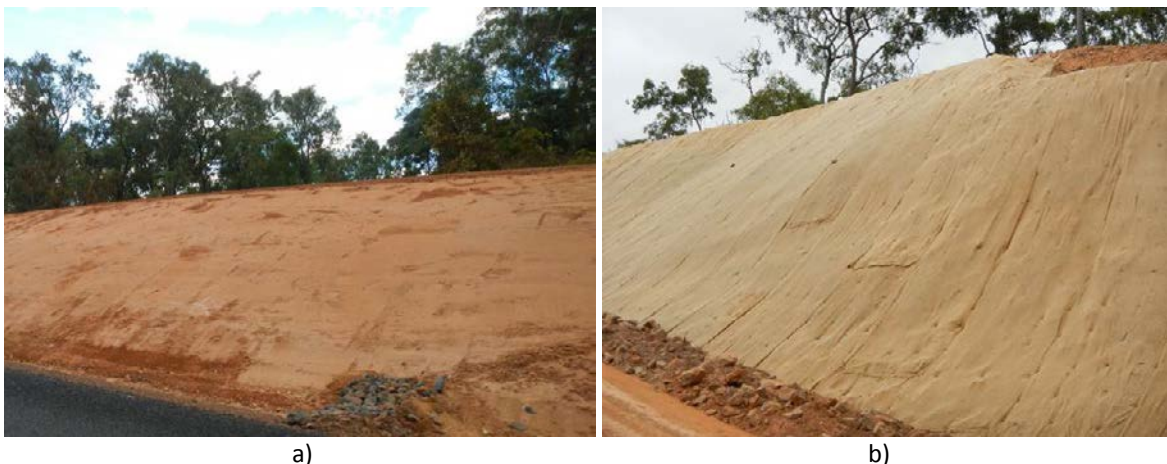
Figure 93 Normanby road batters a) raw without any intervention ready to re-erode and b) using geotextile fabric for stabilisation.

Both historically and currently along most roads in the Normanby catchment (and Cape York Peninsula), battered slopes along road edges generally have not been rehabilitated with vegetation, chemical, or organic amendments to promote long-term stability and reduce sediment erosion (e.g., Figure 93a). Most often these slopes are left to revegetate passively over time. Severe reinitiation of rill and gully erosion of these slopes is often the result, especially on dispersive or sodic soils. By learning from these lessons, management efforts are increasingly being made to rehabilitate or stabilise these slopes with vegetation, matting, and/or rock (e.g., Figure 93b; Figure 94; Figure 95). Both successes and failures are common.

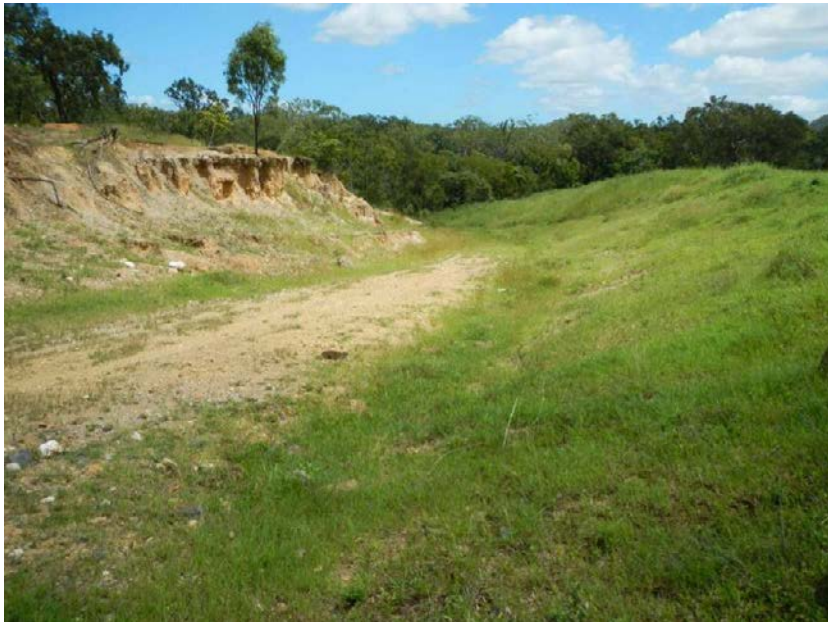
Figure 94 Comparison between the left and right approaches to the south side of the old West Normanby bridge crossing, April 2012. The right side was battered back and revegetated during the decommissioning of the road crossing circa 2006. Note that significant erosion continues down the centre of the old road due to excess water runoff.

battered off by bulldozer, capped with coarser non-sodic soils, sown with grass seeds, and mulched with hay (Annette Marriott personal communication). The other side of the road approach was left as an intact gully scarp. Five (5+) years later, dramatic vegetation differences can be seen between the different sides (Figure 94). While some of the originally planted grass (e.g., *Urochloa mosambicensis*; *Chloris gayana*) still exists, much of the battered slope has also been colonised by weeds such as grader grass (*Themeda quadrivalvis*) and mintweed (*Hyptis suaveolens*). Some of the vegetation success of the site can also be attributed to its partial isolation from cattle grazing due to its location in the corner of an isolated paddock where cattle do not concentrate. Regardless, the right (north) approach slope is dramatically more stable with less erosion than the left (south) approach slope.

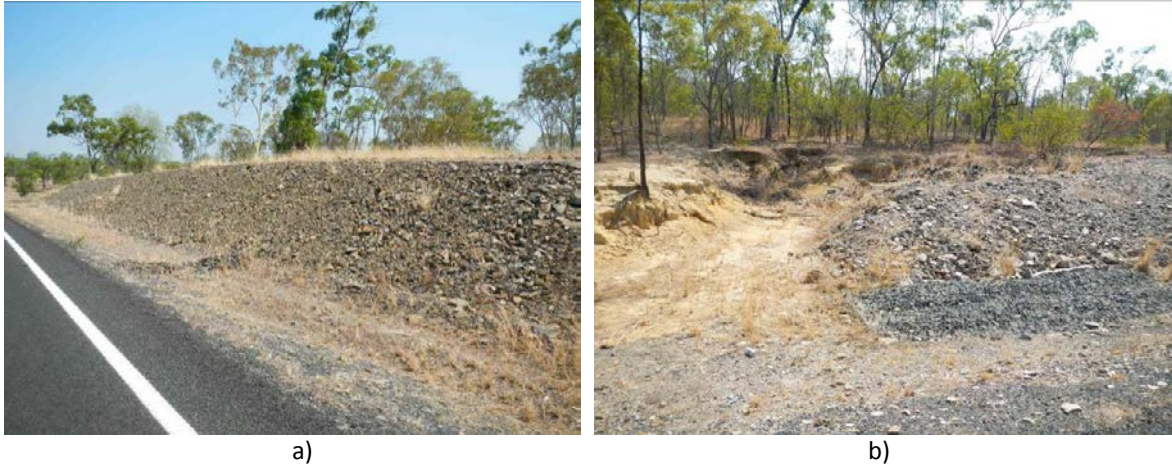
Figure 95 Road batter stabilisation using a) angular gravel armouring on battered slopes of sodic soils and alluvial gullies along the Peninsula Development Road (PDR), and b) a comparison between a raw alluvial gully and a battered rock armoured gully with toe protection.

In another example of recent proactive stabilization of sodic soils along roads, road batters along the Peninsula Development Road between Lakeland and Laura have been armoured with angular gravel from nearby rock quarries. By covering the sodic soils with rock armour, rill and gully erosion of the steepened slope can be minimised. Armouring the toe of the slope with rock, along with periodic rock grade-control structures, can also prevent incision of the road ditch, lowering of the base level, and reactivation of rill and gully erosion (Figure 95a). Compared to adjacent road slopes that are riddled with rills and gullies (Figure 95b), the influence of the rock armouring can be dramatic. The biggest challenge for using this approach to gully stabilization is the need for an abundant local source of angular gravel to cover large areas, which can be problematic and economically prohibitive for gully stabilization projects away from main roads.

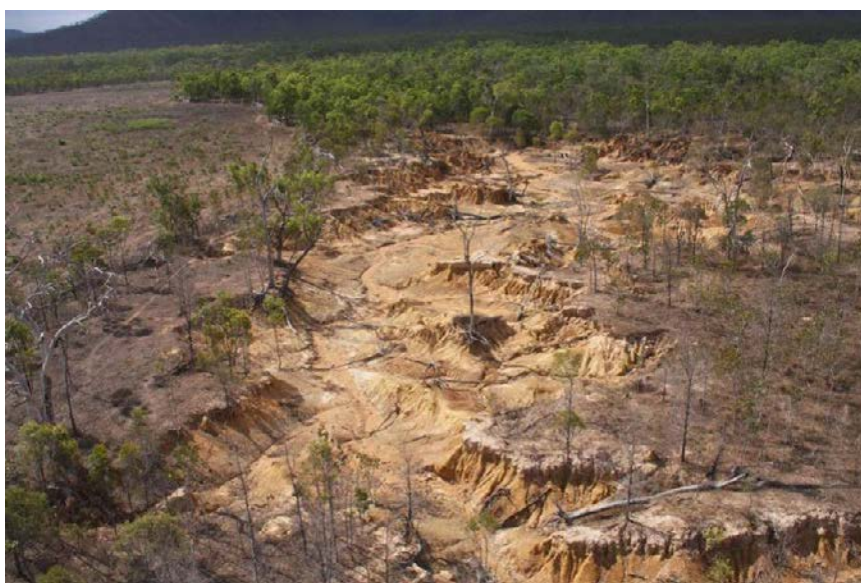
Figure 96 Oblique photo of CRGC1 before project implementation in Nov-2011.

In the Normanby catchment, a full set of physical, chemical and biological rehabilitation treatments was applied to one gully lobe (CRGC1-40; Figure 97a; Figure 99) of a large alluvial gully complex (CRGC1; Figure 96). Several nearby gully lobes were kept as controls (CRGC1-32,39), while others were just treated with physical structures (e.g., rock/wood grade control CRGC1-33-34) or just physically battered (CRGC24) (Table 6; Figure 99). In two other nearby gully lobes (CRGC1-29, CRGC60/61), a more detailed experiment on different combinations of chemical and biological treatments was studied after full battering of slopes to different angles (see Section 7.13.5). The “all” treatment at CRGC1-40 represents the end member of proactive treatments using direct/intensive intervention with sodic soil rehabilitation, but without the next expensive step of completely burying the gully and sodic soils with rock or imported fill and non-sodic topsoil.

At CRGC1-40 (Figure 96; Figure 99), the 0.2 ha gully lobe was initially infilled and battered back to a more stable angle using an excavator in Dec 2011 (Figure 97bc). The soil material for infilling and battering came from the local gully walls, which consisted of ~ 50cm of dispersive non-sodic silt soil, overlaying 3m of sodic clay soils (Figure 103). These layers were fully mixed together during excavation (Figure 97b) to attempt remediation of fully sodic soils more typical for profiles in the region, rather than trying to retain the topsoil layer for later surface spreading. Note that in other situations retaining the topsoil for later surface use would be a preferred alternative, but only if sufficient volumes could be obtained.

On Crocodile Station, two gully slopes in two different gully complexes were chosen as sites for experimental plots. Both gullies CRGC1-29 (Figure 22; Figure 96) and CRGC60-61 (Figure 45) are located in a large cleared paddock on alluvial textural-contrast soils with high levels of exchangeable sodium percentage (ESP>>5) at depth.

At CRGC1-29 (left side of Figure 96; Figure 99), a 50 m long gully side wall was regraded using a bulldozer to create a relatively uniform slope (12% mean, range 11.25 to 13.25%) with a slope-length of 25m. The entire gully profile from the surface to up to 3m deep was thoroughly mixed laterally and vertically via deep ripping and bulldozing so as to create a uniform soil volume that was representative of average sodic sub-surface soils that the gullies were eroding into (Figure 100). There generally were insufficient volumes of non-sodic topsoil (<50cm) to spread over any battered gully slopes, unless topsoil was scraped and borrowed off large areas of the adjacent uneroded paddock to cover gully sub-soils. Thus, locally remaining non-sodic surface soils were mixed and diluted into the much more voluminous sodic sub-soils. The result is representative of the more typical alluvial gully situation in the Normanby catchment where non-sodic surface soils are fairly thin to absent.

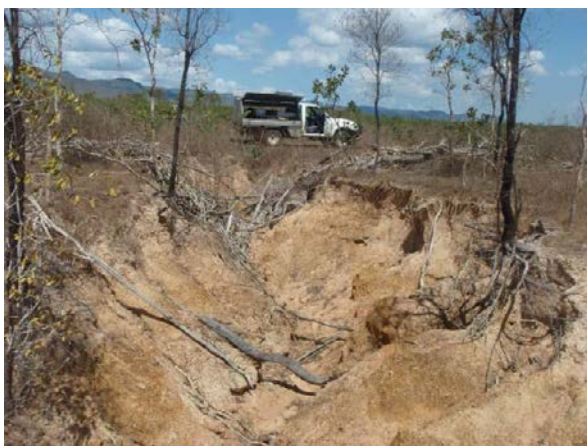
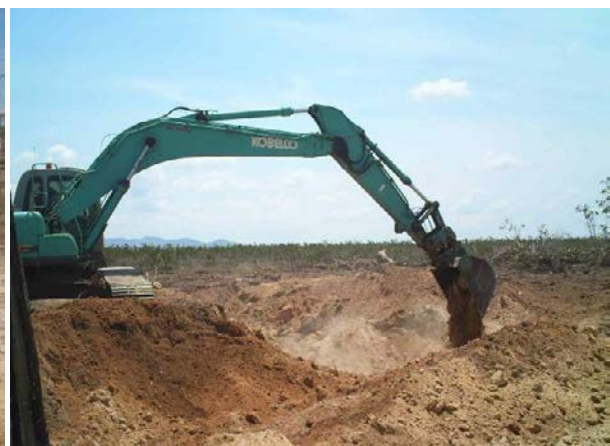
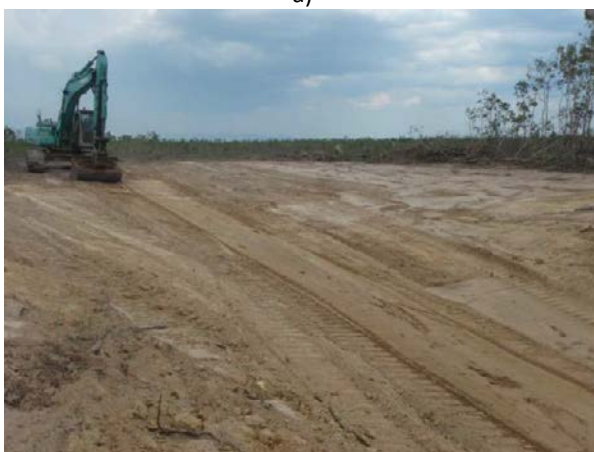
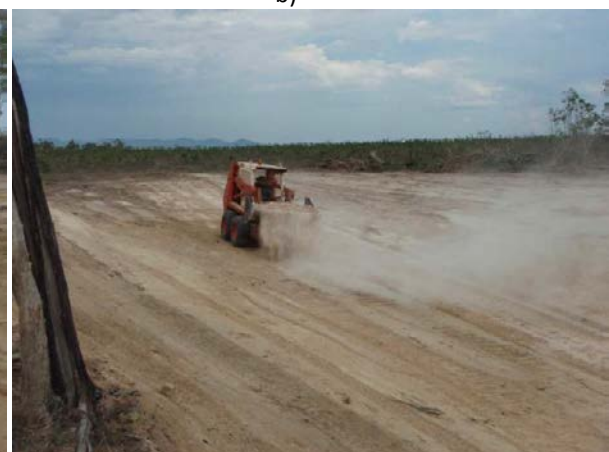
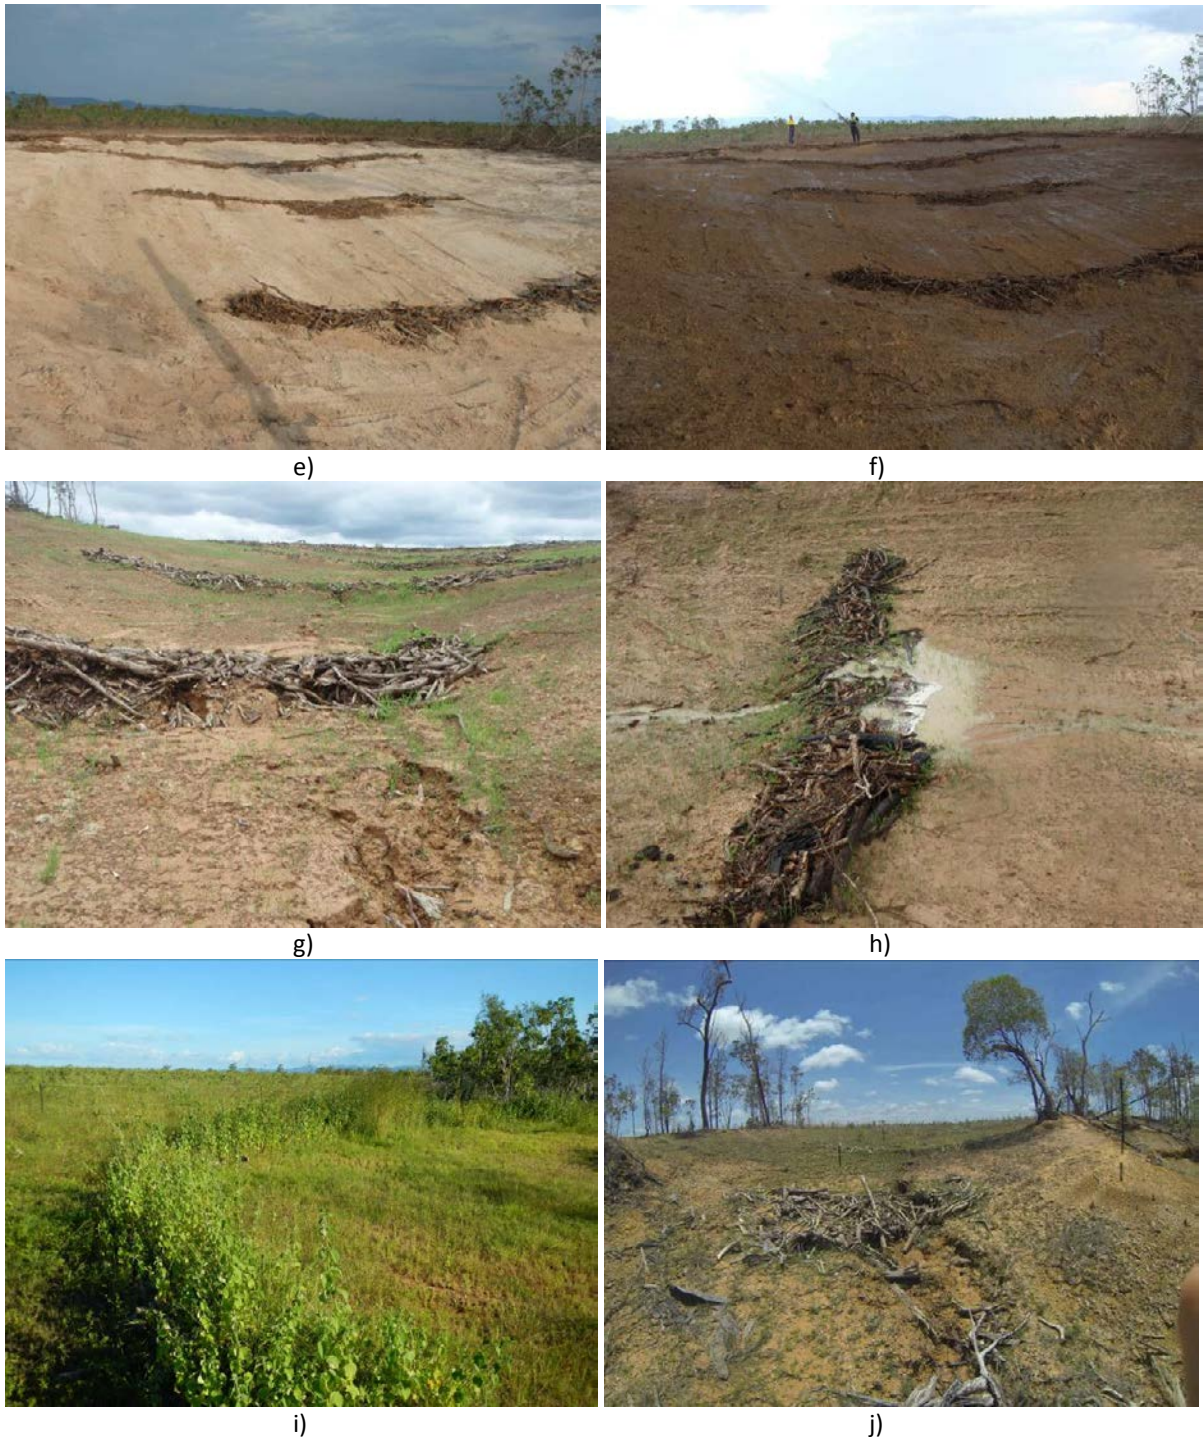
Figure 97 Sequential photographs of treatments at Gully 40 at CRGC1 a) before reshaping in Nov-2011, b) at the beginning of gully battering in Dec-2011, c) toward the end of gully battering in Dec-2011, d) during the addition of gypsum (CaSO_4) in Dec-2011, e) after wood check dams and gypsum addition in Dec-2011, f) during hydromulching in Dec-2011, g) during headcut reinitiation in Jan-2012, h) during a rainstorm with water/sediment retention behind wood check dams in Jan-2012, i) after grass and weed (*Hyptis suaveolens*) vegetation growth in April-2012, and j) after an extended dry season new wet season rains in Jan-2013 with modest grass cover but new growth emerging.

After battering, the surface soils were treated with the equivalent of 70 t/ha gypsum ($\text{CaSO}_4 \cdot 2\text{H}_2\text{O}$) (Figure 97d). This mass was required to treat the top 0.5 m of mixed sodic soil to reduce the average exchangeable sodium percentage (ESP) value from ~ 50 to 5 ESP. The gypsum application rate was estimated from initial down profile measurements of exchangeable sodium percentage (ESP) (Figure 103), cation exchange capacity (CEC), electrical conductivity (EC) and bulk density following calculation methods and models in Nelson et al. (2000) and Coventry (2004).

Wood check dams consisting of small to moderate sized woody debris from the nearby cleared paddock were installed as grade control structures down the longitudinal profile of the reshaped gully in order to reduce overland flow velocity and trap water and sediment (Figure 97ef). These wood structures were placed in 0.5m shallow trenches and pressed into place with an excavator. They were oriented in a slightly concave pattern directed upslope. Furthermore at the top of the swale and reshaped gully, a wood check dam and berm were installed to reduce any excess overland flow from entering the new swale from the uneroded upslope catchment area in the paddock. Therefore most of the new erosive power would come directly from rainfall.

Subsequently, the entire surface was hydromulched for revegetation (Figure 97f). The hydromulch mix consisted of exotic Indian blue grass (*Bothriochloa pertusa*), sabi grass (*Urochloa mosambicensis*), Japanese millet (*Echinochloa esculenta*), verano stylo (*Stylosanthes hamata*), fertiliser (N-P-K = 12-5-14), envirotak and curosol tackifiers, paper, bagasse, and an extra 10 tonnes/ha gypsum (Table 5). Due to initially high grazing pressure in the paddock, the 0.2 ha gully was fenced to exclude stock.

The reshaped and hydromulched gully experienced initially slow but eventually vigorous grass growth through the 2012 wet season (Figure 97ghi). The wood weirs performed well to retain water and sediment (Figure 97h). Rilling was minimal on the slopes of the new swale due to good grass cover and improved infiltration into the soils with gypsum. However within the bottom of the new swale, shallow rilling and head-cutting from the bottom up (base-level control) initiated channel rejuvenation after early rains, putting the lower wood structures at potential future risk of failure (Figure 97ghj). In hindsight, the spacing of the grade control structures could have been increased, as well as the height and depth of the structures. Rock could have also been used to a greater depth to prevent undermining. However overall, the “full” treatment with physical, chemical, and biological measures performed better than other nearby treatments that were lacking one or more stabilization tools.

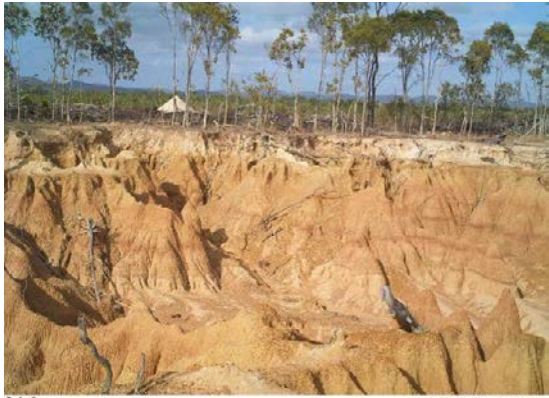
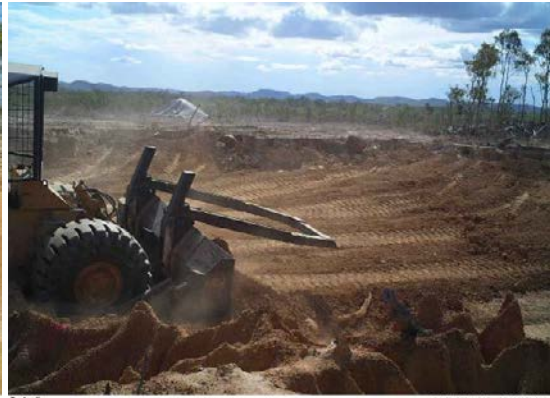
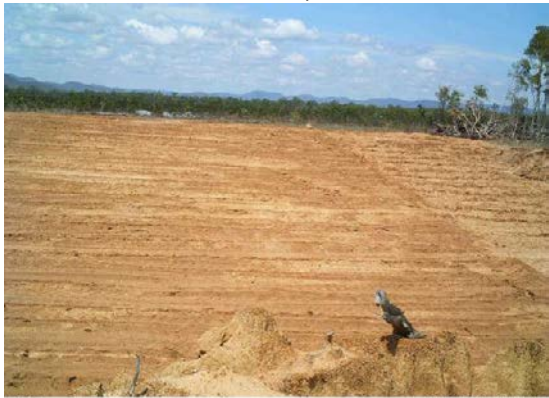
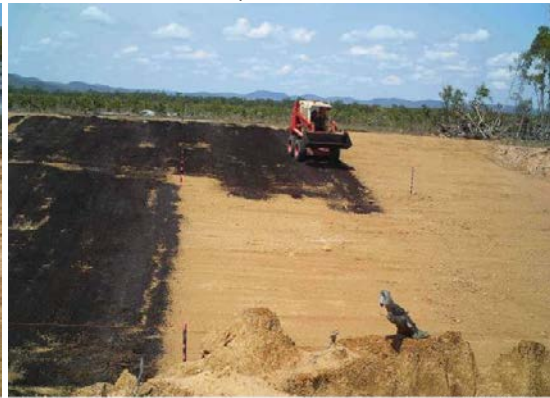
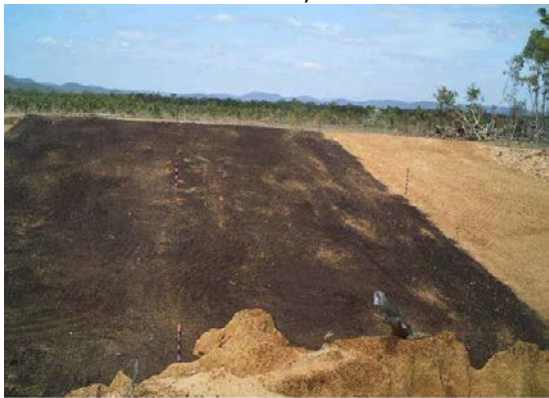
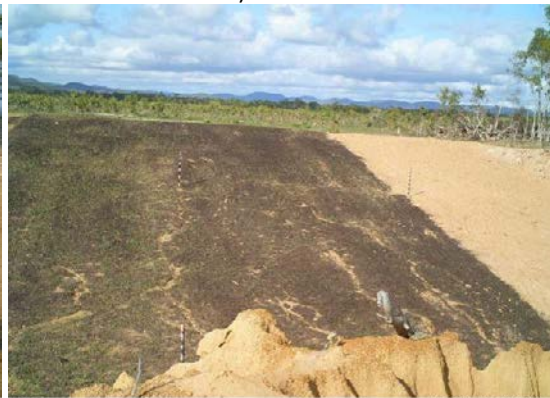
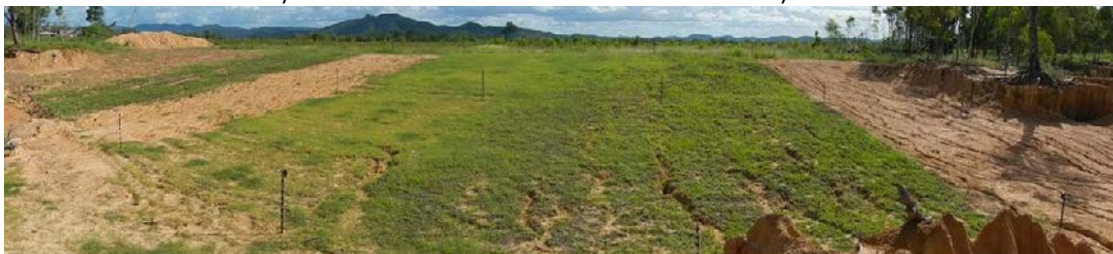
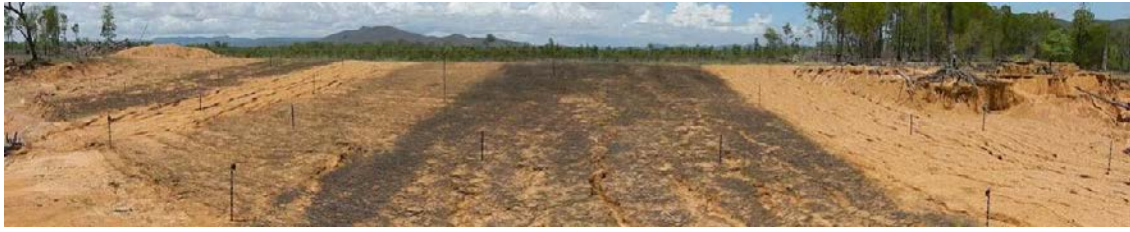
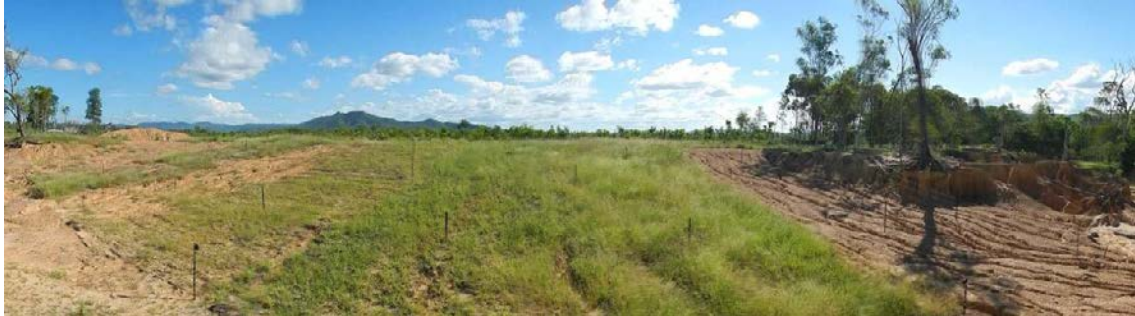
Figure 100 Sequential photographs of CRGC1-29 a) Plots 1 to 3 before reshaping, b) Plots 1 to 3 during reshaping, c) Plots 1 to 3 after reshaping and gypsum addition, d) Plots 1 to 3 during compost spreading, e) Plots 1 to 3 after compost and grass seeding, f) Plots 1 to 3 after initial grass sprouting and rilling during early rainstorms, g) Plots 1 to 7 after the end of the wet season in March 2012 with some grazing by cattle and wallabies and rill erosion, h) Plots 1 to 7 after the end of an extended dry season in January 2013 with significant desiccation of perennial vegetation, and i) Plots 1 to 7 after the end of the wet season in April 2013.

At CRGC1-29, seven (7) experimental plots 7 m wide by 25 m long by 12% slope were established following a before-after control-impact (BACI) design (Underwood 1994a; 1994b; Smith 2002) with the following treatments and controls (Figure 100; Figure 101):

At CRGC1-29 at the seven treatments plots (Figure 100; Figure 101), propagation of rill erosion from the bottom up started almost immediately during the first wet season rains, driven by overland flow from the top down (Figure 106). Rilling was most severe on bare plots without surface cover (Plots 1 & 5; Figure 106a; Figure 123). Rilling was least on the hydromulched surface (effectively a bonded fibre matrix, BFM), which protected the surface

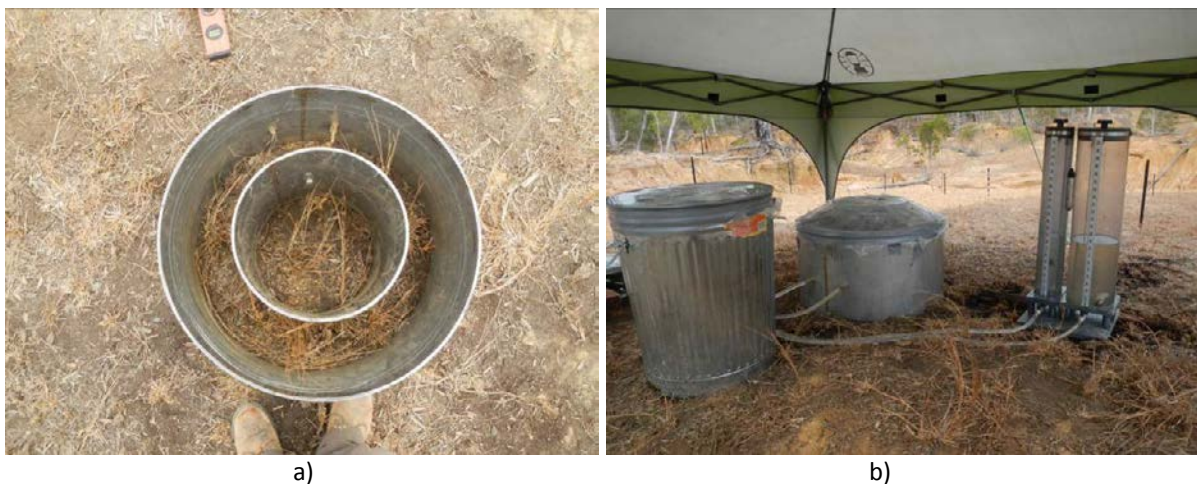
Figure 104 Infiltration measurement setup showing a) the inner and outer measurement rings, and b) the full infiltration measurement setup.

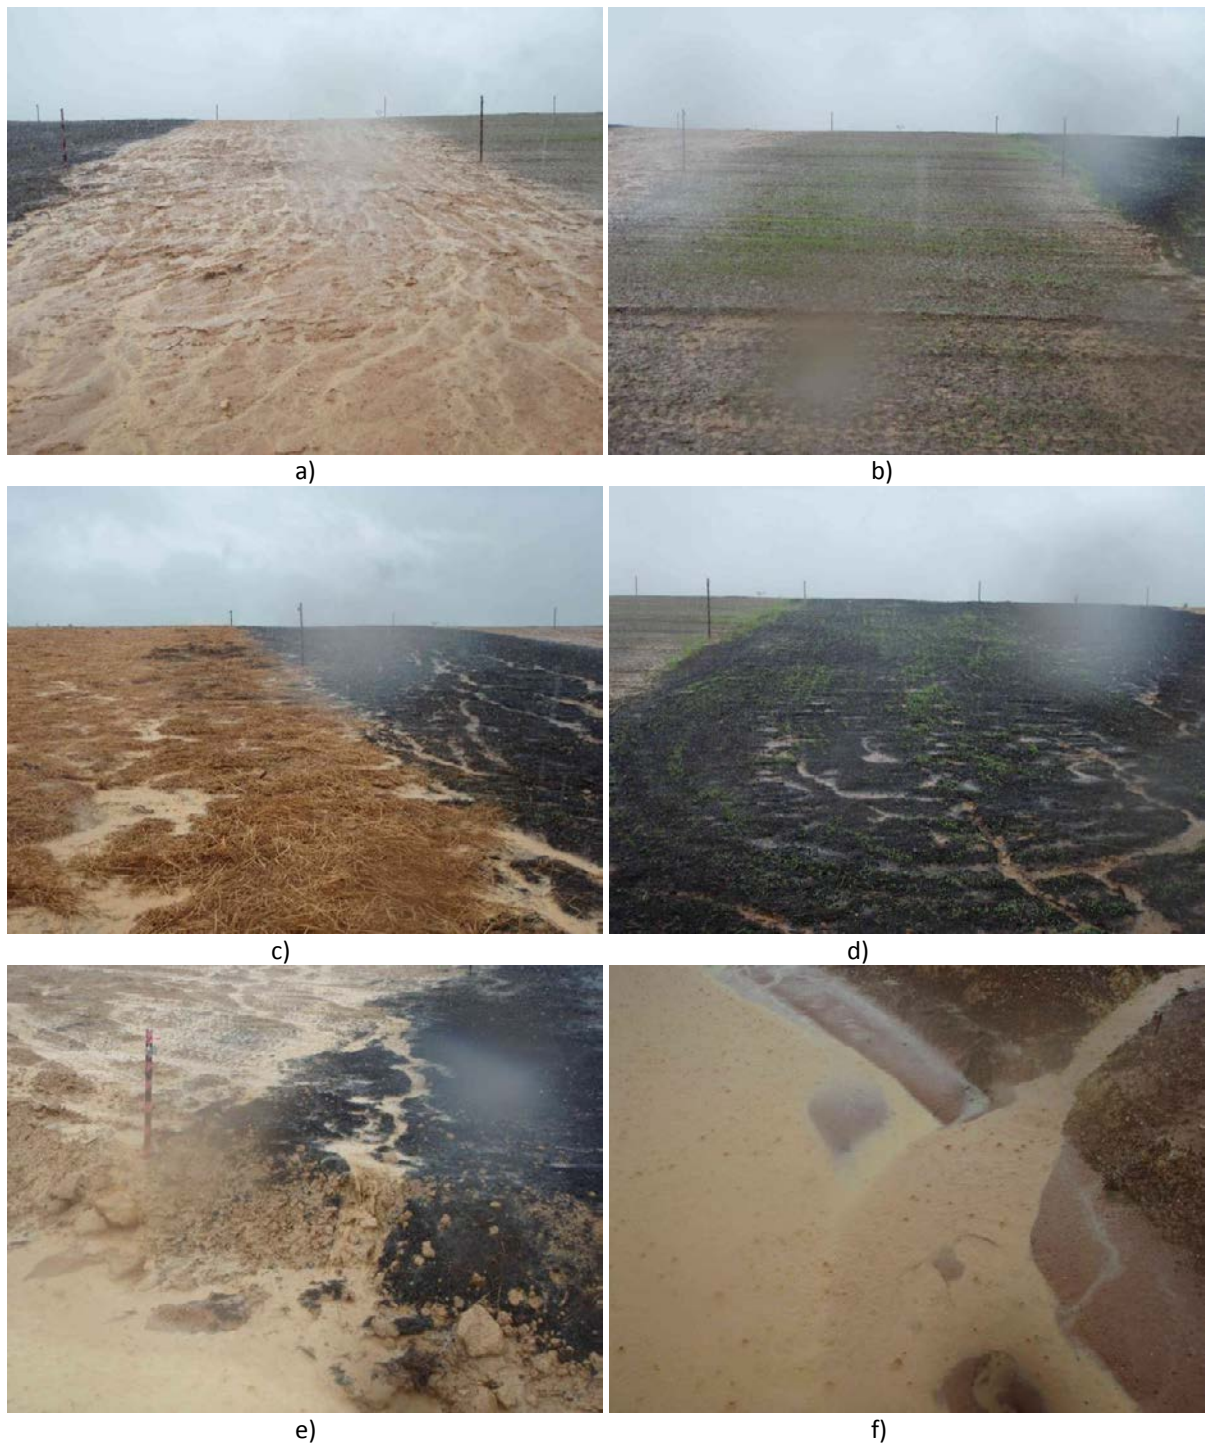
Figure 106 Performance of trial plots at Gully 29 at CRGC1 during a rain event at a) plot 5 with gypsum only, b) plot 4 with hydromulch and gypsum, c) plots 6 & 7 with no gypsum and either straw or compost and exotic or native grass, d) plot 3 with gypsum, compost and exotic grass, e) headcutting and rilling initiating at the base of plot 6, and f) concentrated suspended sediment runoff from plot 1.

soils and reduced rilling during overland flow (Figure 106b; Figure 123). Sheet flow and rilling occurred on all plots regardless of treatment (Figure 106ad; Figure 123). Rilling appeared to be enhanced on plots that had a greater drop in relief at the creek confluence, which promoted the initiation of small headcuts (Figure 106e); however bare plots with less relief drop at the creek confluence still experienced much greater rill erosion (Figure 123). Soil erosion volumes and masses quantified with TLS surveys will be discussed below.

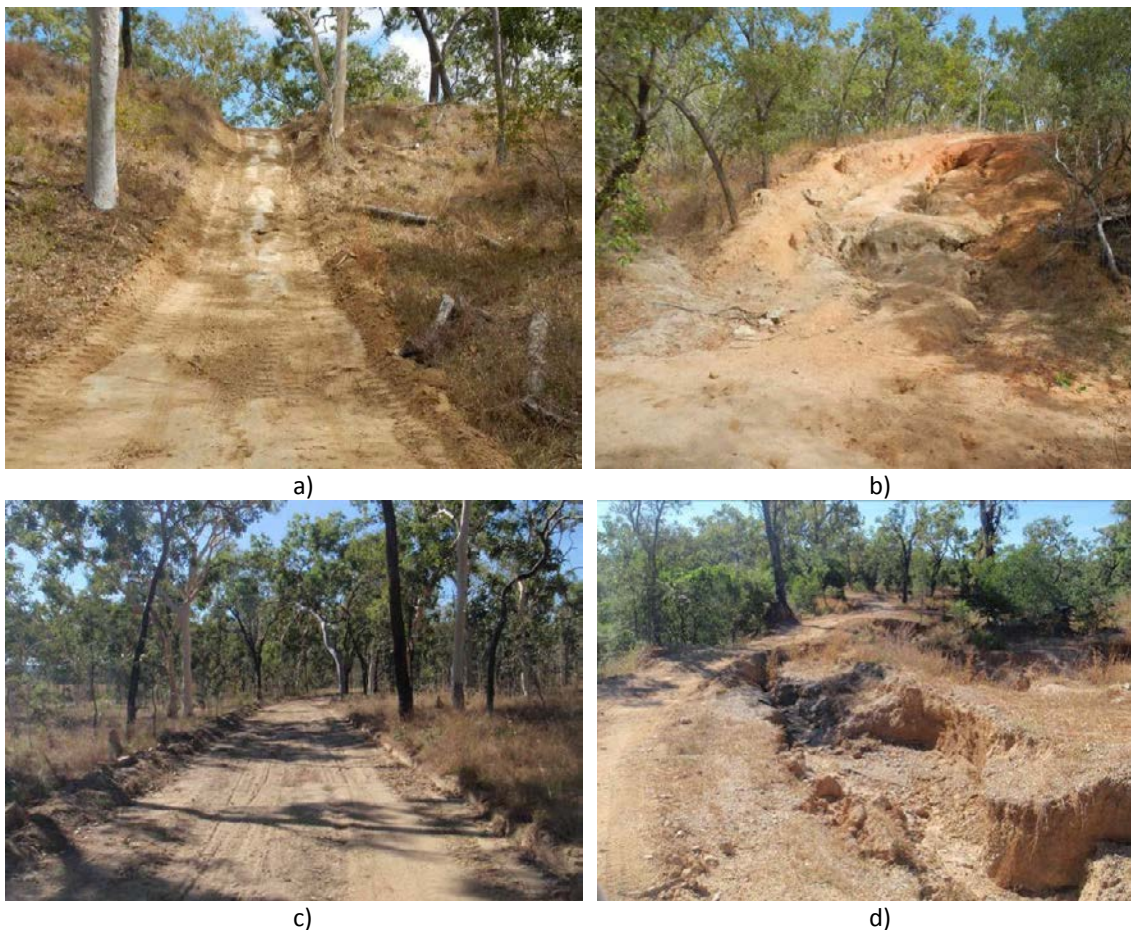
Figure 128 Examples of road erosion conditions along the Granite/West Normanby valley where a) a road has been cut up a steep river bank with no erosion control, b) an old degraded road cut on a creek bank has been eroded by gullies, c) a road on the flat floodplain has been graded too deep causing water to concentrate and funnel into alluvial gullies, and d) a road has been choked on both sides from alluvial gullies that are partially fed by excess runoff along the road.

At the control site (RG33), regrading of the road cut approaching the creek crossing is conducted annually (Figure 136). This is similar to many other sites along this road network where deep gullies form every year and are regraded (Figure 128; Figure 129; Figure 130; Figure 137). Annual regrading is often just enough to get 4x4 vehicles through for property and cattle maintenance. Rills and gullies are filled in, and no BMP structures or actions are taken. Each year during the wet season, the road re-erodes via rilling and gullying making driving difficult (Figure 136a,c,d,e,f). This cycle has continued incrementally for decades, resulting in a deep and eroded road cut. Over the 2012/2013 wet season after 915mm total rainfall (Figure 135), deep rills and gullies had reformed at this control site, making vehicle passage almost impossible (Figure 136e,f). Quantification of erosion volumes using TLS surveys is discussed below.

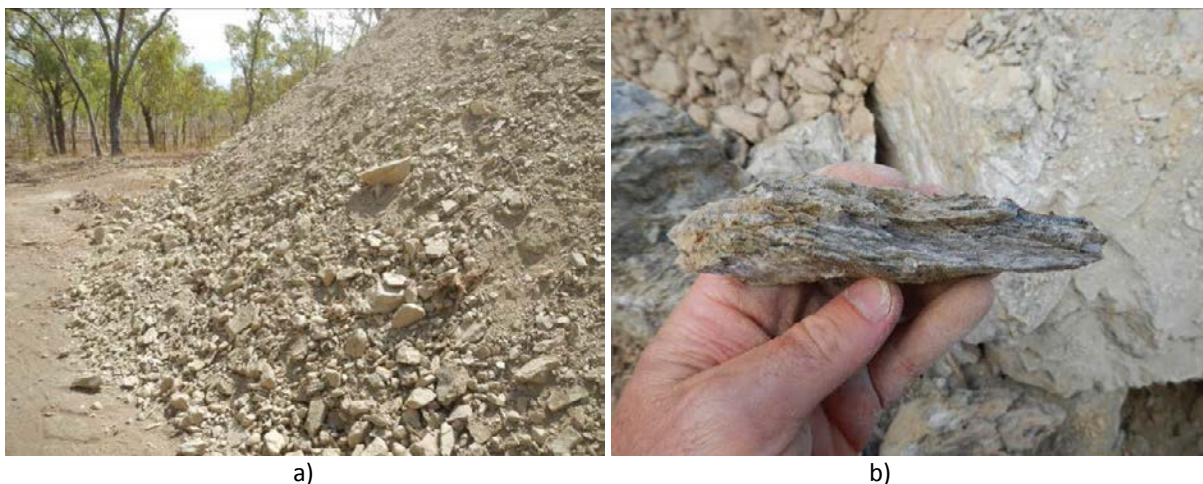
Figure 131 Borrow pit material used for road surface capping and water diversion bank (whoa boy) construction originating from the Hodgkinson Formation meta-sediments (slightly metamorphosed greywacke, siltstone, sandstone). Note poor quality of available material and high percentage of fine sediment.

Due to the remote location of the Granite Normanby, gravel capping for road surfaces and diversion banks had to be sourced locally. Unfortunately, the only local source of rock material within 10 km from road gully sites was from ridgelines of the Hodgkinson Formation, which consist of slightly metamorphosed greywacke, siltstone, sandstone (Figure 131). Gravel to cobble sized rock is easily sourced from these ridgelines using bulldozers, however upon disturbance much of the parent material partially breaks down into finer grained constituents of sand and silt. Thus by using this material for road surfacing, undoubtedly much sand and silt is imported in the process. However, the finer matrix material can help lock larger gravel and cobble in place, and this material tends to hard set after several cycles of wetting and drying despite the continued vulnerability to rilling and sheet wash flushing away the fines. Depending on the outcomes of these different road stabilization trials (see Section 7.14.3.3), it could be recommended to not utilise this material into the future for road works due to its poor quality and pollution potential. This would mean, however, that better quality rock would need to be imported from longer distances increasing stabilization costs.

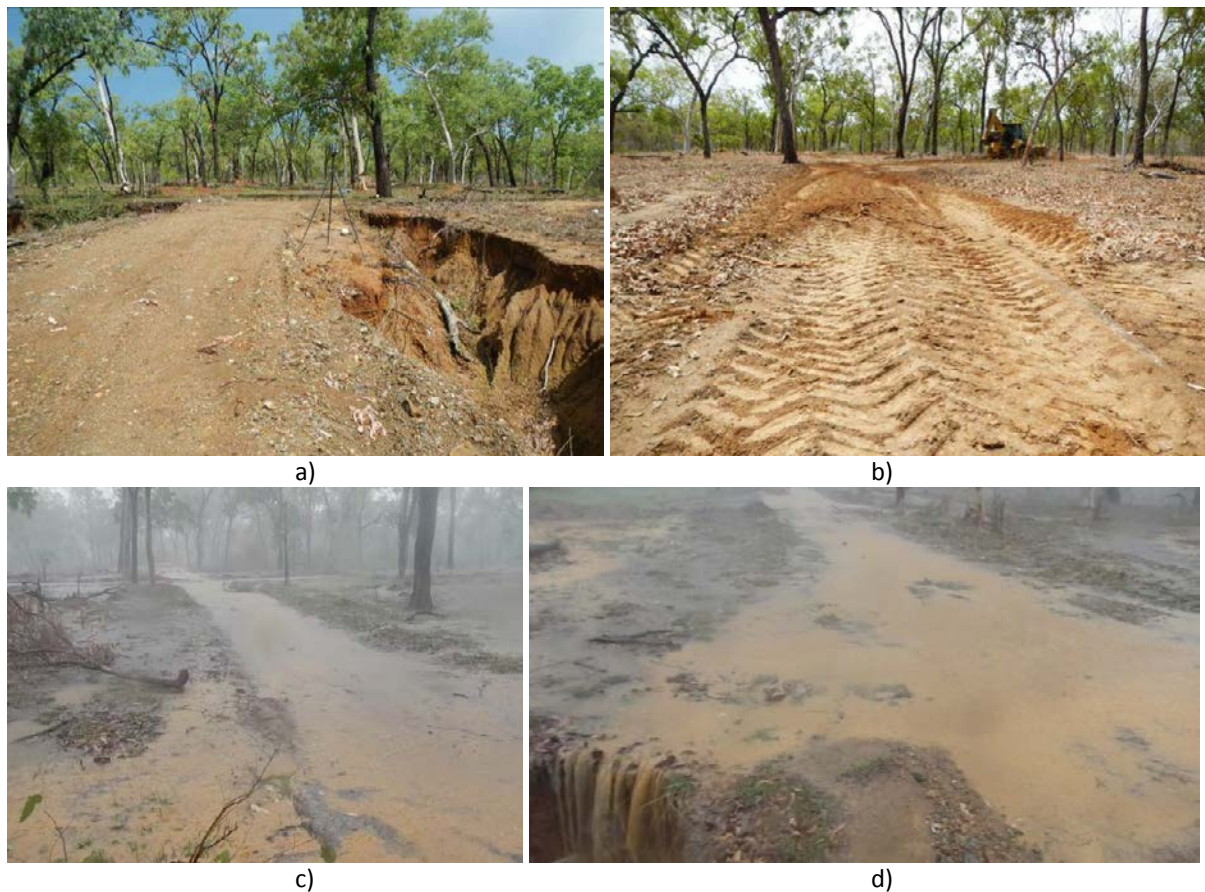
Figure 133 A major road choke point at RG30 where a) gully headcuts threaten the road from either side, b) water diversion banks (whoa boys) were installed to divert water off the road and away from the headcuts, looking downslope, c) water runoff down the road during a major rain storm filling the diversion banks and pits, looking downslope, and d) water runoff down the road bypassing and overtopping the diversion banks and continuing to feed the gully headcut.

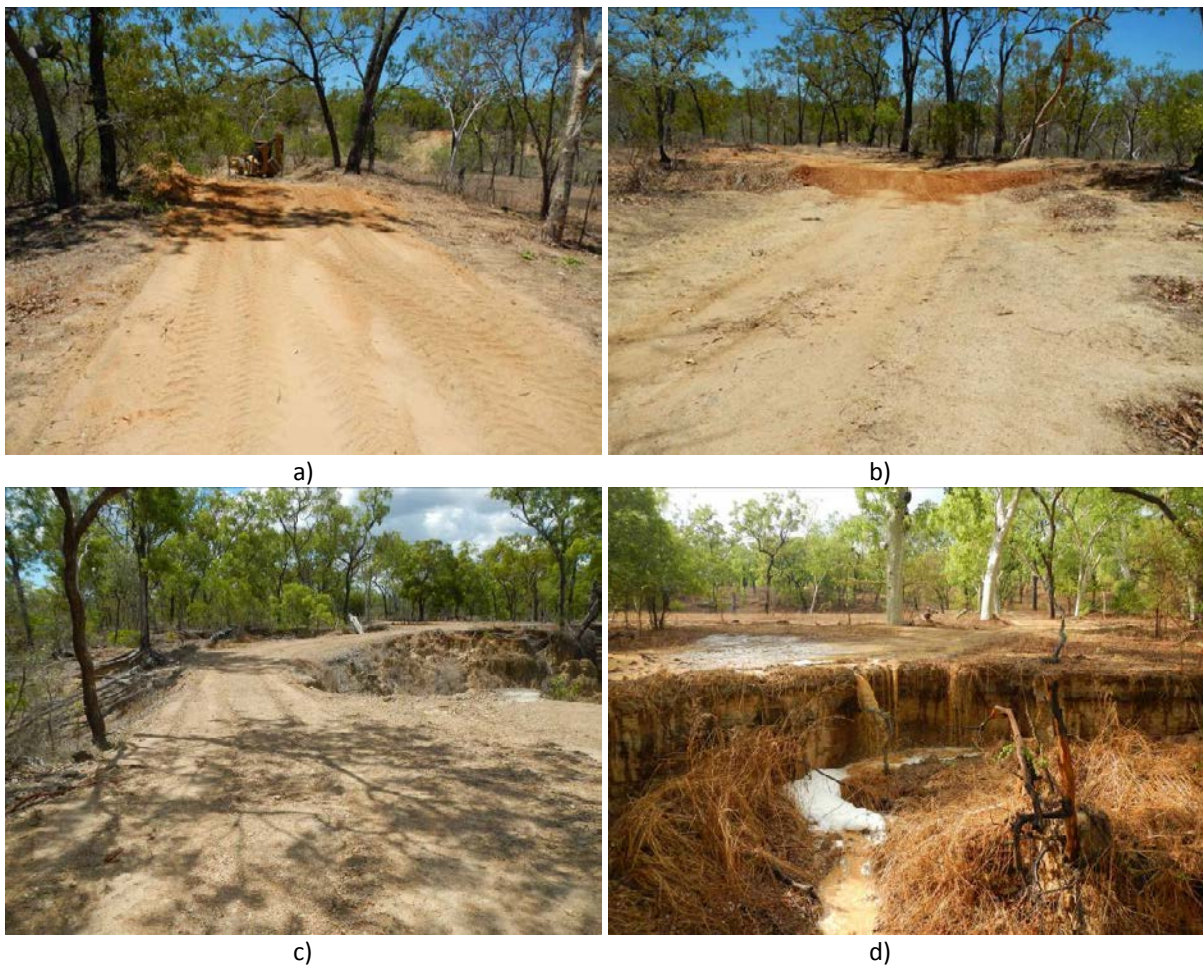
Figure 134 Examples of road improvements along the Granite Normanby road including a) a water diversion bank at the top of a creek approach, RG28 , b) a diversion bank along a long road fetch, RG29, c) gravel sheeting over a narrow road choke point (RG36) to protect the underlying sodic soils from wash and reduce ponding and piping, d) a water diversion bank (in background) used to divert some (1/3) but not all of the runoff water away from this road headcut, RG32.

A very different scenario was present at RG30, where a major road choke point was created by two large alluvial gullies attacking the road location from either side (Figure 134a). Initial intuition was to either install large rock grade control structures at the gully heads, fill the gullies, or batter back the entire area (lowering the road surface) and creating a new road prism. However before any of these actions were taken, the degree to which water runoff down the road off the very flat floodplain was feeding the gully heads needed to be assessed and remedied. Assessment of the subtle topography of the situation indicated that the headcuts were migrating up toward the flat floodplain along the road. Therefore, two water diversion banks and adjacent settling ponds were constructed upslope of the headcuts (Figure 134b). During Jan-2013, the area was observed during a heavy rainstorm. Intense rainfall and low soil infiltration capacities on the fairly flat floodplain created sheets of overland water runoff that concentrated down the road. Initially, the diversion banks and settling ponds worked well to divert water off the road away from the headcuts. However

upon additional rainfall, the structures were overwhelmed with water (Figure 134c). Water flowed out of the ponds and continued downslope, and eventually the shallow diversion banks were also over topped by water backing up behind them. This water eventually fed into the headcuts, albeit at a reduced rate compared to before the structures were installed (Figure 134d). To remedy the water runoff situation at RG30 before any additional structural efforts are targeted at the headcuts, much larger and more frequent water diversion banks are needed that divert overland runoff further away from the road to safe disposal locations. This will address part of the cause, rather than just the symptom.

minimised rilling, reduced piping of concentrated water into the road, and increased diffuse flow off the road that drips over the edge in numerous locations. This technique of sheeting the road surface with rock at gully choke points was trialled in several places (Figure 134c RG36, RG30) in order to make more informed decisions on its effectiveness. However, true fixes for the erosion and road access issues remain elusive, as there are few places to reroute the road due to dense gullied terrain (Figure 130). Relocating the road outside the Granite Normanby valley would be most logical.

At another complex situation (RG32), a large gully headcut was migrating into the road location on an alluvial fan inset within a creek valley (Figure 134d). Water fed the gully from three directions across the alluvial fan and was collected down both road approaches. To reduce the water supply to the headcut, long water diversion banks were installed across the road on either side of the headcut. Surface evidence after several rainstorms indicated that the diversion banks were effective at diverting 1/3 of the water runoff. However, water continued to feed the headcut from the centre of the alluvial fan (Figure 134d), and diverted water around the headcut continued onward to the local creek potentially accelerating gully erosion in other locations.
