Alluvial Gully Prevention and Rehabilitation Options for Reducing Sediment Loads in the Normanby Catchment and Northern Australia

Jeffrey G. Shellberg and Andrew P. Brooks
Griffith University, Australian Rivers Institute

Final Report

December 2013

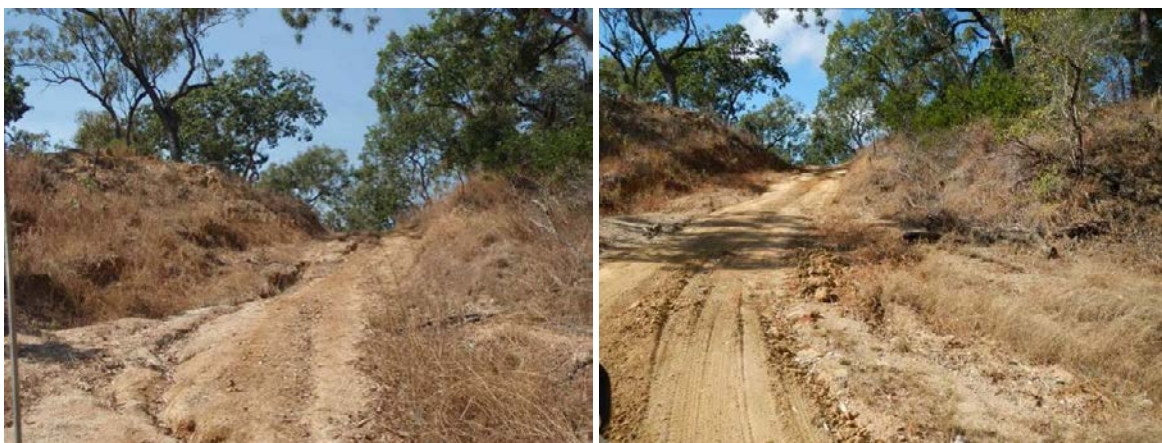
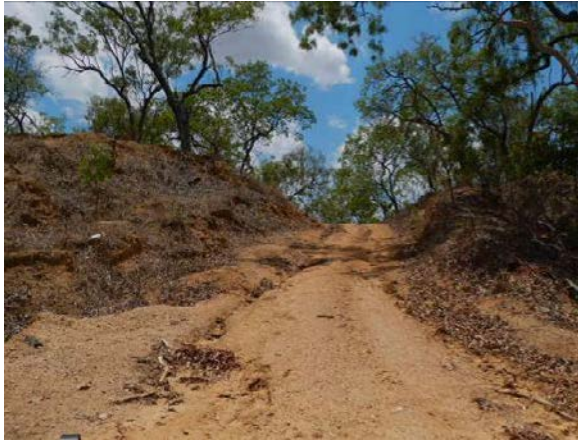
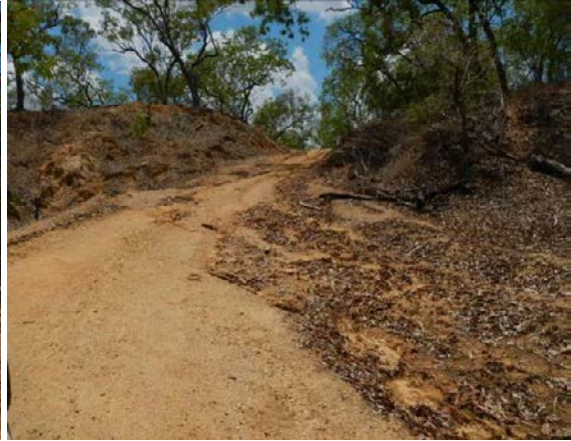
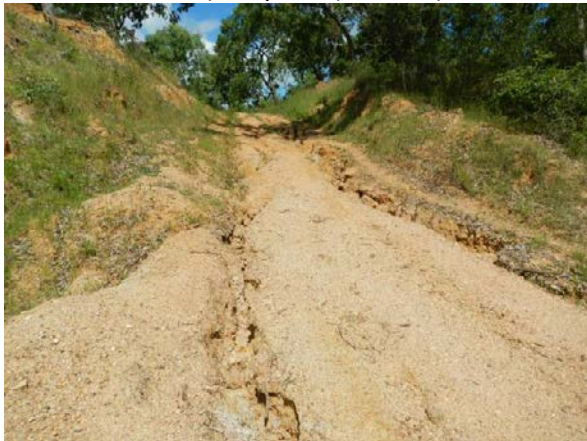
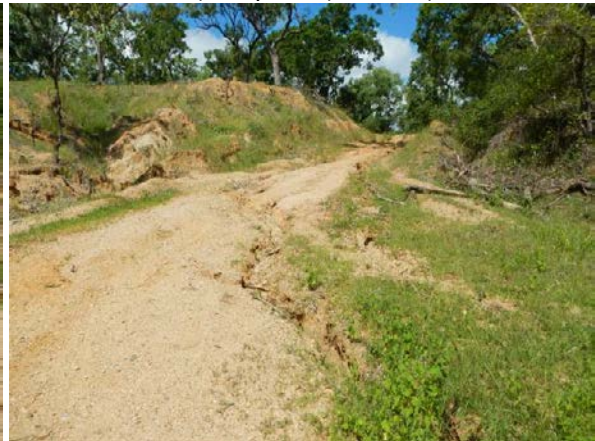
Figure 136 RG33 road gully “control” site in a) Aug-2011 after an average wet season, b) July-2012 after typical annual regrading, c) & d) in Jan-2012 after several rainfall events that reinitiated rilling and gullying, and e) & f) in April 2013 after the wet season (850mm rainfall) and before any regrading.

At the control site (RG33), regrading of the road cut approaching the creek crossing is conducted annually (Figure 136). This is similar to many other sites along this road network where deep gullies form every year and are regraded (Figure 128; Figure 129; Figure 130; Figure 137). Annual regrading is often just enough to get 4x4 vehicles through for property and cattle maintenance. Rills and gullies are filled in, and no BMP structures or actions are taken. Each year during the wet season, the road re-erodes via rilling and gullying making driving difficult (Figure 136a,c,d,e,f). This cycle has continued incrementally for decades, resulting in a deep and eroded road cut. Over the 2012/2013 wet season after 915mm total rainfall (Figure 135), deep rills and gullies had reformed at this control site, making vehicle passage almost impossible (Figure 136e,f). Quantification of erosion volumes using TLS surveys is discussed below.

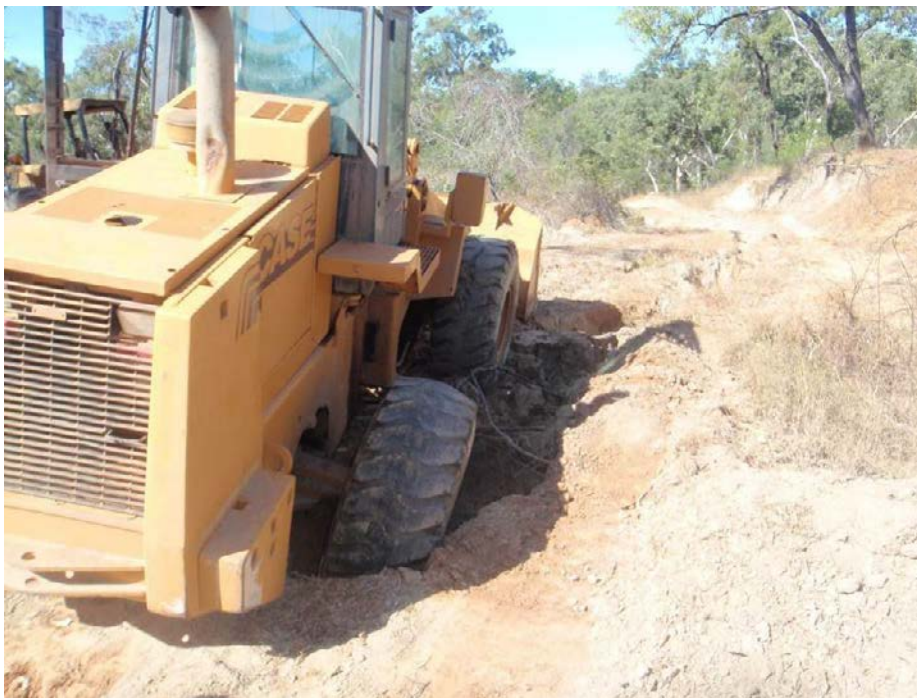
Figure 137 Deep gullies formed annually during the wet season down steep road cuts in sodic soils can be difficult to regrade and fill in using heavy machinery, with very short-term access benefits.

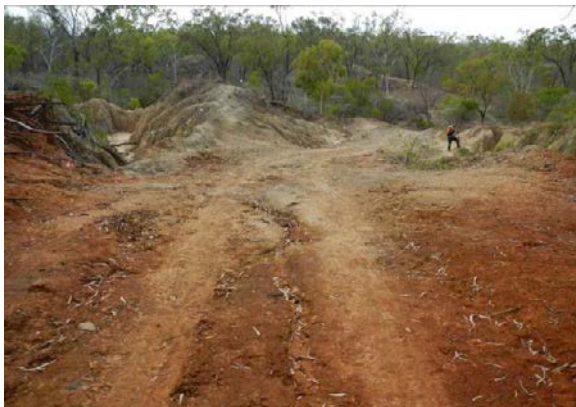
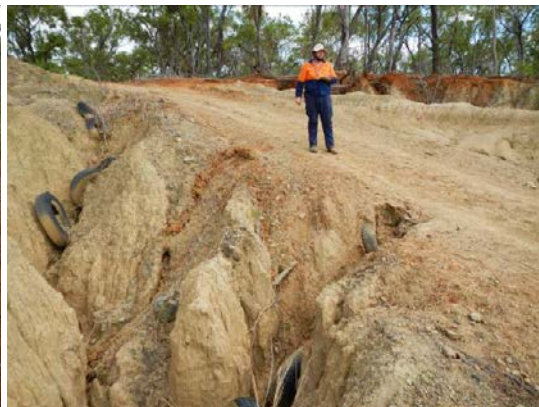
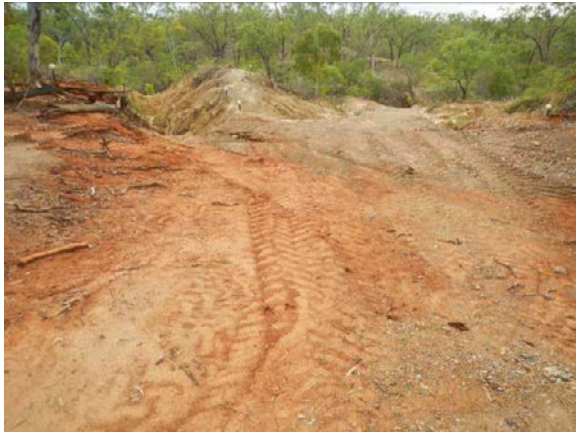
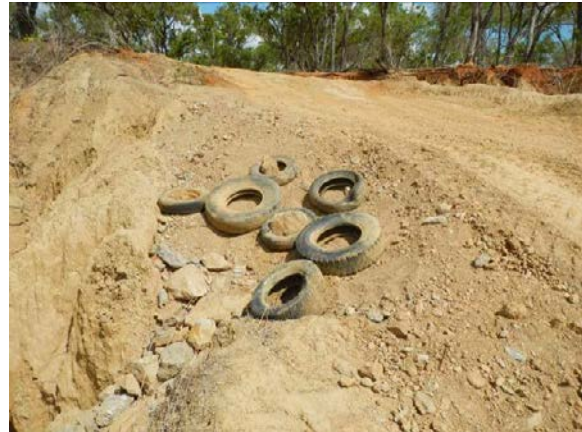
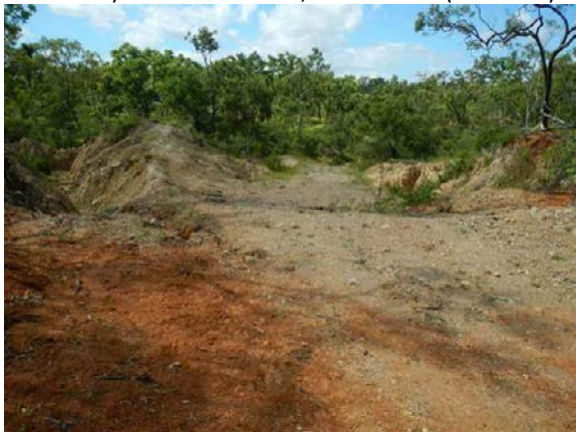
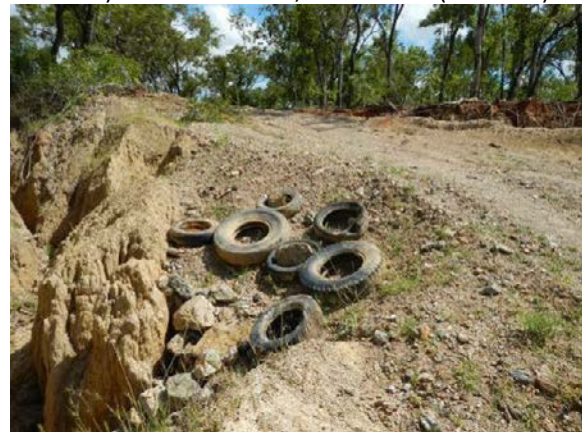
Figure 138 RG27 road gully “treatment” site showing a) before treatment (Nov-2012) with runoff directed straight down the road into a lower gully, b) before treatment (Nov-2012) with headcuts working into road and attempts to stabilise with tyres, c) after treatment (before wet; Jan-2013) with 4 water diversion banks that drain water from much smaller areas of the road into adjacent gullies, d) after treatment (before wet; Jan-2013) of headcut with coarse rock (tyres are cosmetic) and a diversion bank to drain water away from headcut, e) & f) after treatment and after wet season (April 2013) and 750mm rainfall.

At RG27, a road cut and creek approach previously concentrated road water runoff down the slope (Figure 138a) feeding several lateral gully headcuts (Figure 138b) in addition to the creek. Four (4) water diversion banks were carefully placed down the slope using a 4-in-1 bucket loader. A diversion bank was installed at the very top of the slope (behind photographer in Figure 138c) as well as at the first gully drain to the left. This gully drain was reopened to divert water from the top of the slope and prevent concentrated gullying further down slope. However, this gully receives less runoff from a smaller area than it did in the distant past due to installation of a diversion bank. It could be armoured with more rock at its head into the future, but damming it with a berm could redivert water down the road. Rock gravel was placed in this gully channel to dissipate energy, which needs to be enhanced in the future into larger check dams as erosion continues. Further downslope, a gully headcut threatening the road prism (Figure 138b) was excavated, old dysfunctional rubber tyres were removed, the hole was backfilled with coarser rock and gravel, and a diversion bank was placed at its head to divert water away from the headcut (Figure 138d). Further downslope, additional diversion banks were installed to divert water off the road. The entire road surface except for the very top was sheeted with rock gravel to protect the underlying sodic soils from erosion.

Over the 2012/2013 wet season (750mm rainfall after construction; Figure 135), surface rill and gully erosion were fairly minor at RG27 (Figure 138c-f) compared to other control and treatment sites, especially where sheeted with rock gravel and water was diverted. The road was drivable both during and after the wet season without the need for post wet season grading. However, sheet wash of fine sediment associated with rock sheeting was evident. Minor but continued headcut erosion also occurred into the first diversion gully, despite reductions in water runoff (Figure 138e). Gully erosion also continued on the sidewalls of gullies not treated. Quantification of erosion volumes using TLS surveys is discussed below.

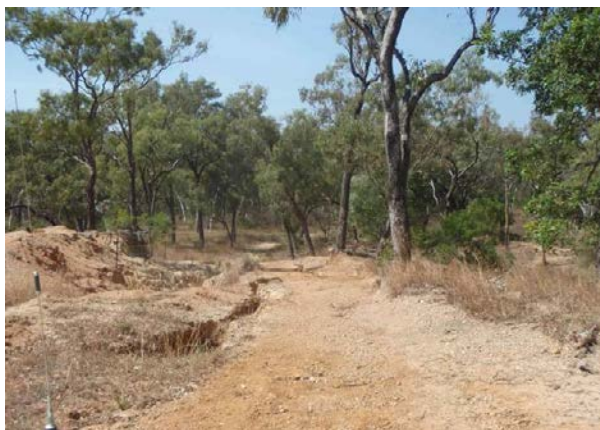
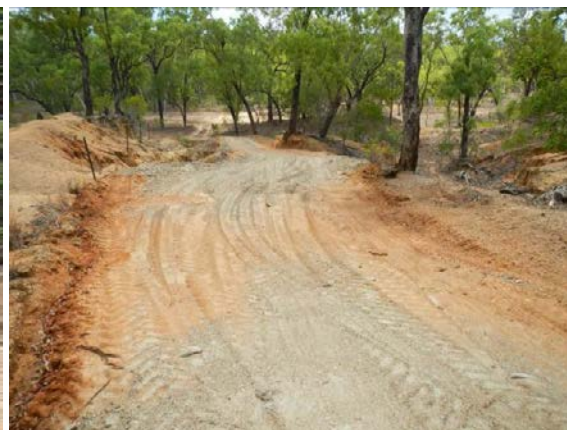
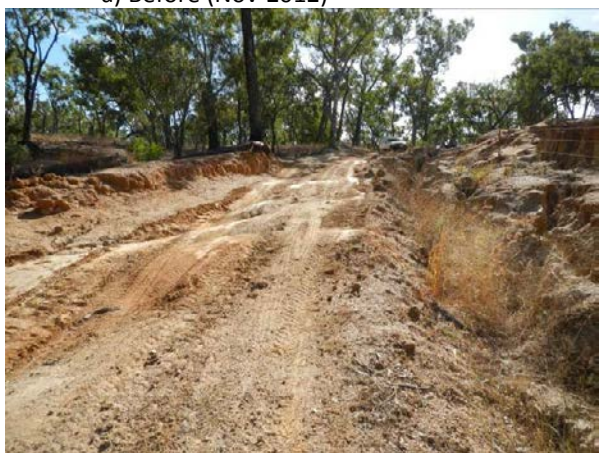
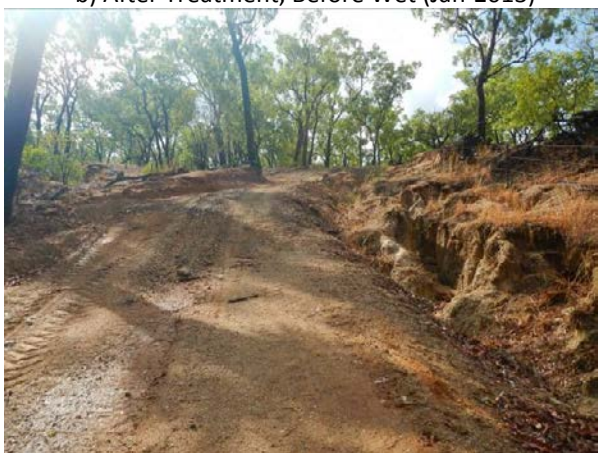
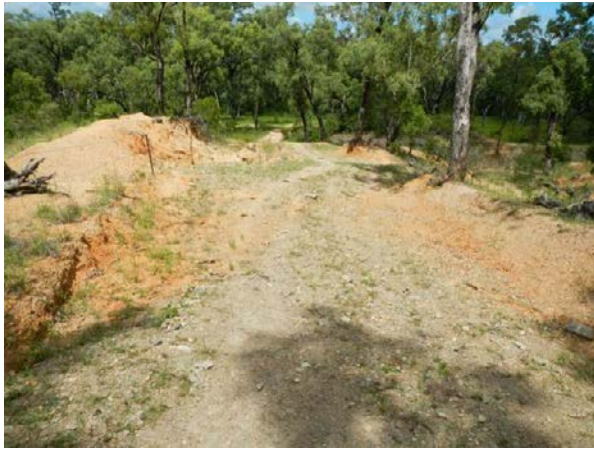
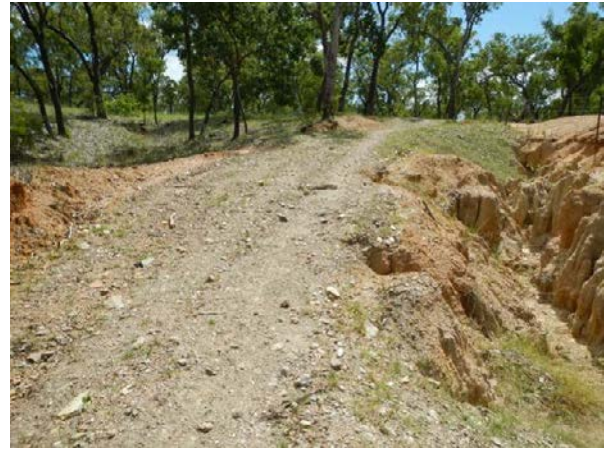
Figure 139 RG31 road gully “treatment” site along a fence line showing a) before treatment (Nov-2012) with runoff directed down road into lower gully, b) after treatment (before wet; Jan-2013) with 4 water diversion banks that drain water from much smaller areas of the road into adjacent gullies, c) before treatment (Nov-2012) with water directed down road and gully, d) after treatment (before wet; Jan-2013) with water diverted off road and away from gully to right, e) & f) after treatment and after wet season (April 2013) and 750mm rainfall.

At RG31, a road cut over the bank of the high floodplain concentrated road water runoff down the slope (Figure 139a) feeding a gully along the fence line in addition to eroding the road (Figure 139c). Four (4) water diversion banks were carefully placed down the slope using a 4-in-1 bucket loader (Figure 139bd). Due to the tight situation of the cut on a broader ridgeline, water diverted off the road drained into adjacent gully catchments with headcuts and could accelerate erosion there over time. However due to the spacing, small catchment area above each diversion bank, and different diversion locations, the erosion impact on any one gully location was reduced compared to the previous situation. At the main gully headcut on the road, a diversion bank was installed immediately above it to drain water away in addition to backfilling the headcut with rock gravel. Each diversion bank was armoured with rock gravel to protect the native sodic soil from erosion; but the entire road surface was not armoured with rock gravel.

Over the 2012/2013 wet season (750mm rainfall after construction; Figure 135), surface rill and gully erosion were reduced as a result of water diversion bank installation (Figure 139). The road was drivable both during and after the wet season without the need for post wet season grading. Diverting water away from the main headcut and capping it with angular rock promoted gully stabilization (Figure 139f). Capping diversion banks with angular rock prevented rill incision through the banks. Minor rill erosion continued however where the road surface was not sheeted with angular rock gravel. Sheet wash of fine sediment associated with rock capping also was evident. Gully erosion also continued on the sidewalls of the main gully not treated (Figure 139f). Quantification of erosion volumes using TLS surveys is discussed below.

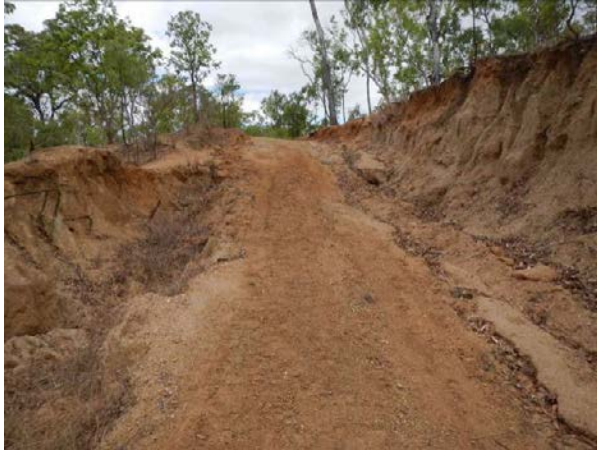
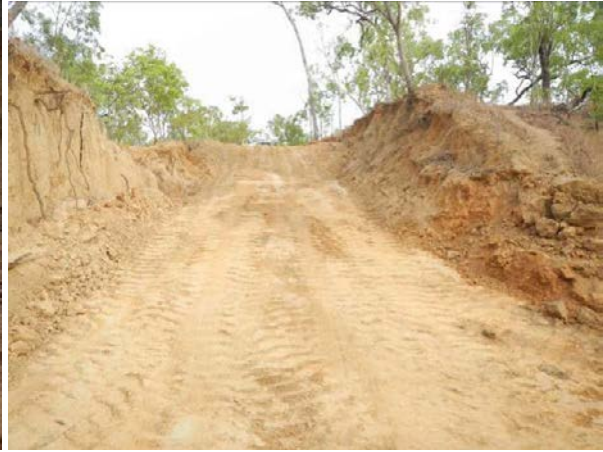
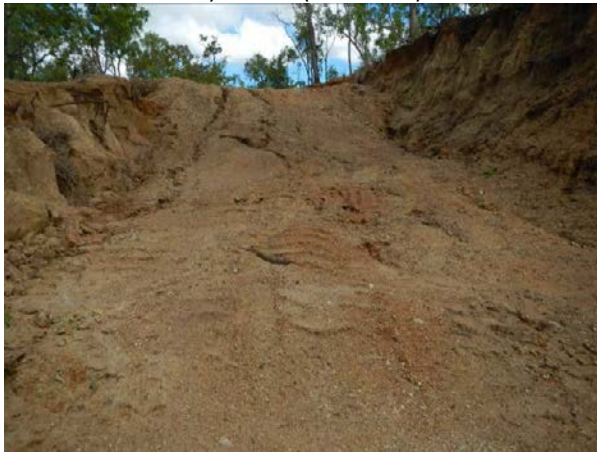
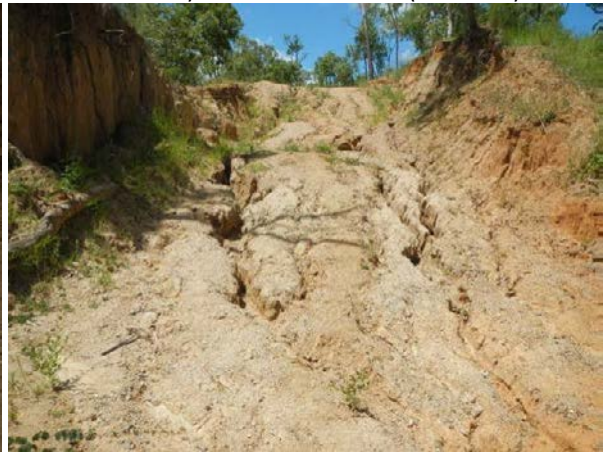
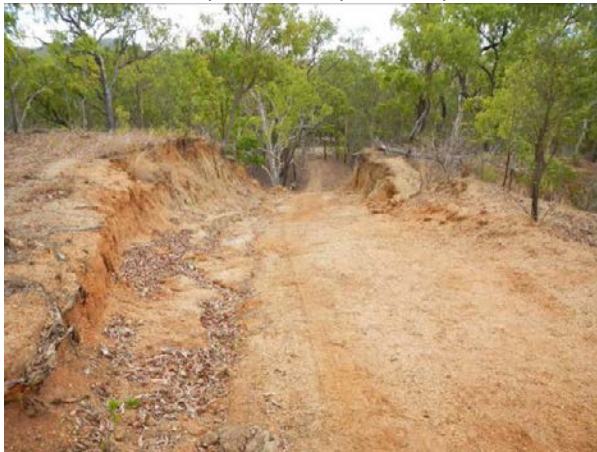
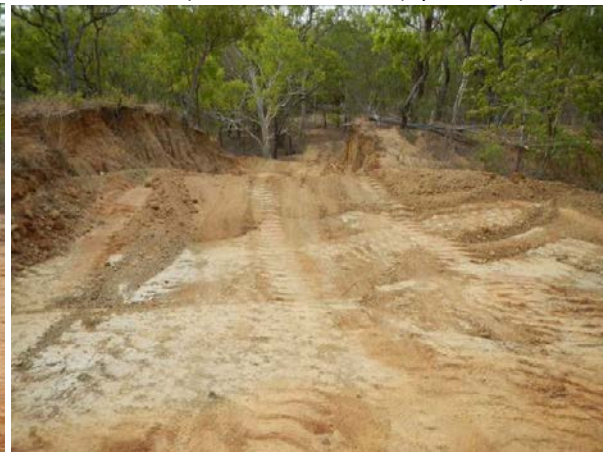
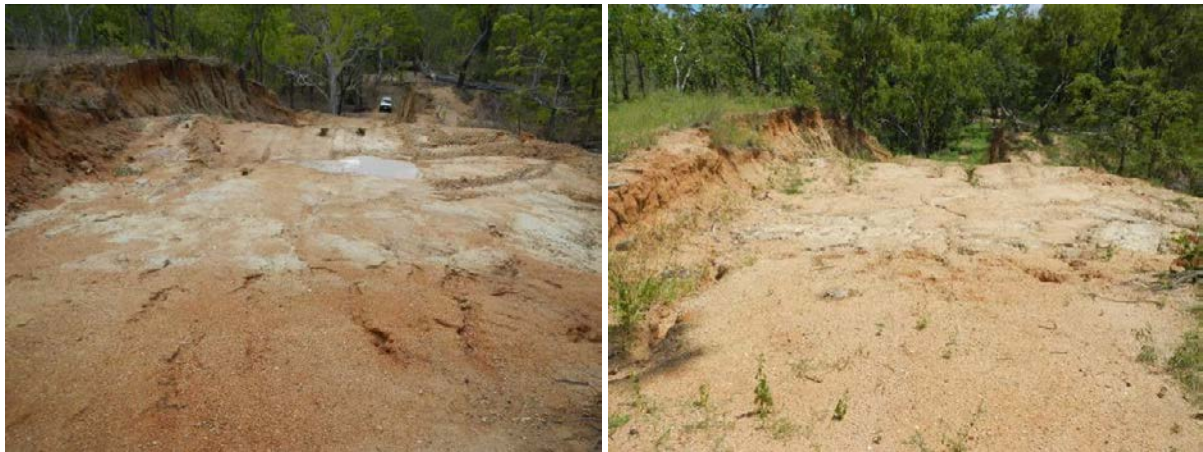
Figure 140 RG106 road gully “treatment” site a) looking upslope before treatment in Nov-2012, b) looking upslope after treatment with bulldozer grading and installation of 4 water diversion banks in Jan-2013, c) looking upslope after one rain event (30mm) in Jan-2013 with rill initiation, d) looking upslope after the wet season in April-2012 (750mm rainfall) with deep rills and gullies, e) looking downslope before treatment in Dec-2012, f) looking downslope after treatment with bulldozer grading and installation of 4 water diversion banks in Jan-2013, and g) looking downslope after one rain event (30mm) in Jan-2013 with rill initiation, and h) looking upslope after the wet season in April-2012 (750mm rainfall) with deep rills cutting through diversion bank.

At RG106, a road cut over the bank of the terrace concentrated road water runoff down the slope causing rill and gully erosion (Figure 140ad), which delivered sediment to the nearby Granite Normanby River and made driving difficult. Instead of just grading the road and smoothing over the rills and gullies in typical annual fashion (e.g., RG 32; Figure 136), four (4) large water diversion banks were pushed into place down the slope using a rubber-tyre bulldozer. Water runoff was diverted into adjacent gully catchments, albeit from smaller catchment areas above each diversion bank and not concentrated in one location. Local sodic soil from the cut bank was used to create the diversion banks, as well as soil from the lower floodplain bench. Diversion banks were not covered with angular rock gravel, but were rather left in their native state to assess erodibility without rock cover but with diversion banks.

Site visits following a rain storm in Jan-2013 (30mm) indicated that deep rilling had reinitiated immediately on the road slope (Figure 140c) and through some of the diversion banks (Figure 140f). However, the banks did function to divert most water off the road. On the lower slopes, diverted water was collected in two settling ponds; however in a few locations water bypassed these ponds as it cut around the other end of the diversion bank. By April 2012 after 750mm of rainfall following construction (Figure 135), deep rills and gullies had cut into the road and had breached through several of the water diversion banks (Figure 140d,h), making vehicle passage impossible. The sodic soils provided little resistance to raindrop impact, sheet wash, and rill and gully erosion, compared to other sites with gravel rock armour (Figure 138; Figure 139). Quantification of erosion volumes using TLS surveys is discussed below.

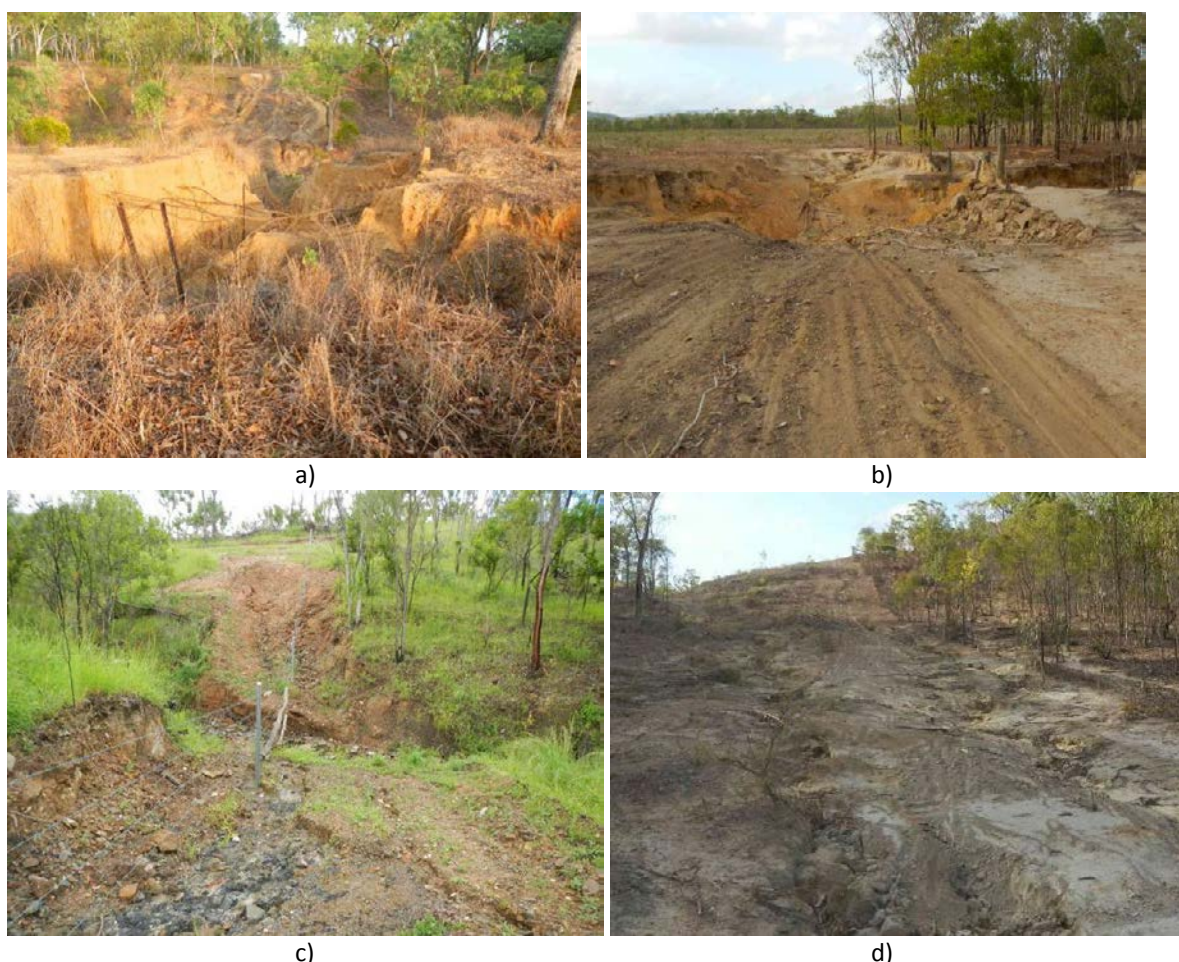
Figure 143 Fence line crossings of a) a steep creek bank with sodic alluvial soils on a high floodplain, b) duplex soils (sodic sub-soils) through a creek on a terrace, c) colluvial soils of a hillslope creek crossing, and d) a steep slope cleared of vegetation regrowth with heavy machinery along a fence line. In all cases, fence construction and maintenance have caused rill and gully erosion from machine grading, lack of water diversion structures, and cattle tracks (pads) along fences over steep banks.

Proper fence placement *around* rather than through erodible alluvial soils (e.g., Figure 130) can minimise future erosion and prolong the life of the fence (Figure 143a). Fences should be located on stable soils and geology, such as on subtle ridge and spur crests between drainage catchments. Carefully planning fence routes will minimise the number of crossings of existing gullies, unchannelled hollows, creeks, and rivers, which will in turn reduce fence maintenance costs and rill and gully erosion (Figure 143; Figure 144). Basic soil/geology and erosion hazard maps can be useful for locating infrastructure during property planning, as well as topographic maps, Google Earth images, and high resolution LiDAR data where available. Subsequently after desktop planning, scouting and mapping the best routes for fences on the ground using motor bikes and GPS can help avoid erosion hazards and unnecessary use of large machinery. Once the most appropriate fence locations are determined, the use of best management practices (BMPs) such as water diversion banks, minimization of tree clearing and grass grading especially on steep banks, and using slashers and prescribed fire for fire breaks can reduce the potential for gully erosion along fence lines.

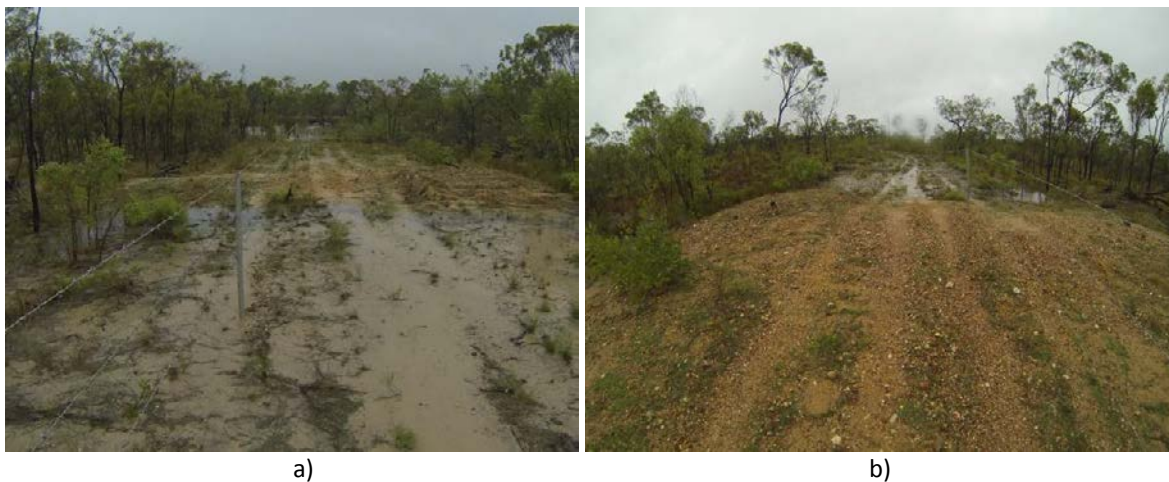
Figure 145 Examples of large water diversion banks (whoa boys) constructed along a terrace fence line by a proactive machine operator and functioning during a rainfall event. Note however, the spacing or frequency of the banks should have been increased (<50m) to minimise water volumes arriving and flowing/eroding around each bank.

frequency of diversion banks depends on the slope, but banks should be placed every 10-15 m on steep or erodible soils. Large banks (>0.5m high; > 6m wide) will ensure long-term functionality and drivability, while preventing future machine operators from grading through them (Figure 145). Extreme caution is needed however for bank construction on steep erodible soils, as construction could actually accelerate erosion. Similar to roads on steep erodible slopes, banks at fence crossings might need to be capped with or constructed out of non-sodic soil/rock to armour the soil and prevent rills and gullies from cutting through them (Figure 145b). In many instances it is better not to disturb soils on steep erodible banks with machinery, and rather use alternative fencing methods such as fencing “tree-to-tree” without soil and vegetation disturbance (Figure 146).

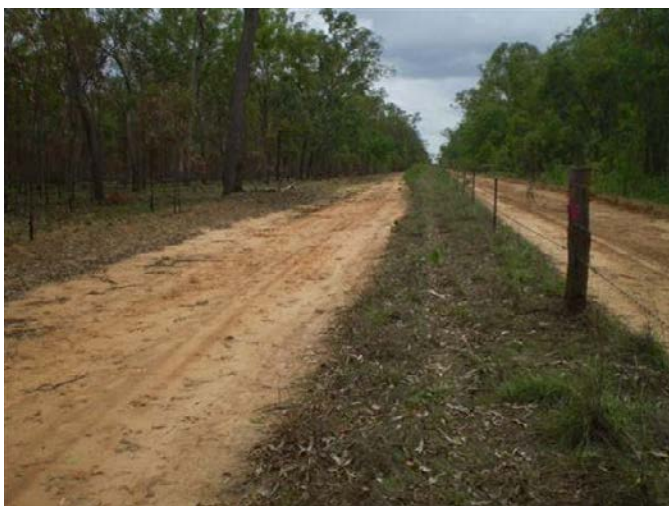
Figure 147 Fence line grading for fire breaks can concentrate water runoff from deep grading and accelerate gully erosion, especially if frequent water diversion banks (whoa boys) are not installed to maintain natural flow paths and mitigate erosion.

For fence lines used as fire breaks, annually grading fence lines to clear grass and sapling growth can accelerate erosion by removing vegetation cover and grass root cohesion, by grading too deeply and thus concentrating water flow, and by grading over or through water diversion banks rather than maintaining them (Figure 147). Indiscriminate clearing of tree growth with heavy machinery along fence lines also can accelerate rill and gully erosion (Figure 143d). Alternatives to graded firebreaks include slashing soon after the wet season or the use of herbicides to reduce grass and tree sucker growth (Jolley 2009). However, off-site pollution needs to be carefully avoided when using herbicides. Furthermore, the trash will either need to be burnt before the surrounding grass has dried out, mechanically raked, or thrown to one side of the break from multiple passes. The combined use of vegetation slashing or herbicide application together with early-dry season prescribed fires along fence lines using aerial incendiary flights could be an effective way of installing large fire breaks over remote country to prevent late-dry season intense fires (see Section 6.5.7).

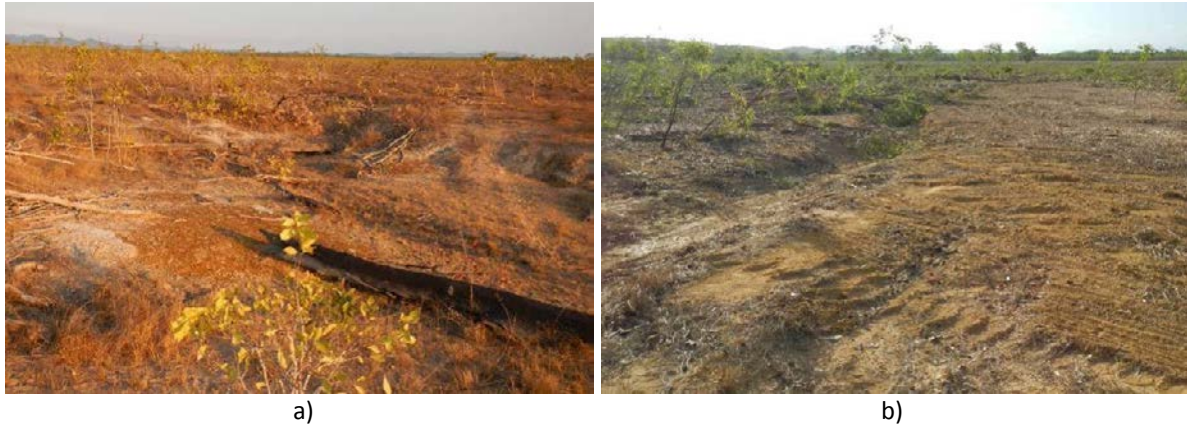
Figure 149 Tree reclearing and chaining through a) a 2m deep alluvial gully (Figure 45) on a river terrace and b) a 0.5m deep alluvial gully on a river terrace. Note that grass and tree vegetation buffers (+50m) should be installed around these features, especially Figure 149a, to allow for revegetation and to protect the gully from periodic reclearing of the improved paddock.

As an example, if a vegetation buffer with cattle fencing had been retained during initial tree clearing in the 1970's around the alluvial gully at CRGC6061 (Figure 148; Figure 149; Figure 45; Section 7.5.2.2), then gully erosion into this small hollow would not have been so severe as a result of clearing, disturbance and vegetation changes. Therefore, by instating a +50m tree and grass buffer around this gully, along with cattle exclusion, it is hypothesised that the gully system will stabilise as indicated by preliminary data (Figure 46; Figure 47). Eucalyptus and Melaleuca tree regrowth will occur within the fenced area and possibly compete with grass understorey vegetation for light, nutrients, and water. However, trees can also help stabilise gullies (Shellberg 2011), and a balance between tree and grass vegetation cover will emerge over time without intense grazing pressure.

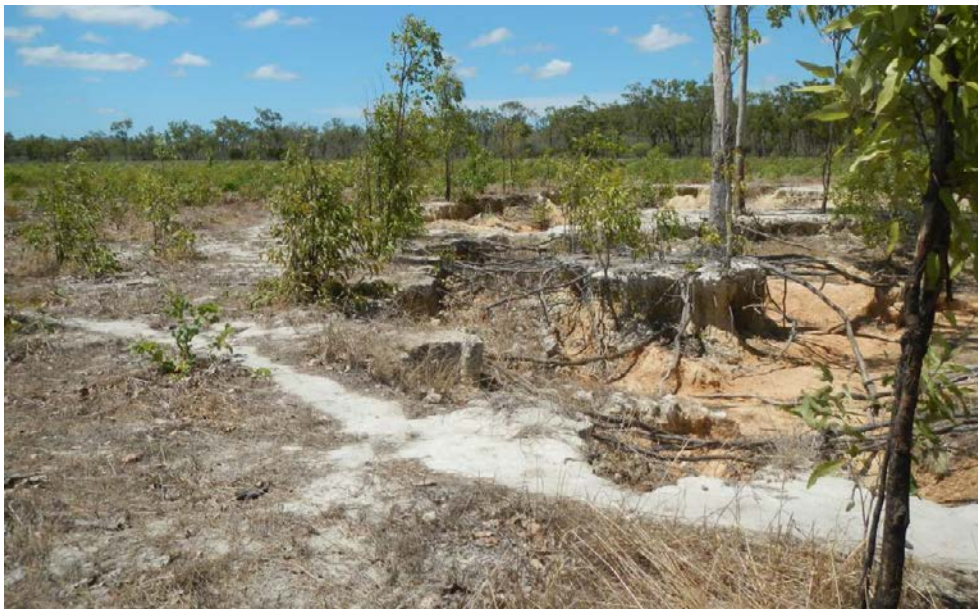
Figure 150 An alluvial gully headcut at the margin of a recently (re)cleared paddock, fed by overland water flow from the clearing. At a minimum a water diversion bank should be placed around this gully, as well as a larger vegetation buffer (+50m). Regrading or tillage is not recommended without major intervention.

As another example, a vegetation buffer was not retained or reinstalled during (re)clearing of the Normanby River frontage paddock in Figure 150 below. A +50m vegetation buffer around the gully headcut would have reduced soil disturbance from machinery, clearing,

and cattle tracks (pads) common along cleared margins (Figure 150). On the edge of this buffer (and/or near the gully scarp), an earthen berm or bank (Section 7.12; Figure 87; Figure 88) should have been installed to divert excess water runoff from the cleared paddock into a safe disposal point, such as a grass waterway or constructed pond on the floodplain (Section 7.12). Installing contour berms could also be appropriate on upslope sections of the cleared paddock (e.g., Figure 85), as long as the surface water runoff is managed appropriately and not diverted to steep creek banks and drainage lines where it could fuel more gully erosion. Proper best practice management of surface water runoff, erosion, and nutrient runoff will be especially important if future agricultural development (tilled pasture, bananas, leucaena, etc.) commences on these fragile river frontage soils next to major rivers and intact habitat.
