East of Lutterworth Strategic Development Area Harborough District Leicestershire

Heritage Statement

CA Project: 661000

CA Report: 17604

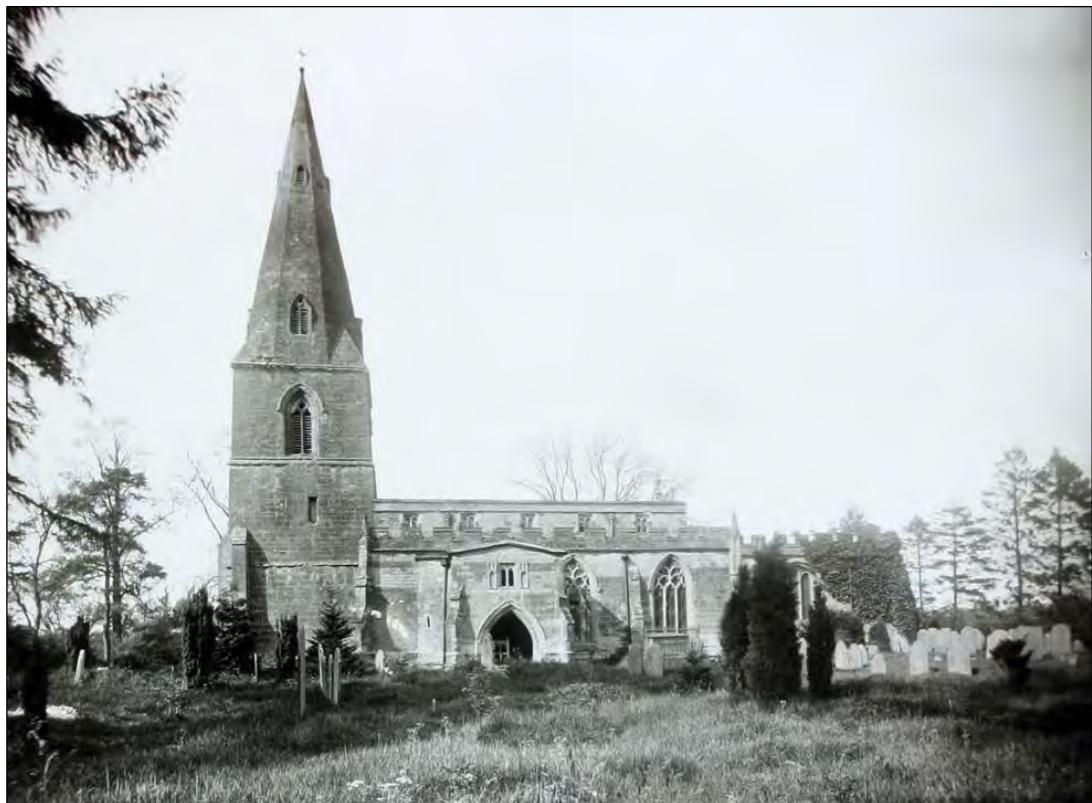
Photo 1 1885 photograph of St Leonard's from the SW corner of its churchyard

- 5.6. The Church of St Leonard is of 14th century origin, but was restored in 1863 by William Smith with further renovations to its spire carried out in 1926 (Photos 1 and 2). The List Entry (NHLE Ref.1294954) provides a detailed description of its exterior and interior form and features, for example: the three-stage tower with angle buttresses, louvred bell openings, and octagonal spire with louvred lucarne with pointed hood; the nave with its coped parapet that possesses corner finials and a blank quatrefoil frieze; the restored two-storey porch with diagonal buttresses, a wide double-chamfered pointed arch doorway with hood mould, a concave cornice and a chamfered rib vaulted roof; and numerous monuments that include 16th and 17th century tombs of the locally-prominent Pulteney family (see Section 3, above). It is apparent that the special architectural and historic interest of St Leonard's is principally derived from a combination of its evidential, historic, aesthetic and communal values – which are embodied by its built fabric.

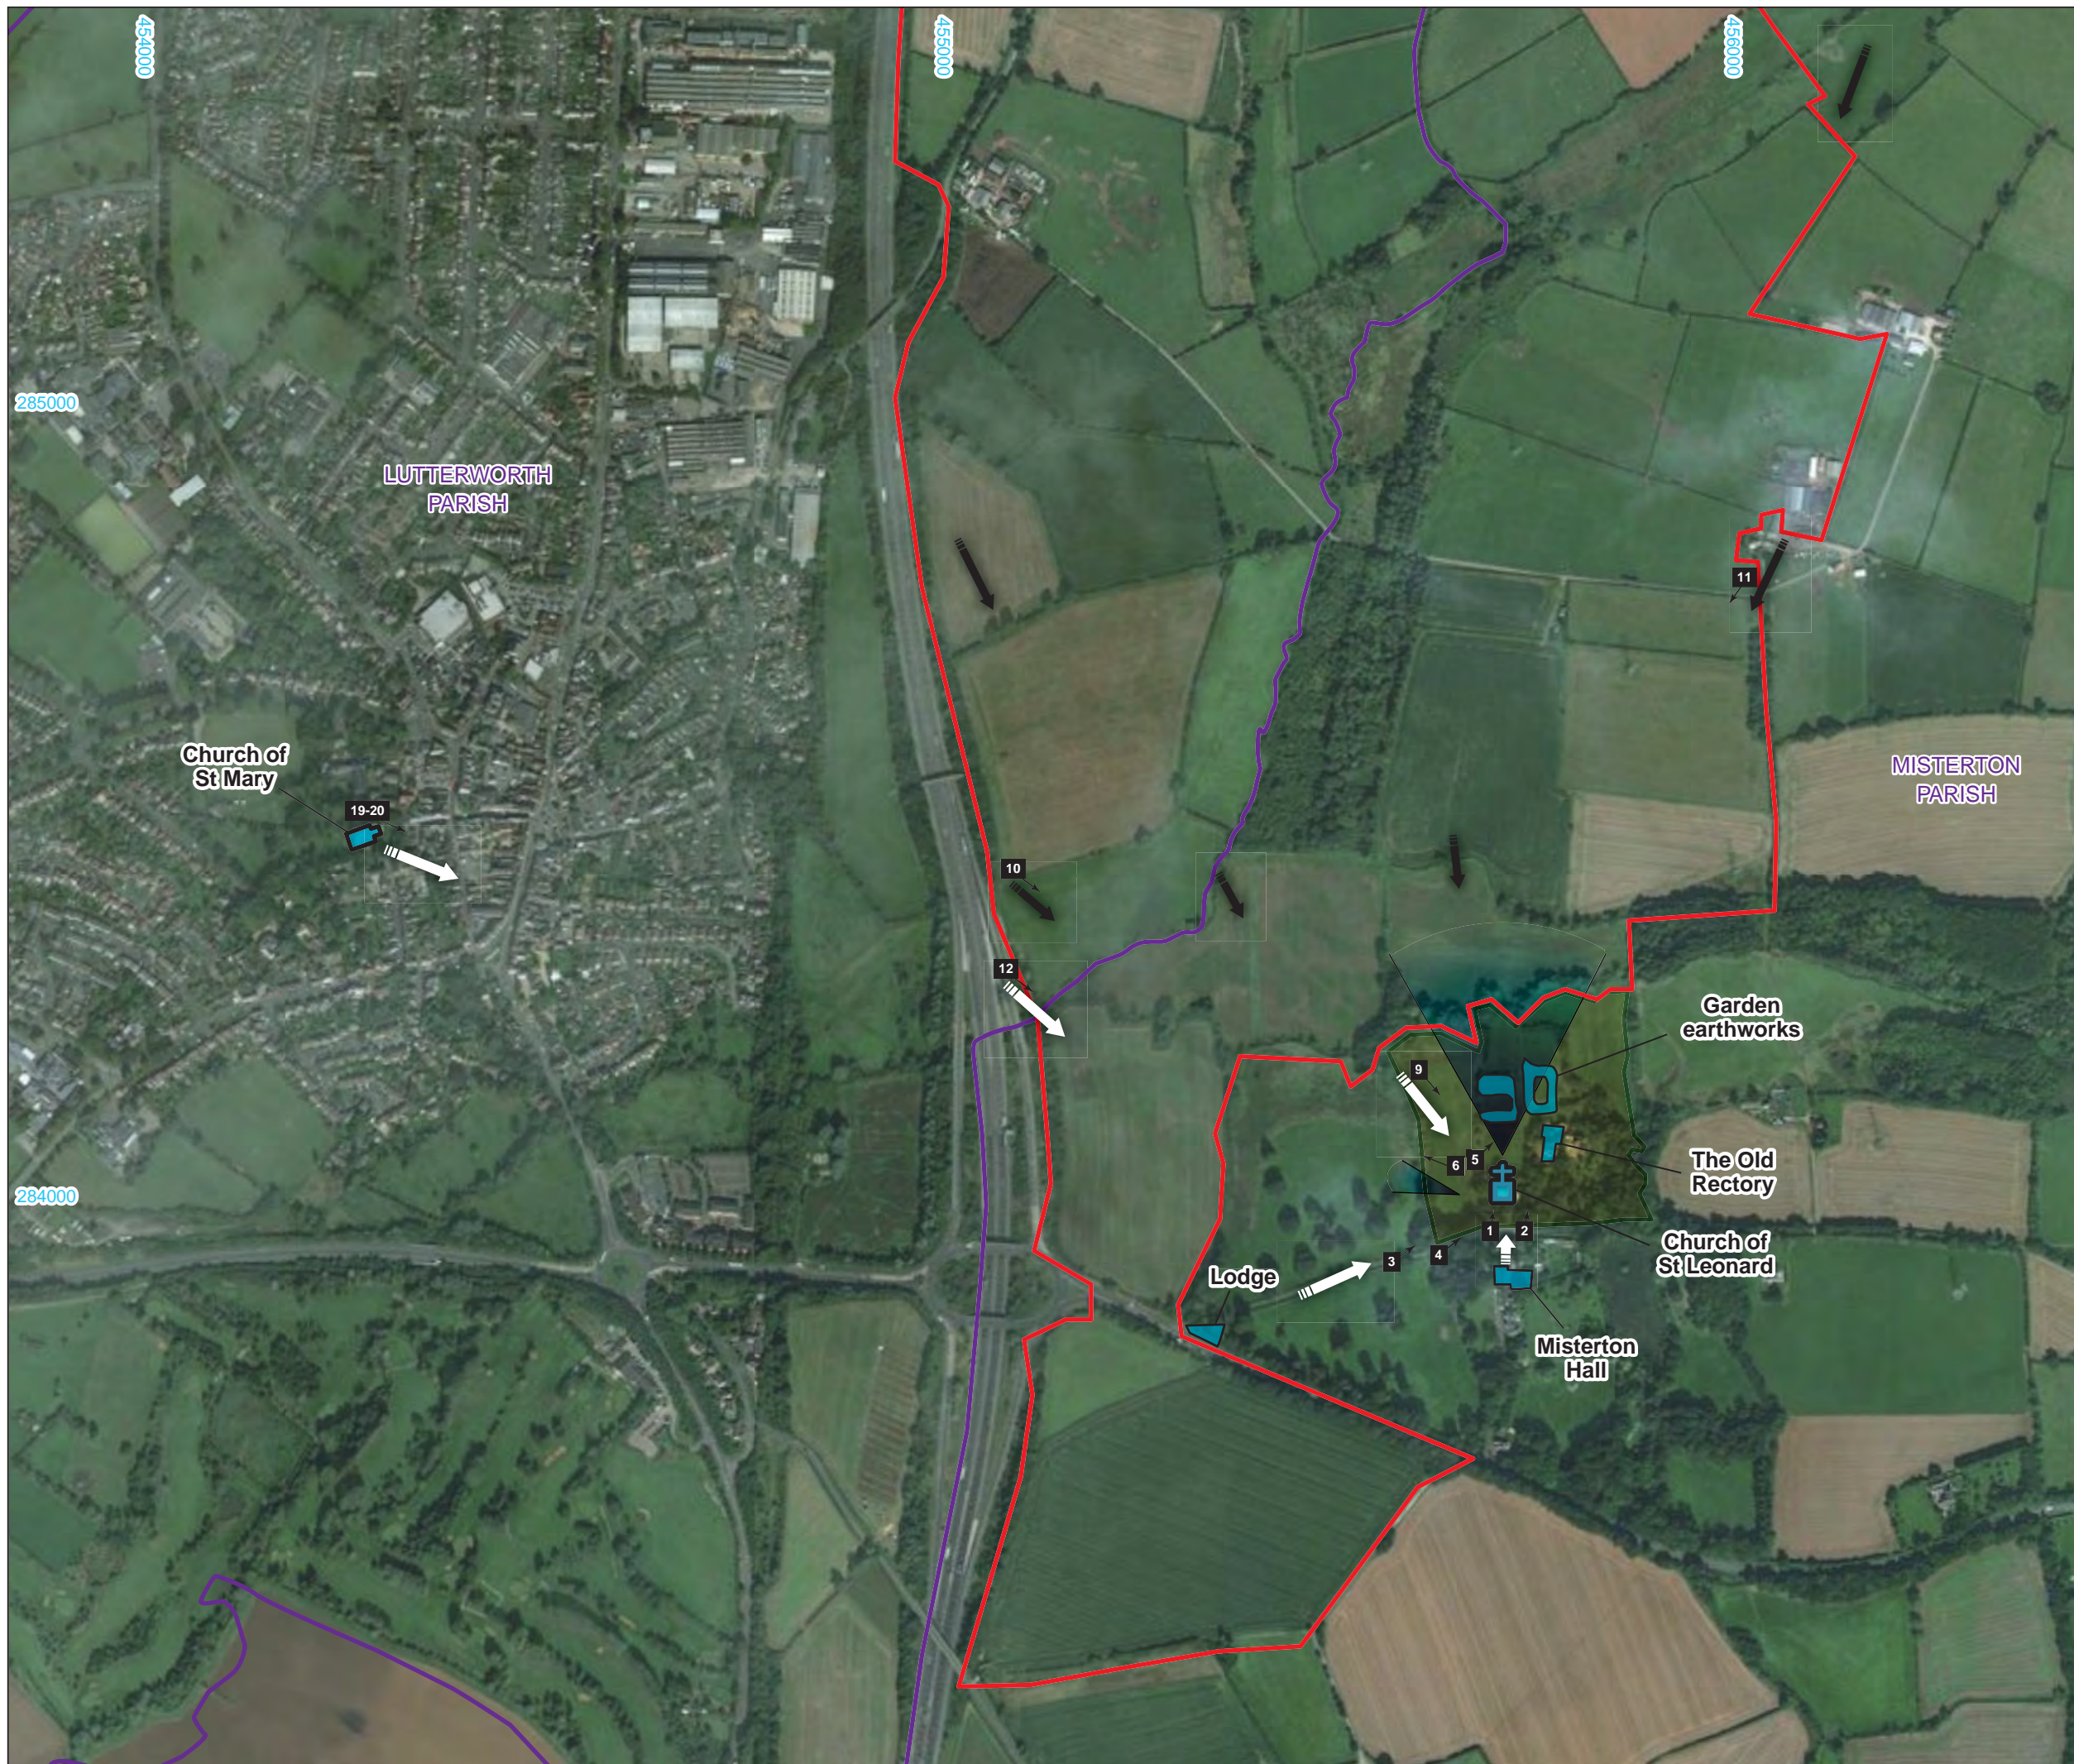
- Site boundary
- Parish boundary
- Glebe land recorded on 1883 Map of the Misterton Estate
- ✚ Church of St Leonard
- Other heritage assets with which the Church of St Leonard is associated
- Key approaches and views of the Church
- Incidental glimpses of the Church
- ▶ Key views from the Church
- Photograph locations

5.10. From the churchyard (and the pasture field to its south, which lies between the churchyard and the Site), there are open views to the north and north-west across the farmland and woodland of the Site and towards the town of Lutterworth (see Fig. 10). But it is important to recognise that the landscape is of a distinctly modern character: the field systems deriving from 18th century enclosure and 19th–20th

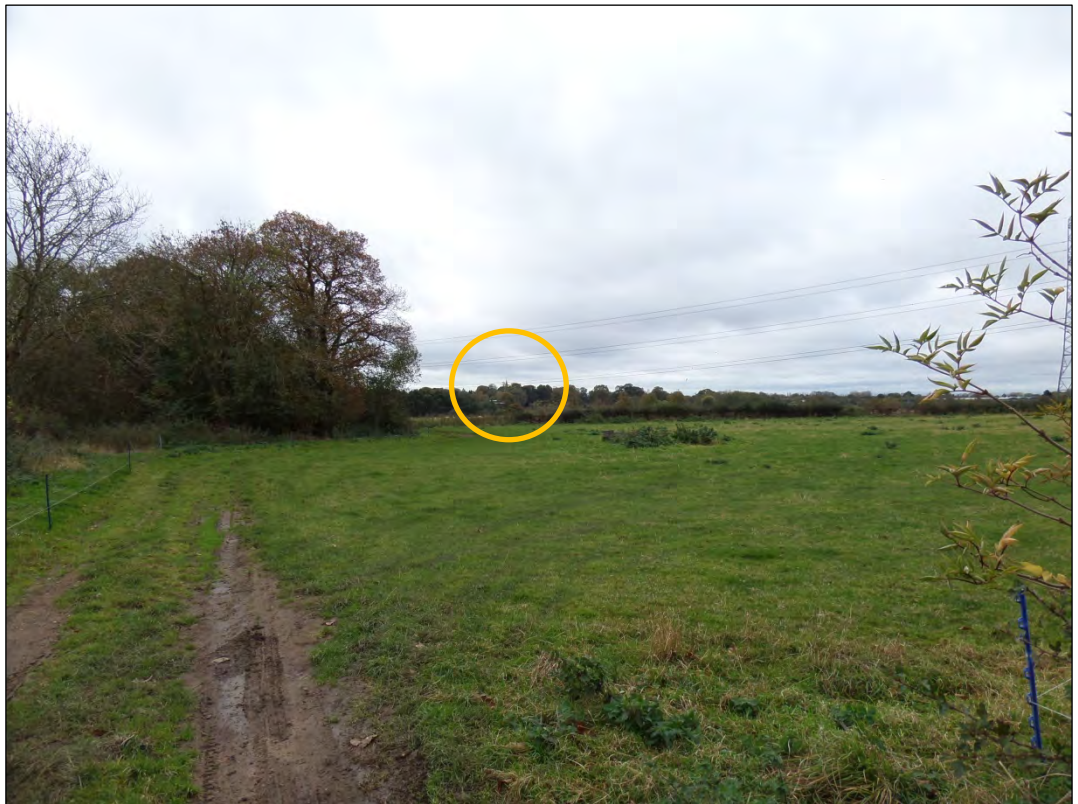
Photo 11 Glimpse of St Leonard's (circled) from the E boundary of the Site at Lea Barn Farm; note the electricity pylon and overhead power lines

5.12. In terms of other views of St Leonard's aside from those identified from Church Lane, its spire can be seen from the footpath that crosses the pasture field to the north of the churchyard (i.e. leading from the churchyard to the south-eastern corner of the Site) (Photo 9), the higher ground in the western and eastern parts of the Site (Photos 10 and 11), the Gilmorton Road bridge (not illustrated) and Junction 20 of the M1 (Photo 12). Some of these views are only incidental glimpses of the church; but in other views, especially from the motorway, the spire takes on 'landmark' status, serving as a built reference point for the hamlet of Misterton. The same is true for the tower of St Mary's at Lutterworth (discussed in the following settings assessment, below). The ethos behind the building of church towers and spires '*has never been satisfactorily understood*', although it has been suggested that these structures are the inevitable product of architectural evolution, a desire to reach '*upwards to the glory of God*', or inter-community competition (i.e. 'bigger is better') (Child 2007, 44–45). It is worth noting, however, that church towers and spires are not the only prominent structures within the study area: a high voltage overhead power line supported by large pylons crosses through the north-eastern part of the Site (Photo 11) and some of the wind turbines at Swinford can be seen from the higher ground in the western-central part of the Site (not illustrated).

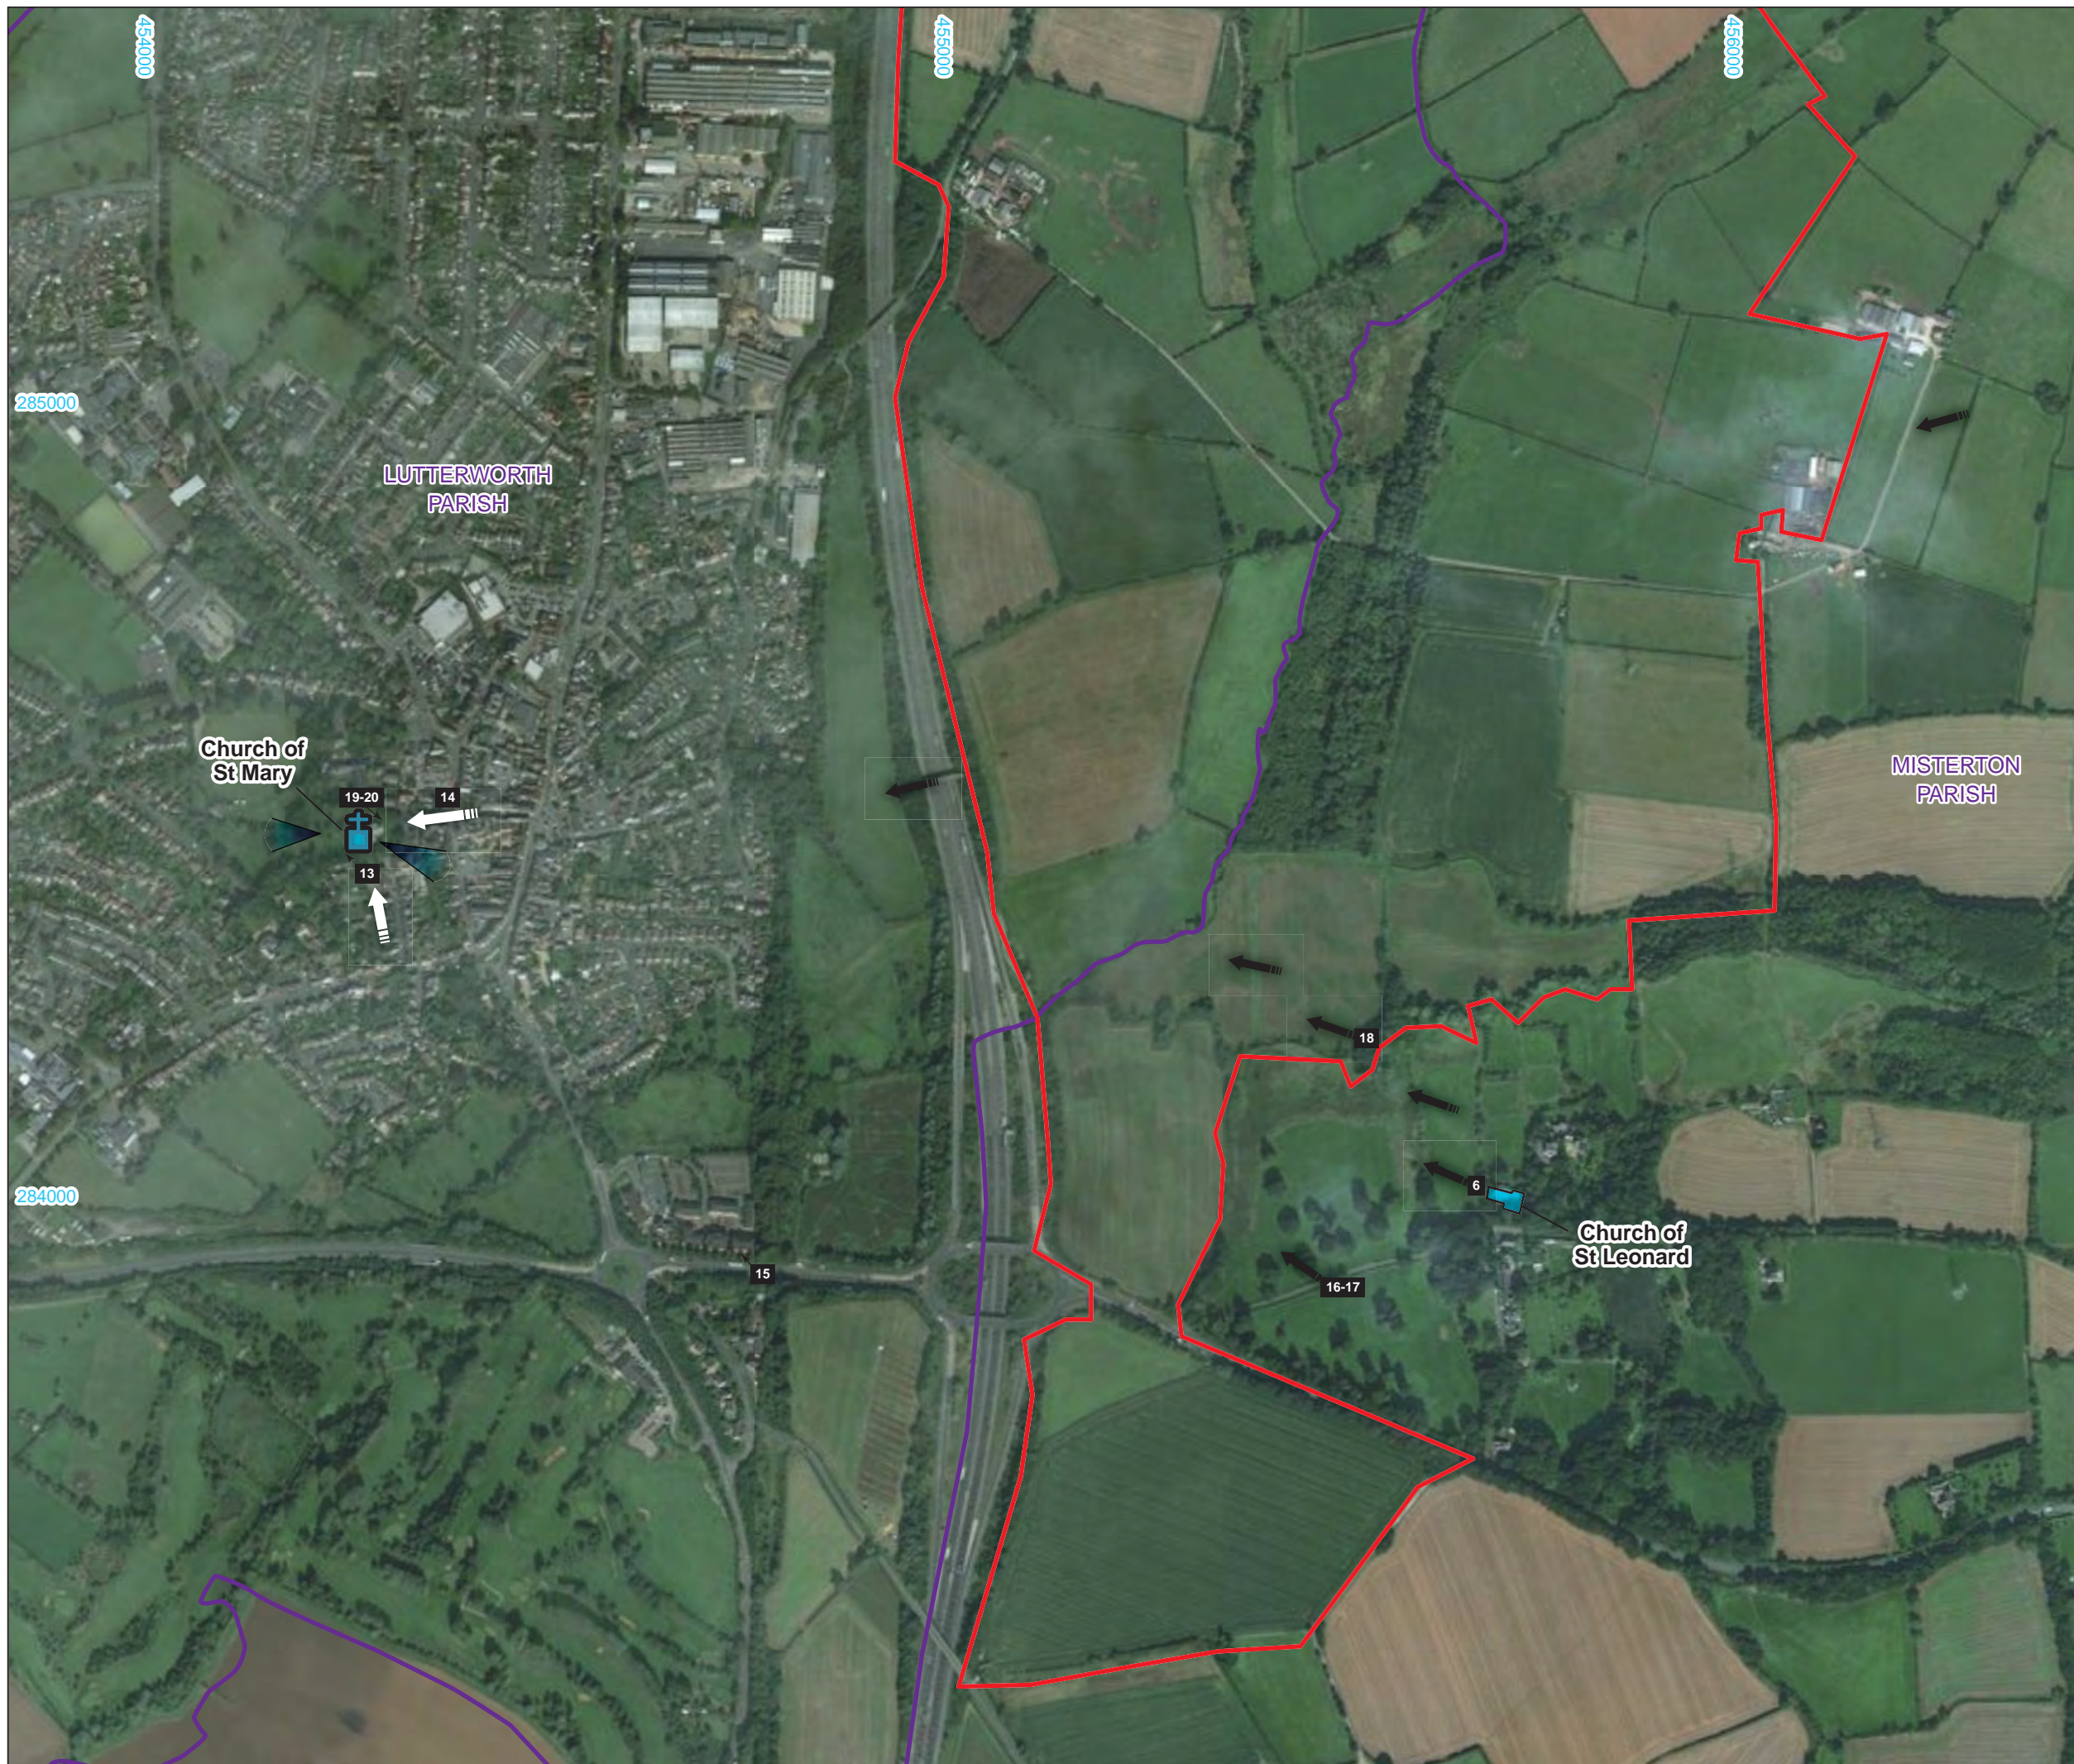
FIGURE TITLE
Setting of St. Mary's Church at Lutterworth

- Site boundary
- Parish boundary
- ✚ Church of St Mary

- Key approaches and views of the Church
- Incidental glimpses of the Church
- ▶ Key views from the Church
- Photograph locations

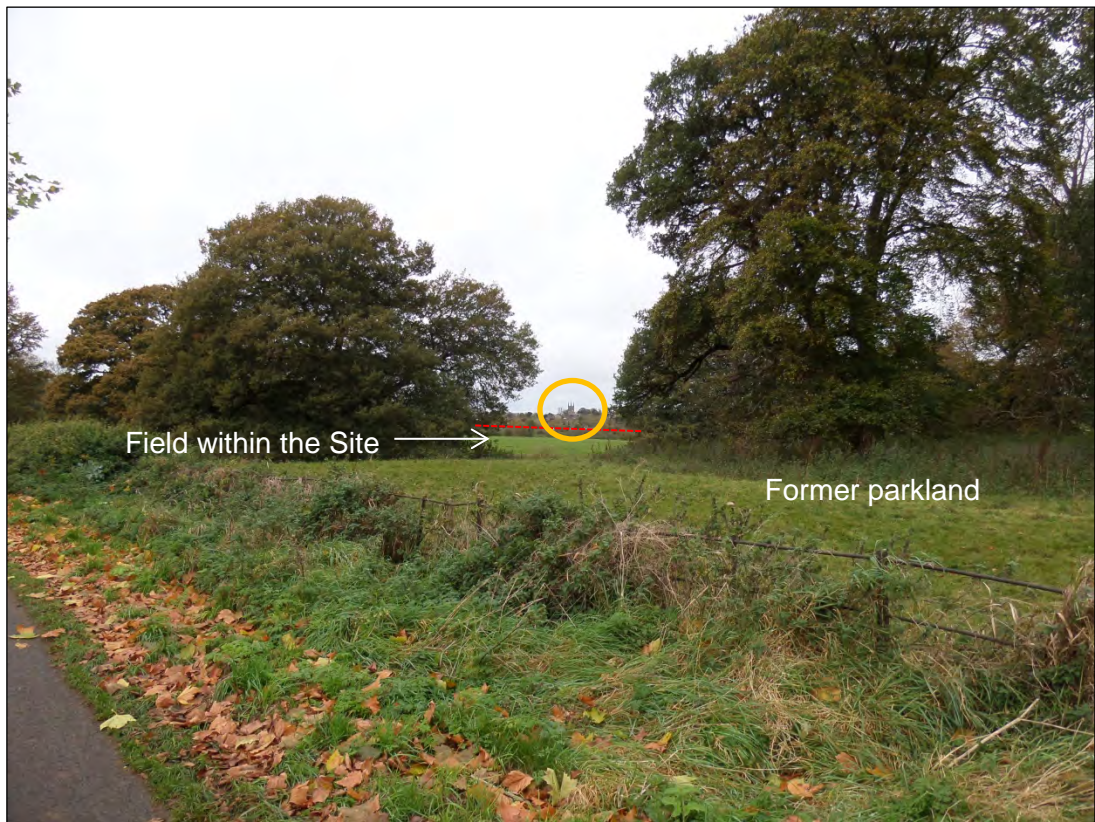
Photo 16 View of St Mary's (circled) from Chapel Lane, with red dashed line indicating the M1 Junction 20 slip road

- 5.17. Photographs from 1885 show the historical prominence of St Mary's from locations in and around Lutterworth, including Cotesbach Road to the south and Misterton Road to the south-west (Photo 15). The walkover survey identified glimpses of St Mary's tower from Chapel Lane (Photo 16) and from the north-western part of St Leonard's churchyard at Misterton (Photo 6). In the foreground of the view from Chapel Lane is the former parkland of Misterton Hall (Fig. 5, **19**), the neighbouring field to the west being the only visible part of the Site; in the mid-ground of the view, heavy goods traffic is frequently seen on the Junction 20 slip road, rendering this view of a distinctly modern character (Photo 17).

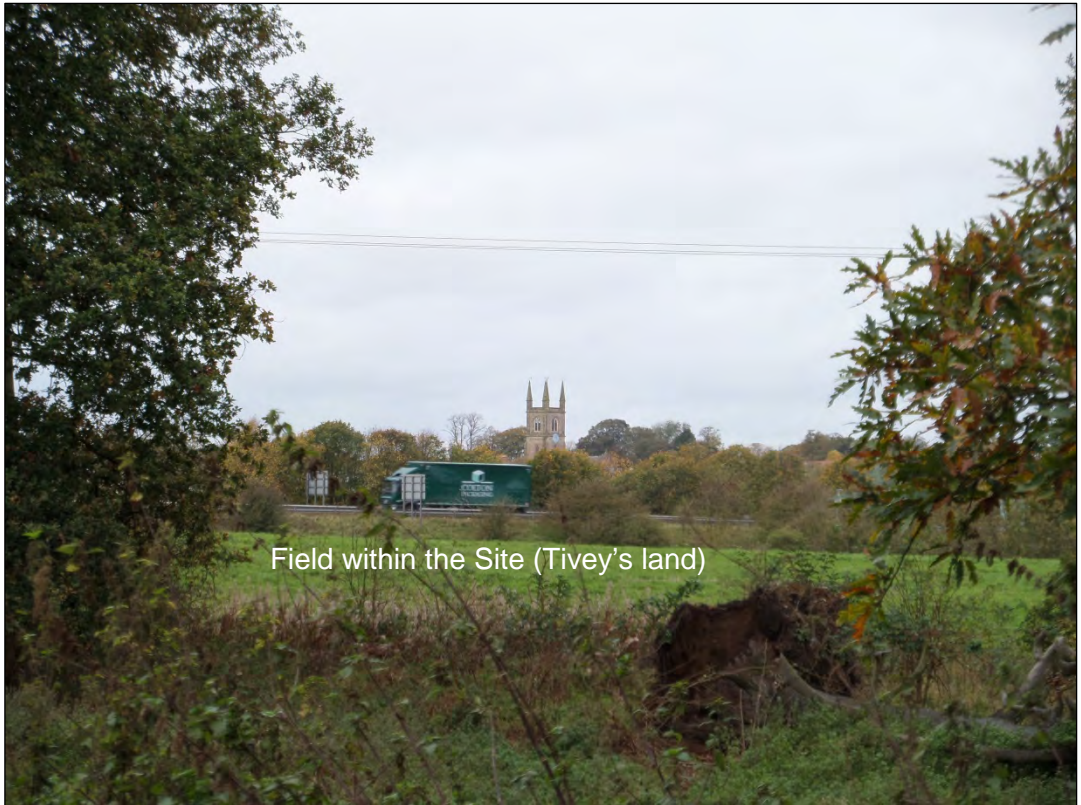
Photo 17 Visibility of traffic on the M1 Junction 20 slip road in the view of St Mary's from Chapel Lane (zoomed photo)

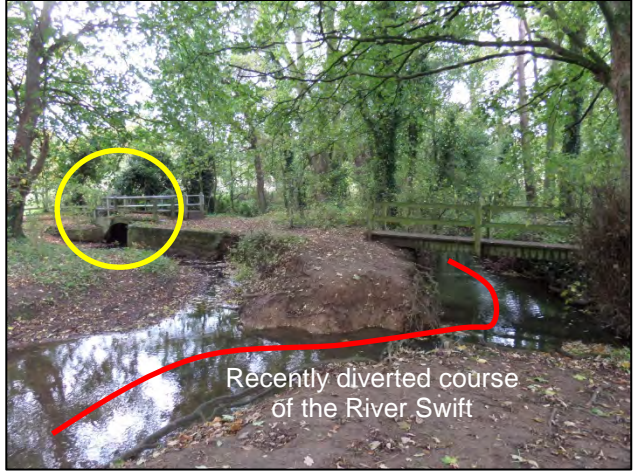
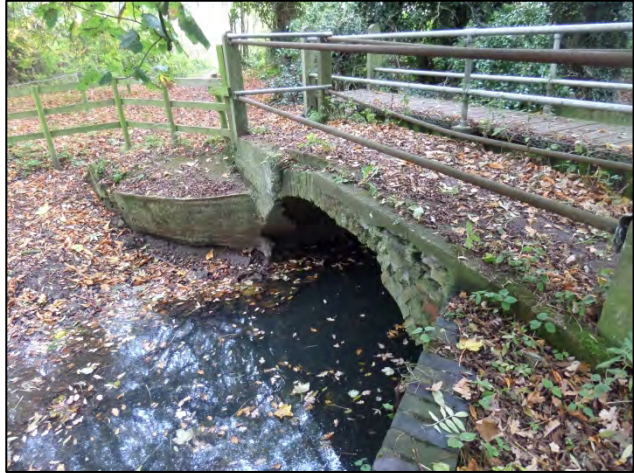
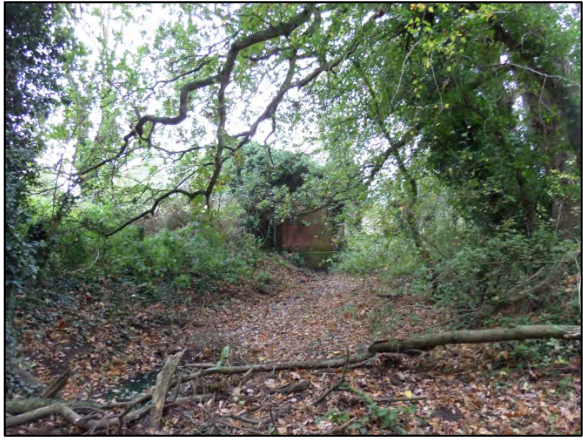
Building name – Bridge over River Swift

<p>Recently diverted course of the River Swift</p>	
NGR: SP 5556 8417		
Designation: None		
Number on plan: see Fig. 5		
Building type/purpose including previous uses where appropriate: Bridge		
Construction materials: Brick	<i>View from north-east</i>	
Approximate date: Mid- to late-19th century (mapped in 1883)

Description: Brick-built footbridge across a former channel of the River Swift. Now in a poor state of repair, with railings to prevent use. Its arch can be discerned from the new concrete footbridge and from the river bank. Its curving piers are capped with blue bricks.		<i>View of arch from east side</i>

<i>View towards asset 21 from footbridge</i>	<i>View of arch from west side</i>
Compiled by: Elizabeth Pratt	Date: 24th October 2017

- 3.29. Only two features of historical interest were observed within the Site: a small brick building (Fig. 5, **21**) and a nearby brick footbridge (Fig. 5, **22**), located beside and across what a now largely-dry channel of the River Swift. The 1883 Map of the Misterton Estate depicts both structures and shows the channel as the main watercourse (see Fig. 6). However, this channel has (recently?) been diverted by linking up a spur shown on the 1886 and later editions of the Ordnance Survey. In other words, the course of the River Swift has been straightened by removing the 'loop' that formerly passed the brick building. Both structures were subject to Level 1 Building Recording, as defined by Historic England's guidance (2016), comprising an external inspection and an assessment of significance (see Appendix 3).
