Part Two:

Five Case Studies

(Rome, Athens, Durham, Magdeburg, Vézelay)

Case Study: Italy, Restoration in Rome

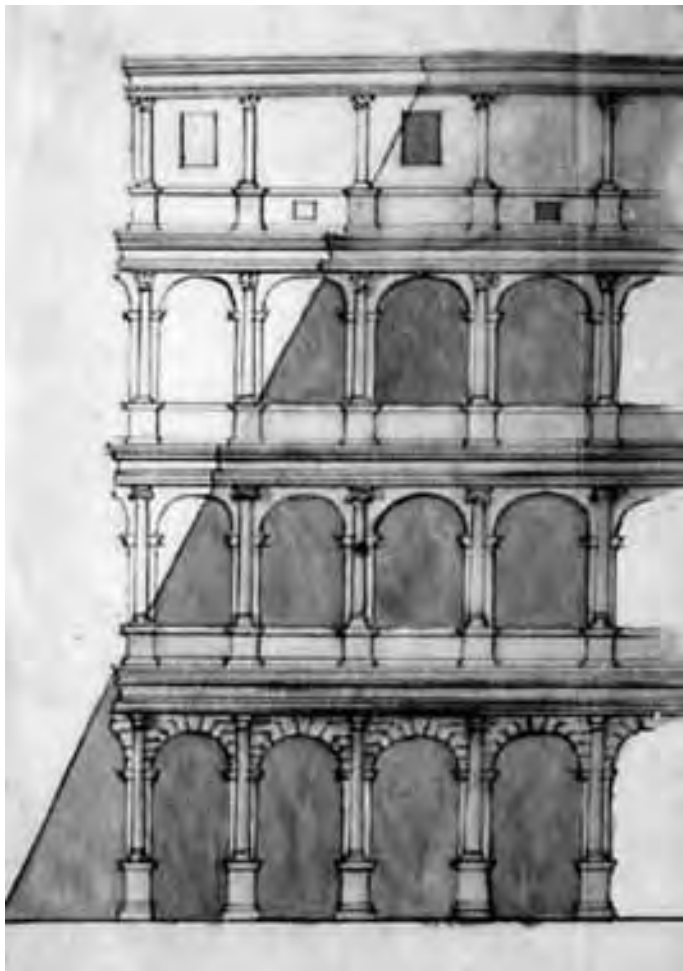
Figure 88. The Colosseum. Proposal for the repair of the east wall by demolishing a part of the original wall

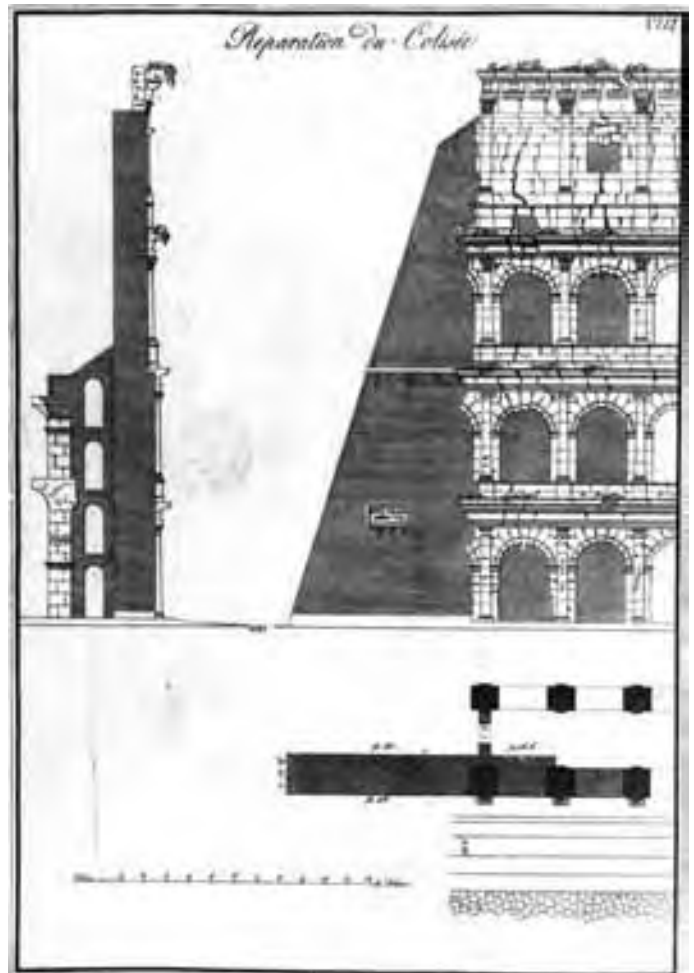
Figure 89. The Colosseum. Accepted proposal for the consolidation of the east wall with a meticulous care to conserve each antique stone

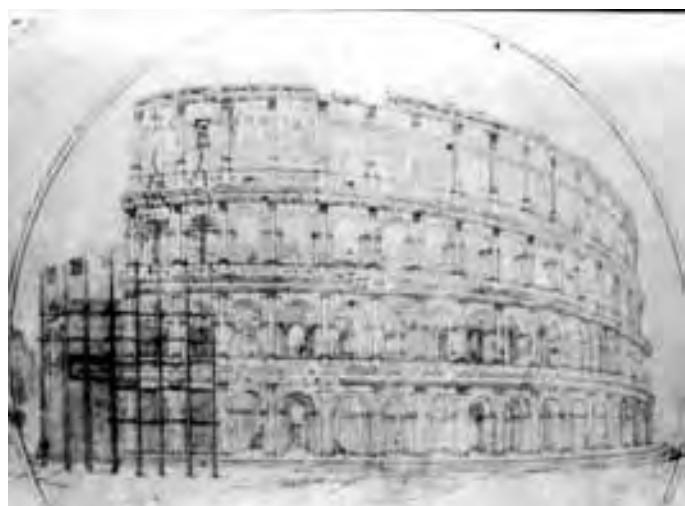
Figure 90. The Colosseum. Start of the restoration work in the east wall

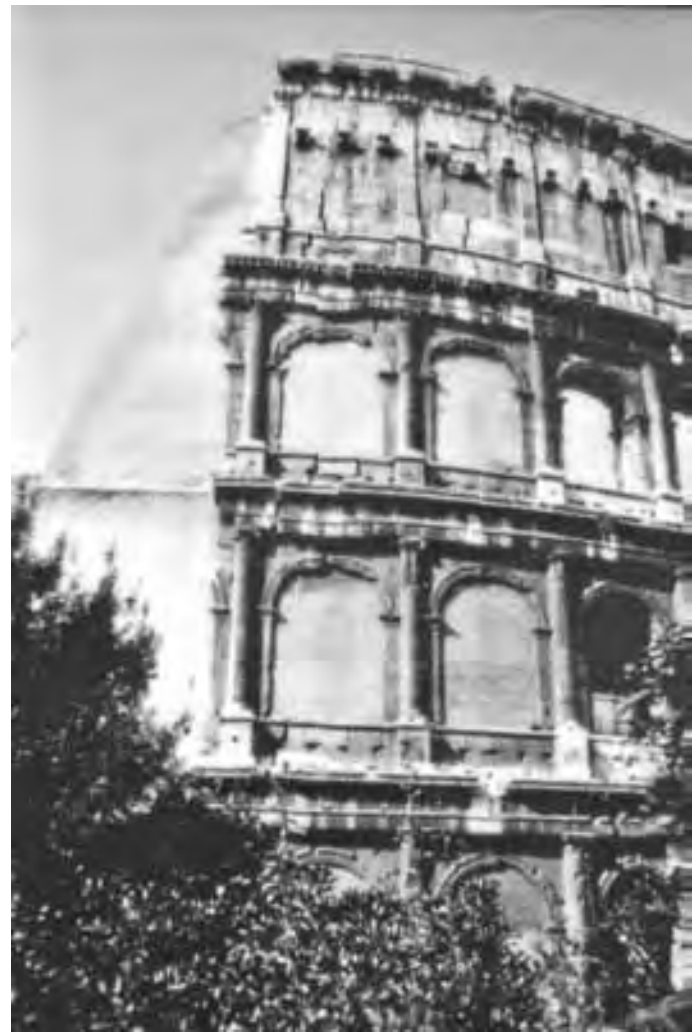
Figure 91. The Colosseum. The brick buttress built by R. Stern in 1806-07 to consolidate the east wall

and arousing deep concern. The first operation was, thus, to provide strong shores to support it against the thrust caused by detached elements. Secondly, the arches were walled in to consolidate them internally. Thirdly, it was necessary to build a cross wall in order to provide further lateral support and to link the buttress, the pillar and the walled in arches with the inner structure of the building. This cross wall was built in imitation of the original radial arched walls. Considering these additional works, the total cost was estimated at two thousand eight hundred scudi. (37) The works proceeded rapidly, and by 6th June 1807, they had advanced to a point where little was needed for completion. The masses of earth that had accumulated in the surrounding area were removed, and some hay-lofts that obstructed the facade were demolished. The recent excavations had also brought to light some interesting facts about the Colosseum, which was now better understood.

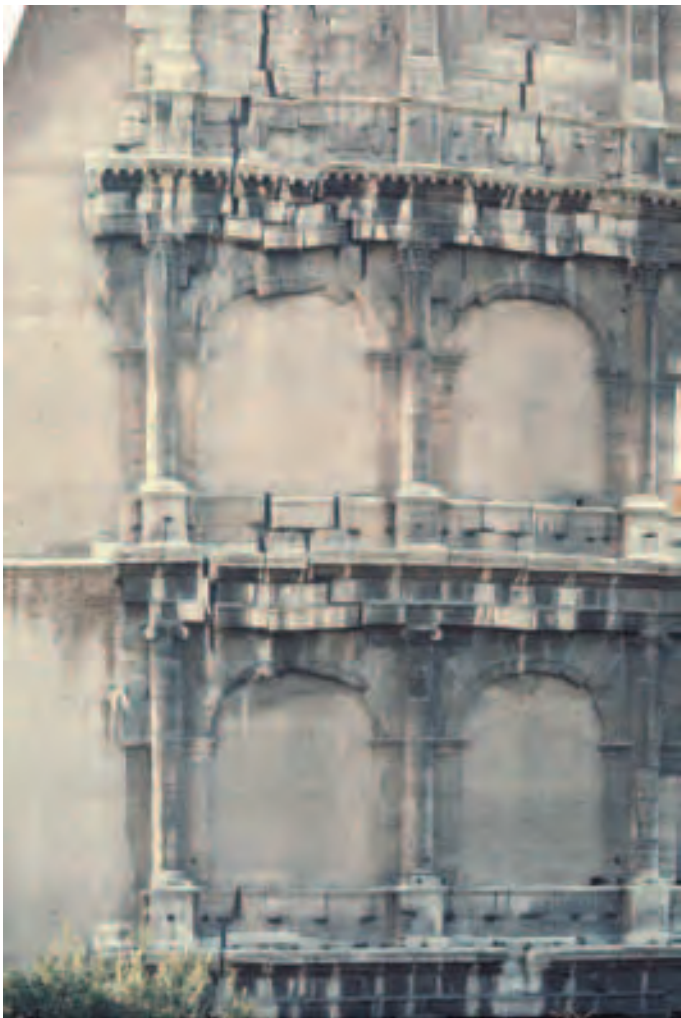
Figure 92. The Colosseum. The brick buttress built to support the east wall; a detail

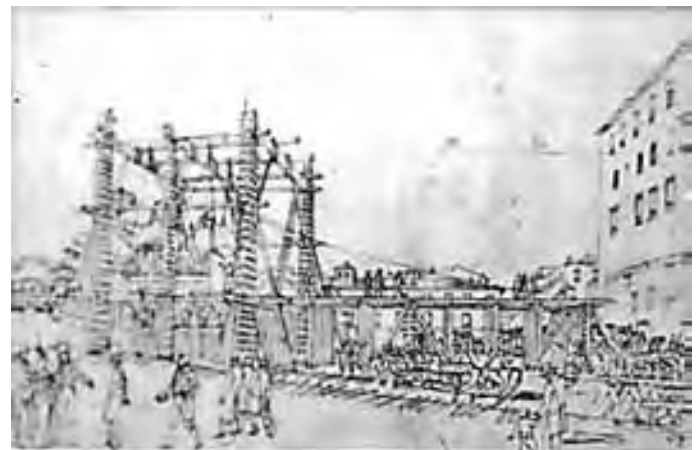
Figure 94. The Temple of Vespasian and Titus, Forum Romanum, Rome. Dismantling of the architrave 1810-11

In 1810, the Accademia di San Luca decided to excavate and consolidate the remaining three columns of the Temple of Vespasian - called the 'Temple of Jupiter Tonans' - in the Roman Forum. After the excavation, the base under the columns was found to be in such a bad condition that it needed rebuilding. For this reason, the columns were taken down and re-erected on the new basement built to the design of Camporesi. Although the original temple was built of marble, the new material was travertine, taken mostly from the demolition of the Colosseum. Plaster casts were made of the very fine marble trabeation and Corinthian capital capitals before they were put back and fixed in position with iron cramps. This was a relatively minor essay in conservation but nevertheless set a standard and provided a model for subsequent works. (44)

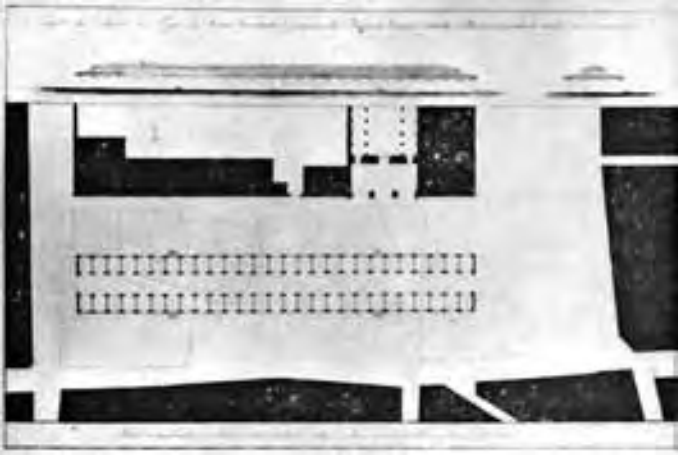
Figure 98. Valadier: plan for a covered market in Piazza S. Marco, Rome

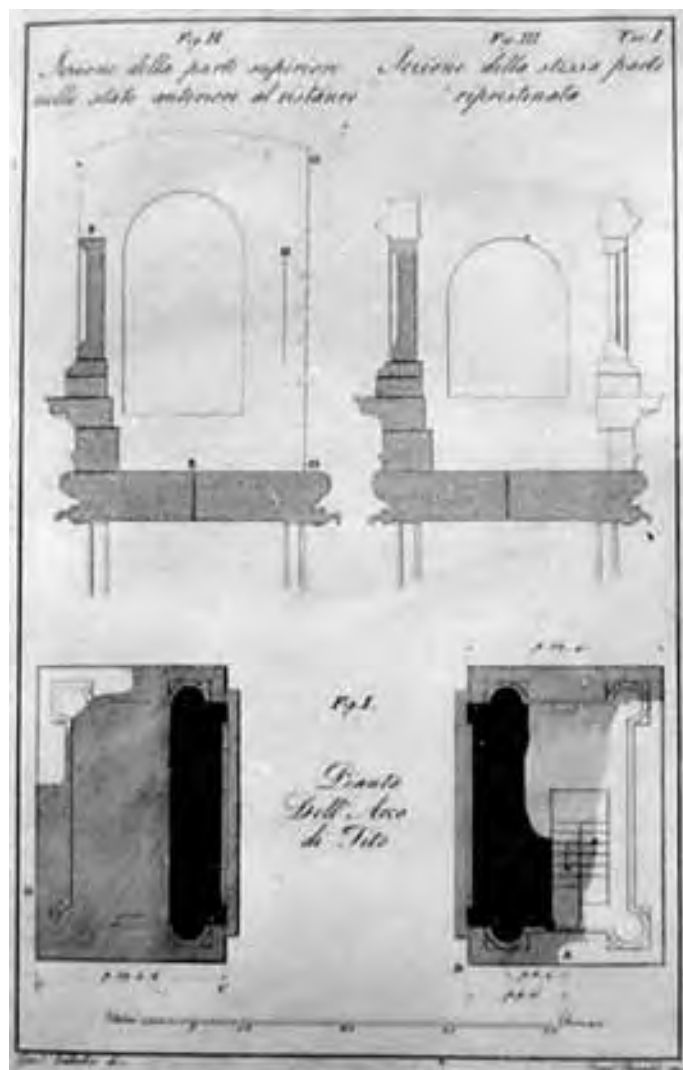
Figure 104. Valadier, Arch of Titus, plan and sections, showing results of excavation in the foundations

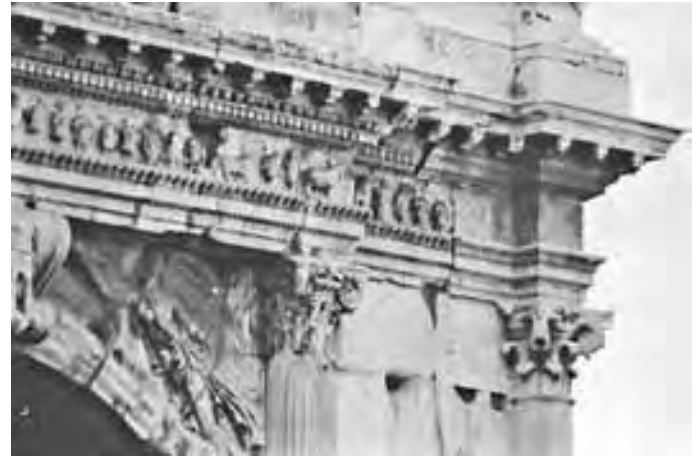
Figure 108. Arch of Titus, detail showing the distinction between original (in marble) and new (in travertine and simplified details)

and its excavated foundations. The triumphal arches of Trajan in Ancona and in Benevento were taken as models - thus following the example of various reconstruction drawings from the Renaissance onwards. The original elements were carefully countermarked and dismantled one by one using the support of a strong centering. After that, the Arch was rebuilt, reassembling the original elements on a new brick core. The reconstructed parts were faced with travertine, which harmonized well with the original marble elements. The new parts were left plain without repeating the decoration, the bas-reliefs or the fluting of the columns, so that “the visitor would have no doubt about what was authentic and what had been built only to give an impression of the whole” as Quatremere de Quincy wrote in his *Dictionnaire d’architecture* in 1825/1832. (71)

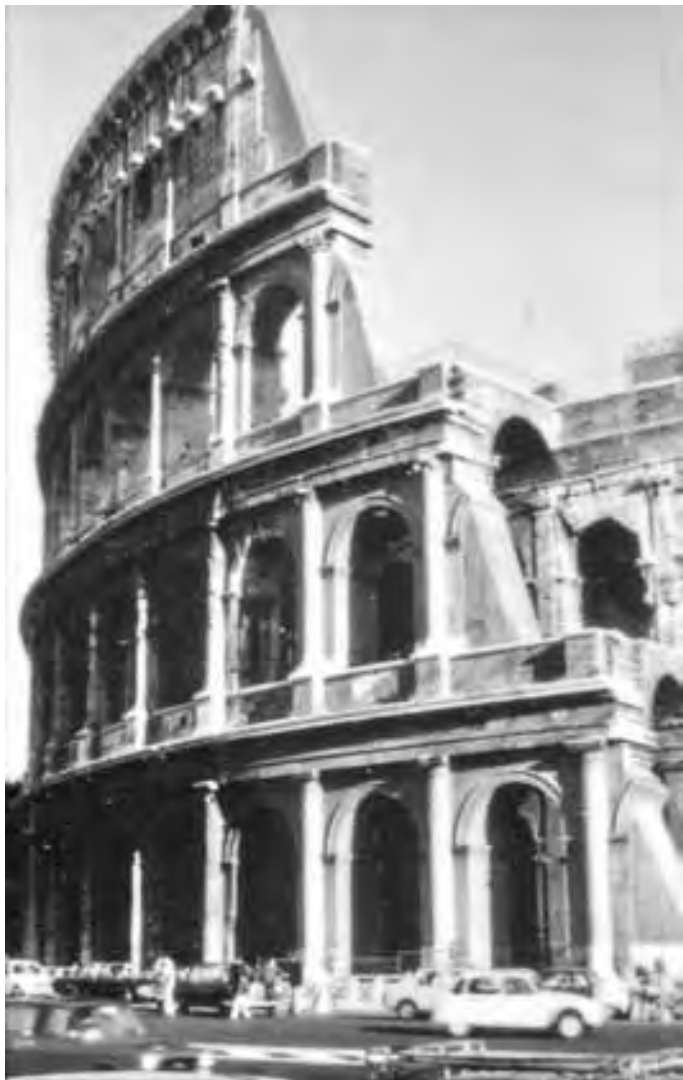
Figure 113. The Colosseum after the construction of the buttress by Valadier for the consolidation of the west wall

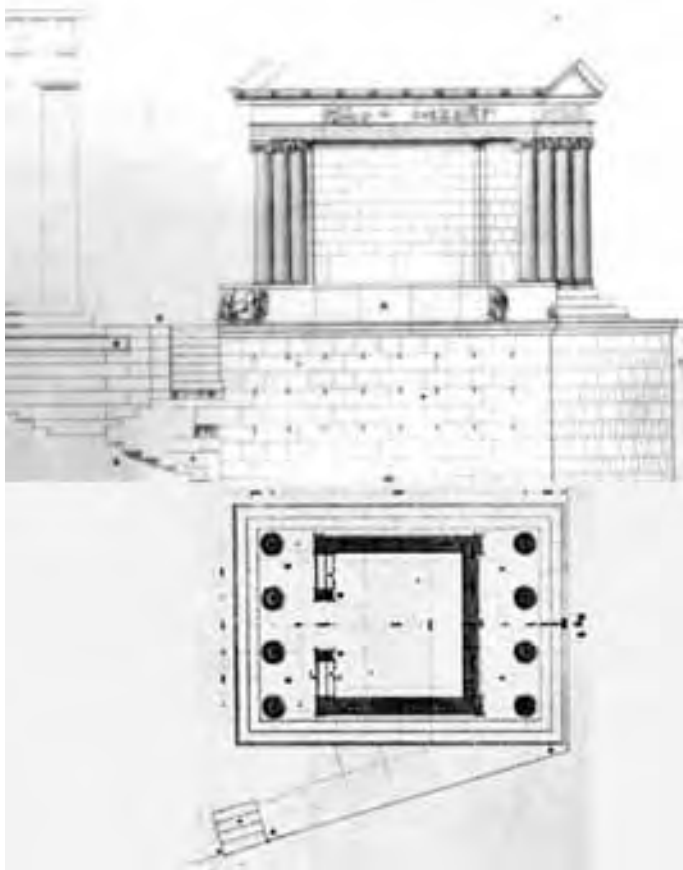
Figures 121 and 122. The Temple of Athena Nike, side elevation and plan (Ross, Schaubert, Hansen, *Die Akropolis von Athen*)

The plan was amphiprostyl-tetrastyle, that is, it had porticoes with four Ionic columns at both ends,

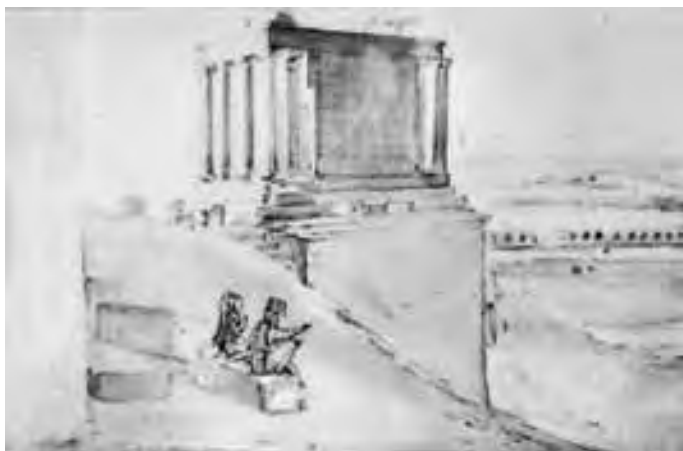
Figure 123. The Temple of Athena Nike under reconstruction. Watercolour by C. Hansen

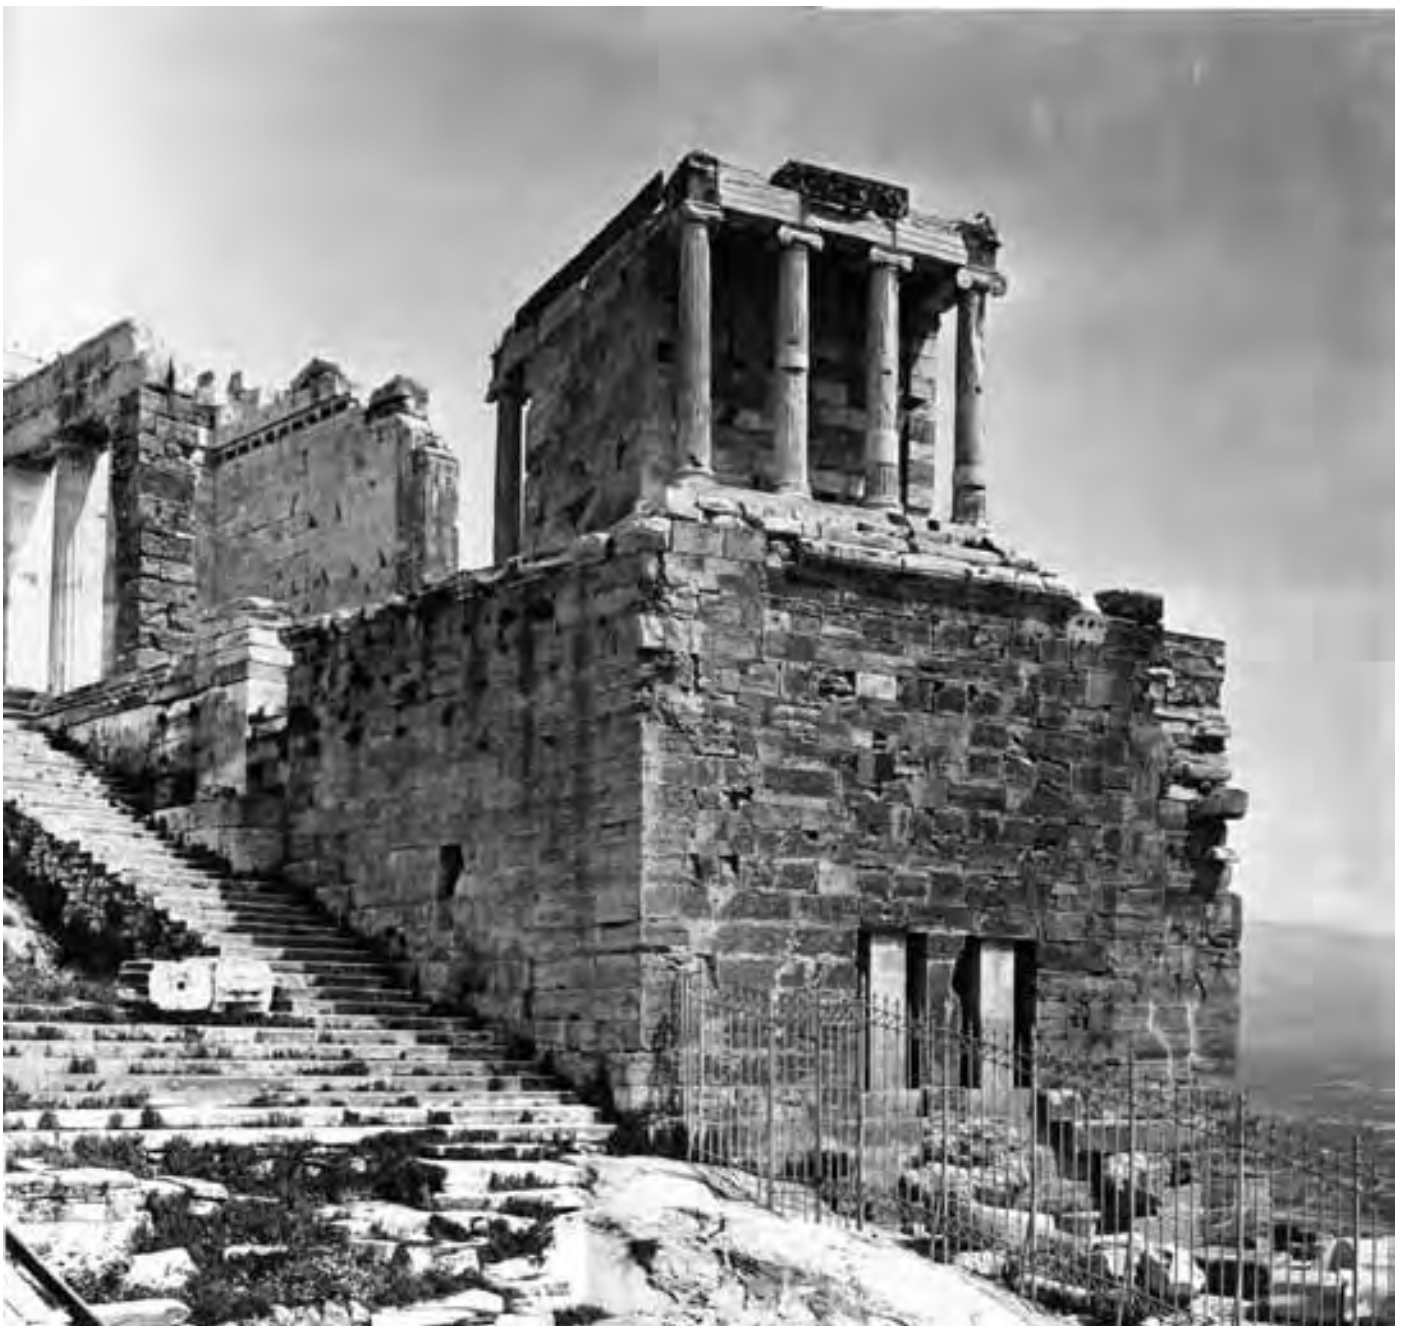
Figure 125. The Temple of Athena Nike c. 1900. The basreliefs have been replaced with terracotta copies from the originals in the British Museum (Elgin Marbles); losses have been integrated in simple forms with no details

The temple was rebuilt using almost entirely original elements. Three broken columns were repaired with blocks of Pentelic marble following Klenze's guidelines. The new blocks were unfluted and a missing base was remade in marble. In the cella walls, some half-broken marble blocks were replaced with new ones in "Poros-stone". The temple was completed to the height of the architrave on the north and east sides, while on the south side part of the cella wall remained unfinished, and in the southwest corner a column was left short of the original height and without a capital. The site supervision was entrusted with E. Laurent, an architect from Dresden. (28)

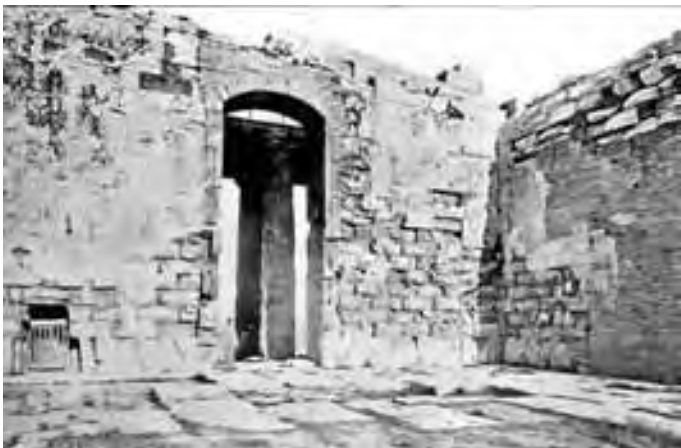
Figure 131. The Parthenon, the interior of the cella c. 1900, showing the 19th-century restoration in brick

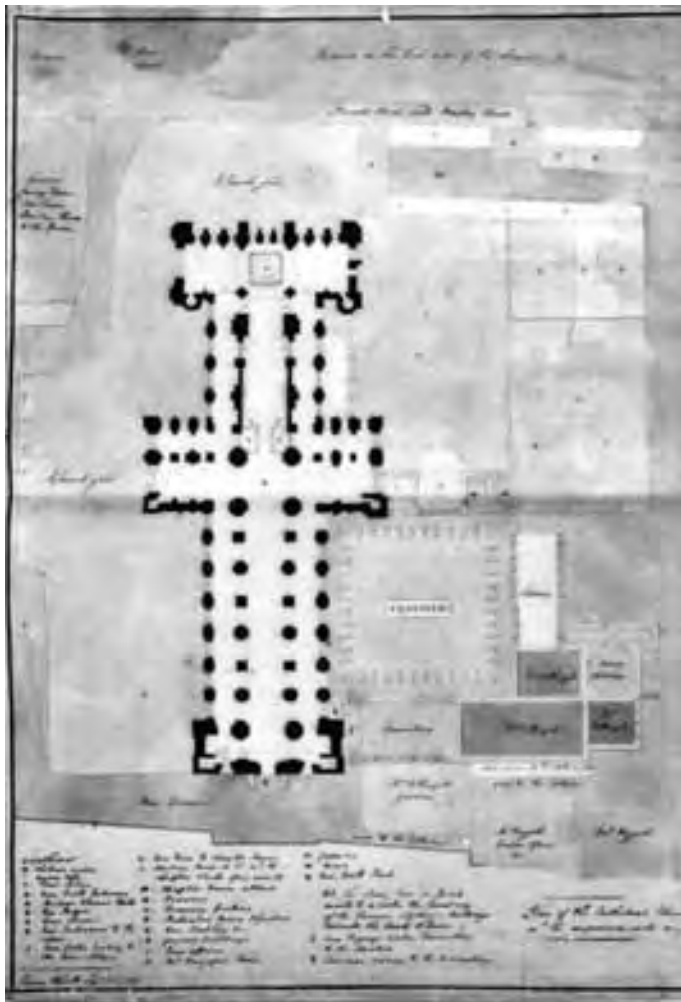
Figure 144. James Wyatt: the floor plan showing the proposed restoration of Durham Cathedral in 1795. The Galilee Chapel has been cancelled, and the main entrance opened from the west end; the main altar has been removed to the Chapel of Nine Altars

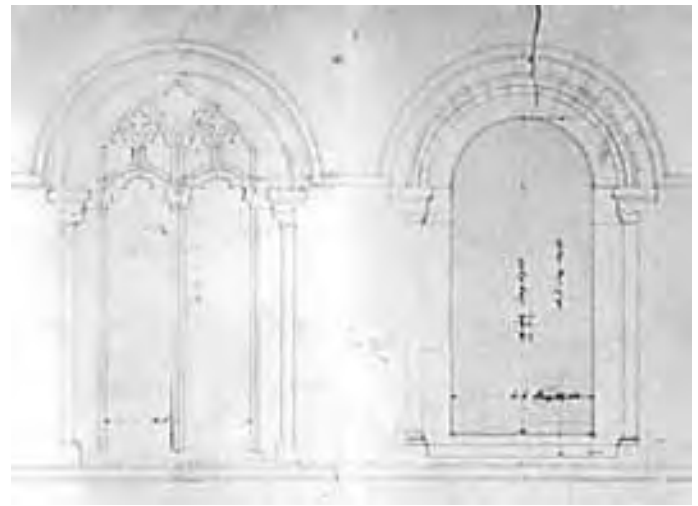
Figures 159-160. Pickering: north nave windows, existing state (left) and proposed restoration (right) 1847-48

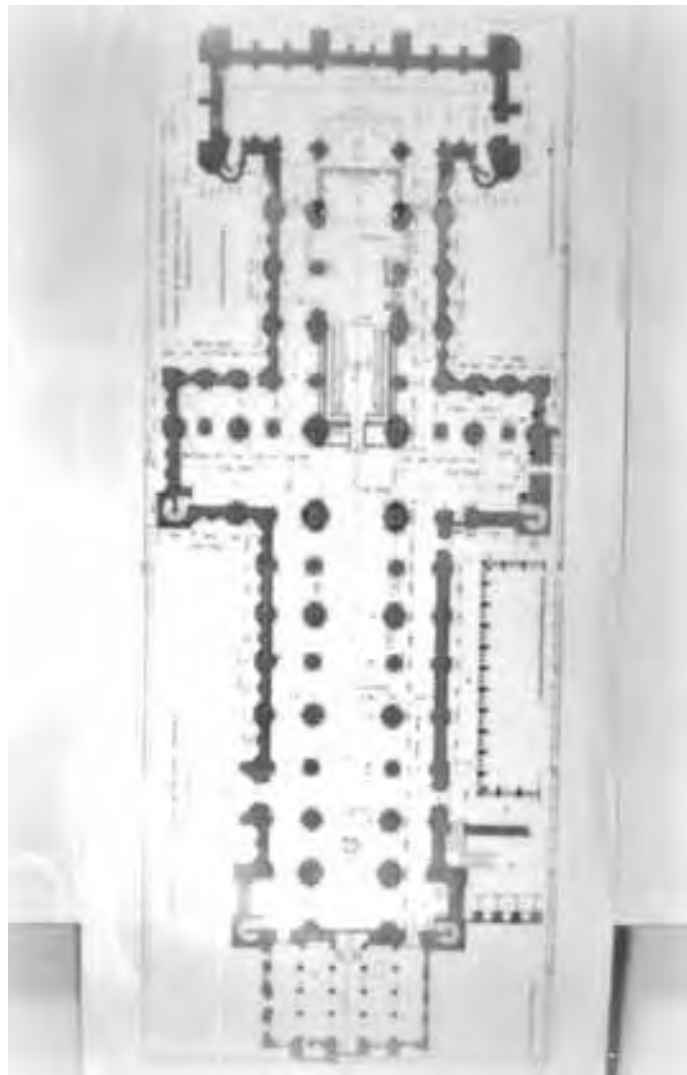
Figure 162. Durham Cathedral, floor plan in 1842
 Figure 163 (below left). South elevation showing windows before restoration and traces of aisle gables
 Figure 164 (right). Drawing for the reconstruction of gables

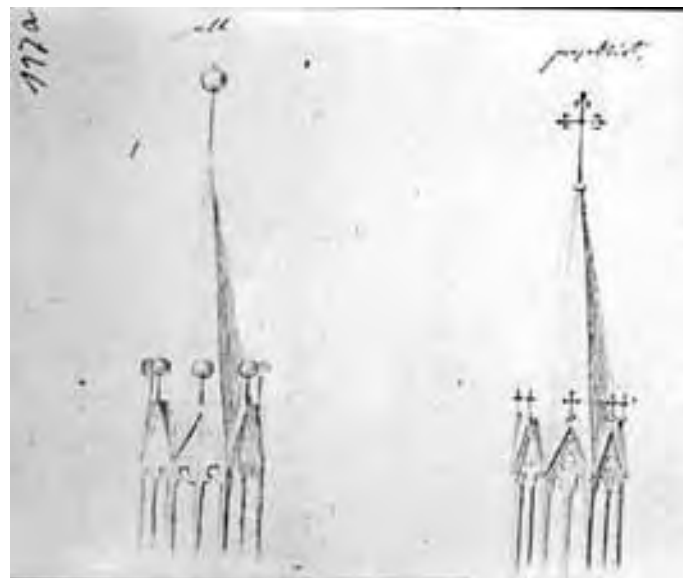
Figure 179. The Lead Tower, the old form and the proposed restoration (illustration in manuscript)

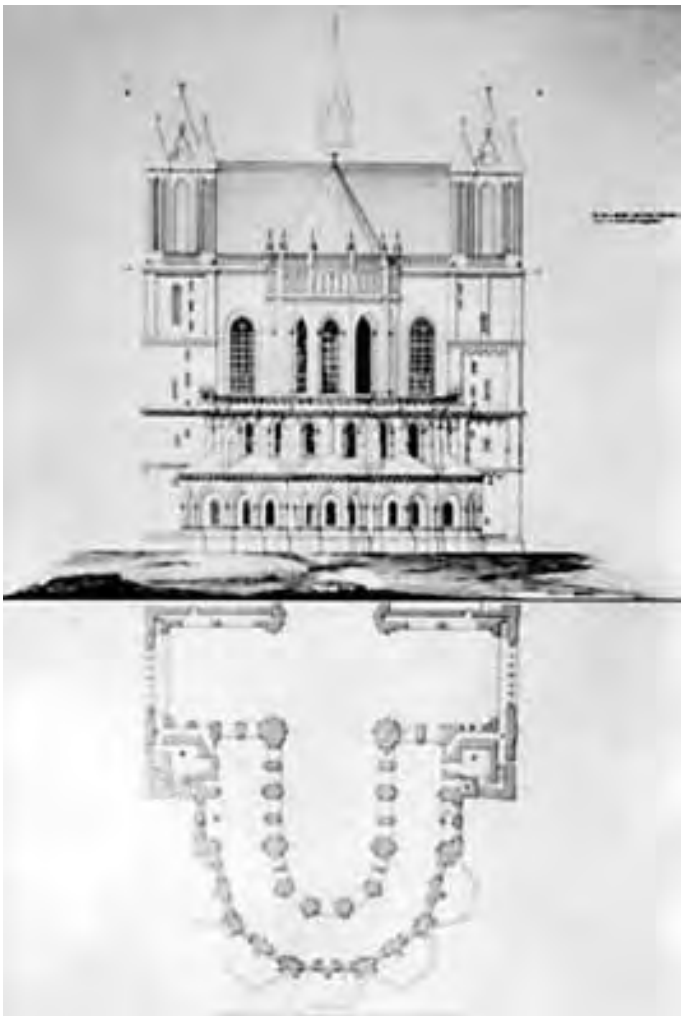
Figure 180. Clemens, Mellin, Rosenthal: Magdeburg Cathedral, east elevation, proposed restoration

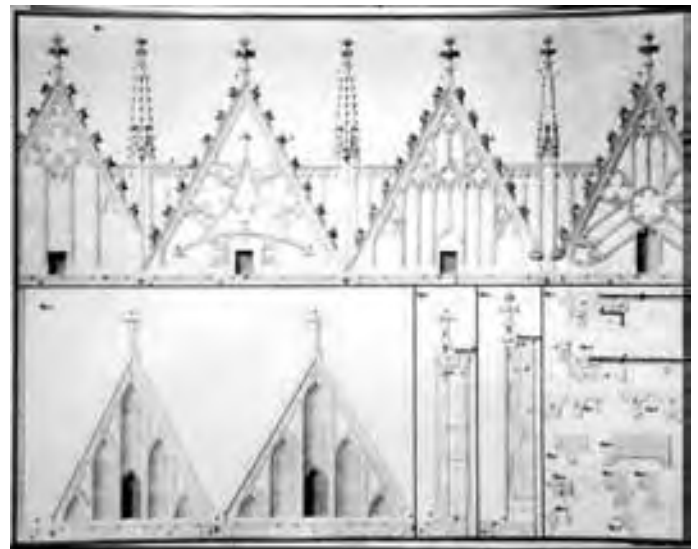
Figure 182. Clemens, Mellin, Rosenthal: Magdeburg Cathedral, proposed restoration of north and south aisle gables. Although north aisle gables were richly ornamented, the south aisle gables were proposed to be left with timber structures. In the restoration, these were proposed to be built in with masonry and brick in the spirit of the north aisle

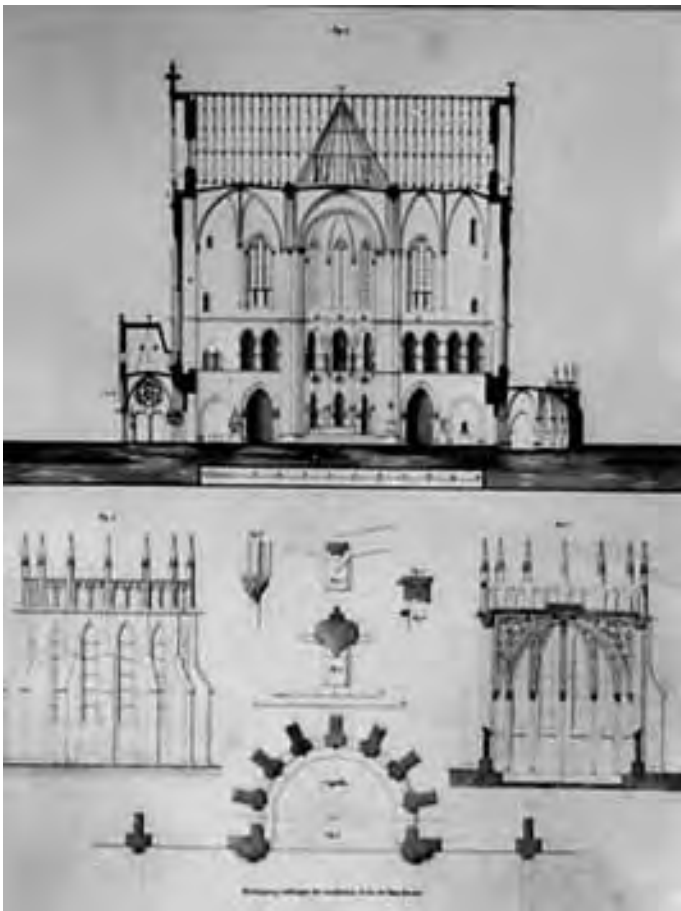
Figure 184. Clemens, Mellin, Rosenthal: Magdeburg Cathedral, proposed restoration of the choir

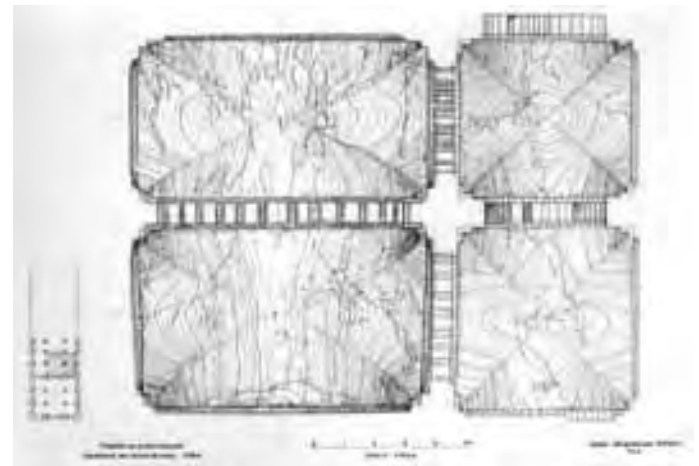
Figure 194. La Madeleine, photogrammetric recording of the vaults that were not rebuilt in 19th century, showing their deformed state
