# Shaking table test of a full scale stone masonry building with stiffened floor and roof diaphragms

Shaking table tests on three full-scale, two-storey prototype buildings in undressed double-leaf stone masonry were performed as part of the extensive experimental program carried out at EUCENTRE, for the evaluation and reduction of the seismic vulnerability of stone masonry structures. The three buildings were designed with the same geometrical configuration and construction materials but the last two were strengthened to improve the connections of floor and roof diaphragms with walls and to achieve different levels of in-plane diaphragm stiffness by using traditional and innovative solutions. The paper concentrates on the third building tested and, in particular, it describes the characteristics of the strengthening interventions and presents the results obtained during the dynamic tests, illustrating the response of the structure, the damage mechanism and its evolution during the tests.

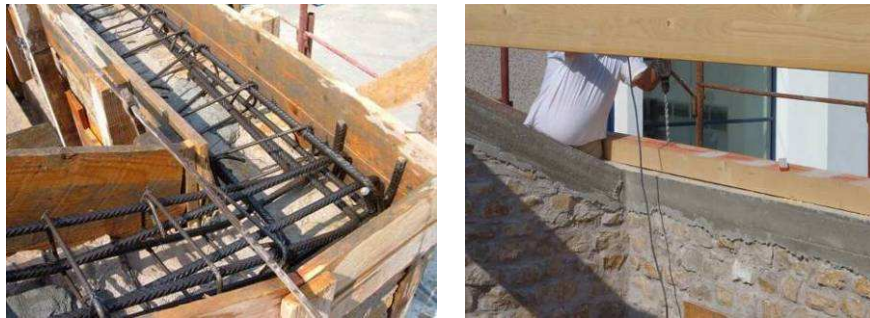
**Figure 2.** Detail of the reinforcement of the joint at the base of the gable wall (left). Operation of drilling the timber spreader beam and the concrete ring beam (right)

Simulating an intervention where the roof structure can be temporarily removed, a reinforced concrete ring beam, 20 cm high and 32 cm wide (as the wall below), was cast at the roof level, on top of the perimeter façades (Fig. 2, left). The reinforcement consisted in 4 $\phi$ 16 longitudinal bars and  $\phi$ 8 stirrups at a spacing of 20 cm, coherently with the prescriptions of the Italian Building Code (NTC08, 2008).

The strengthening of the roof envisaged the improvement of the connection of the ridge beam with the gable walls, which consisted of a steel shoe doweled to the concrete ring beam and bolted to the ridge beam. Timber spreader beams were also doweled to the r.c. ring beam all along the perimeter, by means of connecting steel bars chemically anchored by epoxy resin. Any discontinuity between the timber spreader beam and the ring beam was smoothed by the insertion of a plaster layer to create a continuous contact. The 8 cm x 12 cm joists were reshaped to create a horizontal seat on the ridge beam and on the longitudinal spreader beams. Steel connecting elements were inserted at the top of the ridge beam, at the contact between the two opposite purlins. The matchboard was then placed on top of the timber structure.

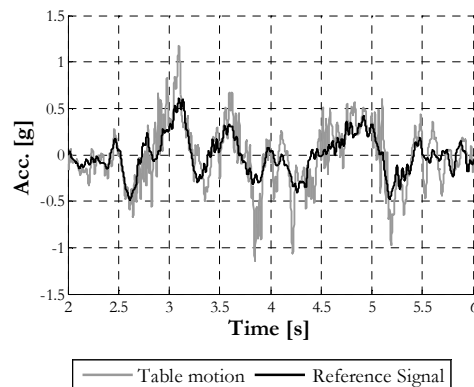
**Figure 6.** Acceleration time histories of the shaking table input during the test at nominal PGA of 0.60g.

As an example, in Fig. 6 the acceleration time history of the input signal of the test at nominal PGA of 0.60g is compared with the reference Montenegro acceleration record scaled at the same nominal PGA: the acceleration input is evidently distorted by amplification of the high frequency components of the signal.

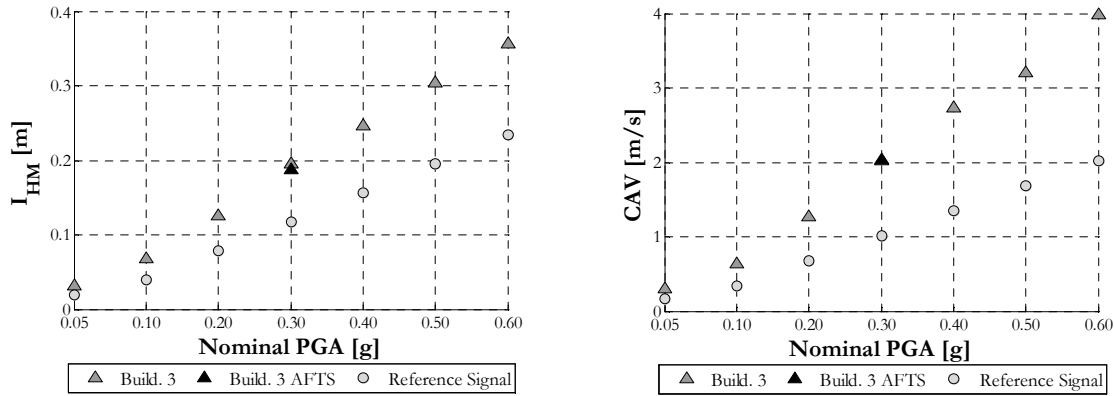
**Figure 8.** Plot of Spectral Intensity versus nominal PGA (left) and Cumulative Absolute Velocity versus nominal PGA (right)

As evident from Fig. 8, the third building was subjected to a much higher intensity of shaking in comparison to the reference Montenegro ground motion signal, with values that are almost 40% larger than the expected ones in terms of  $I_{HM}$  and approximately 50% larger in terms of  $CAV$ .
