# Fauna Baseline Study

*Agri-Food Innovation Park, Kranji Road, Singapore*

20434030-R003-Rev7

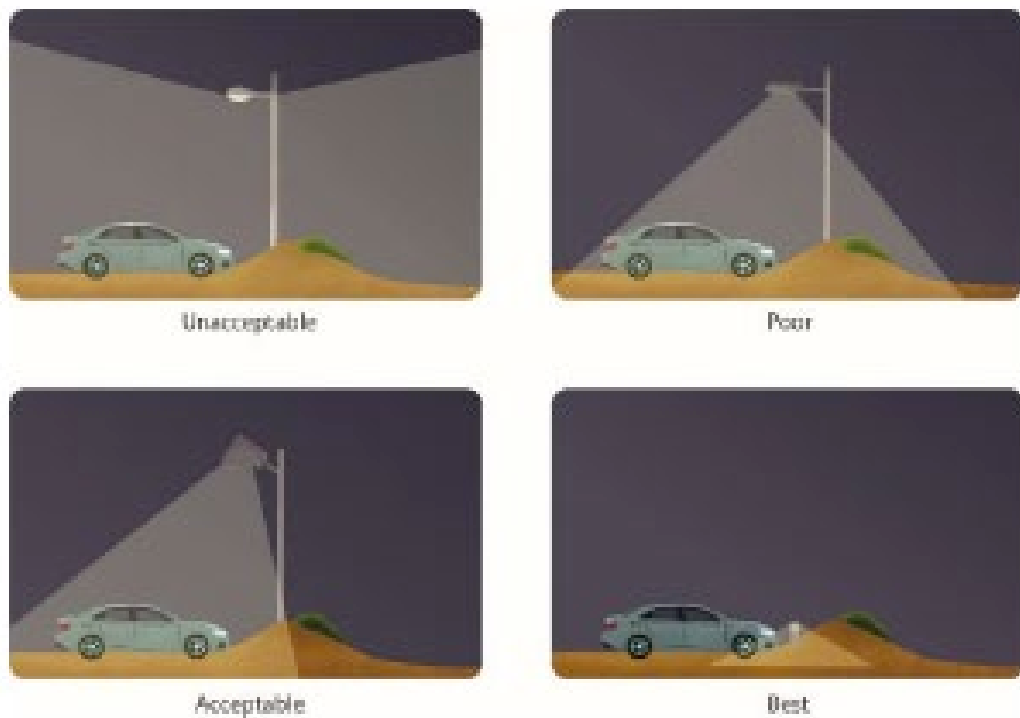
**Figure 46: Lighting options for a parking lot. Reproduced from source: Pendoley et al. (2020) adapted from Withering and Martin (2003)**

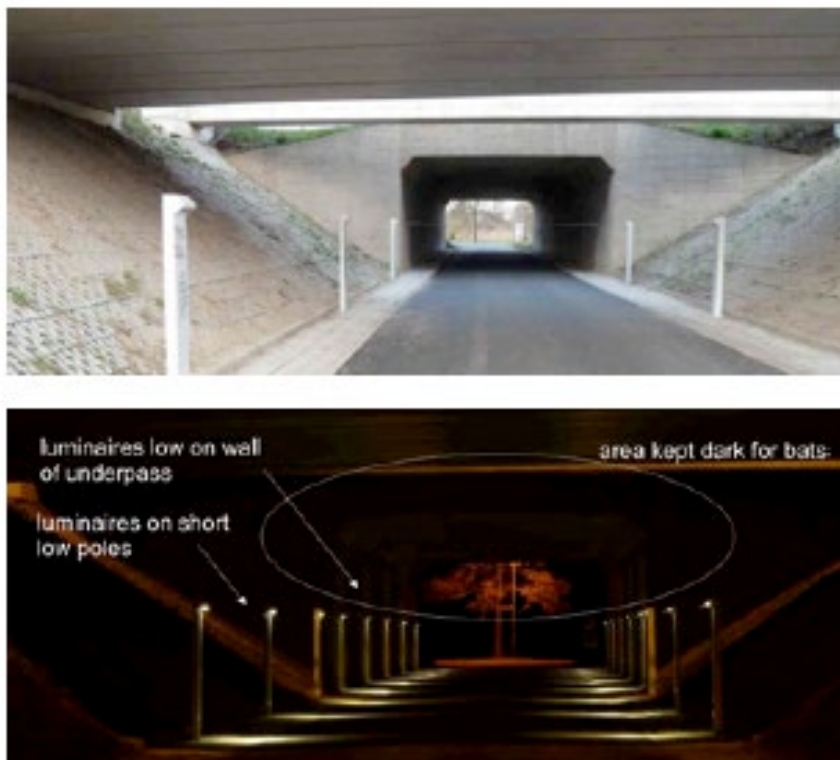
**Figure 50: Installation of luminaires on short poles to reduce artificial light at night on a commuting route for bats through an underpass in the Netherlands (the same place in daylight and at night). Source: Voigt et al. (2018); photograph by F. Brekelmans**

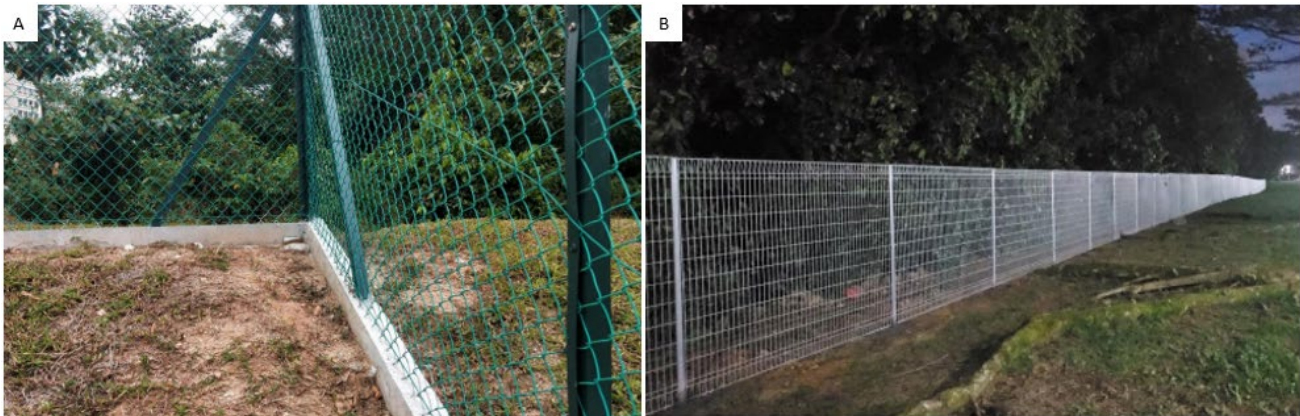
**Figure 55: (A) Fences with cement base to prevent animals from burrowing through them; (B) BRC or weldfences along a vegetated area at Pasir Ris Park**

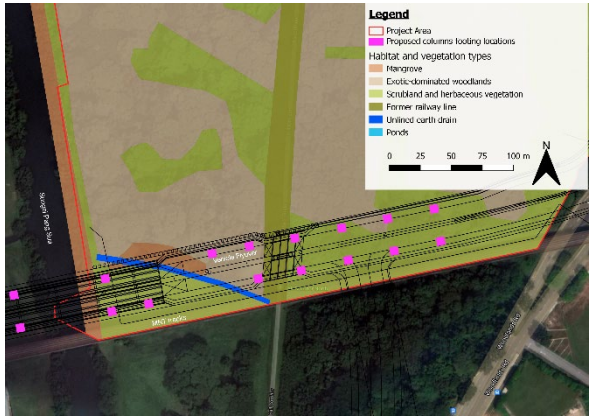
<p><b>Figure G-1. Proposed columns footing locations to support vehicle flyover</b></p>

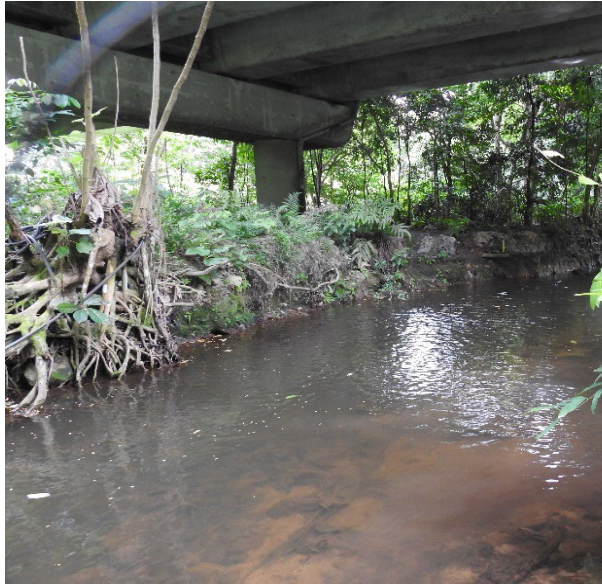
<p><b>Figure G-2. Example for usage of columns to support vehicle flyover (Seletar Expressway) to avoid unlined earth drain at Springleaf</b></p>	<p>These recommendations are out of JTC's current Project scope and boundary. Recommendation is subject to discussion by the developer with the relevant agencies.</p>
