Marine biological and water quality surveys at Hawai'i Kai Marina, Hawai'i Kai, O'ahu

AECOS, Inc.

April 24, 2015

AECOS No. 1150C

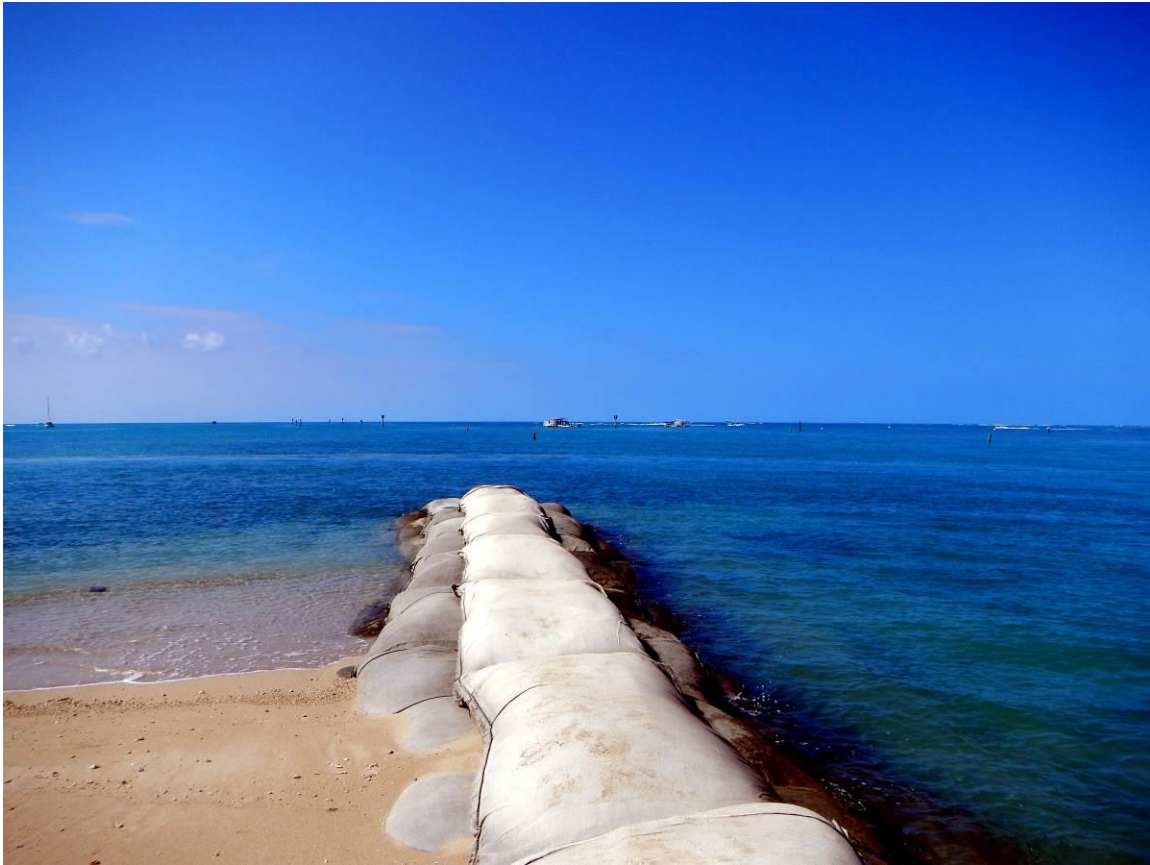
The Hawai'i Kai Marina Community Association proposes to replace an existing sand bag groin (see title page photo) outside the marina entrance channel in Hawai'i Kai along the south shore of O'ahu, Hawai'i (See Figure 1). AECOS was contracted to conduct environmental surveys to support permitting for the project ("Project")¹. Our surveys were conducted on March 17, 2015 and included both water quality sampling and biological surveys on the groin and surrounding area. This report details findings of those surveys.

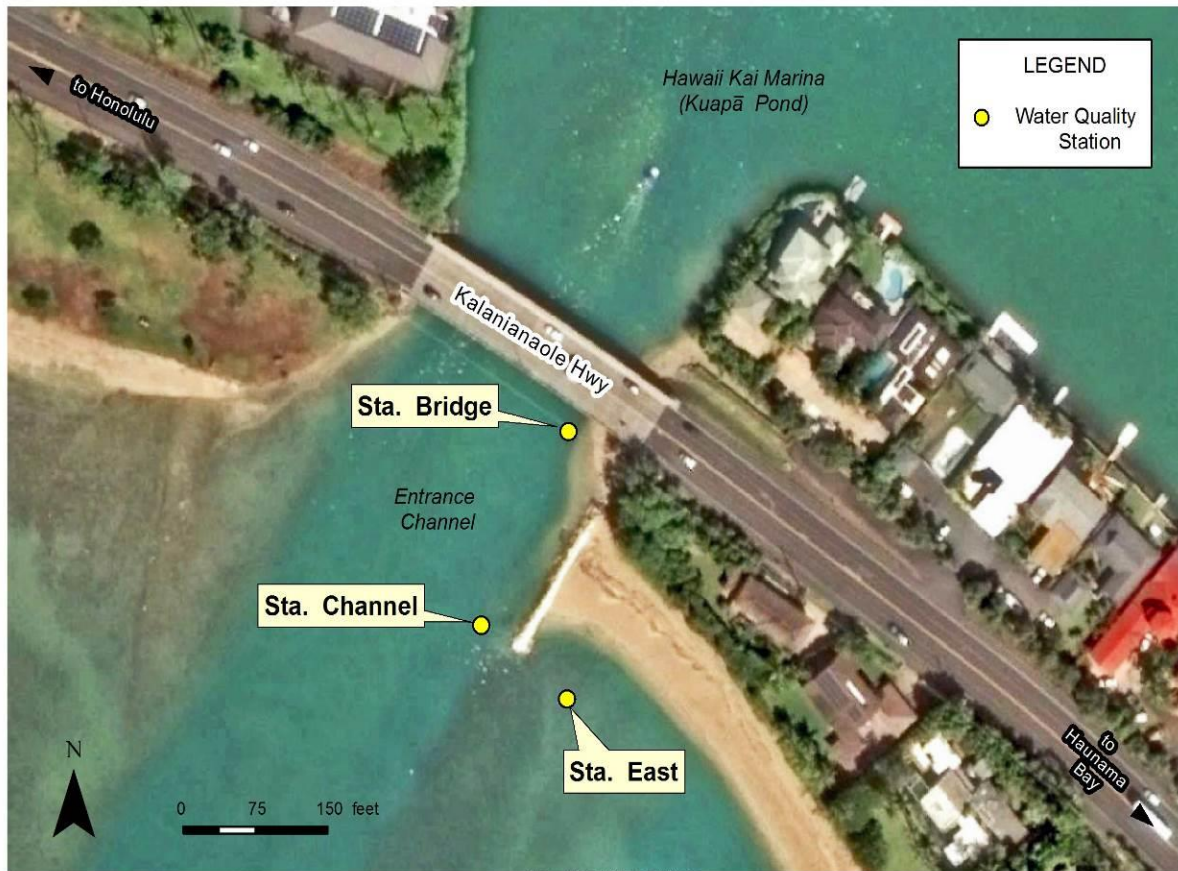
Water quality samples were collected on March 13, 2015 from just below the water surface at three stations in the Project area; these locations are depicted in Figure 2. Station "Bridge" was just south of the Kalaniana'ole Highway bridge, approximately 1 m (3 ft) off the shore. Station "Channel" was located in the entrance channel, approximately 3 m (9.8 ft) west from the groin. Station "East" was located approximately 5 m (16 ft) east of the groin fronting Portlock Beach.

Figure 2. Location of water quality stations sampled on March 17, 2015.

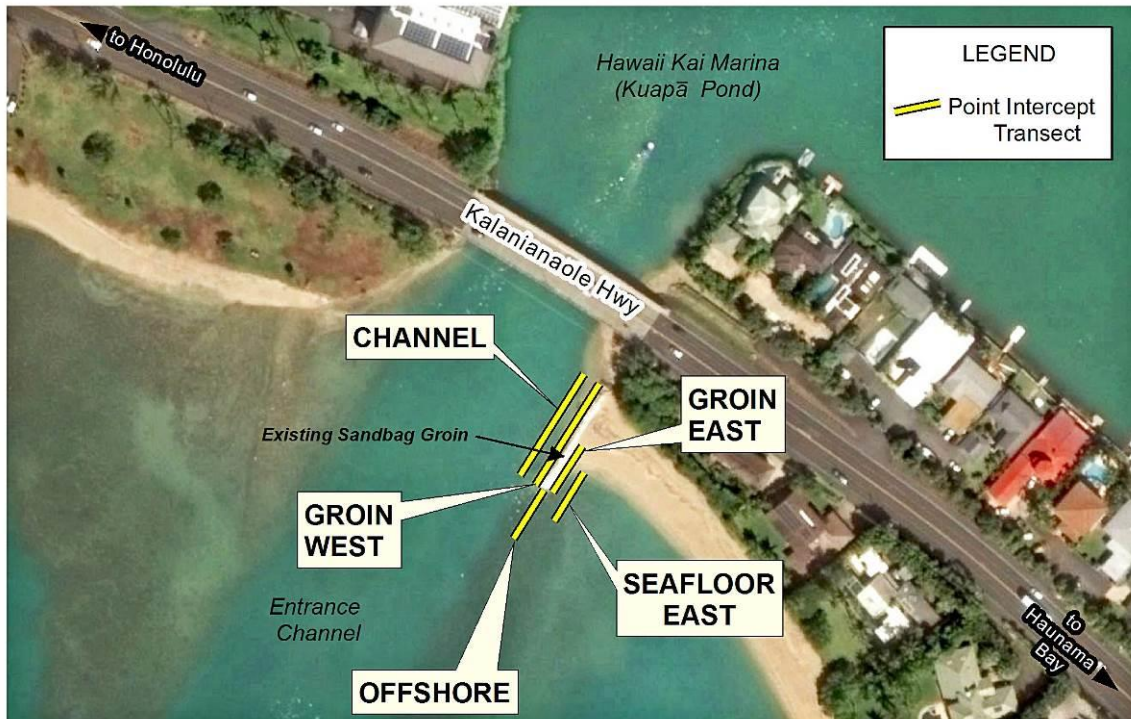
On March 17, AECOS biologists conducted a rapid assessment and quantitative survey of the marine community composition in the Project vicinity. The survey area included the existing sand bag groin, and the seafloor adjacent to either side of the groin and seaward from the groin structure (see Figure 3).

Figure 3. Approximate locations of March 2015 Hawai'i Kai Marina biological transect locations.

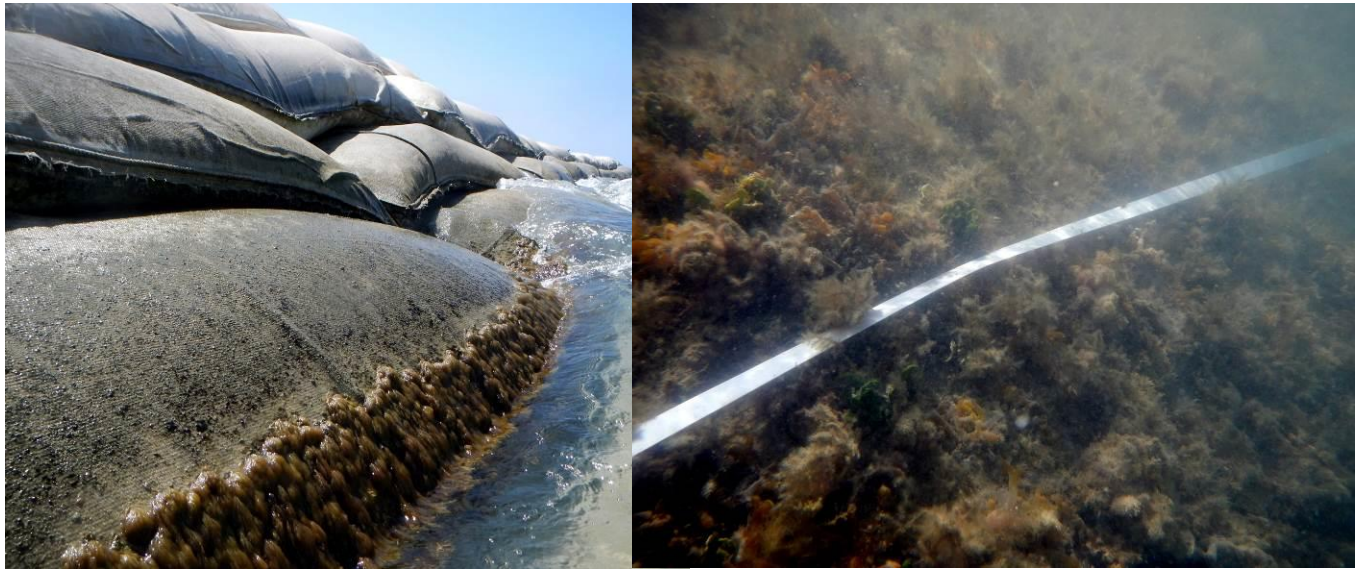
Groin — The intertidal zone of the existing sand groin is covered with macroalgae (*Spyridia filamentosa*, *Gracilaria salicornia*, *Griffithsia heteromorpha*, *Halimeda* sp.) and low-growing turf algae. Other, less frequently observed, algal species include: *Acanthophora spicifera*, *Asparagopsis taxiformis*, *Hypnea cervicornis*, *H. musciformis*, *Avranivillea amadelpa*, *Cladophora socialis*, *Chaetomorpha antennina*, and *Padina* sp. Invertebrates are not common on the groin; those observed include a hydroid (*Pennaria disticha*), bryozoans (*Schizoporella errata* and *Reteporellina denticulate*), molluscs (*Hipponix imbricatus*, *Dendostrea sandwichensis*, *Isognomon perna*), and a barnacle (*Euraphia hembeli*). A few juvenile mullets (*Mugil cephalus*) were observed on the west side of the groin, towards the entrance channel and bridge. Submerged stacked sand bags, with macroalgae and cyanobacteria, lie along the base of the west side of the groin (Fig. 4). Much of the east side of sand bag groin is uncolonized or coated with cyanobacteria and black tuft seaweed (*Sphacelaria* spp.). No corals were observed growing on the groin.

Figure 4. The intertidal zone on the sand bag groin is coated in macroalgae (left photo) that extends as macroalgal and cyanobacterial growth along the base of the west side of the groin (right photo).

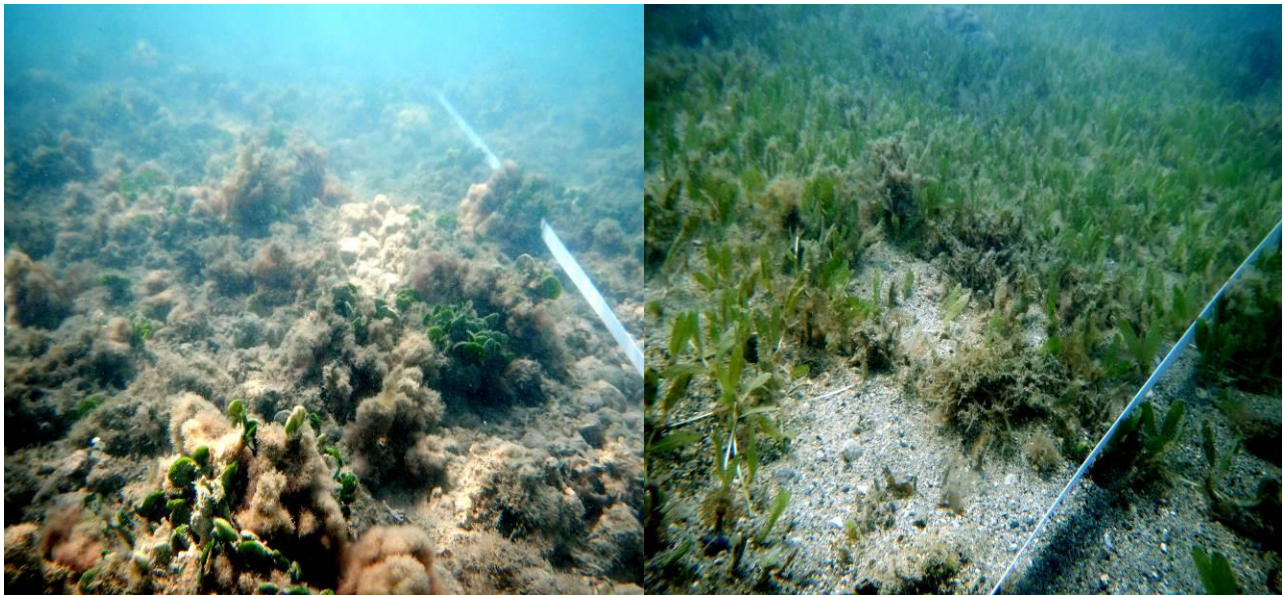
Seafloor beyond groin — The seafloor surrounding the groin is a relatively flat bottom of sand with patches of limestone and rubble. A large area of sand lies to the southeast of the groin, fronting Portlock beach. The reef platform seaward of the groin is coated with turf and macroalgae. Algal species observed in this area include: *G. salicornia*, *A. spicifera*, *Halimeda discoidea*, *H. opuntia*,

Few invertebrates occur on the bottom to either side of the groin and on the reef flat offshore of the groin. The invertebrates encountered include: sponges (*Iotrochota protea* and *Sigmoadocia* sp.), blue octocoral (*Sarcothelia edmondsoni*), annelid worms (*Sabellastarte spectabilis*, *Loimia medusa*, and *Salmacina dysteri*), hermit crab (*Diogenidae* sp.), and sea cucumber (*Eupata godeffroyi*). One frogfish (*Antennarius commerson*) was observed on the reef flat seaward of the groin. Figure 5 displays representative photos of the bottom in the survey area.

Figure 5. The area seaward of the groin is a relatively flat bottom of sand and patches of limestone and rubble with macroalgal cover (left photo). A bed of seagrasses (*Halophlia decipens* and *H. hawaiiiana*) occurs west of the groin (right photo).

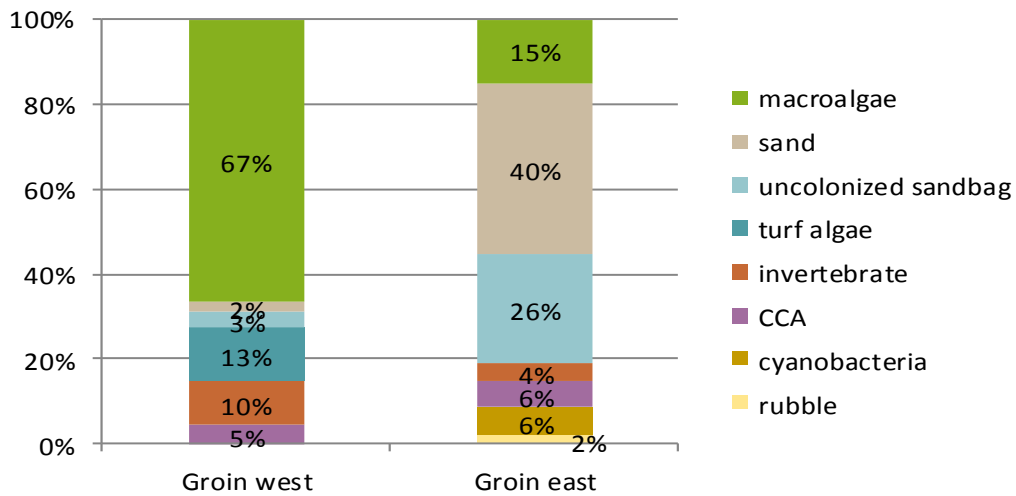
Groin — Data collected from two transects on the groin were used to calculate benthic community composition (Figure 6). The dominant benthic type on the groin is macroalgae (41% mean cover) and sand (21% mean cover). Bare sandbag (as “uncolonized sandbag”) mean cover is 14%, and turf algae mean cover is 13%. Invertebrate, cyanobacteria, and CCA cover are similar, at 7%, 6% and 5% cover, respectively. Rubble is minimal, at 2% mean cover. Coral cover here was zero.

Figure 6. Mean percent benthic cover for groin, as measured using point-intercepts on two transects: one 43-m on the west side of the groin and one 23-m transect on the east side of the groin.

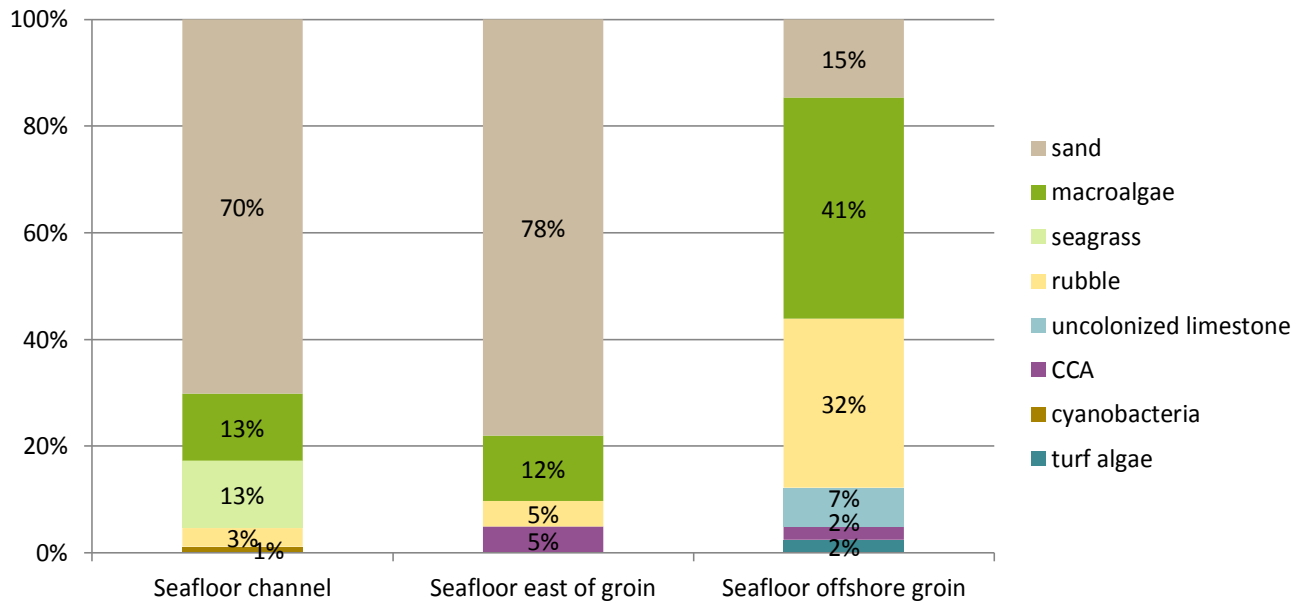
Seafloor surrounding groin — Data obtained from three transects laid on the seafloor surrounding the groin were used to calculate benthic community composition near the groin structure (Figure 7). The dominant benthic type on the seafloor is sand (54% mean cover), macroalgae and seagrass (each 13% mean cover). Rubble mean cover is 13% and bare limestone (as “uncolonized limestone”) mean cover is 7%. CCA, turf, and cyanobacteria mean cover are minimal, at 4%, 2%, and 1%, respectively. Macroinvertebrate and coral cover are zero.

Figure 7. Mean percent benthic cover on reef surrounding groin as measured using point-intercepts on three transects surrounding the groin: one 43-m transect parallel to the west side of the groin, one 20-m transect off the east side of the groin, and one 20-m transect across the bottom, extending offshore of the groin.
