Monitoring Survey at the Rhode Island Sound Disposal Site  
July 2005

# Disposal Area Monitoring System DAMOS

Contribution 176  
July 2007

Report No.  
ENSR-9000-417-320

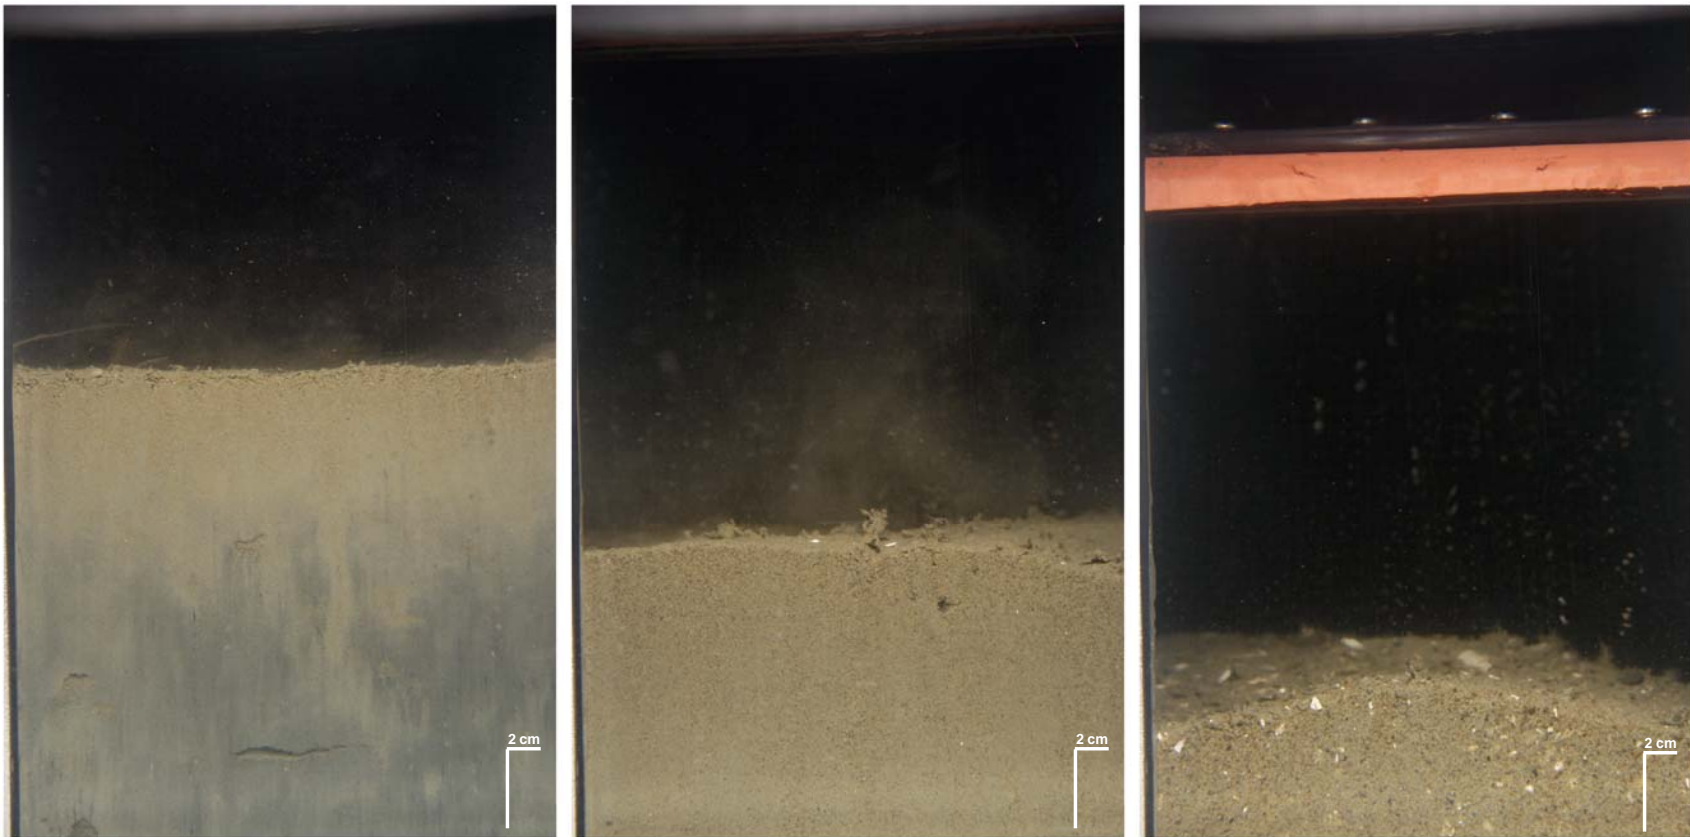
**Figure 3-2.** SPI images from three reference areas illustrate the sediment grain-size major mode in each area as well as the varying percentage of silt. Arranged from left to right in order of highest to lowest silt content: Station REF-E-01 (left), Station REF-SW-03 (middle), and Station REF-NE-03 (right).

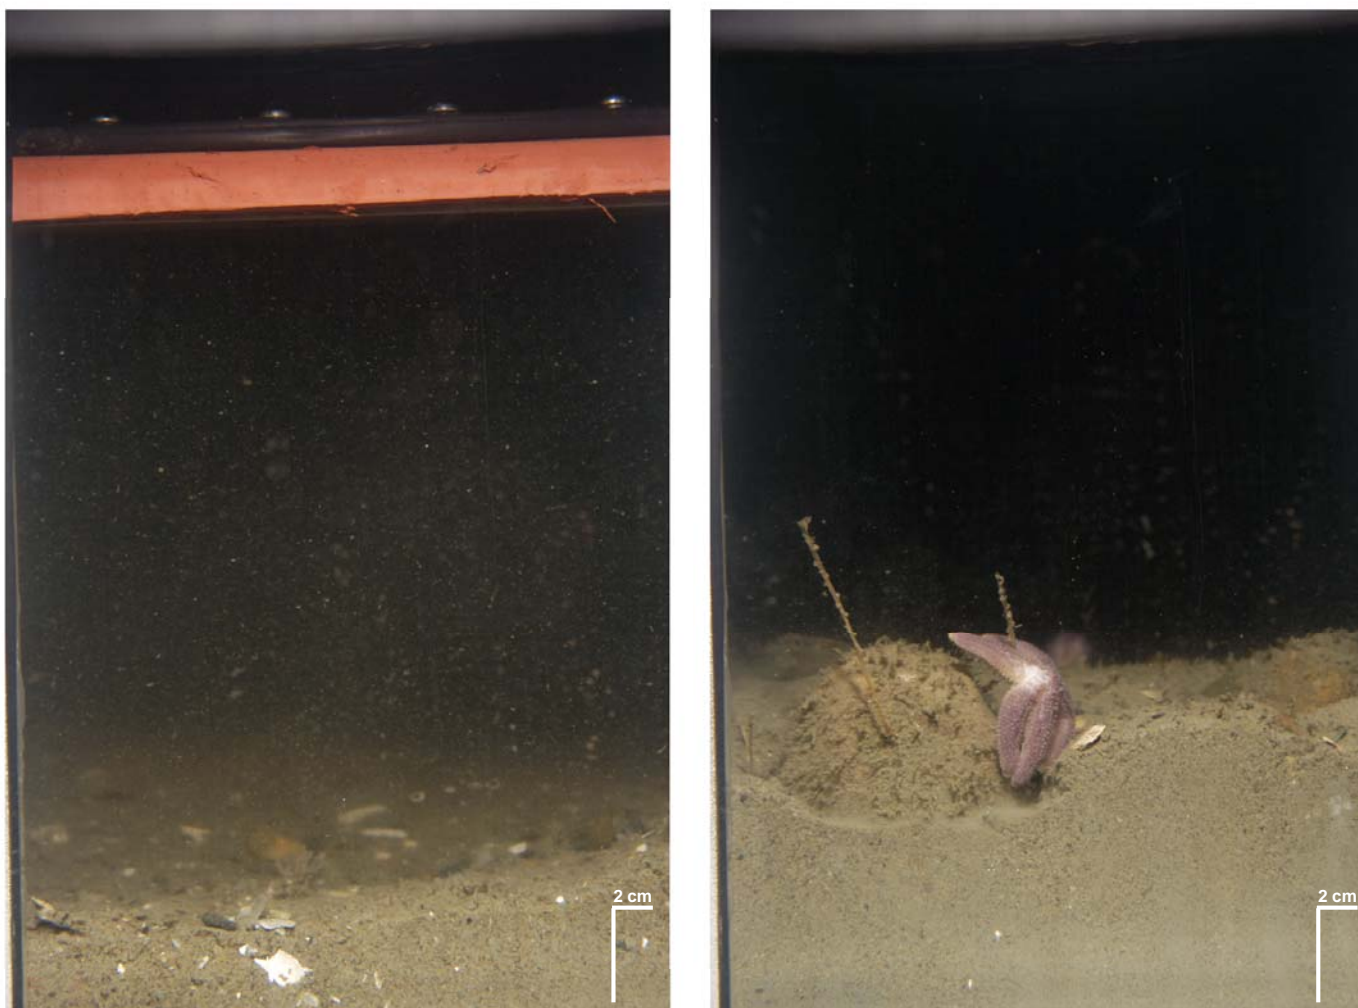
**Figure 3-3.** SPI images from Station REF-NE-03 (left) and Station REF-NE-04 (right) show shell hash and small rocks on the surface of the sandy bottom, which limited camera prism penetration.

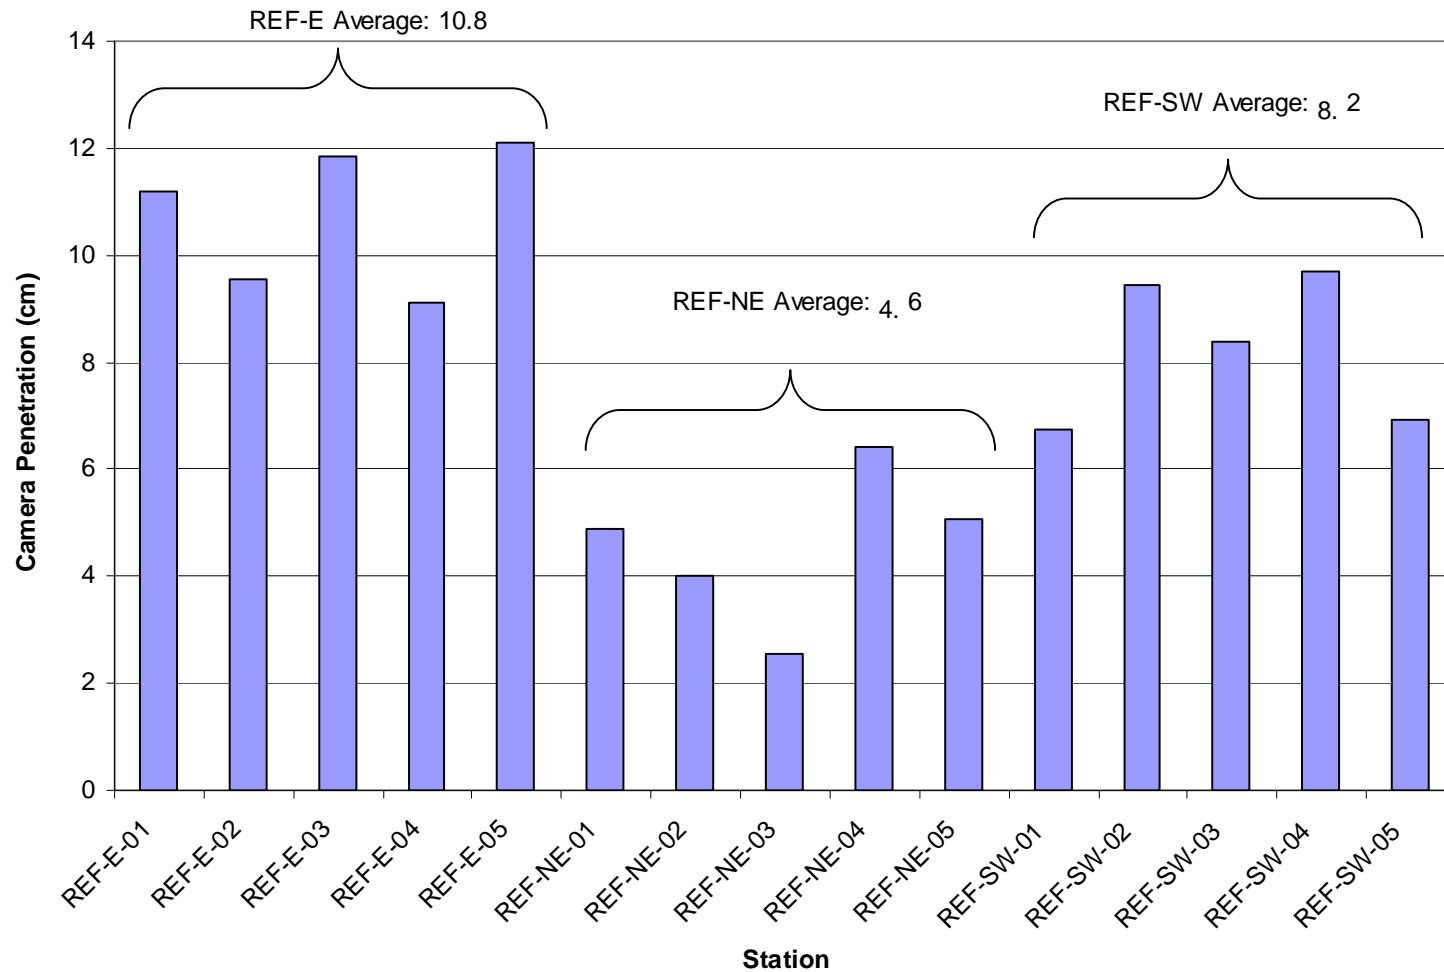
**Figure 3-4.** Distribution of station-averaged prism penetration values at the three RISDS reference areas, July 2005. Weights and camera penetration depths remained constant for all stations.

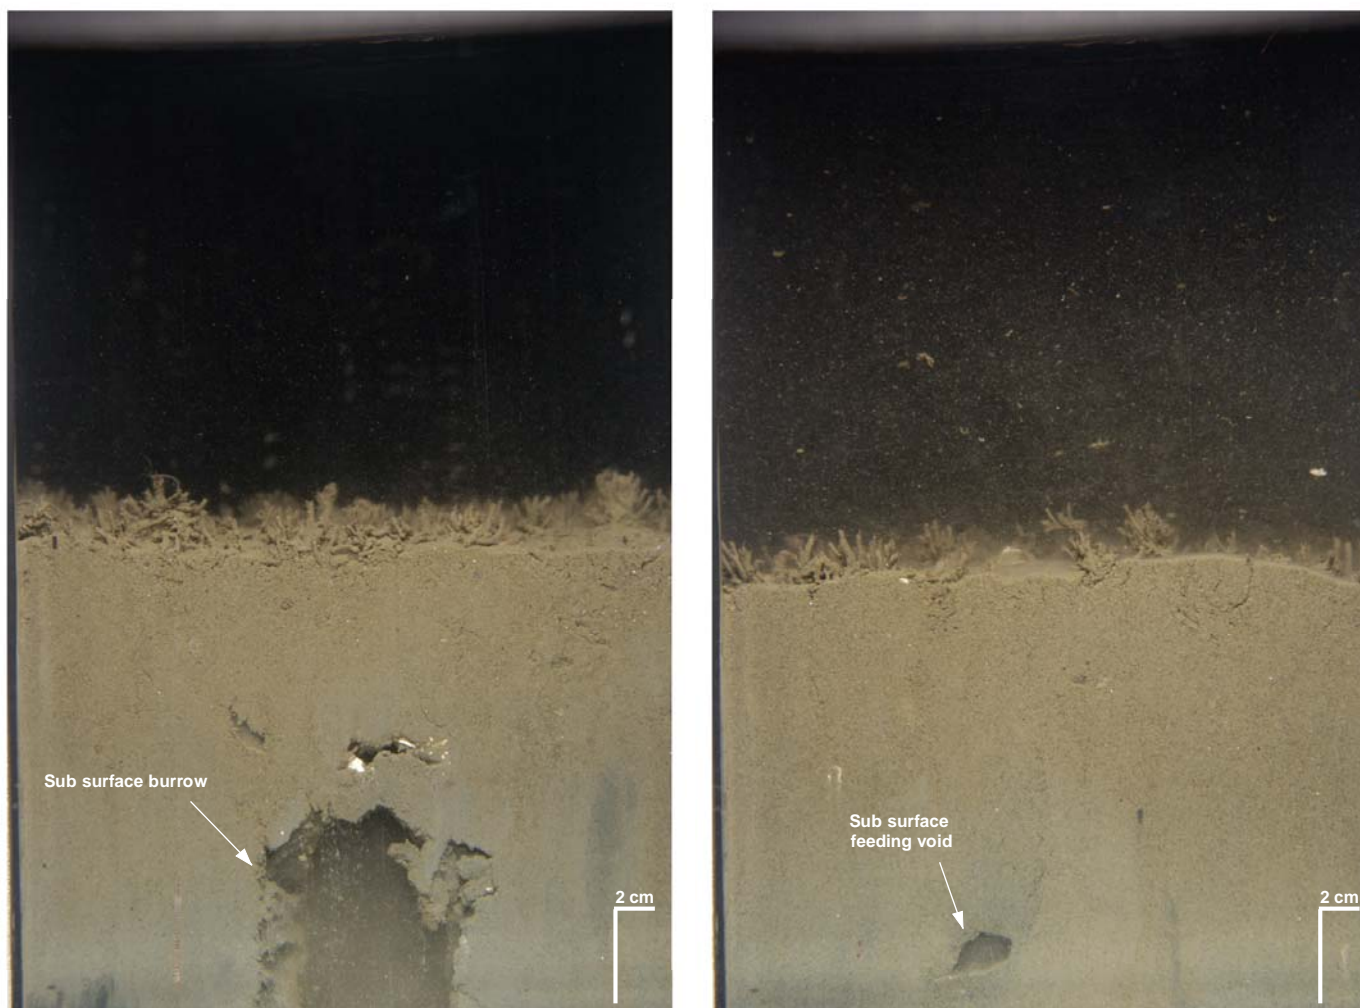
**Figure 3-7.** Large sub-surface burrow transected in the SPI image from Station REF-SW-04 (left) and the sub-surface feeding void at Station REF-SW-02 (right), indicative of the presence of Stage III taxa.

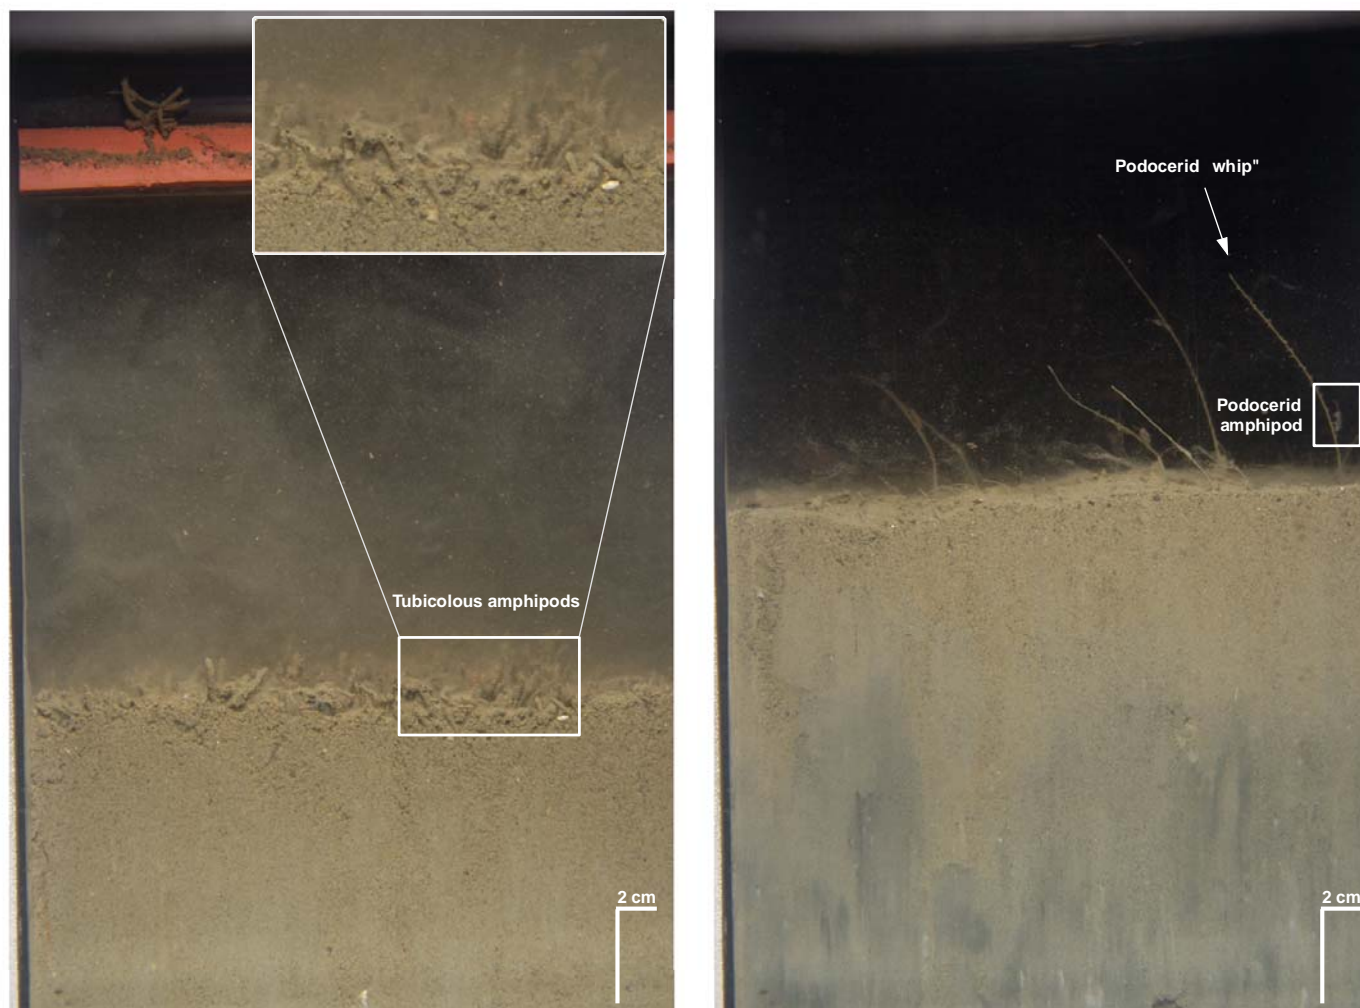
**Figure 3-8.** SPI images from Station REF-NE-02 (left) and Station REF-E-03 (right) showing dense assemblages of tubicolous and podocericid amphipods on the seafloor outside the disposal site.

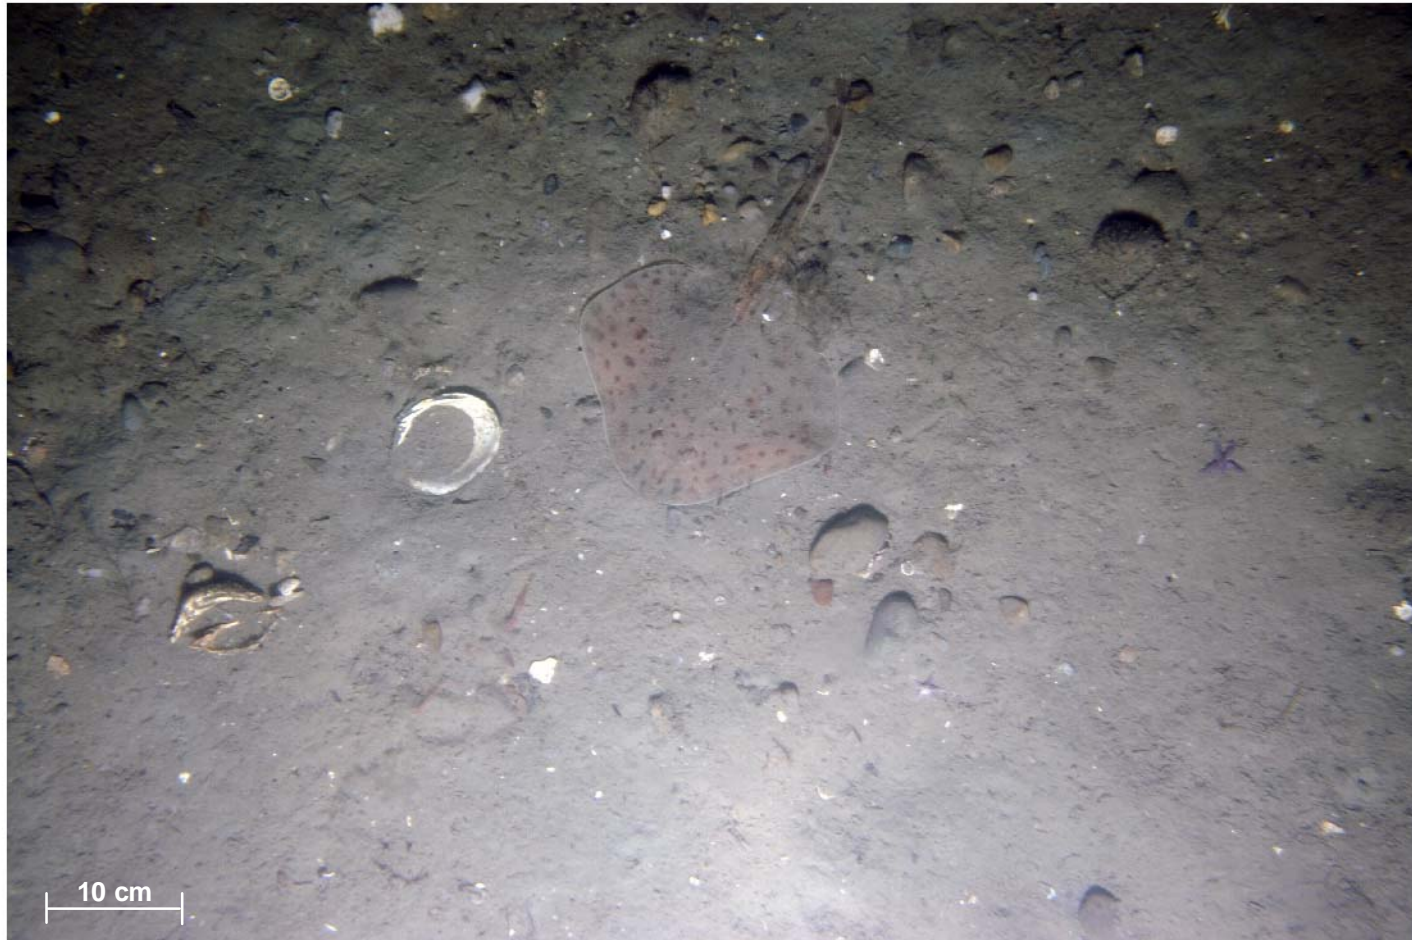
**Figure 3-9.** Plan view image from Station REF-NE-04 shows a skate resting on this poorly-sorted, silty sand bottom.

The presence of coarse sediment (Figure 3-9) and Stage III infauna (Figures 3-10 through 3-12), as detected in the sediment-profile images, was confirmed in the corresponding plan view images from the reference areas. Tubicolous assemblages of *Ampelisca agassizi* (Figure 3-10), cerianthid anemones (Figure 3-11), and podocerid amphipods (Figure 3-12) were also observed at stations across all three reference areas. Individual crab and shrimp were seen on the sediment surface at a handful of locations in the reference areas (Appendix B).

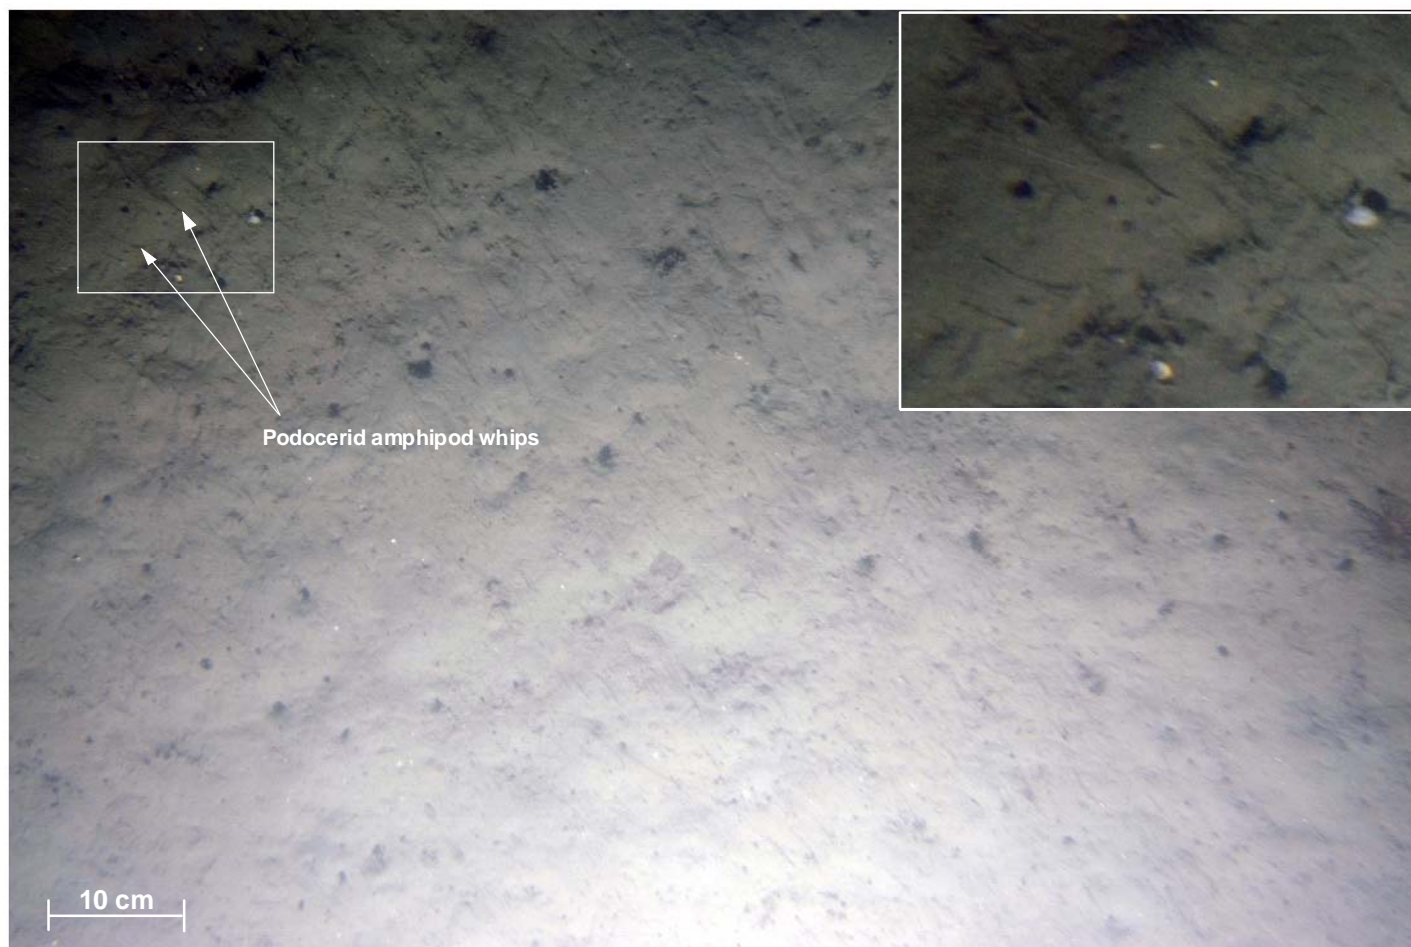
**Figure 3-12.** The patches of the proteinaceous whips of podoceric amphipods can be seen bent over in the bottom currents at Station REF-E-03.

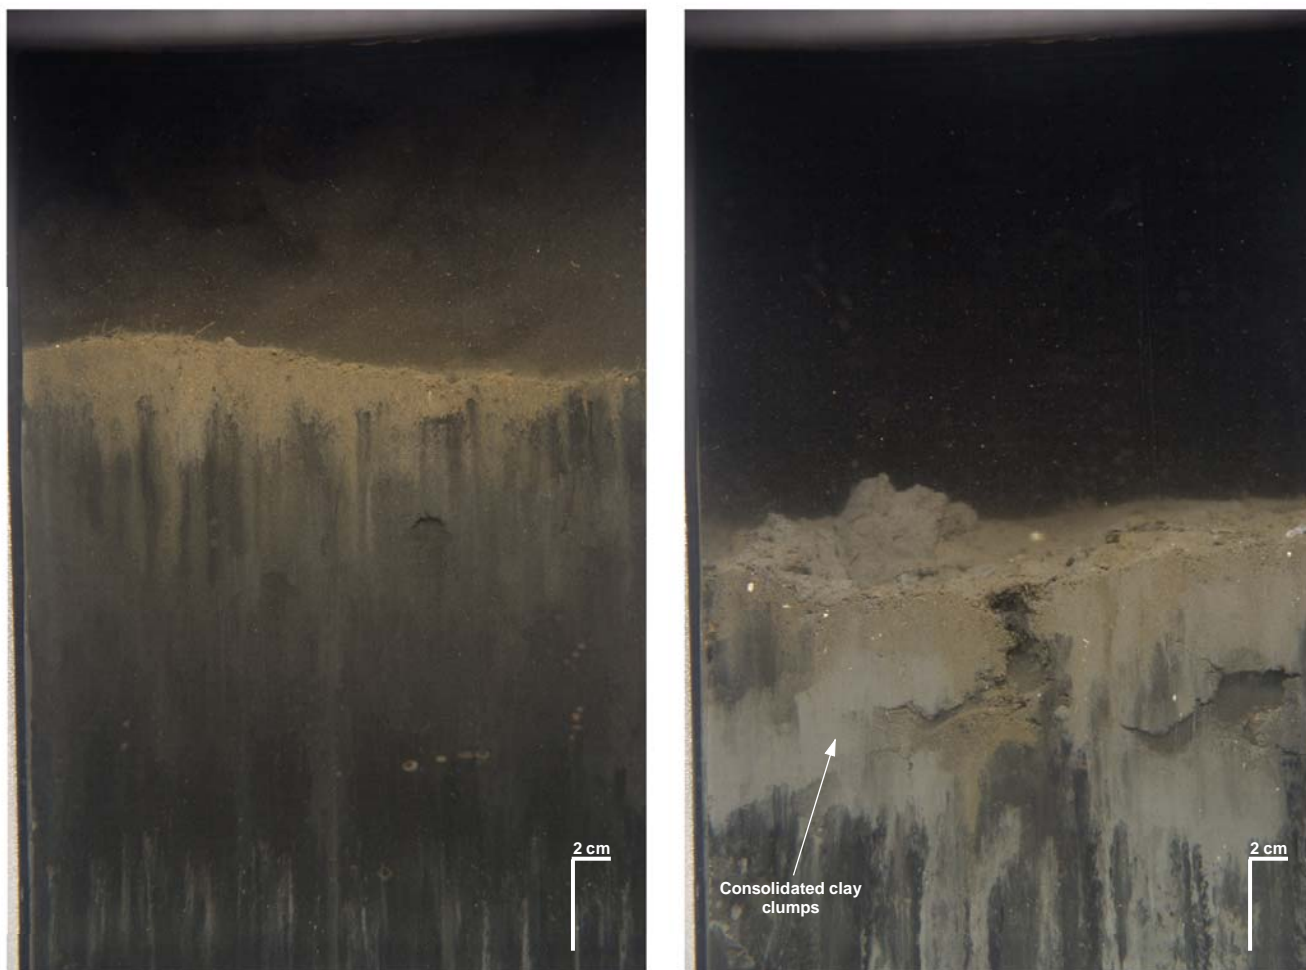
**Figure 3-17.** SPI images from Station B-03 (left) and Station A-04 (right) show the reduced silt-clay sediments found at the majority of the stations within the site; note the lighter-colored consolidated clay clumps included in the sedimentary fabric in the image on the right.

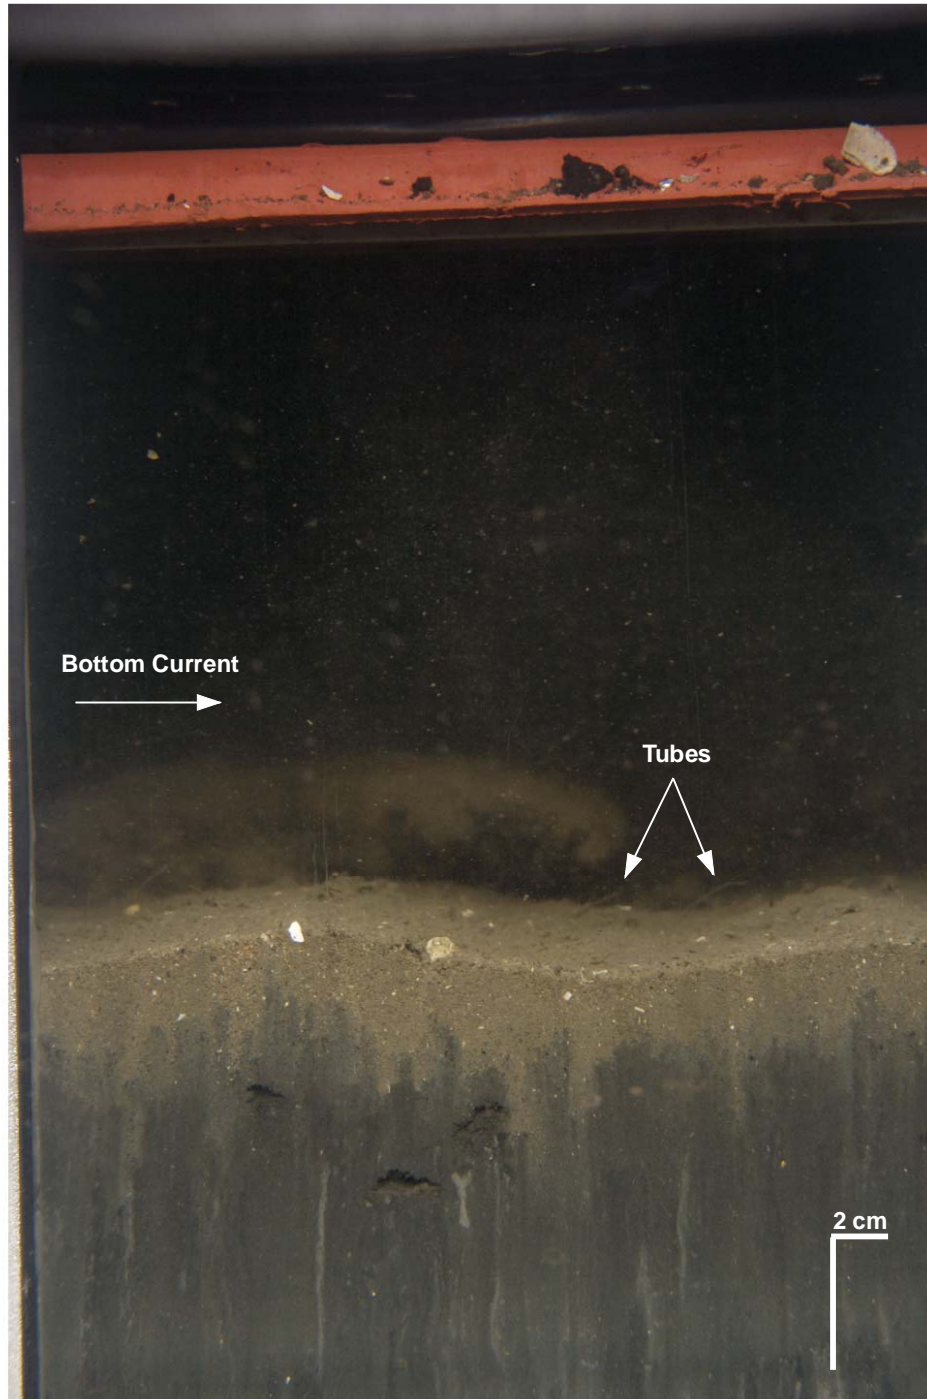
**Figure 3-18.** SPI image from Station A-01 showing a surface layer of very fine sand at the sediment water interface; note the small-scale ripples and bent tubes in the background indicating the direction of the bottom currents.

Three stations had a sediment grain-size major mode that was noticeably different than that found at the other stations surveyed (Table 3-5, Figure 3-16). Stations A-01 and E-04 had thin surface layers of very fine sand over the muds (Figure 3-18) and Station BE-03 on the western berm formation was covered with a layer of small rocks and cobble on the sediment surface (Figure 3-19).

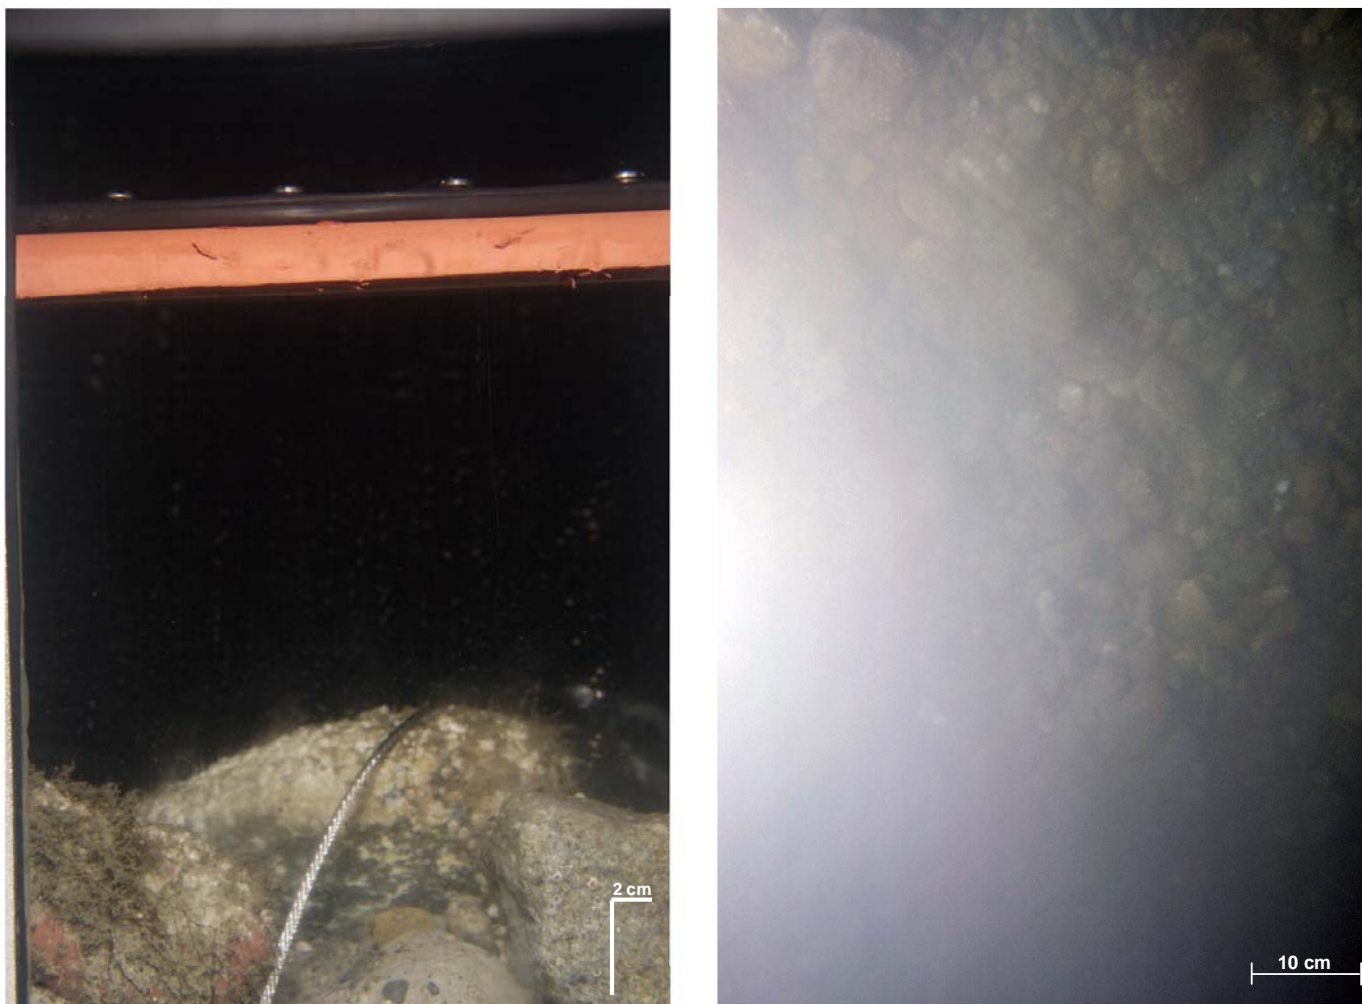
**Figure 3-19.** SPI and plan view images from Station BE-03 showing the sediment surface covered with small rocks and cobble from disposal operations.

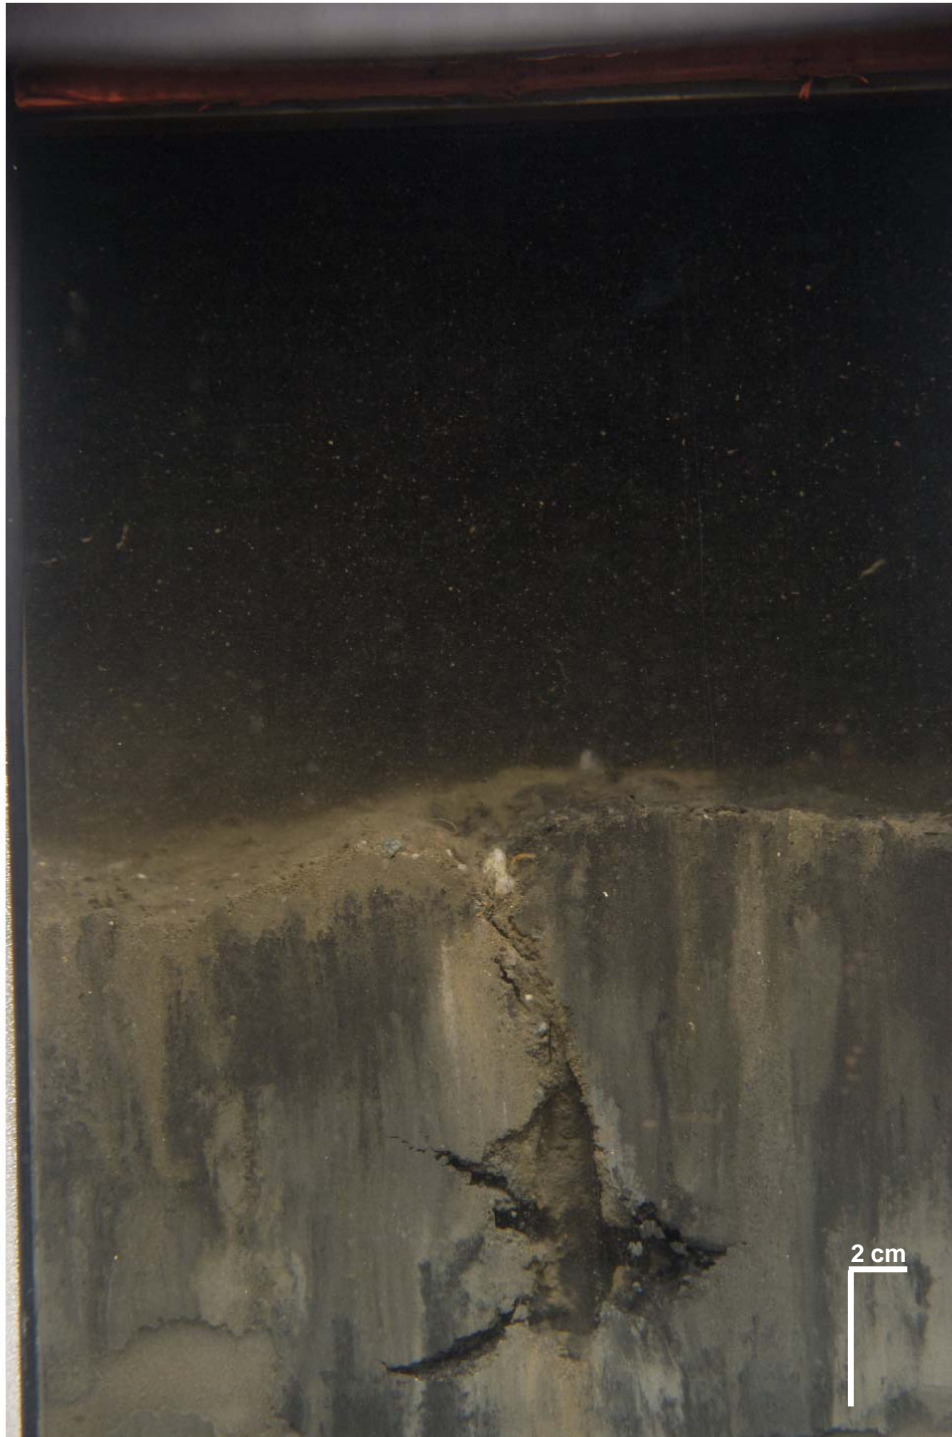
**Figure 3-20.** The small-scale surface boundary roughness in this SPI image from Station BE-01 is due to burrowing activities of a large infaunal organism.

Station-averaged camera prism penetration varied across the site, ranging from 2.2 cm (BE-03) to 17.3 cm (B-05) on the softer muds found in the site basin (Appendix B). Because the stop collars on the camera, the number of weights, and the presence of the mud doors were adjusted frequently during the course of the survey, the variation in penetration values was not an accurate reflection of the relative change in sediment shear strength. Station-averaged small-scale boundary roughness ranged from 0.5 to 2.9 cm across the site, with an overall site average of 1.6 cm. The origin of this small-scale topography was split approximately equally between physical and biological processes among the station replicates (Table 3-5). Physical roughness elements were caused by small-scale bedforms/ripples due to bottom currents (Figure 3-18) or mud clasts from deposited material (Figure 3-17), while biological roughness elements were due to feeding pits, burrow openings, or fecal mounds from infaunal bioturbation (Figure 3-20).

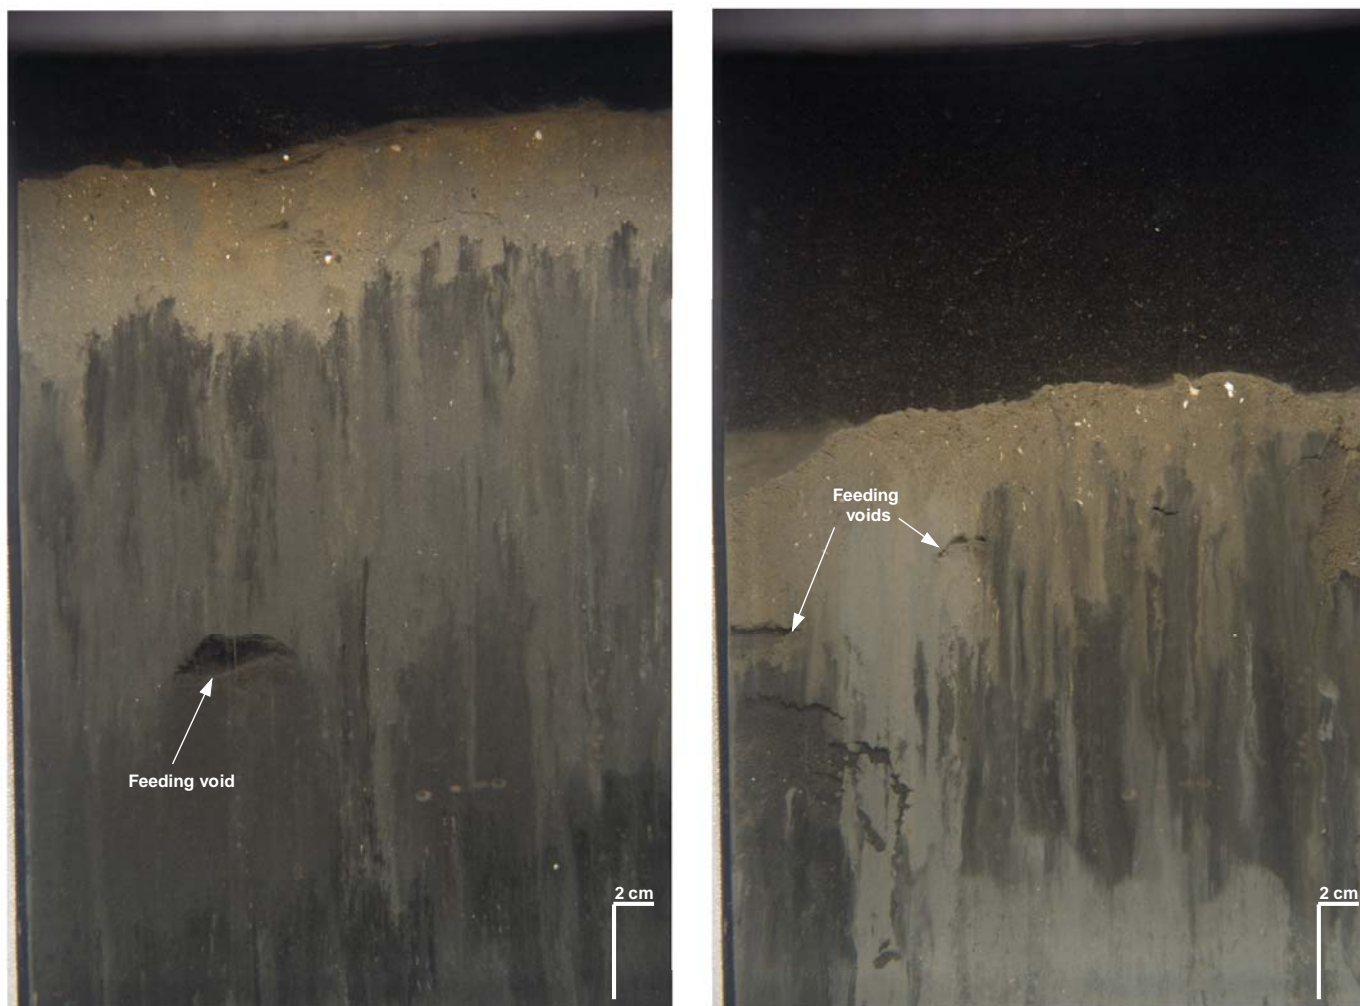
**Figure 3-23.** SPI images from Station A-05 (left) and Station E-01 (right) show subsurface feeding voids created by larger infaunal deposit-feeders.

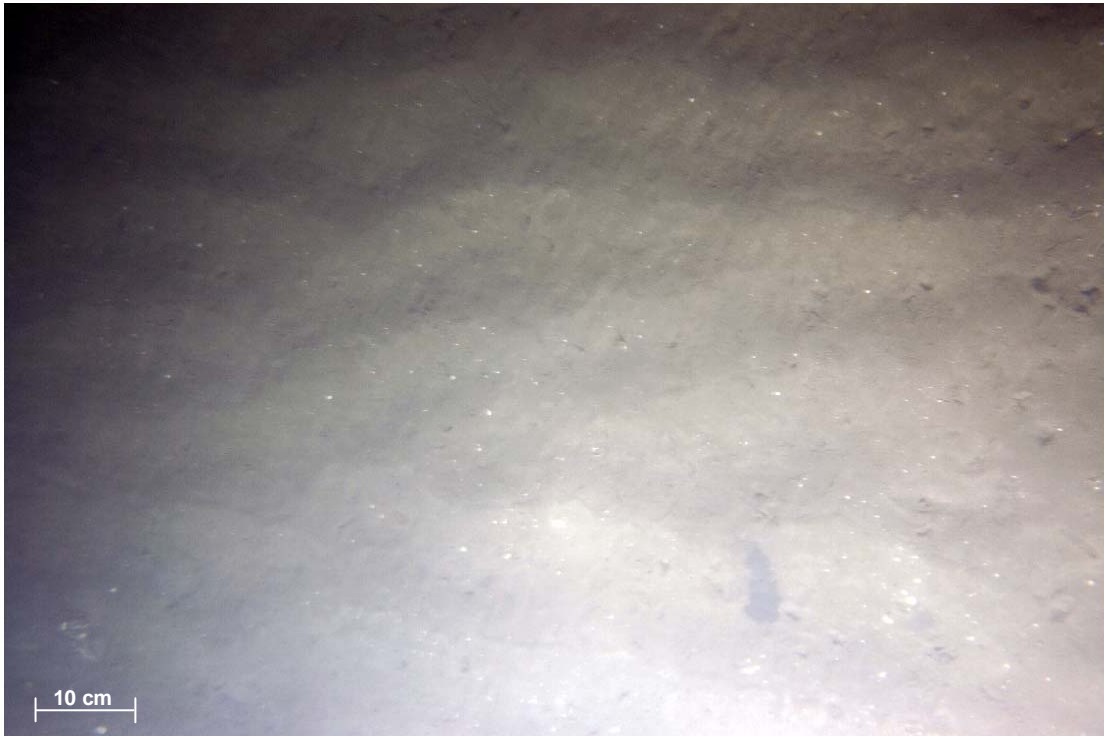
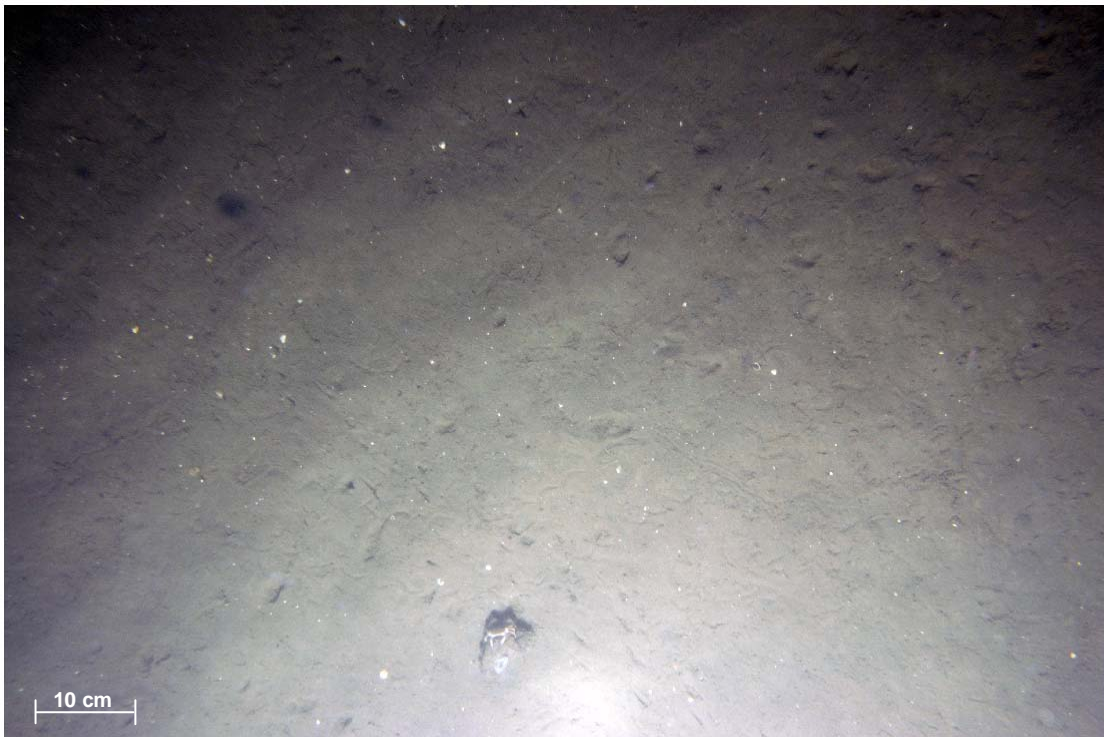
**Figure 3-25.** Plan view images from Station A-05 (top) and Station D-03 (bottom) show the formation of ripples from surface wave or bottom current energy.

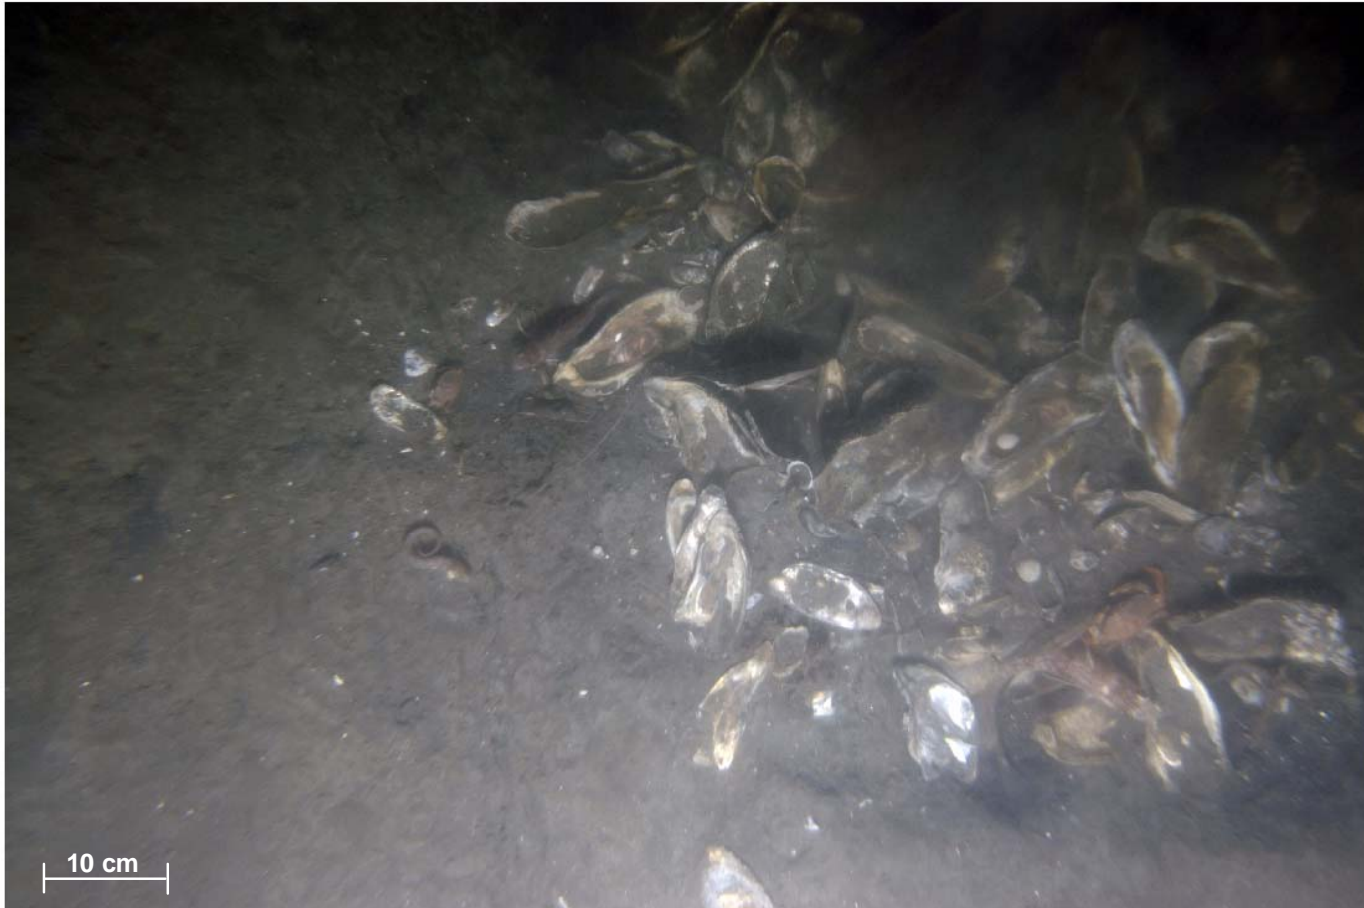
**Figure 3-26.** Concentrated collections of disarticulated oyster shells can be seen at the sediment surface in this plan view image from Station E-02.

The surface sediment texture in the plan view images from the disposal site was quite different from that in the reference areas. While the surface texture of the sediments at the disposal site confirmed the presence of mud, it was quite noticeable that bottom currents were strong enough to create ripples in the fine sediment surface (Figure 3-25). Occasional concentrations of oyster shells, likely transported to the site from inshore dredged sediments, were also found at the sediment surface within RISDS (Figure 3-26).

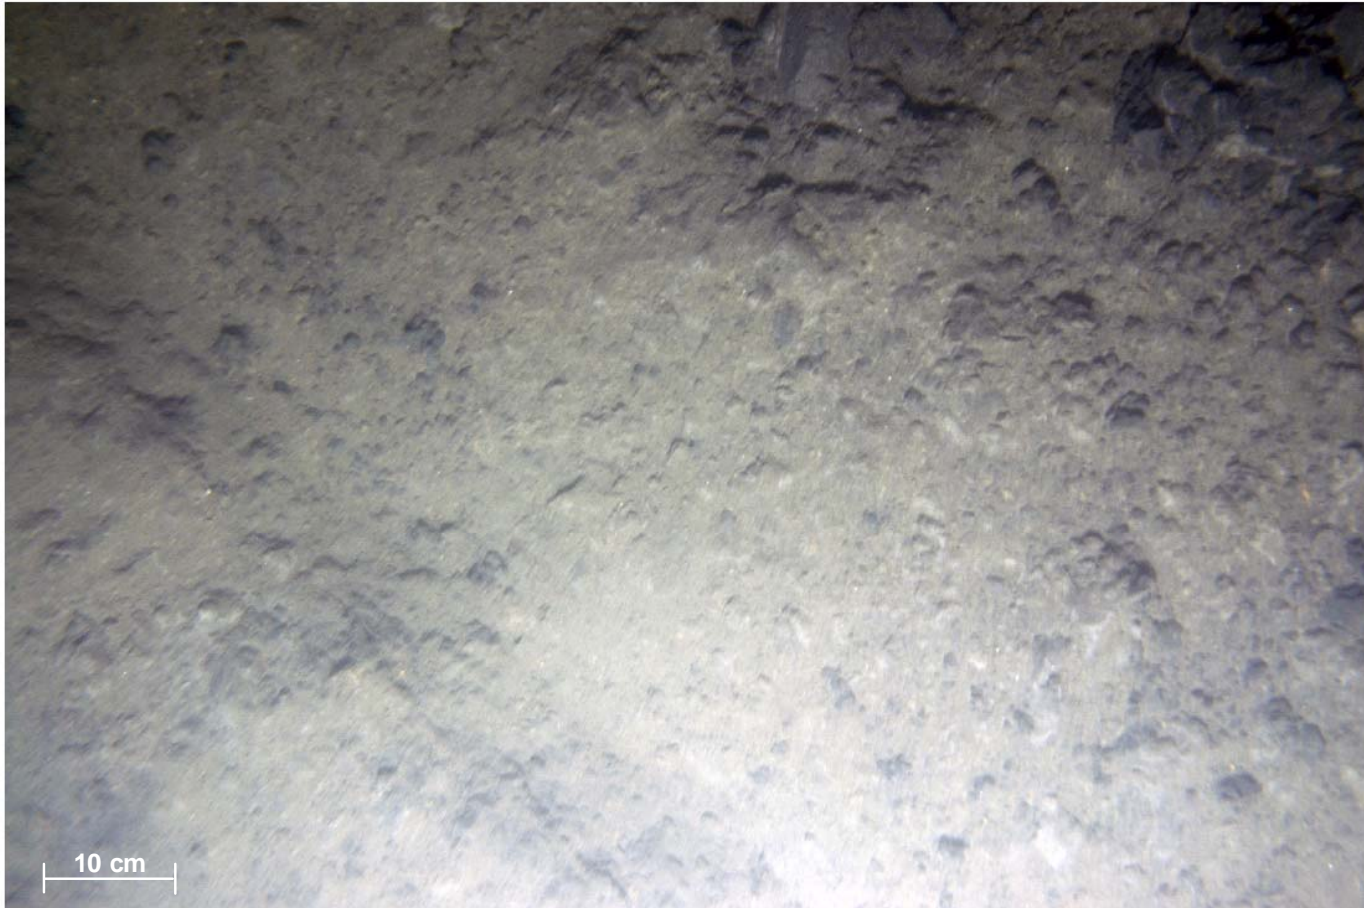
**Figure 3-27.** This plan view image from Station BE-04 shows the sediment surface littered with consolidated clay clumps from the recent disposal operations.

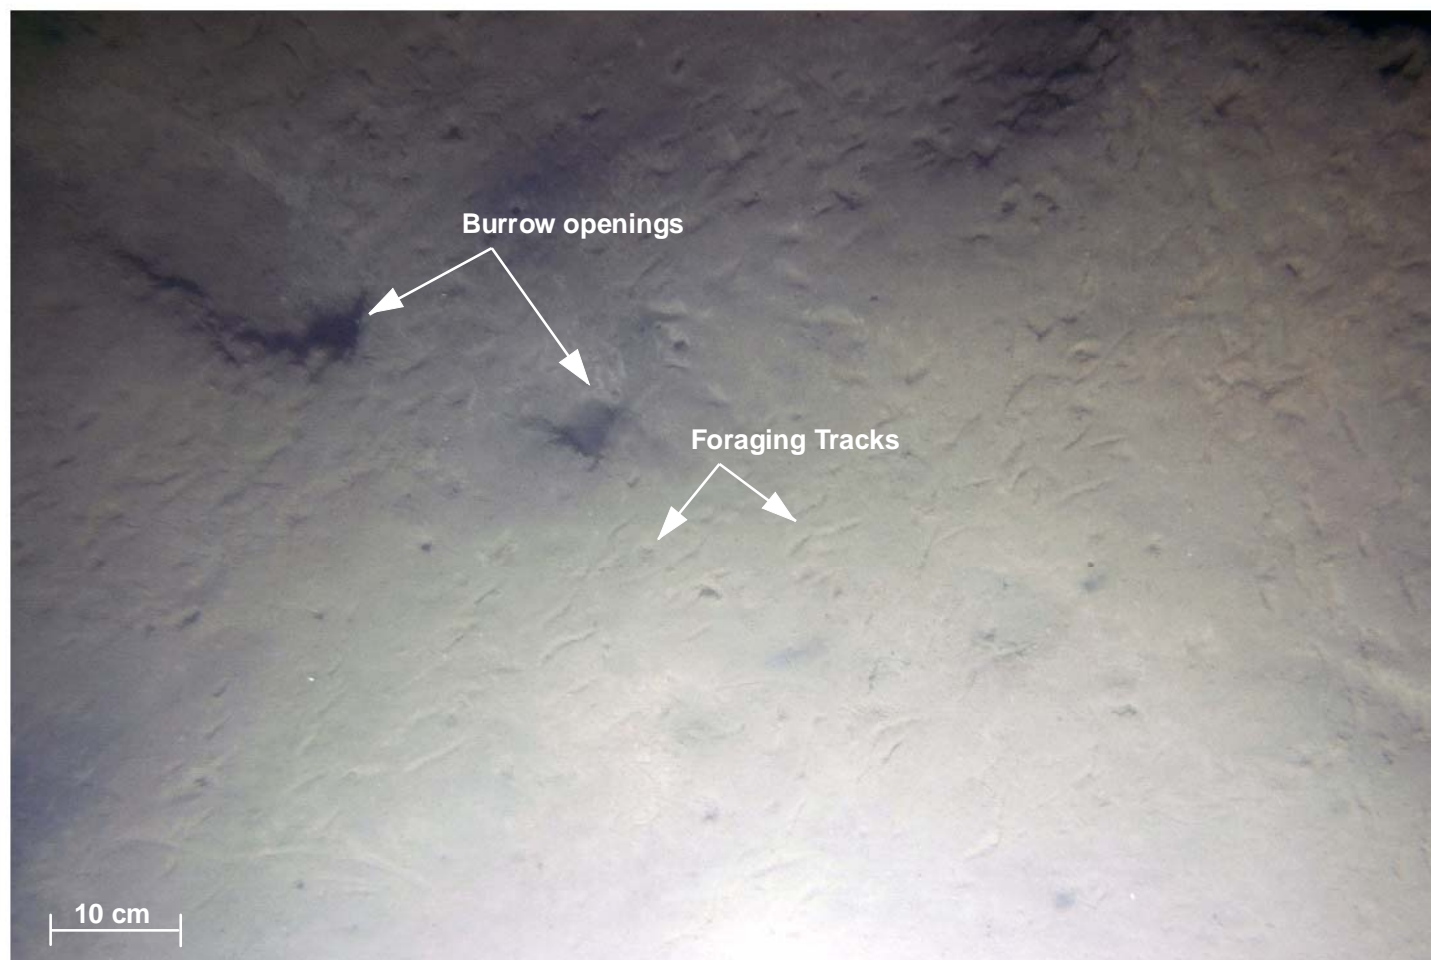
**Figure 3-28.** Plan view image from Station BE-02 showing the typical surface appearance of a soft, muddy bottom with a few large burrow openings and epifaunal foraging tracks.
