Monitoring Survey at the Rhode Island Sound Disposal Site  
July 2005

# Disposal Area Monitoring System DAMOS

Contribution 176  
July 2007

Report No.  
ENSR-9000-417-320

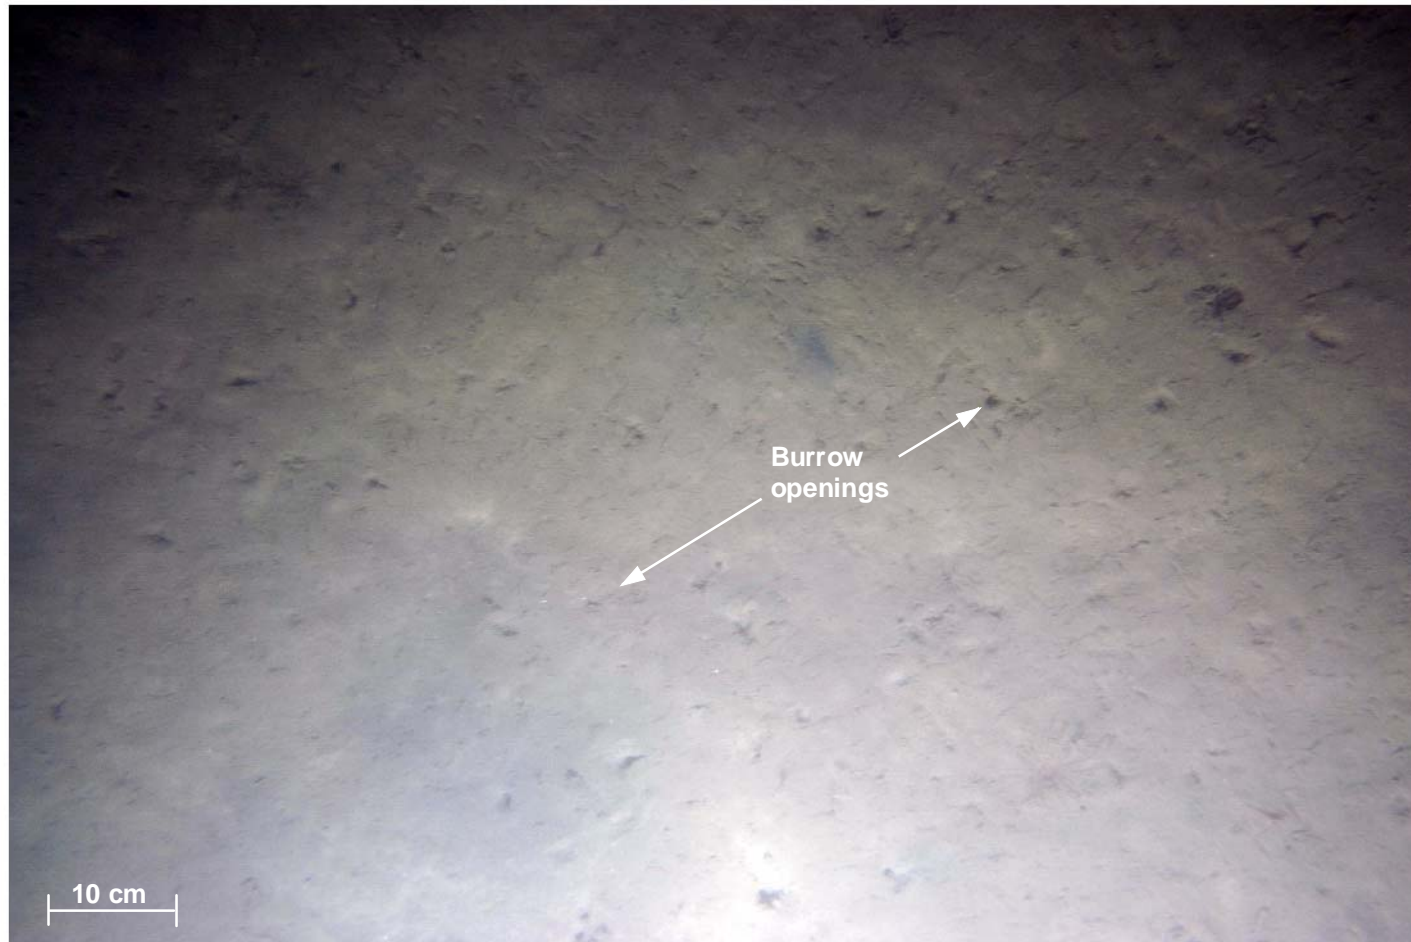
**Figure 3-29.** Only a few burrow openings of Stage III taxa are visible in this plan view image from Station E-03.

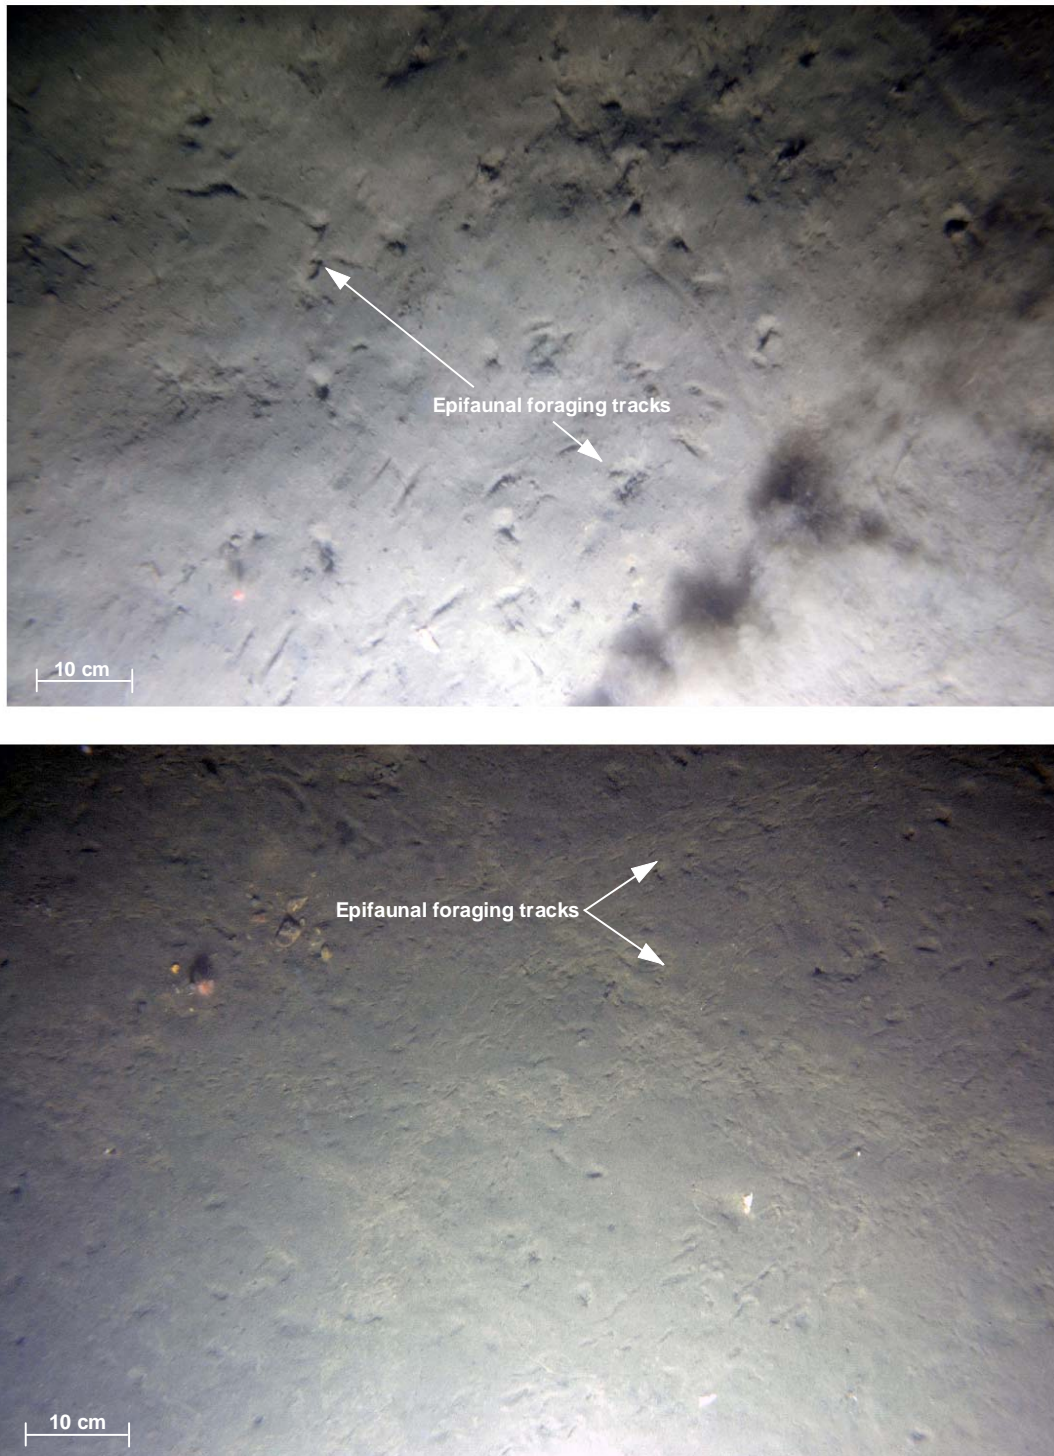
**Figure 3-31.** The foraging tracks of epifaunal crustaceans were very common on the muddy surface of the RISDS stations as can be seen in these plan view images from Station B-05 (top) and Station BE-04 (bottom).
