**ASHBYS BOATYARD
MARITIME SERVICING AREA**

For Far North Holdings Ltd

Assessment of Ecological Effects

September 2019

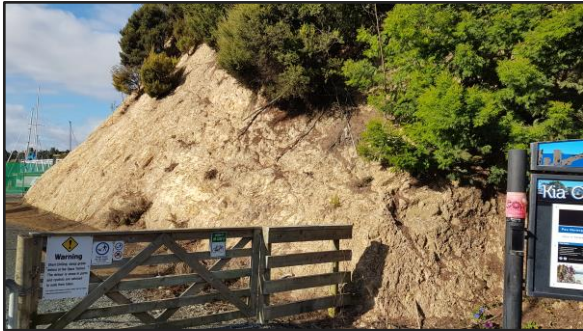
Photo 1: Entrance to existing cycle trail, at north of site. .

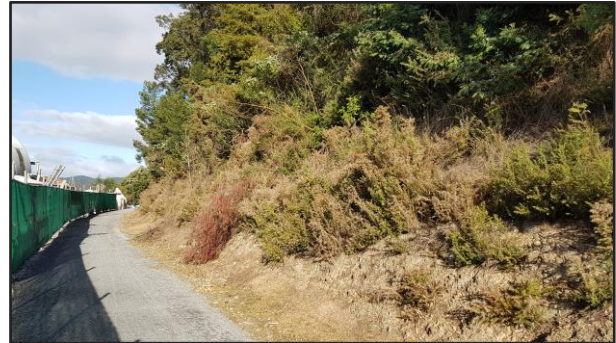
Photo 2: Vegetation on the cliff bank/landward side of cycle trail. Ashby's Boatyard on left.

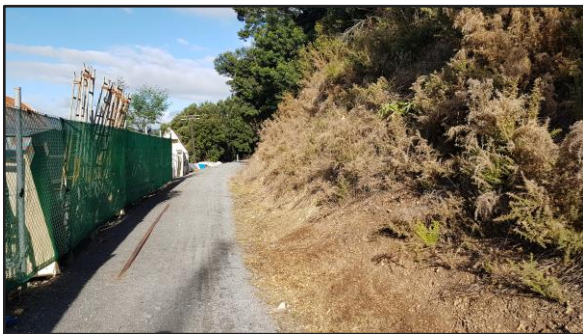
Photo 3: Vegetation on the cliff bank/landward side of cycle trail increasing. Ashby's Boatyard on left.

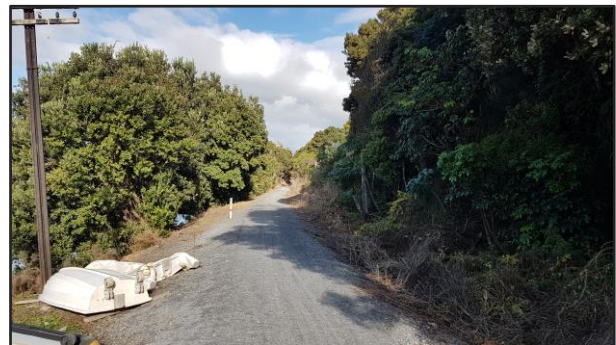
Photo 4: Location where the current boatyard ends, and the proposed reclamation begins. Vegetation on the landward side of the cycle trail slightly increases in value with the presence of more native species.

Where the current boatyard ends and the proposed reclamation begins (Photo 4) the vegetation on the landward side of the cycle trail is more botanically diverse and contains ponga (*Cyathea* sp.), mahoe (*Melicactus ramiflorus*), flax (*Phormium tenax*) and ground ferns, in addition to the native species previously noted. Exotics and pest plants remain and additionally include wild ginger (*Hedygium gardnerianum*) and pampas (*Cortaderia* sp.).

On the proposed reclamation side of the existing cycle trail, vegetation is mainly native (Photos 4-6) and includes red matipo, kanuka, manuka, small totara, pohutukawa, including a large pohutukawa up to eight metres, a cluster of flax and some small juvenile mangroves (*Avicennia marina* subsp. *australasica*) on the lower shore (Photo 6).

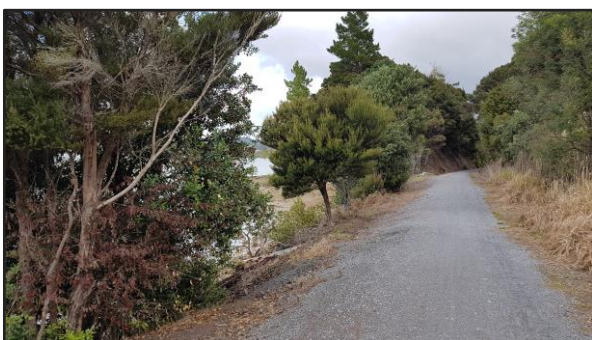
Photo 5: The reclamation side of the cycle trail (left) showing predominantly natives on cycle trail edge and within the rock retaining wall.

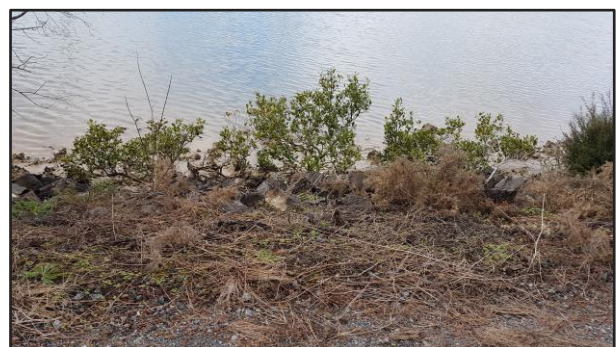
Photo 6: Small juvenile mangroves on the lower shore.

There are a few small/juvenile mangroves along with pneumatophores on the lower shore and within the rock retaining wall (Photo 6). The reclamation and/or works area will potentially involve the removal of these small mangroves.

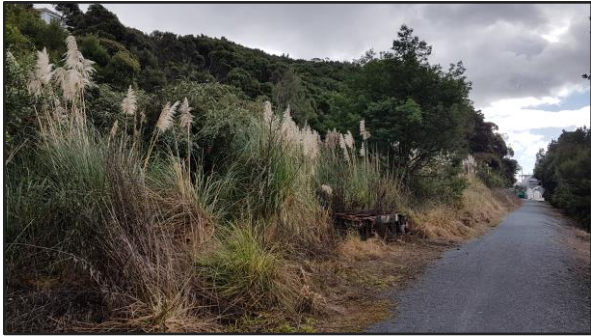
Photo 7: Low value scrub at southern end of site.

At the southern end of the site, where the proposed car parking, truck turning and manoeuvring area to the boat ramp are to be located, there is a small area of scrub (Photo 7) containing pampas, woolly nightshade, brush wattle, gorse, pine, wild ginger along with the some native such as red matipo, ponga, totara, manuka, pukatea, kawakawa, ground ferns and pohutukawa (*Metrosideros excelsa*).

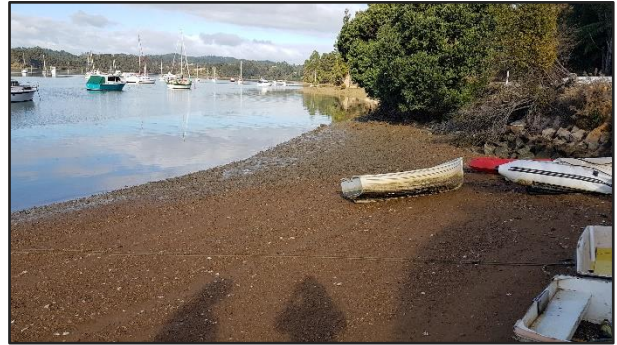
Photo 8: Intertidal area inspected, rock retaining wall which leads up to cycle trail on right.

The intertidal area was inspected at low tide on 16 May 2019 (See photos 8-14, Appendix C). The site includes a rock retaining wall adjacent to the cycle trail and a narrow beach of sandy/gravel which is wider at the northern end, near the current boatyard (Photo 8).

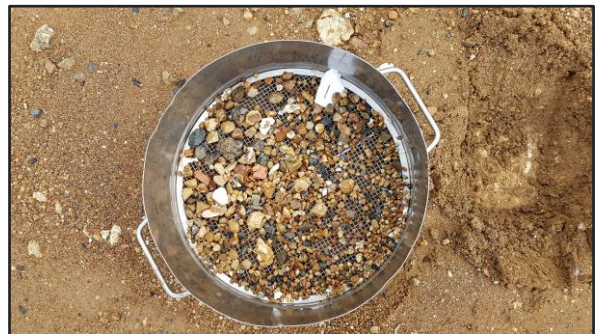
Photo 10: Sieved sediment at intertidal site 1.

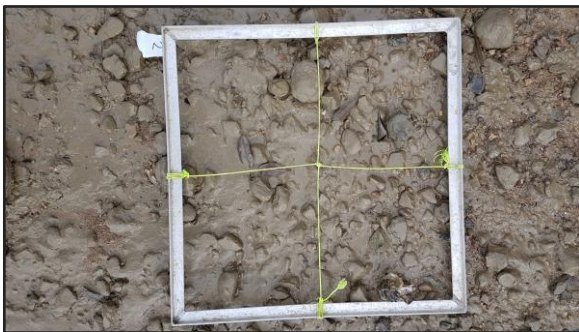
Photo 11: Intertidal quadrat site 2.

Four (0.5 x 0.5 metre) quadrats placed on the beach (Photos 9, 11, 13-14) were assessed for surface and infaunal biota. This included sieving sediment through a 5 mm sieve where substrate permitted (Sites 1 and 2; Photos 10 and 12), to locate any larger macroinvertebrates including shellfish. To assess relative abundance of crabs, mud holes were counted in the four locations. Intertidal sampling locations are shown in Figure 3.

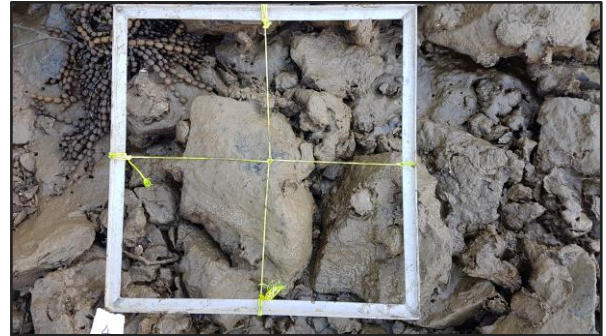
Photo 14: Intertidal quadrat site 4.

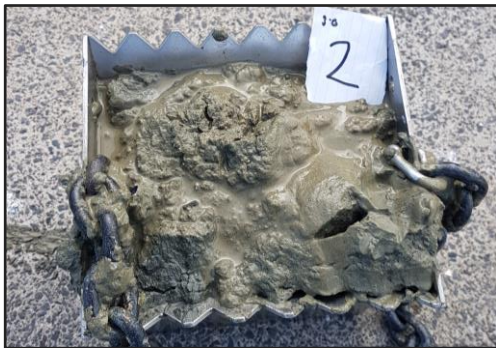
Photo 15: Box dredge sample at subtidal - 3.0 m depth, site 2.

The subtidal marine community was assessed by sampling the *insitu* biota. Nine seabed samples were collected using a biological 'box' dredge towed behind a small boat (Photo 15, Appendix C). Four samples were at approximately 1.5 m depth below chart datum (subtidal-1.5 m depth: sites 1-4) and five at 3.0 m depth (subtidal-3 m depth: sites 1-5).

A summary of the benthic dredge information for the ten seabed samples is shown in Table 2. Sediments were not subjected to grain size analysis but were described based on the observations of the collected samples. Samples were generally fine dark grey muddy sand with a light brown surface layer and most had organic debris and shell hash present. A typical seabed sample is shown in Photo 15, Appendix C.

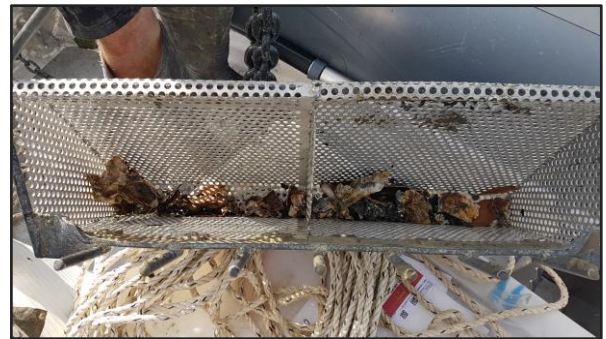
Photo 16: Drag dredge at 1.5 m depth, showing no living biota.

Two drag dredge samples were conducted at approximately 1.5 and 3.0 metres depth (see Figure 3 for drag dredge sample locations). No biota were collected, with the dredges collecting old oyster shells, organic and woody debris and polychaete calcareous tube casings.
