FINAL REPORT

**DELTAPORT THIRD BERTH
ADAPTIVE MANAGEMENT STRATEGY
2008 ANNUAL REPORT**

File: 499-002.11
September 2009

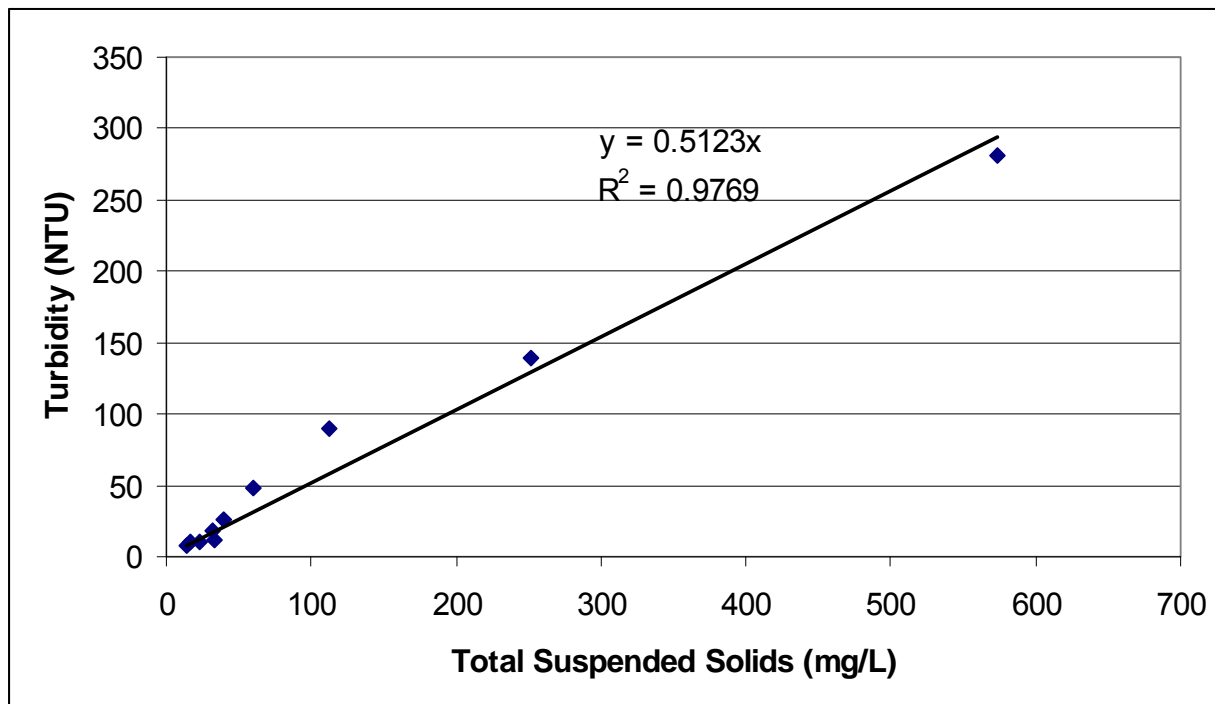
Figure 1.3-1 Plot of TSS versus Mean Turbidity (from NHC memo dated November 5, 2007)

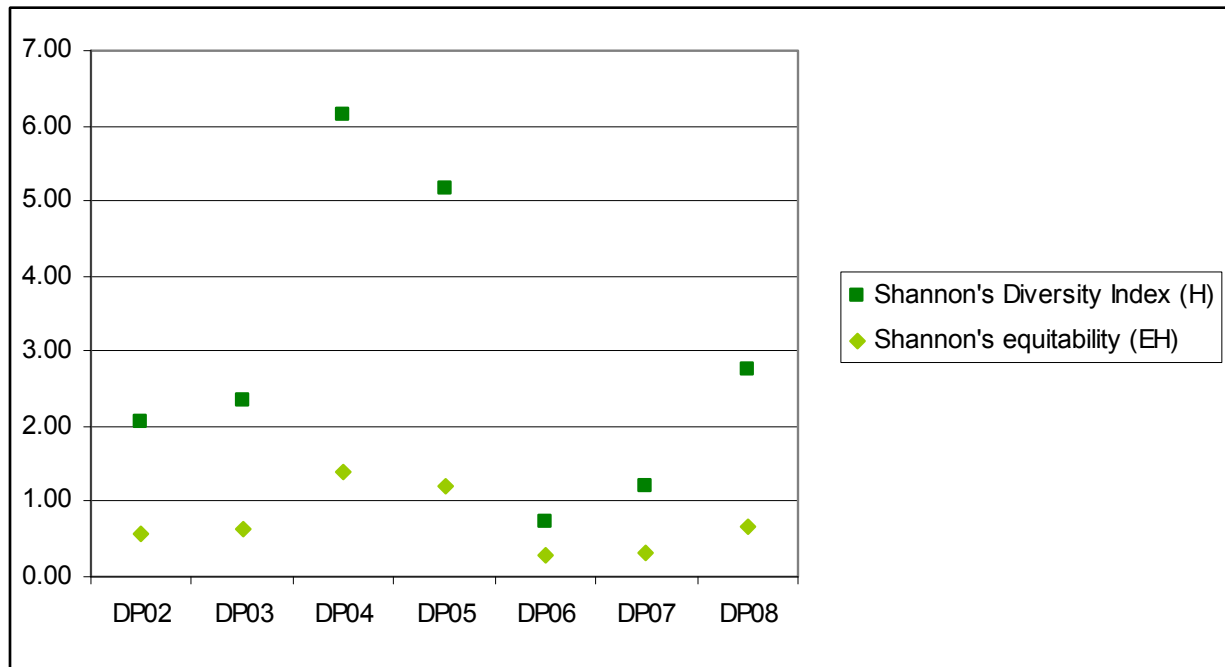
Figure 2.6-1 Shannon's Diversity and Shannon's Equitability (Evenness) Index

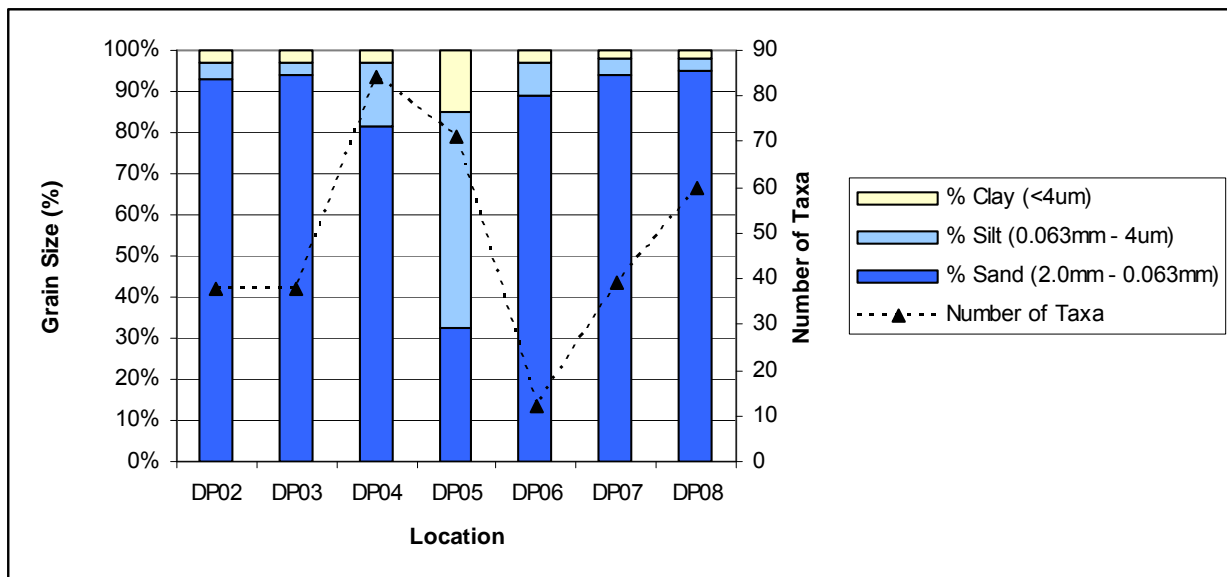
Figure 2.6-3 Total Number of Taxa Observed (Frequency) versus Percentage of Grain Size at each Station

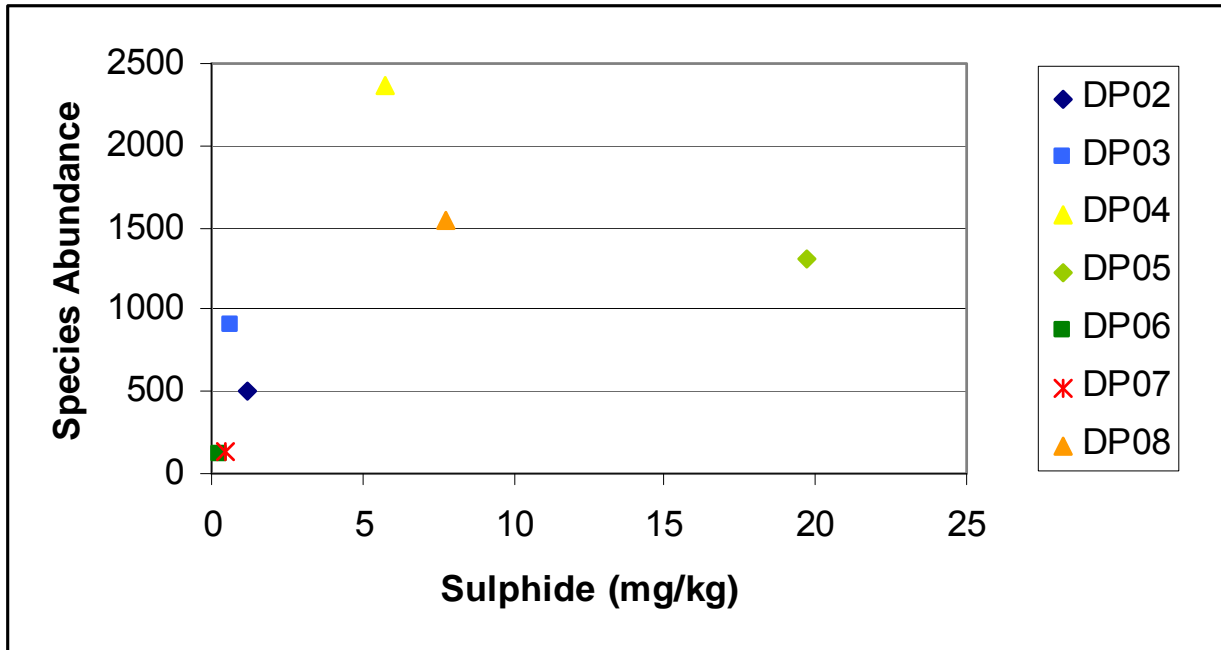
Figure 2.6-4 Species Abundance versus Sulphide Concentration ($\mu\text{g/g}$) at each Station

The majority of the stations, with the exception of DP05, were composed of over 80% sand (0.063mm – 2.0mm). The sediment collected at station DP05 contained 53% silt and 33% sand. No observable correlations between grain size and species abundance or taxa richness were noted (Figures 2.6-2 and 2.6-3). There was a positive correlation observed between sulphide concentrations and species abundance, as well as between sulphide concentrations and taxa richness (Figures 2.6-4 and 2.6-5).

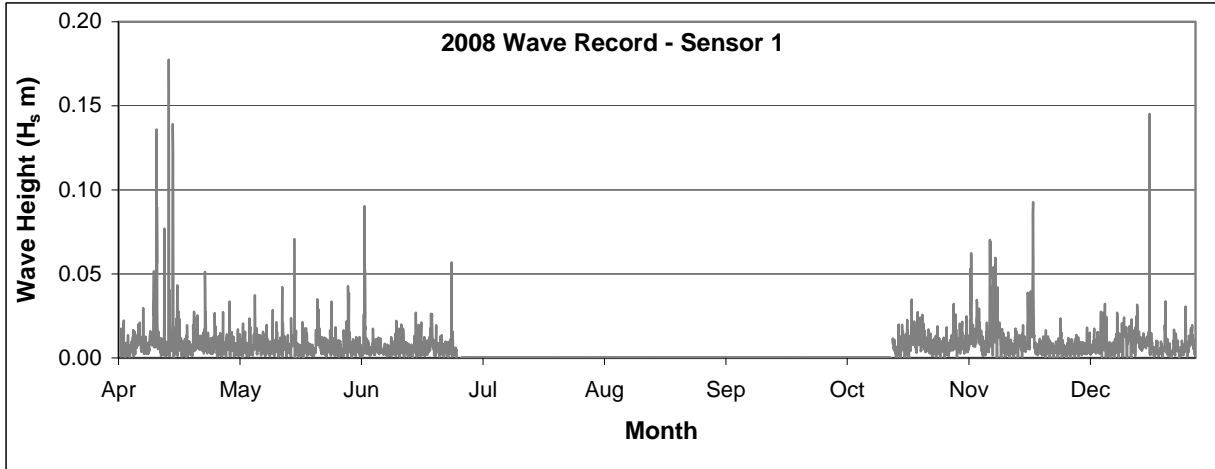
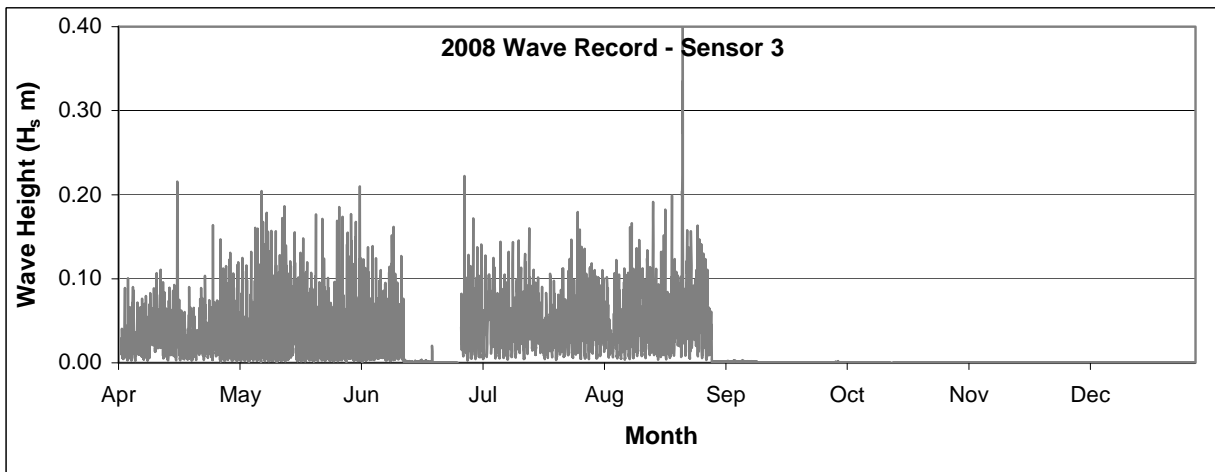
Figure 35 Time-series record of significant wave heights (H_s) measured at the three wave sensors in the study area

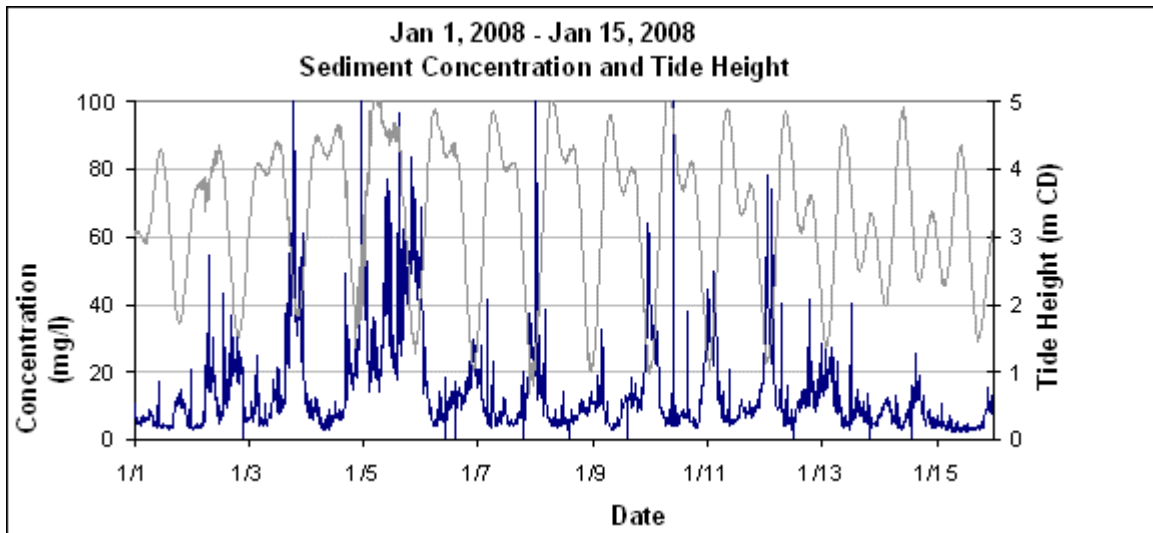
Figure 48. Time series of turbidity and sediment concentration data from Sensor 2 for the period from January 1 to April 10, 2008 at approximately 15-day intervals. Tide height is represented by the grey line and sediment concentration is shown in blue.

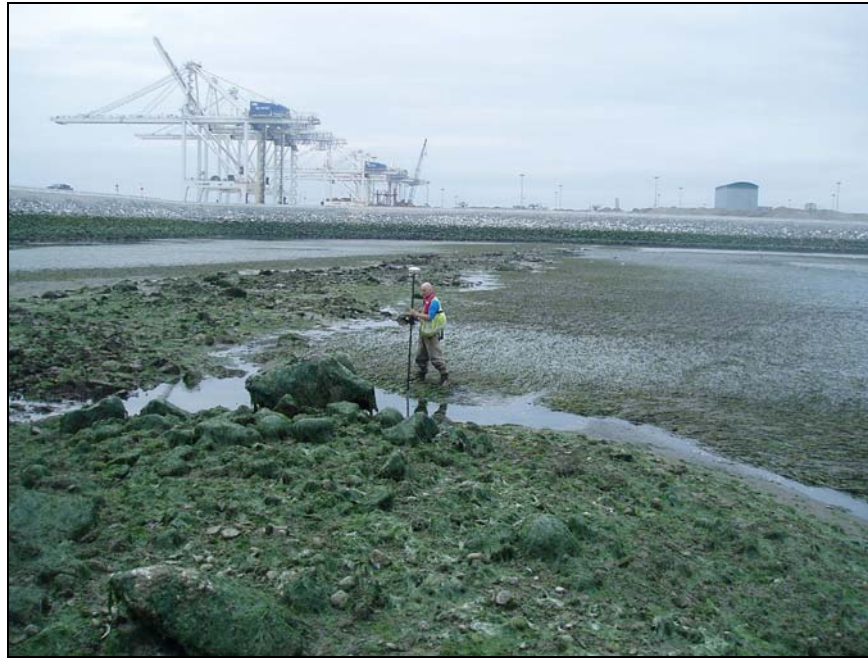
Photo 1: Crest Protection Monitoring XS 1 looking back at Deltaport, July 2008
