Waterfalls in Reservoirs: Tracking the Development of Nickpoints in the Sediments of Declining Reservoirs

Paul E. Grams, Research Hydrologist, U.S. Geological Survey, Flagstaff, AZ,
pgrams@usgs.gov

Robert Tusso, Hydrologist, U.S. Geological Survey, Flagstaff, AZ, rtusso@usgs.gov

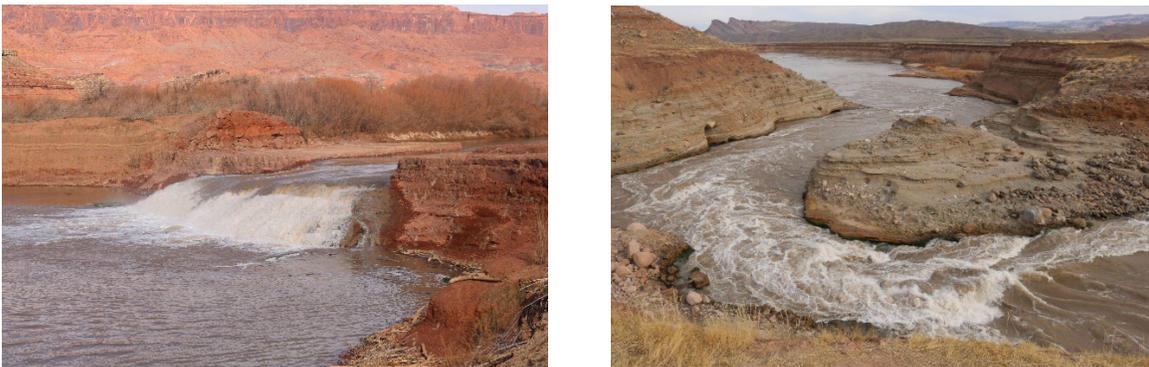
Figure 2. Piute Farms waterfall on the San Juan River previously inundated by Lake Powell (left) on January 19, 2022 and Pearce Ferry Rapid on the Colorado River previously inundated by Lake Mead (right) on February 9, 2021.

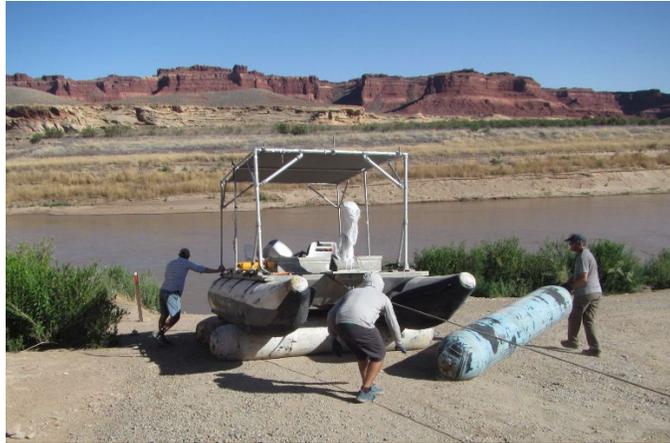
Figure 4. Launching survey vessel at North Wash boat ramp, about 900 m downstream from the mouth of the Dirty Devil River. The incising riverbed has caused the boat ramp to become too steep for safe use with vehicles and boats must be launched and retrieved by mechanical winch.
