Seabed survey of mooring areas, Mapua Inlet

Prepared for Tasman District Council

July 2015

NIWA CLIENT REPORT No: NEL20015-010

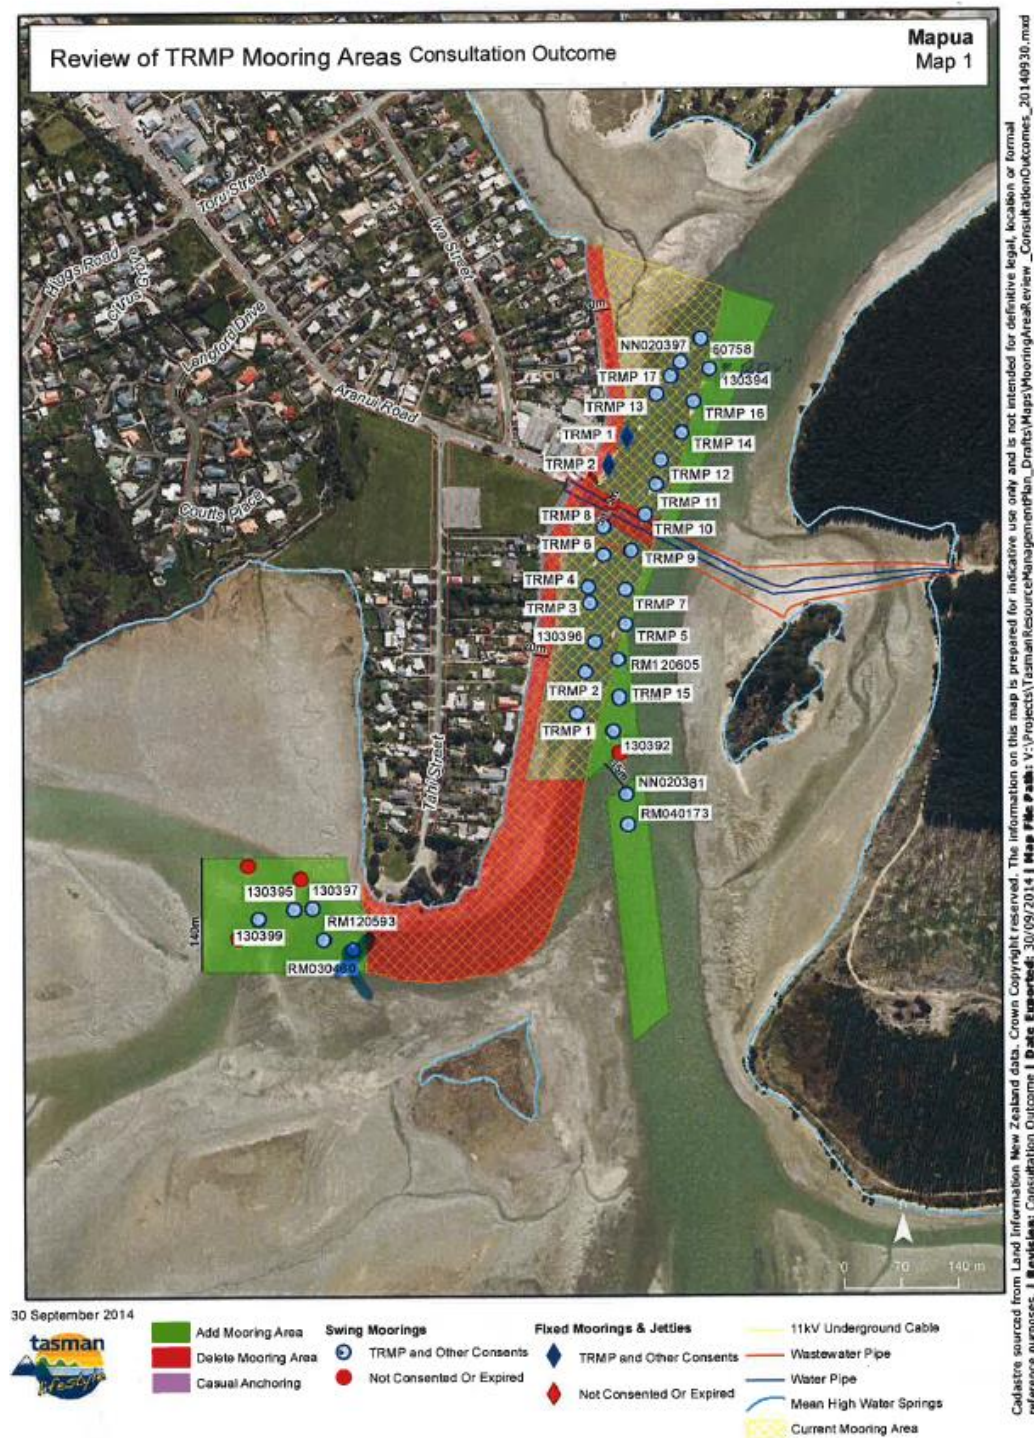
Figure 1-1: Plan of existing mooring areas and potential changes within the Mapua Estuary.

Tasman District Council (TDC) is undertaking a review of the marine mooring areas within the district, which may result in the replacement of existing moorings, and/or the addition or contraction of areas. One area under consideration is the Mapua channel at the entrance to Waimea Inlet, where changes to the existing mooring areas are being considered (Figure 1-1).

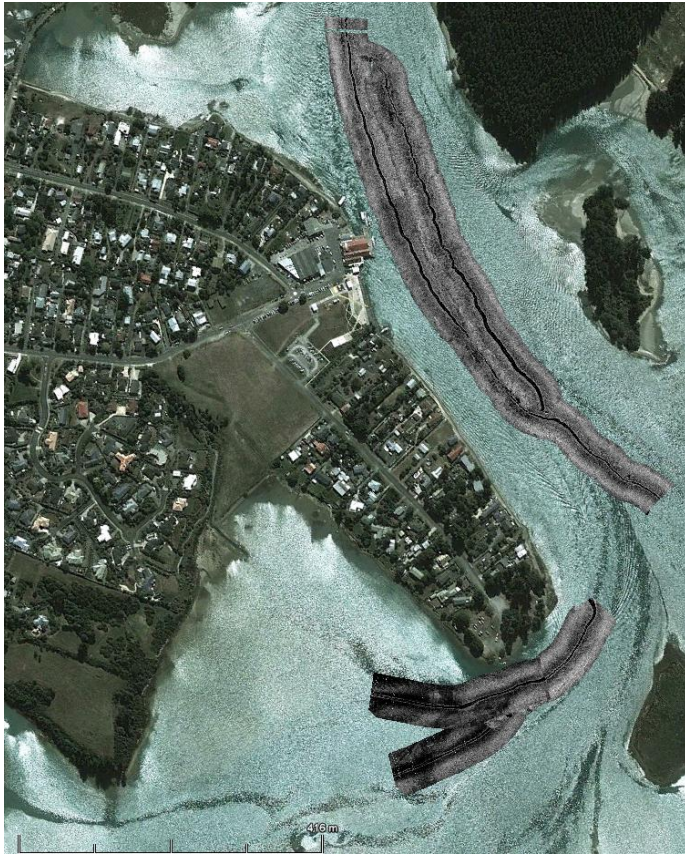
Figure 2-1: Side-scan sonar images from the Mapua mooring location.

To identify sea floor features, five side-scan sonar transects, each 60 m in width (30 m either side of the vessel) and up to 800 m in length (Figure 2-1) were surveyed alongside existing and proposed mooring areas using a high-frequency (675 kHz) Triton sonar towfish. The position of the side-scan sonar was automatically recorded every 2 seconds along each transect using a hand-held GPS and saved in real time to a laptop on board the vessel using SeaNet Pro™ software. The raw files were post-processed using Triton Perspective™ software to produce geo-referenced images from the acoustic data that could be viewed in ArcMap GIS or Google Earth and allow features of interest to be mapped in relation to the existing and newly-proposed mooring sites.

A large proportion (approximately 10 ha) of the sea floor within the Mapua channel, covering both the existing moorings, and the proposed new mooring areas were covered by the side-scan sonar (see Fig 2-1). No reefs or rocky outcrops were identified, with most of the sea floor appearing on the side-scan images as rubble over sandy sediments. Offshore of Grossi Point, the sea floor appeared to be more homogeneous, possibly sandy, with smaller areas of rubble (Fig 3-1).

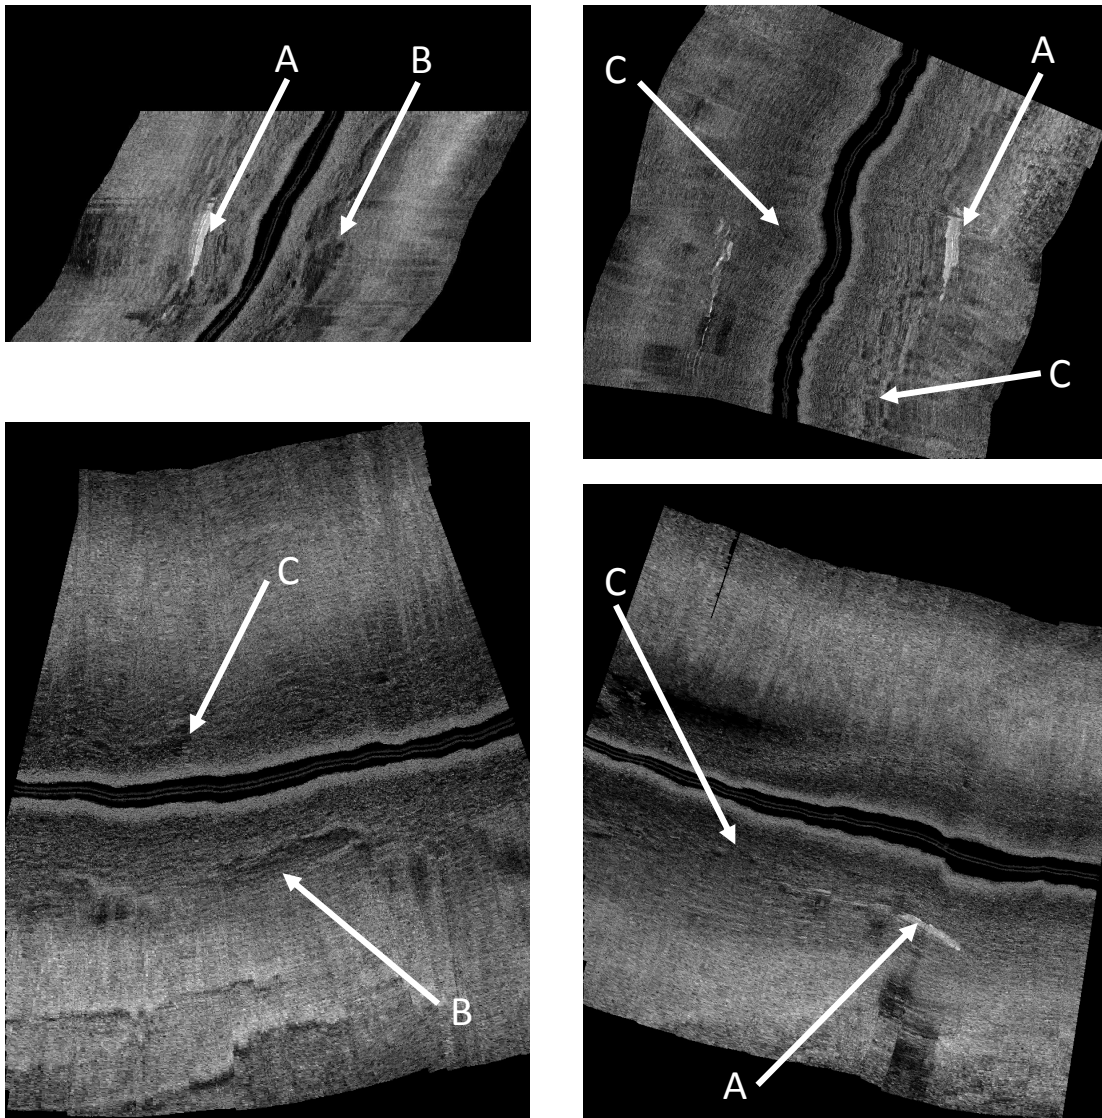
Smaller portions of some of the original side-scan sonar files were reanalysed to show more detail in the images. Examples are shown in Fig 3-2.

Figure 3-2: Side-scan sonar images depicting sea floor features. A= Mooring chain scour marks, lying parallel with tidal currents; B = tidal scour (hummocks and depressions) in sediment; C = Boulders and/or mussel beds. Width of each image = 60 m.

Scour marks were evident around some of the existing moorings, reflecting mooring chains dragging on the sediment with the changing tides. These scour marks were aligned parallel to the dominant tidal currents, i.e. along the axis of the channel, and were generally small, < 10 m in length. The textured appearance of the sediment throughout the area indicated the sea floor was comprised of cobbles and small boulders. This was confirmed by the video images and the dredge samples (see below). Video and dredge samples also contained dense populations of green lip mussels, *Perna canaliculus*, which also would have appeared as textured sediment in the side-scan sonar images. Parts of the soft sediment, particularly in the centre of the channel showed obvious hummocks and depressions, indicating the sediments is likely to be constantly shifting due to the strong tidal currents.

The existing swing moorings along the channel have a less than minor impact on the sea floor habitats and associated species. Short (< 10 m in length) scour marks are visible in the side-scan sonar images, aligned parallel with the channel and tidal flows, caused by vessels swinging with the tide. The moorings appear to have little to no effect on the coarse cobble and boulder habitat, except that the swinging chains have, in places, prevented mussels from colonising the boulders in small patches.
