## Morphological analysis and decadal trends at Groenendijk, Mariakerke and De Haan until Summer 2019

Project: SBO 150028: CREST - Climate resilient coast. Wave action in a changing climate: effects on the dynamics of the coast and implications for future safety strategies

Deliverable: D3.3.1 (1)

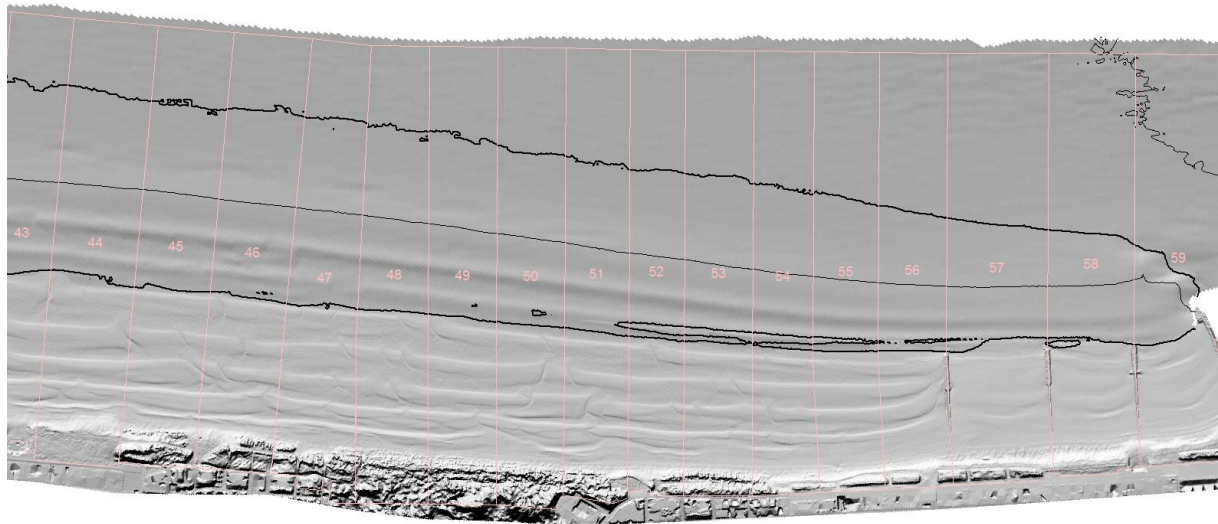
*Figure 2. Hillshade view of Spring 2017 DEM. Illuminated from NW, height exaggeration x5. Elevation contours of 0, -2, and -4 m added for reference. Section boundaries and numbers in pale pink. Nieuwpoort harbour entrance is at the right edge. Mind the different resolution of the submerged (top, cell size 10 m) and emerged (bottom, cell size 2m) parts of the survey DEMs.*

The upper part of the shoreface shows three coast-parallel breaker bars of which the middle one, with crest at -0.75 m, is the most prominent and continuous feature (Figure 2). The separation between the bars decreases to the east, but the bars can be individualized all the way to Nieuwpoort harbour entrance, in spite of the fact that there, three long groins extend from the shoreface down to the uppermost of the three bars.
