Waterproofing Challenges in Hydrostatic Conditions

By Edward L. Lehman, RWC, RRC, AIA,
and Douglas R. Stieve, RRC, AIA

This paper was originally presented at the 2022 IIBEC International Convention and Trade Show.

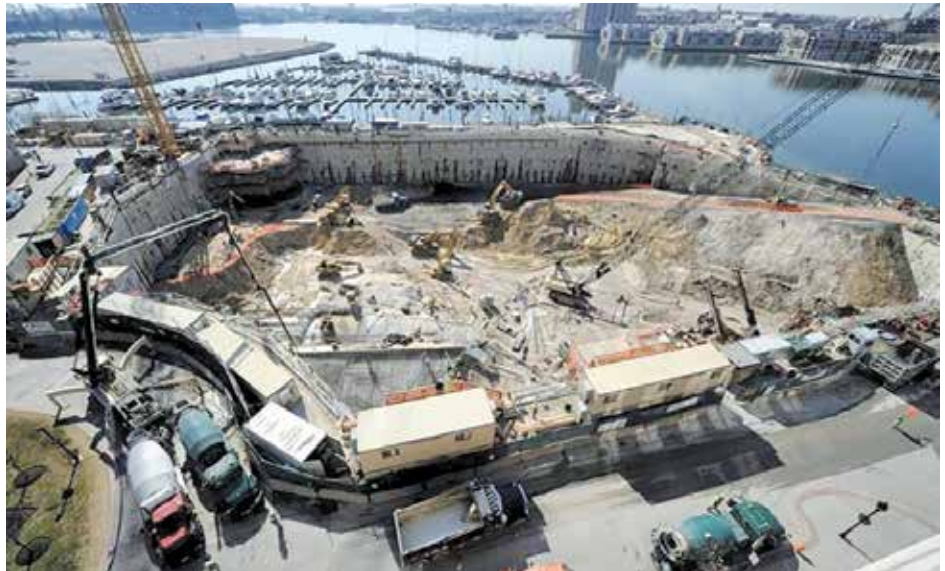
Figure 1. Construction adjacent to water.

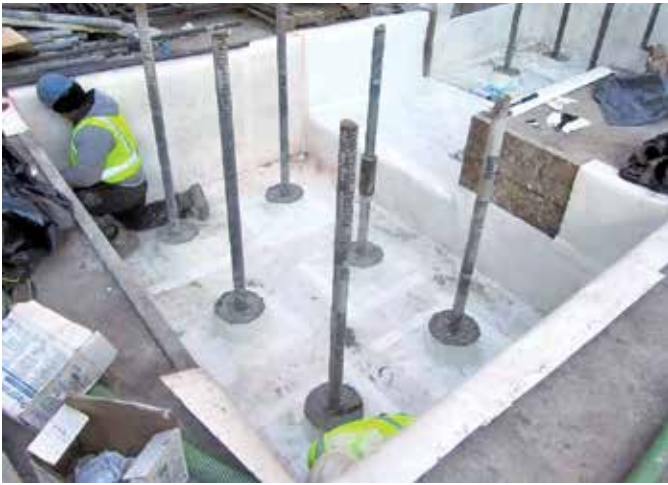
Figure 3. Rock anchor penetrations through foundation waterproofing.

Various foundation systems can be used to resist hydrostatic forces. The selection of these systems is critical for managing another effect of hydrostatic pressure: the ability of the building to resist water penetration. For example, foundations using stabilization systems such as rock and soil anchors require different waterproofing approaches than foundations using secondary structural elements such as "mat slabs" (thickened mat or raft foundation). Stabilization systems can include post-tensioned cables or rods grouted into the rock and/or soil. After the permanent foundation elements have been constructed, the anchors are tensioned and locked off with an anchor plate and nut (**Fig. 3**).

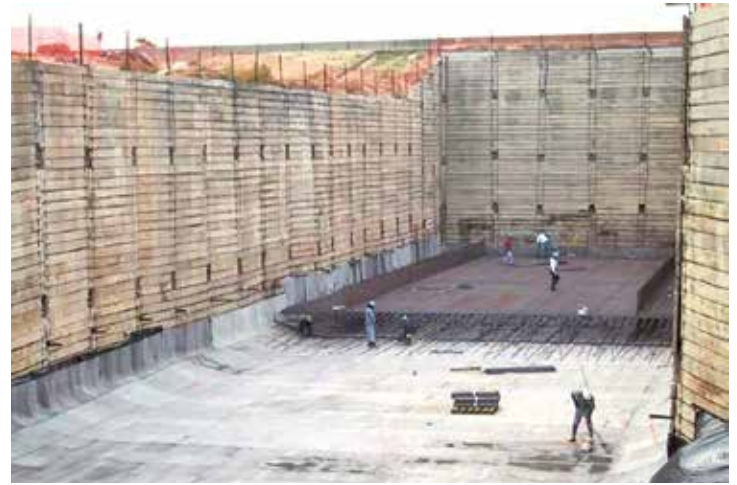
Figure 4. Mat slab under construction.

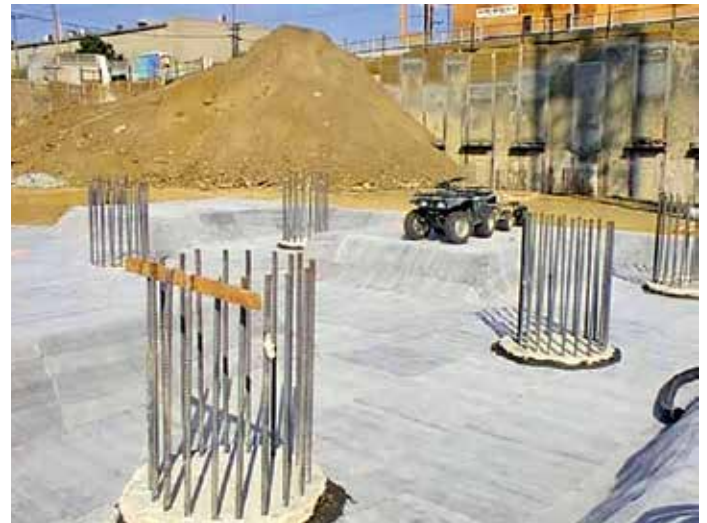
Figure 5. Pile caps.

All of these structural elements can greatly influence the subgrade waterproofing system. As the number of penetrations through the waterproofing increases, the risk of water intrusion also increases because many leaks often occur at penetrations and other flashing details. Furthermore, when thickened mat slabs are used, the waterproofing system is placed below several rows of concrete reinforcement bars, making it very difficult or impossible to repair the waterproofing before concrete placement. Pile caps typically incorporate many reinforcing elements that are needed to connect the floor slab to the piles (**Fig. 5**).

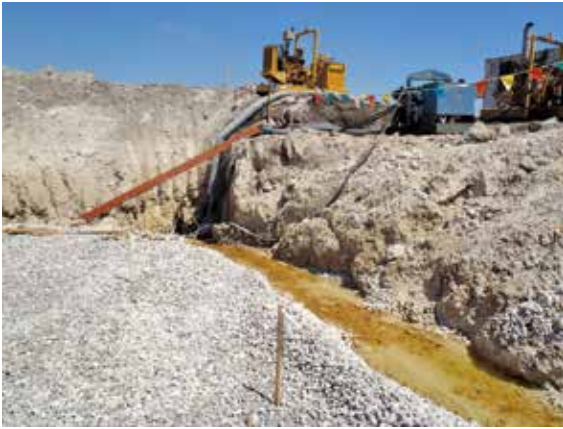
Figure 8. A dewatering pump station at a perimeter trench at the corner of the building pad.

During construction, a dewatering moat-style trench was used around the perimeter of the building pad. This trench remained filled with groundwater and was constantly serviced by a dewatering pump station (Fig. 8). The dewatering pump station included separate primary and secondary emergency pumps.

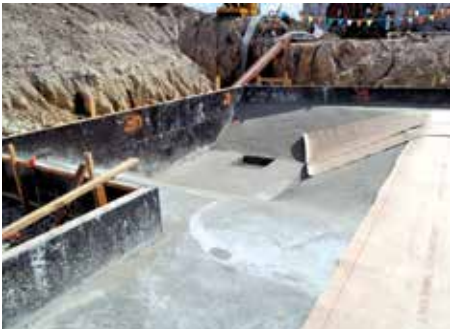
Figure 10. A horizontal bentonite waterproofing sheet being placed at the elevator pit.

A key lesson learned from this project occurred at the elevator pit. The horizontal mat slab was sloped to avoid additional cold joints and 90-degree transitional corners at the membrane (Fig. 10). The reinforced horizontal concrete slab at the pit was designed to be thick enough to resist the force of the hydrostatic pressure.

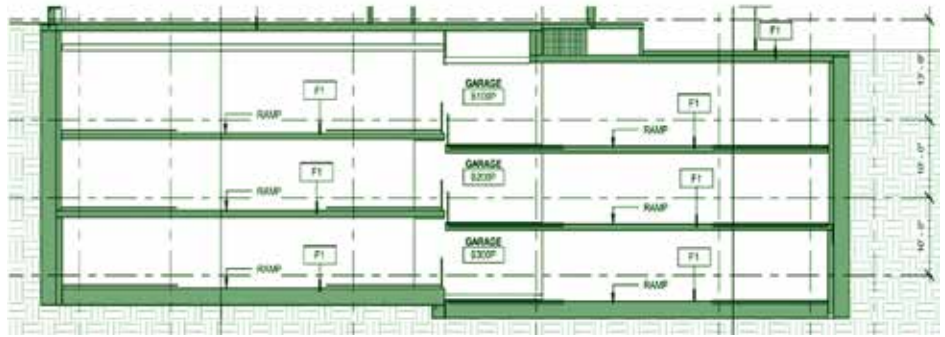
Figure 11. Architectural cross section for below-grade building area.

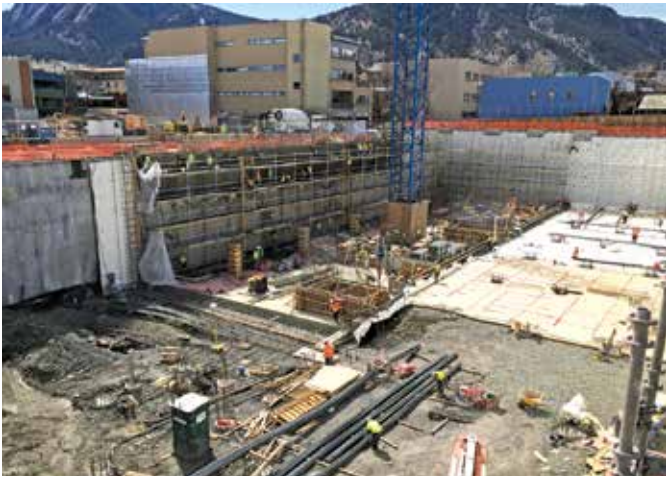
Figure 13. View of the preapplied sheet waterproofing being installed over the support of an excavation wall at a zero-lot-line condition.

The composite HDPE film/adhesive sheet waterproofing and drainage mats were laid out before the placement of the reinforcing steel and concrete (Figs. 13 and 14). The waterproofing seams were all overlapped as the membrane was set into place. The selvage edge seams for the sheet waterproofing membrane were enhanced by the application of seam tape. This adhesive edge is sometimes integrated into the

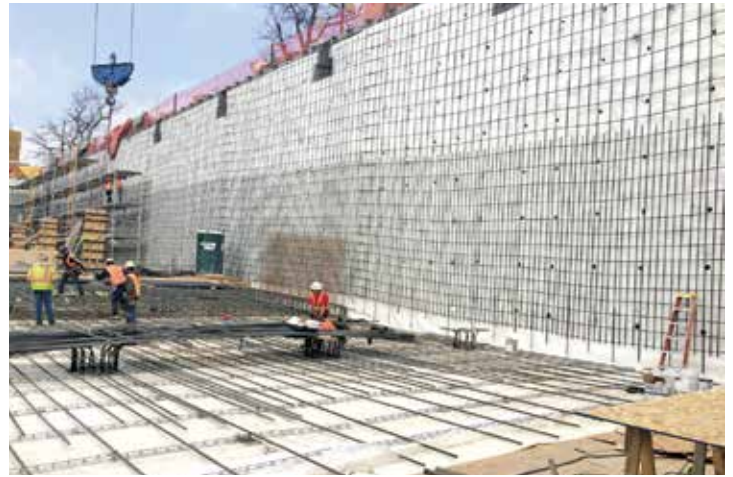
Figure 14. Reinforcing steel being installed over the top of preapplied sheet waterproofing.
