Natura Impact Statement

Construction of Public Toilets and Repair to Helicopter Pad,
Repair to Pier Wall at Landing Pier and Repair of Gate Piers at
Upper Lighthouse on Skellig Michael Island

ISSUE FORM	
Project number	12242
Document number	6040
Document revision	A
Document title	Natura Impact Statement: Construction of Public Toilets, Repair to Helicopter Pad, Repair to Pier Wall at Landing Pier and Repair of Gate Piers at Upper Lighthouse on Skellig Michael Island
Document status	Final
Issue Date	11-05-2021
Document prepared by	HD
Document checked by	MKy (MWP 04-05-2021)

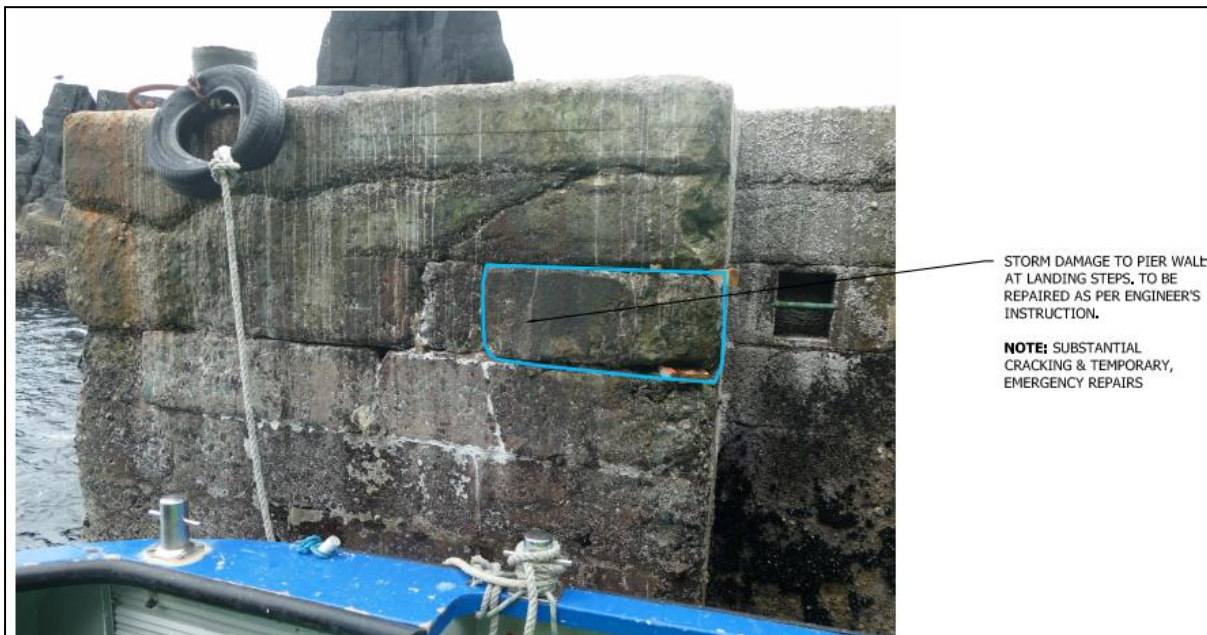
Figure 8. Storm-damaged block work in pier wall

Minor repair works are required to the pier wall at the Landing Pier to address storm damage which has resulted in cracking with the potential to affect the structures integrity if left in its current condition. Repair works are also required to the gate piers at the Upper Lighthouse to address existing defects. Large structural cracks are present in the outer gate pier in particular which is showing signs of substantial movement and is in danger of collapsing over the cliff-face.

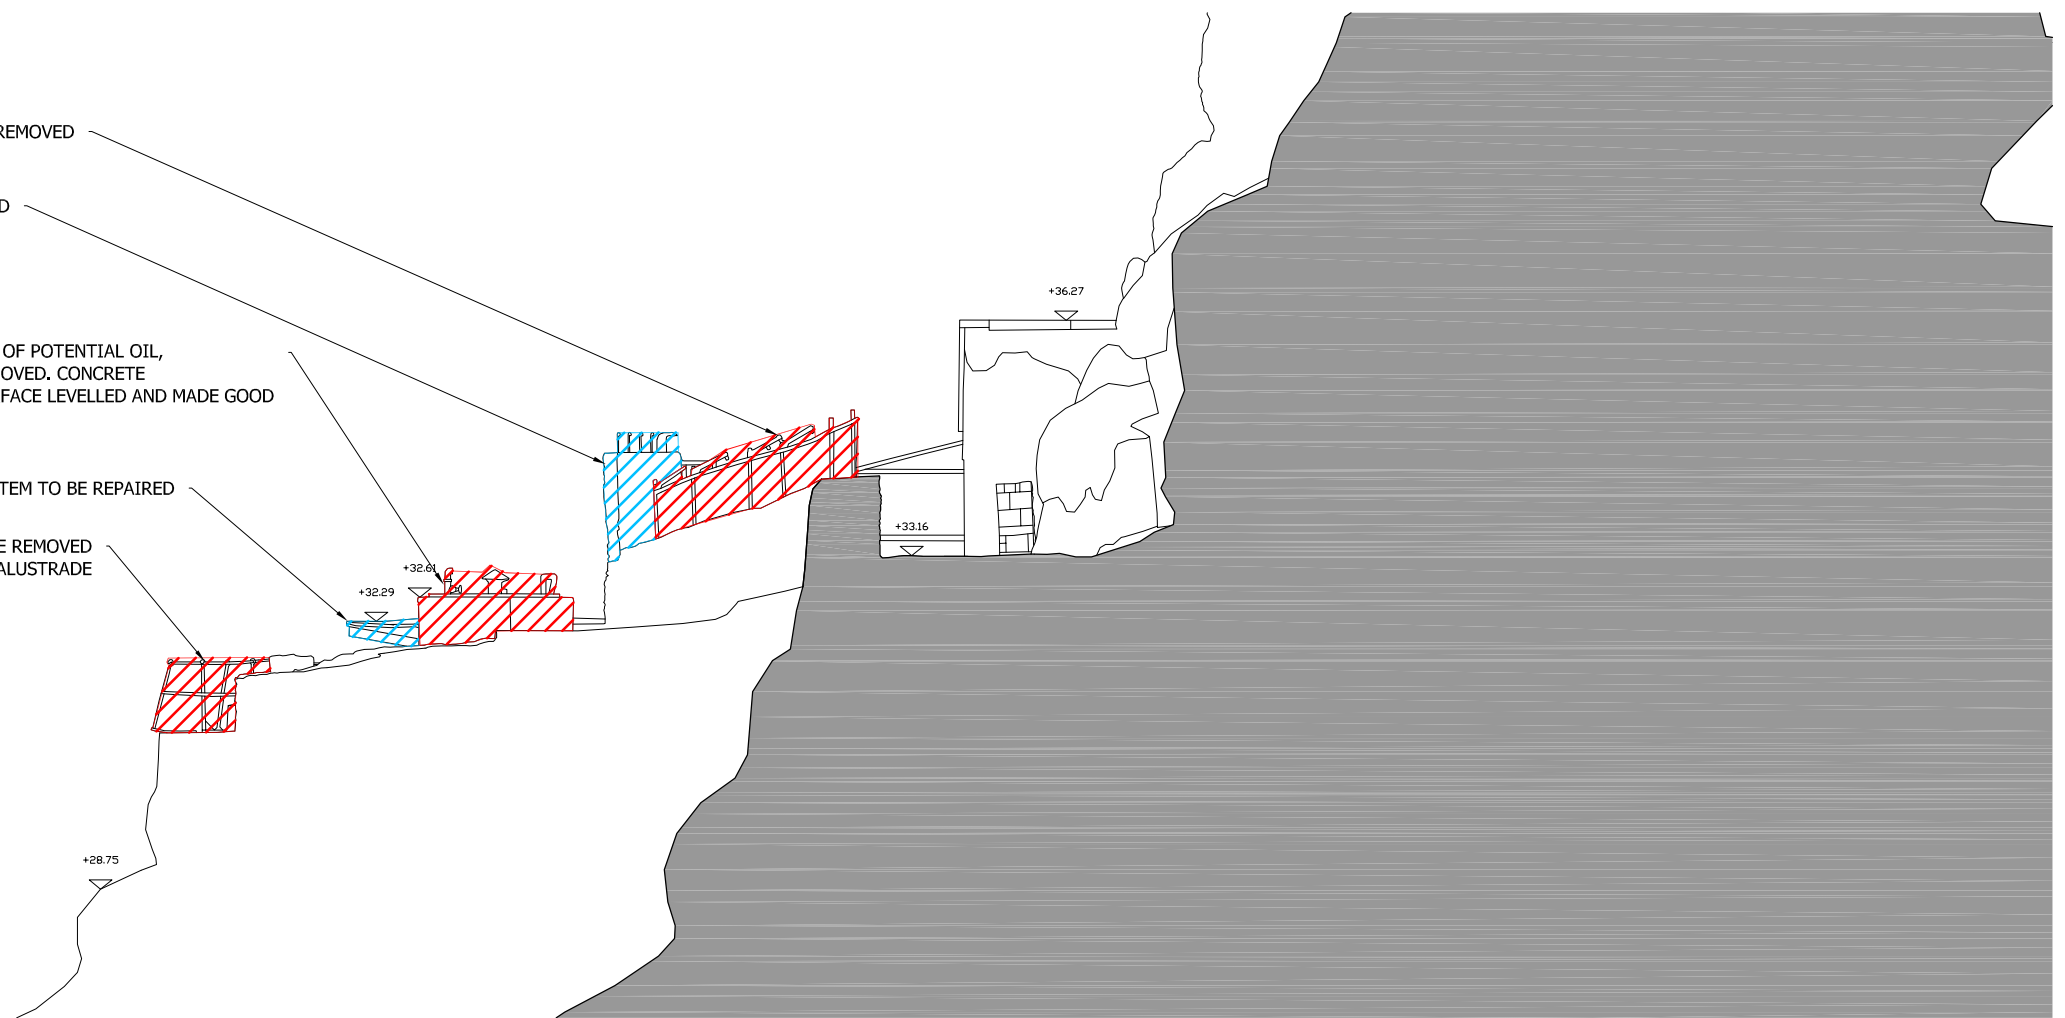
REMOVAL & REPAIR ELEVATION 2
SCALE@A3 1:150

EXISTING HELIPAD FALL ARREST SYSTEM TO BE REPAIRED

EXISTING STEEL BALLUSTRADE TO BE REMOVED AND REPLACED WITH NEW STEEL BALLUSTRADE

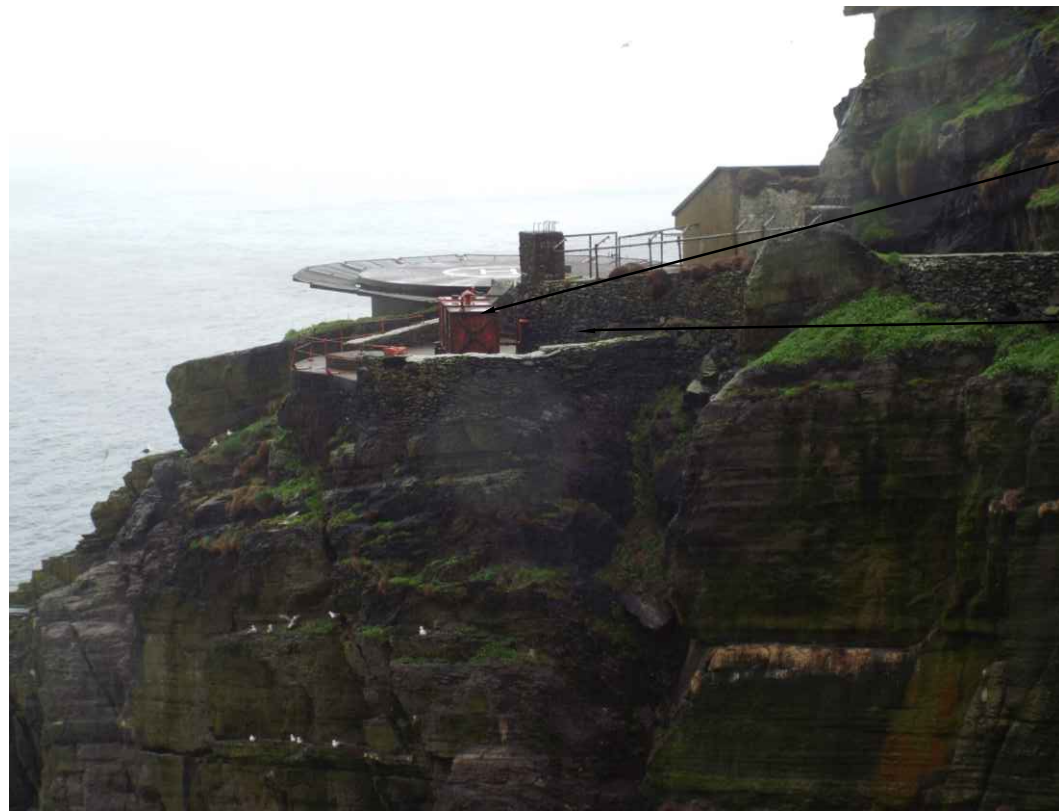
EXISTING OIL TANKS TO BE DRAINED OF POTENTIAL OIL, DESLUDGED, DISMANTELED AND REMOVED. CONCRETE TANK PLINTHS TO BE REMOVED, SURFACE LEVELLED AND MADE GOOD

LOCATION OF PROPOSED TOILET BLOCK

EXISTING CHAINLINK FENCE & GATE TO BE REMOVED
NEW FENCE TO BE INSTALLED

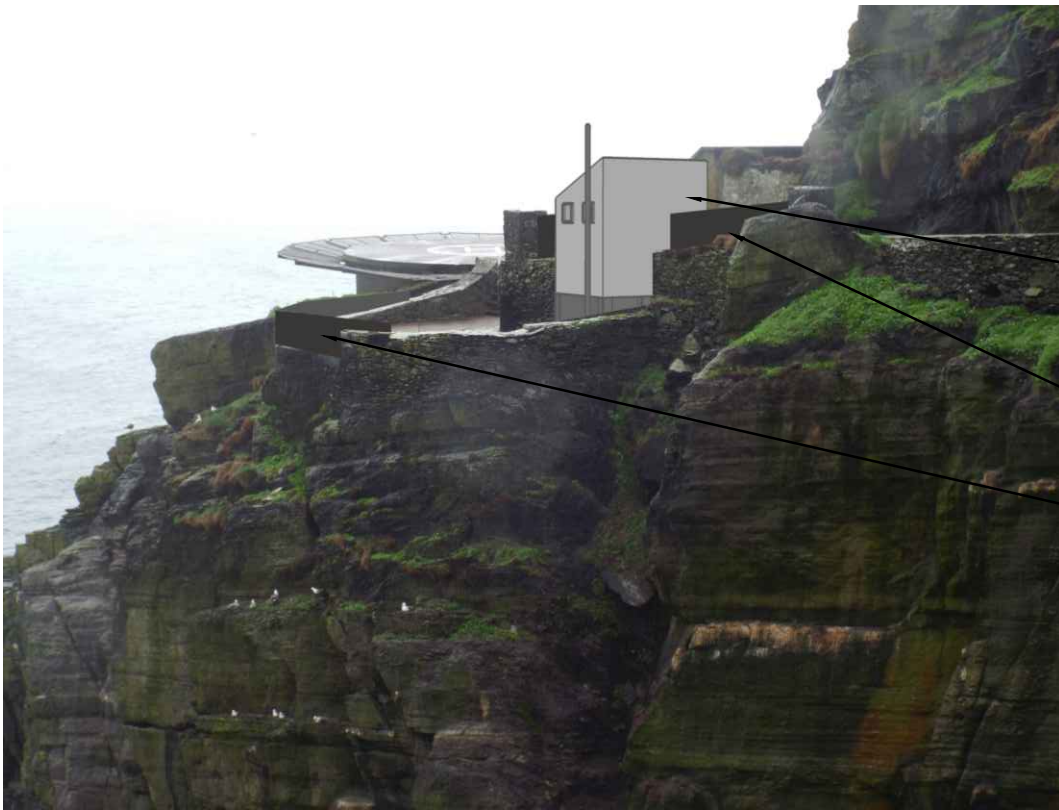
PROPOSED TOILET BLOCK

EXISTING CHAINLINK FENCE & GATE TO BE REMOVED
NEW FENCE TO BE INSTALLED

EXISTING BALLUSTRADE TO BE REMOVED AND REPLACED

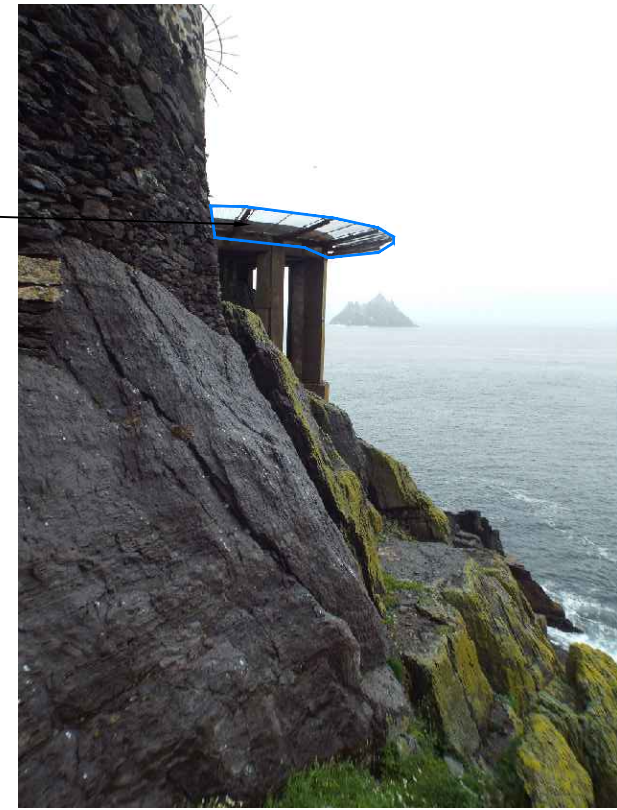
EXISTING HELIPAD WIRE FALL ARREST SYSTEM TO BE REPAIRED

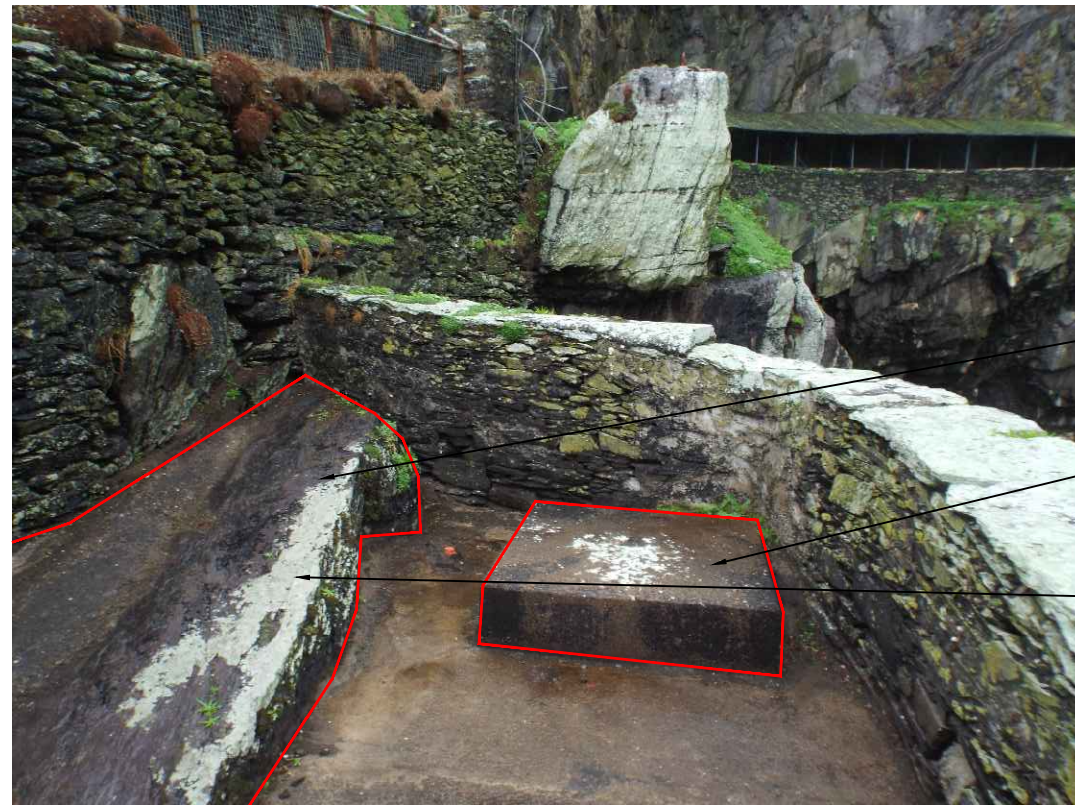
02
003
VIEW OF EXISTING OIL TANKS AND BALUSTRADE

EXISTING OIL TANKS TO BE DRAINED OF POTENTIAL OIL, DESLUDGED, DISMANTELED AND REMOVED. CONCRETE TANK PLINTHS TO BE REMOVED, SURFACE LEVELLED AND MADE GOOD

EXISTING STEEL BALUSTRADE TO BE REMOVED AND REPLACED WITH NEW STEEL BALUSTRADE

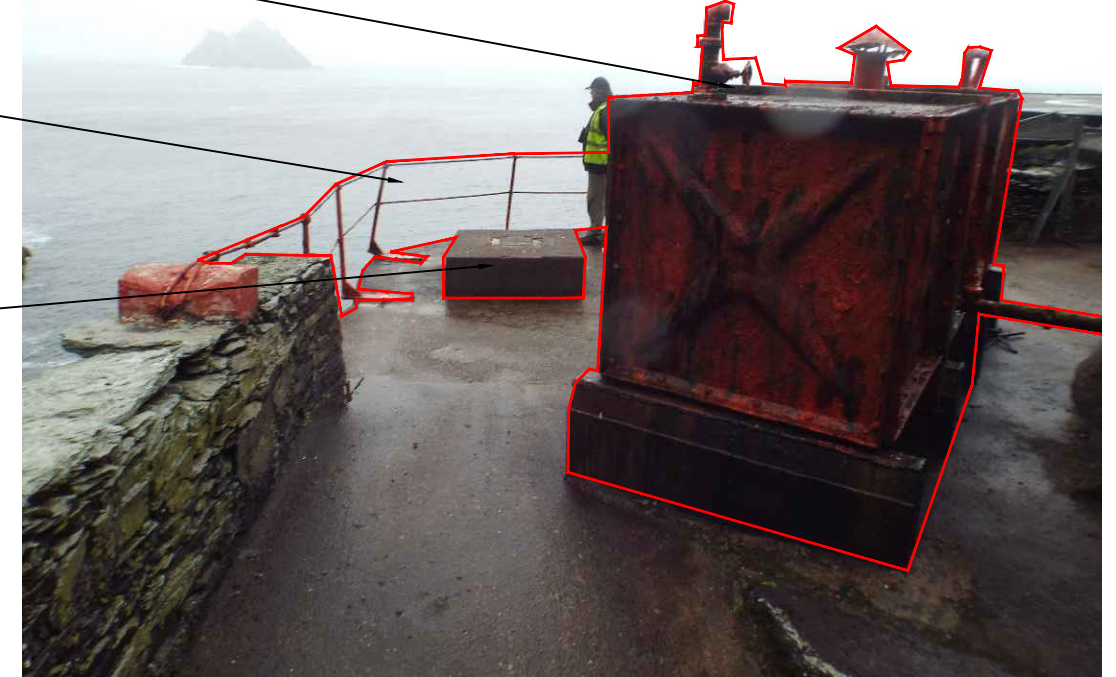
EXISTING CONCRETE PAD TO BE REMOVED, SURFACE LEVELLED AND MADE GOOD

LOCATION OF PROPOSED TOILET BLOCK

01
003
EXISTING BEDROCK AND CONCRETE PAD

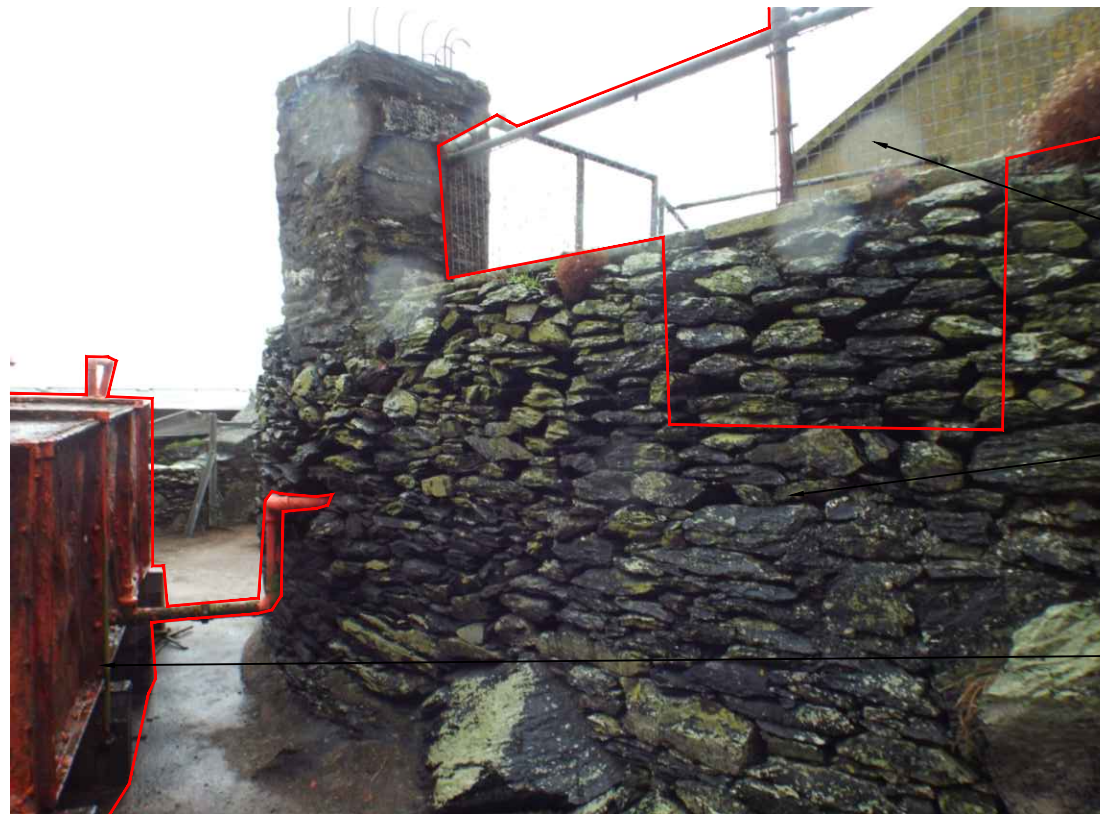
LOCATION OF PROPOSED TOILET BLOCK

EXISTING CHAINLINK FENCE TO BE REMOVED AND REPLACED, SECTION OF EXISTING STONE WALL TO BE REMOVED FOR ACCESS TO NEW WC BLOCK

EXISTING OIL TANKS TO BE DRAINED OF POTENTIAL OIL, DESLUDGED, DISMANTELED AND REMOVED. CONCRETE TANK PLINTHS TO BE REMOVED, SURFACE LEVELLED AND MADE GOOD

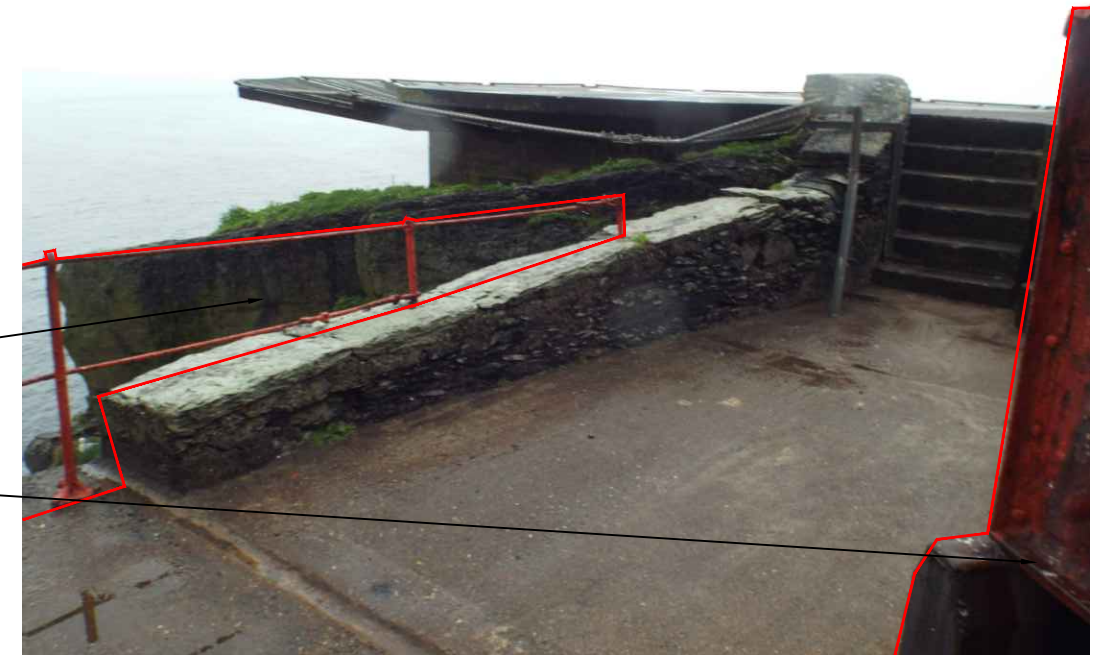
EXISTING STEEL BALUSTRADE TO BE REMOVED AND REPLACED WITH NEW STEEL BALUSTRADE

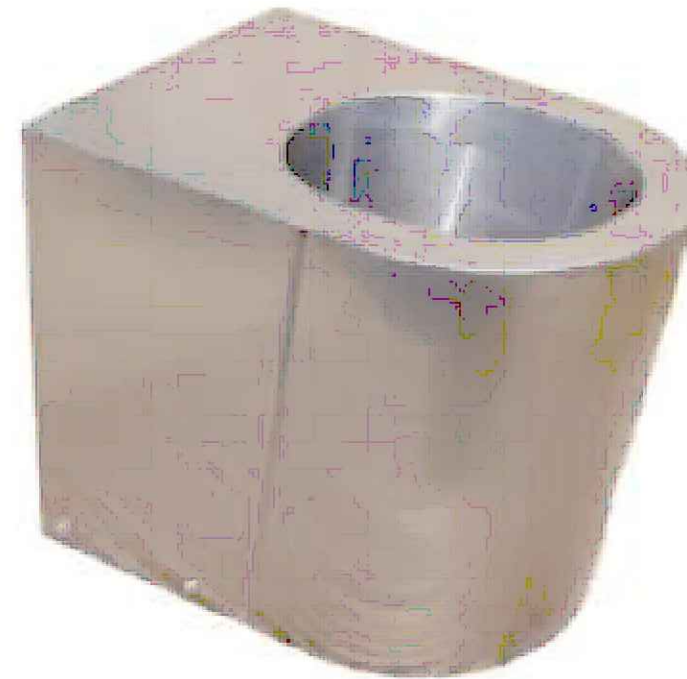
CL810 - Dry Toilet (Stainless Steel)

H x D x W = 39 cm x 50 cm x 34 cm

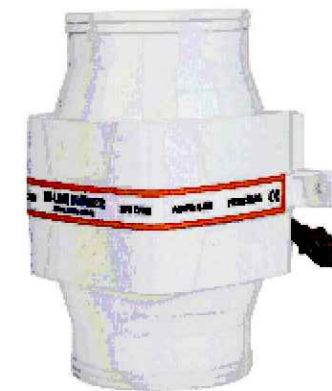
CK500 - Wind Powered Fan

This fan uses wind power to ventilate.

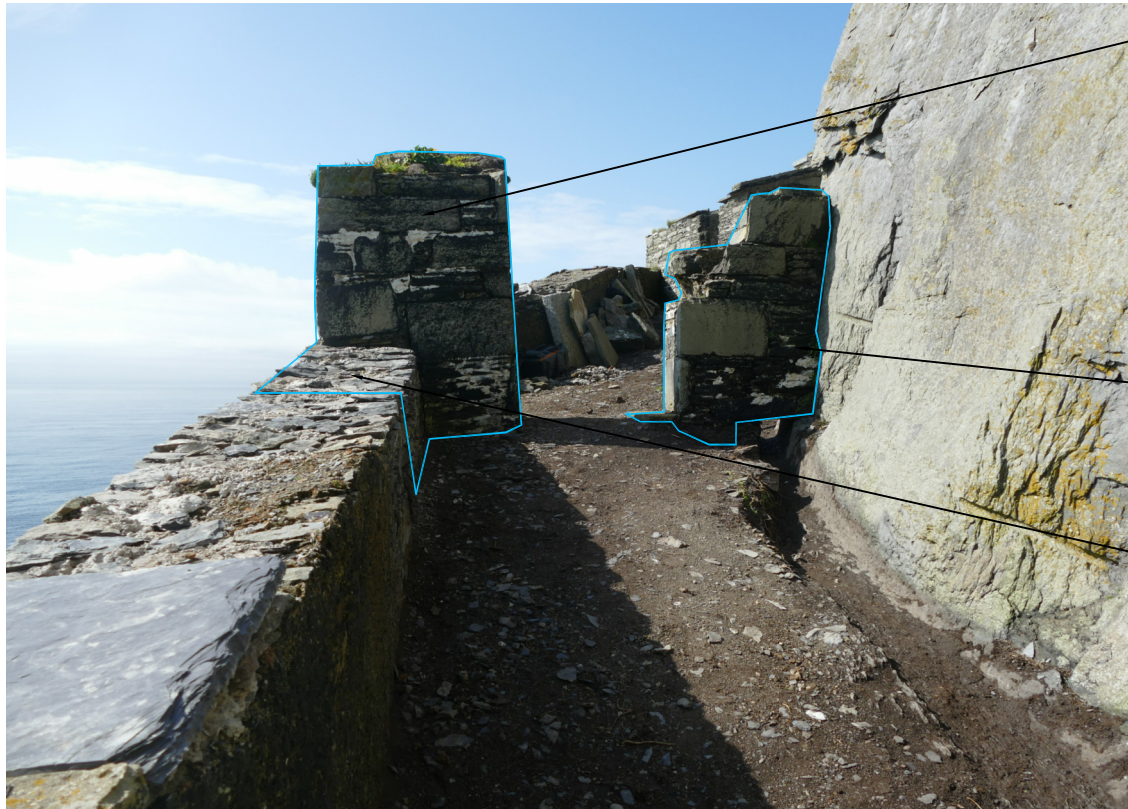
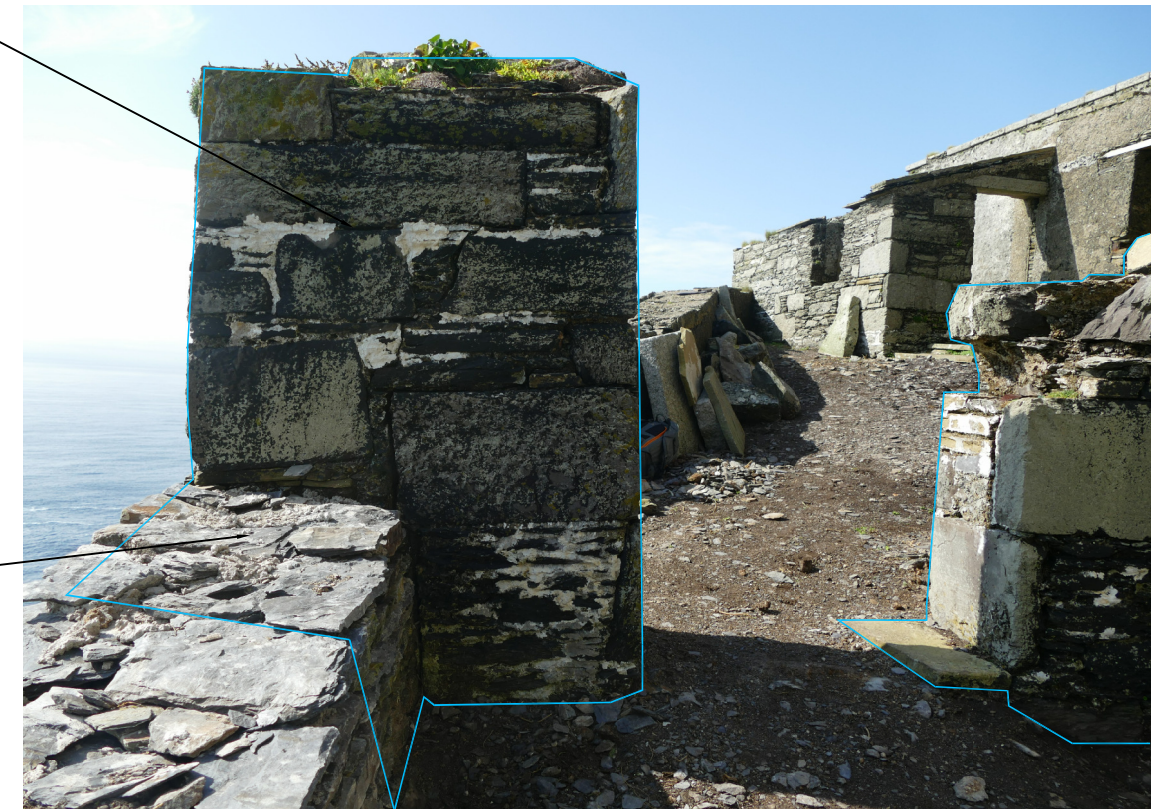
VIEW OF OUTER GATE PIERS FROM EAST - GATE B TO LEFT, GATE A TO RIGHT.

EXISTING GATE PIER B TO BE DISMANTELED & STONES NUMBERED AND RECORDED. PIER TO BE BUILT AS BEFORE USING EXISTING NUMBERED AND SAVED STONES & LIME MORTAR.

NOTE: SUBSTANTIAL STRUCTURAL CRACKING & SUBSIDENCE.

EXISTING WALL ADJACENT TO GATE PIER TO BE REPAIRED & REPOINTED WITH LIME MORTAR

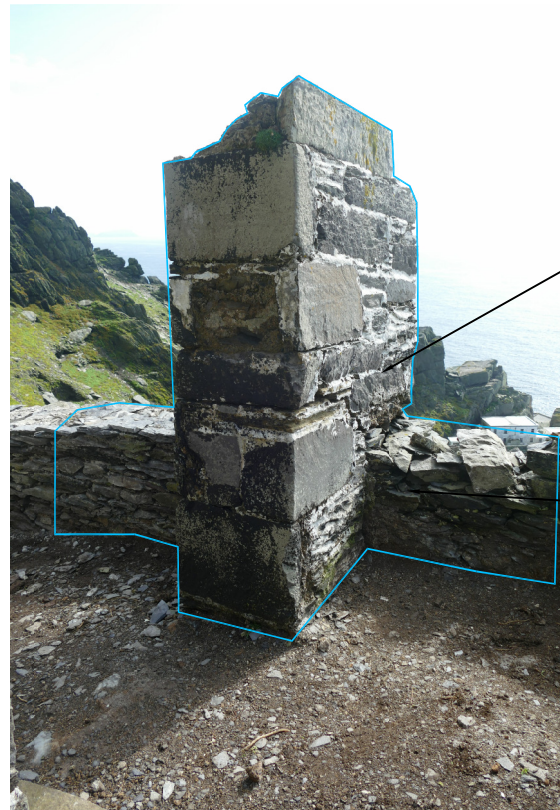
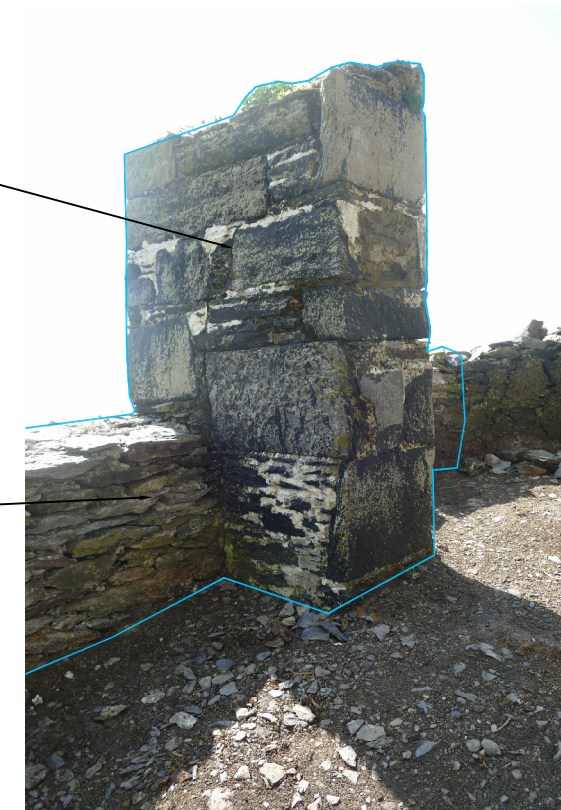
VIEW OF OUTER GATE PIER B FROM WEST

EXISTING GATE PIER B TO BE DISMANTELED & STONES NUMBERED AND RECORDED. PIER TO BE BUILT AS BEFORE USING EXISTING NUMBERED AND SAVED STONES & LIME MORTAR.

NOTE: SUBSTANTIAL STRUCTURAL CRACKING & SUBSIDENCE.

EXISTING WALL ADJACENT TO GATE PIER TO BE REPAIRED & REPOINTED WITH LIME MORTAR

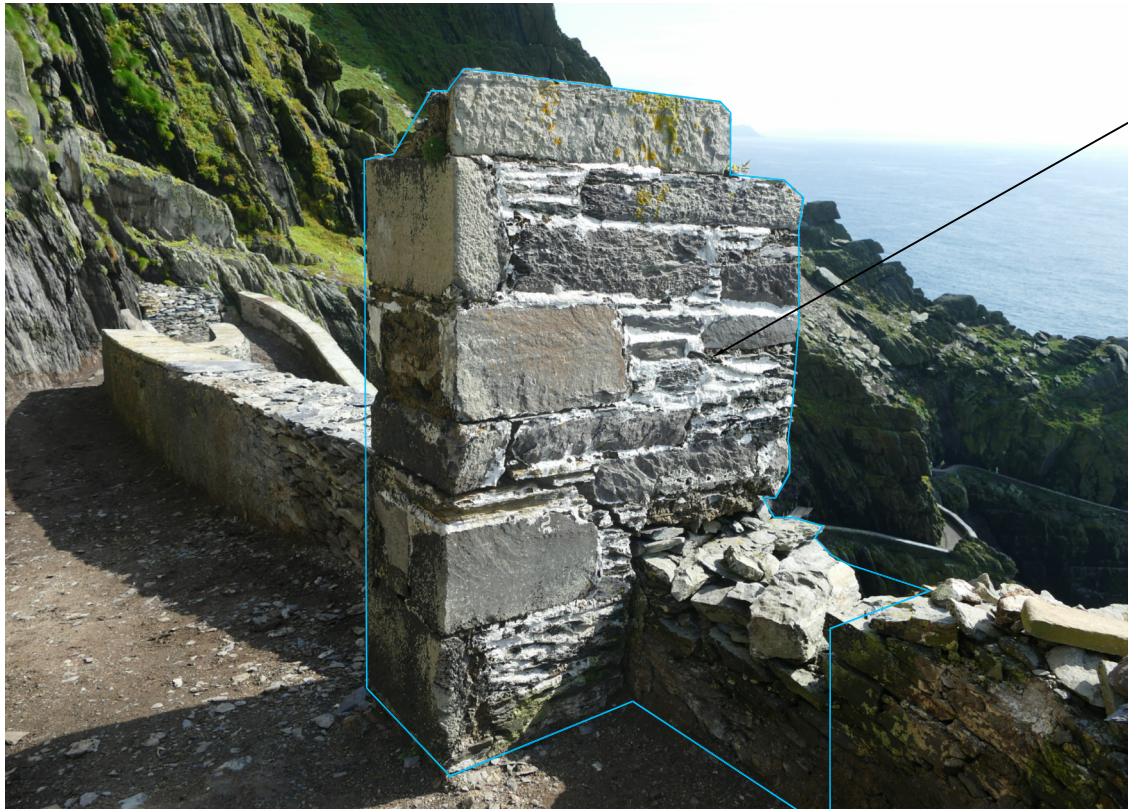
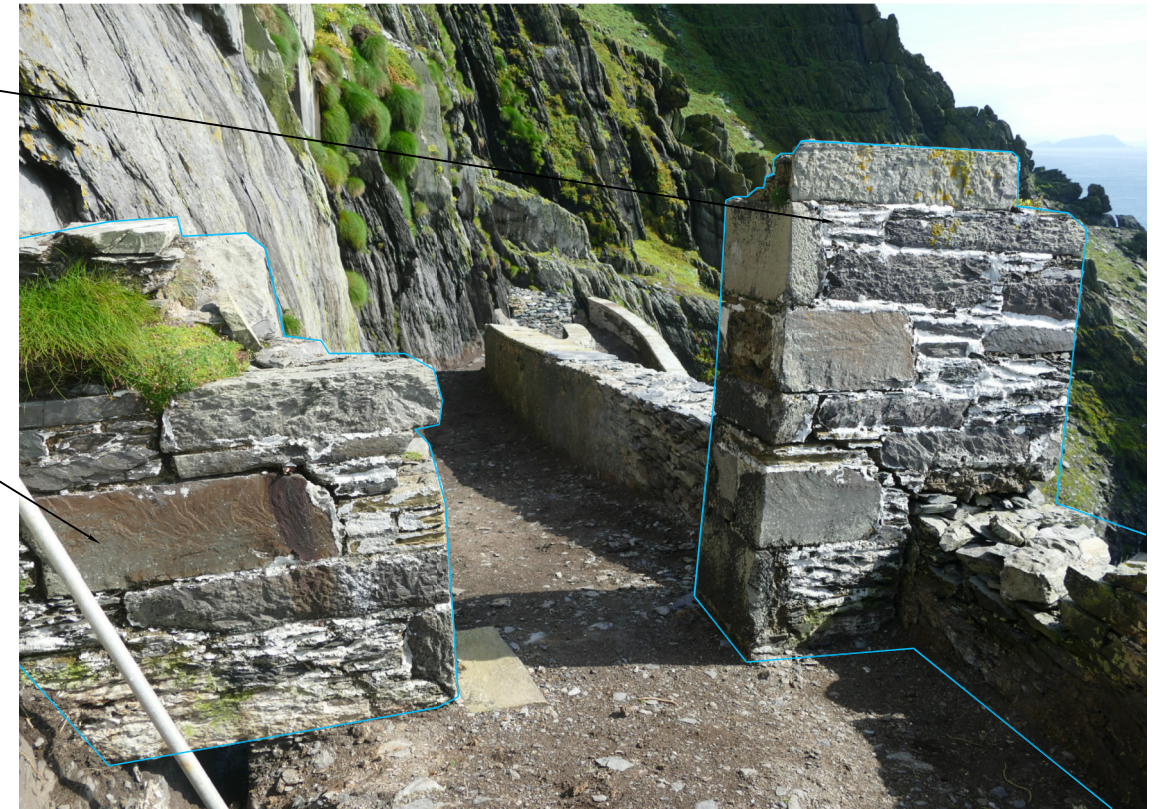
01
002 VIEW OF OUTER GATE PIER B FROM WEST

EXISTING GATE PIER B TO BE DISMANTELED & STONES NUMBERED AND RECORDED. PIER TO BE BUILT AS BEFORE USING EXISTING NUMBERED AND SAVED STONES & LIME MORTAR.

NOTE: SUBSTANTIAL STRUCTURAL CRACKING & SUBSIDENCE.

EXISTING GATE PIER A TO BE REPAIRED AND REPOINTED WITH LIME MORTAR.

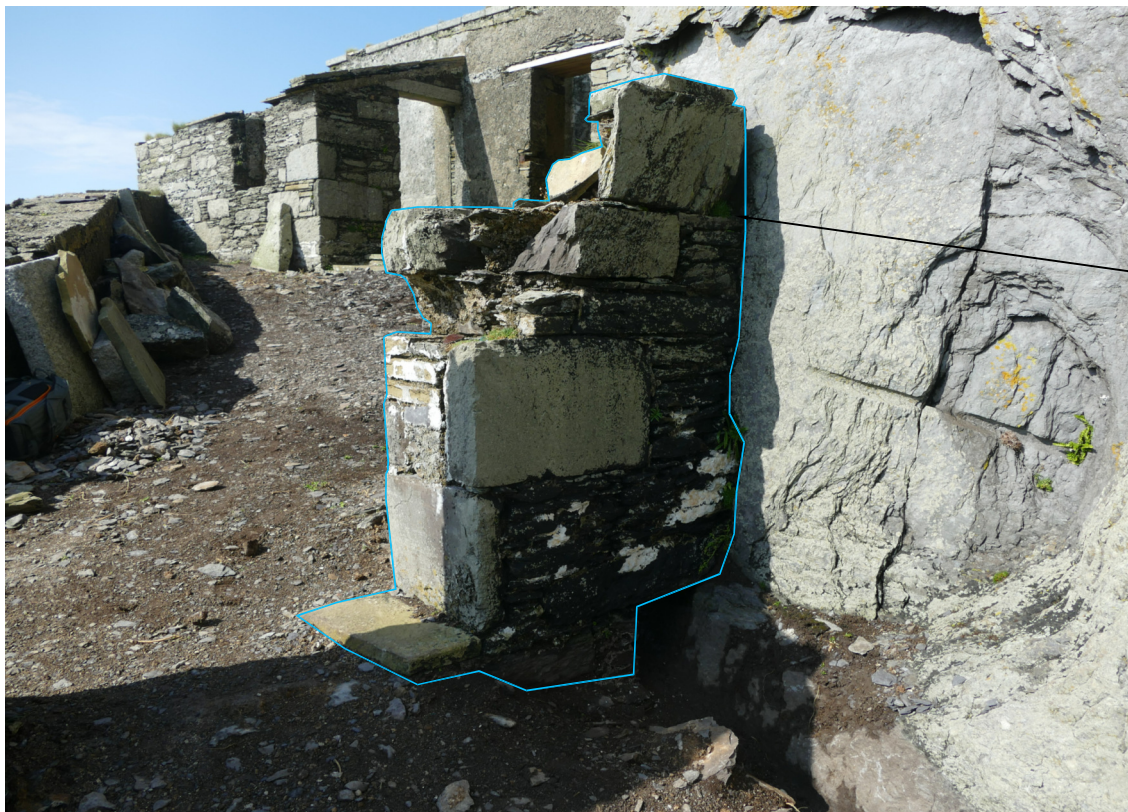
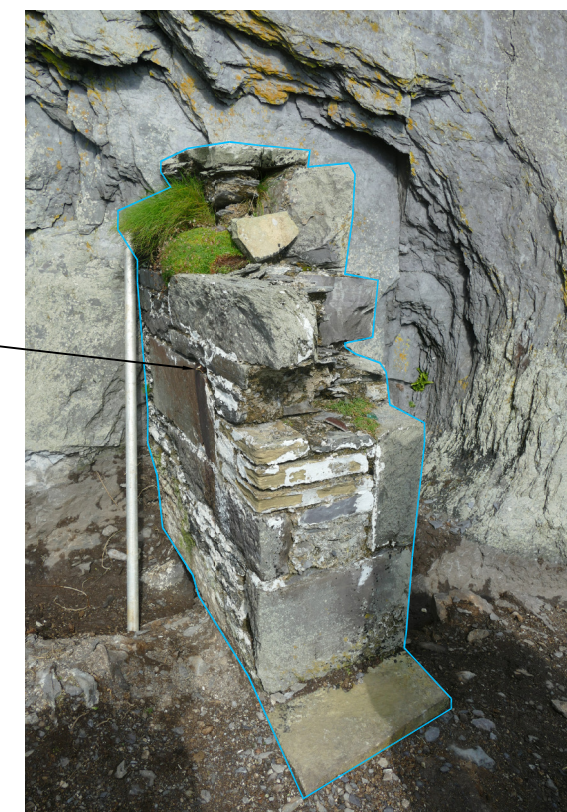
03
002 VIEW OF OUTER GATE PIER A FROM EAST

EXISTING GATE PIER A TO BE REPAIRED AND REPOINTED WITH LIME MORTAR.

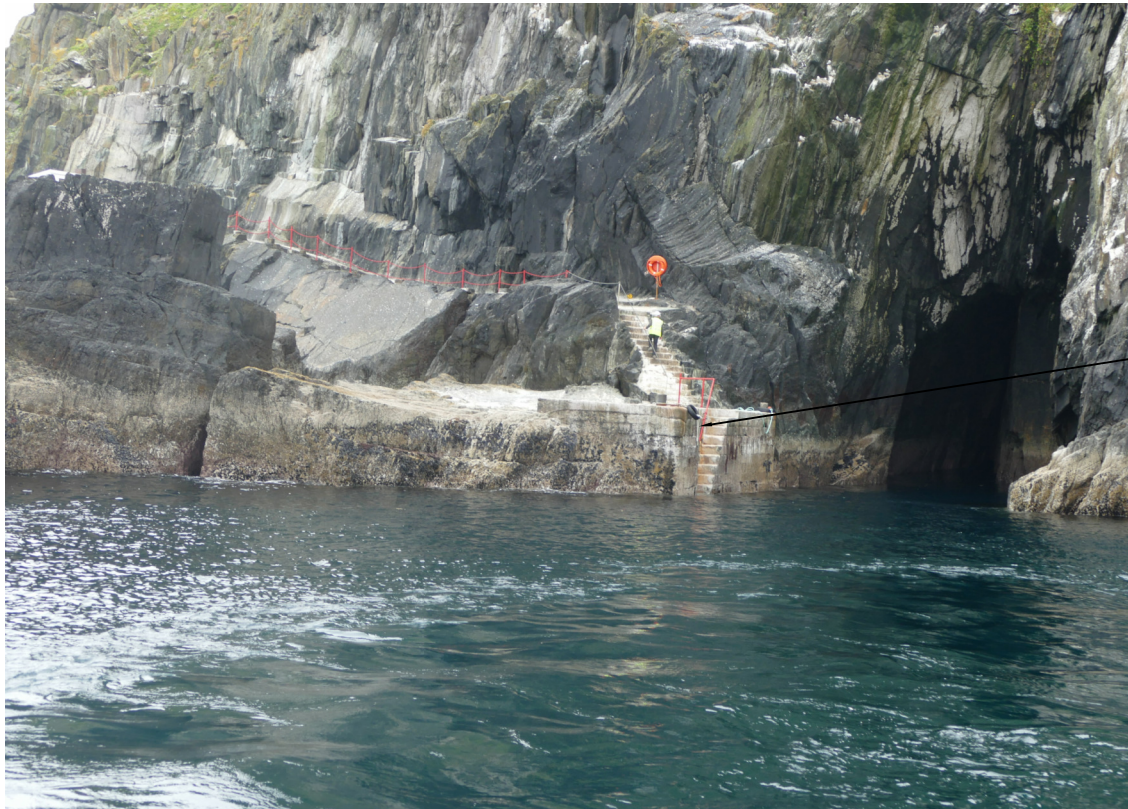
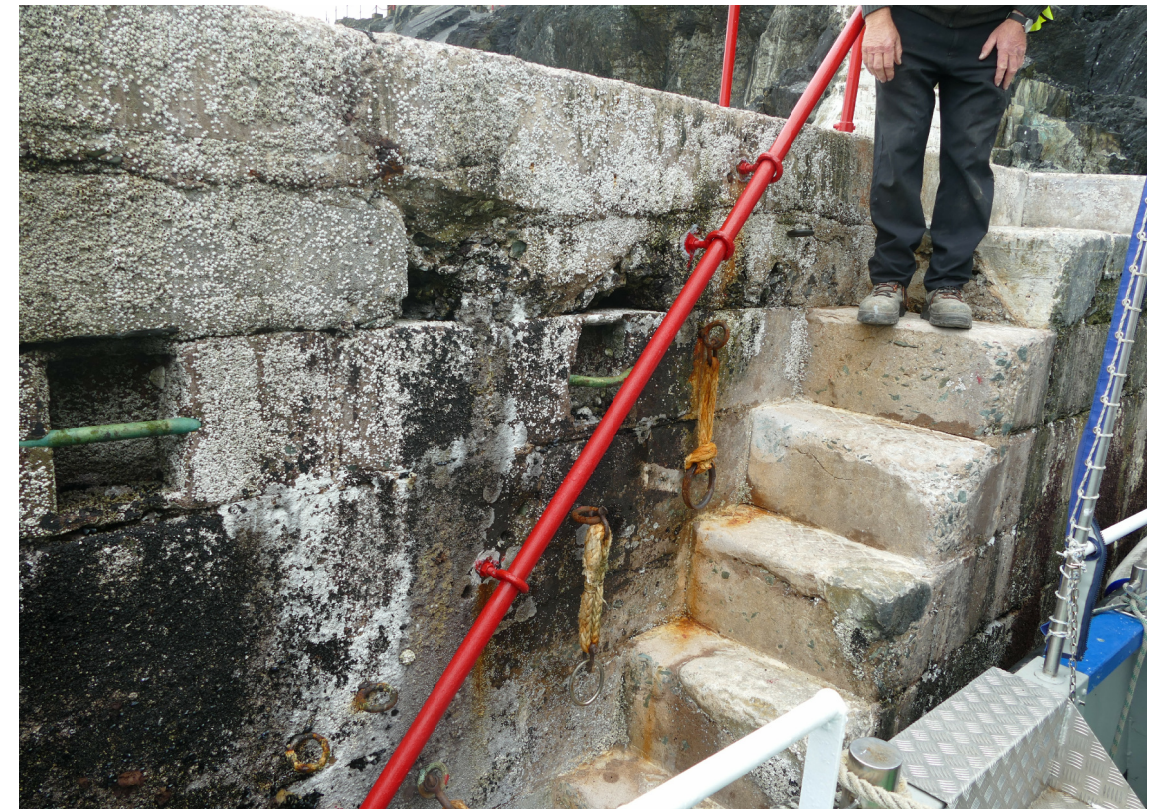
01
001 VIEW OF LANDING PIER FROM EAST

STORM DAMAGE TO PIER WALL AT LANDING STEPS. TO BE REPAIRED AS PER ENGINEER'S INSTRUCTION.

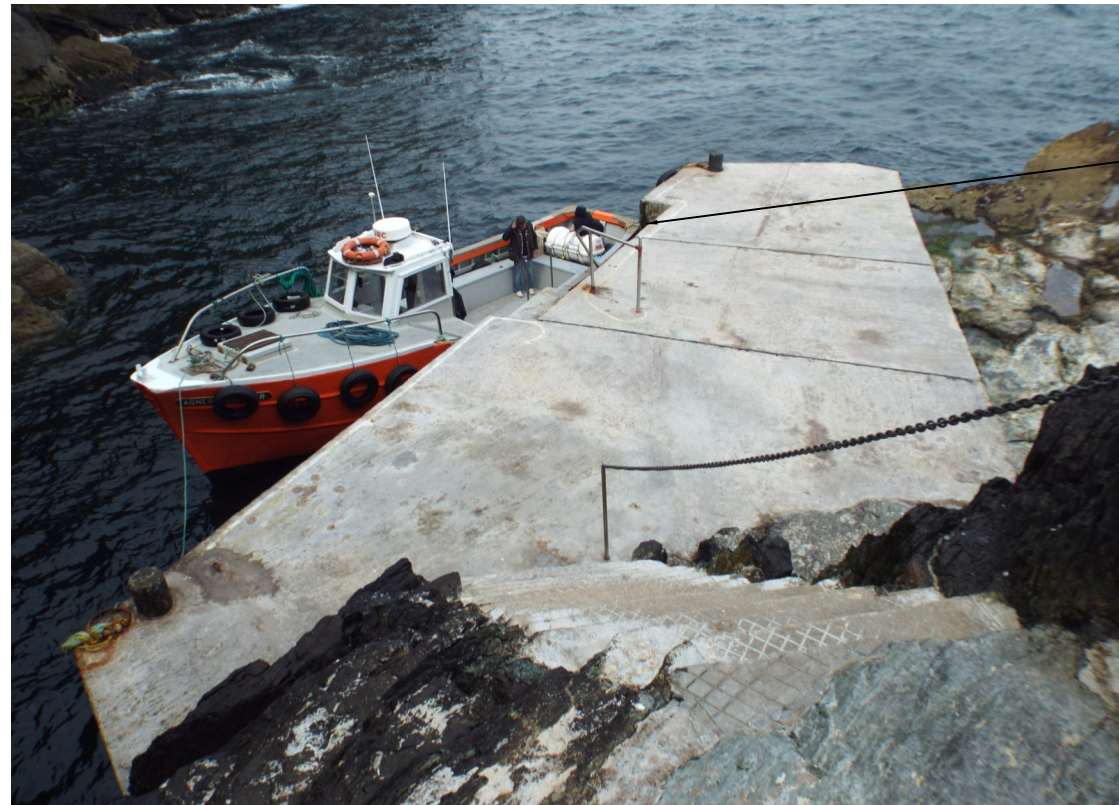
STORM DAMAGE LOCATION

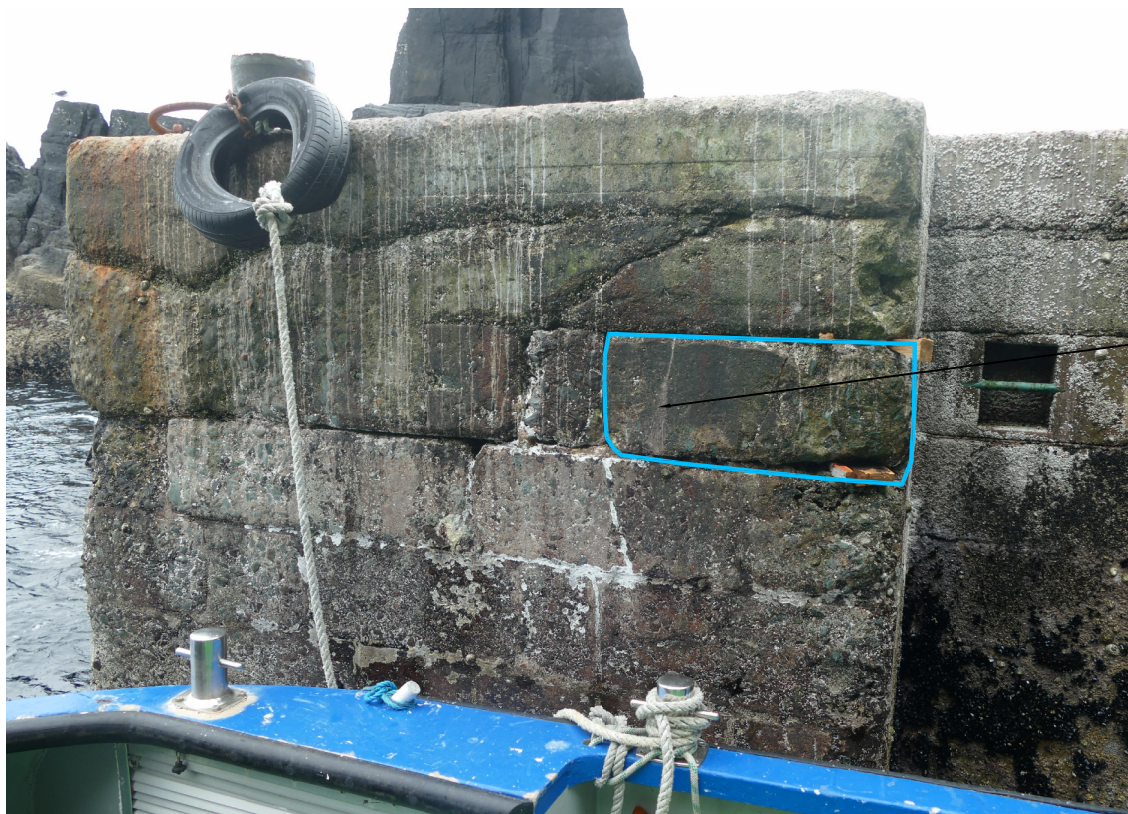
01
002

VIEW OF DAMAGE TO PIER WALL

NOTE: SUBSTANTIAL
CRACKING & TEMPORARY,
EMERGENCY REPAIRS

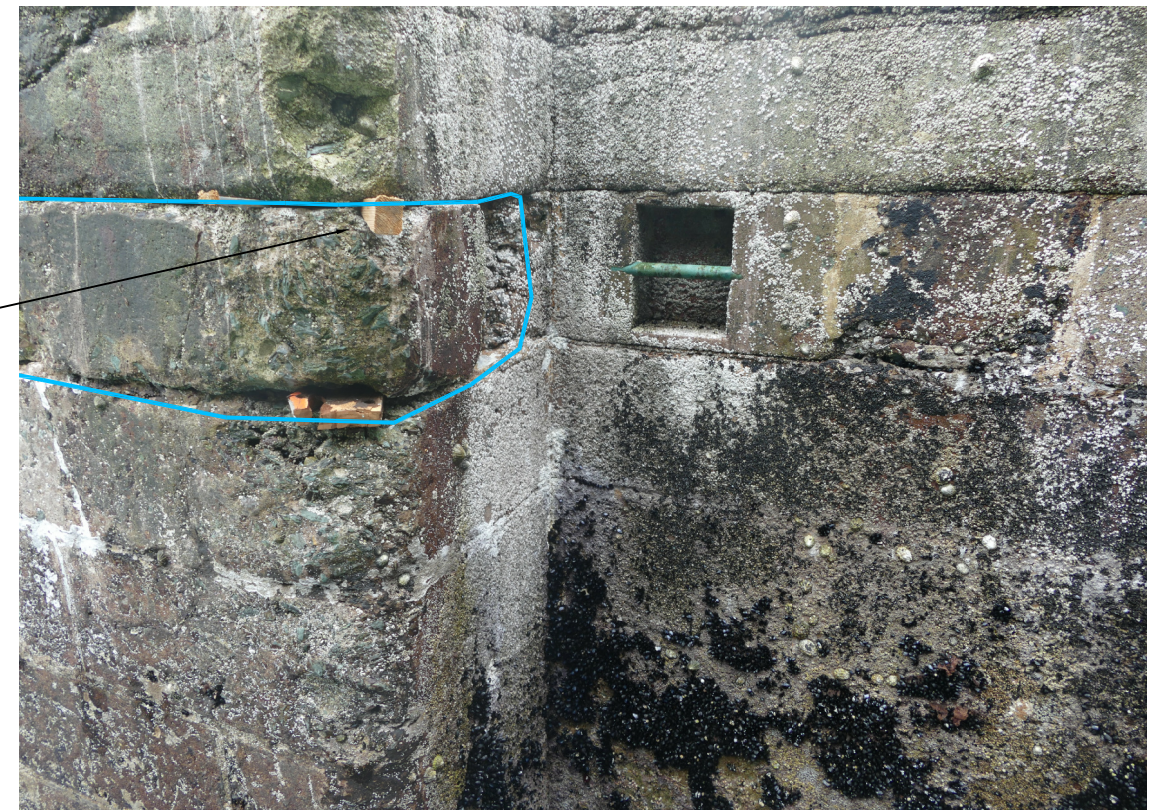
02
002

VIEW OF DAMAGE TO PIER WALL
