**Natura Impact Statement**  
Construction of 3 No. Permanent Crash Decks on  
Lighthouse Road, Skellig Michael Island

ISSUE FORM	
Project number	12242
Document number	6042
Document revision	A
Document title	Natura Impact Statement: Construction of 3 No. Permanent Crash Decks on Lighthouse Road, Skellig Michael Island
Document status	Final
Issue Date	22-06-2021
Document prepared by	HD
Document checked by	MKy – MWP – 22-06-2021

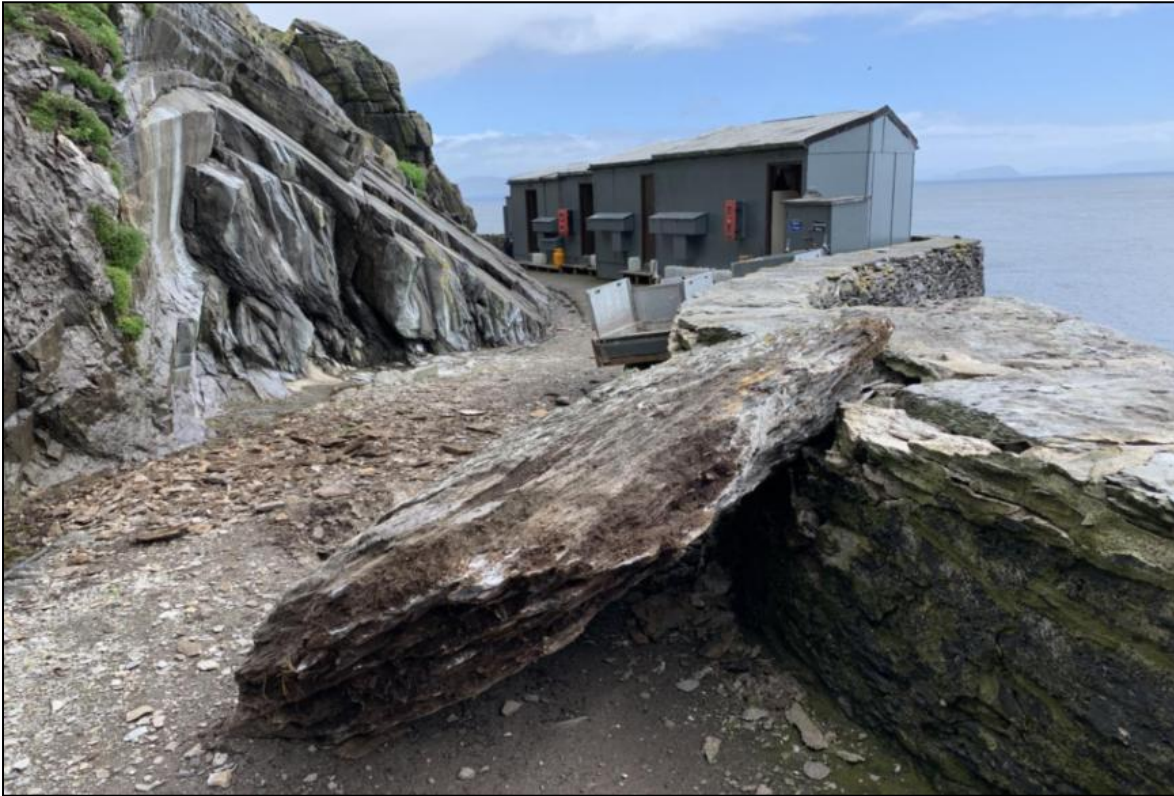
Plate 1. Displaced boulder on roadway following rock-fall near OPW accommodation huts in July 2020

On 27<sup>th</sup> July 2020, another rock-fall occurred in this area, with another large boulder landing on the roadway in the same location, again causing damage to the seawall. The area in which the rock fall occurred is a route where water flows down from above, displacing rocks and earth, and washing them down onto the Lighthouse Road and into its drainage channel. A large volume of water flows down the cliff-face in this particular area during heavy rainfall. This location is currently a safety risk to OPW personnel and visitors to the island.

**Plate 1** and **2** below show the aftermath of the 2017 and 2020 rock falls in this area and in particular the proximity of the displaced boulders to the OPW worker's accommodation huts.

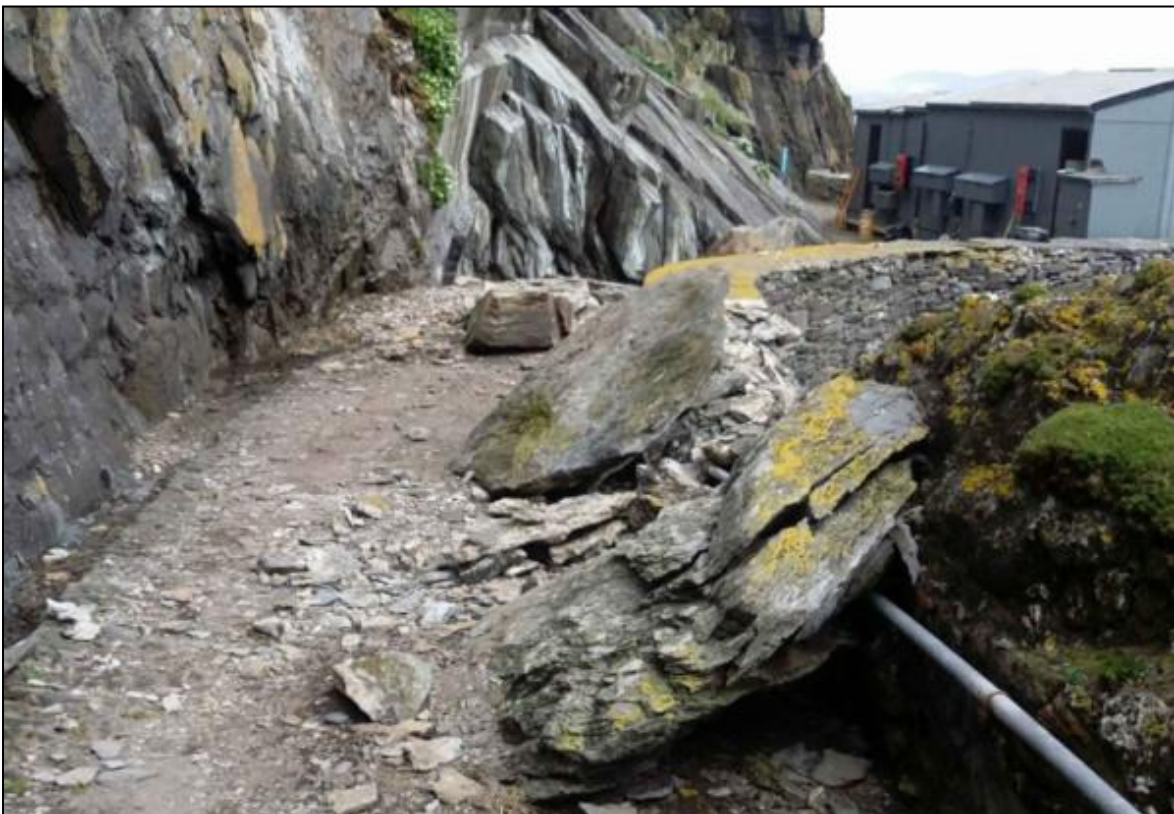
Plate 2. Displaced boulders on roadway following rock-fall near OPW accommodation huts in August 2017

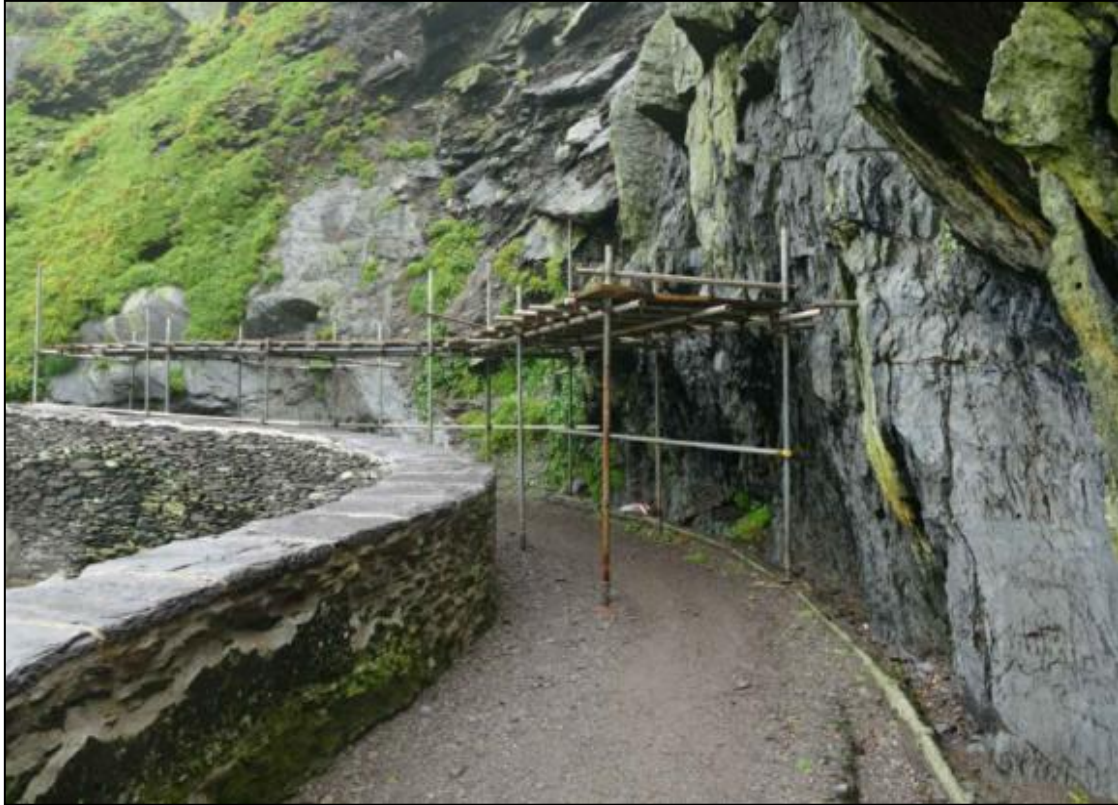
Plate 3. Temporary crash deck installed at location of proposed crash deck 2 on the Upper Lighthouse Road

Crash Deck 2 and Crash Deck 3 are located in areas prone to rock falls on the Upper Lighthouse Road.

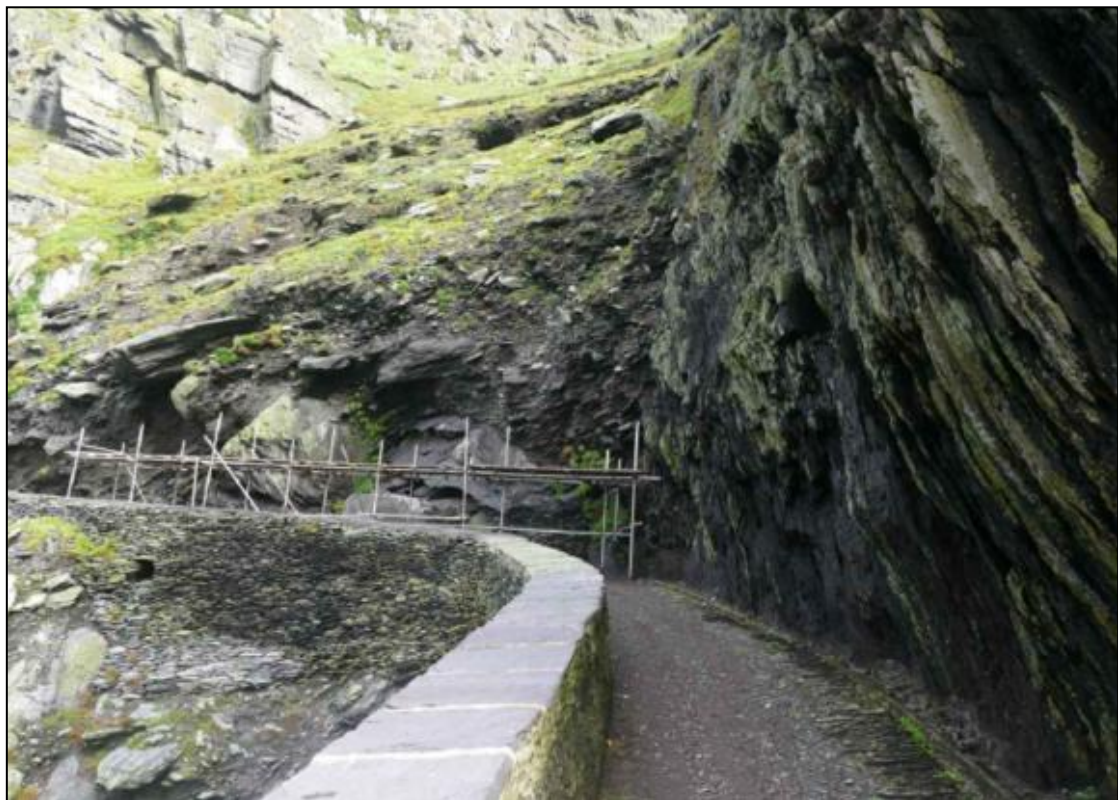
Plate 4. Temporary crash deck installed at location of proposed crash deck 3 on the Upper Lighthouse Road

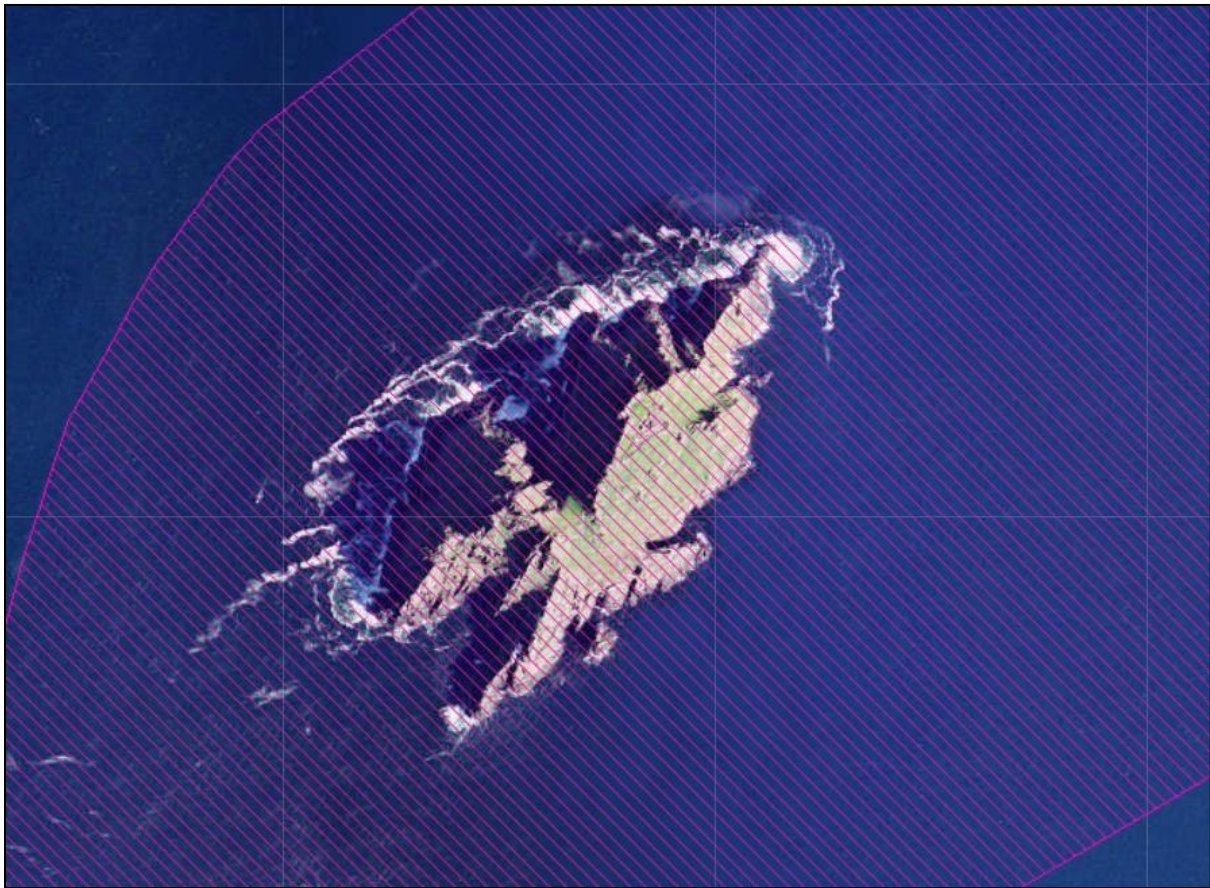
**Figure 3. Skellig Michael and the Skelligs SPA (004007) boundary**

However, Skellig Michael, and thus the proposed works, are encompassed entirely within the boundary of the Skelligs SPA, as shown in **Figure 3** below.

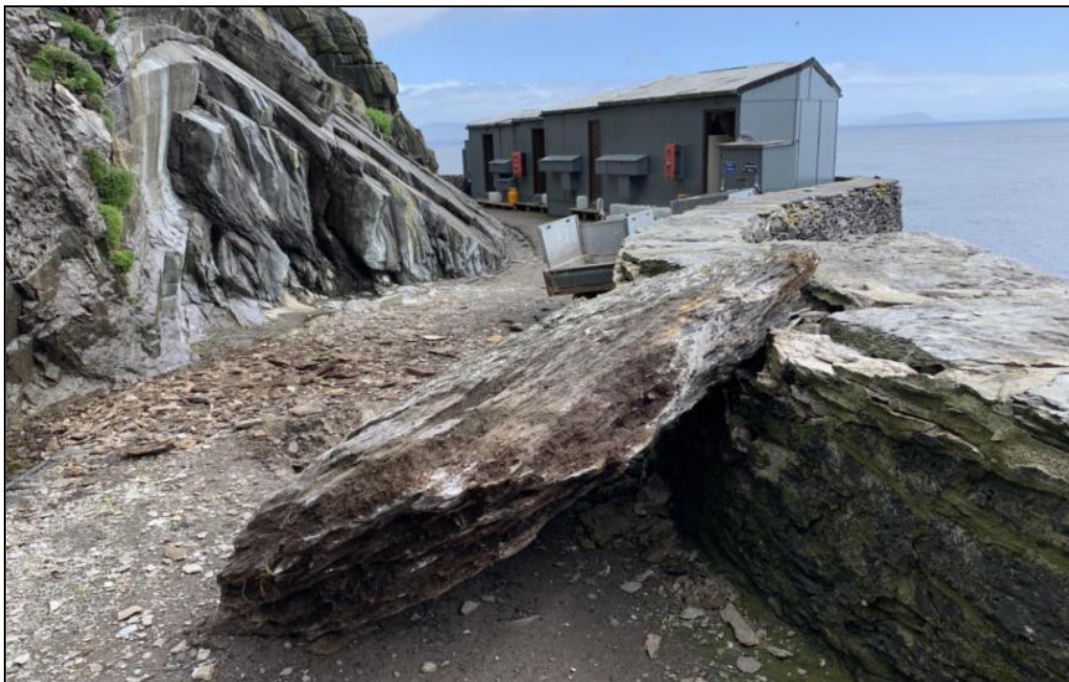
Plate 1. Displaced boulder on roadway following rock-fall near worker's accommodation huts in July 2020

**Crash Deck 1** is located on the Lower Lighthouse Road near the existing OPW site huts. Dangerous rock falls occurred in this area in 2017 and 2020 (see **Plate 1** below). **Crash Deck 2** and **Crash Deck 3** are located in areas prone to rock falls on the Upper Lighthouse Road. Refer to **Figure 1** above for crash deck locations.
