ERDC TR-10-4

Airfield Damage Repair Civil Engineer Modernization Program

Laboratory and Field Evaluation of Rapid Setting Cementitious Materials for Large Crater Repair

May 2010

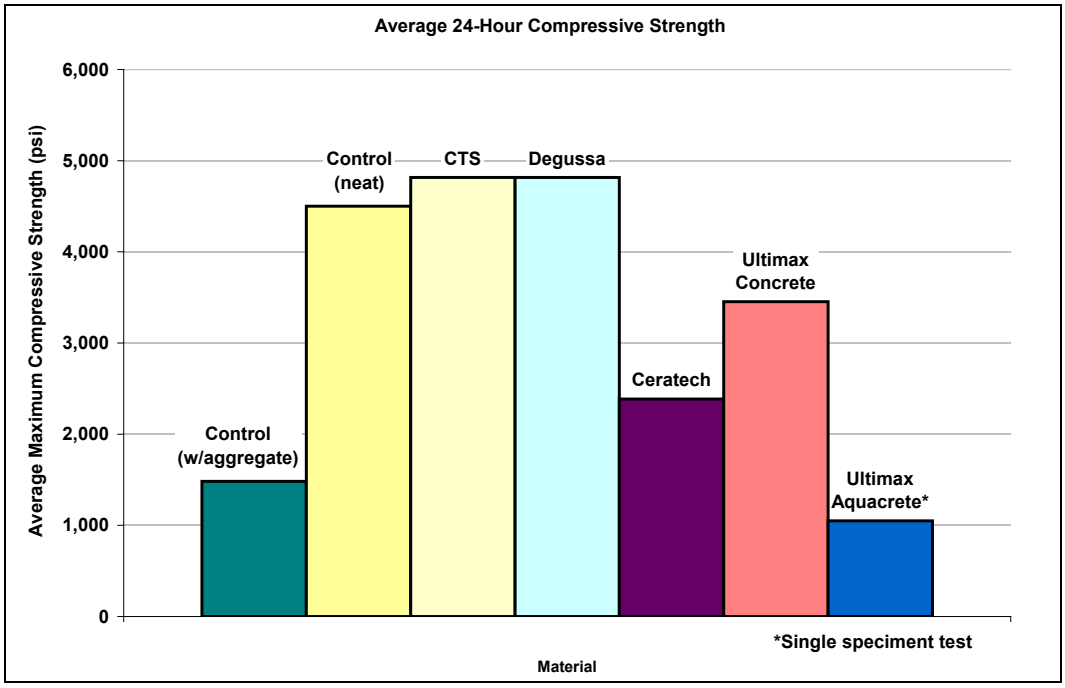
The test results, shown in Figure 100 for the 2 hr test age and Figure 101 for the 24 hr test age, are average values. All compressive strength test results at 2 and 24 hr are listed in Table 14 and Table 15 respectively.

Figure 101. Results of 24 hr average compressive strength tests on field cast cylinders.

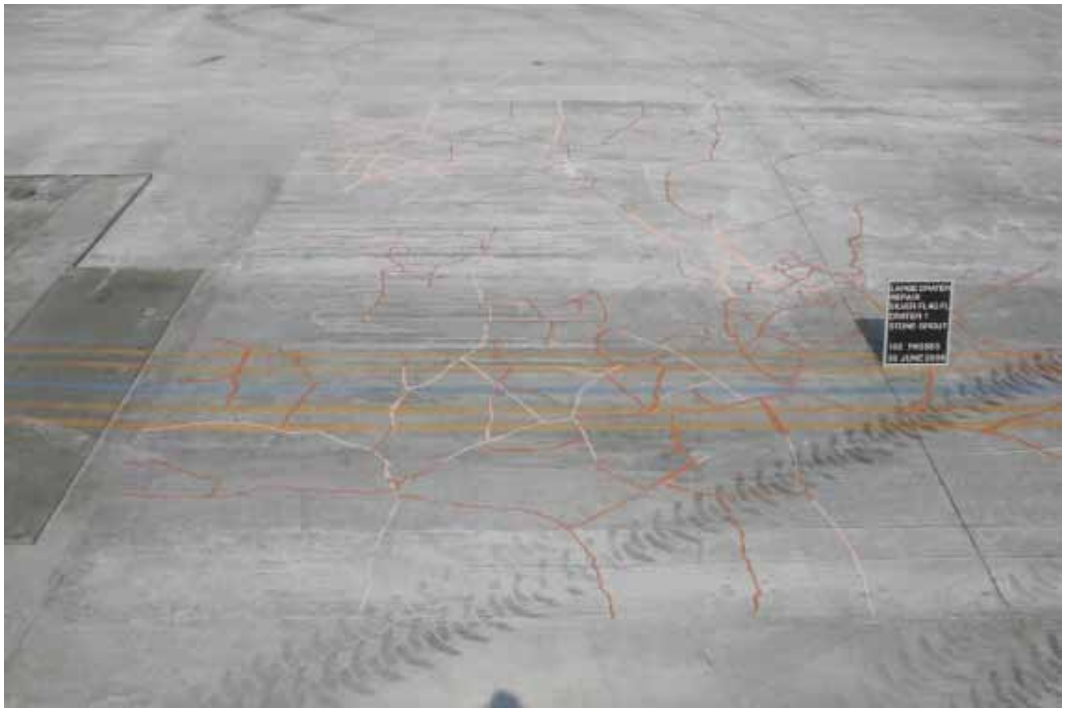
Figure 135. Crater 1, Stone & grout after 102 passes of load cart.

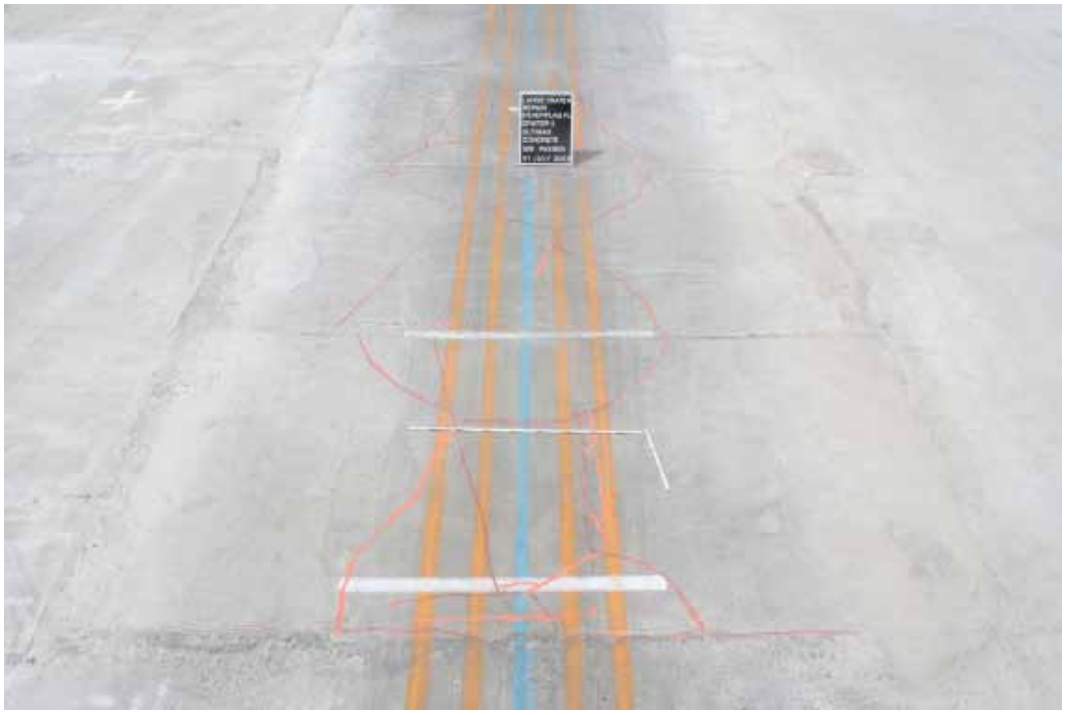
Figure 143. Crater 4 after 528 completed load cart passes.

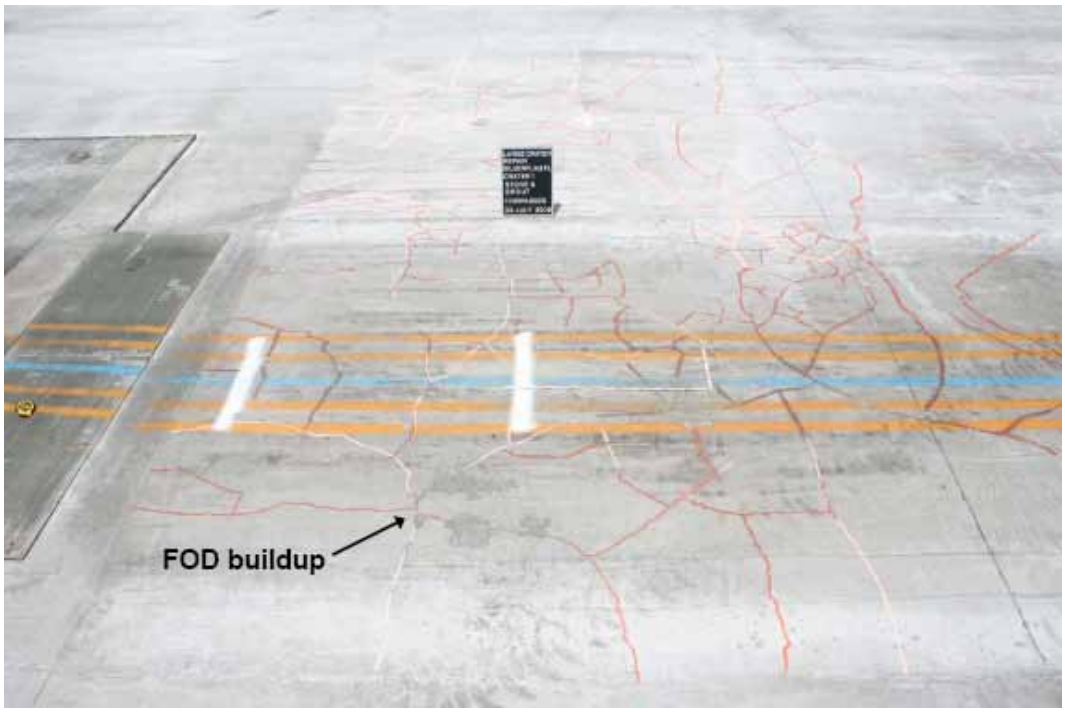
Figure 146. Crater 1 after 1,008 completed load cart passes.

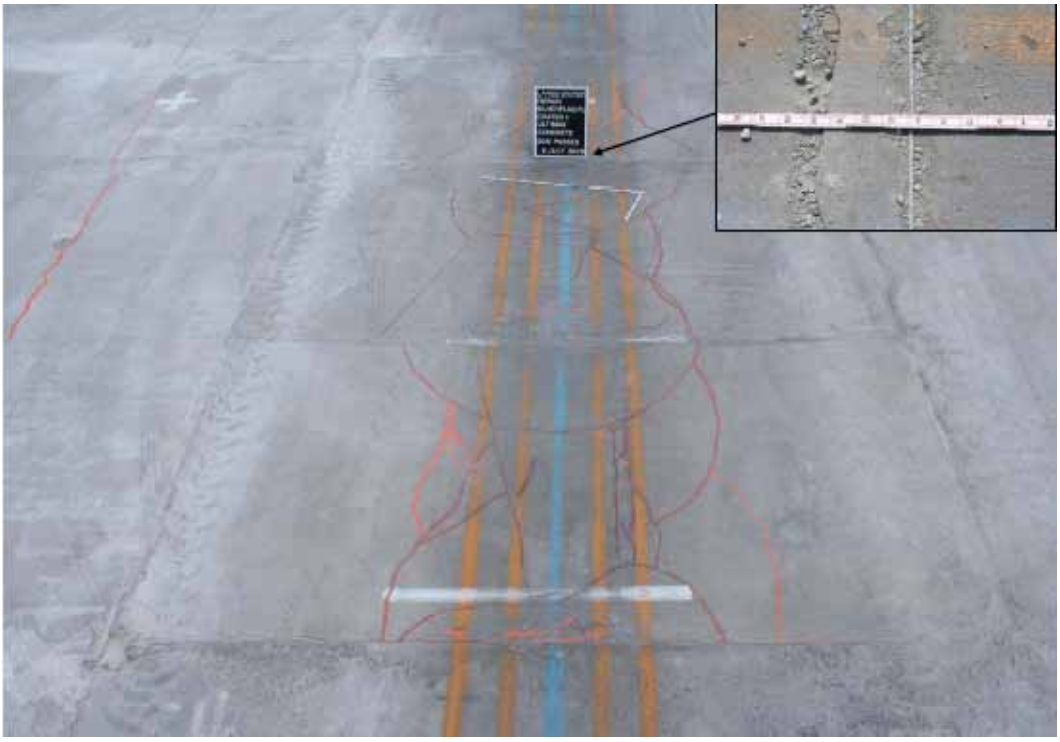
Figure 154. Crater 4 after 2,016 completed load cart passes.

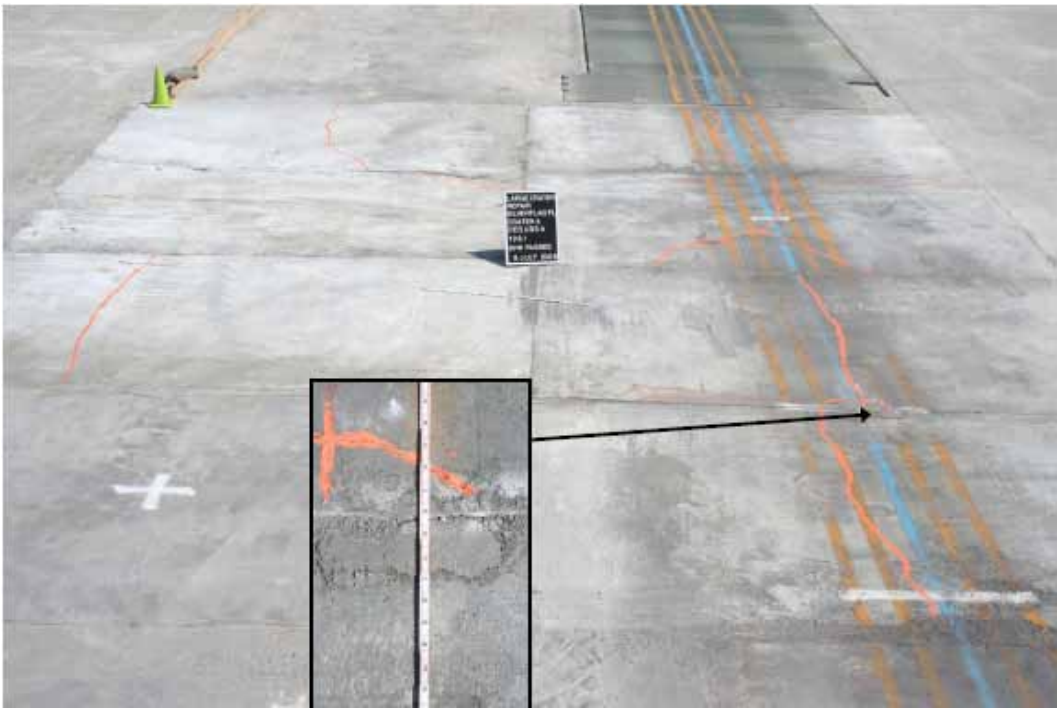
Figure 155. Crater 5 after 2,016 completed load cart passes.

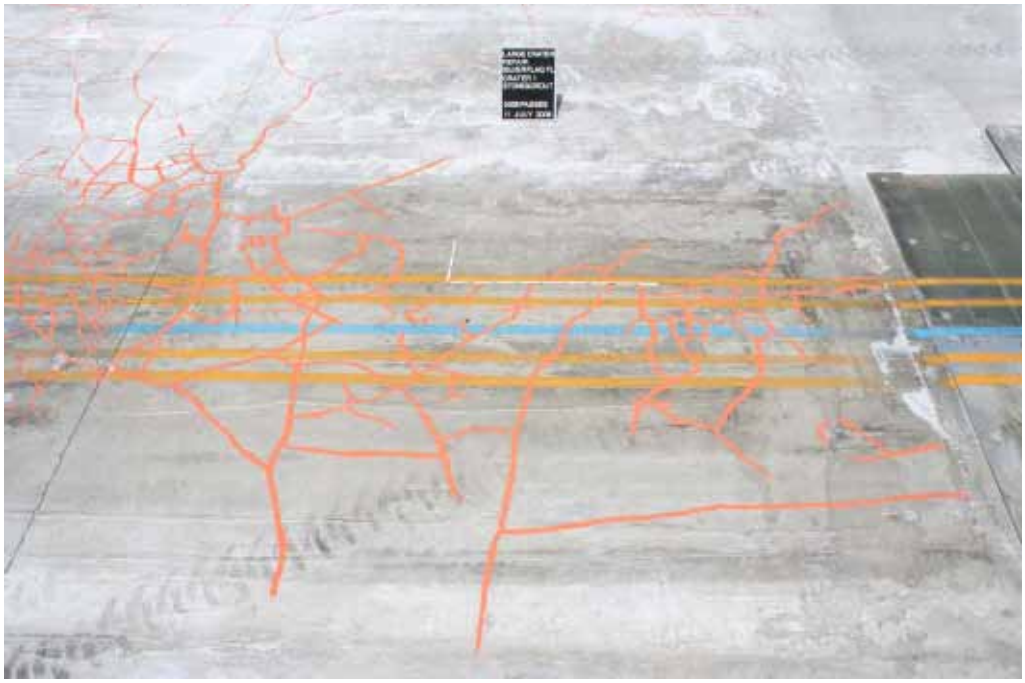
Figure 157. Crater 1 after 5,008 passes of load cart.

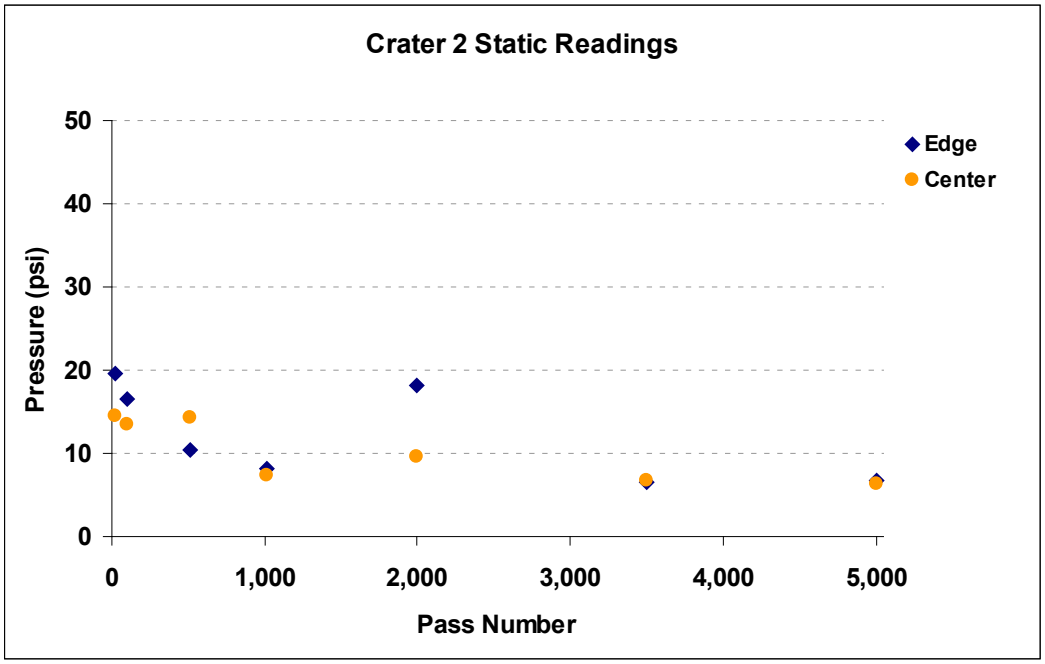
Static pressure readings were collected by the pressure cells at both the edge and center locations when the F-15E load cart wheel was stopped directly above the gage location. The pressure readings are shown in Figure 165 to Figure 168 for Craters 2, 4, 5, and 6, respectively. The pressure readings for Crater 1 are not included since this is the control test section. In Crater 2, the pressure readings decreased with pass level (Figure 165), likely due to the longer period of time the CeraTech material required to gain strength, similar to the laboratory testing. The general trend for Crater 4 (Figure 166) indicates an increase in the pressure readings with increased pass level, due to the deterioration from cracking. Both Crater 5 (Figure 167) and Crater 6 (Figure 168) show steady pressure readings with increasing pass level as no structural cracks formed in these repairs.

Figure 165. Crater 2, pressure cell readings during static load tests.

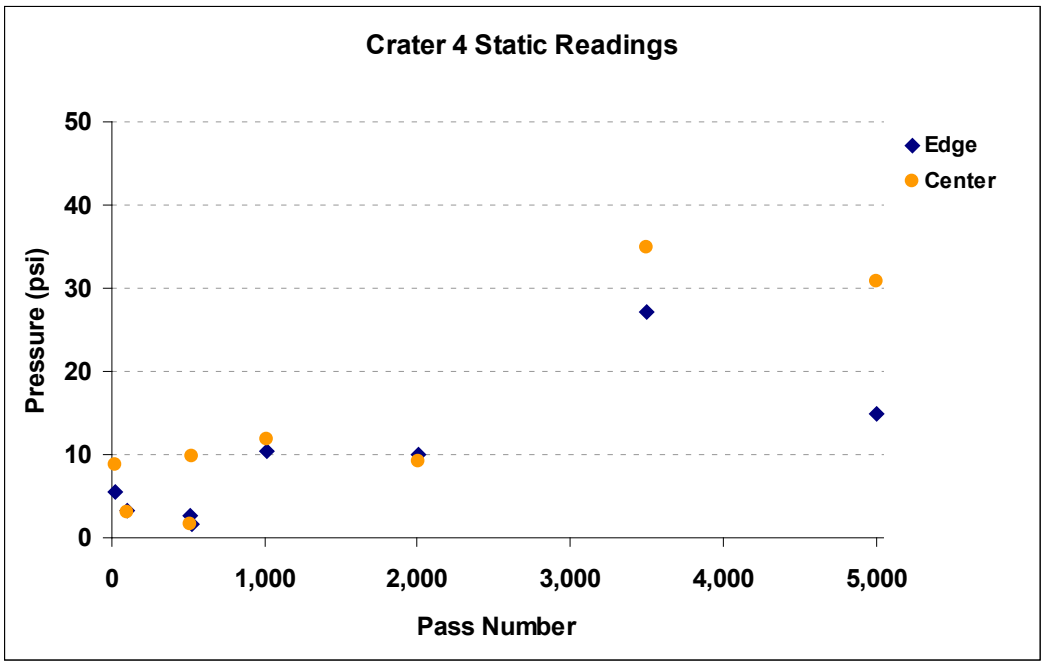
Figure 166. Crater 4, pressure cell readings during static load tests.

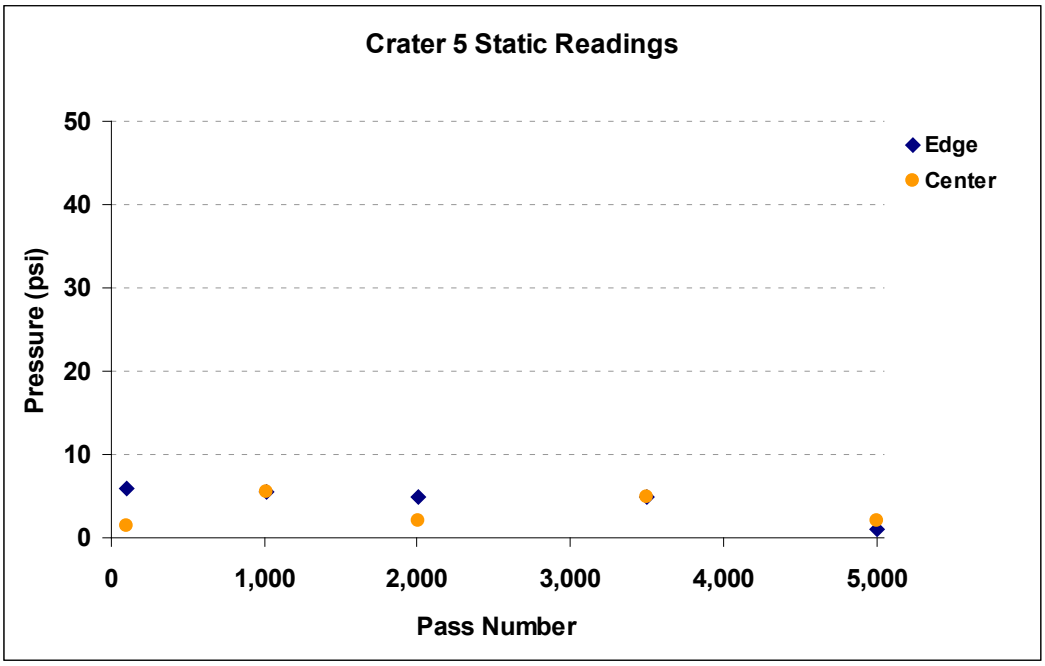
Figure 167. Crater 5, pressure cell readings during static load tests.

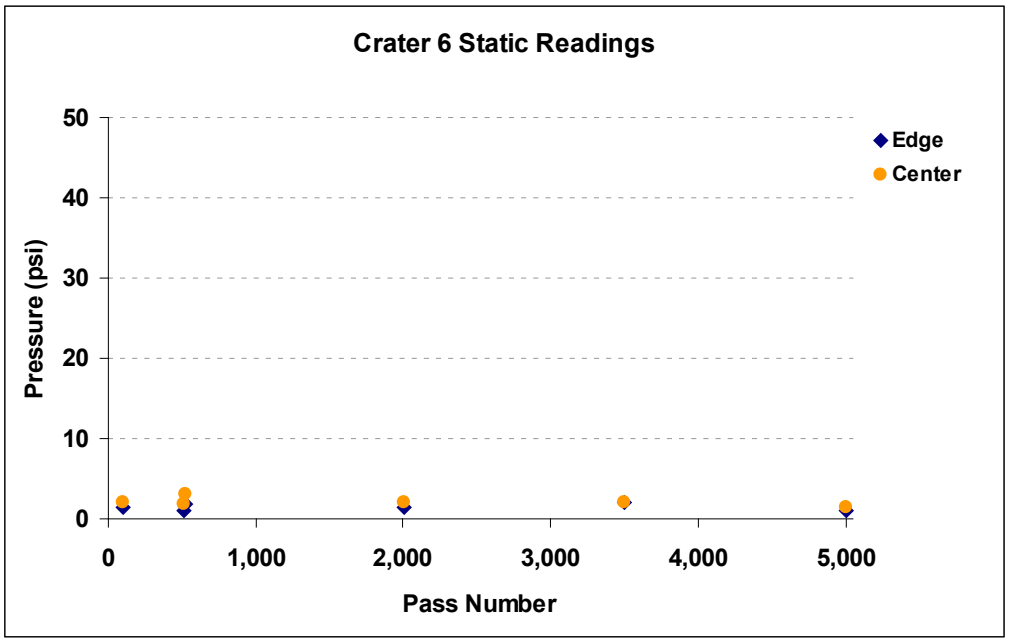
Figure 168. Crater 6, pressure cell readings during static load tests.

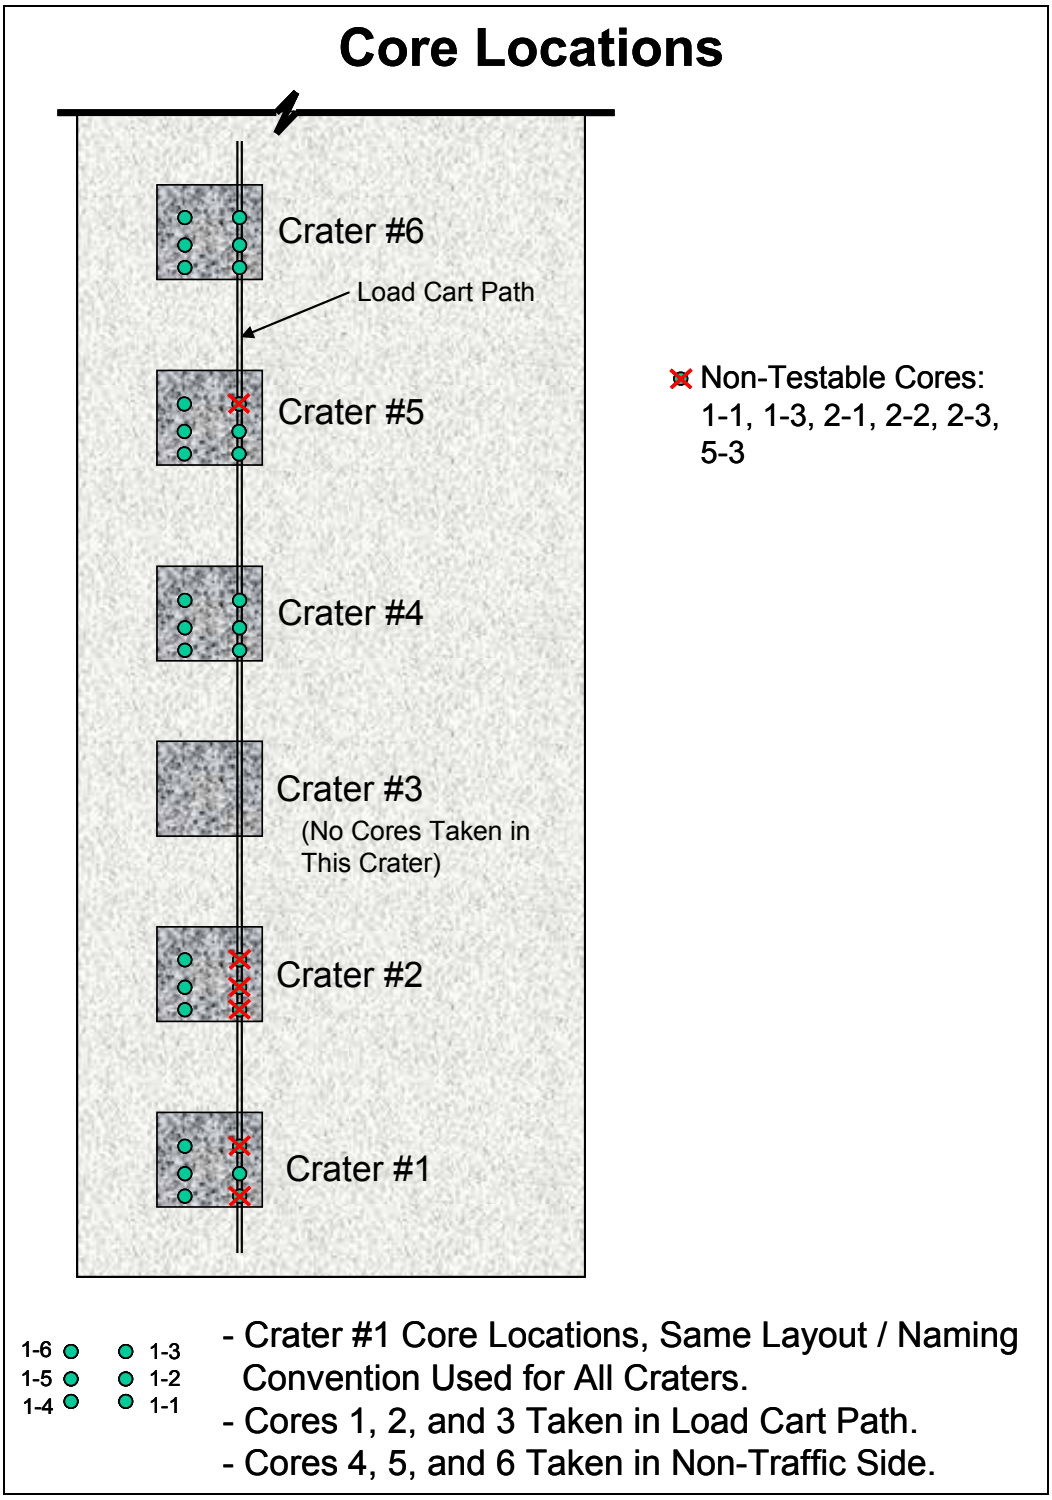
At the conclusion of load cart trafficking, cores were collected by AFCESA for splitting tensile tests, conducted at their test facility. Six cores were collected in each test crater, with the exception of Crater 3. Three cores were collected from the sections within the traffic lane and three were collected from non-trafficked sections. The sketch in Figure 169 illustrates the locations where the core samples were collected. The photographs in Figure 170 through Figure 175 show representative cores collected for testing.

The three core specimens collected in the traffic lane from Crater 2 (CeraTech, Pavemend EX-H) were deemed un-testable as they were fractured when removed from the core hole (Figure 171). Instead, tensile testing was conducted on the cores collected from the non-trafficked side (Figure 172). Note the voids indicating the layering from the placement of multiple batches. Figure 173 shows Core 2 located within the traffic lane in Crater 4 (Ultimax Concrete). Figure 174 shows a core collected from the wheel path of Crater 5 (Degussa, Thoroc 10-61). Toward the surface of the core – left side of the photograph – there are voids, indicating where one mix was placed over a previous layer due to multiple batching. This was

Figure 169. Core hole locations in each test crater showing cores not acceptable for testing (from AFCESA).

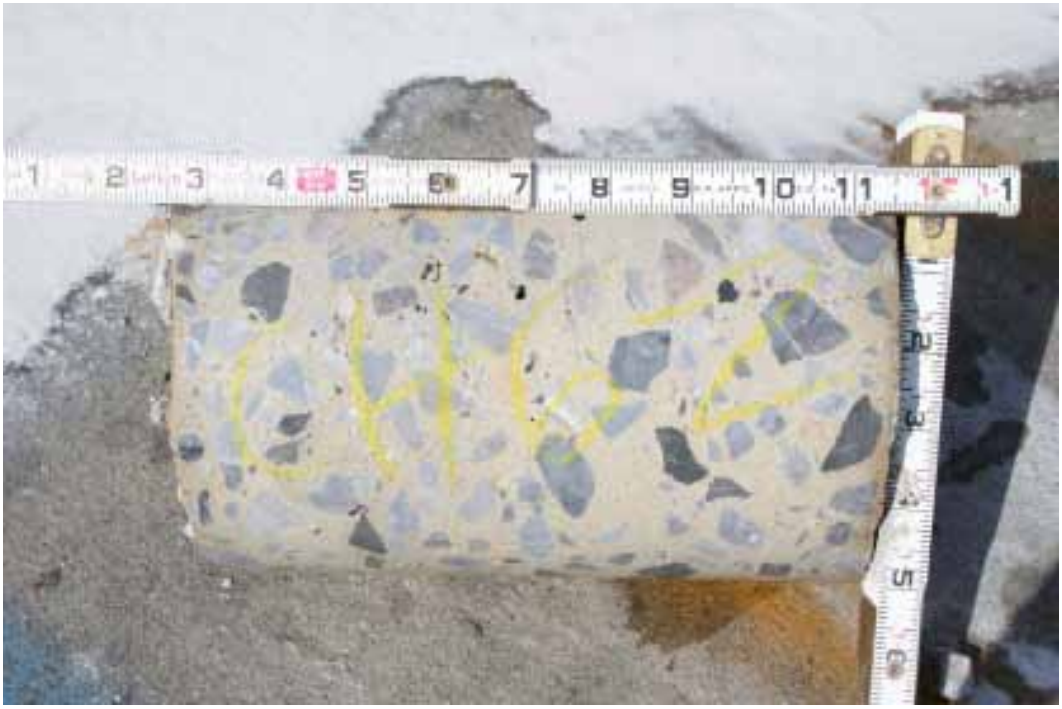
Figure 175. Core 2 from Crater 6 above pressure cell, CTS Rapid Set DOT Cement.

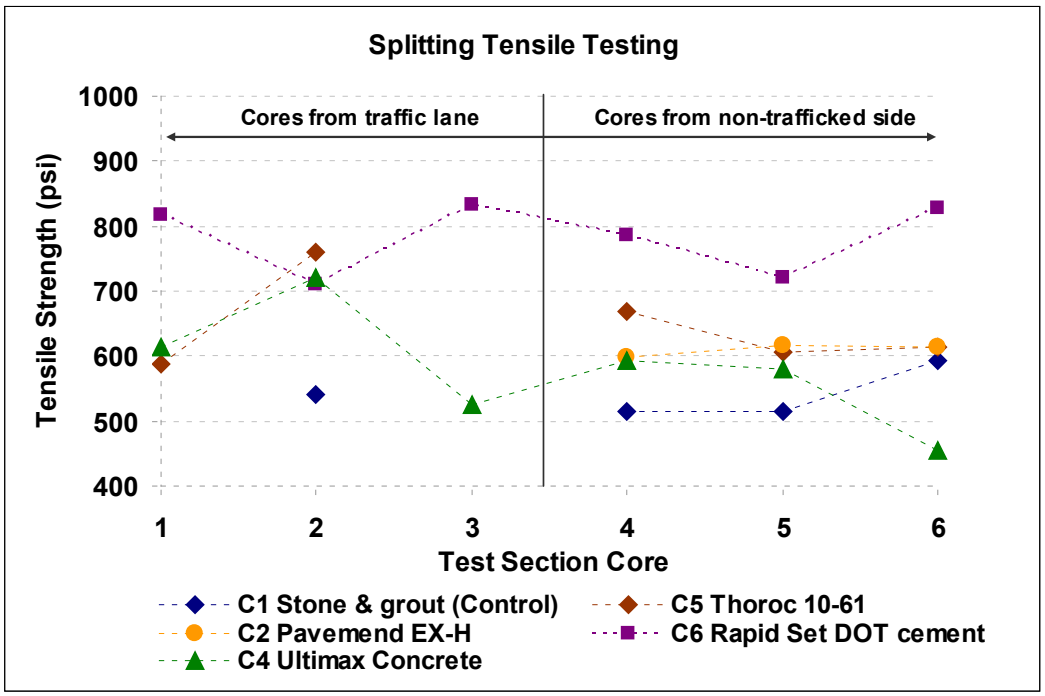
The chart in Figure 176 and Table 21 summarize the tensile testing results. Cores from the CTS Cement, Rapid Set DOT cement (Crater 6) had the highest tensile strengths. This was a very consistent mix, and it was mixed using a volumetric mixer. The Ultimax Concrete material, Crater 4, varied in strength from 454 to 721 psi, likely due to the variation in the quantity of mix water added to the batches. Comparatively, the RS materials from Degussa (Crater 5) showed decent strengths, while the tensile strengths for the CeraTech were lower (Crater 2). Overall, the RS materials showed higher strengths than the stone and grout material (Crater 1).

Figure 176. Results of splitting tensile tests on cores drilled out of test craters.
