Reliability of CGA/LGA/HDI Package Board/Assembly

Reza Ghaffarian, Ph.D.
Jet Propulsion Laboratory
Pasadena, California

NASA Electronic Parts and Packaging (NEPP) Program
Office of Safety and Mission Assurance

NASA WBS: 939904.01.11
JPL Project Number: 104593
Task Number: 40.49.02.02

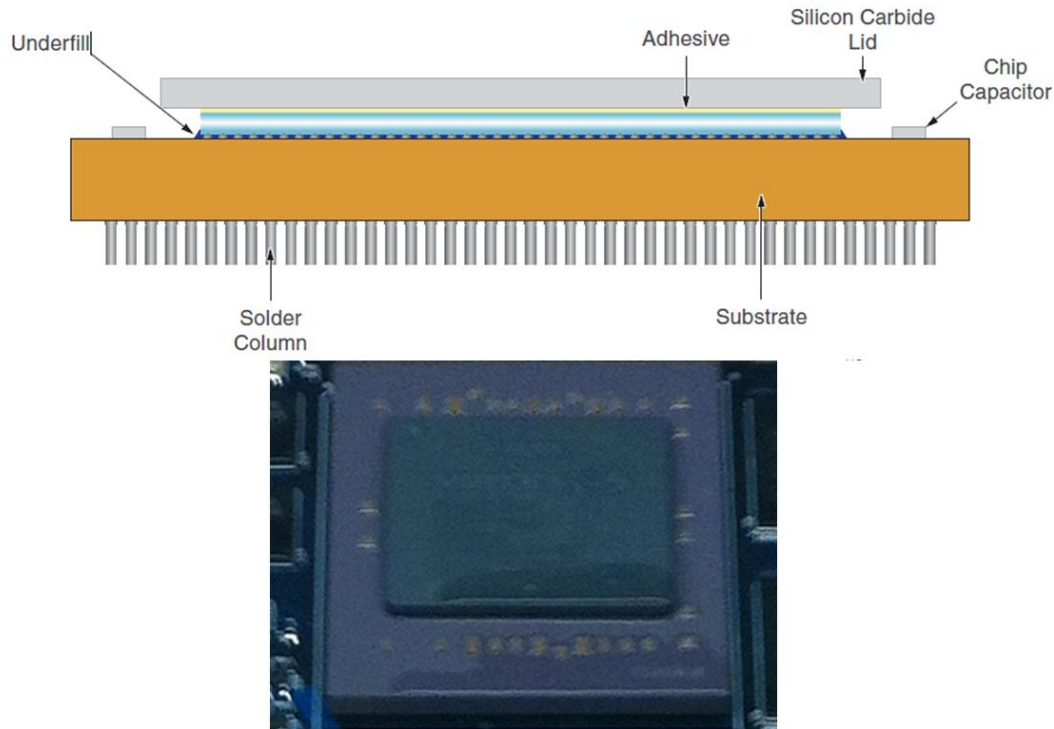
Figure 6. Construction of CGA 1752 I/O package (top) and photo of package showing the exposed chip capacitors.

and is exposed. Figure 6 shows a generic construction of this package provided by the manufacturer along with a photo of the package from the top. Inspection of chip capacitor solder joints for a package received in December 2010 revealed a number of unacceptable solder joints, based on NASA workmanship standards. For this reason, the solder joints for these chip capacitors were further characterized by SEM and subjected to a limited number of thermal shock cycles. The results of inspection and environmental evaluation are discussed in the following sections.

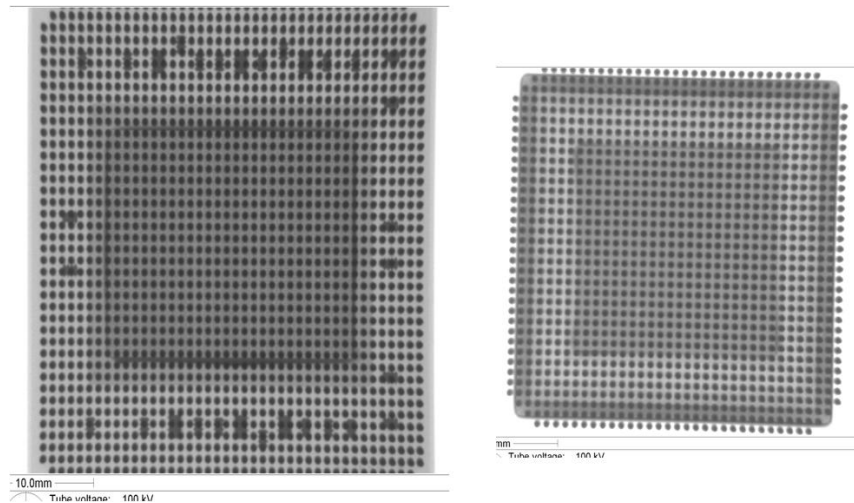
Figure 7. X-ray photomicrographs of CGA 1752 I/Os (left) and CGA 1272 I/Os (right); the darker areas are where chip capacitors are located.

A real-time 2D X-ray system was used to determine the integrity of column solder joint attachment, among other features of these packages. Figure 7 shows representative X-ray photomicrographs of CGA1752 and CGA1272.

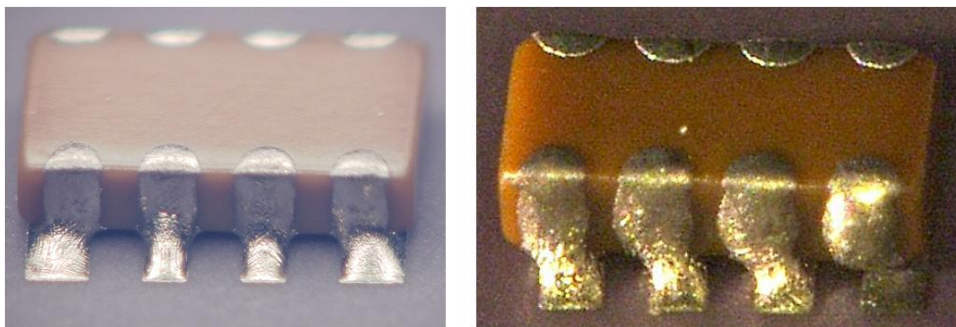
The first set of daisy chain package samples was received late in December of 2010. Inspections revealed workmanship deficiencies of chip capacitor solder joints, which are formed into the side metallization rather than conventional two-end solder joints. Figure 8 shows optical photomicrographs of representative solder joints. There are six (6) 0805 and twenty-five (25) 0603 capacitors, making a total of 248 solder joints. Thorough inspection of one package revealed that out of 248 solder joints, 24 showed potentially poor quality, based on NASA workmanship requirements.

An extreme case of shifting away from side metallization on a package with unacceptable solder joints is shown in the following figure (the far right joint). Note that these are daisy chain packages and may not be representative of a functional package. Functional packages should be inspected for such workmanship anomalies before committing to an expensive assembly process and extremely difficult rework process.

Figure 8. Chip capacitors showing inconsistency in solder joint quality; the far right solder is clearly unacceptable.

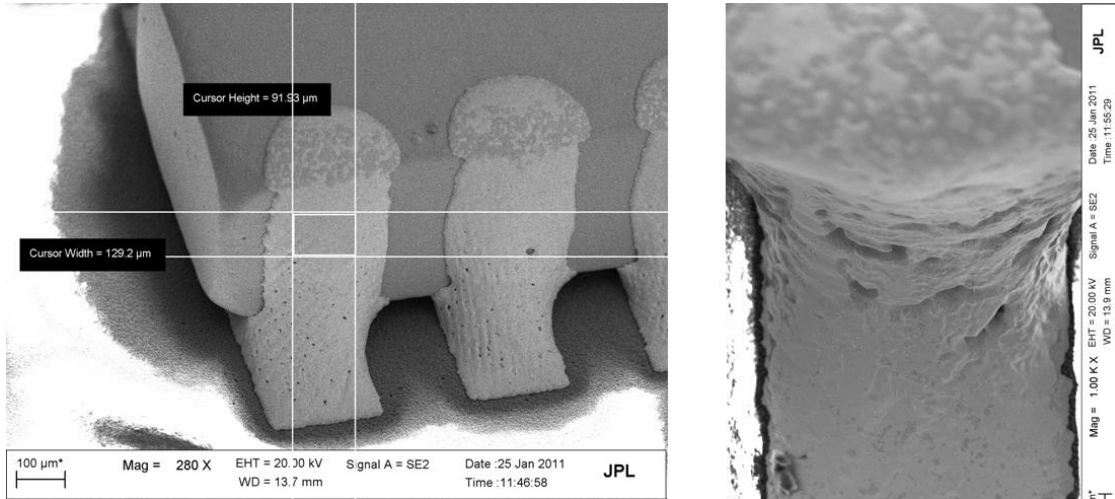
Figure 9. SEM photomicrographs showing the nature of solder joints at much higher magnification.

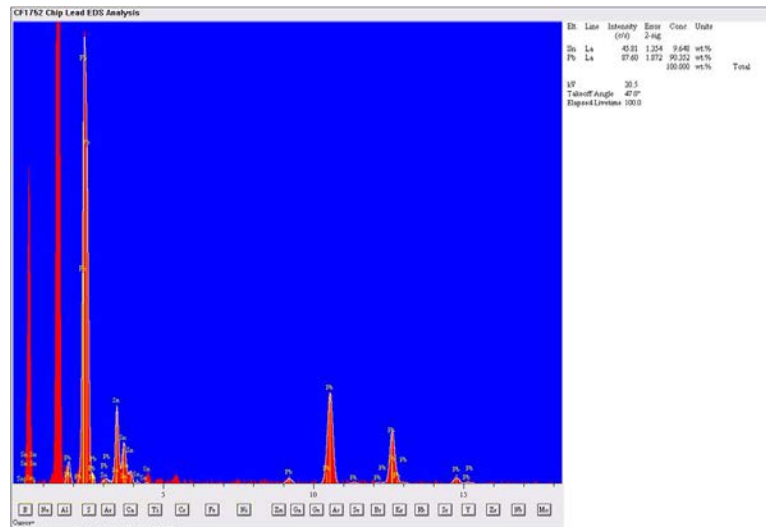
Figure 11 shows representative solder joints after 200 thermal shock cycles. No evidence of significant damage or crack initiation was observed. Resistance of solder joint to thermal shock is attributed to good CTE match of ceramic chip capacitors to ceramic CGA substrate. The higher melting temperature of high lead tin-lead solder also contributed to its high resistance to thermal shock cycle.

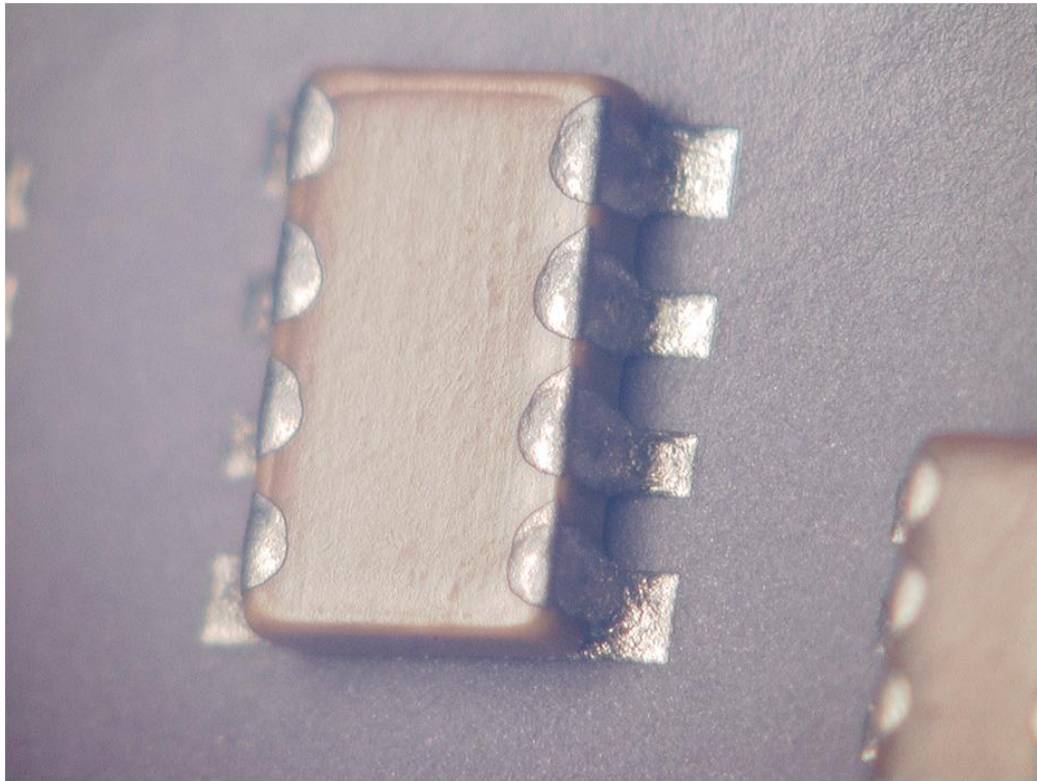
Figure 11. Chip-capacitor solder joint quality after 200 thermal shocks (–55° to 130°C) showing no signs of cracks.

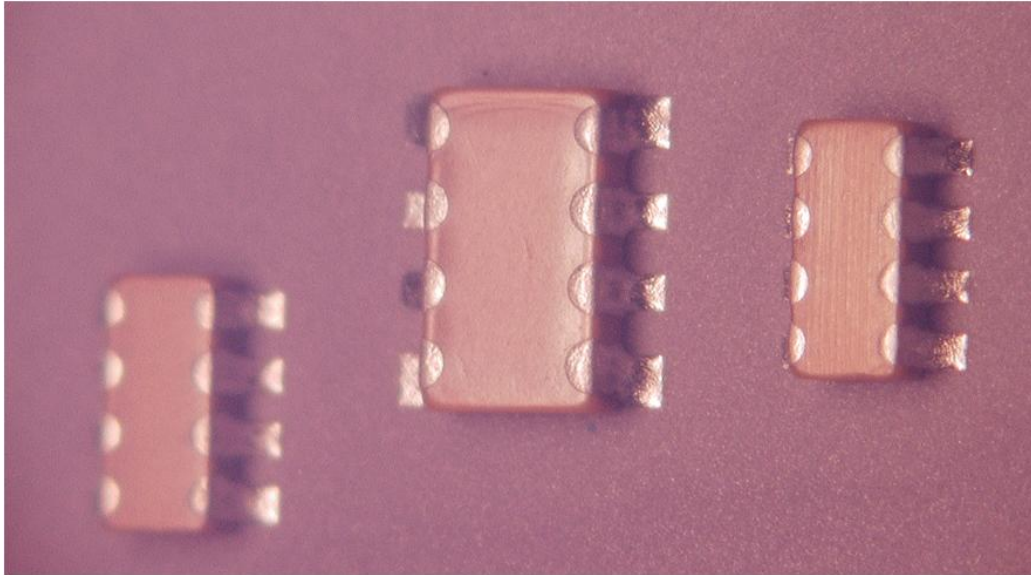
representative of the side solder joints. For this new batch only 7 out 248 solder joints were marginally acceptable, using the NASA workmanship standard as a baseline. This is a significant improvement compared to the previous batch, indicating a more stringent quality control. Nonetheless, an inspection plan may be required to be implemented at receiving to assure adequate quality of solder joints.

Figure 12. Chip capacitors showing better solder joint quality in the May 2011 set.

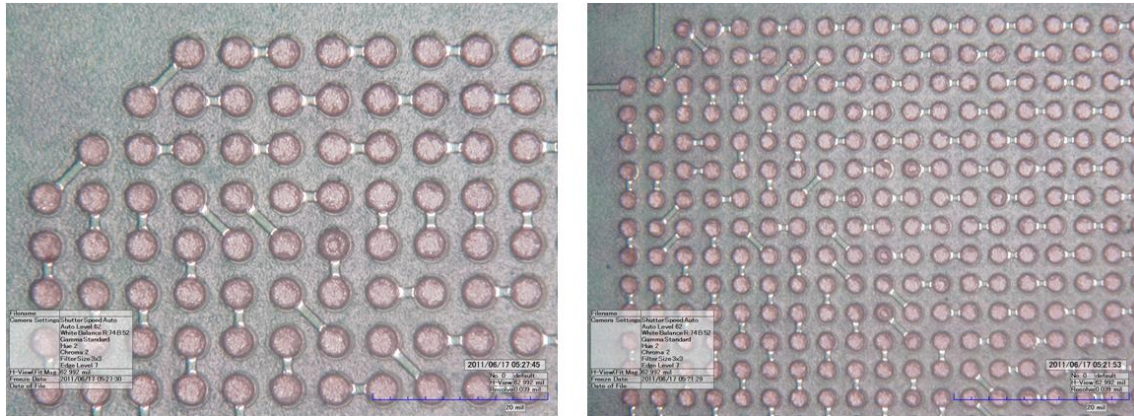
Figure 15. Representative photomicrographs of paste print deposition quality for the CGA1272 I/O (left) and CGA1752 I/O (right).

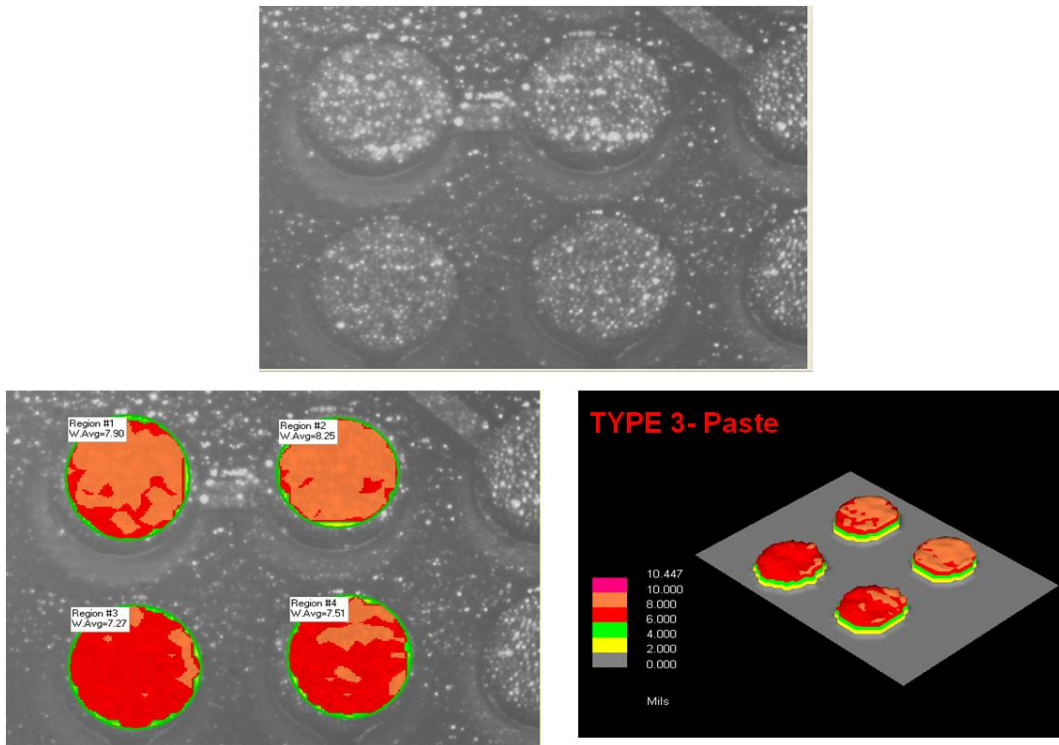
**Figure 16.** Type 3 solder paste print quality and color-coded height distribution for CGA1752 I/O.

Figures 16 to 18 show photomicrographs of CGA1752 pads after solder paste deposition and their characteristic parameters, including height values for type III–V pastes. The figures also show color-coded height distribution of solder paste prints for these sets of pads. Overall, no major manufacturing issues were encountered with the paste depositions for the two CGAs with 1.0-mm pitches. In general, there were no significant differences among the three solder paste types for the CGAs, even though a sharper height periphery was observed as the size of solder paste particulates decreased from type III to type V.

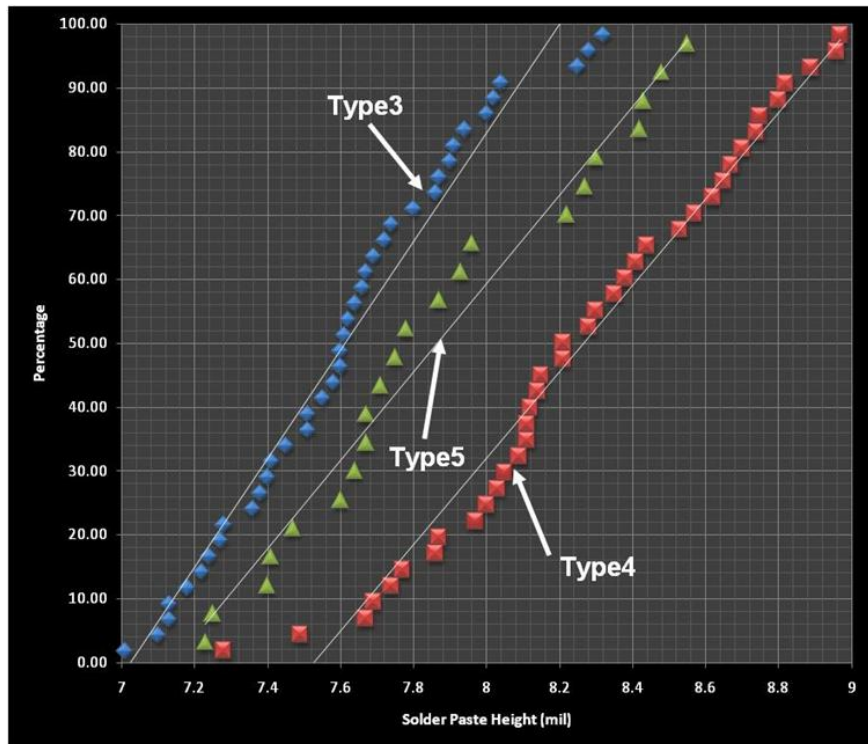
Figure 19. Comparison of paste print height distribution of CGA1752 and 1272 I/O pads for type 3, type 4 and type 5.

Figure 19 shows plots of solder height distribution for three different paste types using a 6-mil stencil thickness with a 28-aperture opening. The height measurement was relative to a few surface areas at each location, not relative to copper traces; therefore results shown are a copper thickness higher that actual height values. Different solder paste types showed similar trends and heights, considering the potential of other paste print variations. Nevertheless, the height did not correlate with the solder paste particulate sizes; it did not increase as particle sizes decreases. It increases first from paste type III to type IV and then decreases for type V, fitting values between the two.

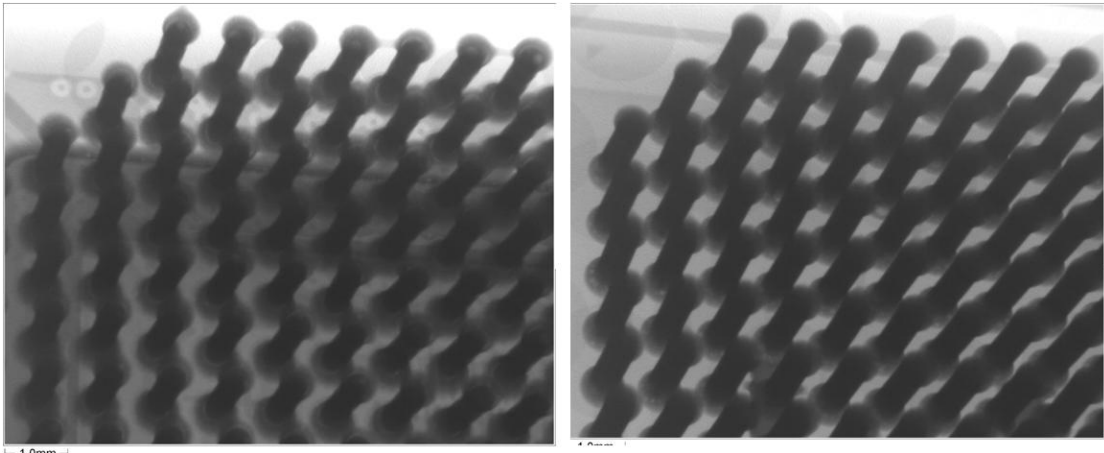
Figure 20. As-assembled X-ray photomicrographs for the CGA1272 I/O (left) and CGA1752 I/O (right). There were no signs of shorts.

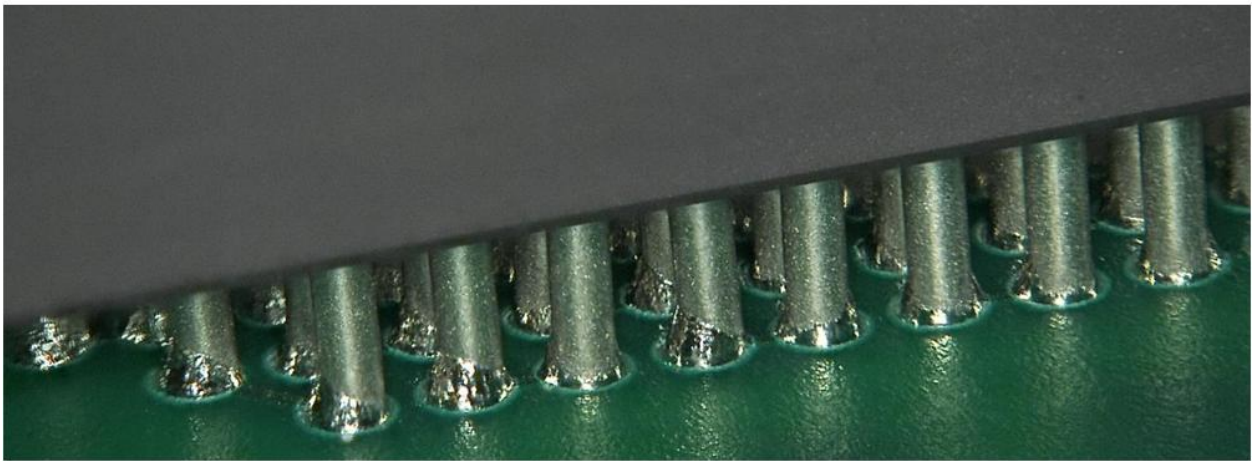
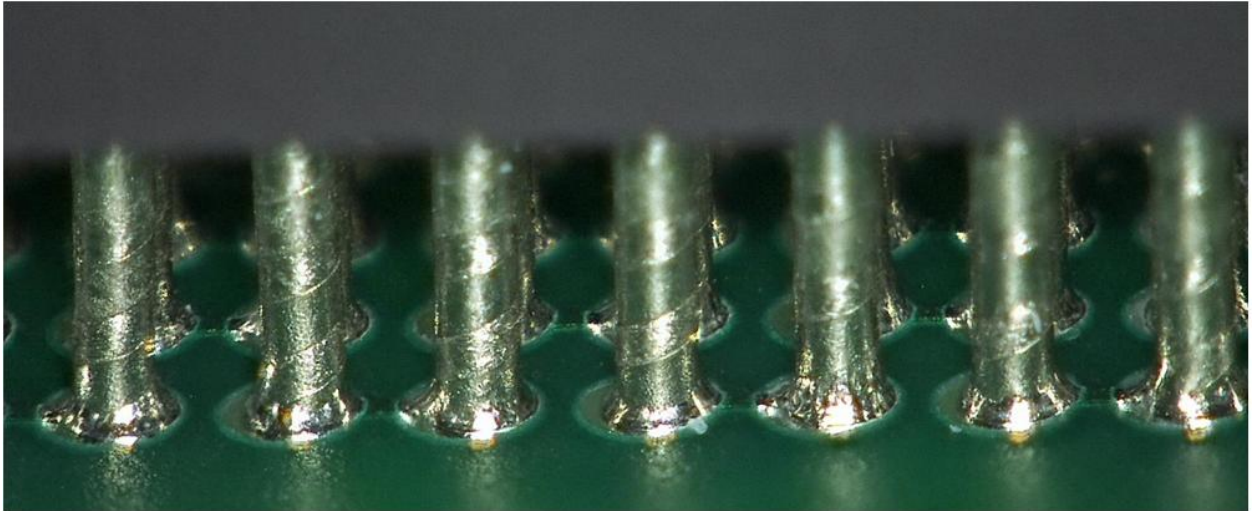
Figure 21. Representative photomicrographs of solder joint quality after assembly for CGA1272 (top) and CGA1752 (bottom).

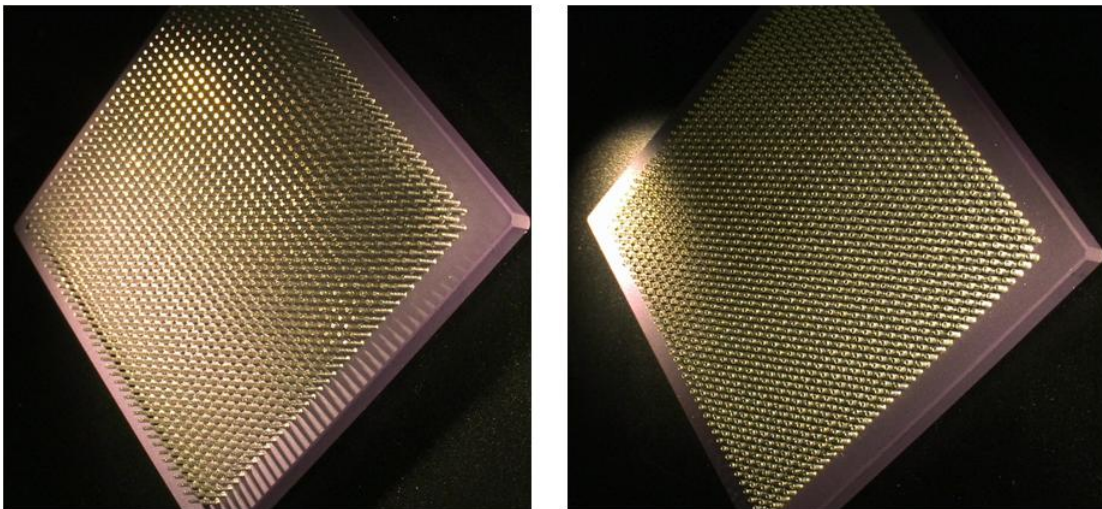
Figure 22. Representative photomicrographs of an LGA package after copper column (left)and micro-spring coil column (right) attachment.

This report covered many aspects of advanced area array packaging and high density printed circuit boards. The purpose of the following aspect of the investigation was to characterize the reliability of LGA1517 packages with 1-mm pitch. LGAs were subject to both copper-wrapped column and micro-spring coil attachment for subsequent evaluation. Column attachment integrity was evaluated by subjecting a CGA version to isothermal aging and pull tested before and at intervals during environmental aging. Figure 22 shows photomicrographs of the LGA package after it was transformed to CGA.

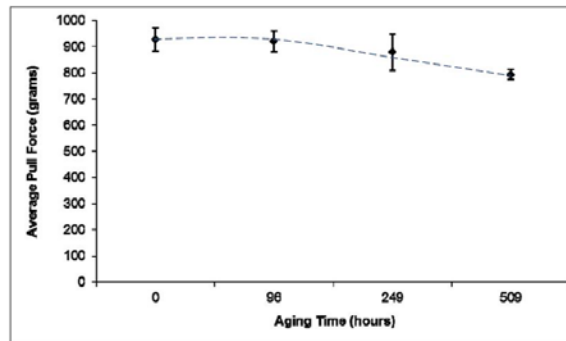
- There is no statistical difference between no aging and 96 hours of aging
- There is a statistical difference between 96 hours and 249 hours of aging
- There is a statistical difference between 249 hours and 509 hours of aging

Figure 24. Pull strength decreases with isothermal aging at 125°C for 509 hours for the 1517 I/O LGA with columns.

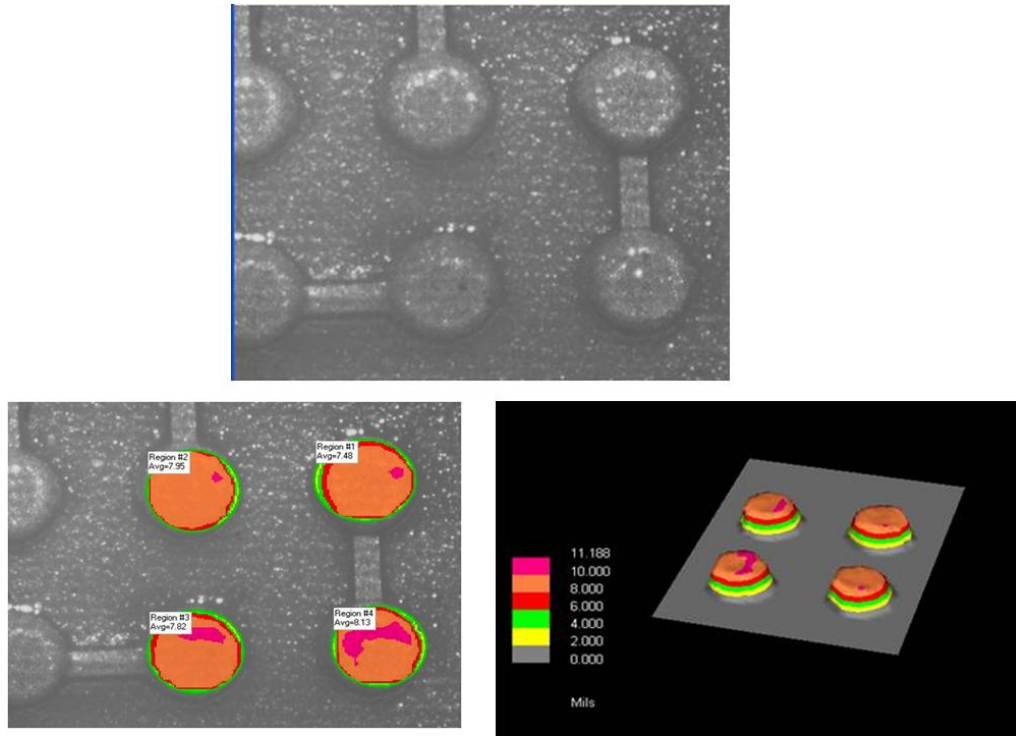
Figure 26. Type V solder paste print quality and color-coded height distribution for CGA1517 I/O.

Figure 26 shows representative examples of photomicrographs of CGA1517 pads after solder paste deposition and their characteristic parameters, including height values for type V

paste. These figures also show color-coded height distribution of solder paste print for these set of pads. Overall, no major manufacturing issues were found with the paste depositions for the columned LGA with 1.0-mm pitches. Type IV paste print quality was similar, so it is not reported.

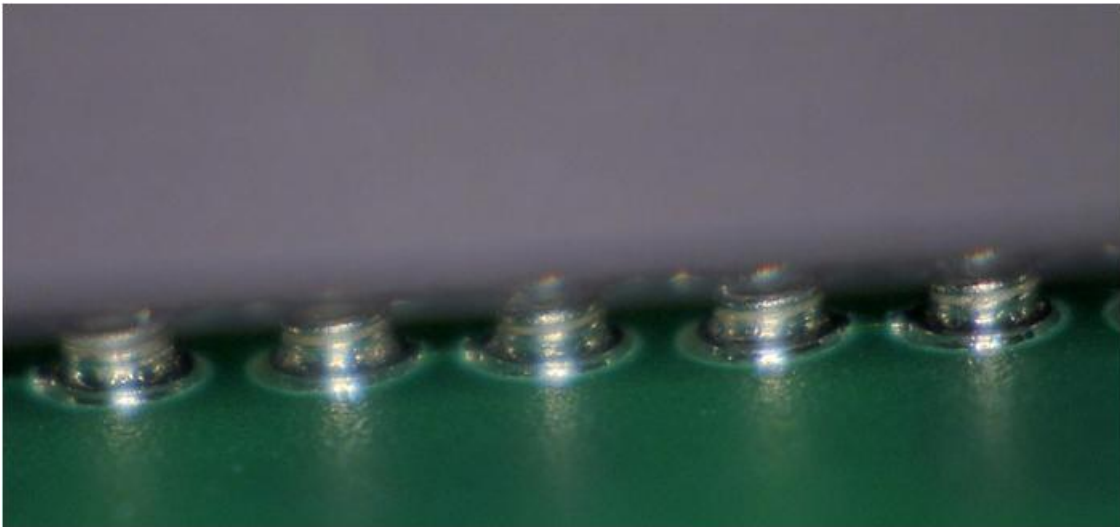
formations are different since there are no solid solder columns; however, good quality solder fillet formation is apparent.

Figure 27. Representative photomicrographs of solder joint quality after assembly for micro-spring coil column CGA1571**.**

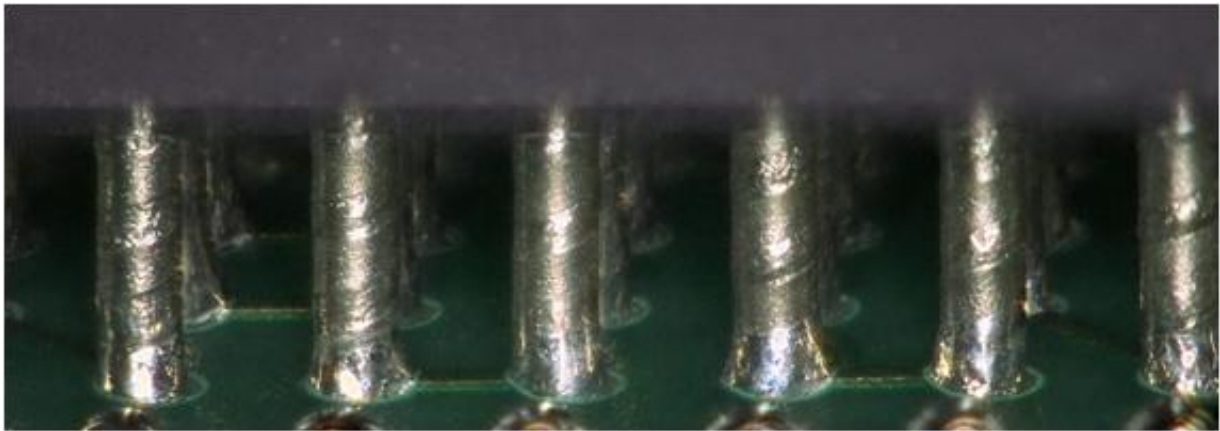
Figure 28. Representative photomicrographs of solder joints quality after assembly for CGA1571 with copper-wrapped solder columns**.**
