KOCHI SMART CANAL

FINAL REPORT

(1 April 2022 – 31 January 2023)

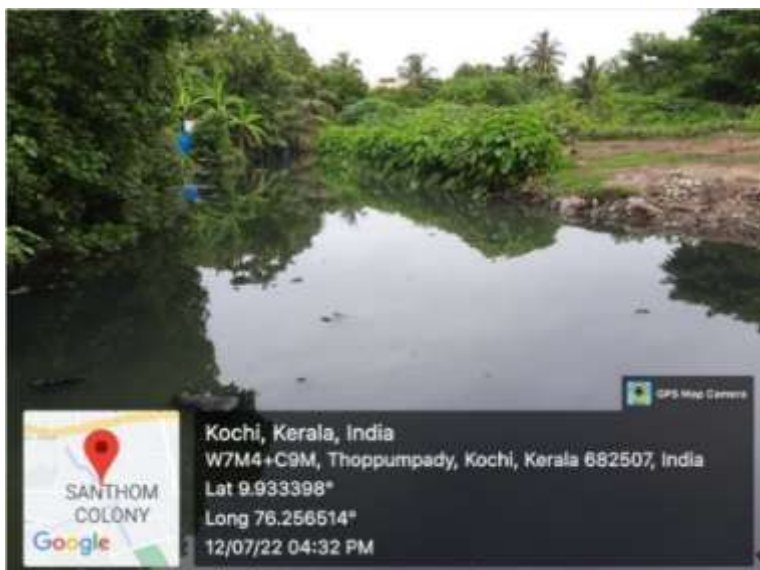
> Unlined canal banks leads to easy flooding of adjacent lands and erosion of side walls.

Figure 4-8: Unlined canal banks

- Lining the canal banks with rubble masonry at locations where there are no linings or damaged linings. Lining the canal banks would protect the canal banks from erosion over time and creates a defined water passage.
- Installing bar screens upstream of culverts. This would help arrest entry of solid waste into the culverts. Cleaning the bar screens would be an easier option than cleaning the inside of the culverts. The bar screens can be installed at certain intervals so that there is no heavy trash collection at a single point.

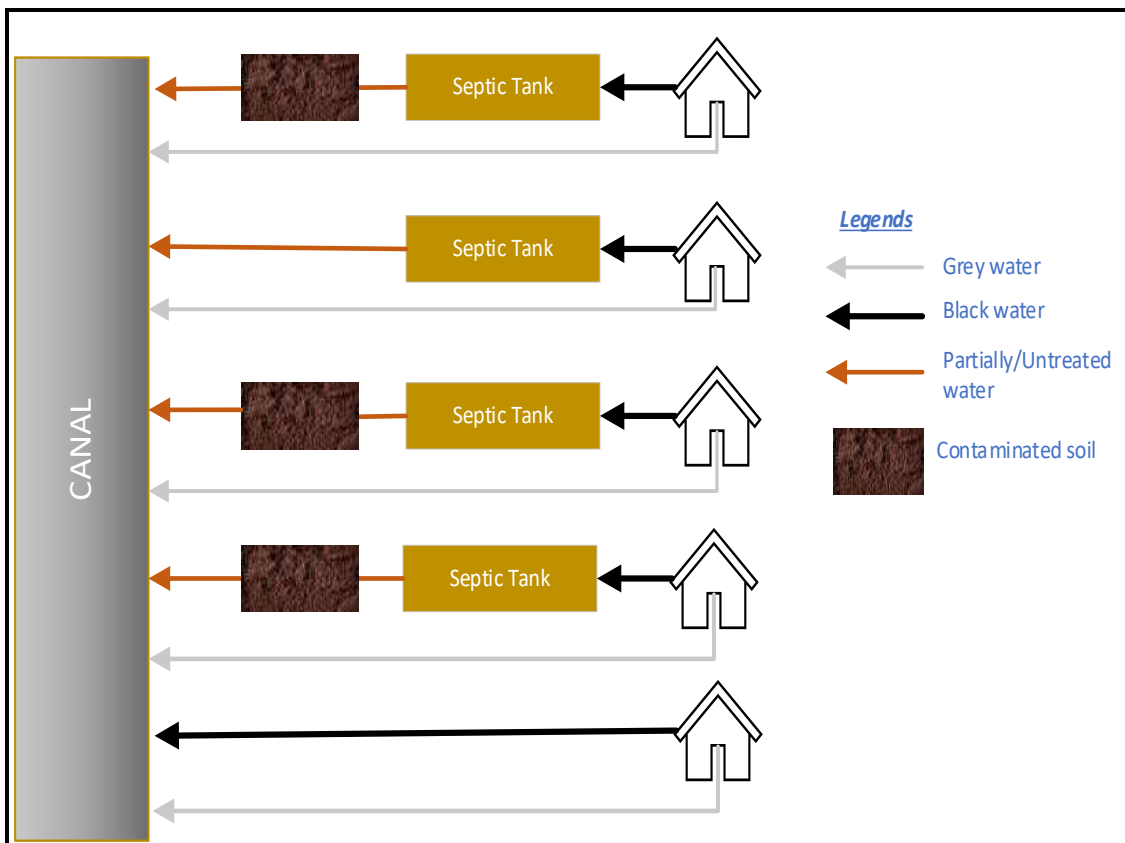
There is absence of an integrated sewage collection infrastructure in Fort Kochi. Almost every household has a toilet which is dependent on an on-site sanitation facility. These sanitation facilities are limited to septic tank systems that often show signs of malfunctioning due to aging systems and lack of proper maintenance.

Figure 4-17: Wastewater discharge into canals in Fort Kochi

- **Closing the outlets opening to the canals:** The sewage outlets from household discharging into the canals need to be plugged.
- **New STPs:** It was found during the survey that about 15% of the houses require new septic tanks. Houses without septic tanks along the canal to be identified and septic tanks need to be provided.

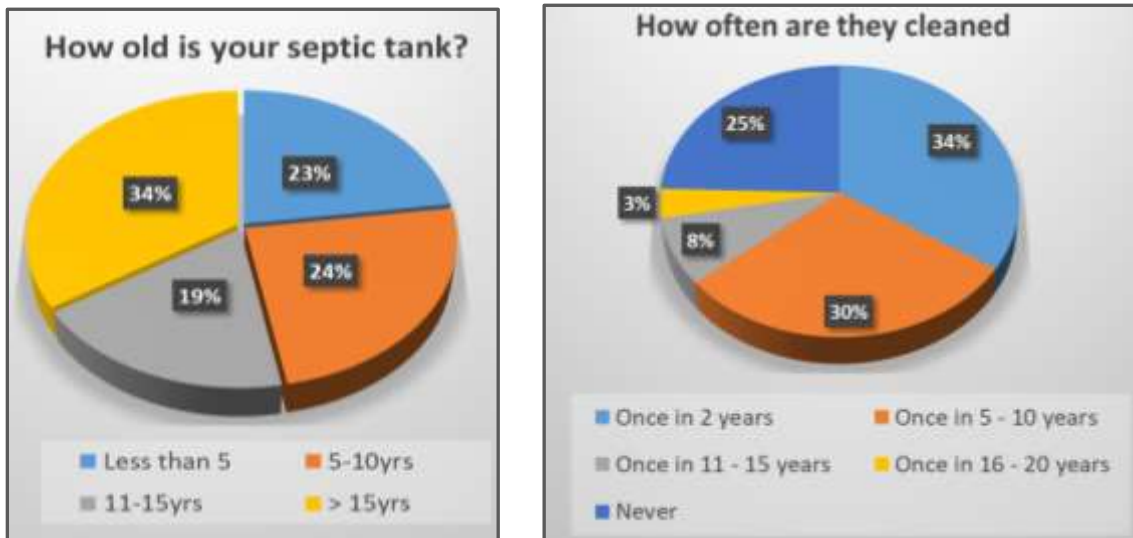
The survey also corroborated this finding with nearly 85% of the respondents reporting to have septic tank in their households. However, 34% have reported these septic tanks to have been constructed more than 15 years back and around 48% were constructed less than 10 years old. The survey also showed that most households without septic tanks belong to representatives from the very low-income group. Around 25 % respondents indicated that they had never cleaned their septic tanks (which seems to suggest that there is a likely chance of either percolation or leakage into adjacent drains). 43 % indicated a cleaning frequency of once in three years. Around 25% have indicated a cleaning frequency of once in two years.

Figure 4-18: Condition of the septic tanks in houses along Pandarachirathodu canal

- Septic tank leakages with high water table cause untreated sewage to leak into the groundwater and thereby into the canal without being visible, leading to groundwater and canal pollution. Old and malfunctioning septic tanks will need to be replaced during pilot implementation.

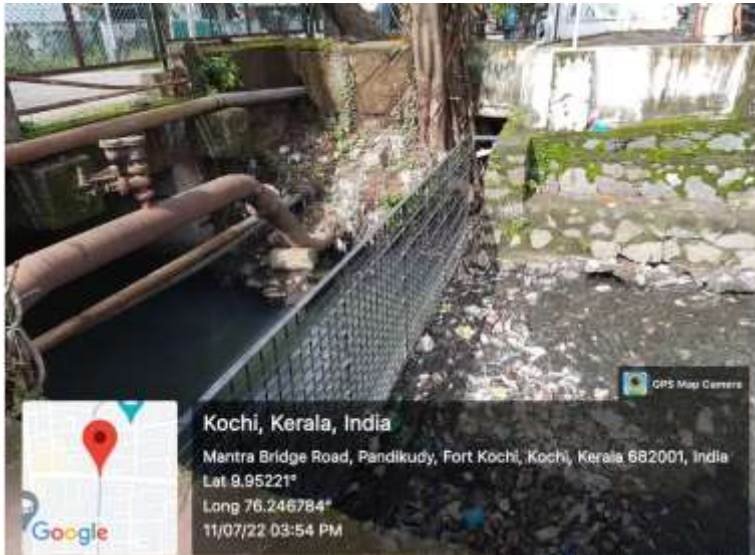
Solid waste accumulated at the mouth of the culvert restricts the flow through the culvert and causes flooding on the upstream.

Figure 5-10: Newly installed bar screen installed at the culvert entry location

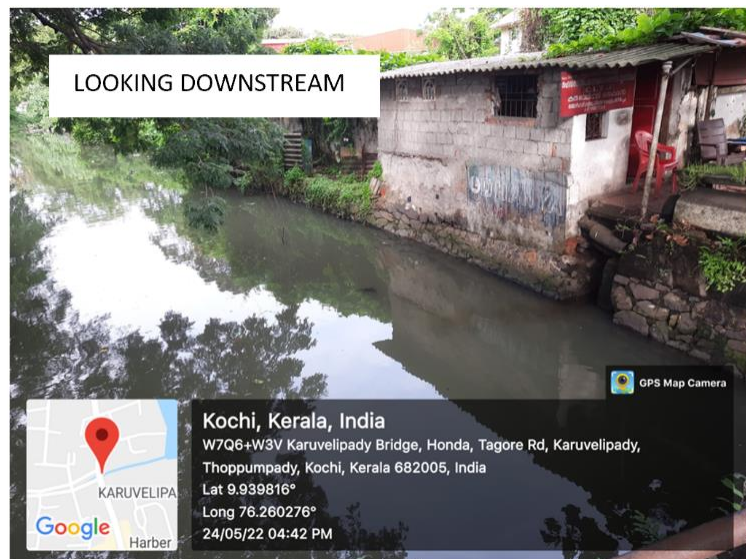
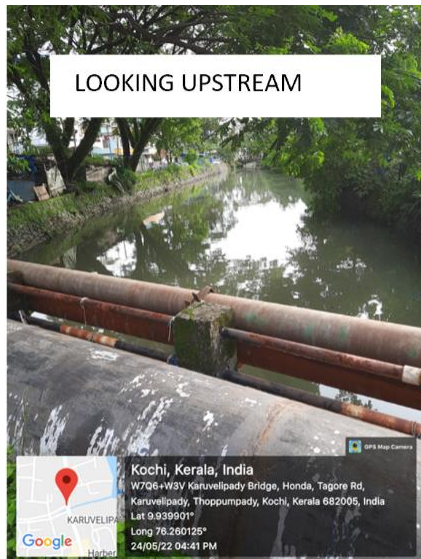
- Submerged drinking water pipes were found to be running along and across the canals and in some places, plastic waste in the canal was found wrapped around these pipes blocking the flow through the canal thereby making it stagnant. As these pipes carry drinking water, potential contamination is also possible.

- Encroachments along the canal was also very clearly seen at various places, leading to reduced width of the canal thereby decreasing the discharge capacity.

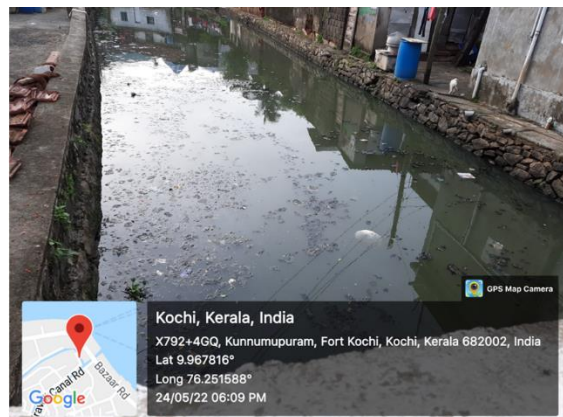
- A spot near the mouth of Kalvathy/Eruveli canal was visited last. This area had a stretch of slum like houses next to the canal. The toilet and kitchen discharge outlet pipes from these were seen to be discharging directly into the canal.

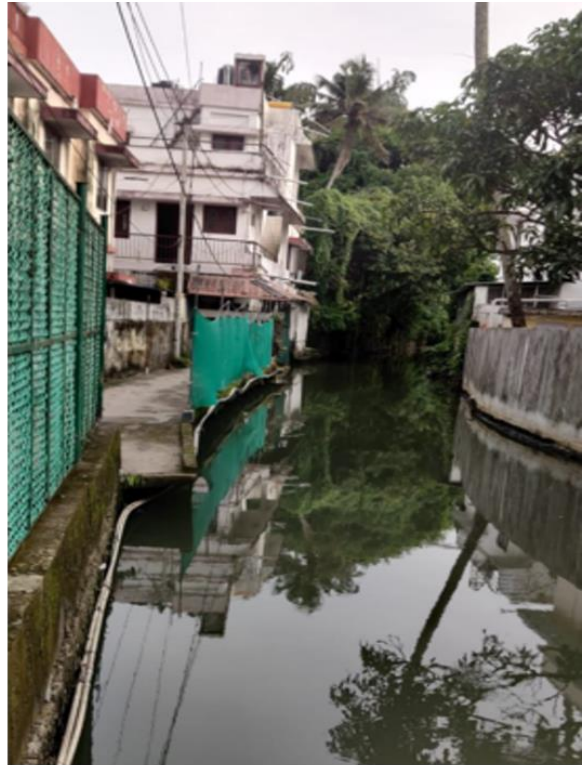
- Visit to the rest of the stretch of Rameshwaram Manthra Kalvathy canal was carried out.
- Stagnant water was seen at the Kochi college stretch as indicated by the irrigation department. Other similar issues as in other parts of the canal such as encroachment, unauthorized footbridges, waste thrown in the canal resulting in clogging of canal was also seen.

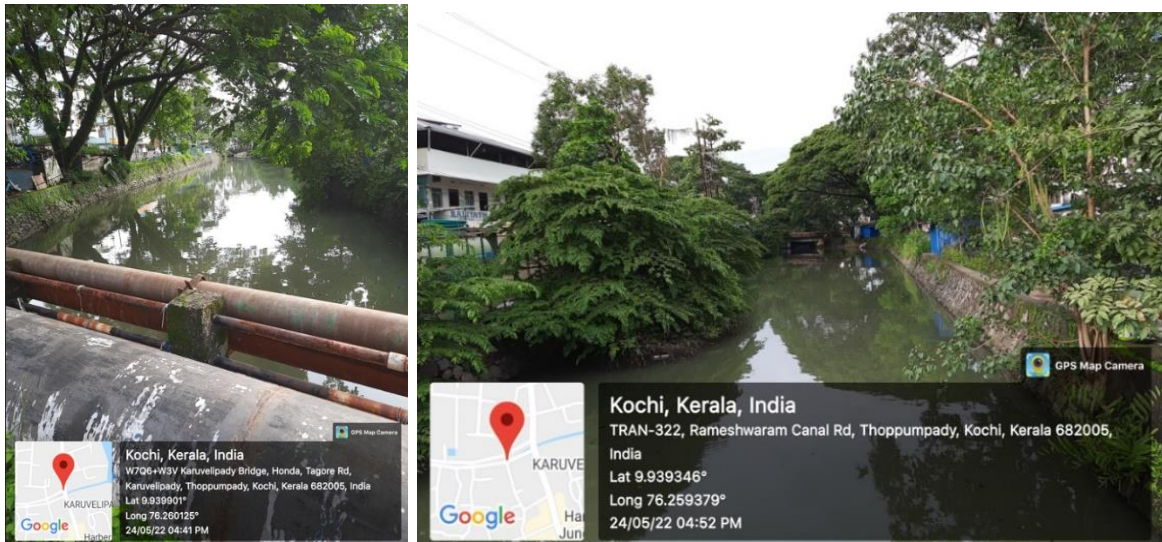
Trees growing on the banks of the canal (Photo Credit: bechtel.org)

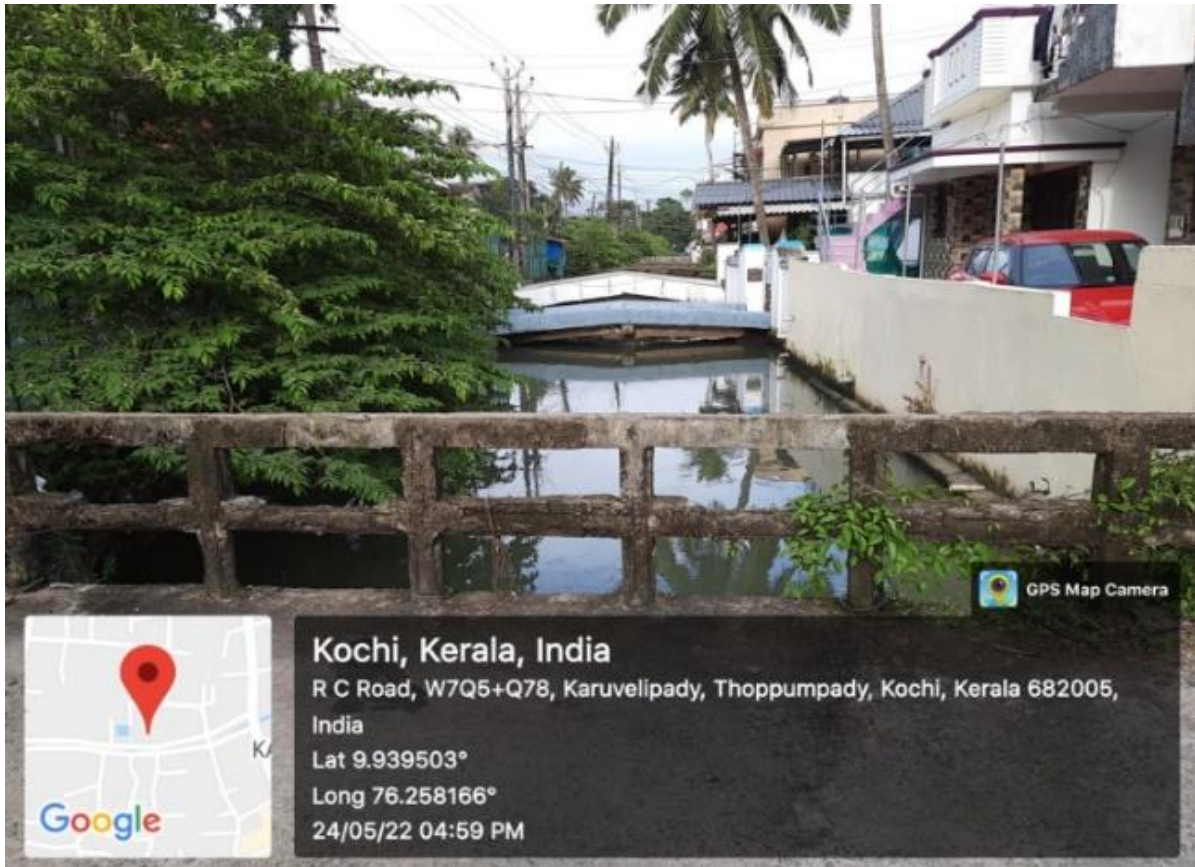
Footbridges built by each individual houses across the canal without ample headroom impedes the flow and cleaning operations (Photo Credit: bechtel.org)

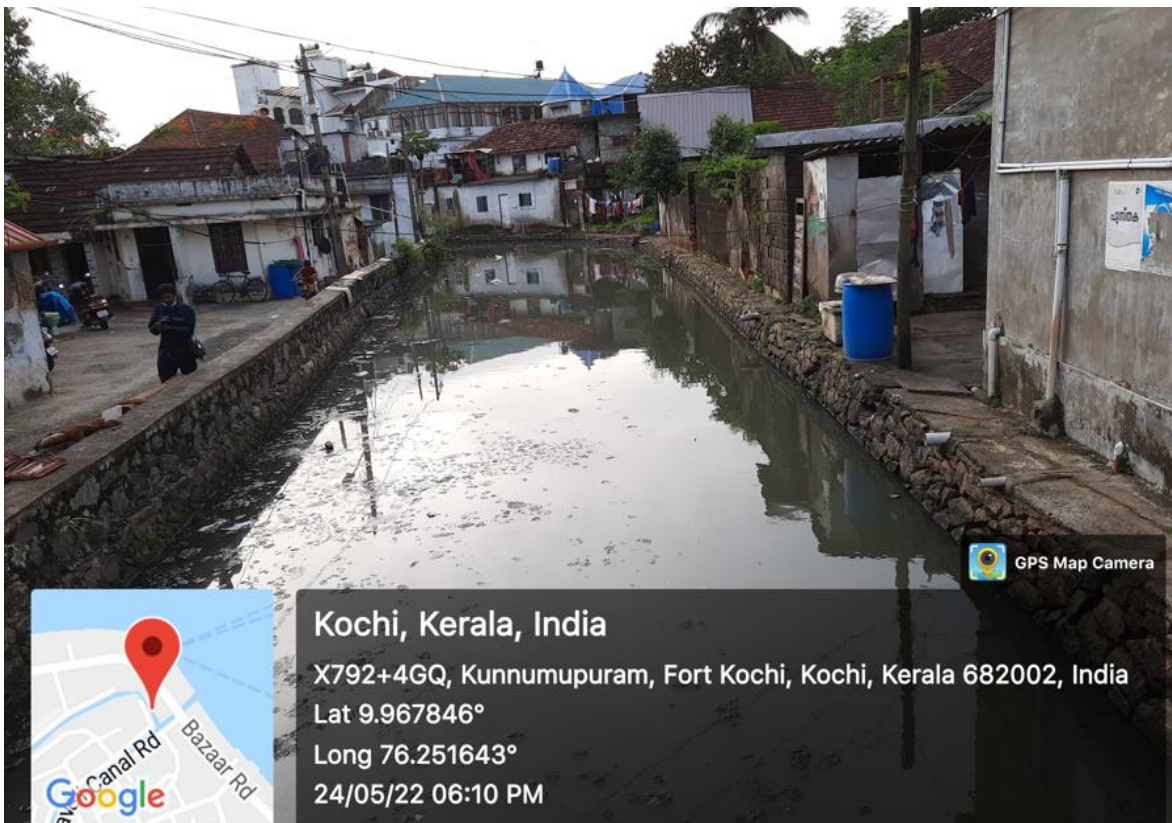
Grey and black wastewater getting discharged directly into the canal (Photo Credit: bechtel.org)

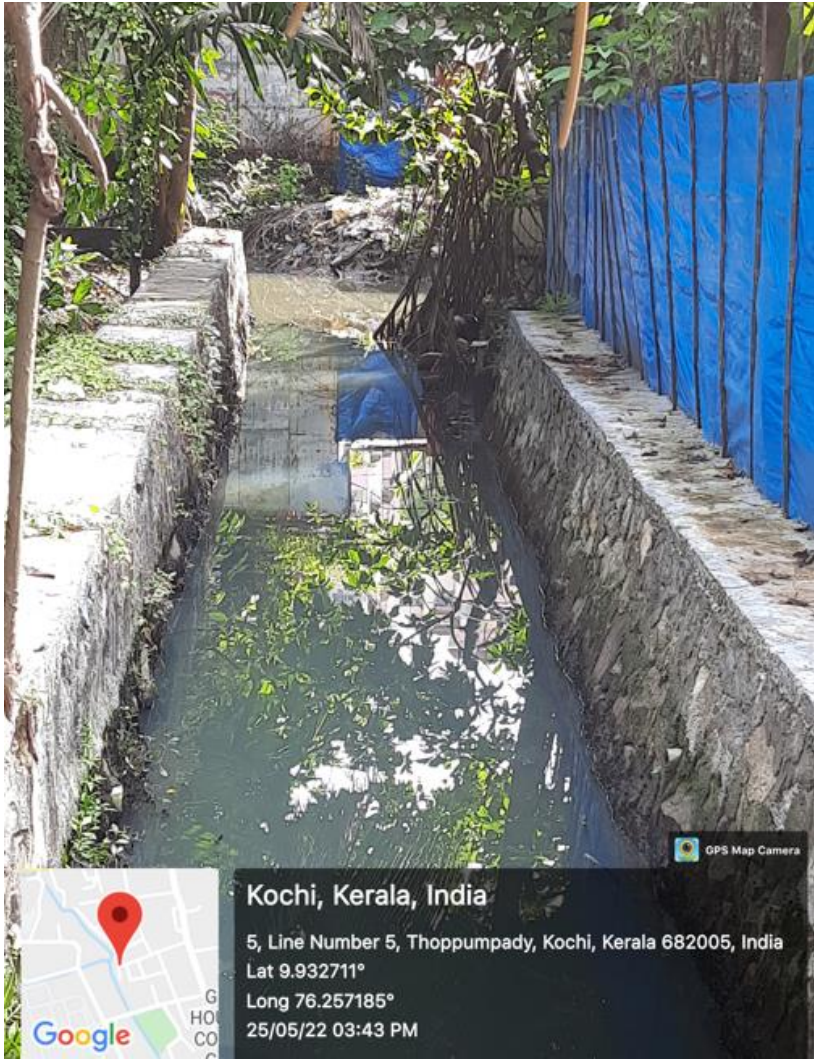
Unlined Canal behind Santhom Colony (Photo Credit: bechtel.org)

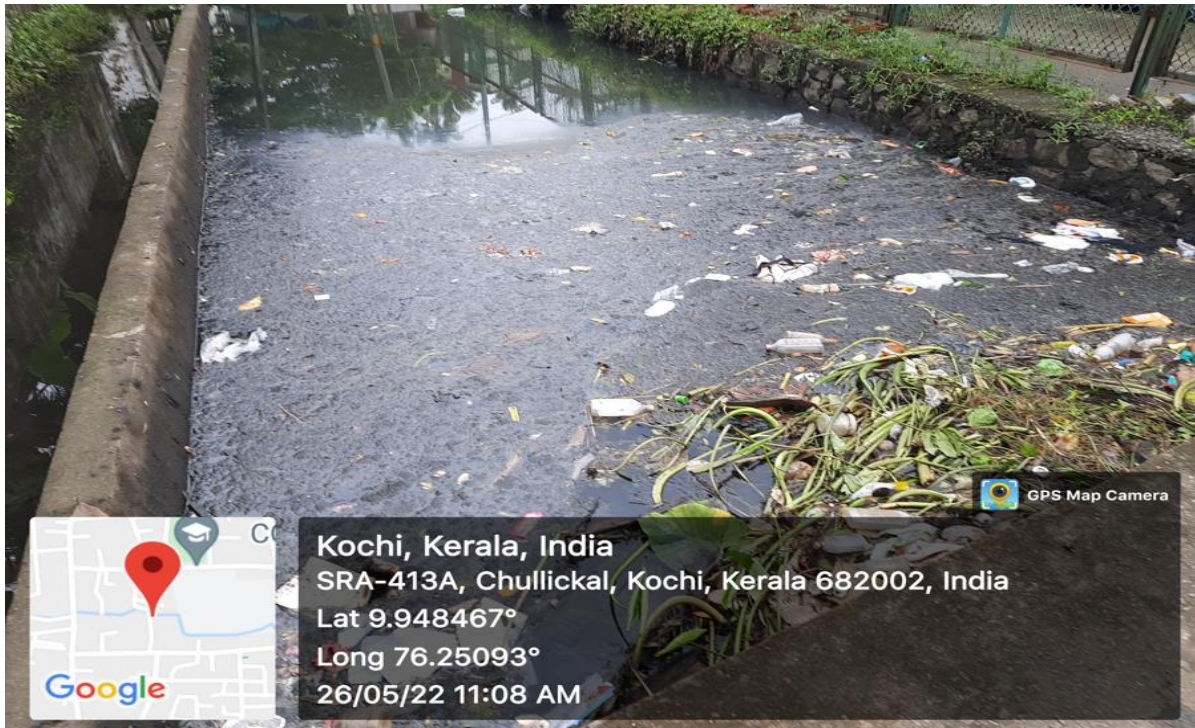
Stagnant stretch of Rameshwaram Canal near Cochin University (Photo Credit: bechtel.org)

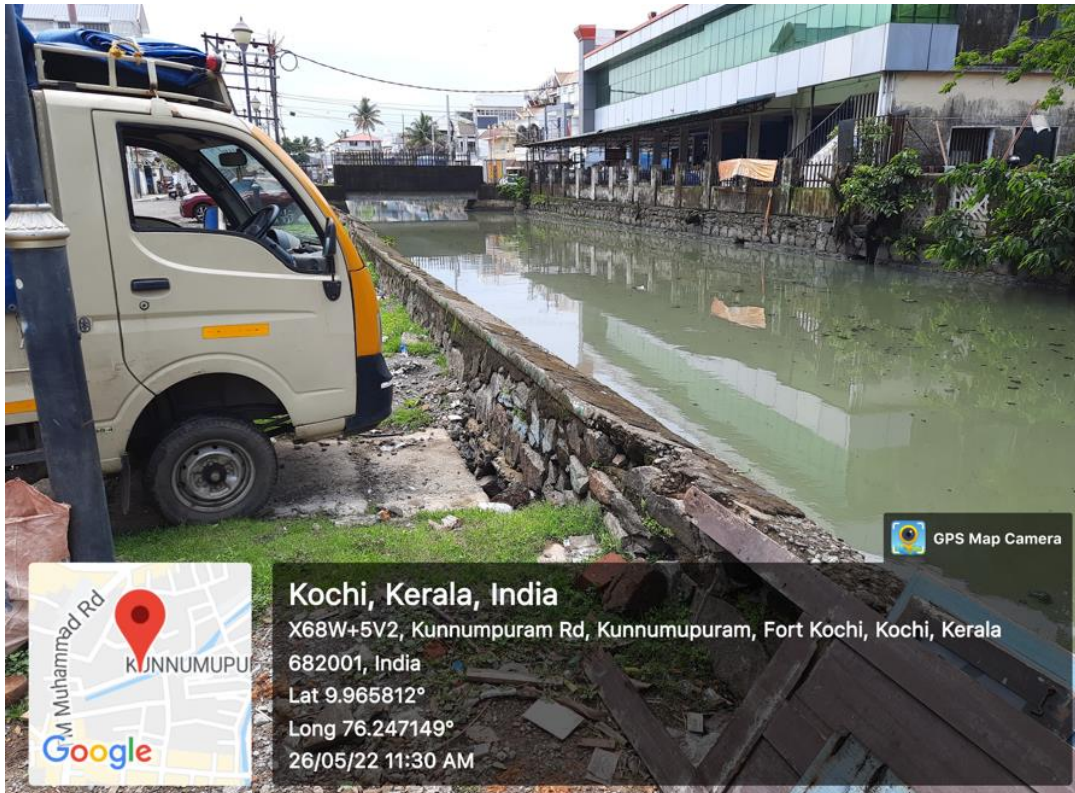
Canal Lining to be repaired (Photo Credit: bechtel.org)

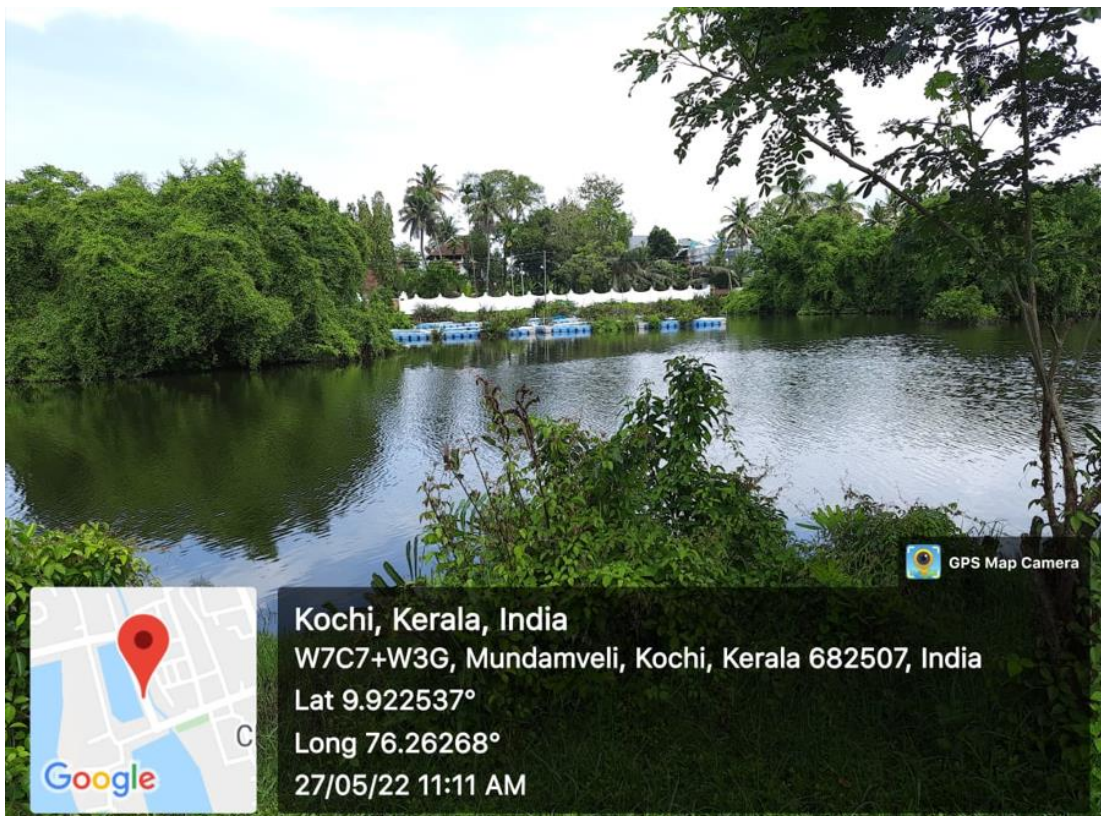
Pandarachirathodu canal covered with water hyacinth for a considerable length (Photo Credit: bechtel.org)
