# Frugal Rehabilitation Demonstration (FRD) in Mongolia

## FRD Case Studies Handbook

**Frugal rehabilitation of lands degraded by artisanal and small-scale mining at seventeen sites within nine aimags and fourteen soums across Mongolia.**

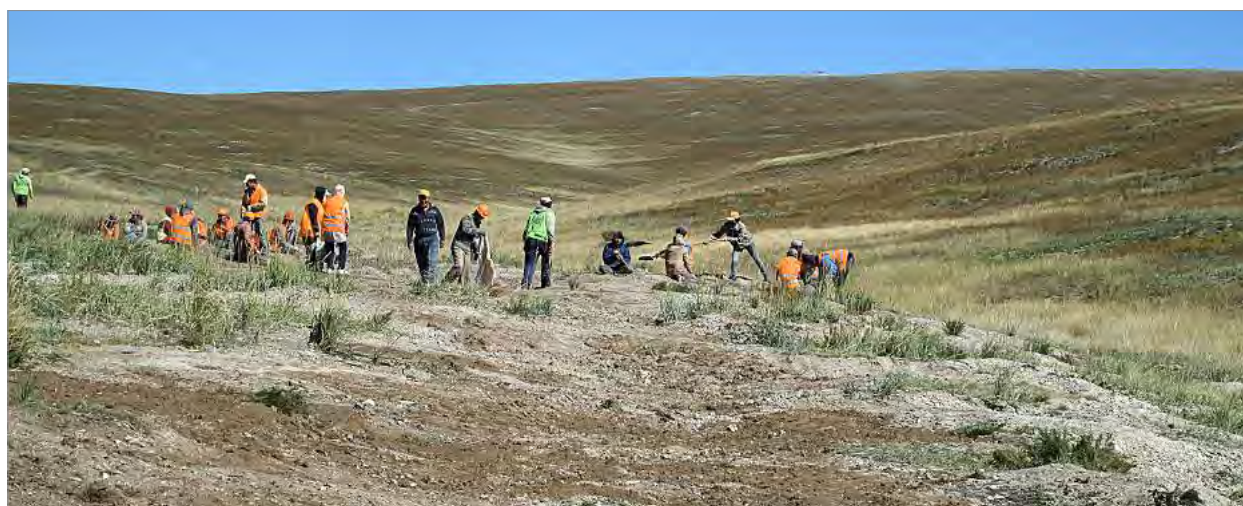
*Biological rehabilitation underway*

Seeds of target plant species for rehabilitation were collected in September and early October. The seeds were mixed with a manure base and dispersed manually over the targeted areas. Dispersed seeds and manure were raked into the soil surface, and hay spread over these areas to provide rehabilitation support, being mixed into the topsoils for added stability. The site and its topsoil were responsive to summer rainfall and natural colonizer species quickly regenerated during the growing season, establishing a first wave of natural regeneration of typical species. Biological rehabilitation had to be supervised at this site to ensure the desired prescriptions were carried out.

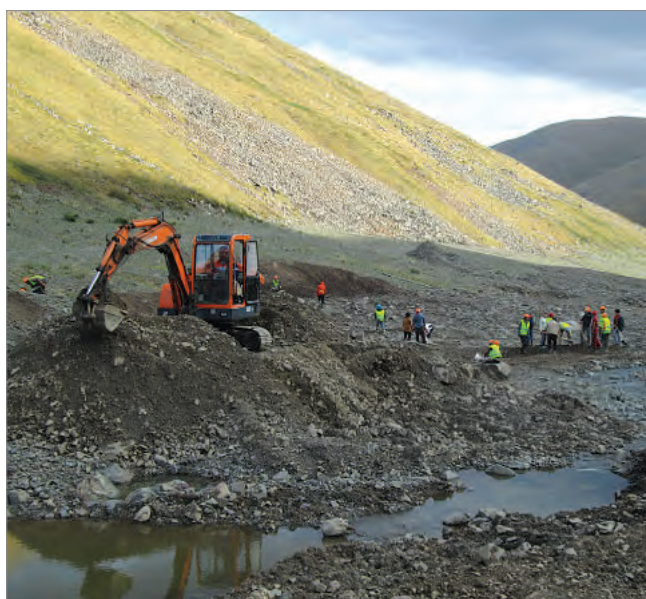
*A light excavator was used for technical rehabilitation*

Garbage removal were undertaken as a first step, and this was followed by mechanized infilling of pits initially using heavier materials and rocks. The ASM NGO had use of a light excavator which was used to demolish piles and redistribute and re-grade materials, as well as move larger rocks required for watercourse management. The light specification of this machine avoided unnecessary compaction issues (unlike ongoing rehabilitation at the neighboring active mine site). In addition, effective manual labor did the final reprofiling and topsoil work, further preventing compaction and giving attention to detail. In particular, watercourse design and rehabilitation was conducted manually following heavy rock placement by machine. All waste piles were completely used for infilling pits. Slopes were re-profiled to a maximum of 35 degrees in most cases.

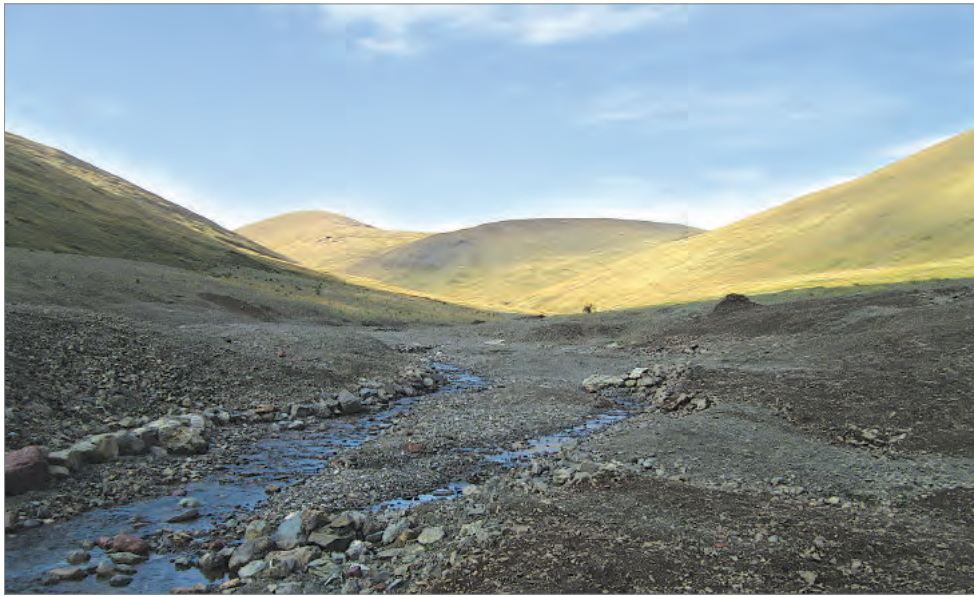
*Technical rehabilitation almost complete*

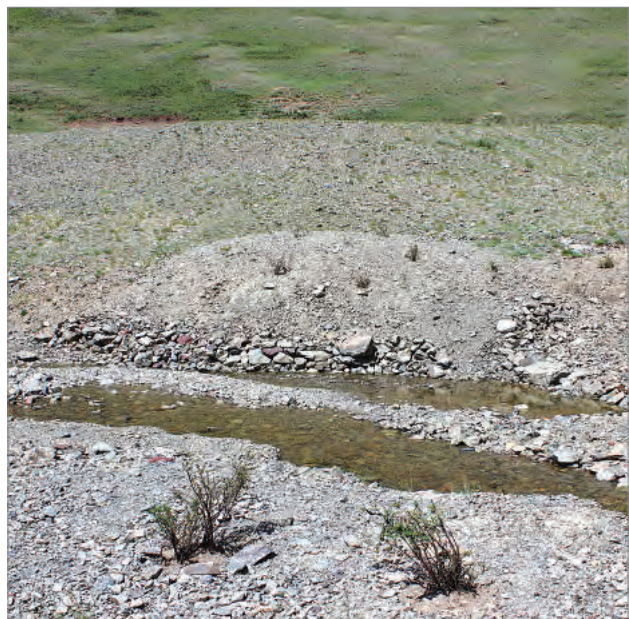
*Potentilla shrubs planted but need irrigation*

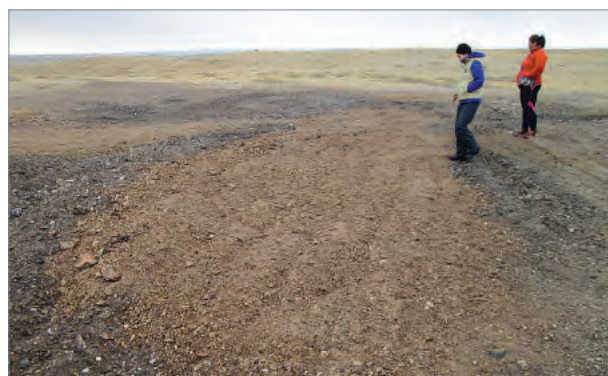
*Technical rehabilitation surface ready for recovery*

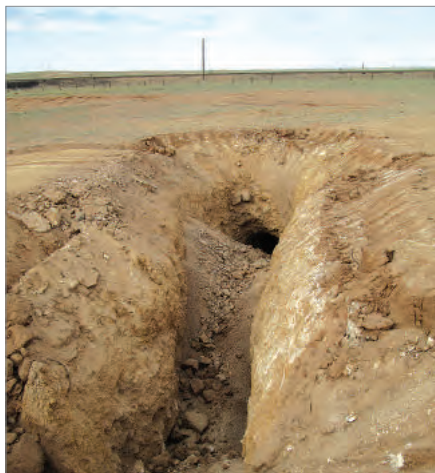
*Technical infilling underway*

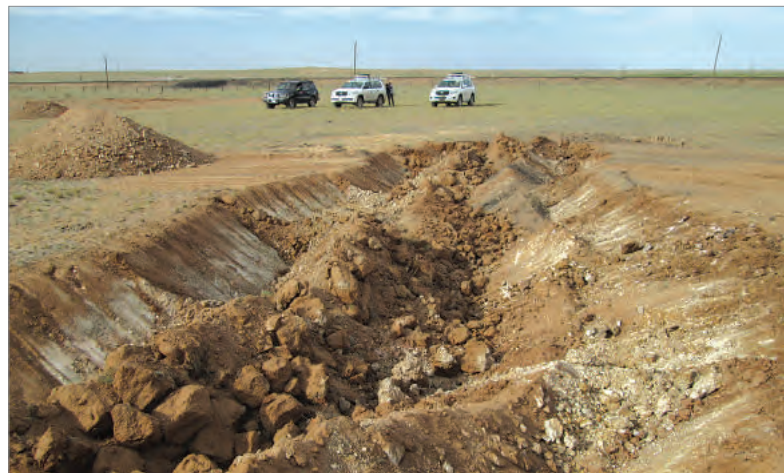
*Mechanized infill almost complete*

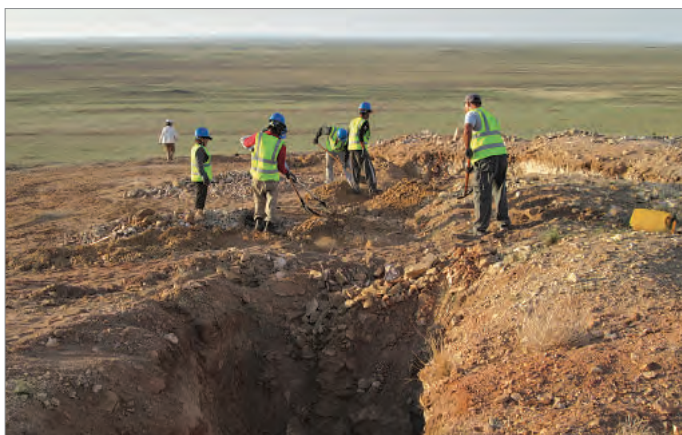
*Manual approaches also necessary to distribute topsoils*

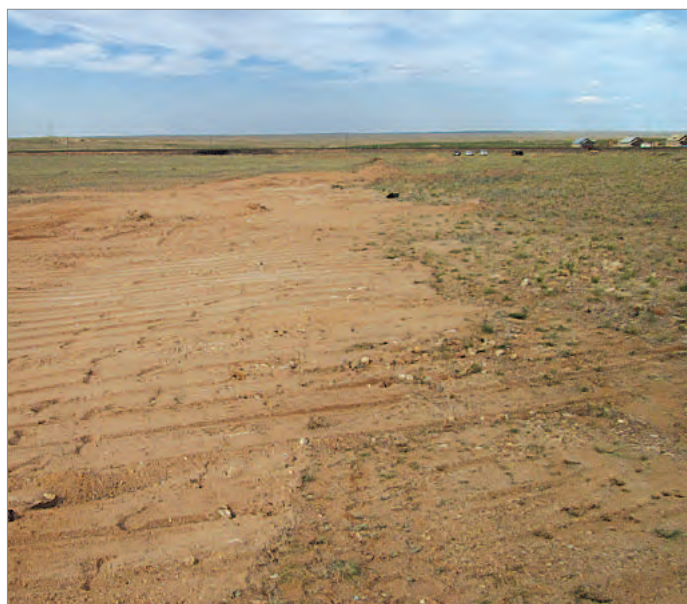
*Technical rehabilitation complete*

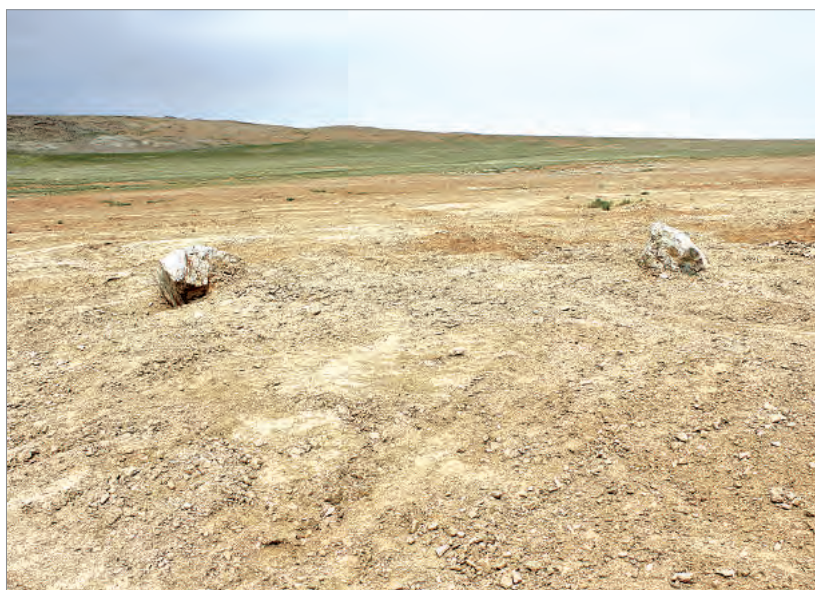
*Technical rehabilitation completed at Shar Khoshuu*

Between the dates of 3 July – 23 August 2015, the technical rehabilitation was performed by artisanal miners. Garbage removal and the safe demolition of unstable tunnels, was undertaken following FRM prescriptions. The use of mechanized assistance for infilling was advocated by the ASM NGO, and this work was undertaken with soum assistance. Elsewhere, manual approaches were adopted, with shafts filled with heavier rocks first, followed by small stones, then covered by available topsoil recovered from the area. Re-profiling was conducted to match with original slope profiles of the gully and open steppe. All stockpiles were completely used for infilling pits. Machines were used and so decompaction was addressed using manual approaches at the end of the technical rehabilitation. The upper reaches of a gully between low hills may experience water erosion in future, so monitoring will need to assess such changes, should occasional flooding occur there.

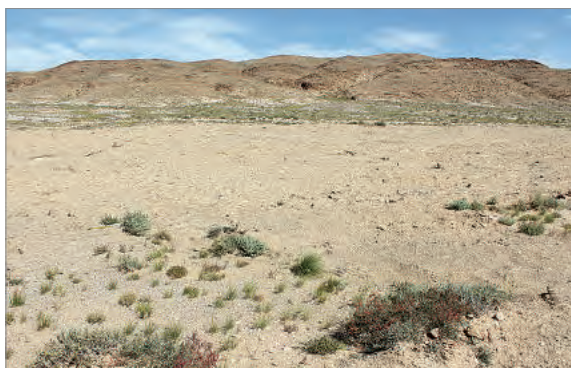
*Technical rehabilitation completed at Khutul*

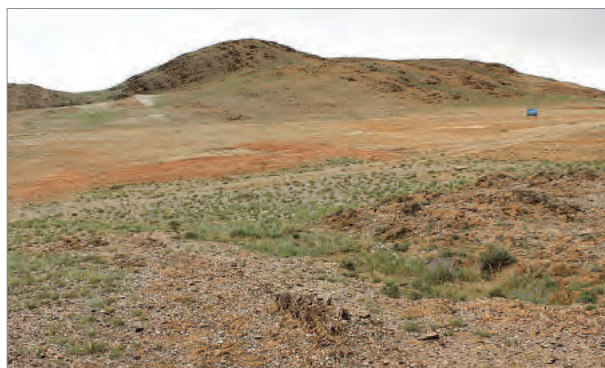
*Technical rehabilitation completed at Khutul*

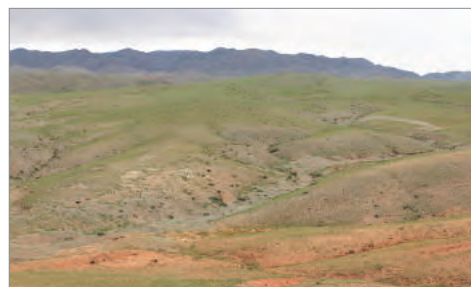
*Monitoring indicated successful technical & biological recovery*

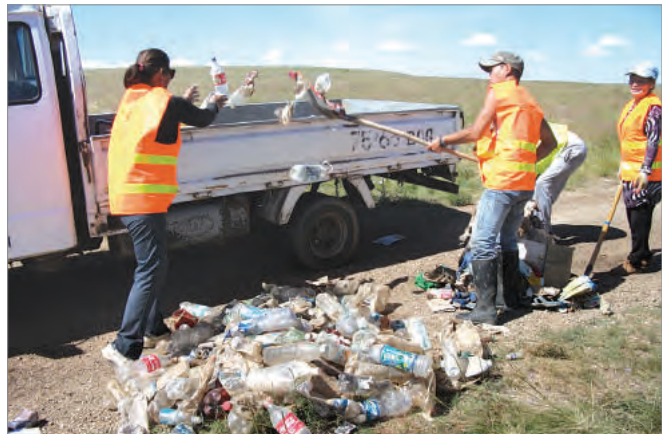
*Removing plastics and other garbage from the site*

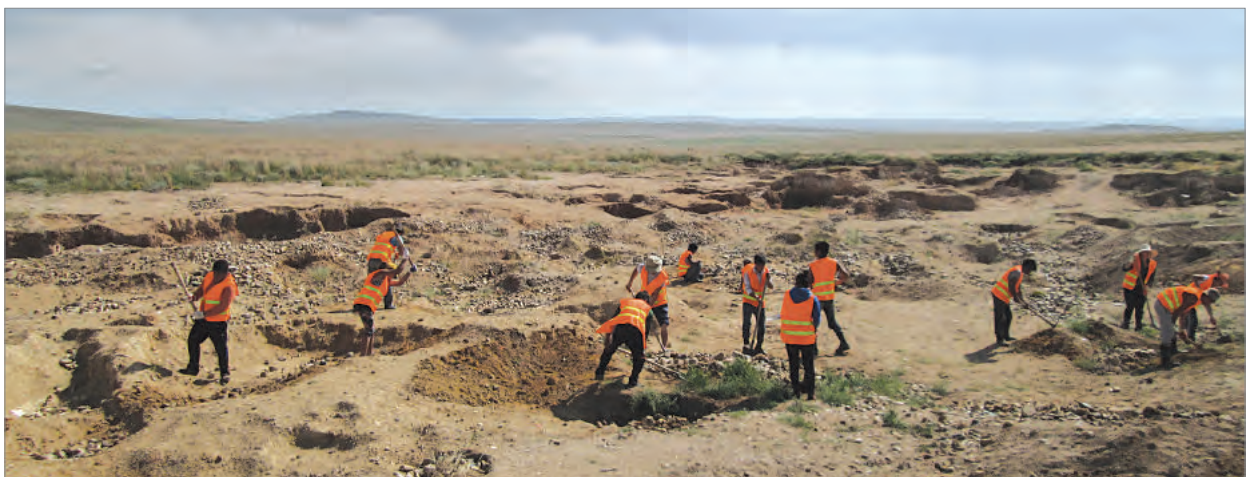
*Technical rehabilitation underway*

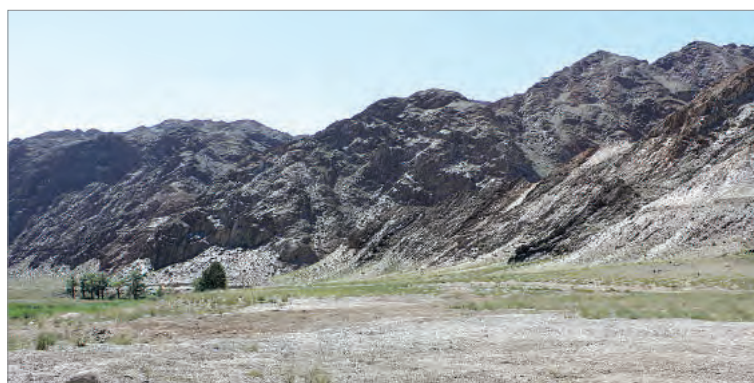
Technical rehabilitation completed at Tsagaan Chuluut Am

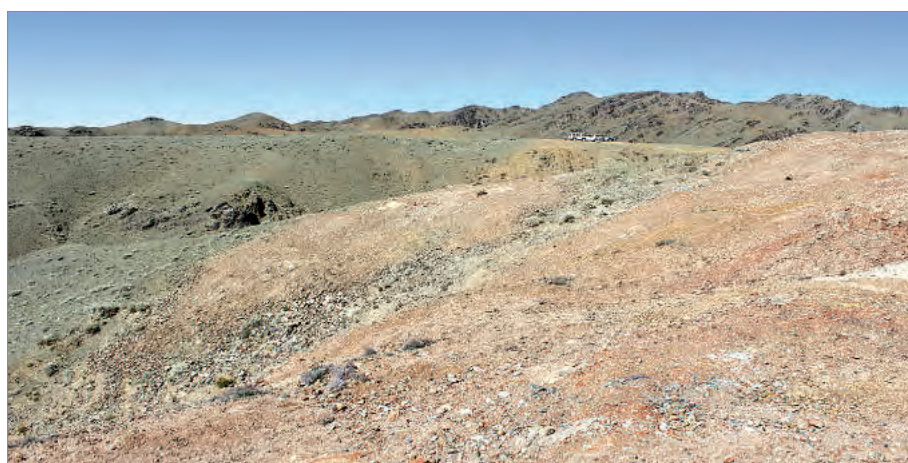
*Hard rock shafts infilled and reprofiled*

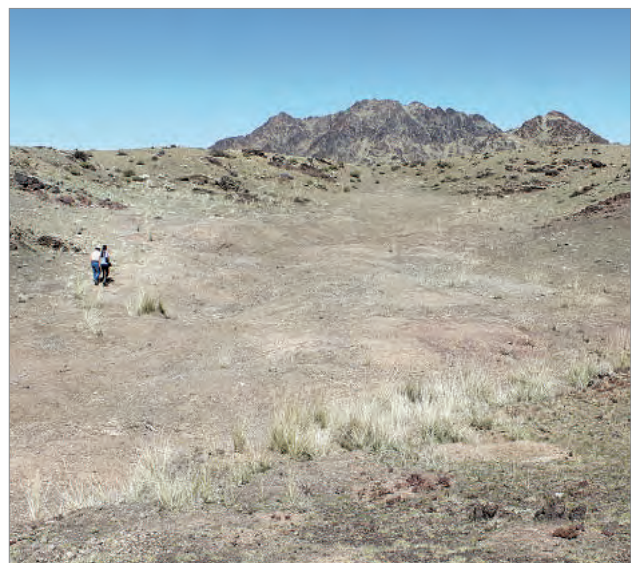
*Technical rehabilitation completed at Chavgans Tolgoi*

Between the dates of 3 July – 23 August 2015, the technical rehabilitation was performed by the ASM NGO. Garbage removal and safe demolition of unstable tunnels, were undertaken following the FRM. By using hand tools, shafts were filled with heavier rocks first and with small stones, then covered by available topsoil recovered from the area. Re-profiling was conducted to match with original slope profiles of the gully and hillsides, with slope re-profiling presenting a challenge that was met with a very high degree of success. All stockpiles were completely used for infilling pits. Machines were not used so compaction problems were avoided. Gullies are a dynamic environment with active erosion following rainfall so special attention was paid to provide and re-design a water channel, so facilitating a flood channel when needed in the event of occasional flooding.

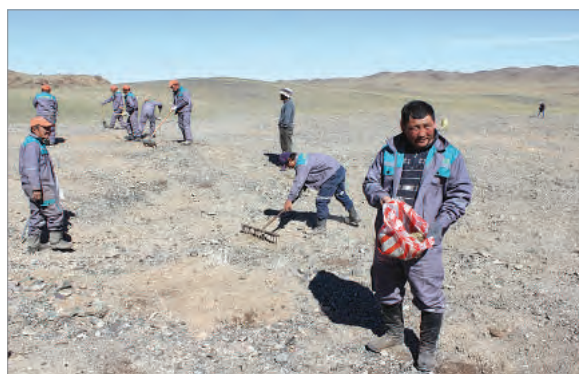
*Biological rehabilitation underway*

After technical rehabilitation, biological rehabilitation was continued until 3 September 2015. Seeds of target plant species for rehabilitation were collected in late August and early September. The collected seeds were mixed with manure, in particular bulis *Amygdalus pedunculata*, *Allium polyrhizum* and *Achnatherum splendens*. Dispersed seeds and manure were raked into the topsoil surface and hay spread over these areas to provide rehabilitation support (moisture retention) and protection (wind erosion). Bulis *Amygdalus pedunculata* was targeted along higher ridge margins and hillsides areas above the alluvium, whereas *Achnatherum splendens* was distributed along alluvial gullies. The site with its seedbanks in topsoil was responsive to summer rainfall and natural colonizer species and rapidly regenerated during the 2015 growing season, establishing a first wave of natural regeneration of typical species. Technical assistance at the site was provided by the ESEC II project on three monitoring visits during the rehabilitation effort to ensure successful implementation of technical, topsoil management and biological rehabilitation processes.

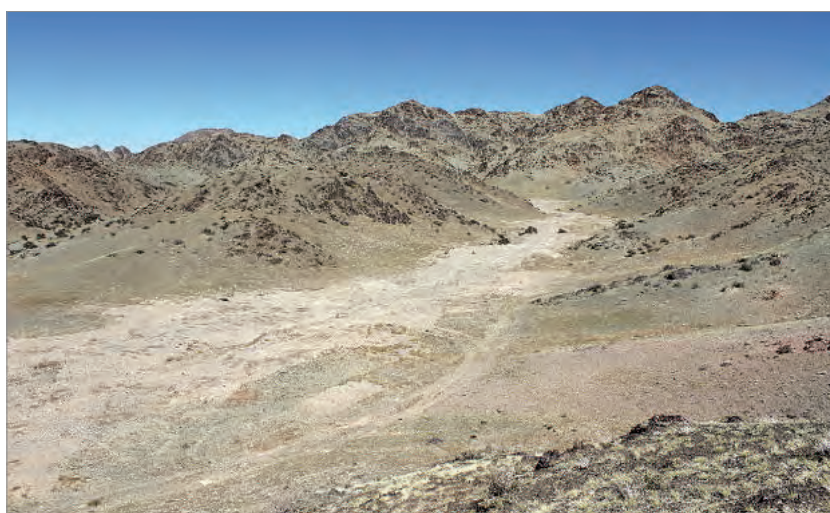
*Frugal rehabilitation completed  
at 850 gully*

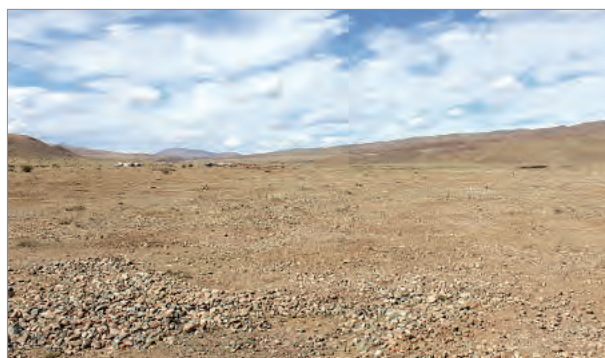
*Technical rehabilitation completed*

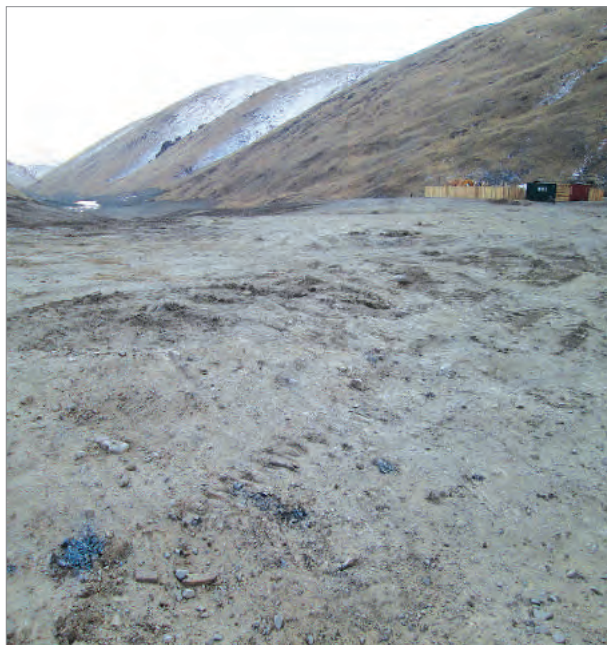
1. Mechanized compaction at non-FRD rehabilitation area, Jargalant October 2014

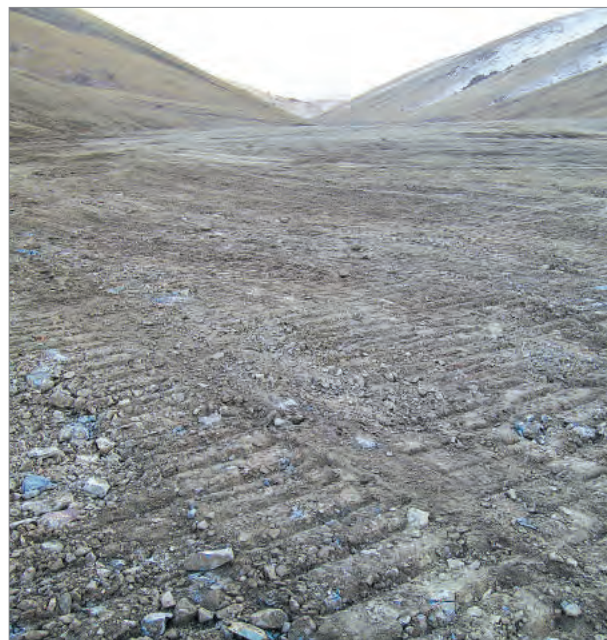
2. Compaction at non-FRD rehabilitation area, Jargalant October 2014

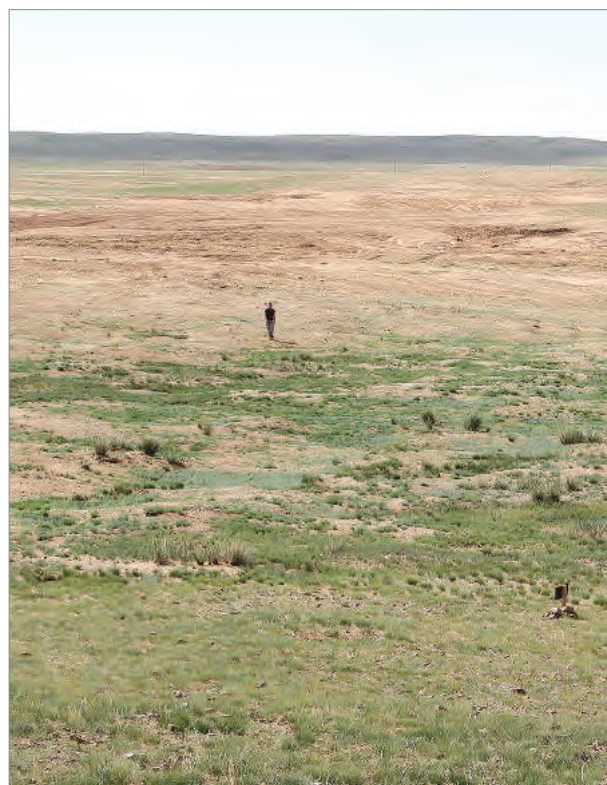
4. Contrast between non-FRD rehabilitation (background) and FRD (foreground), Altan Us, Bayan Ovoo June 2015

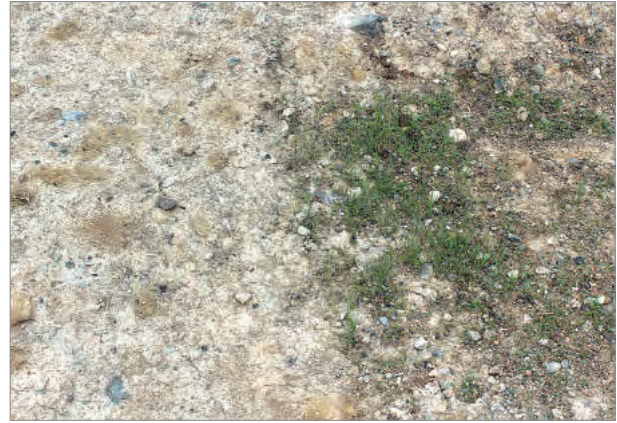
6. FRD site (right) with biological effort and non-FRD rehabilitation (left), Zurkh Tolgoi 2015

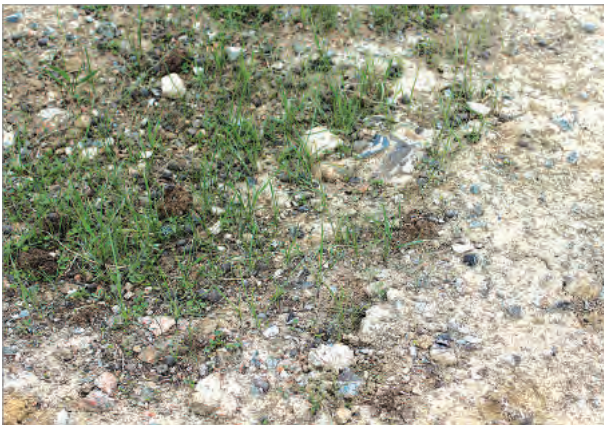
7. Contrast between FRD biological rehabilitation result and no biological effort, Zurkh Tolgoi 2015
