March 2007  
Issue 3

Welcome to the 3rd edition of the HP LaserJet Product Update Newsletter! This newsletter provides “hot off the press” technical information about the HP LaserJet printers you use and support. Our focus this quarter is on the HP Universal Print Driver (UPD). We know that you have questions about the UPD, and we have the answers! Look inside for information on the latest UPD version 3.1 along with the most popular Frequently Asked Questions from customers like you.

# HP Universal Print Driver

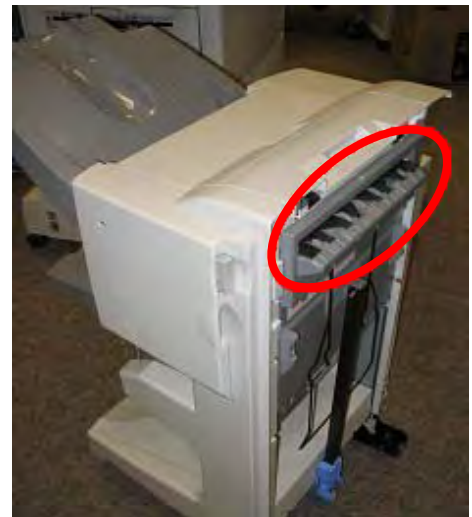
A control panel message of “13.12.21 Jam in Left Accessory” is usually due to contaminated sensors. The flipper assembly’s optical sensors are being blocked or contaminated by environmental dirt/dust or media dust. Cleaning the optical sensors usually resolves this error condition. To clean the optical sensors, follow the steps below.

The flipper assembly is located on the side of the multi-function finisher

1. Move the multi-function finisher away from the printer.

- Remove the jammed paper from the multi-function finisher, along with any other media in the paper path.
- Identify the upper sensor (transmitter) location. See the photos below.

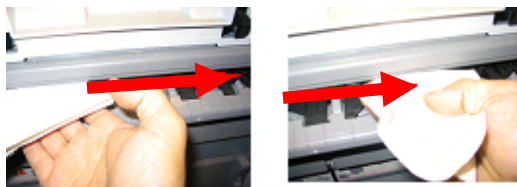
**Clean with a dry, lint-free cloth**

- Clean the upper optical sensor with a dry, lint-free cloth.

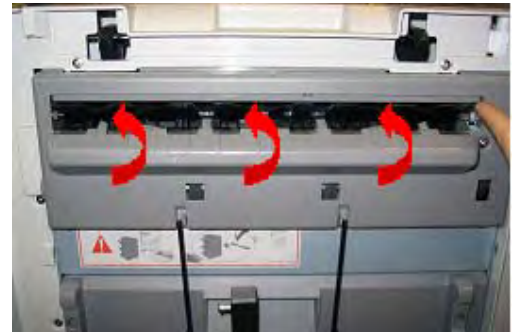
**Lift the flapper**

- Lift the flapper as shown below.

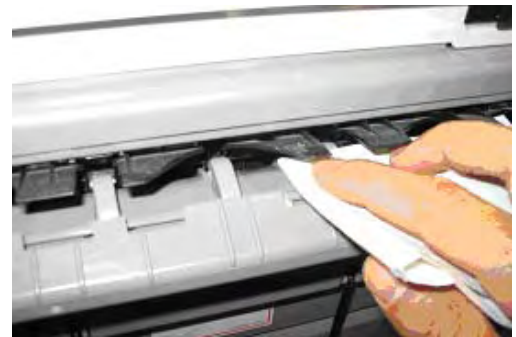
**Clean with a dry, lint-free cloth**

- Clean the lower optical sensor with a lint-free cloth.

- Re-attach the multi-function finisher to the side of the printer. The printer may continue to flush any media left in the paper path.
- If the printer does not come to a READY status, turn the power OFF then back ON.
- If the "13.12.21 Jam in Left Accessory" error continues after cleaning the optical sensors, contact HP or an HP Authorized Service Provider.

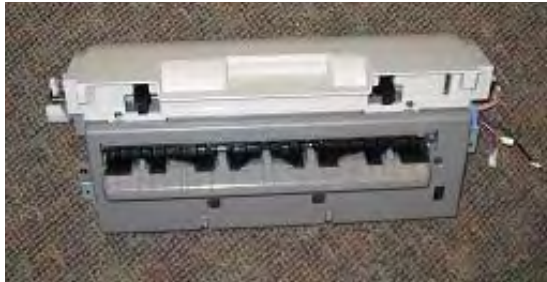
New flipper assemblies have been returned to HP as defective or as a DOA part because of a "13.12.22 Jam in Left Accessory" message appearing on the control panel after a new flipper assembly installation.

HP has evaluated field service returned flipper assemblies (part number 4G1-5219-030CN) and determined that the shipping locks and orange packaging tape was not removed prior to installation in the multi-function finisher. The flipper assemblies were re-tested, and found to work properly when the packaging material was removed.

The flipper assembly

Ensure that the shipping locks and orange packaging tape have been removed. See the photo below for identification and location of the shipping locks and packaging tape.

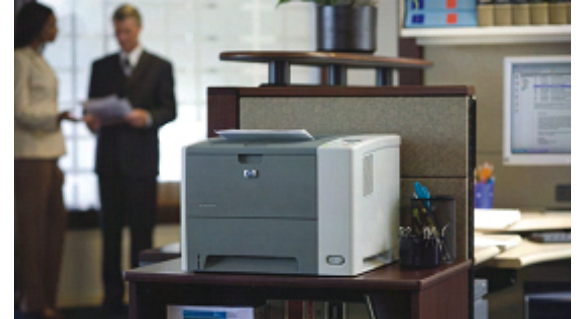
In some instances the HP LaserJet P3005 printer base and duplex models will start up with a blank display, or will not start up at all. This may be caused by wrong timing values set in firmware version 20060807 02.034.0 in combination with Infineon-B memory chips on the formatter board.

### HP LaserJet P3005 printer

This issue is caused by incorrect timing values in firmware version 02.034.0 that cause the printer to fail start-up under certain conditions (such as low or high temperatures) without additional memory. Firmware version 02.034.1 or later corrects these timing values. Only several hundred units were built with firmware version 02.034.0, and very few of these will fail because of incorrect timing values.

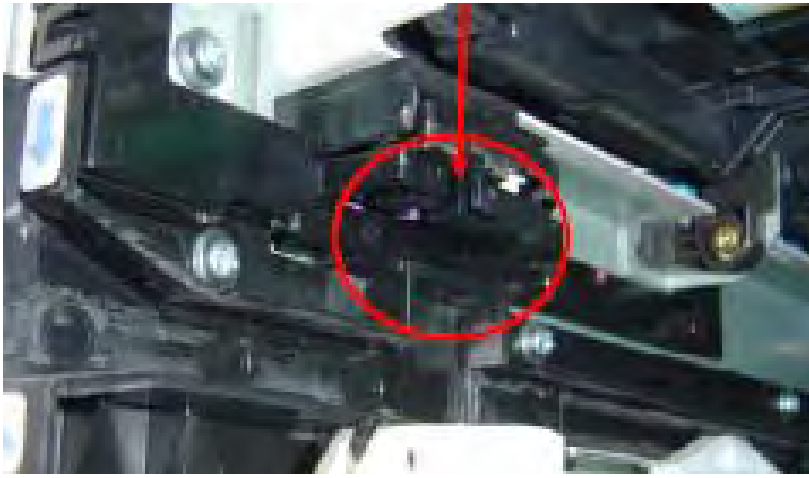
The second instance where the “Replace Transfer Kit” message may appear is when the device is not recognizing the presence of the Intermediate Transfer Belt (ITB) for some reason or is sensing that the belt has shifted and is not aligned. In this instance further troubleshooting should be performed. See the workaround in the next column.

**Correct alignment**

1. Print out a Supplies Status Page and check the Image Transfer Kit page count. If it is at 200,000 pages; replace the transfer kit with a new kit (part number C8555A).
2. If the page count is not at 200,000 pages or within 20% of that range (160,000 or higher), check the alignment of the ITB sensor flag, sensor 44.

2. Take the ITB out of the drawer, and look inside, to the left. You will see the sensor itself. See the photo on the next page.

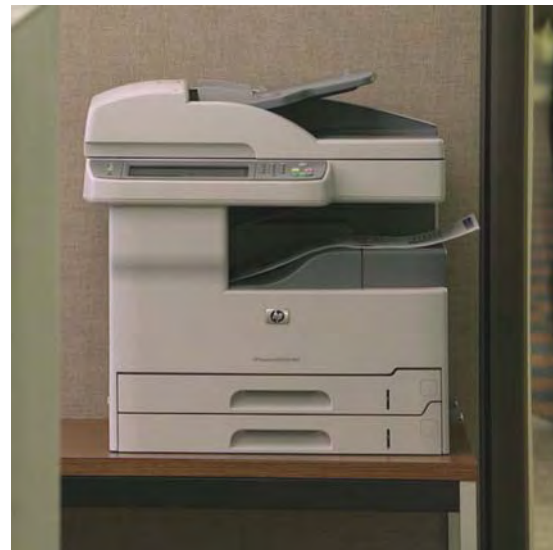
The M-series products eliminate the Save Current Settings? screen. There is also a defect in the Auto Settings Reset function: it is only active if authentication is enabled. With any type of authentication enabled, the Auto Settings Reset timeout selection works, but **Immediate** does not. The result is that the fax or digital send screen stays active for the number of seconds set in the Inactivity Timeout. The default value for Inactivity Timeout is 60 seconds.

- User 1 sends a fax or digital send job and immediately walks away
- User 2 puts a job in the Automatic Document Feeder and presses the **Start** button, intending to make a copy. The display still has the fax screen, but the user doesn’t notice.
- User 2’s job is sent to the same destination as User 1’s.

**HP LaserJet M5025 MFP**

Any type of authentication will cause a screen to appear after a sending job. The screen says: “Do you want to remain logged in?” Your choices are **YES** and **NO**.

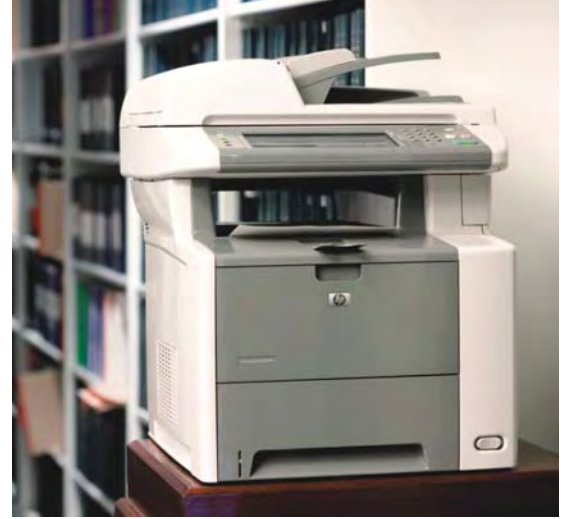
The stapler's actuator rod is coming off during transportation. The stapler will not work and appears to be broken. See the example photo below.

### HP LaserJet M3035 MFP

2. Verify proper installation of the stapler's actuator rod. This picture shows the correct installation.

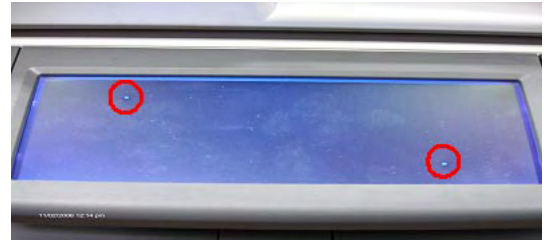
This photo shows the two squares on the M3035 MFP's touch-screen

Touch the small square in the upper left corner only ONCE. The square will not disappear when touched.

5. As soon as the square in the upper left corner is touched, another square will appear at the lower right corner of the touch-screen.
6. With a pen, touch the small square at the lower right corner.
7. At this point, calibration is complete and the device will continue booting up.

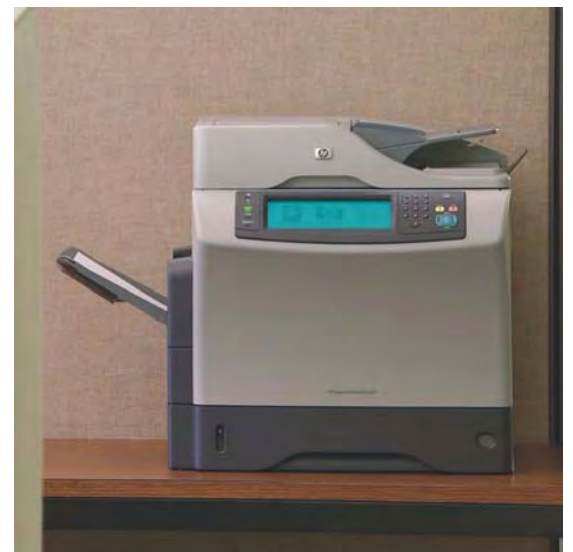
This error often occurs when a firmware RFU file is sent to the MFP and the MFP reboots to an error (for example, a 49.xxxx error) afterwards. In most cases, this error message indicates the output accessory does not have the necessary firmware loaded on it. Resending the RFU file will reload the firmware.

HP LaserJet M4345 MFP
