# The Winning Line

A Forensic Engineer's Casebook

Andrew Samuel, BE (Mech), MEngSci, PhD, DrEngFIE Aust  
Professorial Fellow  
University of Melbourne  
*and*  
Principal Consultant  
Engineering Investigations & Associates Pty. Ltd.  
Australia

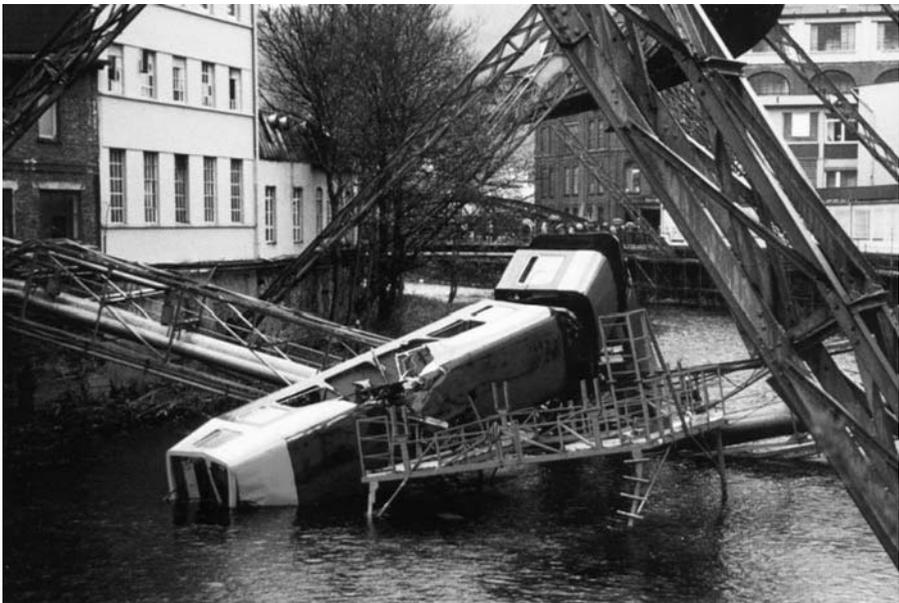
Figure 1.3 The collapse of the Wuppertal suspended railway in 1999 following incorrect installation during maintenance

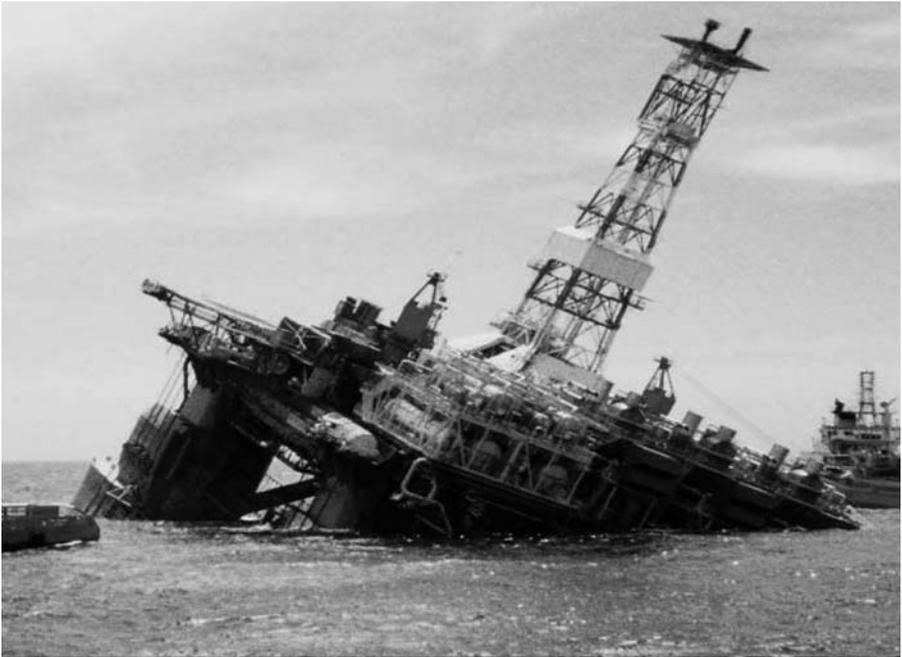
*Figure 1.5 Sinking of an oil exploration platform (Insurance loss of \$500 million)*

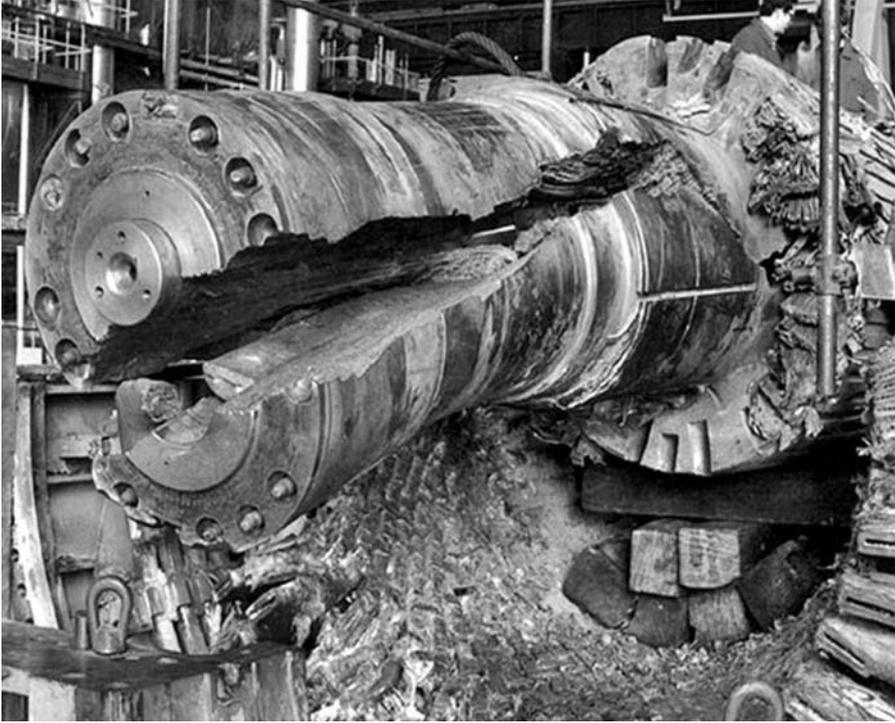
Figure 1.6 Failure of a 600 MW set with an eventual insurance loss of \$40 million

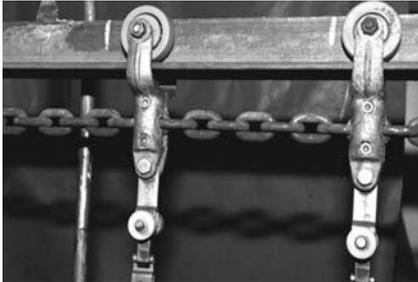
Figure 1.8 Chickweigh line chain and shackle arrangement

link size. The corner wheels of the conveyor were inspected to establish the fit of the drive chain in the driving tabs on these wheels. (Refer to photos in Figures 1.8 and 1.9)

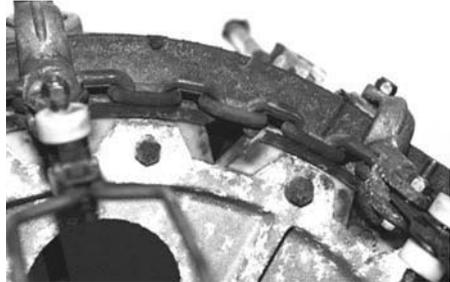
Figure 1.9 Chickweigh line corner pulley showing shackles fitting into slots on wheel

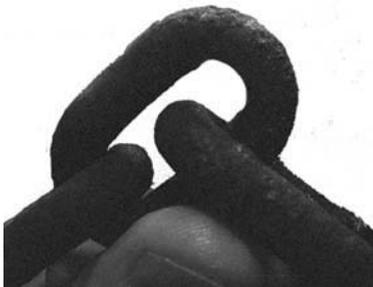
Figure 1.12 Close-up of chain showing substantial wear at the end of the link

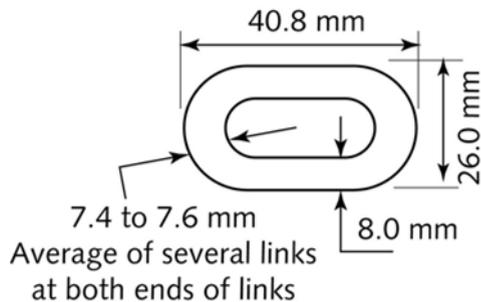
$$A = 40.8/2 = 20.4 \text{ mm}; B = 7.5 \text{ mm}$$

Figure 1.13 Chain link measurements on chickweigh line

$$\begin{aligned} CD_{shackle/worn} &= 16 (20.4 - 7.5) \\ &= 206.4 \text{ mm (205 measured)} \end{aligned}$$

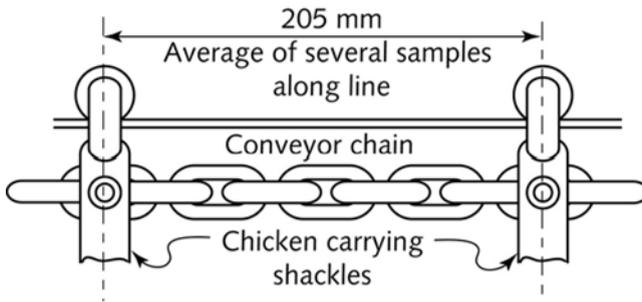
Figure 1.14 Inter-shackle distance on chickweigh line

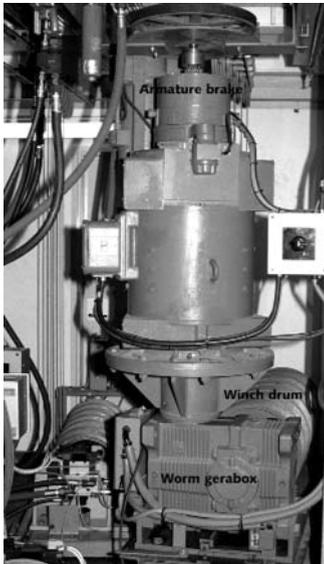
My personal involvement in this case commenced after the GMT evaluation as well as after the issue of the various writs against the thirteen defendants. Figure 2.3 shows a winch motor attached to a worm gearbox, from which the winch drums are driven. The smaller diameter component attached to the motor is a separate armature brake. This device is intended to stop the motor from over-revving or freewheeling in case of a power failure. Figure 2.4 is a view of the winch floor and Figure 2.5 is a typical winch motor shaft with the worm screw attached to it. At the time of my involvement in this matter, virtually no expense had been spared to investigate the mechanical issues identified by Goalie Ltd. My brief was to evaluate the whole system of winches and winching systems in addition to that found by Goalie Ltd. I suspected that my involvement was supposed to heavily reinforce the Art Centre insurer's case against the thirteen defendants and specifically against Ruckman, the American suppliers of the winching motors and gearboxes.

Figure 2.3 A winch motor and gearing system. The motor drive is attached to a worm gearbox

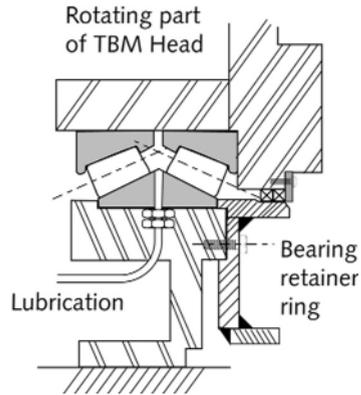
Figure 2.15 Original design of bearing mounting. This partial view shows the relatively flexible retainer ring

Figure 2.14 is a schematic representation of the various loads acting on the bearing and in turn on the retainer ring designed to maintain the bearing in its mounting within the deflection limits specified by the manufacturers. Torrington's specification for this bearing was a maximum tilt of the central plane of the bearing of 0.5 minutes of arc. Consequently it was necessary to investigate the mounting geometry and its flexibility.

Figure 2.15 shows part of the sectional drawing of the TBM with its original bearing mounting configuration.

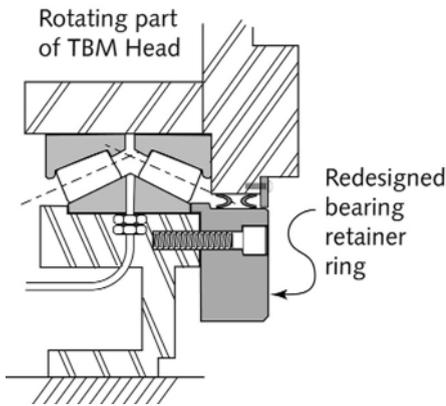
Figure 2.18 Bearing mounting with redesigned retainer ring

Figure 2.18 shows (approximately to the same scale as the original retainer shown in Figure 2.15) the sectional drawing with the modified bearing retainer. Clearly, the new retainer ring has been substantially increased in thickness, as a result of this investigation. Fortunately, there was sufficient space available in the original design to permit the replacement of the original retainer with this substantially thicker retainer ring.

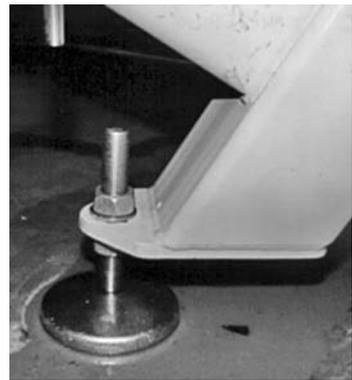
Figure 2.24 Photograph of a typical leg support pad

indeed cause local yielding of the bearing surface. The originally supplied machine levelling pads were made of solid polypropylene. These pads were replaced with the metal pads (see Figure 2.24) when one of the plastic pads collapsed during commissioning of the machine. From the evidence of the bearing damage it appeared highly probable that the failed bearing was indeed subject to this type of damage.

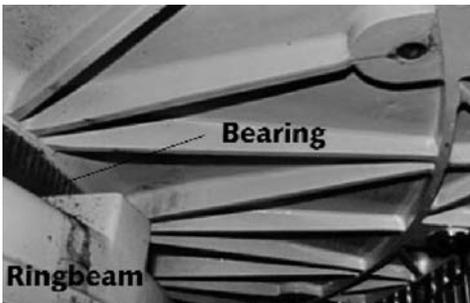
Figure 2.25 Photograph under turntable

Figure 2.25 is a photograph of the underneath of the machine turntable. This photograph indicates the robust ring beam structure used to support the machine bearing. Simple calculations of deflection in the ring beam under normal loading showed these deflections to be negligible.<sup>2.15</sup>

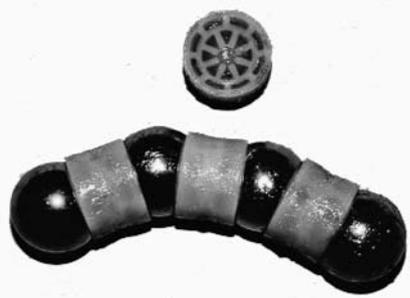
Figure 2.26 Ball and spacer arrangement

Figure 2.26 is a photograph of the 35 mm diameter balls and the plastic spacers used in the machine bearing. The bearing outer ring has a slot that permits the entry of balls into the bearing during assembly. Lubricant grease is pumped into the bearing at regular time intervals and there is a location on the bearing where the “new” lubricant extrudes “older” used lubricant from the bearing. Samples are taken from the extruded lubricant daily and analysed for metal content. When the content of metal shards in the grease exceeds some level specified by the manufacturer, the bearing is deemed to be near incipient failure. A few months after the failed original bearing was replaced by GBF engineers, the lubricating grease monitoring process showed up with unacceptably high metal particle content. It was this event that initiated the investigation described here.

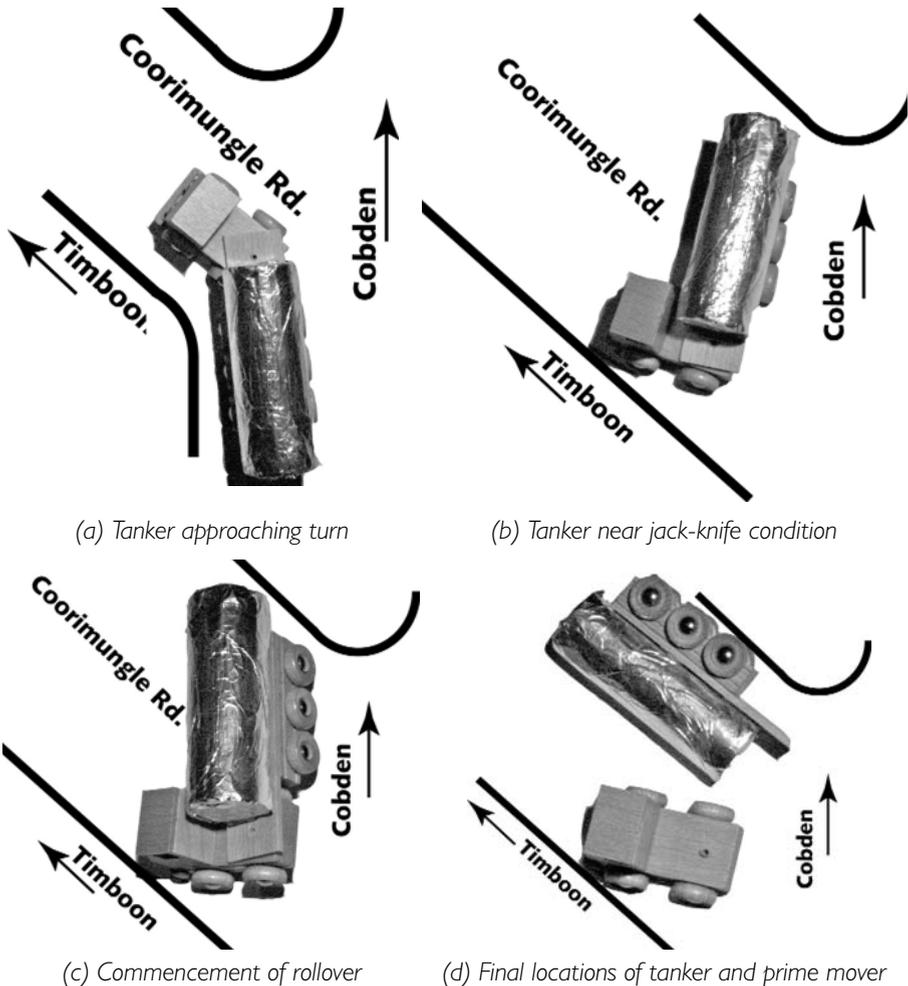
One aspect of constructing this particular traffic accident scenario was that of modelling the behaviour of the tanker in the turn. In this case the initial modelling was conjectured as indicated by the model pictures in Figure 2.35. The conjectured chronology of the tanker rollover was as follows:

Figure 2.35 Model demonstration of the tanker rollover process (not to scale)

- (b) Tanker trailer begins to slide on wet road;
- (c) Inexperienced driver applies brakes;
- (d) Tanker trailer rolls and tears out kingpin bolt from the bottom plate of the hitch. Trailer and prime mover settle in locations indicated in the photo of Figure 2.35 (d). This was confirmed by the police report of the accident scene.

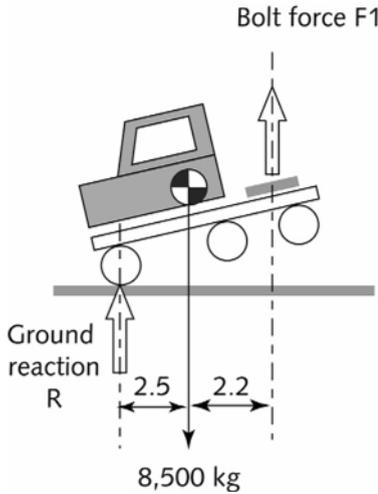
Figure 2.36 Phase 1 of the roll

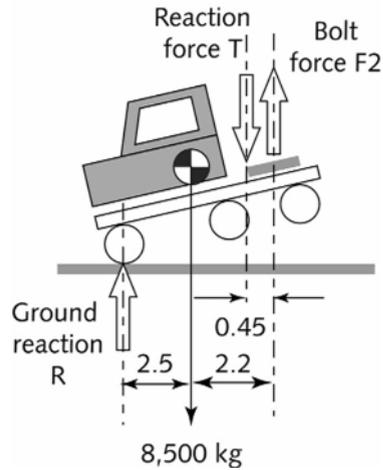
In Phase 2 of the rollover the moment acting on the top plate due to the rolling over of the trailer is  $F2 \times 0.45 \text{ Nm}$ .  $F2$  could have been estimated from the conjectured centrifugal forces acting on the rolling trailer at various road speeds and turn diameters. However, a simpler approach was to recognise that the bolt had indeed been torn out from its location and the twisting moment responsible for this was as indicated in Figure 2.37.

Figure 2.37 Phase 2 of the roll

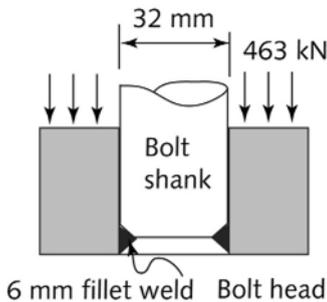
Figure 2.38 Schematic view of bolt head under load

Figure 2.38 is a schematic view of the bolt head under load during Phase 2 of the roll. The stress developed in the weld is given by<sup>2.17</sup>

This is a very large shearing stress that would have easily failed the weld holding the machined head of the bolt onto the shank. However, the standard bolt originally used in the hitch was a *Duraflex* CS1045 steel bolt with a tensile strength of 440 MPa.<sup>2.18</sup> In the event that a standard kingpin bolt had been used in the hitch during the accident the failure criterion for this standard bolt would have been the tensile strength of the bolt shank.

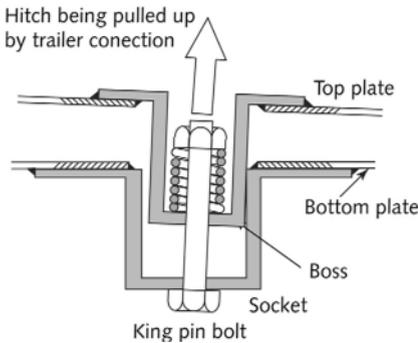
Figure 2.39 Greasy-plate hitch at its extreme displacement

This calculation does not take into account the failure of the bolt at its thread, where the root diameter is smaller than the shank diameter, and stress concentrations are introduced by the thread elements. The significance of the calculated stress on the bolt is that it would have failed in any circumstances whether it had been a standard bolt or a modified manufactured bolt. This bolt is not expected to carry substantial loading at any time other than when the hitch spring (refer to Figure 2.39) is fully compressed. In this condition the load is taken by the kingpin

head and nut as well as the metal bases of both boss and socket components. Under sufficient loading the thread on the kingpin bolt may shear off, the head of the bolt might be pulled through the base of the socket, or the kingpin bolt might fail in tension. These failure modes are listed in order of greatest to least likelihood, estimated from the engineering mechanics of the greasy-plate assembly. In the Cherry Transport accident, the kingpin bolt head was welded on to the bolt stem, as indicated in Figure 2.38, and it was the fillet weld of this construction that became the weakest part of the greasy-plate assembly.

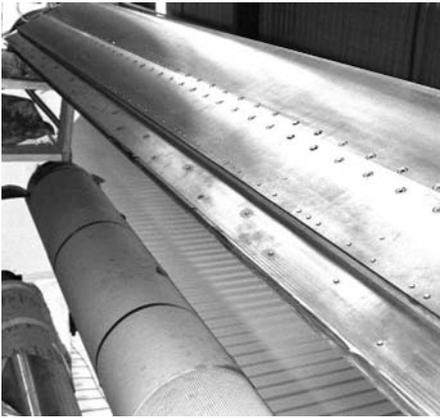
Figure 2.41 shows the partially unpacked airknife machine. Figures 2.42 through 2.45 show closer views of various elements of the airknife machine. On first inspection it appeared that the machine in its crate had suffered a substantial bump. The most easily apparent damaged items were found to be as follows:

Figure 2.42 View along air delivery nozzle, with airknife blades removed

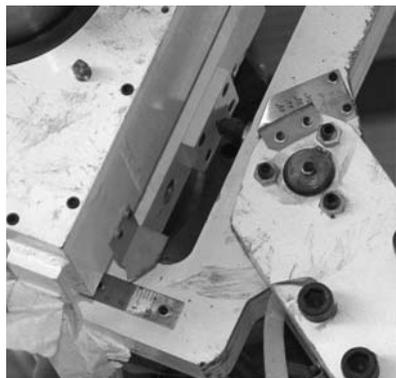
Figure 2.45 Close up of support head indicating gap and attitude adjustments

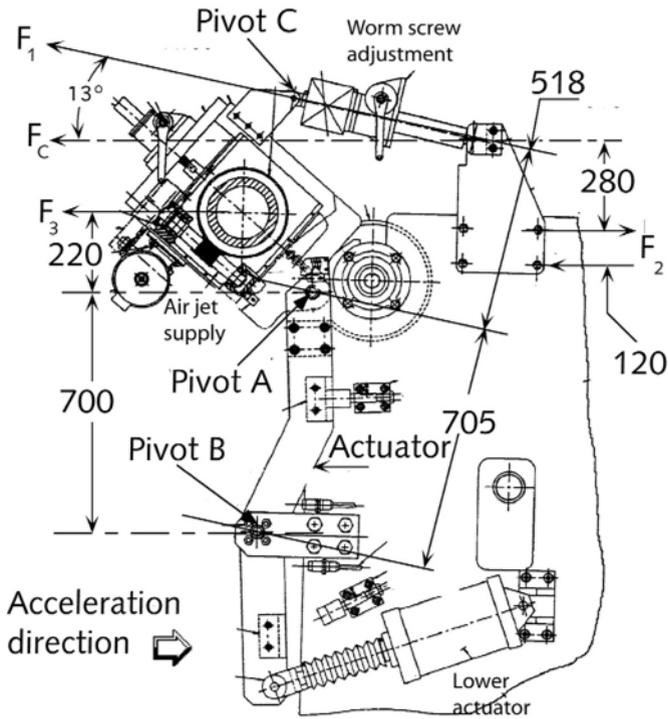
Figure 2.46 Side view of the airknife coater indicating some of the major features of adjustment to the machine

**(a) The Accident Scenario** – Figure 2.46 shows a side elevation of the airknife machine taken from a copy of drawings supplied by the Holker Corporation. The measurements were scaled from the drawing, using comparative dimensions measured on the actual Holker machine on site. Figure 2.47 is a simplified mechanism view of the moving parts of the airknife machine. The lower actuator is a pneumatic cylinder and in principle the air in this cylinder will act as a pneumatic spring until the lever arm pivoted at B hits a machine stop (see Figure 2.47). The following nomenclature is assigned to the analysis:

This moment is generated by the inertia force of the airknife assembly. Referring to Figure 2.46, the assembly will commence rotating about pivot C, under the action of the applied rearward acceleration on the packaged machine. This rotation will cause the actuating lever to move out to its out-board position about pivot B, where it will be stopped by the mechanical stops. When the lever comes to a sudden stop, the airknife assembly inertia load will be experienced in the screw jack connecting the pivot C to the actuator mounts. The magnitude of this impact load will depend on how

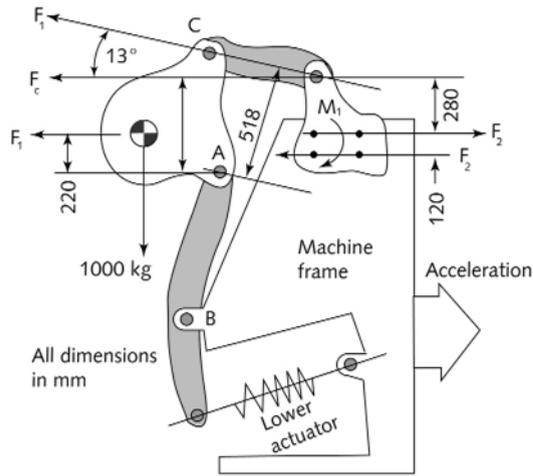
Figure 2.47 Simplified mechanism schematic of the major moving parts of the airknife machine indicating acceleration of the crated machine

This is a relatively low level of acceleration due to an impact load. It could well have been produced by the front of the machine (in its packaging) receiving a severe blow. Moreover, the damage at the rear of the machine is also consistent with a rearward acceleration of the machine package. The idler roll is resting substantially forward of its original mounting position and all the indications of its damage suggest that the machine was accelerated suddenly (hit) in a rearward direction. The four bolts holding the machine to its package base seem to be intact. If the machine were dropped on its front, one would expect the rear pair of these bolts to be, at least partially, dislodged from the package base. The only conclusion one can draw from these estimates is that the machine package either hit something during loading or unloading, or a heavy load impacted on it while stationary.

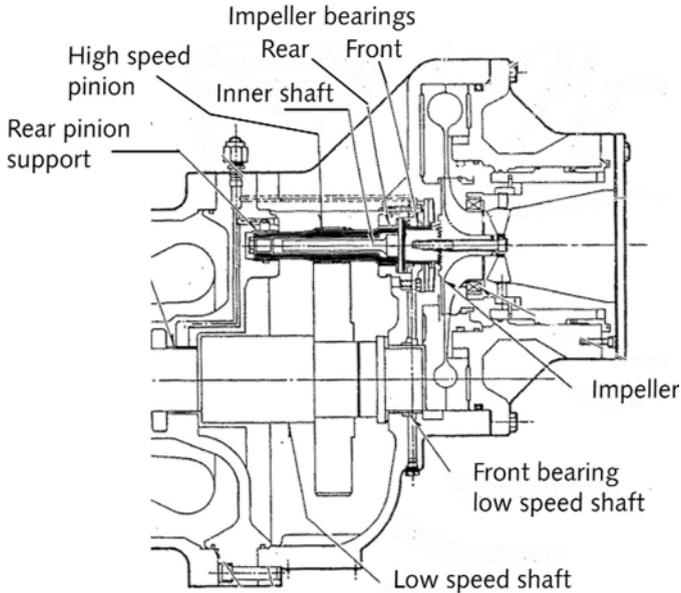
Figure 2.48 is a sectional drawing of the compressor. The shaded component is the high-speed pinion running at approximately 20,000 rpm. This pinion is hollow and carries a smaller diameter shaft inside it. The impeller of the compressor is attached to this inner shaft. The apparently strange design of this impeller drive system was dictated by manufacturing economy and weight saving considerations. The pinion gear cut on the outer shaft is expected to last considerably longer than the simple sliding bearings on the unit. Simple sliding bearings were used in the design to save on space and inertial loads that might be imposed by rolling element bearings. The most critical part of this construction is seen to be the thrust bearing

Figure 2.48 Sectional drawing of airconditioning compressor

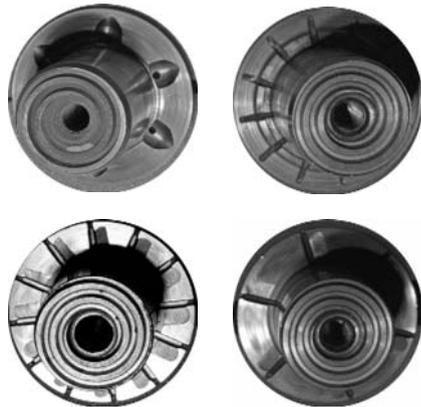
It is evident from Figure 2.54 that when overhauling the original bearing Electra chose to replace the original hydrostatic bearing with an angled pad design. There was no evidence suggesting the reasoning behind this decision, but it may be conjectured that obsolescence of the unit or inability to get replacement parts could have been responsible for the decision. From

Figure 2.54 Original thrust face compared to various alternatives tried by Electra

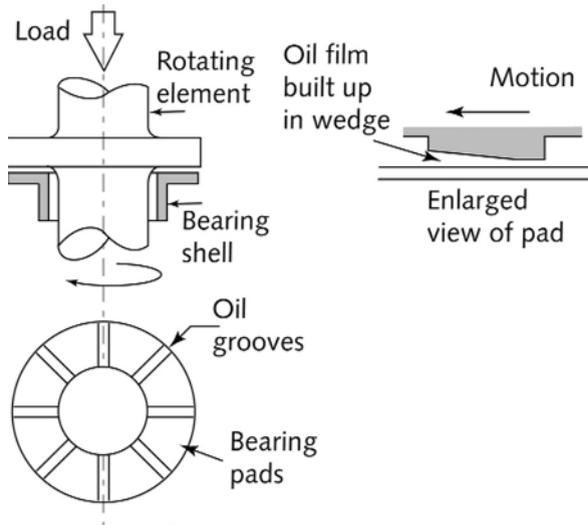
Figure 2.55 Angled pad thrust bearing geometry (schematic only)<sup>2.21</sup>

the several failed attempts at replacing the bearing it is also clear that Electra's design approach was one of trial and error rather than informed analysis. A reference to Neale's handbook on thrust pad design would have enlightened Electra to the real nature of angled pad thrust bearing design (refer to Figure 2.55). Moreover, tables in that publication would have advised them of the proper geometry for the loads and speeds encountered in the compressor. In the event the rather crude attempt at concocting such a bearing resulted in the ultimate seizure and failure of the compressor.

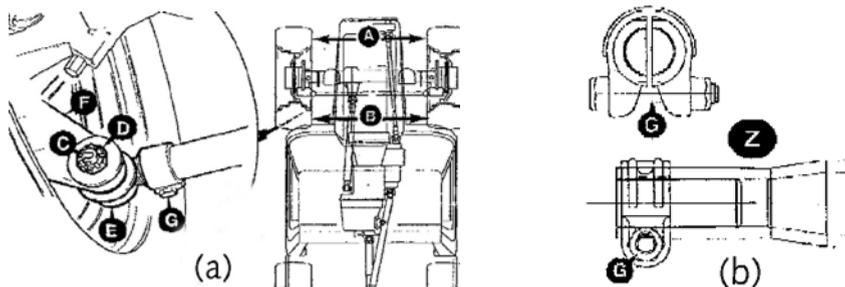
Figure 2.57 Maintenance instruction diagrams for the RS232 tractor

The advice offered to maintenance staff for adjusting the camber on the front wheels of the tractor is taken from the Bigbrother maintenance handbook for the RS232 tractor (refer to Figure 2.57).

2.5 Refit track rod end and firmly tighten nuts **D** and nut/bolt **G** which must be positioned horizontal as shown at **Z** and not vertical (see Figure 2.57 – diagram (b)).”

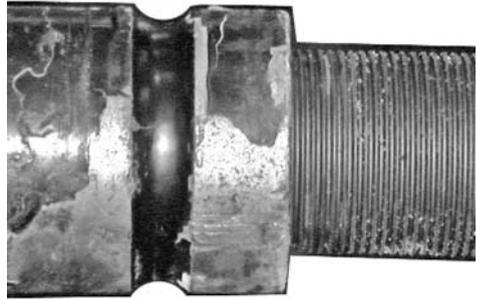
Figure 2.59 Redesigned track rod end as found on flipped tractor

From Figure 2.59 it is evident that the locking bolt of the tube clamp used on the new track rod end is constrained to be oriented at right angles to the tube axis by the bolt groove. However, the bolt is not constrained to be located at any specific orientation relative to the slot in the tube end (refer to Figure 2.62). It is this slot that should permit the clamping together of the tube end onto the steering knuckle thread. If the clamp bolt is not at right angles to these slots, the clamping force will be partly dissipated in clamp friction, the worst case being when the bolt is parallel to the plane of the slots (refer to Figure 2.64).

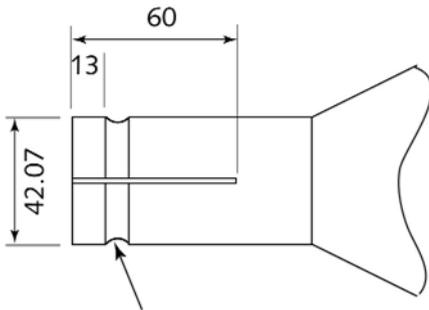
Approx. 10 mm dia groove embedded to 2.2 mm depth into track-rod surface

Figure 2.62 Sketch of track rod end as found on flipped tractor

Tractors, as well as other farm implements are regularly redesigned to meet customer requirements. No doubt, the Bigbrother design team responded to a need for greater transmission power, probably for driving the tractor in heavy mud, when they substantially increased the size of the front differential on the RS232 tractor. This design change called for a redesign of the originally straight track rod, to permit it to pass around the now much larger differential. The new design also made use of substantially heavier tubing with increased wall thickness. To accommodate the original steering knuckles the tubing was swaged<sup>2,22</sup> down to the original smaller diameter tube at the end. However, the wall thickness of the heavier tubing was retained. Figure 2.58 is a photo of the original design for track rod and steering knuckle. This photo is of a worn sample track rod, found in the Fillary scrap box. It was intended for comparison with the new track rod design. Figure 2.59 shows the track rod end taken from the flipped tractor. On inspection, this track rod end had one transverse slot cut in it for clamping the steering knuckle thread and it had a circumferential groove for the clamping bolt. Figure 2.62 is a schematic sketch of this new track rod end.

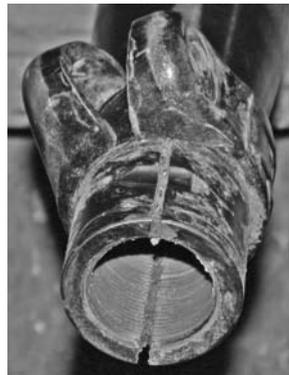
Figure 2.63 Modified track rod design with improved clamping bolt locator

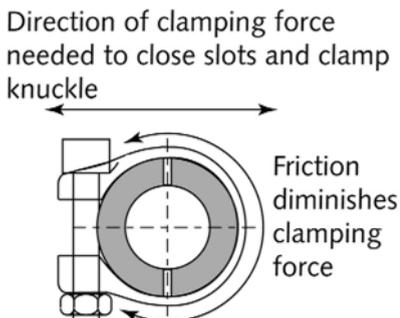
Figure 2.64 Schematic view of tube clamp with the clamping bolt oriented in the least desirable direction

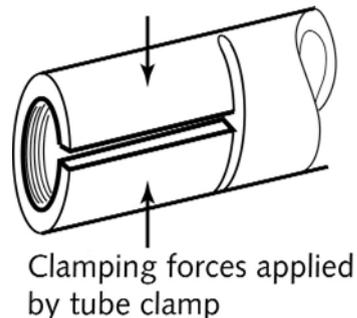
Figure 2.65 Schematic sketch of a pipe clamp designed to permit better grip on the steering knuckle thread

design shown in Figure 2.65 is well known and used in many engineering applications, though perhaps not in the farm machinery industry.

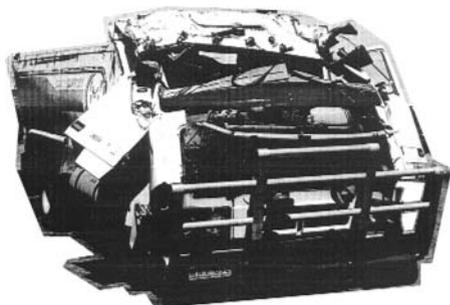
Figure 2.67 The damaged tipper owned and driven by Baritone

9. The failed ball joint is oriented in the vertical direction with the sealing boot uppermost (see Figure 2.67 – it was the joint nearer the wheel that slewed and rolled the tipper). Once the boot had been damaged the ball joint would become a convenient receptacle for any dirt landing on its surface. In the conditions of operation to which the Safedrive tipper was exposed it is not surprising that failure of this joint occurred so rapidly. It was my considered opinion that roadworthiness evaluation of a vehicle would be related to operational history of the vehicle. That type of inspection can only evaluate the operational care with which the vehicle was used in the past. It is certainly not able to predict the safety of a vehicle under any future operating conditions. That had to be the ultimate responsibility of the vehicle operator.

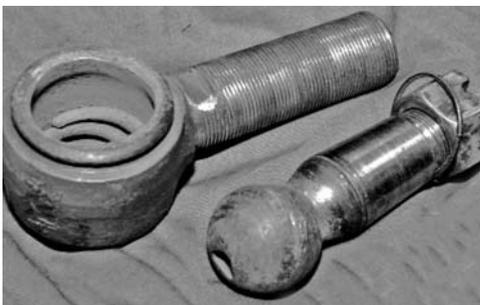
Figure 2.71 shows the two major parts of the failed ball joint. The socket was found to be completely filled with local clay and had to be cleaned out for full metallurgical examination. Figure 2.72 shows the ball joint at the other end of the failed steering link. Figure 2.73 shows a schematic sketch through a typical ball joint used on Safedrive vehicles. In the investigation of the accident the nylon bushes were not recovered. Figure 2.74 shows some parts of the sealing boot recovered from the failed joint. Sealed ball joints are generally expected to last for many years. If the sealing boot remained intact then it would be reasonable to expect such joints to last the full lifetime of the vehicle. The dispute in this case resolved into the following two issues:

Figure 2.71 The failed ball joint on the steering link. The socket had been cleaned out for this photo

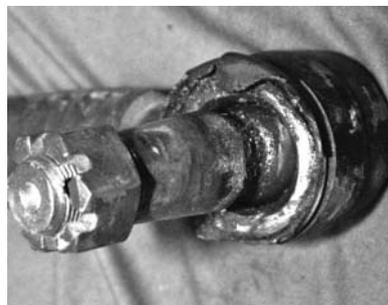
Figure 2.72 The ball joint at the other end of the steering link. Note the damaged grease boot

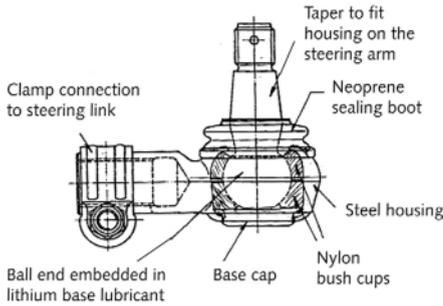
Figure 2.73 Typical ball joint (not to scale) The nylon bushes were missing from the failed joint

7. Based on my experience with tip truck and general dirt handling operations in the building industry I considered it entirely reasonable to find wear of the nature experienced in the failed ball joint within the time period of 73 days. The heavy scoring on the surface of the failed ball element (see Figure 2.70) was consistent with very erosive material being incorporated into the joint during tipping operations. This type of heavy localised wear was also consistent with erosive clay soil with embedded small rocks being incorporated into the exposed ball joint.

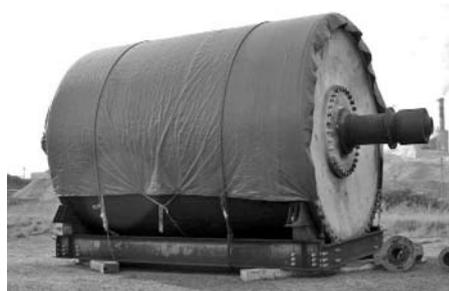
Figure 2.76 The discarded Yankee dryer stored on a field float at Marigold

9. On the evidence and advice offered to them, Primrose Paper operations decided to discard the vessel and replace it with a new dryer vessel. Figure 2.76 shows the discarded vessel at the Marigold plant.

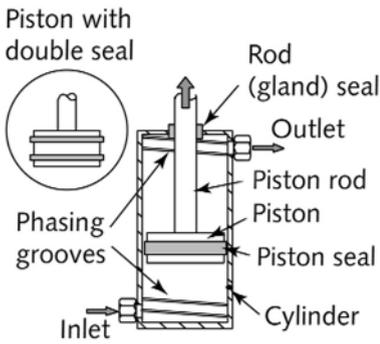
Figure 3.3 Phasing cylinder

In response to this request, Truscott produced a design that had an internally machined spiral groove in the phasing cylinders (refer to Figure 3.3). In addition, even though the original Rasputin phasing pistons had double seals, the Truscott phasing pistons were designed with a single seal (refer to

Figure 3.3). This arrangement was designed to permit internally equalising oil pressures when all pistons were raised to the top of their respective cylinders, where the single seals all rested on the spiral grooves. Several phasing sets of Truscott's new design were delivered to CSN in mid 1989. After some field testing by CSN, the Condor600 equipped with the new Truscott phasers was released for sale. By late 1989 substantial numbers Condor600 failures were reported to CSN. This failure of the Condor600 cultivators was originally associated with substantial numbers (more than 100) of hydraulic cylinder seal failures in the Truscott phasing sets. Eventually the failure of phasing cylinder sets became the basis of a dispute where several farmers sued CSN, who, in turn, sued Truscott Hydraulics. The plaintiffs (farmers) cited the failure of the Truscott phasing cylinders for poor germination of several crops, allegedly caused by poorly controlled sowing depth.

The provision of phasing grooves in their cylinders was based on Truscott’s reasoning that the grooves would allow oil to “flush” through them and even when contaminated by dust they would not become blocked. This had been borne out by empirical testing during manufacture of the cylinder sets. The spiral grooves provided in the phasing cylinders were originally equivalent to a 25 mm pitch thread. Truscott manufactured the phasing cylinders by machining cold-drawn steel tubing followed by fitting the two ends to complete the assembly. As a way of “helping” production staff ensure that phasing grooves were provided at the top of each cylinder, the cylinder tubes had mirrored phasing grooves machined into them at both ends (refer Figure 3.3).

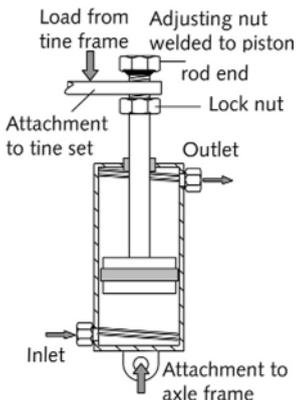
Figure 3.5 Phasing cylinder adjustment

In the Condor600 the adjustment system is indicated schematically in Figure 3.5. To adjust the tine set, the operator would turn the top nut (welded to the piston rod end) and the attachment plate would move up or down on the thread machined into the piston rod end. Note that this procedure requires the piston with its fixed rod to rotate inside the cylinder. With the original Rasputin phasing sets this procedure would be harmless since the cylinder walls of those sets were smooth. However, in the Truscott phasing cylinders, this adjustment would damage the piston seals if the seals were resting on

the relief grooves during this adjustment. There was significant evidence that this style of seal damage was experienced with the Condor600. Figure 3.6 is a photo of a seal removed from a failed Truscott phasing set.

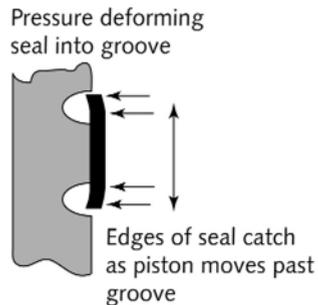
Figure 3.7 Initiation of seal damage

In the first instance, Truscott reasoned that the soft seals used in their phasing sets would be “chewed” by the phasing grooves either during tine adjustment or during transport, when the pistons were lifted to the top of the cylinder. Figure 3.7 indicates schematically the imagined initiation of these types of seal failures. After many seal replacements these failures were finally attributed to the repeated passage of the seals over phasing grooves and seal edges being caught by the edges of grooves. Figure 3.8 shows this assumed process. Tillage machine operators linked the seal problems on the Condor600 to the following major effects in the field:

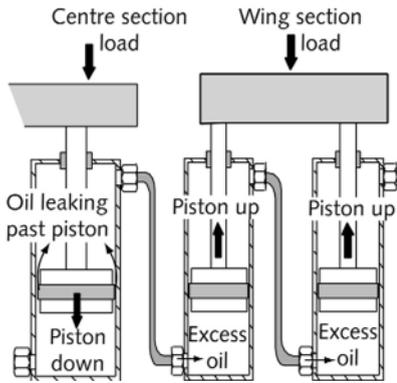
Figure 3.9 Out-of-phase error due to seal leakage

(b) *Out-of-phase operation and loss of seed depth control* – several machines were found to have failed in this way.

(c) *Wheel lift during tilling* – consequent failure to control the cultivator either in direction or seed depth was reported by several operators. Figures 3.9 and 3.10 illustrate these problems schematically.

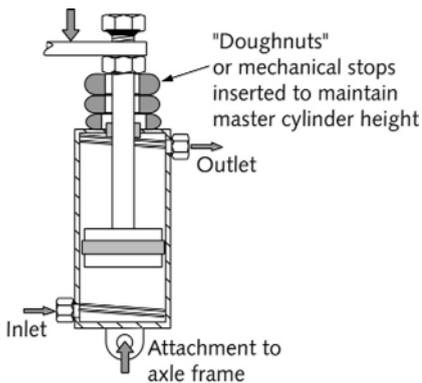
Figure 3.11 Mechanical master cylinder height limit

(d) *Height setting in operation* – The master cylinder of the phasing set was expected to be maintained at some desired height by the various check valves in the hydraulic supply line. Due to leakages in the system, possibly due to early seal damage, machine operators chose to maintain master cylinder height by using spacers inserted between the piston rod ends and the top of the cylinder. The arrangement is shown in Figure 3.11 schematically.

Both of these mechanical height-limiting arrangements imposed substantial eccentric bending loads on the master cylinder piston rods, causing some of them to be bent in service. The single piston seal of the Truscott design permitted the piston to pivot about the seal and exacerbate oil leakages in the phasing set, as well as occasionally damaging the internal wall of the cylinder. In addition, this process also placed extra load on the seals, increasing their likelihood of failure.

5. The need for mechanical stops on the master cylinders indicates that the height control was inadequate from the beginning. Seal failures might have exacerbated the problem, but clearly, they were not the primary cause of it.

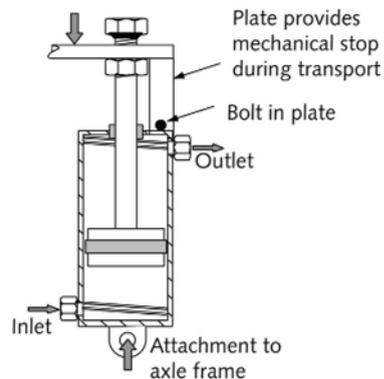
Figure 3.12 Mechanical height limit during transport

the hydraulics. During machine transport the cylinders are expected to be protected from bumps and other sudden load changes by mechanical stops similar to the doughnuts inserted on the master cylinder. On several of the failed Condor600 machines a mechanical stop was imposed by inserting a bolt into a plate attached to the tine height adjuster (Figure 3.12).

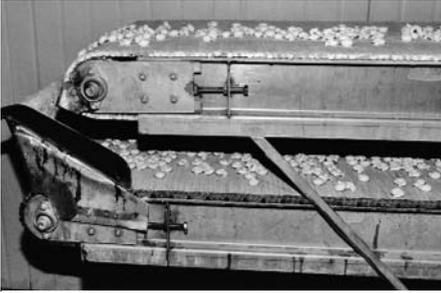
Figure 3.24 Transfer end of conveyor inside the freezing tunnel

tion. Figure 3.24 shows the transfer end of the pasta conveyor inside the freezing tunnel. Figure 3.25 is a photograph of the arrangement of wipers beneath the conveyor mesh. These were introduced by Carreras to combat the hoar frost that continued to form beneath the conveyor mesh.

The overall design of the conveying system is very poor. There are many nooks and crannies, which are difficult to clean or disinfect adequately. The use of exposed chains and shaft ends (see Figure 3.24) is another weakness of the design in terms of hygiene. Material scraped off from the underside of the belt as it moves along can fall down (and through the mesh) onto the return belt taking frozen pasta to the delivery conveyor.

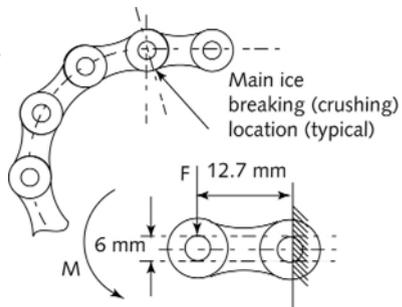
Figure 3.26 Built-up ice needs to be broken as conveyor belt and chain wind around pulleys

*Ice-breaking power requirements* – Once the conveyor ices up, as the belt passes over the pulley at the inner end (inside the freezing tunnel), the ice will need to be broken. This breaking process is independent of the radius of curvature of the pulley, since whatever the radius, excepting unnaturally small radii, ice breaking will be determined by the chain pitch (refer to Figure 3.26).

Adding this to the friction power of 45.7 W brings the power requirement to 261.7 W. Noting that as well as breaking ice for half the sprocket circumference, any ice retained in the gap between sprockets will be crushed as the conveyor mesh straightens out for its return journey on the underside.

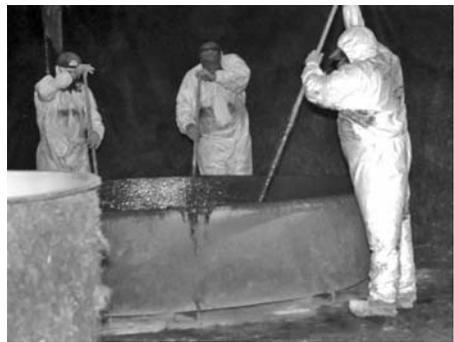
Figure 3.31 Roll-out of the FRP matrix

31. Figure 3.31 is a photograph of the rolling-out process applied to the wet FRP matrix on completion of the spray-up. This is a manual process relying on the skill and experience of the spray-up operator. This process can introduce considerable unevenness into the glass fibre distribution in the FRP matrix. Figure 3.32 illustrates some hypothetical sample distributions of glass reinforcement through a fibre reinforced plastic laminate.

32. Hypothetically, in a 3 mm tank wall a 0.5 mm unevenness; i.e., even distribution over 2.5 mm of the wall (say) would have the effect of reducing bending rupture strength in the ratio of  $(2.5/3)^2$ . This is a reduction of bending strength to about 69% of that of an evenly distributed glass section of 3 mm thickness. Stiffness reduction is even worse, with the reduction of the order of  $(2.5/3)^3$ . This would be about 58% of expected stiffness. In other words, a relatively small (16% in the example) unevenness in the distribution of glass through the laminate will

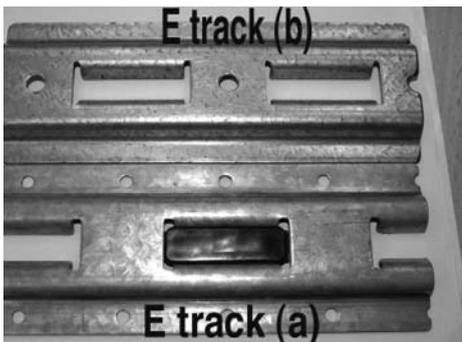
28. Figure 3.34 is a photographic comparison of the two types of E-track. The one marked E-track (a) is the originally supplied Canadian product and the other marked E-track (b) is the Australian product. Figure 3.35 shows the two types of track installed in transport vehicles. The modification made by Tiergarten to E-track (b) is also seen.

29. Referring to the photograph in Figure 3.34, I have been advised that the track identified as E track (b) in this photo is the product made from Australian steel.

Figure 3.34 Two types of E-track. E-track (a) is the Canadian product and E-track (b) is the Australian version

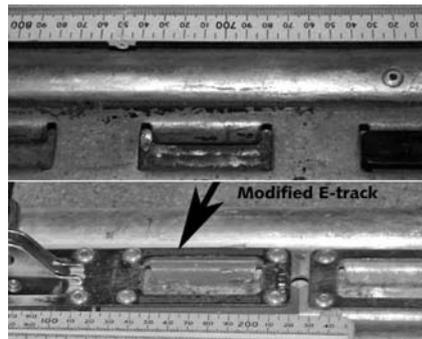
Figure 3.35 Two types of E-track mounted in transport vehicles. The lower photo shows the modification to the Australian product

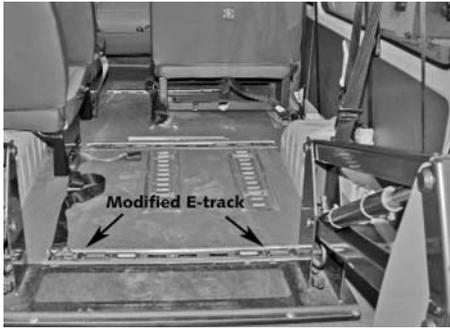
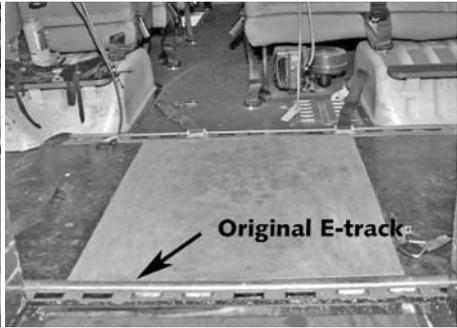
35. The photos of Crashlab report TR2000/042 show that the product made from Australian steel (E-track (b)) was mounted by the edges of the track during these tests (See also the photographs in Figures 3.36 and 3.37). The central holes in the product made from Australian steel appear to represent a significant structural weakness in the track, particularly when considering the type of loading placed on the track during side impact. This type of impact places unevenly distributed loads on the track elements as indicated in Figure 3.38, a schematic view of the seat belt clip inserted into E-track experiencing side impact loading. Clearly, in the arrangement shown, the seat belt clip will tend to slide closer to the left edge of the track slot due to the clearance between the clip and slot engagement. In this way more of the seat belt clip will be in contact with the left edge of the track slot than with the right edge and uneven loading on the track results.

36. The uneven loading on the track during side impact further exacerbates the structural weakening of the track by its central holes and severe bending of the track locally and disengagement of the seat belt clips is the most likely failure mode. The results of the Crashlab tests, report TR2000/042, clearly show this effect in the failure mode of the product made from Australian steel.

37. When Crashlab tests in April 2000 found that the product made from Australian steel failed to meet AS 2942 during side impact loading, Tiergarten designed and installed a modification to the tracks. The modification was a rectangular plate installed around the track slots where the seat belt clips engage. These modifications were designed to strengthen the track slots at their engagement points with the seat belt clips and to basically overcome the failures experienced in the earlier Crashlab compliance tests (Refer to Figures 3.36 and 3.37).

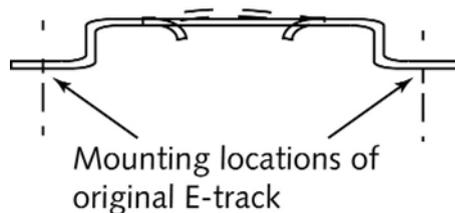
Figure 3.39 Mounting arrangement of originally supplied E-track

38. Further Crashlab tests followed in September 2000, to evaluate the modifications made to the product made from Australian steel. These tests showed that the modified track met the requirements of AS 2942 in that it no longer deformed so severely or allowed the seat belt clips to disengage during side impact loading.

41. Notably, the modified E-tracks have been mounted in the transport vehicle by their edges. Also, as noted above in paragraph 35, in the Crashlab tests the various tracks were all mounted by their edges during testing.

45. Because the tracks were supplied without edge holes (in many transport truck applications the tracks are welded to the chassis of the truck) it would have been a simple matter to mount the tracks via the already present central holes. Had Tiergarten taken this approach, then the seat belt securing arrangement, using the E-track made from Australian steel, would have been structurally stronger than the edge-mounted product made from Canadian steel under the same seat belt anchorage loading conditions.

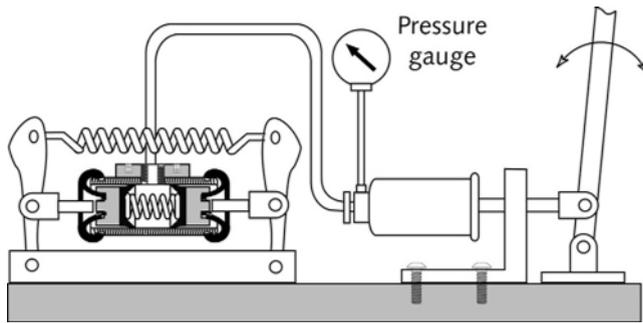
Figure 3.40 Brake cylinder leakage test rig (schematic)

failed brake cylinders with some seals originally obtained from RPB. These reassembled brake cylinders were exposed to bench testing for extended periods and found to function satisfactorily. Figure 3.40 shows the style of test rig used by KGK to test their brake cylinders for leakage. After this shattering experience with their new brake cylinders, Kostas and George sought professional help in their quest to continue with production, while hoping to be compensated by Dunpac.

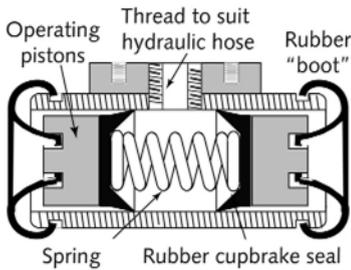
Figure 3.41 Brake cylinder (schematic)

Figure 3.41 shows a schematic section through the brake cylinder. These cylinders range in size from 60 mm to 100 mm in length. The seal cups, contracted to be made by Dunpac, had a complex chemical formulation. In the first batch they produced for KGK, the rubber cup brake seals were found to shrink approximately 15% to 25%, by

volume when exposed to the brake fluid for extended periods. On examination, the brake fluid used in the taxi brakes that were found to leak, was Castrol Anti-Corrosion oil type TS23-2-01, a diacetone alcohol (2 methyl-2-pentanol-4-ona), which is a ketone and an alcohol (25%). The data sheet provided by Castrol lists its use as a power transfer medium. In my experience such fluids are used in hydraulic rams and other power control equipment. In this sense they are designed to operate in more demanding conditions than the brake cylinder application.

When the original RPB seals, the models for the Dunpac seals, were immersed in this oil they were actually found to expand in volume by between 5% and 10%. The Dunpac seals were found to always shrink in volume. The substance of the dispute between KGK and Dunpac may be summarised by their respective claims and pleadings.

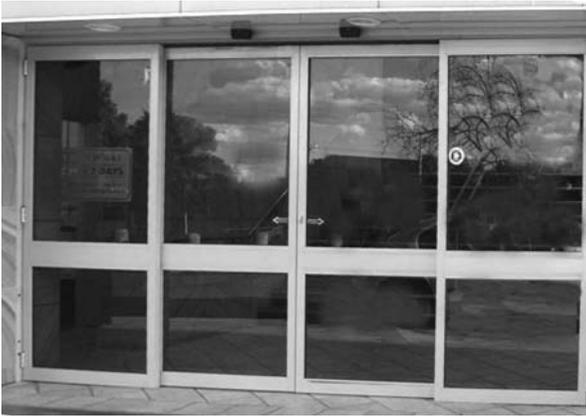
Figure 4.3 General view of the SPSC entrance

3. The surface of the floor near the doors appears to be tiled and hence slippery under some conditions. This is poor design when providing for the ingress and exit of anyone, not just some frail people.

occasionally striking people who are moving through them, it would have been prudent to install safety railing at both the entry and exit locations of these doors. If such railing were installed, Dover's accident could well have been avoided.

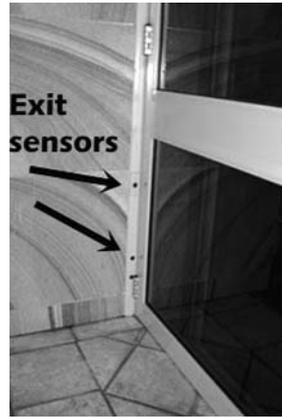
Figure 4.4 Close-up view of the exit sensor

In contrast to this, the counter-intuitively named exit sensors are located near the entry surface of the sliding door pair. As may be observed from the control diagram in Figure 4.2, the exit sensor signal triggers a count-down sequence that permits the door controller to determine when to commence the closing sequence. Figure 4.2 is a simplified representation of the control schematic, from which acceleration and braking sequences have been excluded. The sensor gap is determined from the expected time taken by the slowest member of 95%<sup>4.8</sup> of the population in passing through the doors before the closing sequence is initiated. When several people pass through the entry, the time count is restarted each time the exit sensor is triggered.

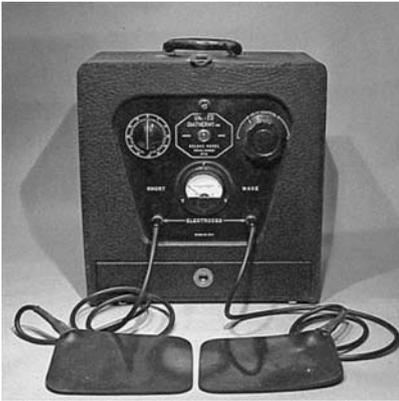
Figure 4.9 The P250 diathermy machine that was used by the Hyde therapy centre

No such features were available on the P250 machine operated by the Hyde therapy centre. Although the machine predated the standard, the requirements of the standard appear to be based on a rational avoidance of the most obvious hazards with the operation of such machines. At the Hyde therapy centre diathermy machines were often operated unattended by the physiotherapist. This unattended operation was the condition experienced by the plaintiff according to documentation supplied to me.

The treatment room was approximately 2.5 m × 3.5 m in size with two treatment areas separated by a curtain. It appeared cramped and I had some difficulty in moving around the couch on which patients would be treated during therapy. Figure 4.9 shows the P250 machine identified as the one used in treating Frey. Figure 4.10 is a general view of the treatment area in which Frey received her diathermy treatments. According to documentation, Frey's diathermy treatment had the following regular routine:

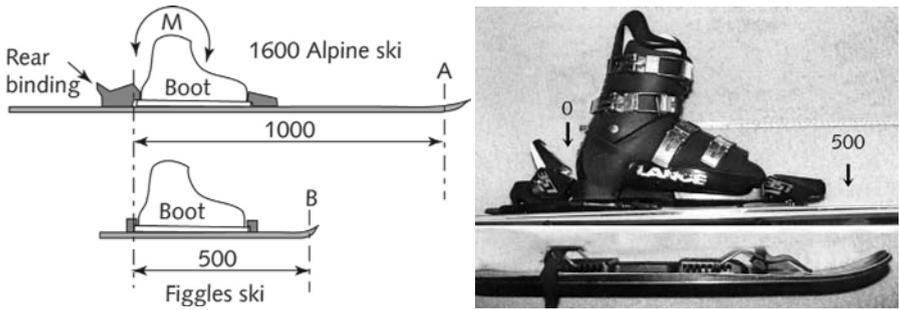
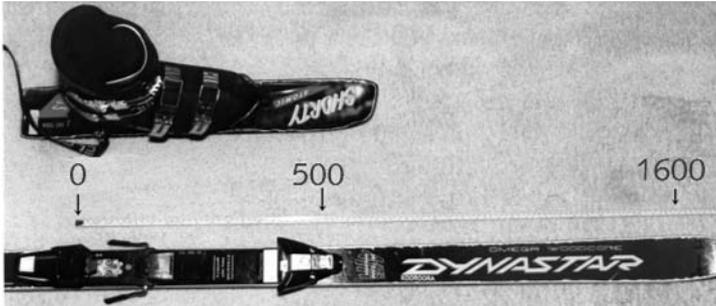
Figure 4.12 Relative dimensions of a standard Alpine ski and a figgles ski and elevation and plan photographs of the ski used by Small. The photo also shows the boot used by Small fitted to a standard 1600 mm Alpine ski

The standard Alpine downhill ski hired to MS was 1600 mm long (nominally). The figgles ski, alleged to be responsible for MS's injuries, was 630 mm long (nominally). Figure 4.12 shows the two skis schematically as well as photographs of the two skis indicating the differences in bindings.

During forward motion on the snow, the curved-up tip of the alpine ski will smooth the snow in front of the ski. When forward pressure is applied to the ski by the moment  $M_y$ , exerted by the skier during a forward fall, the moment arm, available for generating sufficient release torque, is the distance between the heel registration of the ski boot in the release binding and a point near the tip, designated point *A*. Point *A* is the location on the alpine ski where the tip commences to turn upwards. Measurement on the alpine ski hired to MS indicates this distance between the heel registration of the ski boot in its binding and point *A* to be 1000 mm, shown in Figure 4.12. For the shorter figgles ski, the moment arm for generating a potential release torque is the distance between the tip of the ski (designated point *B* in Figure 4.12) and the heel registration of the ski boot in its binding. This distance was measured to be 500 mm.
