# The Winning Line

A Forensic Engineer's Casebook

Andrew Samuel, BE (Mech), MEngSci, PhD, DrEngFIE Aust  
Professorial Fellow  
University of Melbourne  
*and*  
Principal Consultant  
Engineering Investigations & Associates Pty. Ltd.  
Australia

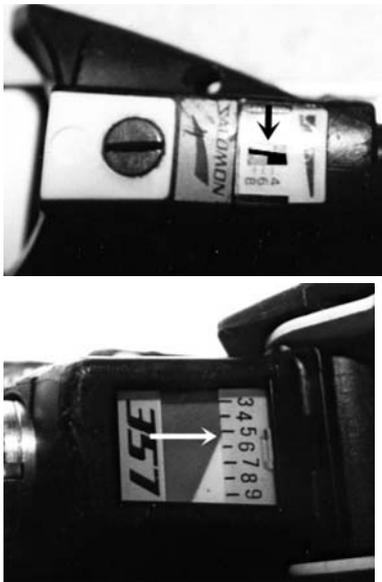
Figure 4.13 Toe and heel binding settings for Small on a 1600 Alpine ski (see arrows)

Figure 4.13 shows photographs of heel and toe release bindings for the 1600 mm ski hired to MS. These photographs show that the bindings were indeed adjusted to be in accordance with the recommendations of ISO 11088 Table B.1. Figure 4.14 shows schematically the forces generated on the ski boot and Alpine ski at the instant just before binding release, when the body moment  $M_{body}$  reaches the value of the release torque  $M_y$  (Figure 4.15). The forces acting on the leg (knee and tibia) are calculated from the release moment applied to the boot sole length (*S*) as seen in the free body diagram of the boot in Figure 4.14. The sole length of the boots issued to MS by BSL was 310 mm. Based on the ISO recommended release torque  $M_y$  and the moment arm *S*, I estimated the forces acting on the tibia and knee in a forward fall, at the instant of release from the binding, as

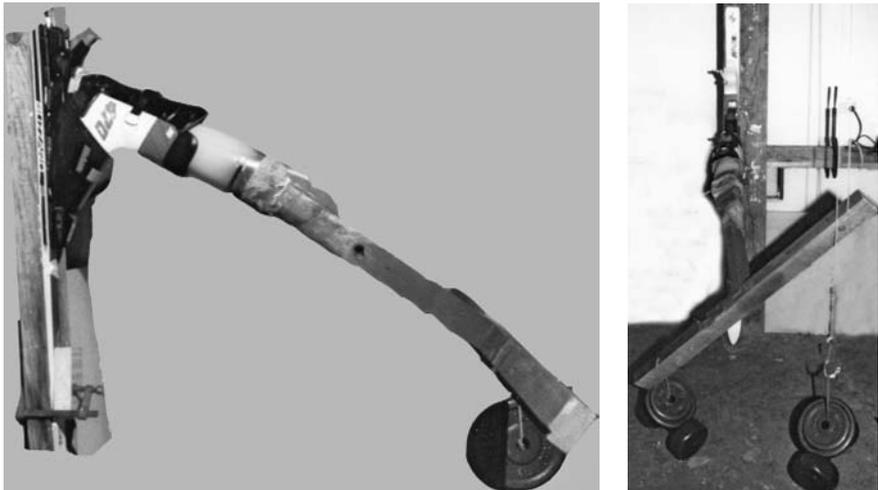
Figure 4.18 Ski being tested for overturning moment and twisting moment. The prosthetic leg, matching the boot size used by AO, was kindly provided by a rehabilitation unit of the Caulfield Community Hospital in Melbourne

Release moment  $M_y = 22.7 \times 9.81 \times 0.998 = 222 \text{ Nm}$

$$\begin{aligned} \text{Twisting release load} &= 13.6 \text{ kg (30 lb)} \\ \text{Twisting moment} \quad M_z &= 13.6 \times 9.81 \times 0.48 = 64 \text{ Nm} \end{aligned}$$

Clearly, the values of release moments found for AO's skis with the recommended settings lie well within the ranges of values judged appropriate by Table B.1 in ISO 11088 for release moments corresponding to his physique and skill level.

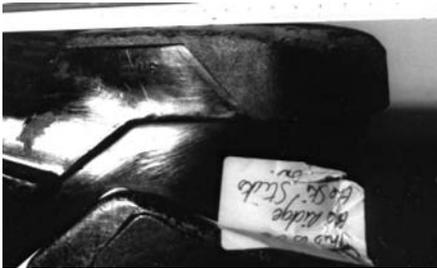
Figure 4.19 The worn heel pad on AO's right boot

In the dispute under investigation a further complication arose due to the claim by AO that the failure of the release bindings to operate during his fall was due to a worn heel pad on his right ski boot. Figure 4.19 shows the nature of wear on the heel of the boot. When skiers walk in these boots (on the way to the ski slope, for example), due to the restricted bending afforded by the boot heel, most of the wear takes place on the heel. For this rea-

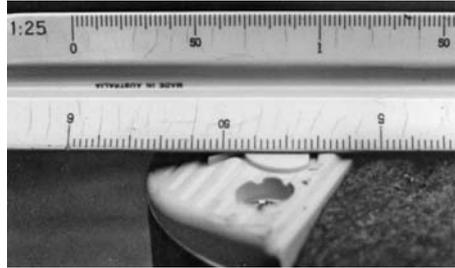
Figure 4.20 A new heel pad on a ski boot similar to AO's right boot

son, most ski boot manufacturers provide a replacement heel pad that may be installed on the worn boot. The photograph of Figure 4.20 shows a typical replacement heel. This photograph also shows that the new heel pad has a slight bevel upwards away from the heel plane. This bevel is intended to overcome the point loading, and consequent substantial initial wear on the heel, that would be experienced by walkers in ski boots without the bevel on their heel pads.

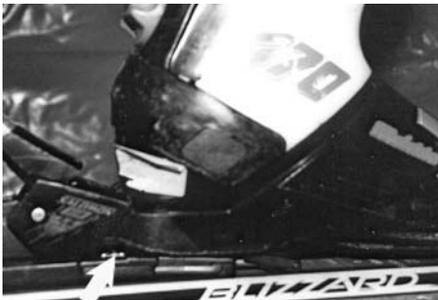
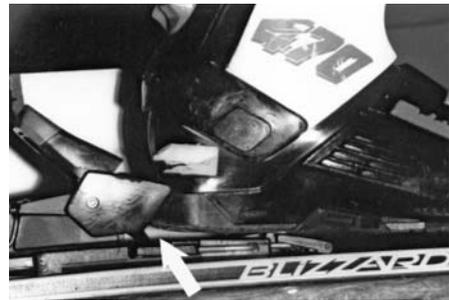
Figure 4.21 The right ski boot under forward release moment test

Figure 4.22 The right ski boot just before forward release

Photographs in Figures 4.21 and 4.22 show the worn ski boot under forward release test and just prior to forward release respectively. It is clear from these photographs that the heel is lifted clear of the ski during forward release (see the arrows in the figures). Consequently, it is unlikely that heel wear would play any part in the mechanics of forward release.

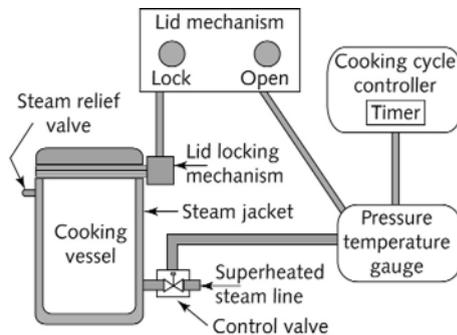
Pressure is relatively easy to regulate by appropriate opening and closing of valves. This was the type of temperature control used in the *JustMix* cooker. If the pressure in the vessel exceeded the set value, a relief valve would activate and vent the excess pressure to atmosphere. Batch cooking time was set on an electronic timer. Once the set time expired, the heating was switched off at a shut-off valve and the vessel was allowed to cool. As a result of the cooling process the pressure inside the vessel would fall to atmospheric. Safety interlocks were so arranged that the vessel could not be opened until the pressure inside the vessel had reached atmospheric pressure. Figure 4.24 shows the control circuitry schematically.

Figure 4.24 Schematic diagram of the *JustMix* cooker and controller

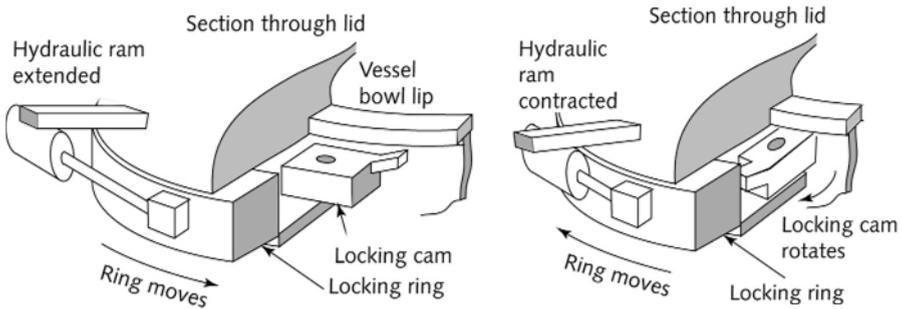
Figure 4.25 Schematic sketch of the lid locking mechanism showing the locking cam (there are several of these around the vessel's perimeter) both fully locked and fully unlocked

Figure 4.25 shows the operation of the lid locking mechanism schematically. Figure 4.26 is a plan view of one of the actual cams used in locking the

The effect of using the release button to check if the vessel had cooled sufficiently to permit opening had some influence on the initiation of the accident. When JK pressed the open button and “*nothing happened*”, something actually did happen. The hydraulics received an “*open*” signal and may have initiated an opening cycle. However, the temperature interlock signalled to prevent opening. This is a common feature of all interlock systems that a small time delay takes place during servoing, depending on the servo stiffness (responsiveness) of the controller. As can be seen in Figure 4.26, each locking cam had a “*lead-in*” chamfer to permit smooth operation during the locking cycle. Even a very slight servo delay in the response of the hydraulic closure system to the temperature interlock could have dislodged the locking cams to a configuration where the lead-in chamfer of the cams would be bearing on the edge of the vessel bowl’s lip (see the right-hand diagram in Figure 4.25). At 110 kPa (operating pressure) the

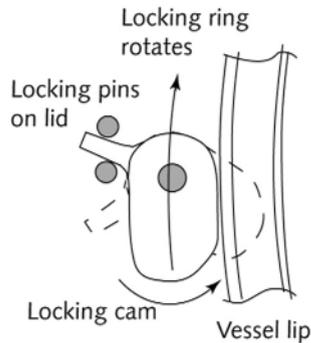
Figure 4.26 Plan view sketch of actual lid locking cam from drawings of the JustMix cooker (not to scale)

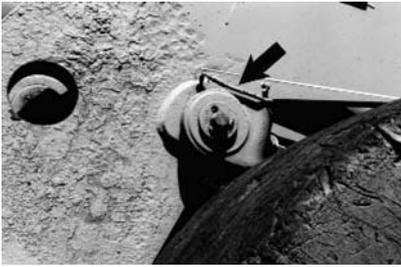
Sometime on Sunday, 21 November, 1999, Dennis went to Tarabell Hydraulics to work on, or to remove, a component from the R2800 machine. This component is a short length of lubricating hose on the lift arm of the machine and provides lubrication to the front pivot of the lift ram. Figure 4.28 is a close-up view of the lubricating hose in question. Presumably Dennis had a need for this component to maintain his own machine. Although it may appear an insignificant component, there may have been several factors that may have helped to contrive the situation Dennis found himself in. Purchase of the hose from the supplier may have been both costly and time consuming. Dennis may have had a pending contract for his own machine, generating an urgent need for replacing a damaged hose. Whatever the case it was during the process of removing this hose that Dennis Gibbon was killed.

Figure 4.28 Close up view of the lift arm pivot lubricating hose

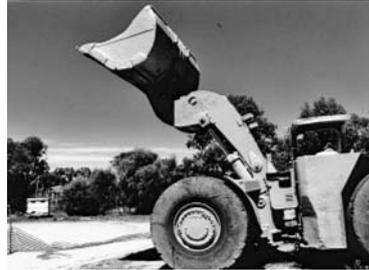
Work on the lubricating hose was difficult without lifting the bucket to a position indicated in Figure 4.29. According to the police report of the accident, there were tools found on the machine (a shifting spanner on the hose coupling), consistent with the supposition that the Dennis was in the act of working on the coupling when the accident occurred.

Figure 4.29 Bucket raised to provide access to outer pivot on lift arm

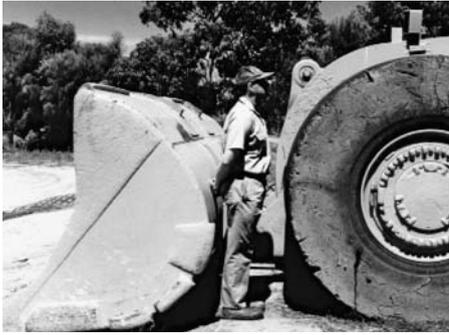
Figure 4.30 Bucket lowered and tilted forward (man approximately 1.8 m height)

Figure 4.30 is a photograph of the R2800 with the bucket forward and the lift arms lowered. The man standing between the wheel and the bucket is indicative of the scale of the machine. Figure 4.31 shows the narrowest distance between the bucket and the wheel when the lift arms are down and the bucket is in the crowd position. Figure 4.32 is a schematic sketch of the front end of the R2800, indicating this narrowest distance ("pinch point").

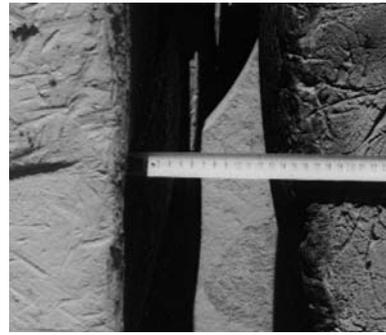
Figure 4.31 Lift arm lowered with bucket in "crowd" position and tape indicating "pinch point" width of 120 mm

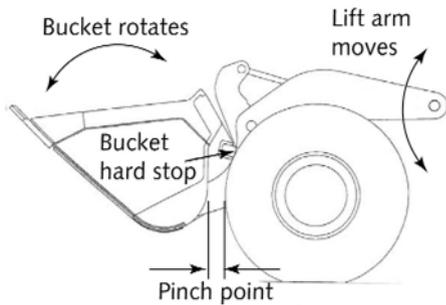
When the deceased was found at the site he was in a location identified as the pinch point, with the hydraulic controls of the vehicle indicating that Dennis had put the bucket in the crowd position.

Figure 4.32 Bucket in crowd position, indicating the "pinch point"

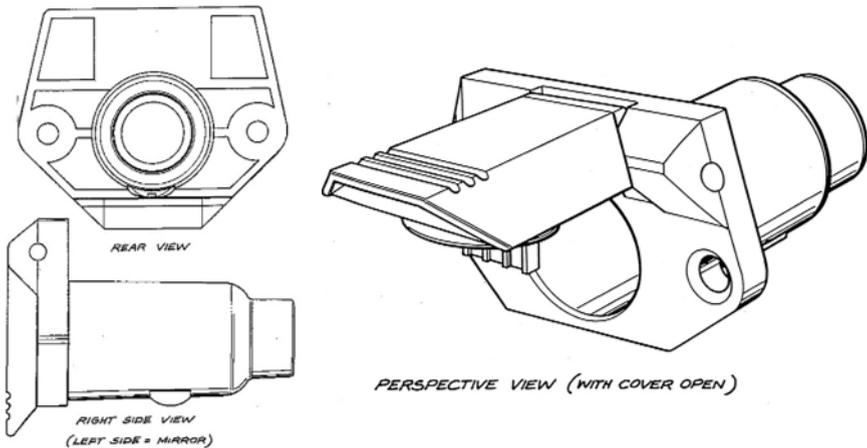
Figure 5.4 is a rear view taken from the CRD98557, with measurements added by the author. The measurements are approximate only and they are taken directly from the Luxative design, as these measurements do not appear in CRD98557. Figure 5.4 also shows a partial right side view of the the Luxative design clearly illustrating the appearance of the hinge housing as well as the shape of the lifting lip (front lip) on the cover of the Luxative connector base.

In addition, Figure 5.4 shows a perspective view of the Luxative design (as registered) taken from CRD98557. Note particularly the appearance of the two mounting holes in the “as-registered” design. In this registered embodiment the mounting holes have a countersunk lead-in. This indicates that a countersunk head screw or bolt would be used for mounting the connec-

Figure 5.4 Drawings of the Luxative design taken directly from their registered design specification

tor on the trailer. A countersunk head screw has a tapered head commonly used in engineering and automotive applications requiring a conical surface on the part to which such screws are mated. However, in the embodiment sample provided to me, the Luxative design had counterbored holes, with cylindrical surfaces, and in this sense the sample embodiment differed from the original registered design.

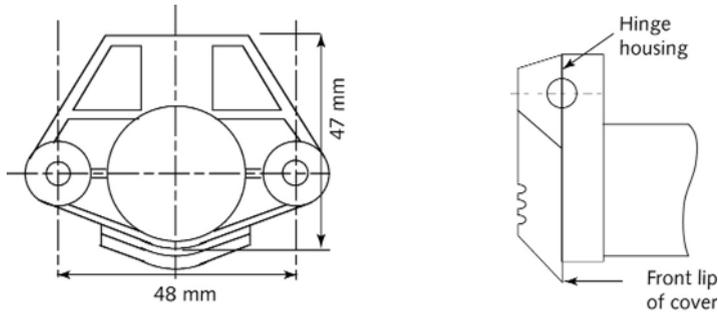
Figure 5.5 shows the approximate rear and right-side views respectively for the Cheepian design connector. Clearly, there are significant shape differences in both the rear view and in elevation (right-side view). The

Figure 5.5 Drawings of the Cheepian design produced from direct measurements by the author. The left-hand diagram is a rear view and the right-hand figure is a side view

Cheepian design has a curved lower profile compared to the Luxative design, which has a flat lower profile. In addition, the front cover lips on the two designs differ considerably. The upward slope on the Cheepian connector lip is quite different from the downward sloping lip of the Luxative design. Although these differences may appear minor, they have serious implication for the design as a whole.

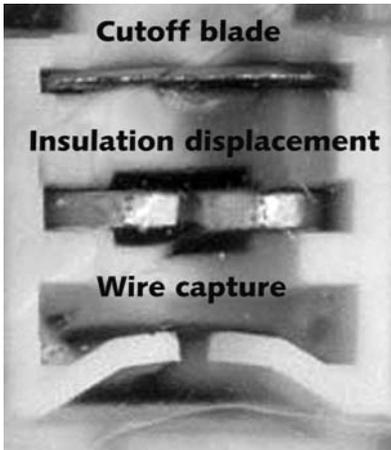
Figure 5.13 Photomicrograph of one segment of the Tyco product

Figure 5.13 shows an enlarged photo of one module in the Tyco product. The 'insulation displacement' feature is similar to many other products as well as the one described in the Patent. The cable capture feature has a pair of 'arms' that are angled inwards towards the insulation displacement feature. The effect of these arms is to hold the cable in a way similar to the operation of the 'tongues' described in the Patent, except that these 'arms' do not rely on any geometric feature to bend them inwards. In this way they are different from the cable capture feature described in the Patent. These 'arms' will still operate as a toggle mechanism for preventing the cable being released from them."

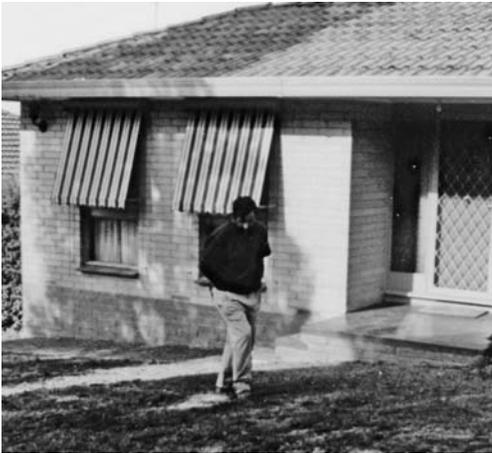
Paul Garibaldi was asked by LEP Insurers to identify the location of the tree he was lopping (see Figure 6.1). To provide a survey datum reference, Stanley Dover was photographed with a 4 m surveyor's staff in the location identified by Garibaldi (see Figure 6.2). The staff is held vertical with the aid of a plumb gauge in Dover's hand (not easy to see in the photo). Figures 6.3 and 6.4 are views of the site at 72 Warburton St. just after the accident. These figures are taken from the Dover photos. As may be observed from Figure 6.4 the tree that had been lopped by Garibaldi appears substantially reduced in scale compared to the other trees sur-

Figure 6.1 Paul Garibaldi identifying the location of the tree

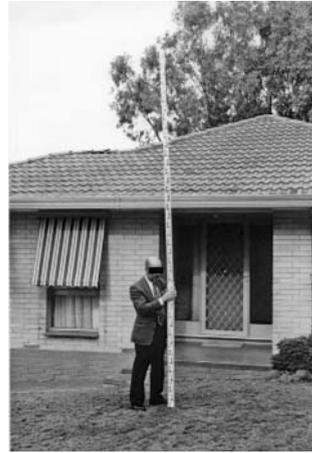
Figure 6.2 Stan Dover at tree location with a 4 m surveyor's staff

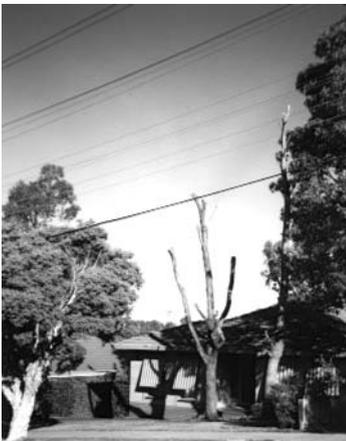
Figure 6.3 Lopped tree just after the accident, from Dover photo

rounding it. This scale reduction is mostly a result of the lopping performed by Garibaldi, but partly due to photographic illusion. In the photograph of Figure 6.3 there is shown another, somewhat larger, tree just west of the tree identified by Garibaldi as the tree that had caused the accident. This second tree, seen in the photograph of Figure 6.3, also appears to have been trimmed. However, as there was no data available about this tree or its

Examination of the photograph in Figure 6.3 shows the end of the central branch of the lopped tree to be above the Foxtel communication cable (thick black cable). Based on the angle of view in this photo, I estimated the height of this central branch to be at an elevation greater than 6 m from the ground (refer to Figure 6.13). Whatever the elevation at which the accident causing branch was being cut, Garibaldi had been lopping at heights well above the 3 m limit of his insurance policy.

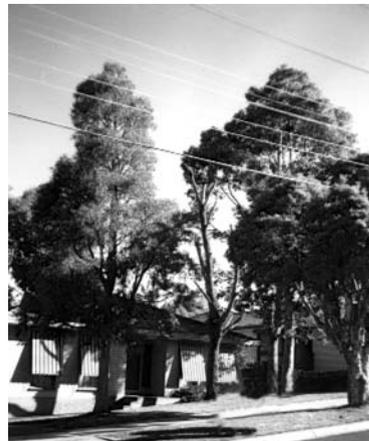
Figure 6.4 Lopped tree and surrounds from opposite side of street, from Dover photo

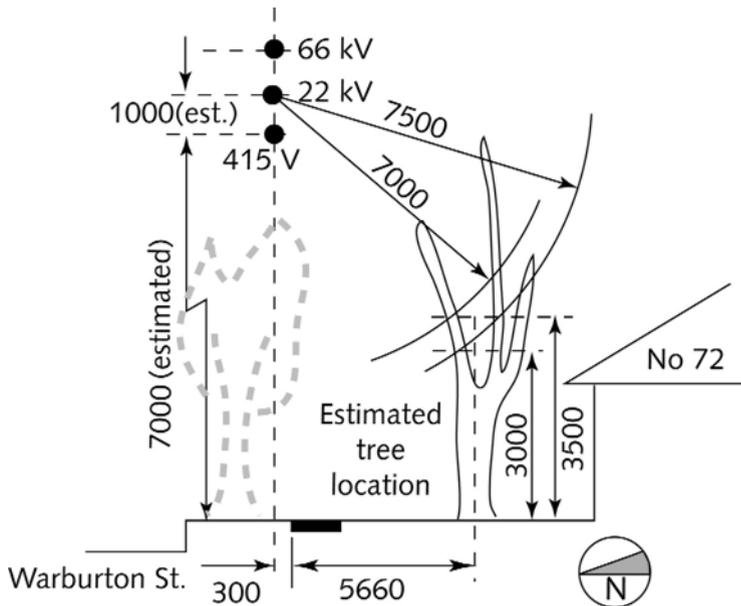
Figure 6.11 Elevation schematic showing the two trimming cut locations investigated in the survey. The lower cut is the one identified by Garibaldi and the higher one is a cut on an alternative branch (refer to the photo in Figure 6.5, all dimensions are mm, not to scale)

Figure 6.11 is a conjectured arrangement of the tree being lopped by Garibaldi during the accident. The diagram is intended to demonstrate the lengths of tree branches required to enable them to touch the 22 kV cable. This diagram also confirms the estimation that Garibaldi was indeed lopping at heights outside the limits of his insurance policy.

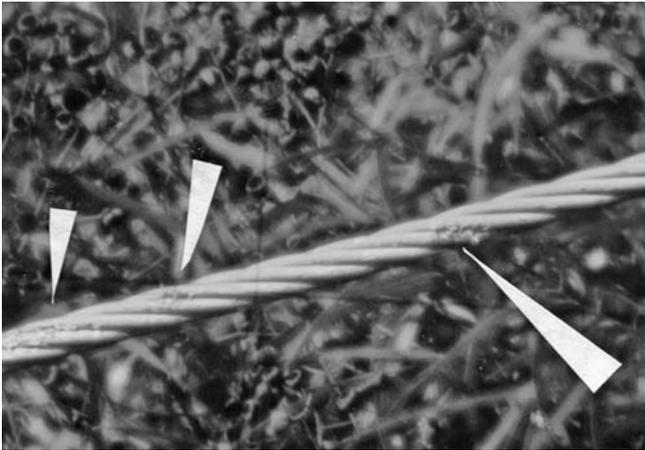
Figure 6.12 Spark-eroded section of 22 kV cable. Photo taken through theodolite telescope

from survey data have  $2300 + 380 = 2680$  mm added to them in order to reduce the measurements to the same reference plane. Horizontal distances were measured with a surveyor's 100 m steel tape. Spark-erosion of the 22 kV cable (shown in the photograph of Figure 6.12) suggests that it was involved in the accidental short circuit of April 1997. Figure 6.13 is an elevation schematic and Figure 6.14 is a photo outside 72 Warburton St., both figures showing the power cables well above the tree on the nature strip.

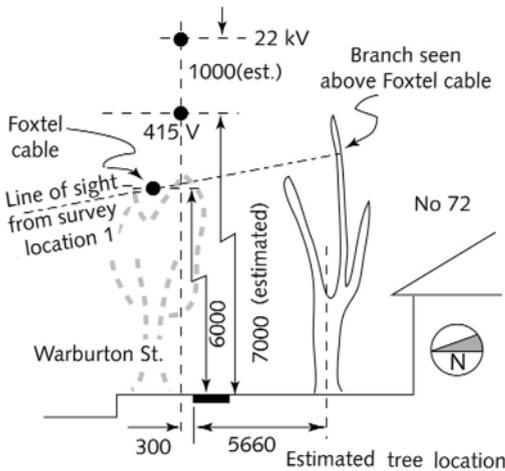
Figure 6.13 Line-of-sight schematic showing the tree branch above the Foxtel communication cable

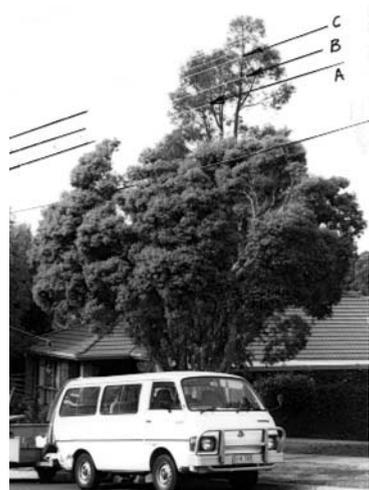
Figure 6.14 Power cables outside 72 Warburton St. A = 415 V; B = 22 kV; C = 66 kV

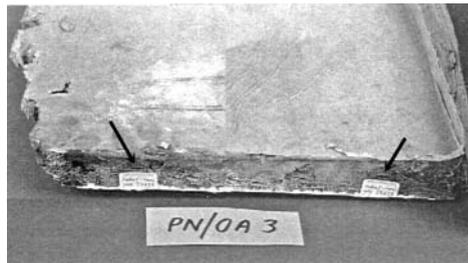
Figure 6.16 Screwdriver impressions in the edge of wooden frame

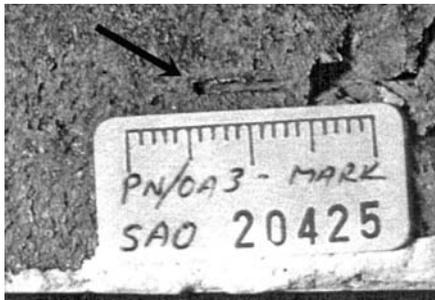
Figure 6.17 Close-up of three impressions (evidence 20425)

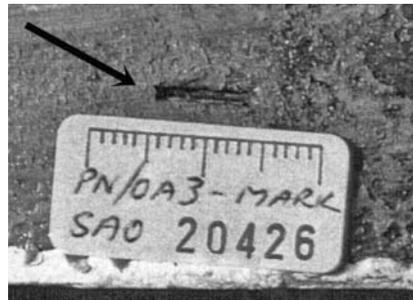
Figure 6.18 Close-up of one impression (evidence 20426)

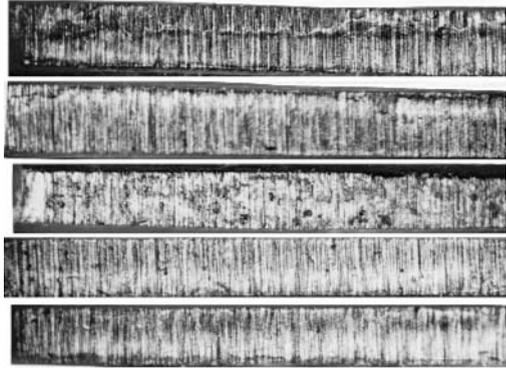
Figure 6.19 is a photograph of the five 65-549 screwdrivers purchased for this examination. In Figure 6.20 a composite photomicrograph is shown of the tips of these sample screwdrivers. As may be observed in this photograph the tip markings differ markedly between sample screwdrivers. These markings are produced in the final grinding process used on the tips.

Figure 6.20 Blade tip photo micrographs of the sample set of screwdrivers

As the grinding particles chip away the material of the tip, fine grooves are produced on the tips. It is the combination of these grooves that form the unique and clearly identifiable “fingerprint” for each tip.

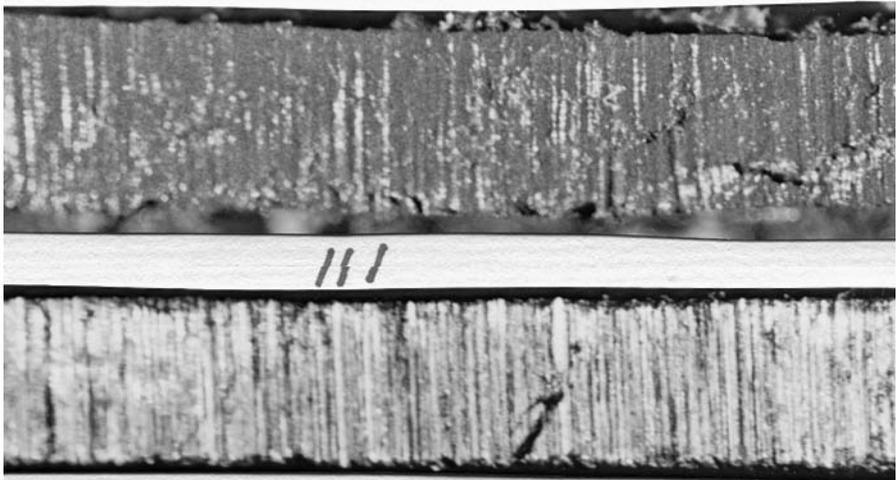
Figure 6.21 Evidence screwdriver tool mark casting impression prepared and photographed by the Author. The three lines in the photograph show corresponding features in the tool and the impression taken from the tool mark

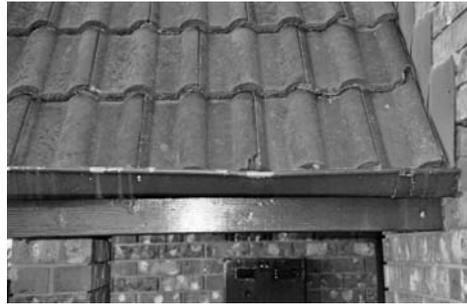
Figure 6.27 Photo showing the gutter and the locations on the gutter edge where some rubbing and deformation had occurred

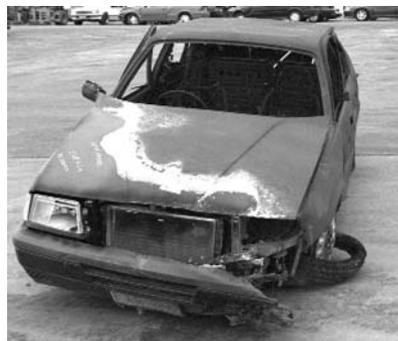
Figure 6.29 Nero's Alfa 33 after burnout

ment of his Alfa. He and his passenger took flight from the vehicle and sought the help of the local fire department, who attended the vehicle. Unfortunately, by the time the fire truck arrived, the vehicle was well and truly alight and ultimately completely burnt out. Compensation for the vehicle was a matter for basic fire insurance and Artemis was well endowed in that department. However, a routine post-fire examination of the burnt-out vehicle by a "well-known vehicle expert", *Andy Kneebone*, alleged that there may have been some manufacturing fault with the original vehicle. As a further proof of the steely determination of insurers to dispute payouts, Artemis' insurers chose to institute retrograde litigation against the manufacturer of the Alfa and their local agency *Deluca Motors*.

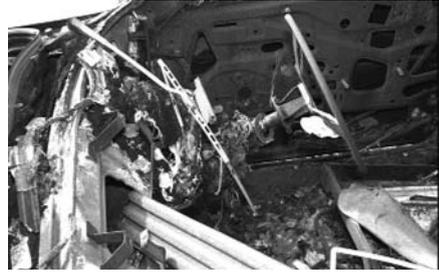
Figure 6.31 The burnt-out driver area

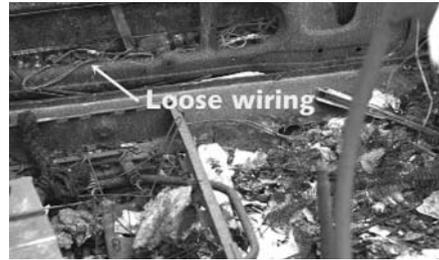
Figure 6.32 View into front passenger area

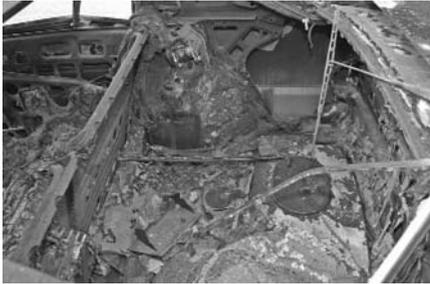
Figure 6.33 View into rear passenger area

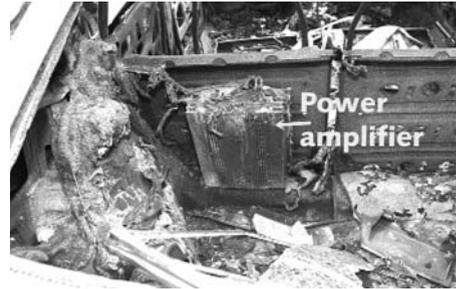
Figure 6.34 View into trunk compartment

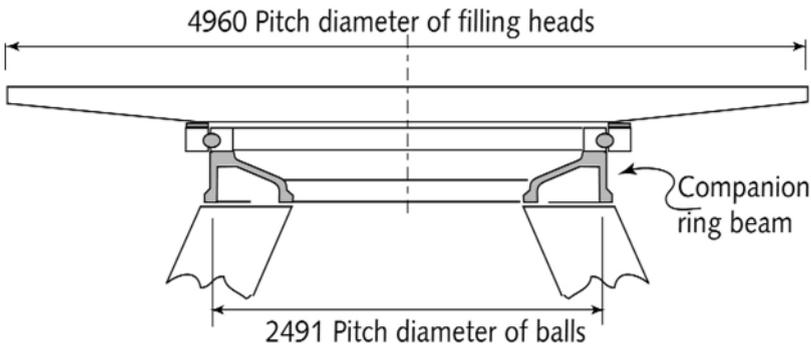
Figure A2.8 Schematic sketch of the bottle washer turntable (not to scale)

In this case a key issue was the structural deflection of the *companion structure* of the main bearing, which had suffered damage through brinelling. The bearing involved was a Rothe Erde single-row angular contact slewing ring bearing. These bearings are designed to be supported on a stiff companion structure to ensure that the bearing does not deflect under load. The companion structure in this case was a ring beam, identified in the photograph of Figure 2.25, and shown here schematically in Figure A 2.8. In Figure A2.9 a segment of this ring beam is shown schematically for the purpose of deflection estimation.

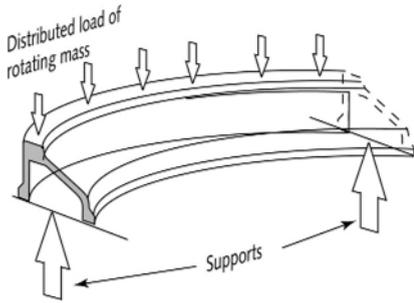
Figure A2.9 Schematic sketch of the ring beam segment evaluated for deflection

The ring beam was supported on several legs and the portion of the ring considered in this calculation was that where the legs were the furthest distance apart. This was over a section of the ring representing  $111^\circ$  of arc. As a conservative assumption, this longest arc between supports was modelled as a simply supported beam with the distributed load calculated from the

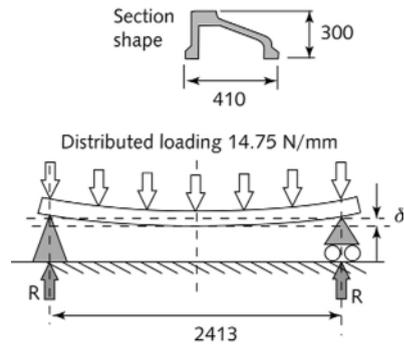
Figure A2.10 Schematic sketch of the ring-beam modelled as a simply supported beam

total load carried by the ring beam. Figure A2.10 shows this conservatively simplified model of the ring beam schematically.

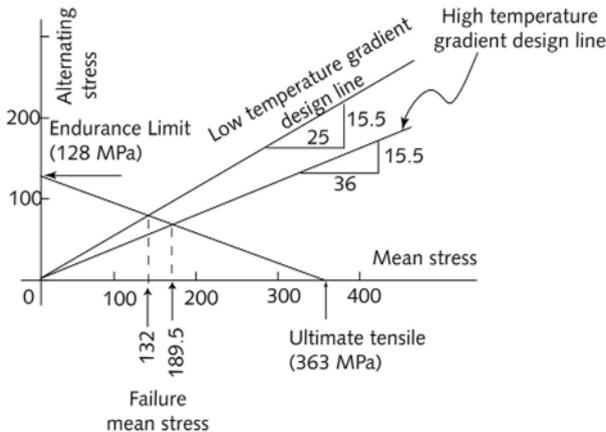
Figure A2.18 Goodman Diagram with the design conditions of the two dynamic stress cases above

A graphic evaluation of the design conditions for the two dynamic stress cases is presented in Figure A2.18. From each design condition the permissible mean stress (or corresponding fluctuating stress component) is found.

Permitted mean stress to failure  
 $= 132 \text{ MPa}$

Permitted mean stress to failure  $= 189.5 \text{ MPa}$

Dynamic load (both temp. gradients)  $= 5.3$

Clearly still quite conservative design.
