HISTORIC STRUCTURE REPORTS
FOR HOUSE 105
AND THE OLD SCHOOL

ADMINISTRATIVE, PHYSICAL HISTORY AND ANALYSIS SECTIONS
SITKA NATIONAL HISTORICAL PARK
SITKA, ALASKA

Prepared By
Paul C. Cloyd E.I.T., Historical Architect

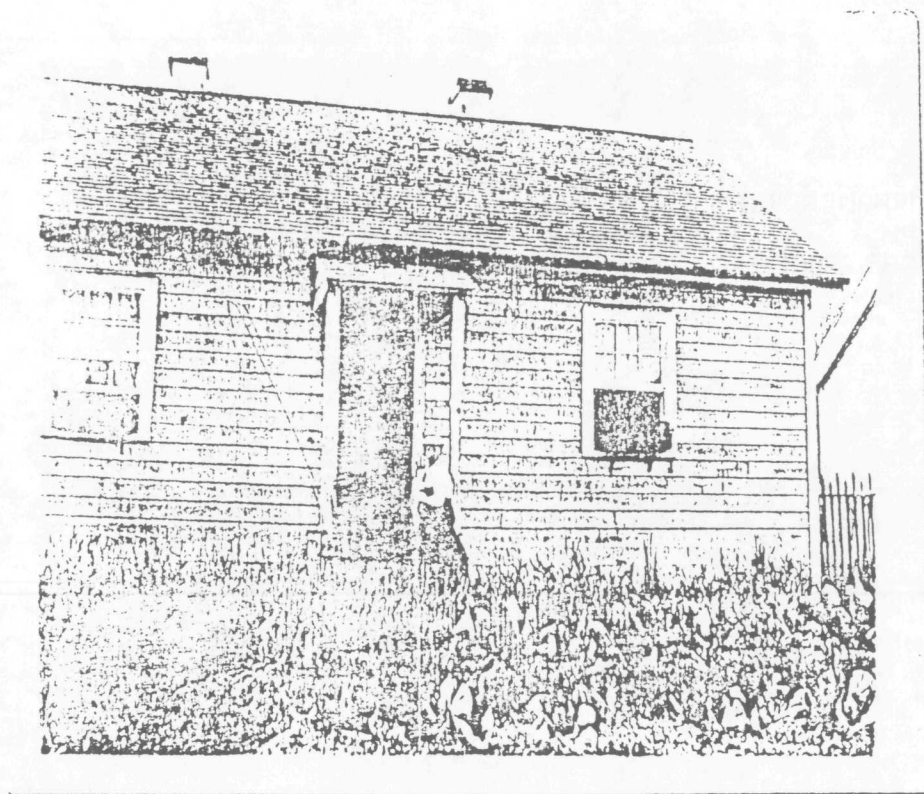
HOUSE OF BOONIE POTTER STONE AND
 MAUD MARGARETE (GRANT) STONE WHILE
 STATIONED IN SITKA, ALASKA.
 PICTURES: TAKEN SUMMER 1891.

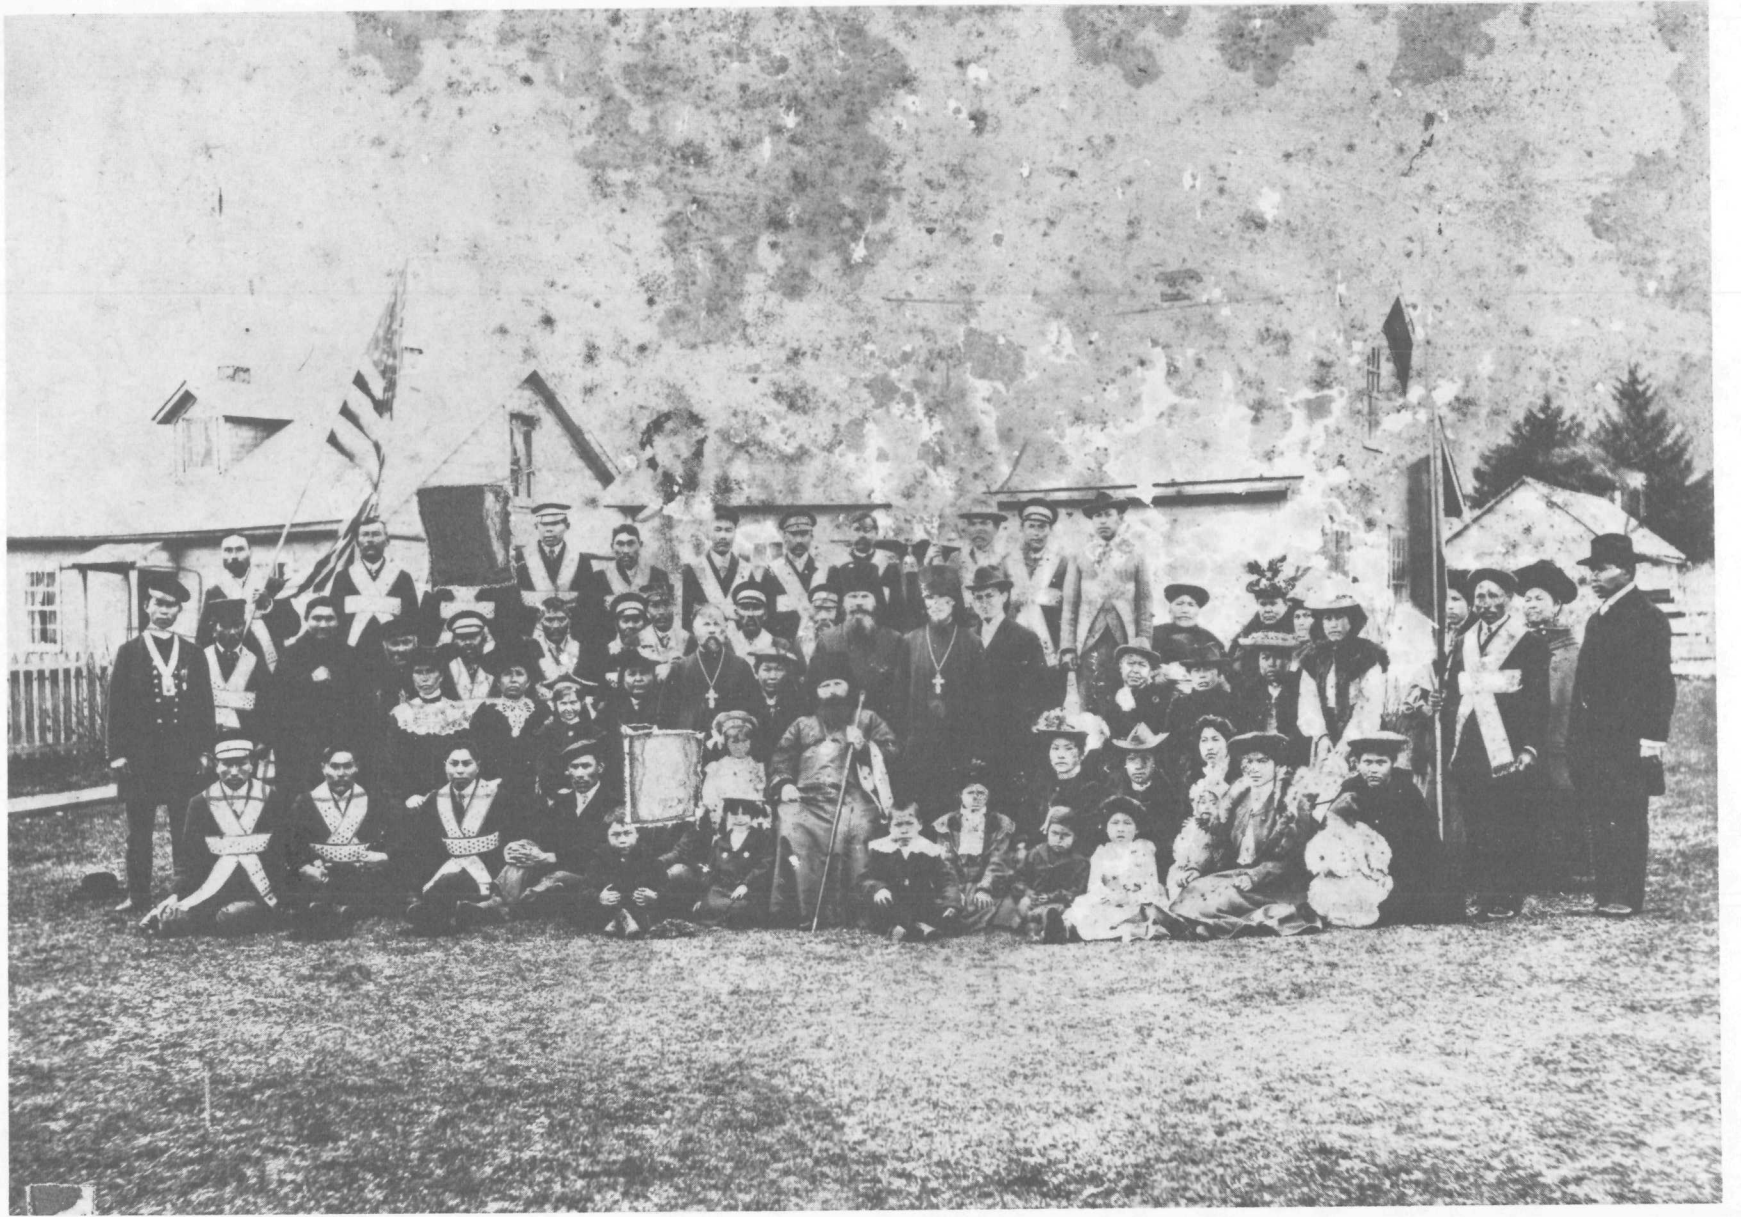
FIGURE 4. Ca. 1902. House 104 at left,
House 105 at right.
Sitka National Historical Park

Few changes to House 105 can be detected in historic photographs. Figure 4, although of poor clarity, indicates the house unchanged from its original construction, although House 104 is seen with a dormer.

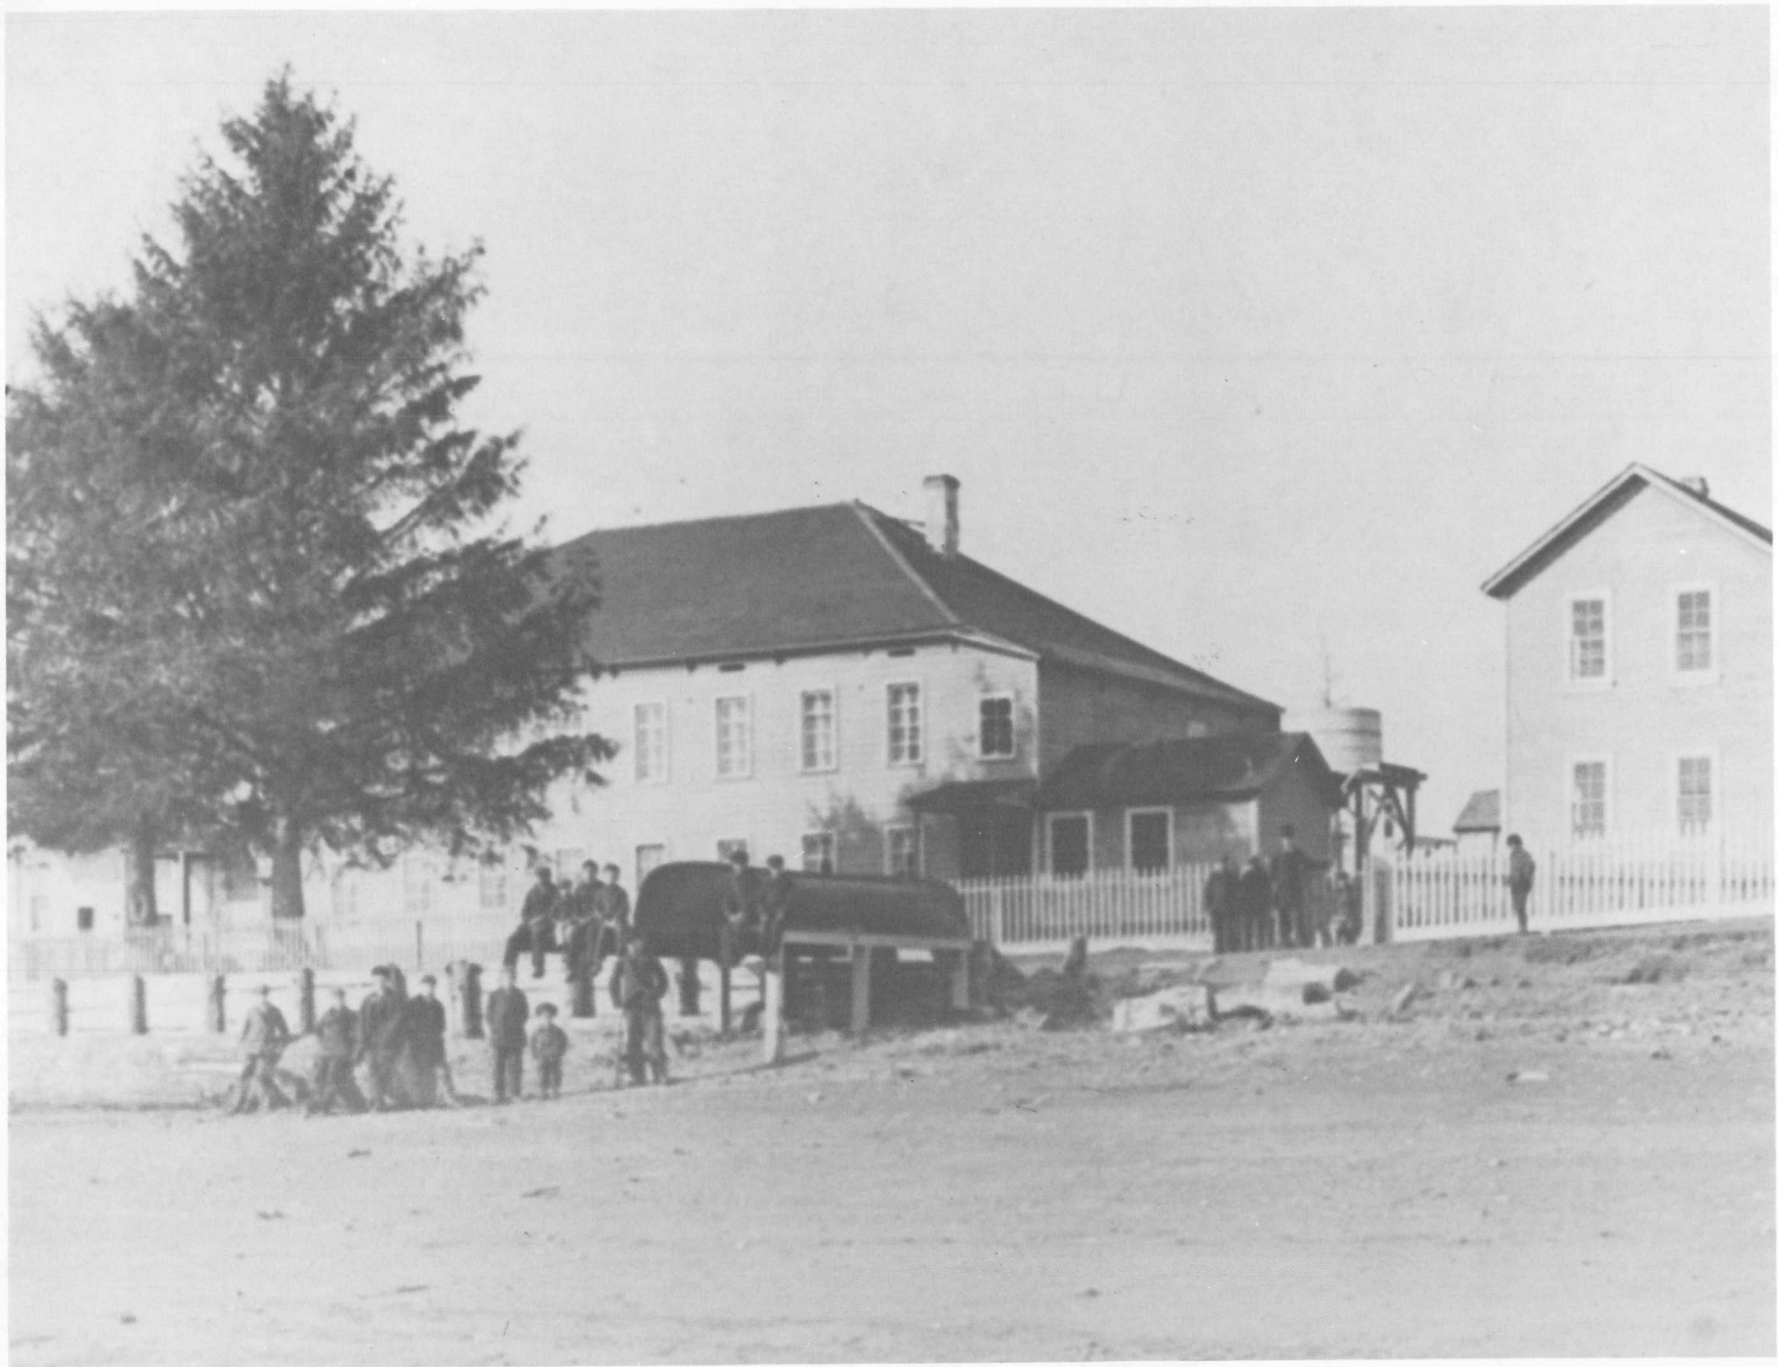
FIGURE 1. ca. 1900. View from southeast, Old School at right.

A ca. 1900 photograph (Figure 1) shows the building with a masonry chimney and four-over-four light, double-hung windows, elements in existence in 1975, although deteriorated to varying degrees. A ca. 1905 photograph (Figure 2) shows the wood shingle roofing. By that time, gutters and downspouts had been installed.

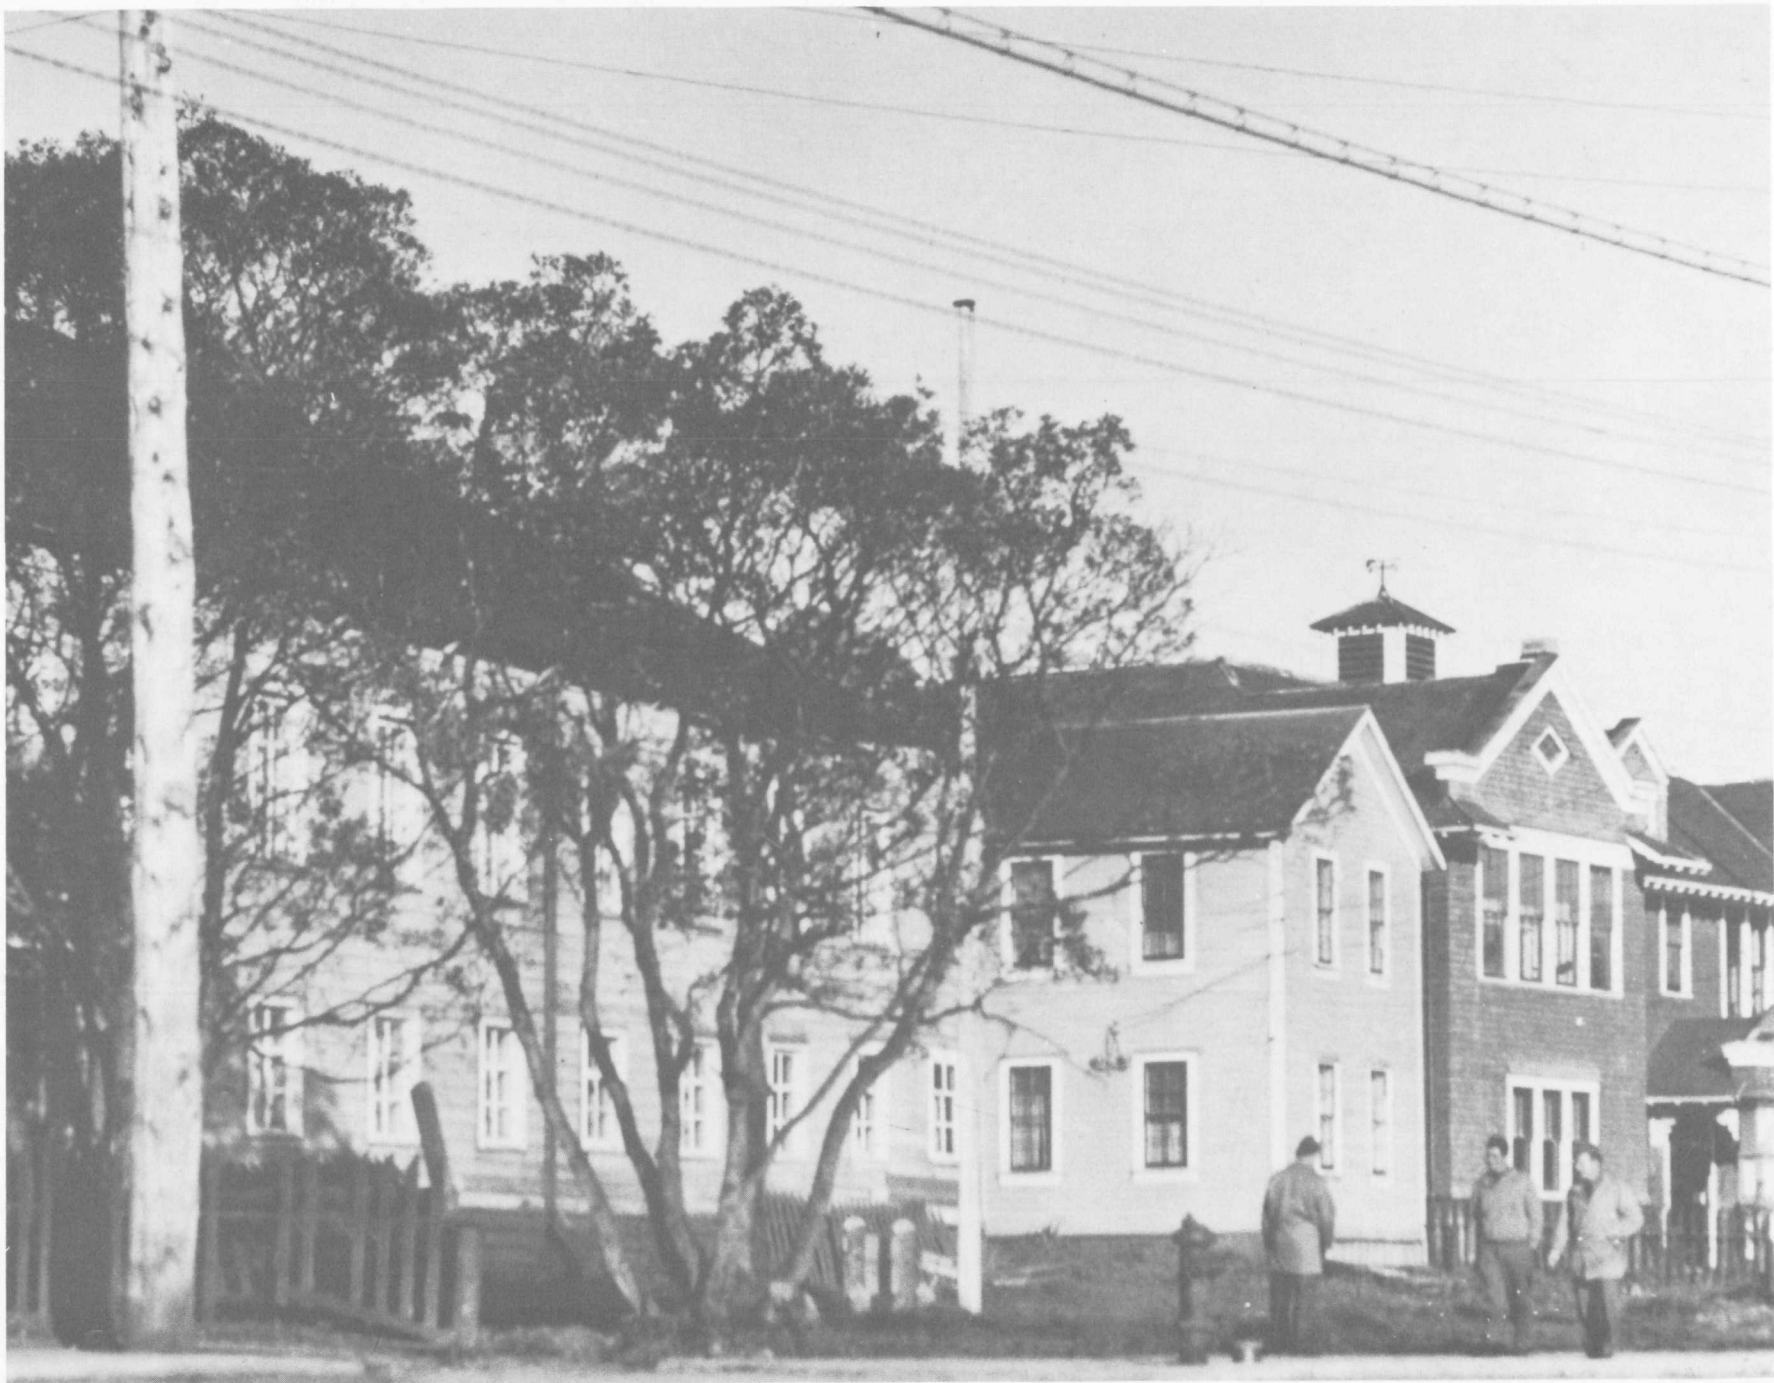
FIGURE 9. ca. 1943. View from southwest.
Sitka National Historical Park.

Historic photographs of the 1930s and ca. 1942 indicate little change on the exterior of the building. A ladder is seen on the roof in Figure 8. The ca. 1943 photograph (Figure 9) suggests a paint scheme change from the 1930s. Paint sampling confirms a gray with white trim paint scheme. From what little can be seen through the windows in Figure 9, it appears that the north-south center walls had been installed in the large south classrooms on the first and second floors.

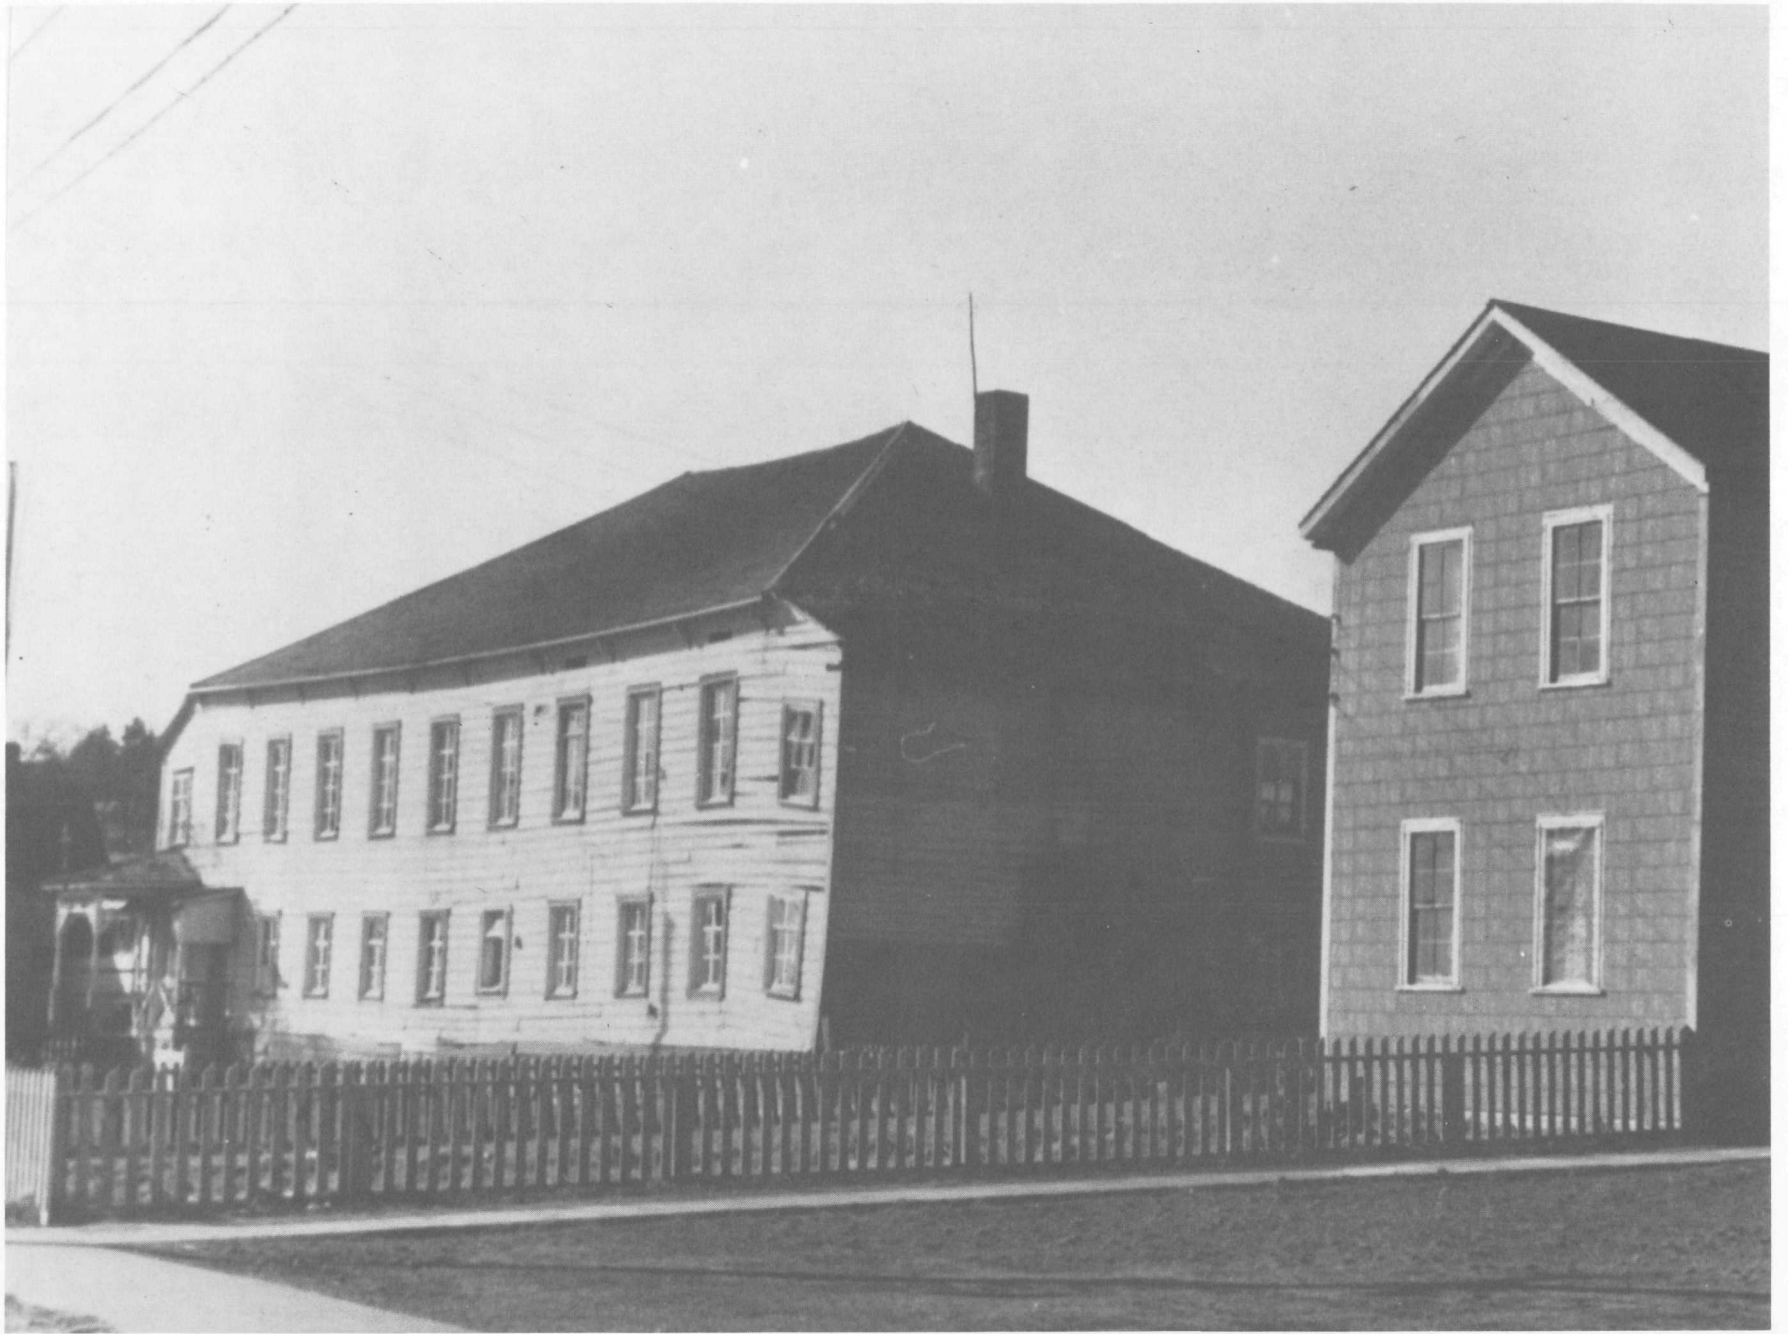
FIGURE 10. ca. 1963. South elevation of old school at right.
Sitka National Historical Park.

Asphalt shingle siding was applied to the south wall (Figure 10) ca. 1963). In July 1981, the asphalt shingles were removed, revealing the wood siding beneath (see Figure 18). Figure 11 shows a structure attached to the north end of the building, but its function is unknown. Remnants of this attached structure can be seen in the record photographs (see Figure 20).

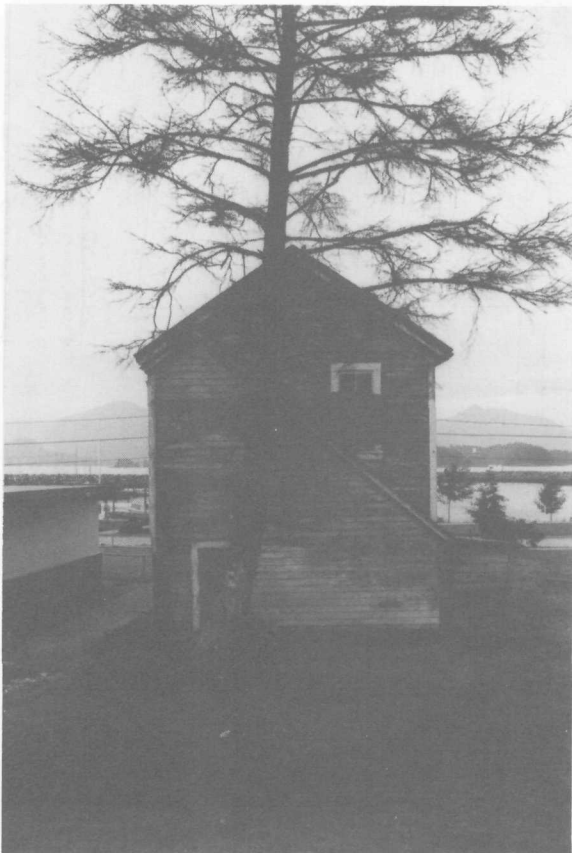
FIGURE 15. North elevation.

Wall area converted
to door in 1922, then
converted to window.

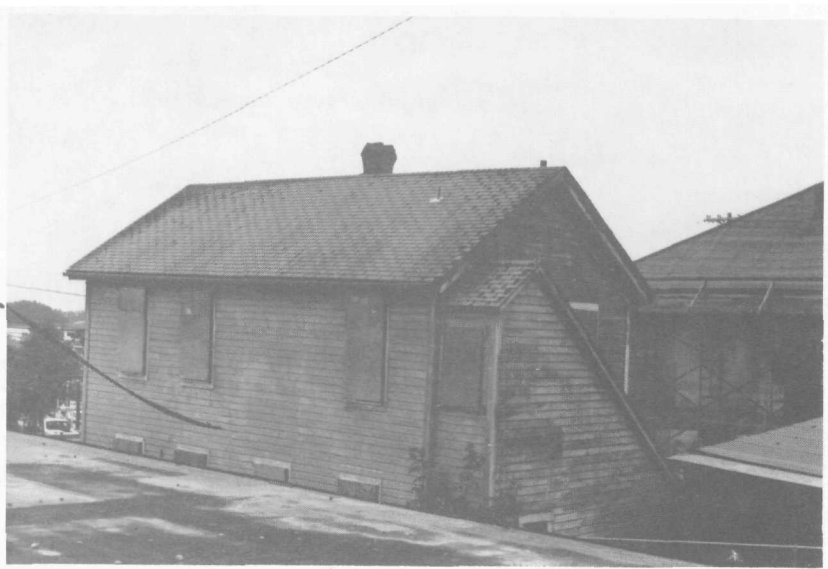
FIGURE 19. View from northeast.

Ghosting on siding appears to be some type of stairway. See Figure 7.

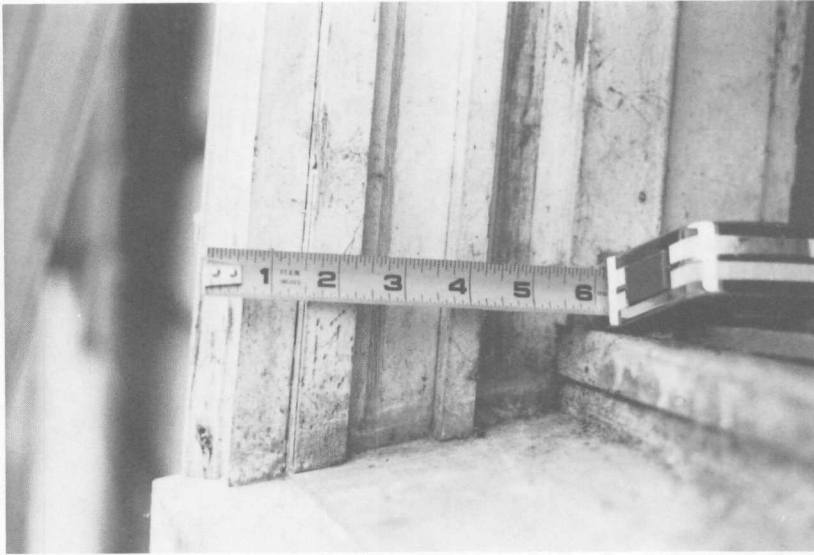
FIGURE 22. Jamb detail.

Original doorway converted to window. Probably in 1922.

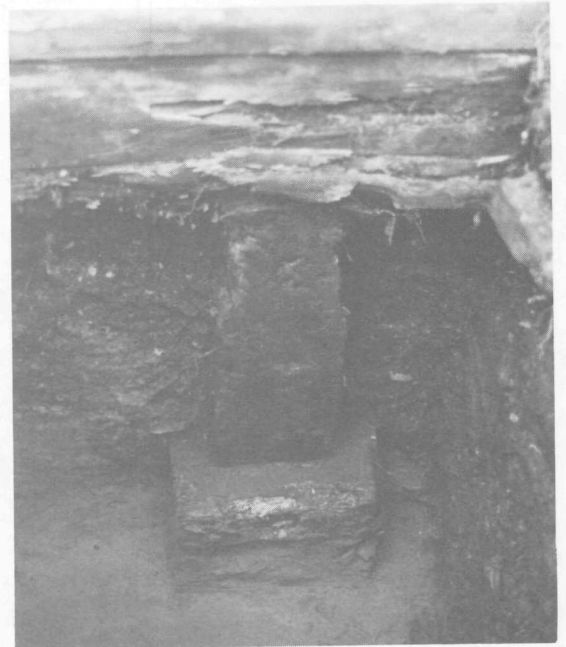
FIGURE 28.
Pier at north wall with concrete footing.

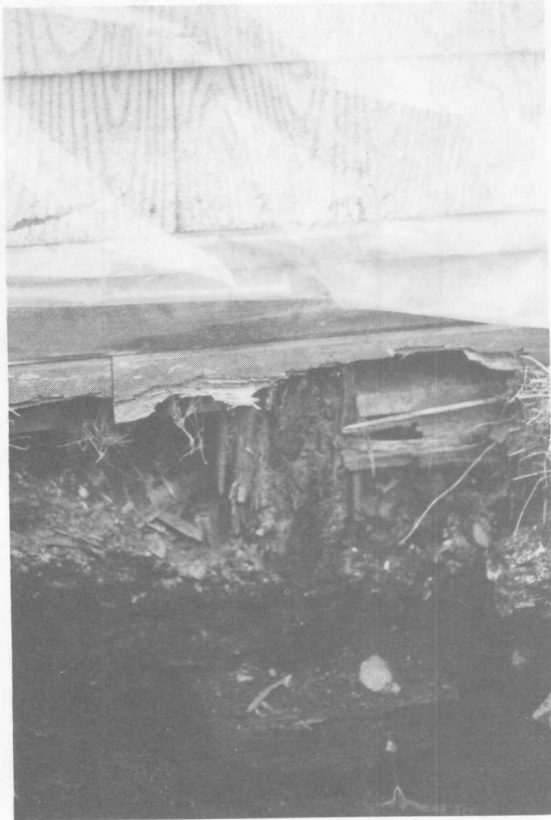
FIGURE 29.
Rotted timber pier at south wall.
