ANSLEY WILCOX HOUSE

Theodore Roosevelt Inaugural
National Historic Site
Buffalo, Erie County, New York

HISTORIC STRUCTURE REPORT

October 2006

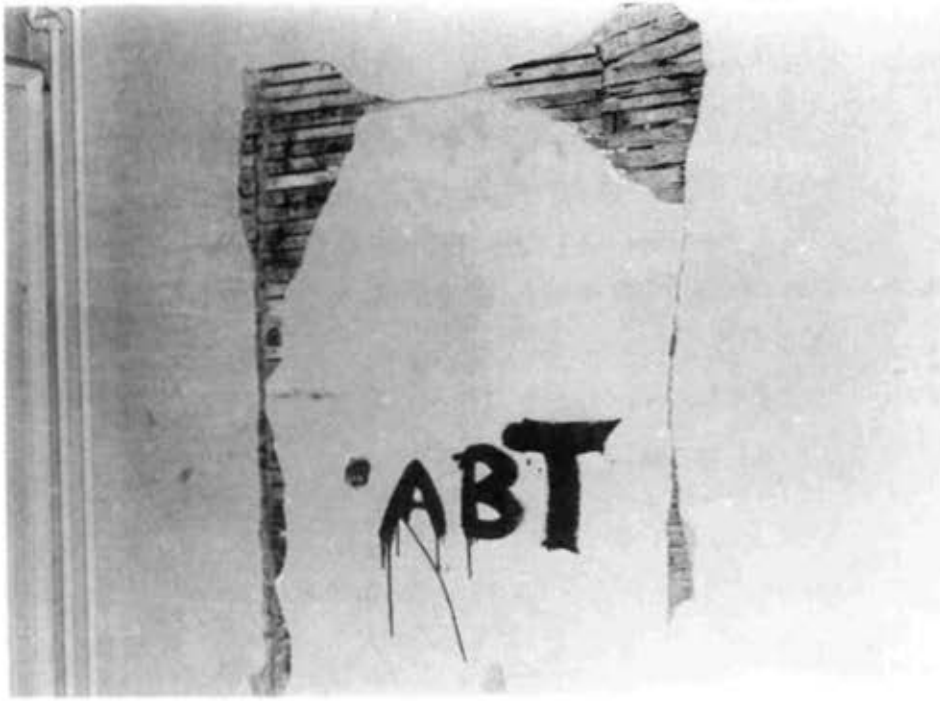
Figure 1.52. First story, closed northwest window, circa 1966.

The original building's exterior walls are three bricks thick. The interior is furred with split-board lath and plaster. As shown in historic photographs, window openings were later filled and other alterations constructed using sawn lath. (See Figure 1.52.) The brick is set in common bond with a header or tie course at every eighth course. Stone window sills are two bricks tall and project 1 inch from the face of the wall. Stone lintels are four bricks tall and set flush with the wall surface. The original bricks are 7 ⁵/₈ inches long by 2 ¹/₄ inches tall.

There may have been a typical double- hung window at the southwest corner of the first story similar to the present windows N5 and N6. This is unconfirmed, but suggested by evidence of a blocked window in the same position on the north elevation. (See Figure 1.52.) The Library bay window originated between 1885 and 1889. (See Figure 2.3.) There are patches in the

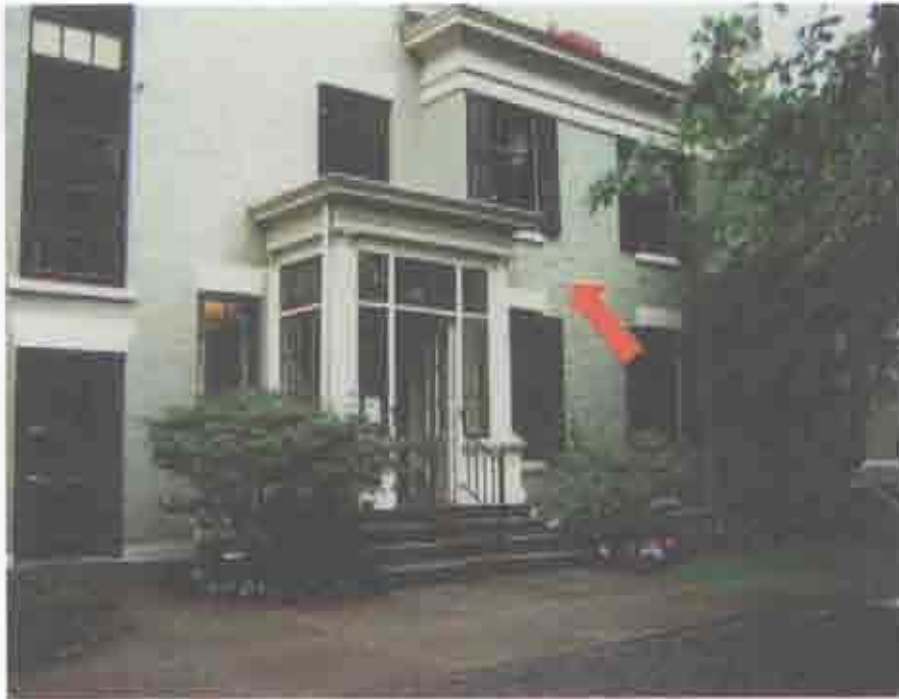
Figure 2.13. North elevation, location of brickwork scars from formerly attached barracks building.

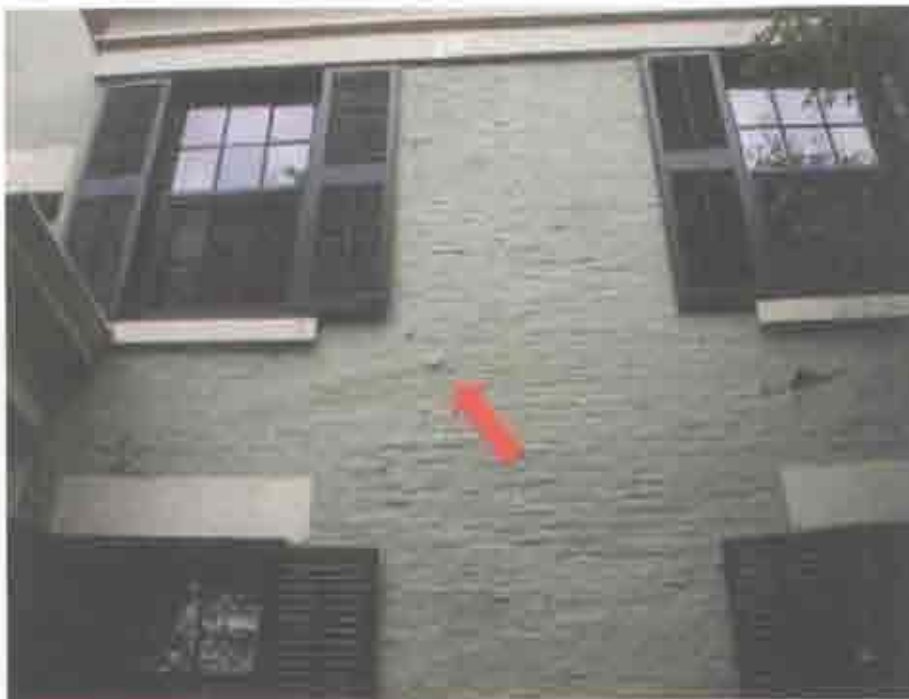
Figure 2.14. North elevation, detail of brickwork scars from formerly attached barracks building.

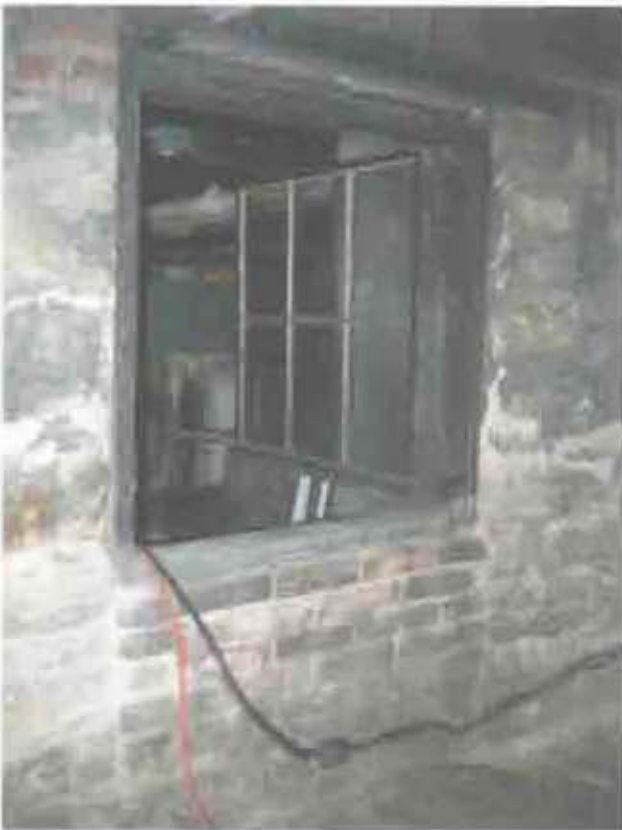
Figure 2.27. Room 001c (areaway below west portico), showing brick infill and casement window at former doorway opening.

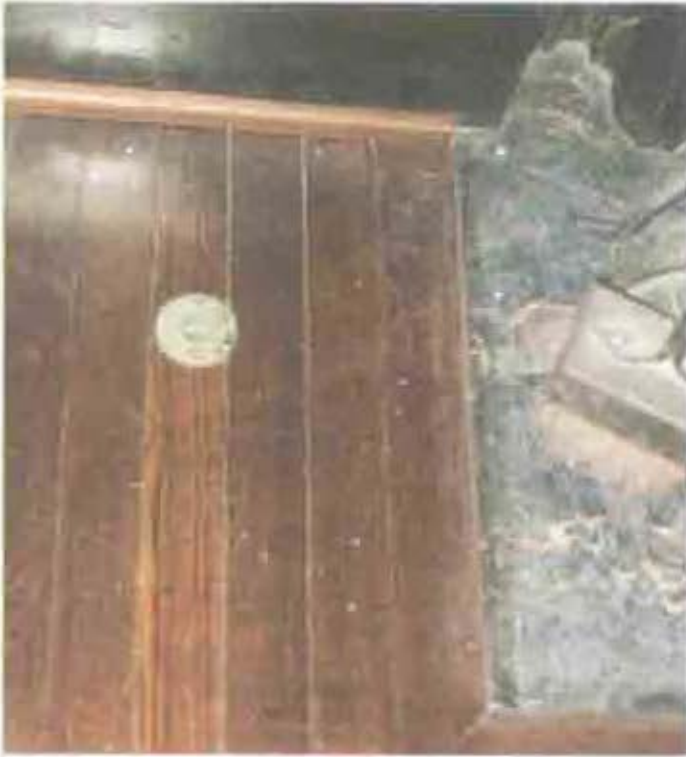
Figure 2.39. Room 107 (Living Room), unidentified floor feature.

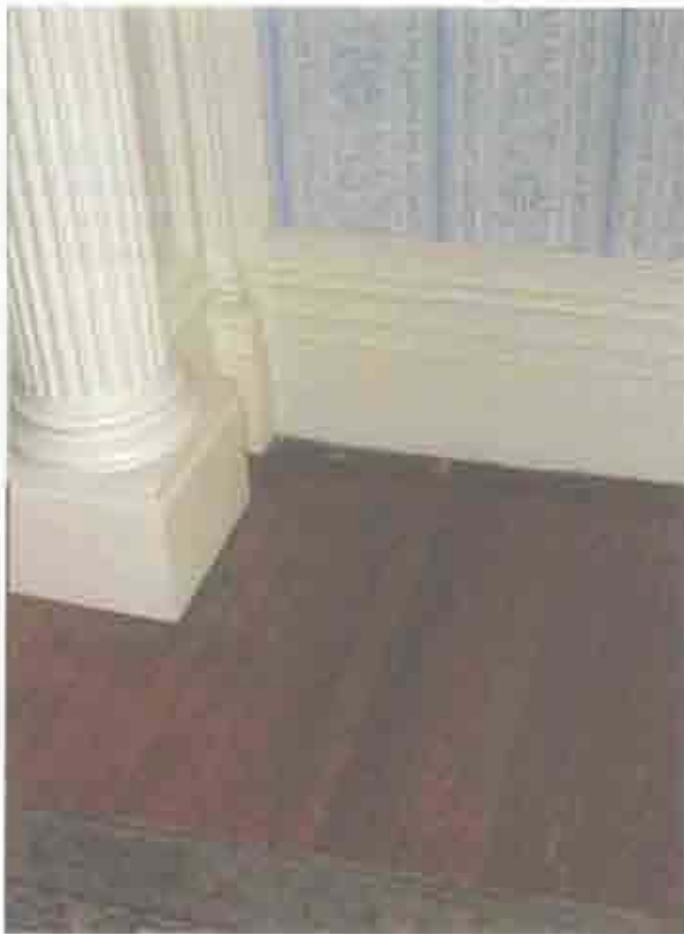
Figure 2.44. Room 108 (Dining Room), unidentified floor feature.

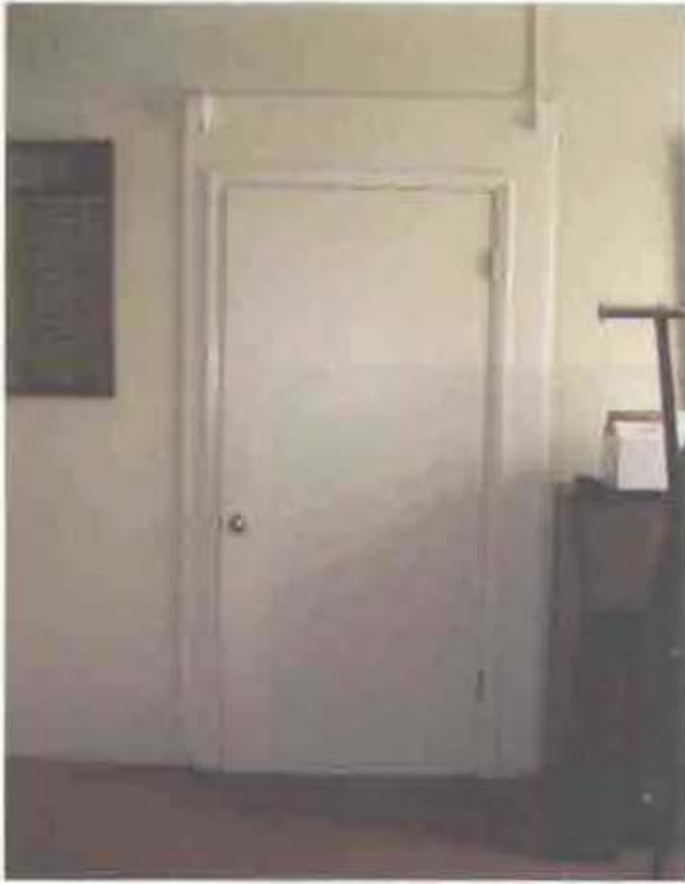
Figure 2.46. Room 112 (Kitchen), north wall, 1896 window opening converted to doorway.

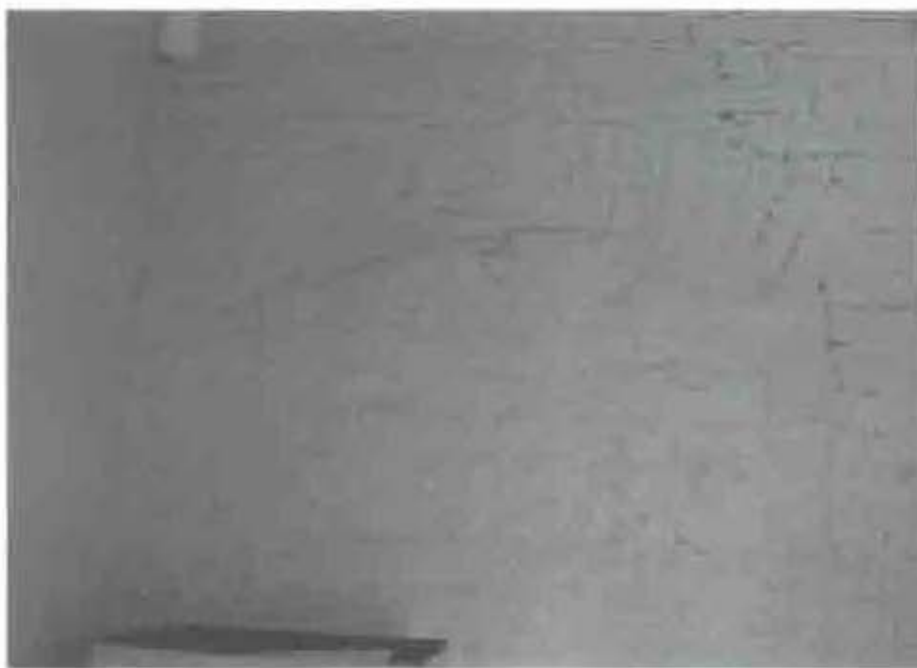
Figure 2.50. Room 115 in the 1938 addition, north wall, infilled arched window opening in brick wall of former carriage house.

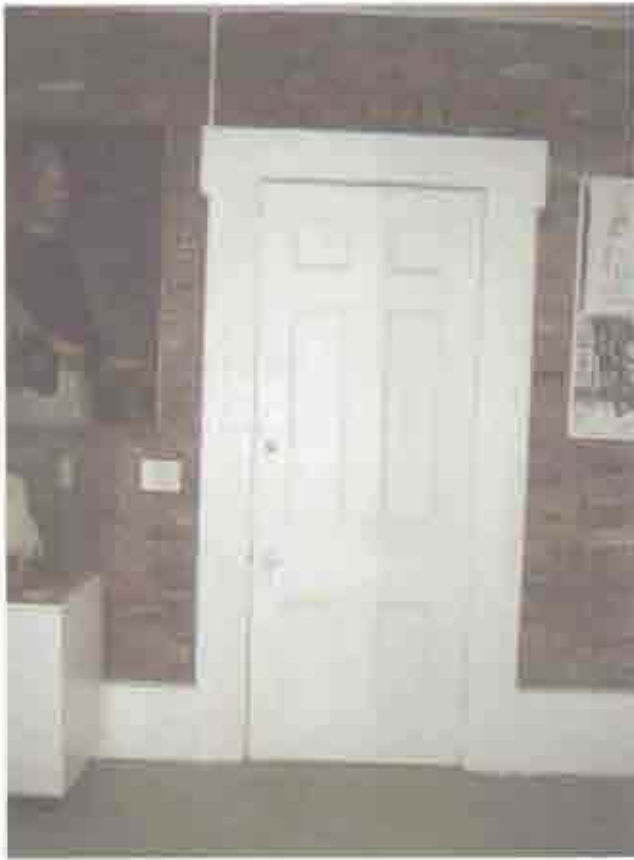
This doorway is the remnant of a doorway between the original stair hall and the second- story hall in the 1896 addition (room 203). In 1896, this was a wide opening with a soffit supported on ornamented console brackets. (See Appendix B.) The iron lintel for this opening is still visible in Room 203. (See Figure 2.54.) By 1938, the wide opening was partially filled with brick and reduced to the present doorway.

The west wall is exposed brick, with a doorway at its center. The brick to the south of the doorway is part of the original structure. The brick to the north of the structure was installed sometime prior to 1938, to reduce the wide 1896 doorway here to its present size. The steel lintel over the 1896 opening is still visible; its length corresponds to the 6-foot, 10-inch-wide opening shown on the 1896 architectural drawings. (See Figure 2.54.) The width of this opening suggests that Cary considered the stairway in the original structure to be the principle staircase in the house, and that he intended to unite the second-story halls in the original structure and the 1896 addition.

Figure 2.54. Room 203 (Second-Story Back Hall), west wall, pre-1938 doorway and brick infill.

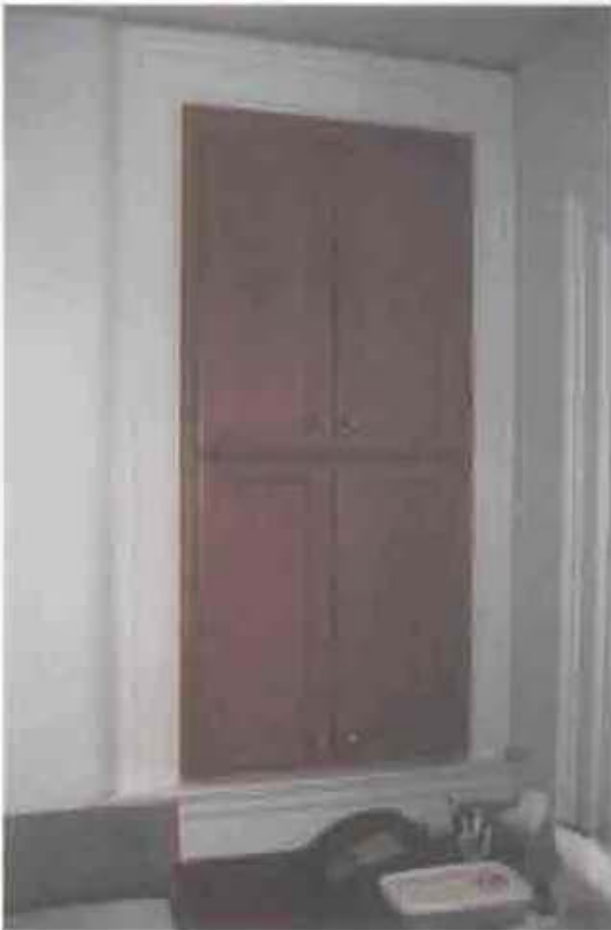
The west wall is furred plaster on original brick with its 1896 fabric remaining intact. In the center of the room is a doorway to the original part of the house, with flat molded and mitered casings. The door swings into the original structure – the reverse of the swing indicated on the 1896 drawings. At the north end of the west wall is a similar doorway that opens to a modern cabinet set into the doorway recess. (See Figure 2.59.) This doorway is labeled on the 1896

Figure 2.59. Room 204,
west wall, "old closet"
with modern cabinet
insert.

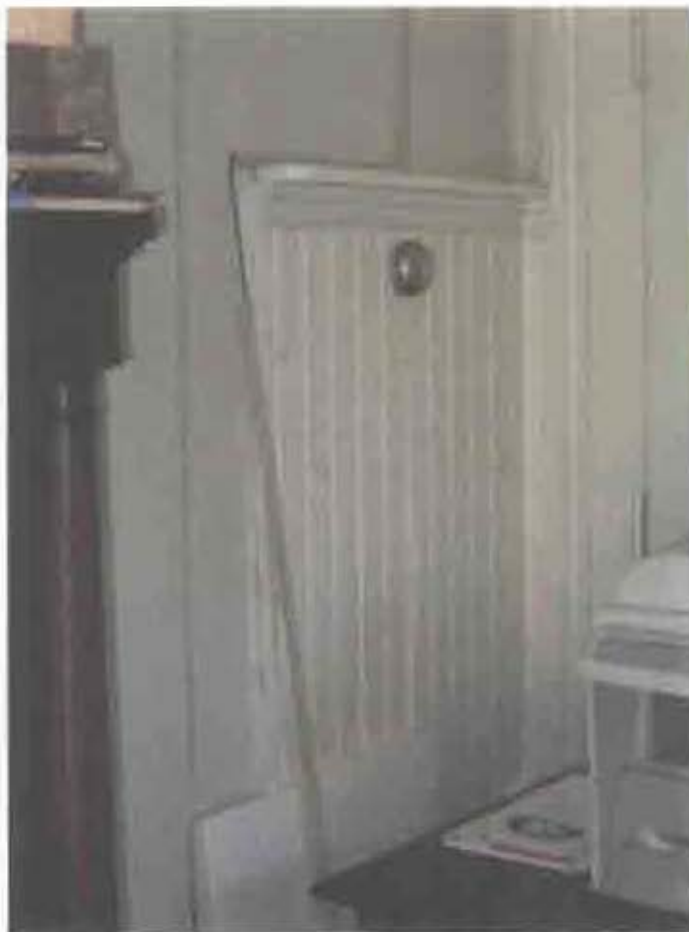
The present north wall consists of two sections, reflecting its 1896 construction. The west section is an 1896 frame partition with lath and plaster and a molded wood baseboard. A doorway connects to the Back Hall (room 203); it is cased with molded and mitered boards and plinth blocks, and has a paneled door. The east section was formerly a thin frame partition containing a wide opening to the walk-in closet in the southeast corner of the Back Hall. At the east end of the wall was the side of the chimney breast for the first-story Kitchen. This configuration is documented by the 1896 architectural drawings. The walk-in closet was removed after 1971, and the opening to it infilled with a frame partition and gypsum plasterboard. Remnants of a tongue-and-groove wood wainscot survive at the east end of the north wall, on the side of the chimney. It displays vertical "V"-groove boards, and a molded dado cap and shelf. (See Figure 2.60.) It probably dates to 1896.

Figure 2.60. Room 206,
wainscot remnant at north
end of east wall.

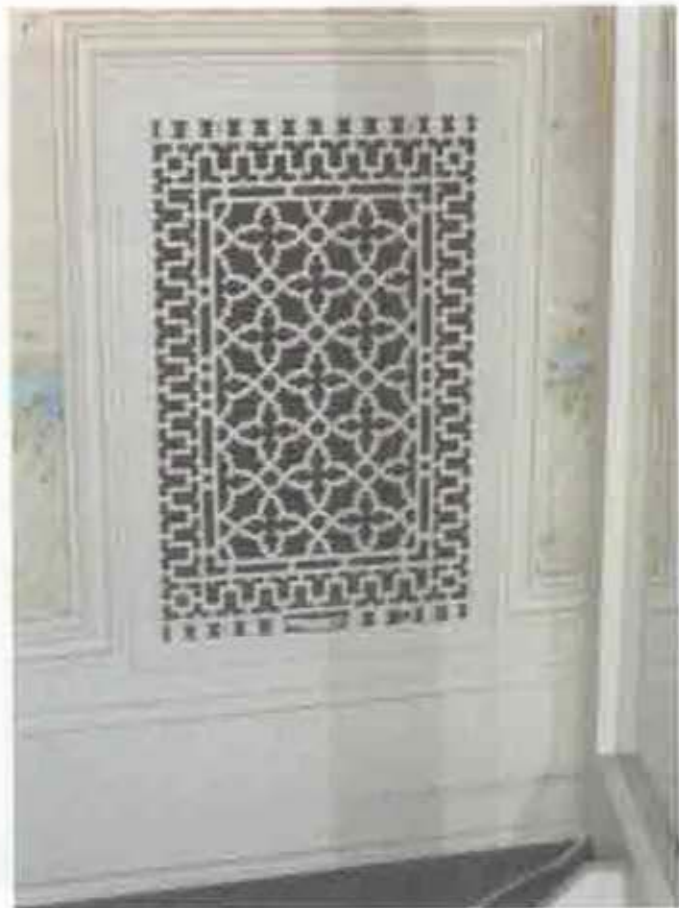
On the west wall are two doorways with paneled jambs and paneled wood doors. The south door is presently fixed and blocked from the adjacent room (room 206). Between the two doorways is an ornamented wall register, which is cased with molded wood boards matching the baseboards. (See Figure 2.63.) This is shown on the 1896 architectural drawings.

Figure 2.63. Room 207,
wall register.

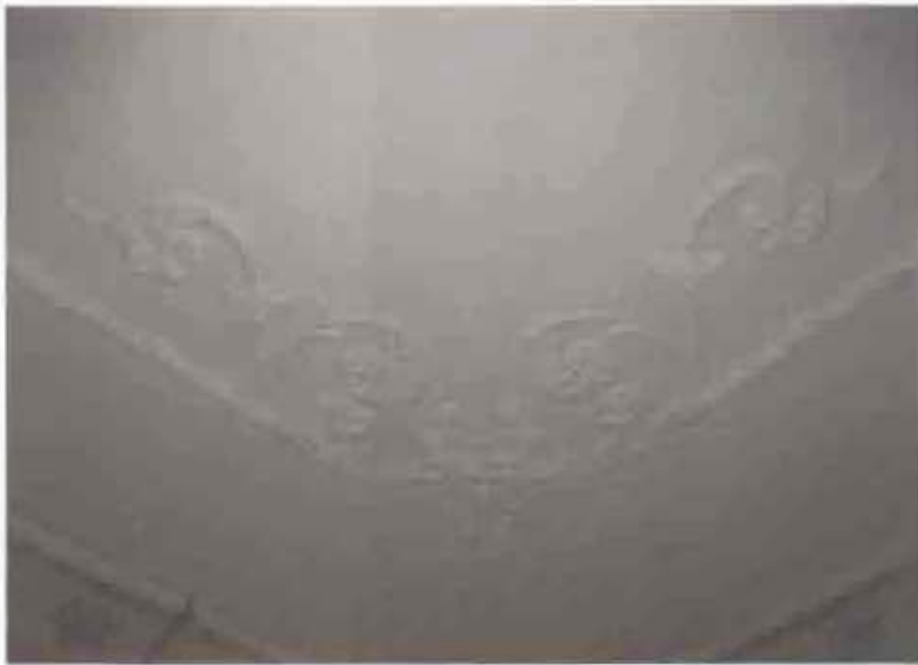
The ceiling is flat lath and plaster with plaster relief or appliqué ornament. (See Figure 2.64.)

Figure 2.64. Room 207, ceiling.

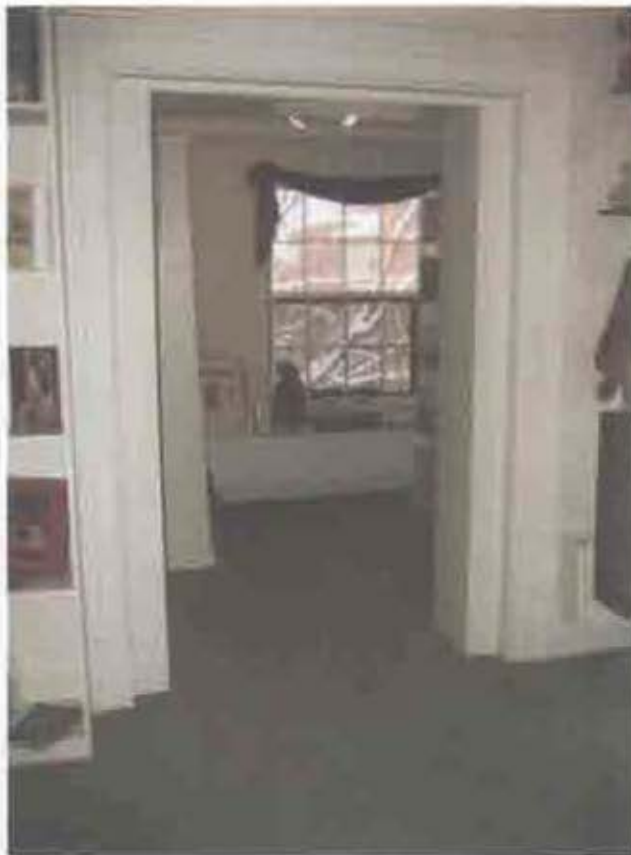
Centered on the east wall is a projecting chimney breast with brick hearth and facing, and a mantelpiece similar to that in the adjacent bedroom (room 207). At the center of the north wall is a former 1896 window opening that was converted to a doorway in 1938 to access the new addition of that date. The brick below the window sill was removed, the paneled skirt and jambs were removed, and the opening was narrowed to create the doorway. This opening is cased with the original salvaged window trim. (See Figure 2.65.)

Figure 2.65. Room 208, north wall, 1896 window converted to doorway in 1938.

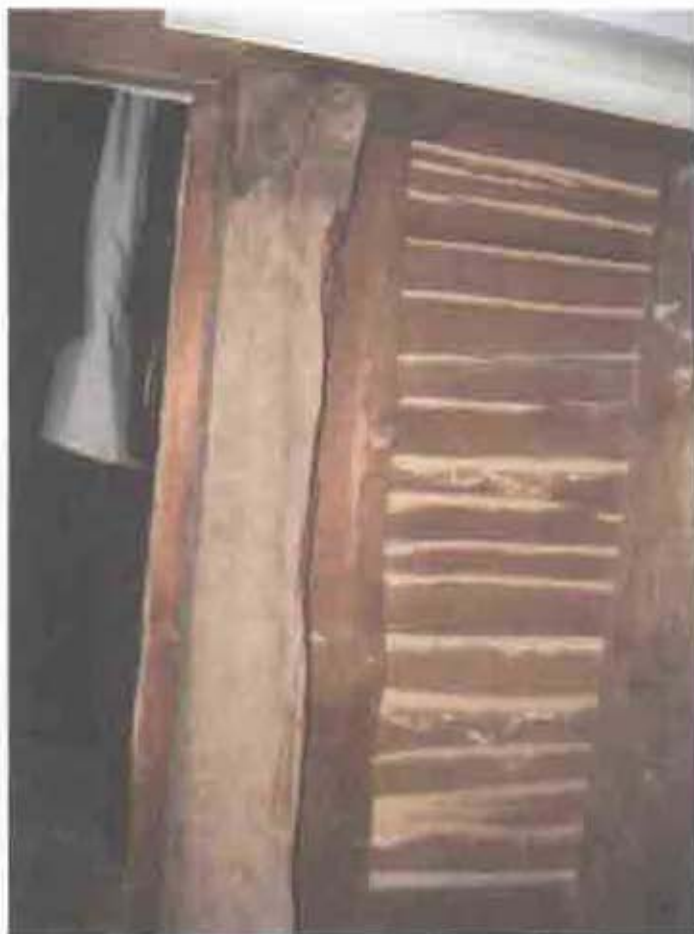
The north and south walls are knee walls consisting of split- board lath and plaster supported on vertical boards fastened to the roof and floor framing. The lath on the back of the knee walls is visible in room 308a. The plaster is mostly missing, presumably the result of deflection of the supporting boards and roof rafters. Two layers of plasterboard have been applied over the lath to enclose and stiffen the wall. The split- board lath is similar to that uncovered in the northwest corner of the library in 1971, suggesting that these knee walls probably date from the original construction, representing the “furnished garret” described in the 1840 Chapman letter.²⁵ (See Figures 1.50 and 2.69.)

Figure 2.69. Room 308a,
looking north toward
back side of early knee
wall.

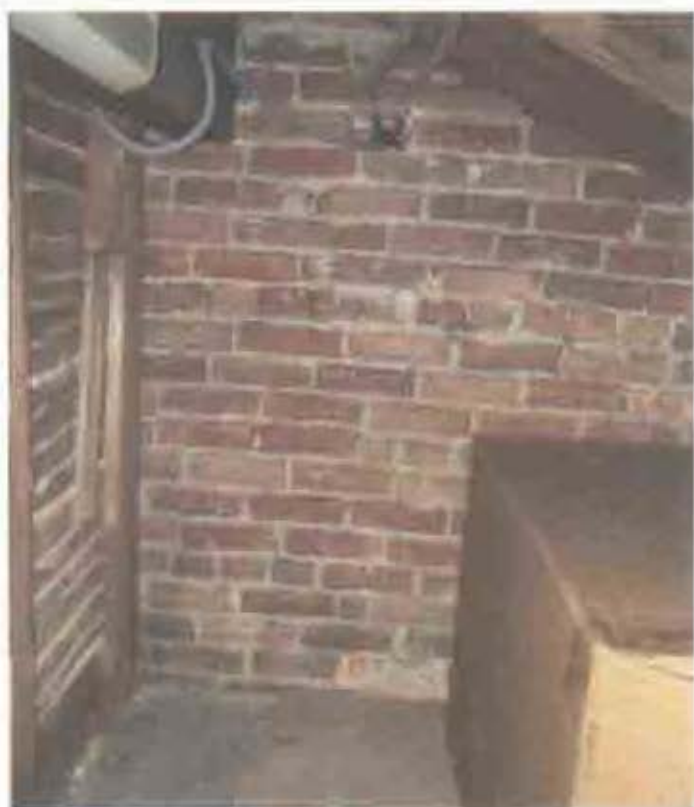
The east wall is the interior surface of the original brick gable end wall. (See Figure 2.70.) The end wall is three bricks (12 inches) thick. The brick is laid in common bond with headers at every eighth course. Individual bricks are regularly formed, but vary in color from pale salmon to deep red, suggesting a somewhat uneven temper. Joints are filled to the surface with bedding mortar and struck flush.

Figure 2.70. Room 308a,
looking east toward original
brick gable end wall.

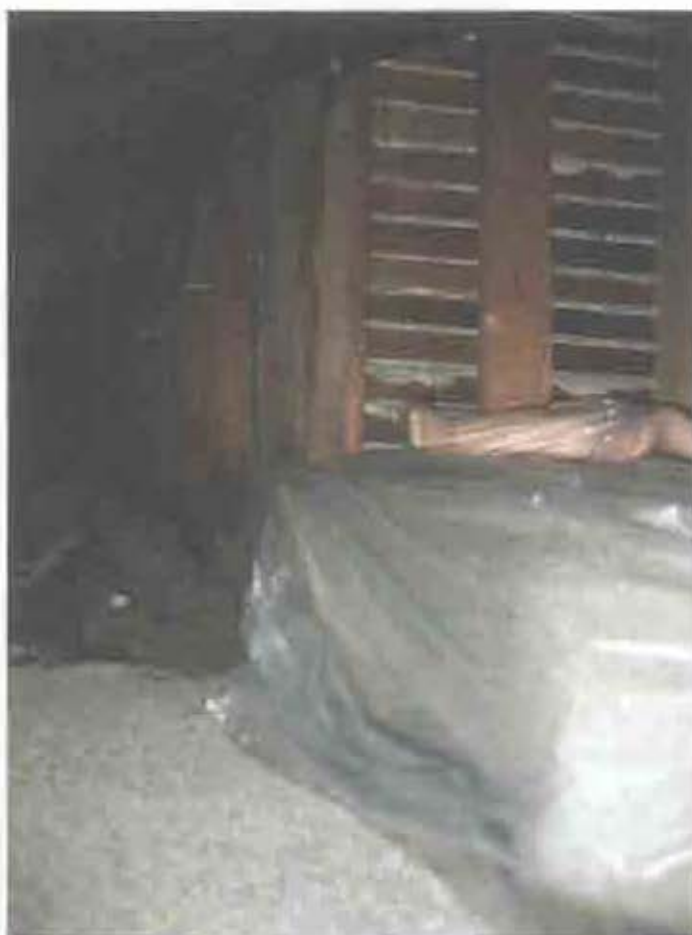
The west wall is formed by the back sides of the dormer in room 309 and that room's closet (309a). It can be seen that the frame partitions of the dormer and the closet walls consist entirely of sawn lumber and sawn wood lath, indicating a later period of construction than the knee walls, probably dating to the Wilcox occupancy. (See Figure 2.71.)

Figure 2.71. Room 308a, looking west toward dormer check wall.

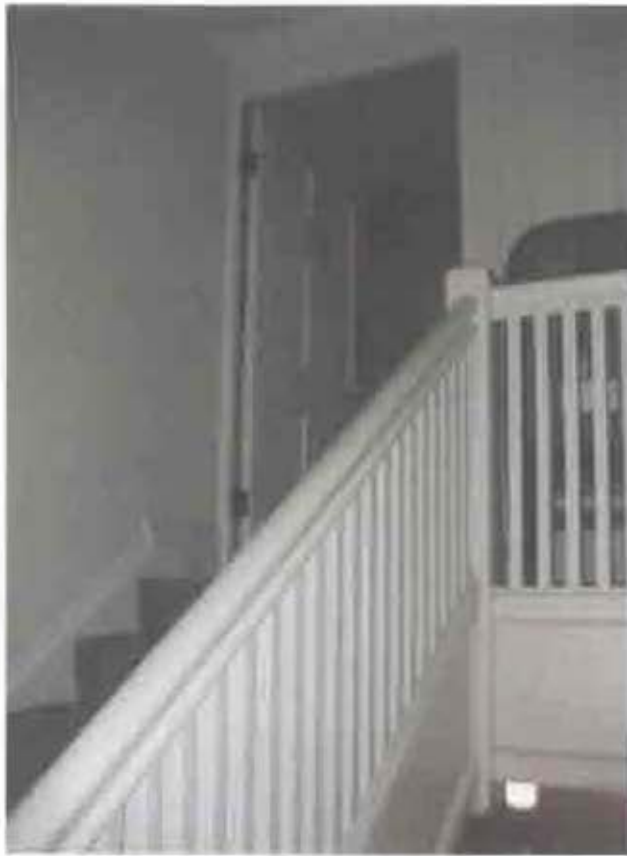
The east and west walls are 1896 frame partitions with lath and plaster finish. There are 8- inch- high molded baseboards on the east wall, and 9 ½- inch- high baseboards with a more complex molded profile on the west wall descending to the second story. No attempt was made to align and miter the sloped baseboard on the staircase with the level baseboard on the landings. This fact underscores the room's utilitarian character. (See Figures 2.72 and 2.73.)

Figure 2.72. Room 301
(North Staircase).

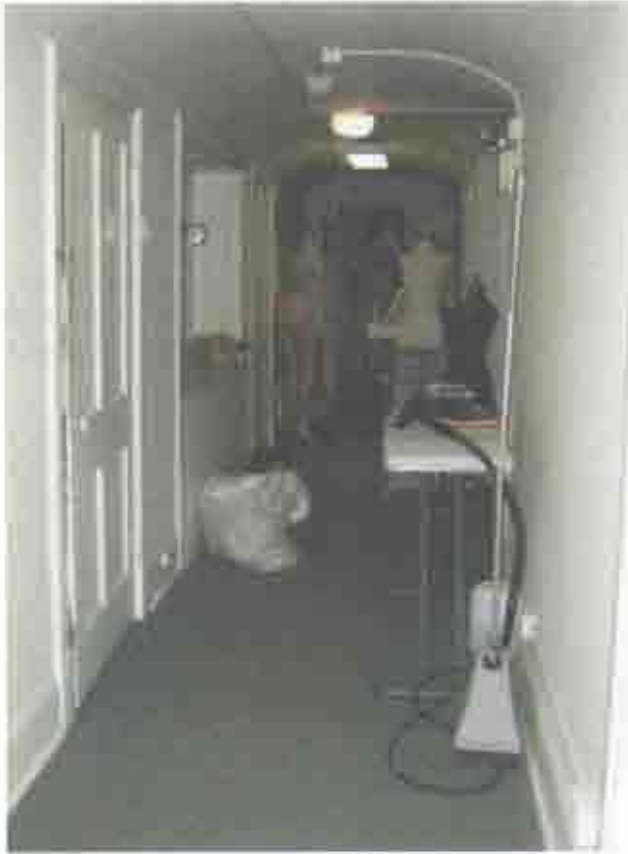
Room 302 is shown on the 1896 architectural drawings, and it remains as originally designed. (See Figure 2.74.)

Figure 2.74.
Room 302 (Hall).

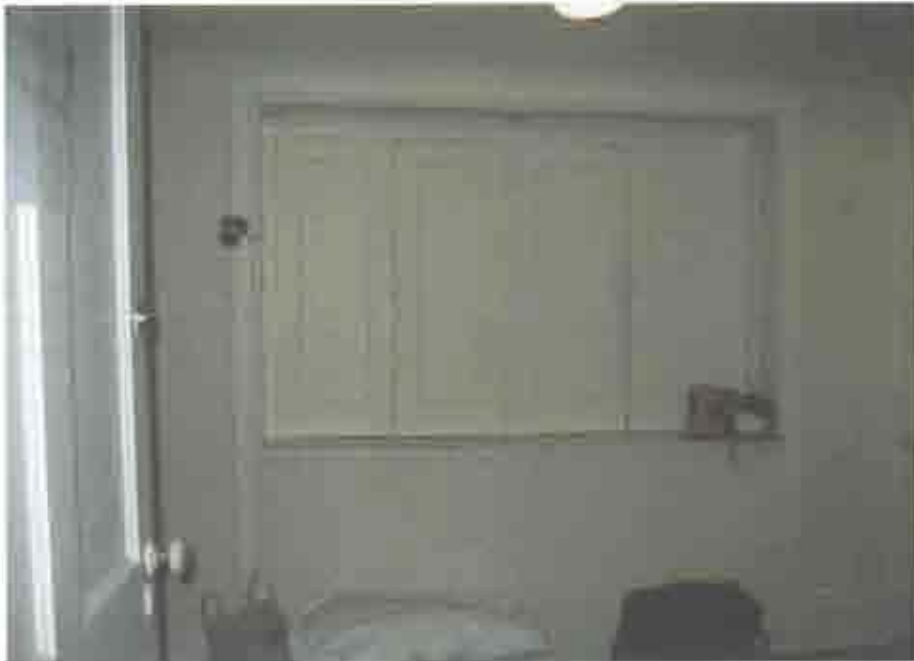
Opposite the staircase is a linen closet recessed into the south wall. (See Figure 2.75.) This closet consists of two compartments, each enclosed by a pair of paneled wood doors and lined with double- beaded cedar boards 5 inches wide. There are two wood shelves in each compartment. Below the doors is a plywood panel, where drawers were probably originally located. (See the description of the built- in cabinet in room 306.)

Figure 2.75. Room 302 (Hall), south- wall linen closet.

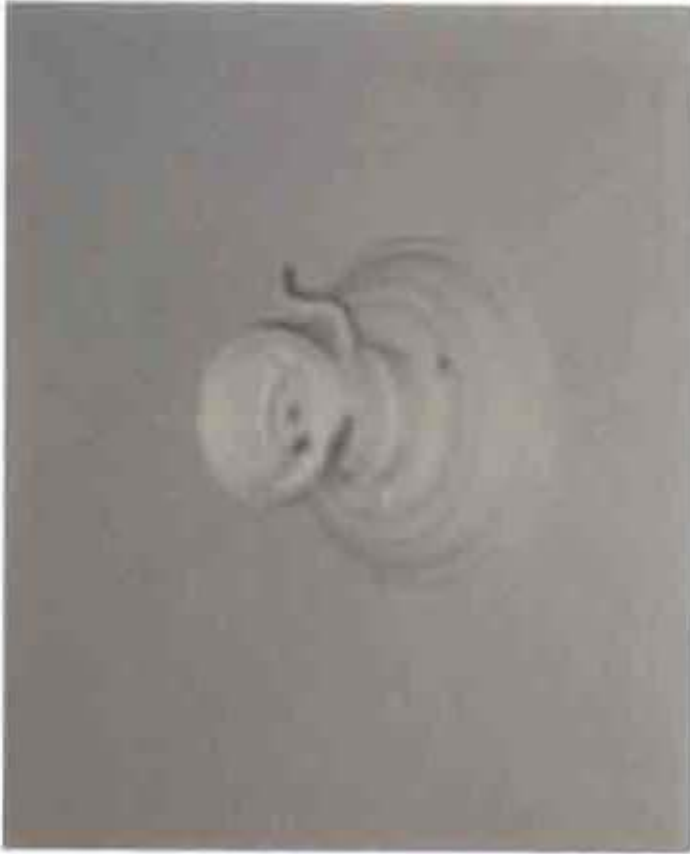
At the east end of the south wall is a speaking tube and spun- metal whistle piece. (See Figure 2.76.) According to the 1896 specifications, speaking- tube communication was provided between the first- story Kitchen and the third- story servants' hall. The whistle piece has been crushed by the swing of the door to room 305. A turned wood doorstop is mounted on the baseboard below, and was probably added after the damage. (See Figure 2.77.) It is identical to the doorstop at the doorway to the North Staircase (room 301).

Figure 2.76. Room 302 (Hall), wall-mounted speaking-tube fixture.

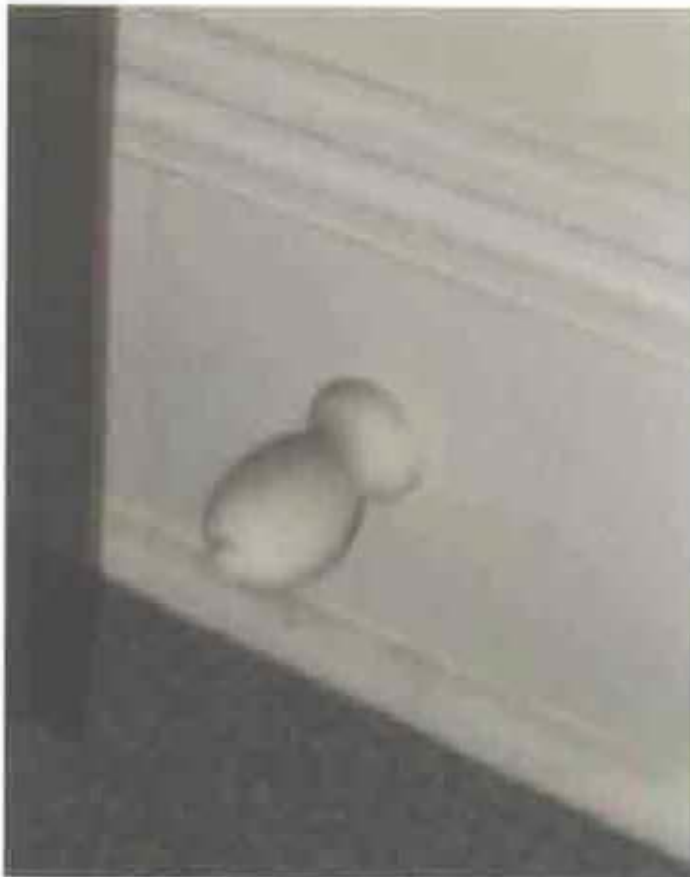
Figure 2.77. Room 302 (Hall), doorstop below speaking-tube fixture.

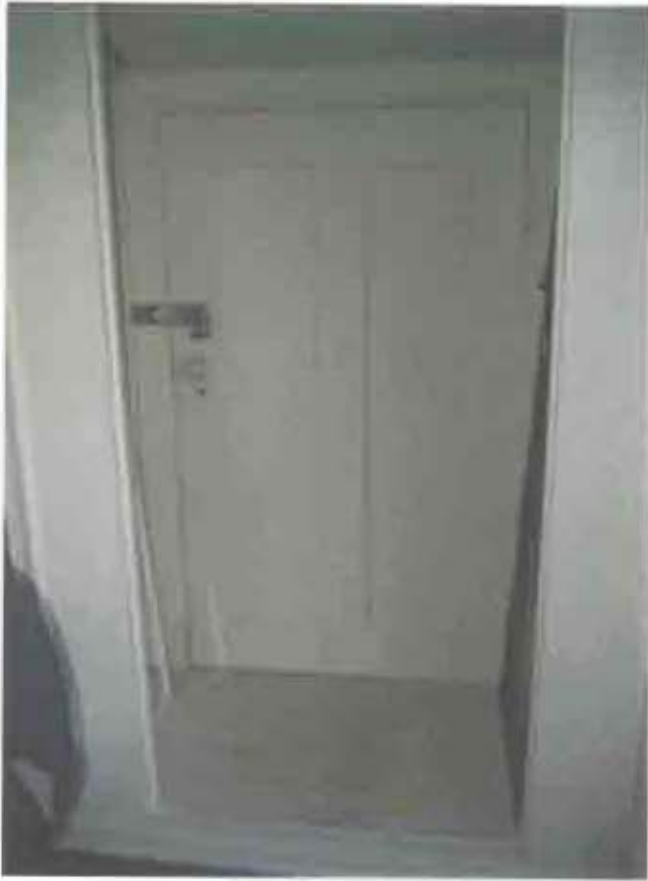
Doorway and window casings are plain boards with mitered corners and molded edges; doorway casings also have plinth blocks. The door to room 305a is a two- panel wood door situated at the back of the northeast closet. (See Figure 2.78.) The door to room 305b is a plywood panel; the doorway's casing is missing.

Figure 2.78. Room 305,
northeast closet containing
doorway to room 305a.

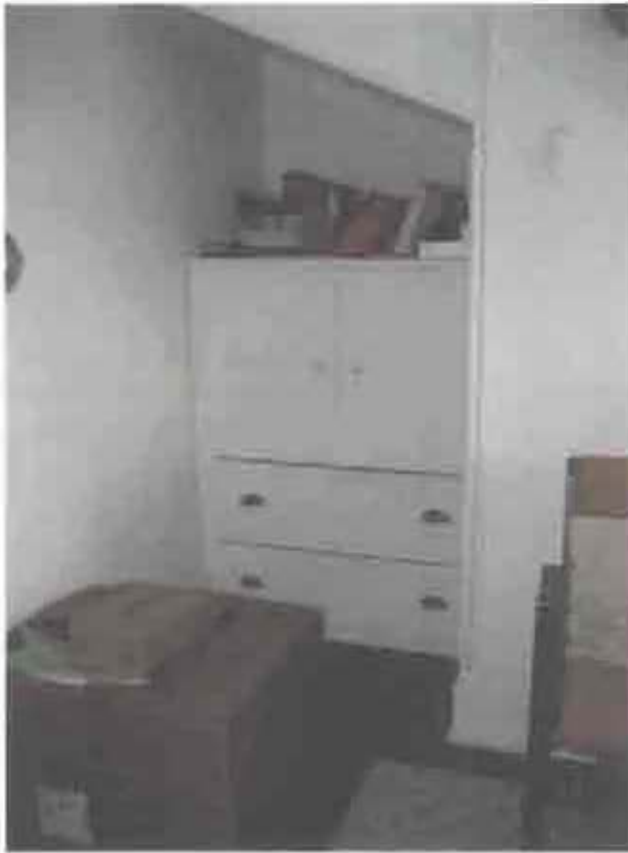
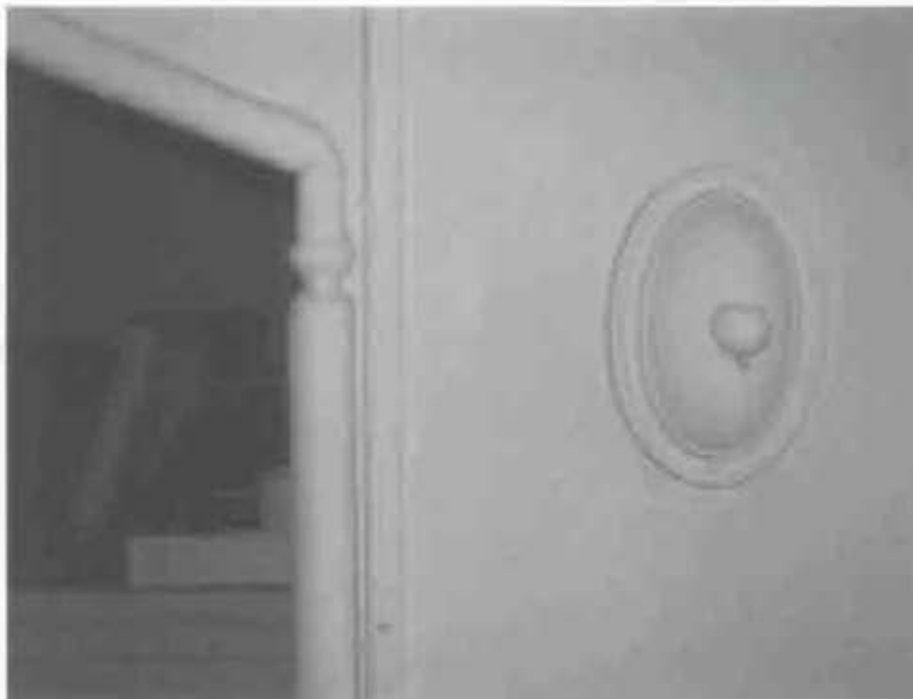
In the northeast corner of the room (anteroom) there is a recess containing a built-in wood cabinet. The edges of this recess are covered by wood corner guards with ornamental turnings. The cabinet front consists of a pair of flush doors and two drawers with metal pulls. The pair of doors probably replaced two additional drawers. To the right of the cabinet (also in the anteroom space) is an oval wall bracket for a light fixture. (See Figures 2.80 and 2.81.)

Figure 2.80. Room 306, recess with built-in wood cabinet.

Figure 2.81. Room 306, wood corner guard on edge of recess, and remnant of light fixture.

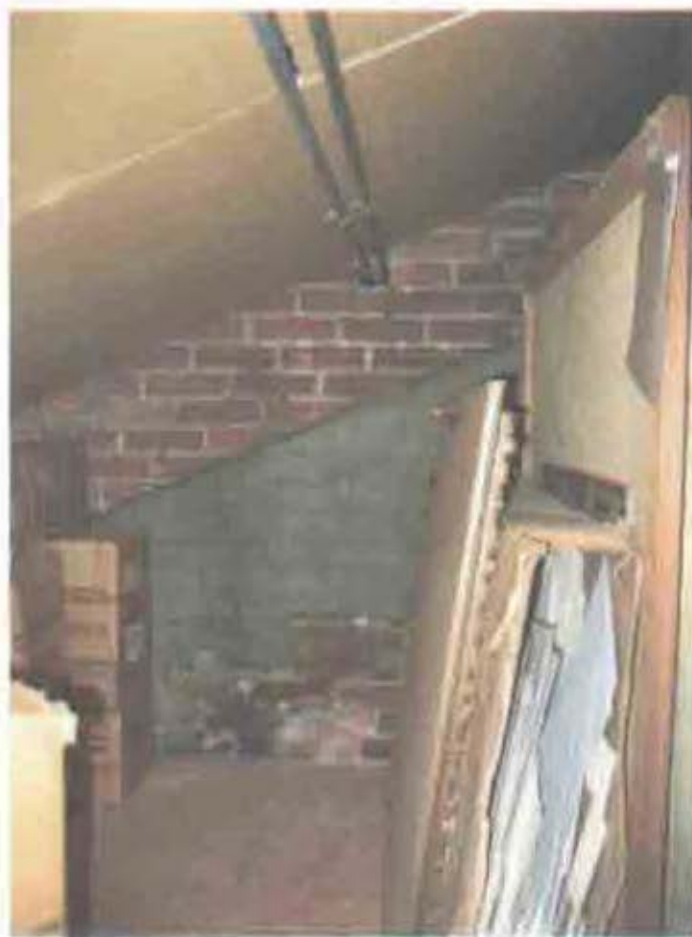
The north and east walls are unfinished frame partitions, revealing the back side of the sawn wood lath and plaster finishes in rooms 302, 302b, and 306. The west wall is the original brick gable end wall. On this wall, remnants of the stepped flashing for the roof of the 1864- 1865 addition survive. Above the flashing are multiple paint coatings that extend up to the line of the former wood frieze, now removed. (See Figure 2.82). The south wall is the 1896 brick gable end wall, which holds an ornamentally leaded lunette window. The arch of this window is formed by two rows of brick headers. The boiler room chimney passes through this room to the roof.

Figure 2.82. Room 307, looking west toward original brick gable end wall, showing roof line of 1864- 1865 addition and paint evidence.
