NAVAL RESEARCH LAB WASHINGTON DC

MAR 81 H H CHASKELIS

NRL-MR-4473

ULTRASONIC INSPECTION OF A GRAPHITE/EPOXY STRUCTURAL MEMBER USING A THICKNESS-IMAGING DEVICE

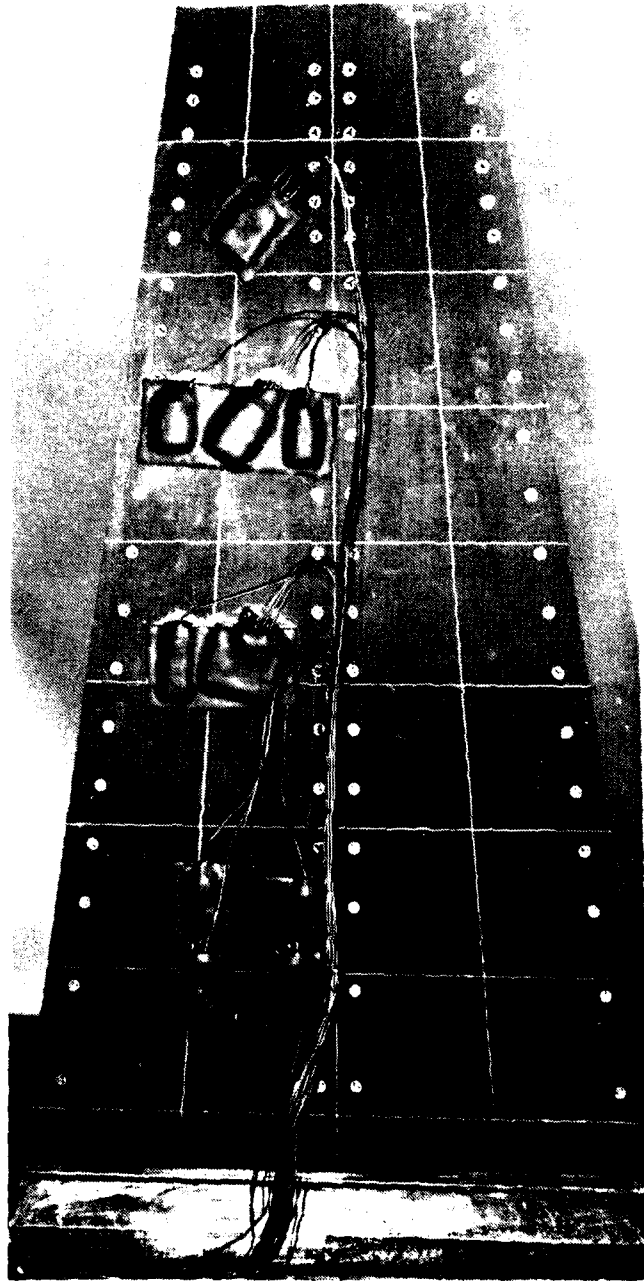
The Box Beam (Figs. 1 and 2) consists of a skeletal steel structure with graphite/epoxy face members, bonded and attached with countersunk bolts. The base is configured so that it may be bolted to the structural test stand. A hole, near the top of the tapered structure, is for attachment of the hydraulic ram used to apply the loads. The composite skin is 12.2 mm thick (0.48 in) constructed by laying up 85 plies, in various orientations, each 0.14 mm thick. Shown in Fig. 3 is a closeup of the scarf-joint region. This is the region where the graphite/epoxy is reduced in thickness and is bonded to the steel member.

Fig 1 - Box Beam, face view

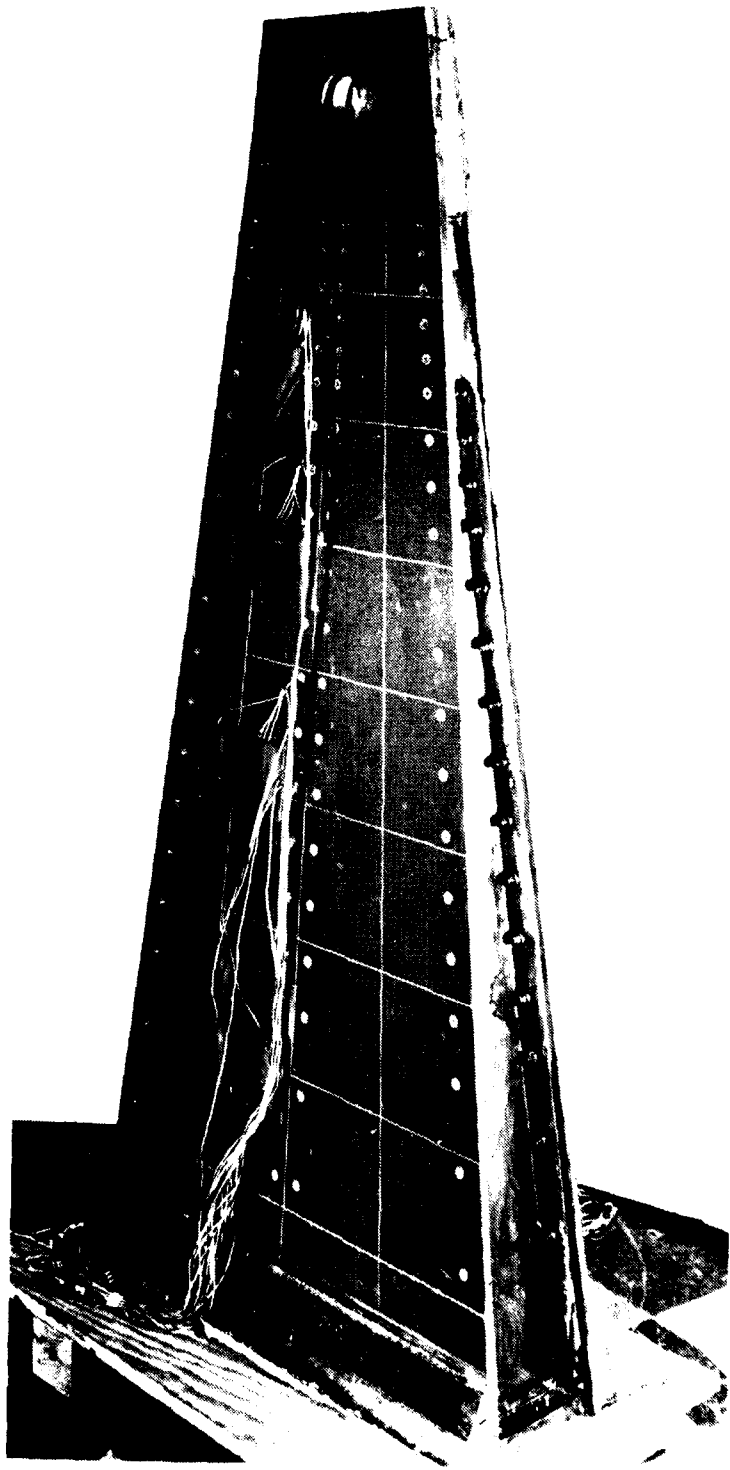
Fig. 2 - Side view of Box Beam

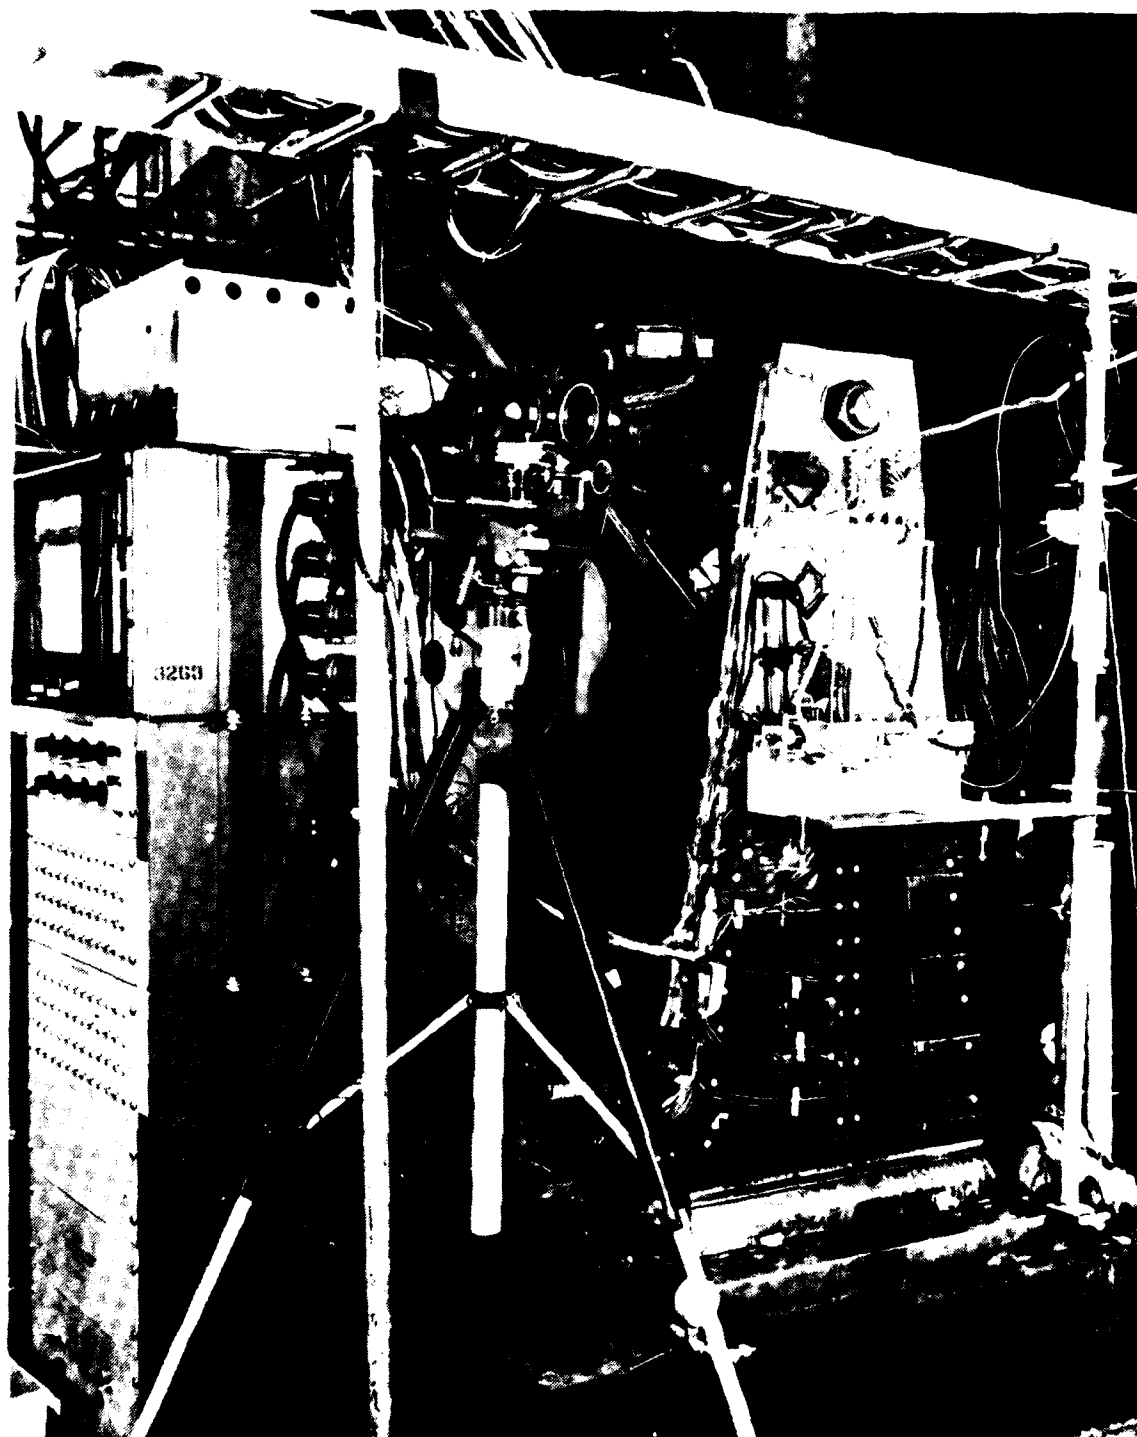
The Box Beam was set-up in the test frame as shown in Fig. 4. A hydraulic ram was attached to the top of the beam, providing the means of applying the required loads. Grid marks drawn and numbered on the graphite/epoxy faces served as site references. Nine areas were selected to be inspected by the SCIMI instrument; shown in Fig. 5. These areas were chosen as a result of the hand scan previously done. Each area had a known delamination. In addition a few problem areas, such as beveled bolt heads and thinning walls at the scarf joint, were included in the scanning sites.

Fig 4 - Box Beam in test frame

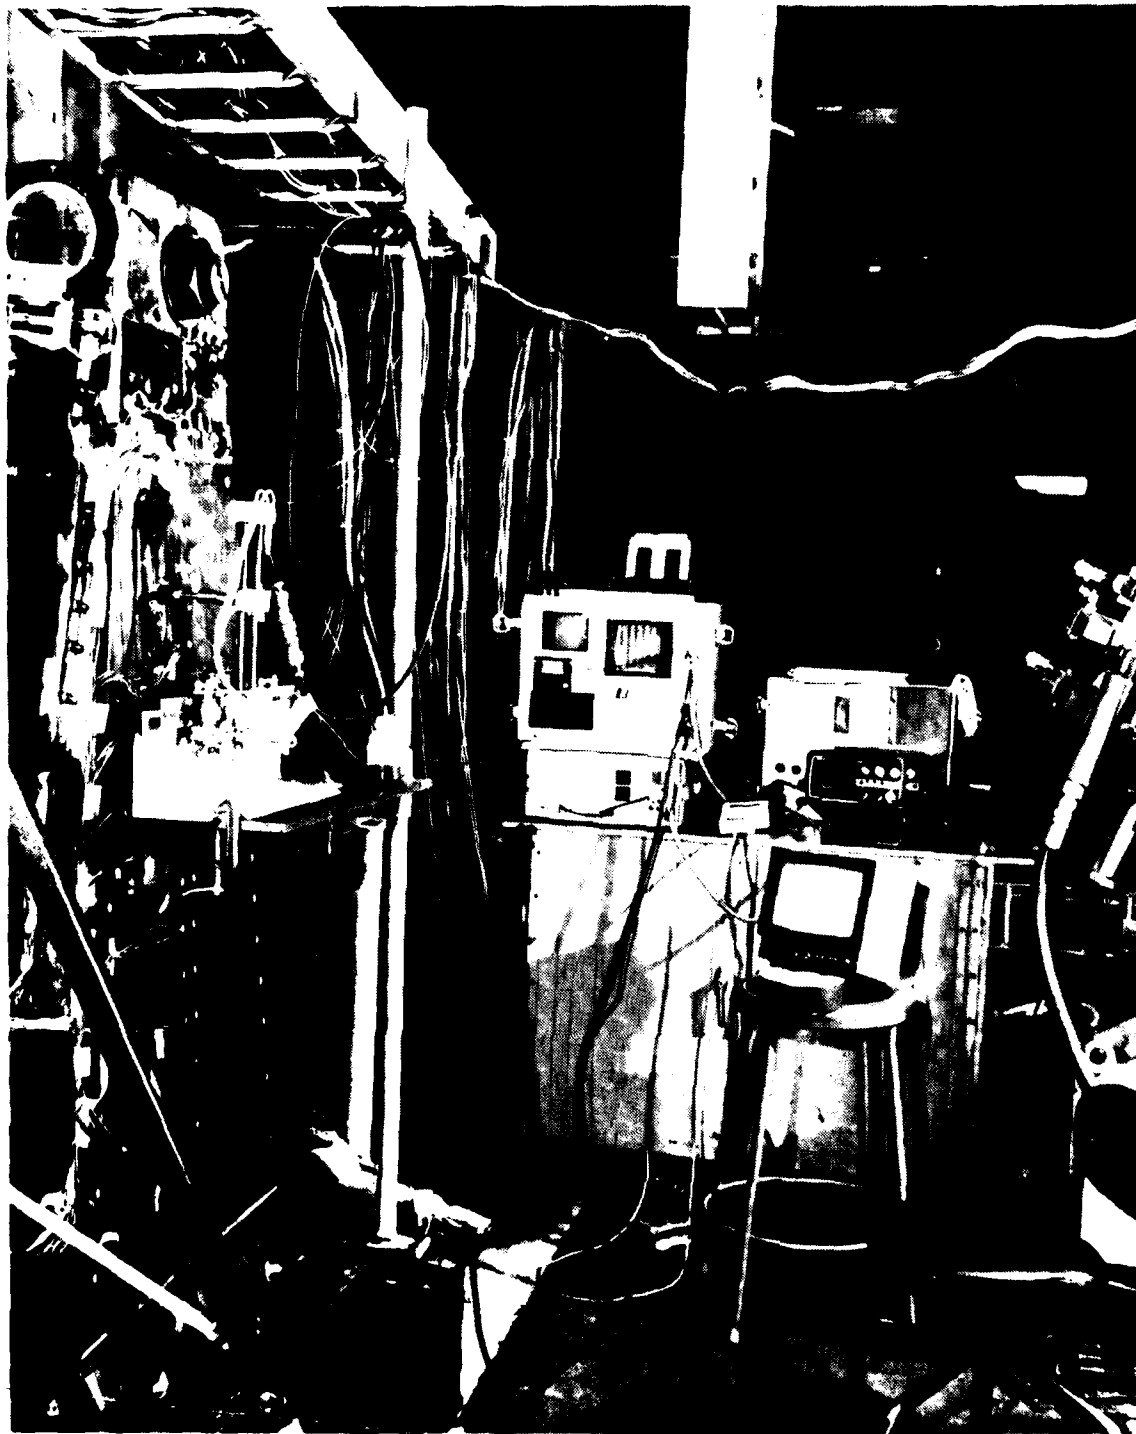
The test set-up of the SCIMI system is shown in Fig. 6. A close-up of the scanner portion is shown in Fig. 7. A total of nine test areas on both the front and back faces of the Box Beam were inspected. The first series of scans provided baseline data. The next two series were taken after the beams were stressed to a low load. No major failures were expected and none were found in the areas selected to be monitored.

Fig 6 - The SCIMI instrument
