DELAWARE RIVER BASIN,
Tributary of Mill Creek, Berks County,
Pennsylvania. Phase I Inspection Report,
SCS PA 476
BERKS COUNTY, PENNSYLVANIA

NDS I.D. NO. PA 00719
DER I.D. NO. 6-456

PHASE I INSPECTION REPORT
NATIONAL DAM INSPECTION PROGRAM

JANUARY 1980

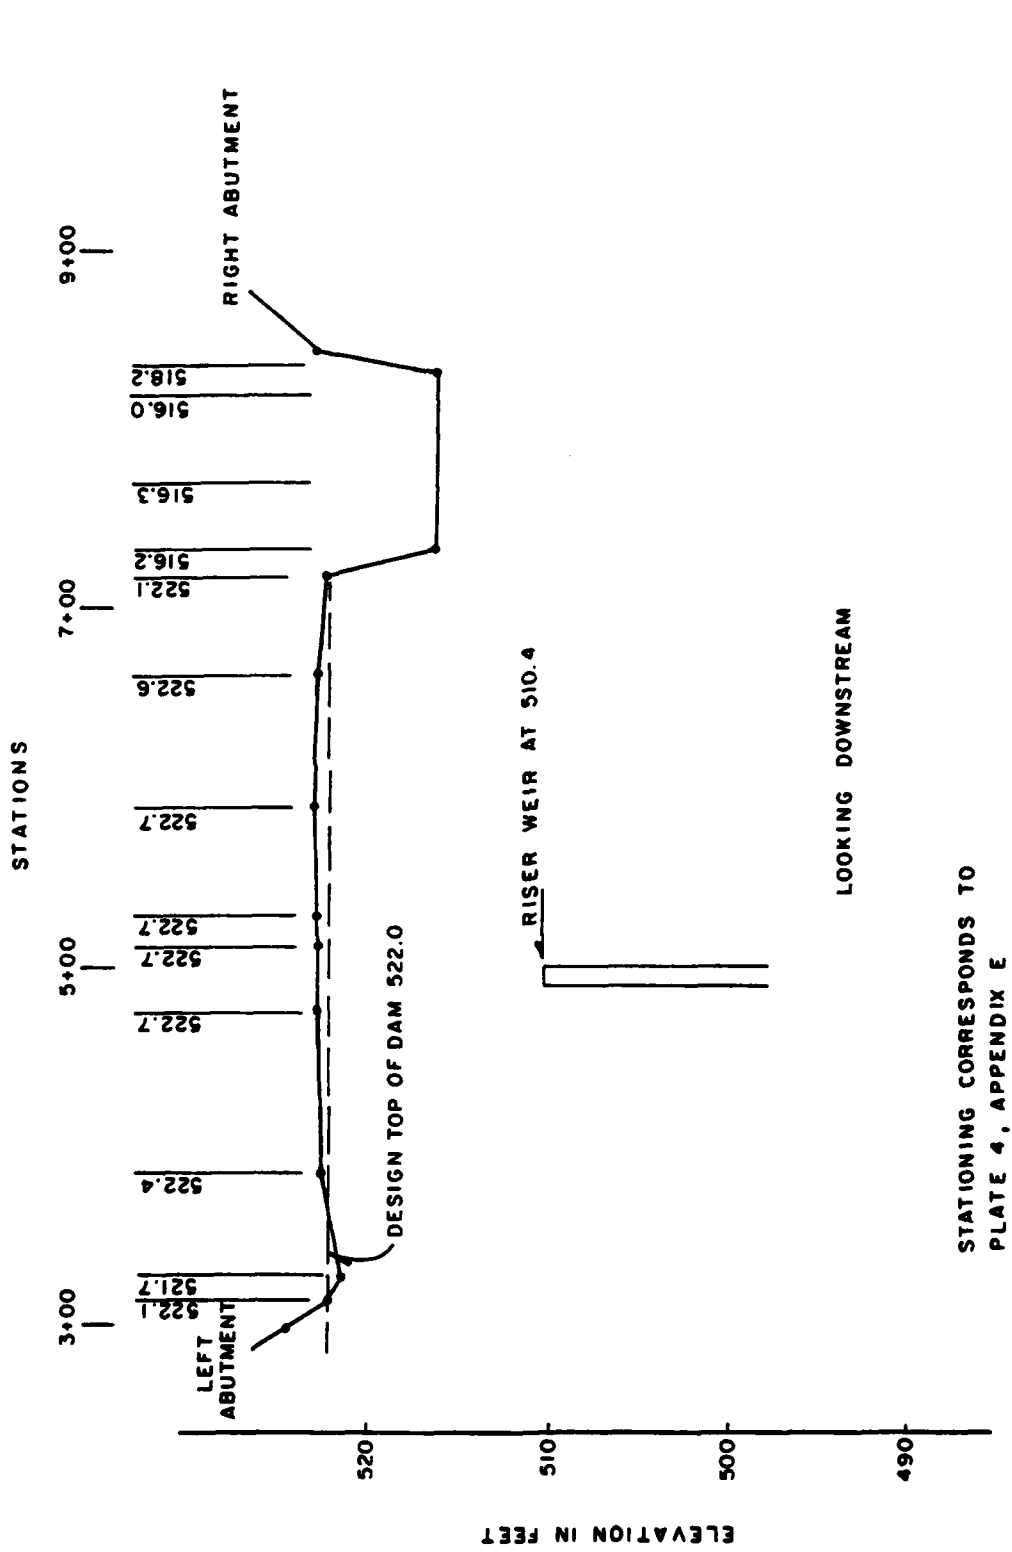
FIELD OBSERVATION PROFILE
SCS PA 476

The vertical alignment was checked and found to be essentially in agreement with the post-construction survey. A low point of about 521.7 was noted near the left abutment. Junctions between the embankment and abutment and the embankment and spillway are judged to be good, with no excessive erosion or deterioration. There was no seepage observed along or beyond the toe of the dam. The embankment drains outlet through the impact basin wall. A small amount of clear water was flowing from the left drain. It is to be noted that there was a limited head of water behind the embankment at the time of the inspection.
