US Army Corps
of Engineers
Seattle District

Construction Foundation Report

Mud Mountain Dam Seepage Control Cutoff Wall

CONSTRUCTION FOUNDATION REPORT
 SEEPAGE CONTROL WALL
 CONTRACT NO. DACW67-83-C-0047

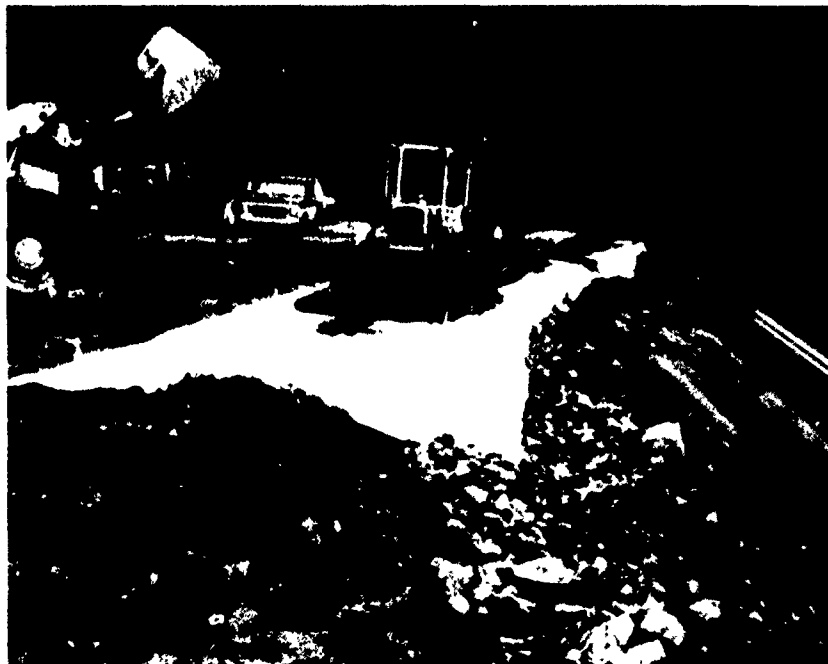
Geotextile placement on lowered dam work platform. 6" of base course material over fabric.

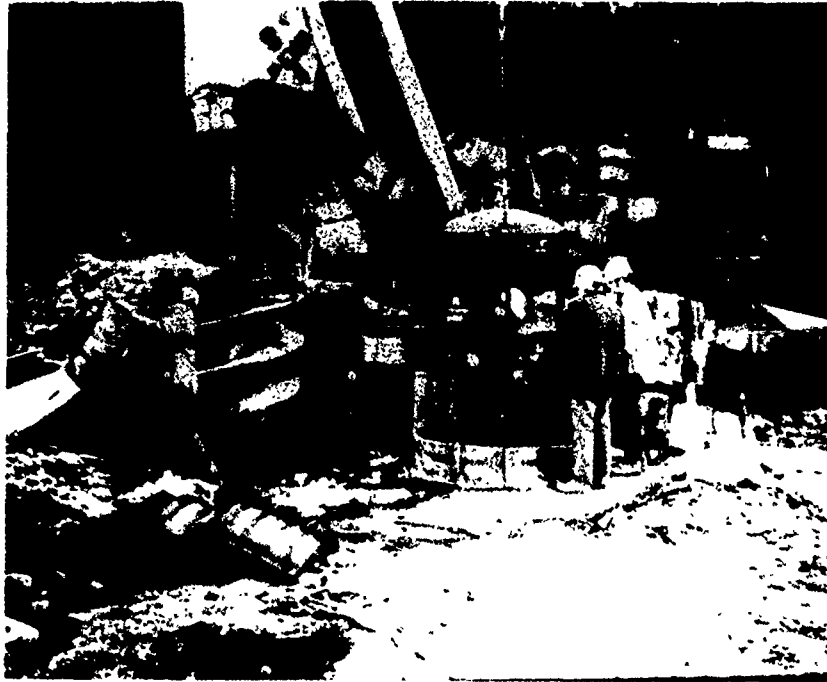
Inspector being lowered into access shaft with a man basket. Note liner plates, left.

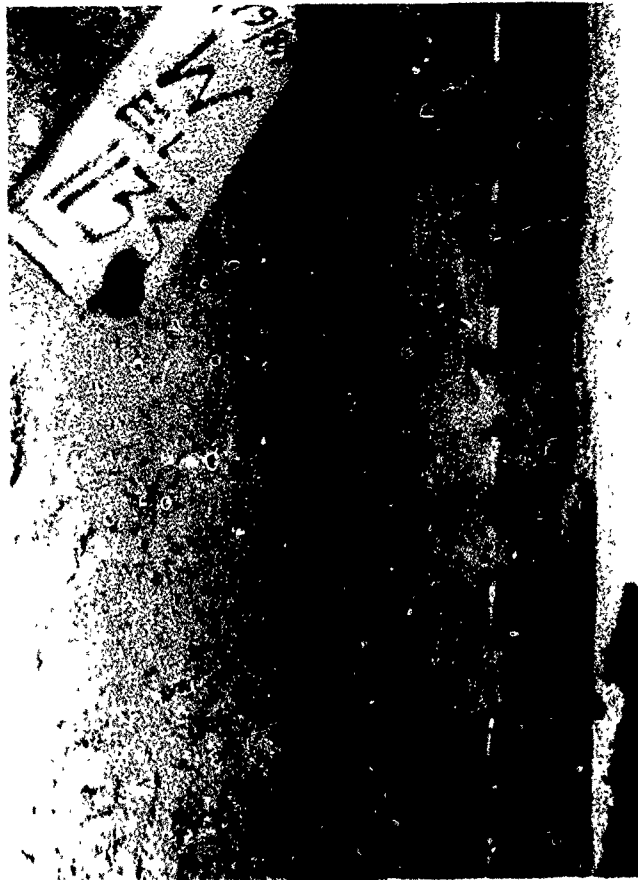
F-50 6" casing in access shaft @ 107 ft. depth. Note perforations did not penetrate casing.

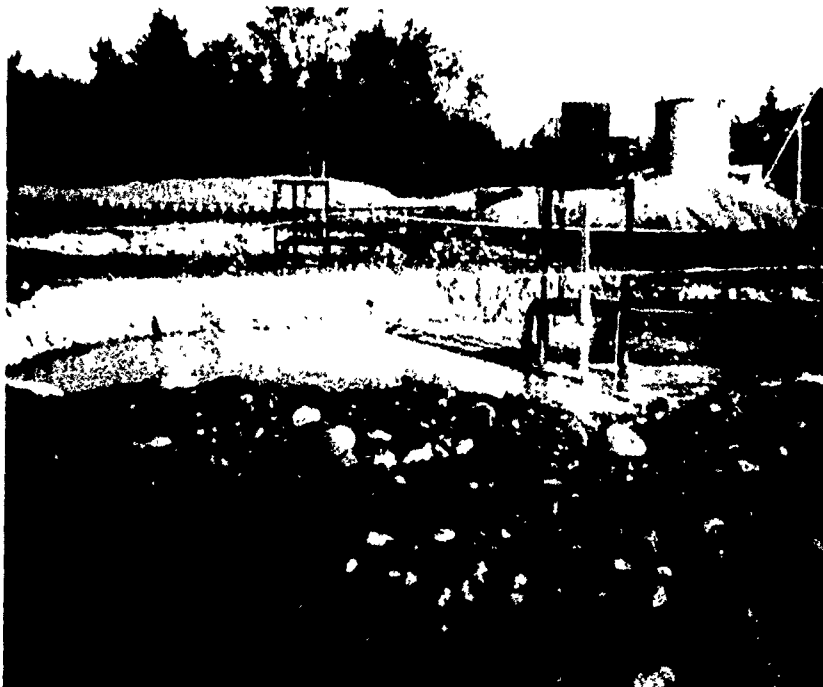
One of four bentonite slurry ponds. Note central pump and agitator. Concrete plant in background.

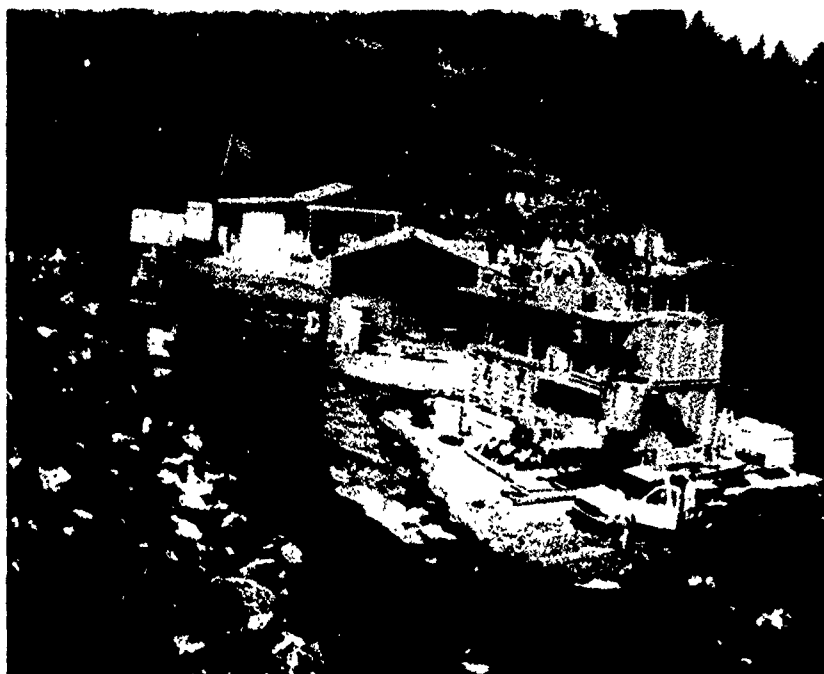
Looking at right side of spillway invert.
Desander (Caviem) at right, welding shop in
middle and machine/parts shop in background.
Note spillway access road at left.

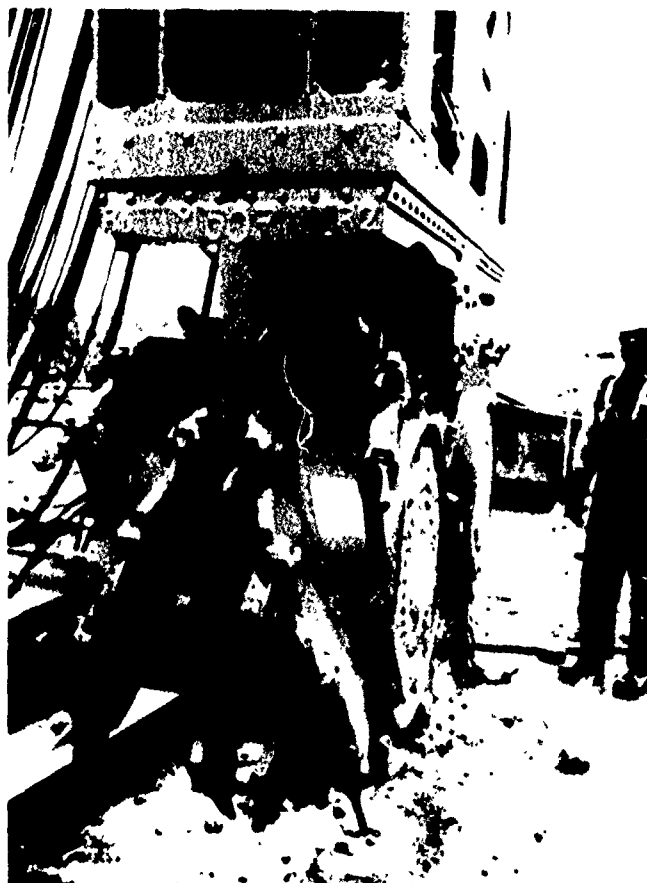
Business end of Hydrofraise. Finishing a "pic"
(tooth) change and ready to go back into panel
(left). Note the guide frame on top of wall.

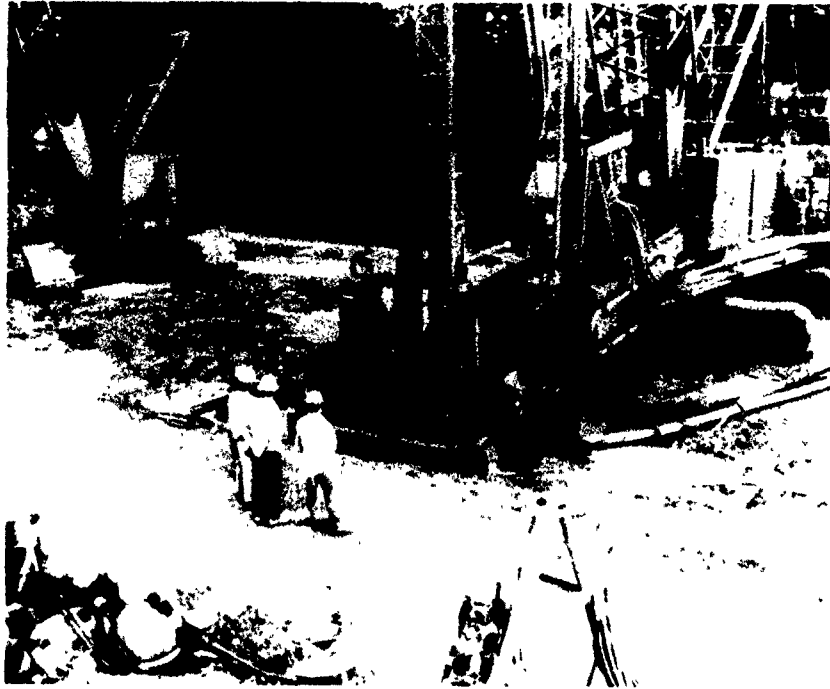
Hydrofraise excavating Type I panel in left back. Looking down stream. Top portion of hydrofraise frame is visible. Cutter heads at 75 ft. depth . Note guide frame on top of wall.

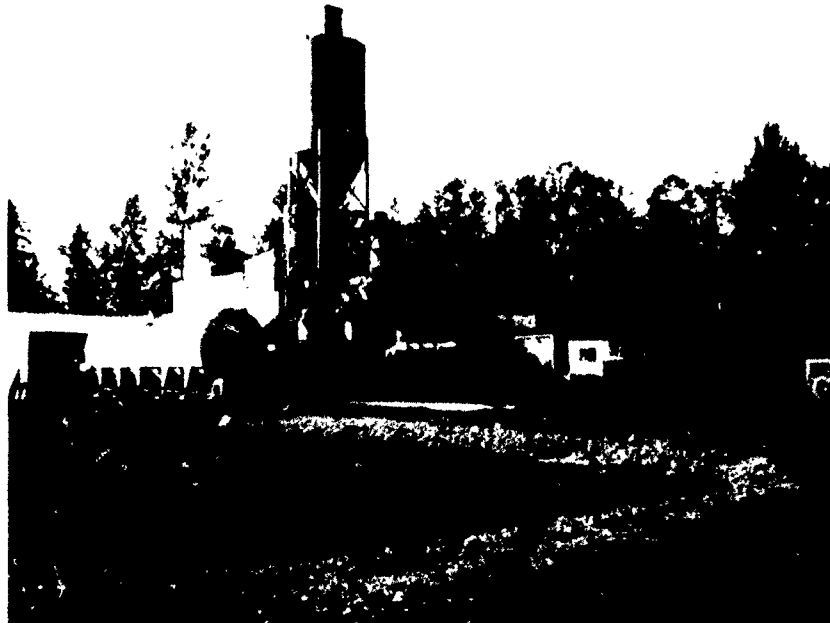
Batch plant with 115 tons cement silo, 100 tons pozzolan silo, and 175 tons storage guppy.

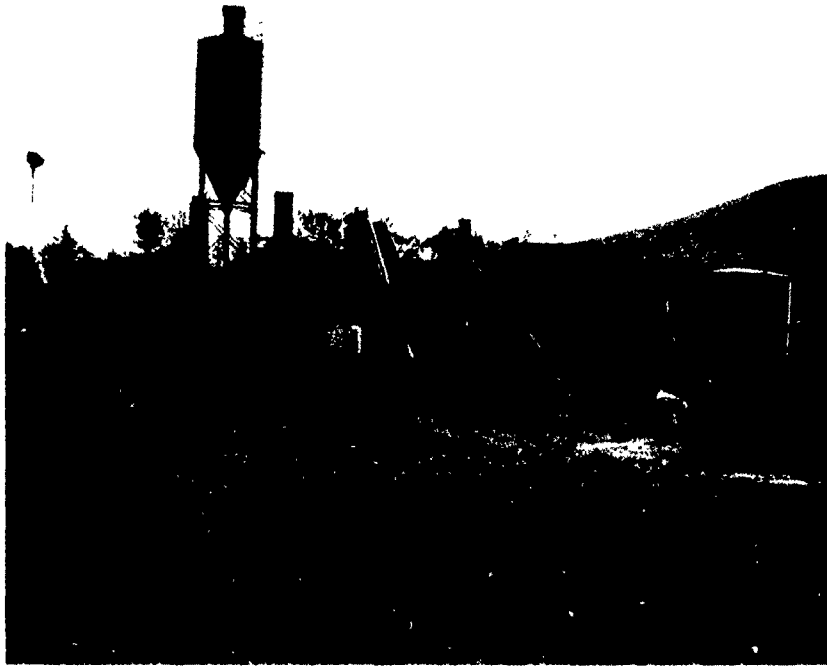
30-inch wide conveyors. Sand conveyor on the left and the coarse aggregate conveyor on the right. The contractor quality control laboratory is the building on the far left.

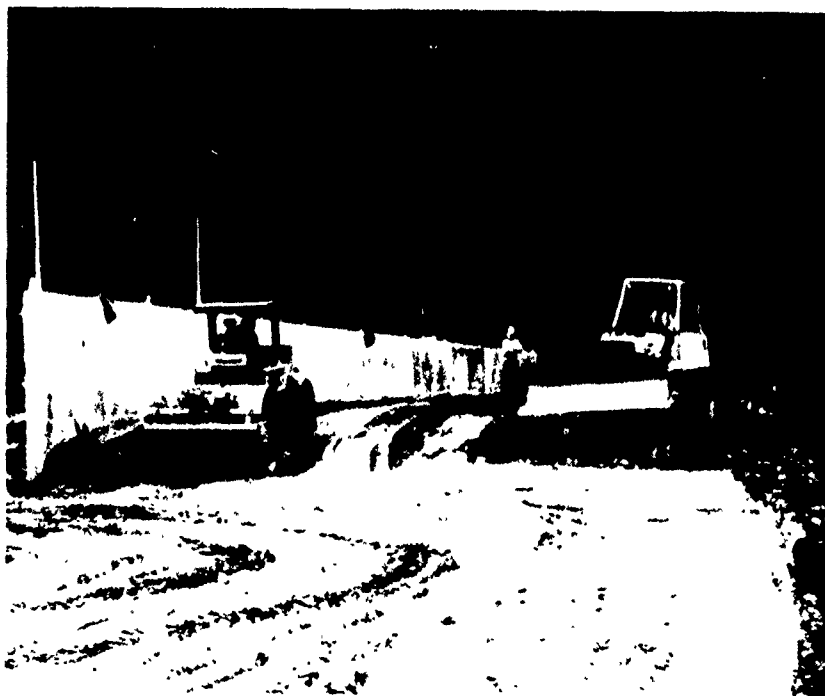
Backfill and compaction during dam raising. This strip either side of CIP wall was compacted with hand-operated tamper.
