PB99-910401
NTSB/AAR-99/01
DCA94MA076

AIRCRAFT ACCIDENT REPORT

UNCONTROLLED DESCENT AND COLLISION WITH TERRAIN
USAIR FLIGHT 427
BOEING 737-300, N513AU
NEAR ALIQUIPPA, PENNSYLVANIA
SEPTEMBER 8, 1994

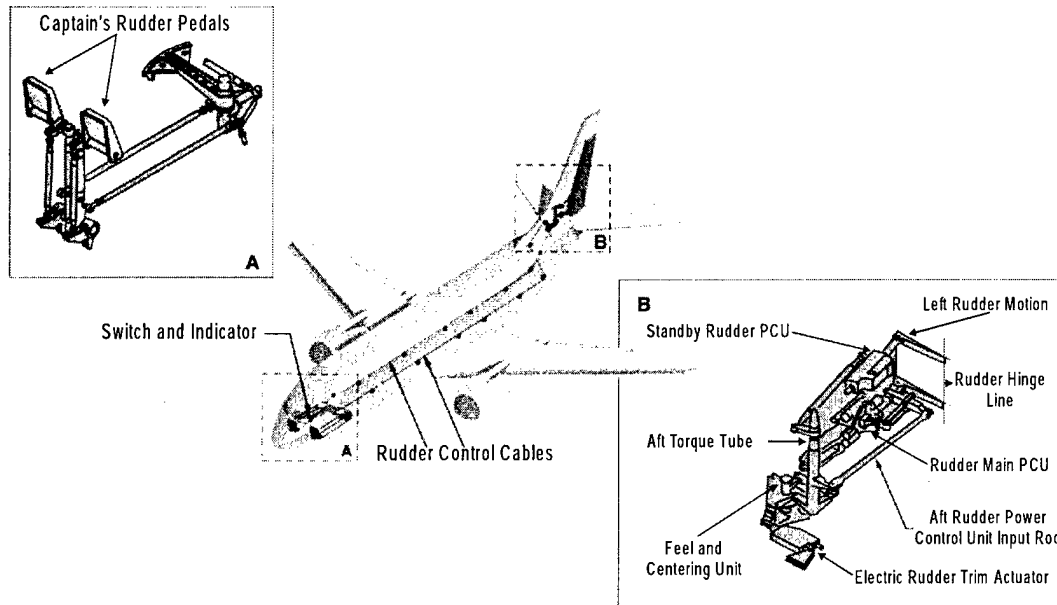
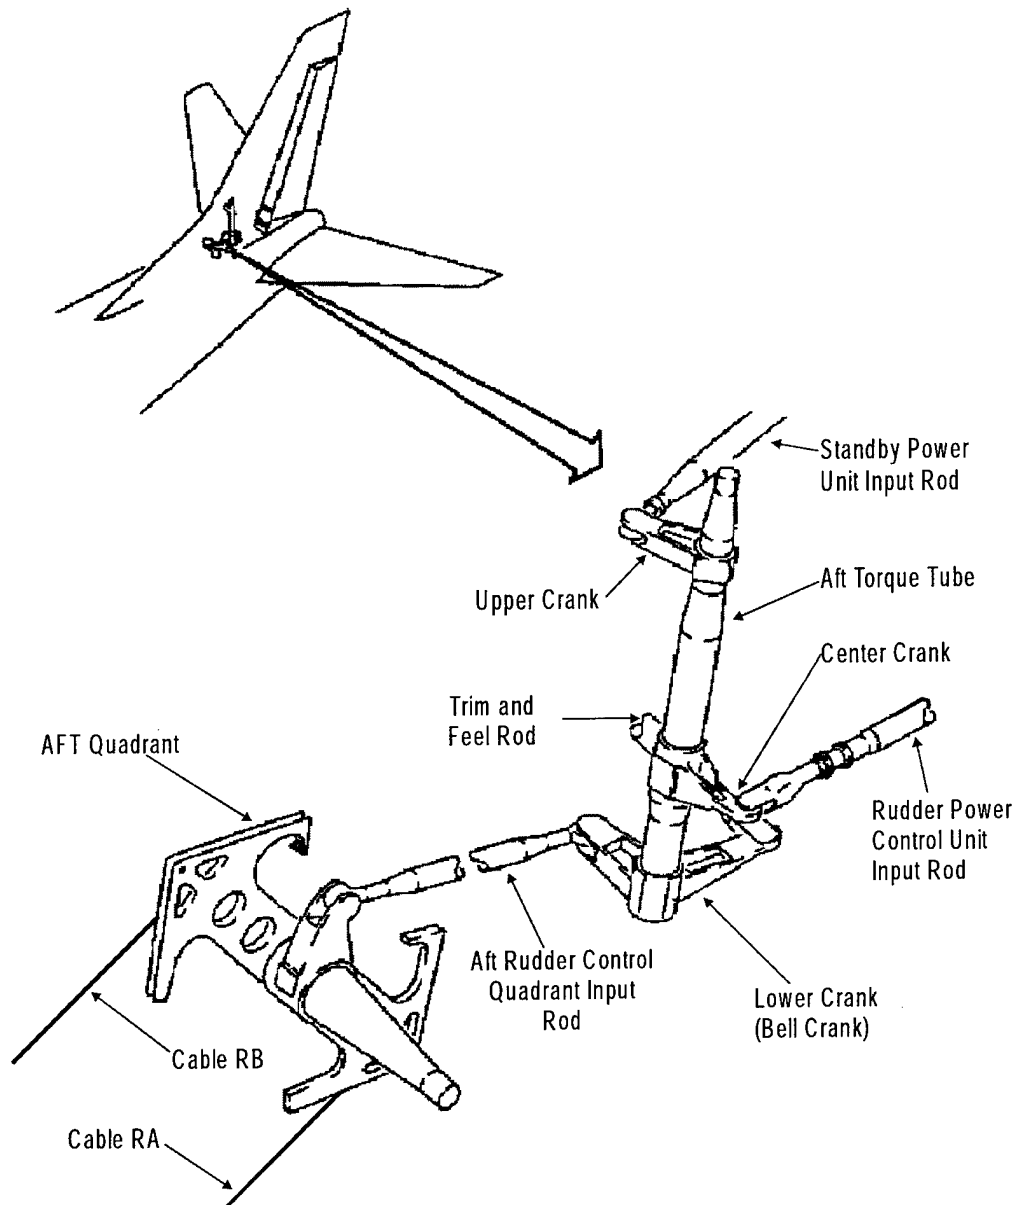
Figure 6. Boeing 737 rudder system.

The aft rudder control quadrant was found attached to its mounting bracket and separated from the vertical stabilizer. The aft rudder control quadrant input rod, the main rudder PCU input rod, and the lower end of the rudder torque tube (see figures 6 and 6a) were fractured, and the cable attach points were separated from the quadrant on each end. The upper portion of the tower shaft was located at the vertical fin with the main and standby rudder PCUs attached. The input rod for the standby PCU remained attached with no signs of damage or binding.

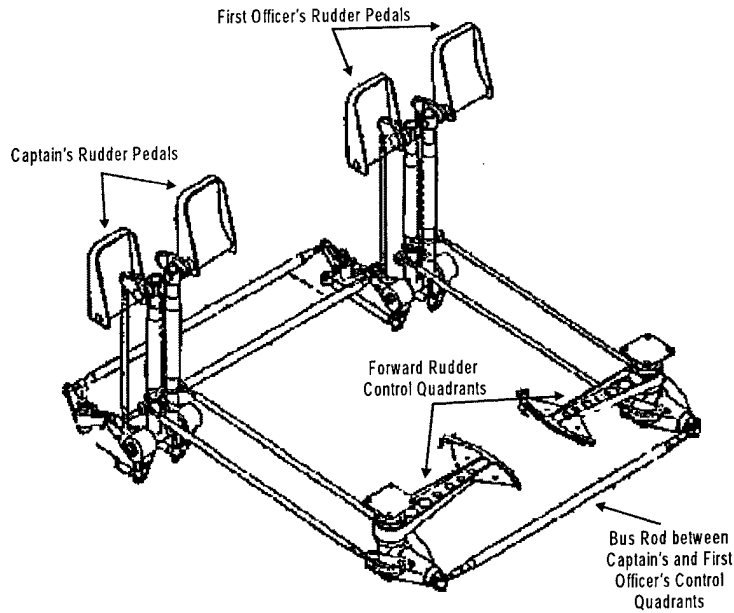
Figure 12. Rudder pedal assemblies as installed on the USAir flight 427 airplane.

The accident airplane's rudder pedal assemblies from both flight crew positions were removed from the wreckage. Both rudder pedal assemblies were fragmented and heavily distorted. The rudder pedal assembly from the first officer's position exhibited postimpact fire damage. The left rudder pedal pivot lugs on both rudder pedal assemblies were fractured near their respective support tubes.¹²⁶ Figure 12 shows a diagram of the rudder pedal assemblies as installed on the accident airplane.

direction. The right rudder pedal pivot lugs on both assemblies were bent but remained attached to their support tubes. With the support tubes positioned vertically, the right rudder pedal pivot lug at the captain's position was bent forward and downward, but the right rudder pedal pivot lug at the first officer's position was bent forward and upward.

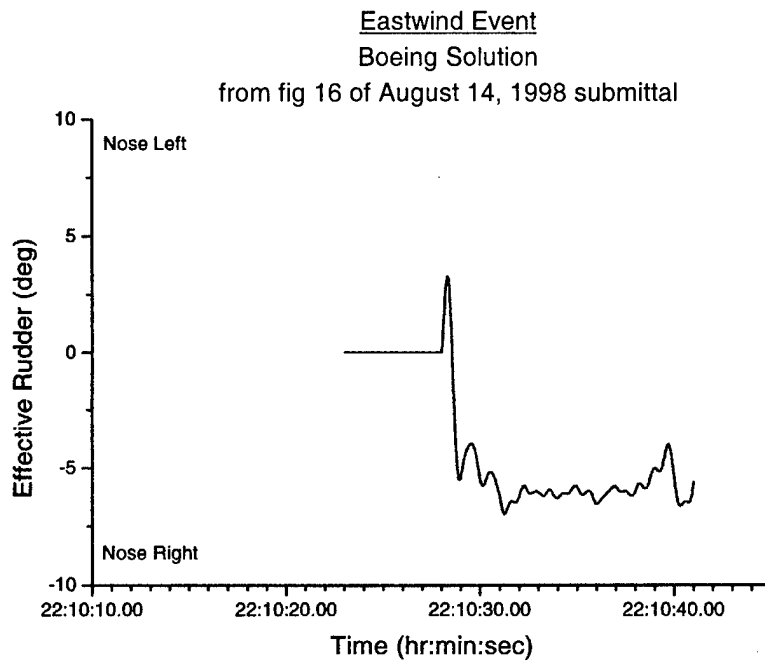
Figure 28a. Eastwind flight 517 rudder positions according to Boeing's scenario.

Figure 28a presents the rudder time history that resulted from Boeing's kinematic analysis of scenario 4. The heading time history that Boeing derived from its kinematically developed rudder (uncorrected for what Boeing has determined to be a simulator heading error) and used in its computer simulations is shown in figure 28b. Figure 28c shows the average flight test heading error, and 28d presents the "error corrected" heading time history compared with the FDR heading data.

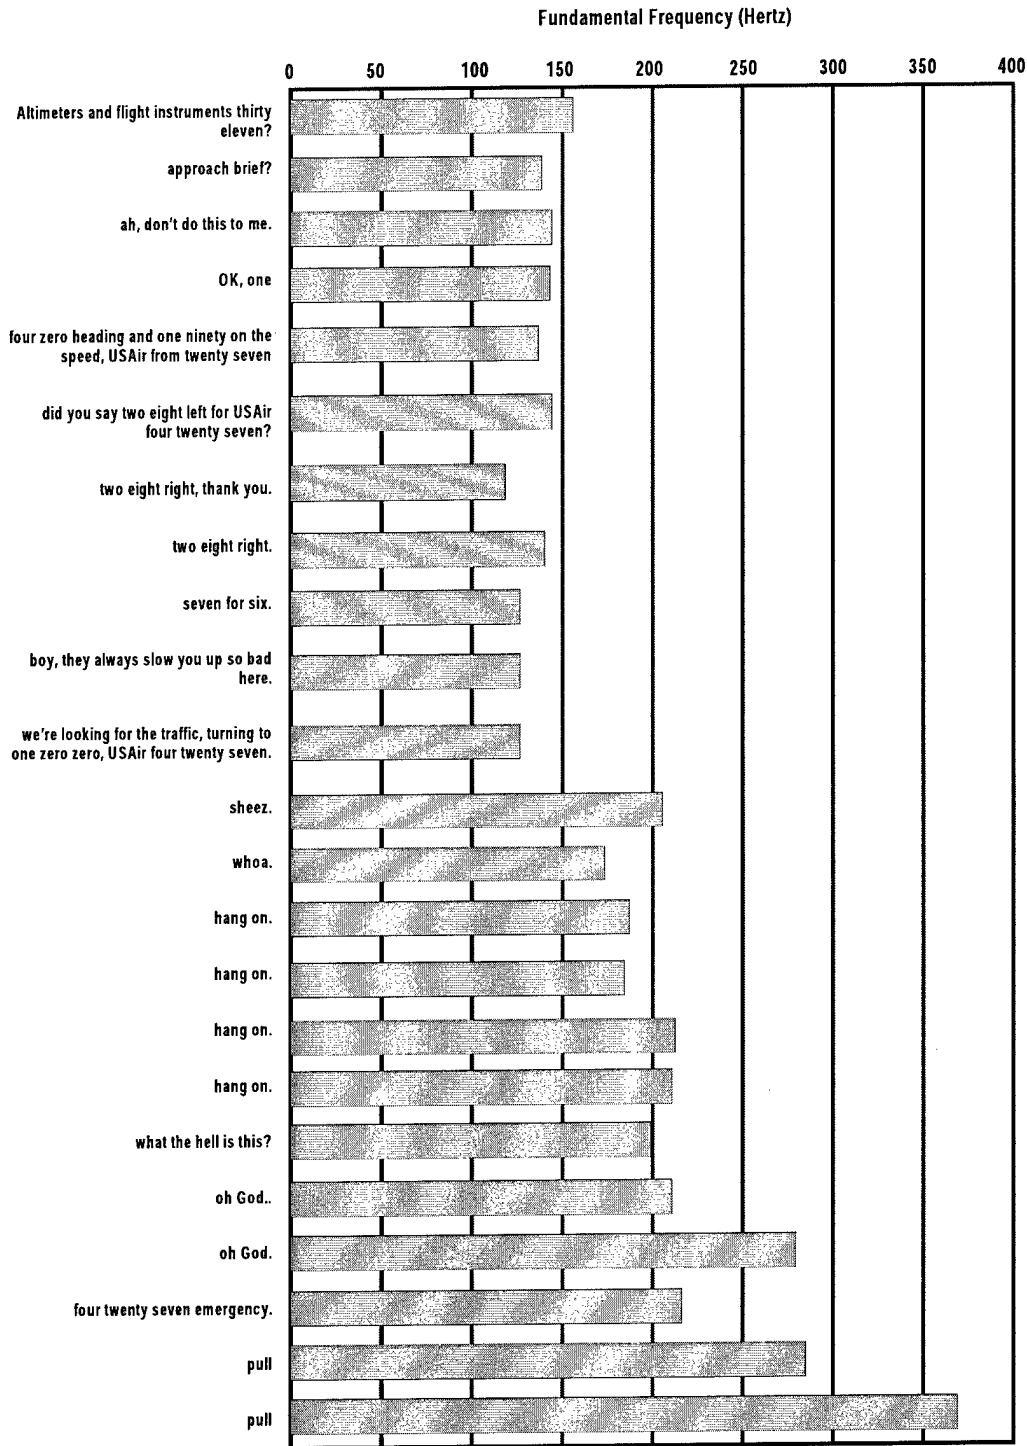
Figure 29. Fundamental frequency measures of the USAir flight 427 captain's speech.

The Safety Board reviewed the USAir flight 427 CVR for pilot speech samples appropriate for computer speech analysis. The Safety Board observed that the captain spoke the airplane's call sign, "four twenty seven," during routine and emergency radio transmissions, providing a basis for direct comparison using the same words. When the captain spoke the phrase "four twenty seven" during routine flight operations, the average fundamental frequency value was 144.6 Hz. However, when the captain stated four twenty seven about 1903:15 during the emergency descent, the speech fundamental frequency increased 47 percent, to 214 Hz. Figure 29 graphs the fundamental frequency measures obtained for the captain's statements before and during the upset period, showing changes in the fundamental frequency of his speech as the emergency situation developed.²¹⁰ Figure 30 graphs the amplitude measures obtained for the same statements. According to scientific literature,²¹¹ fundamental frequency, amplitude, and speaking rate tend to increase in response to increased psychological stress.

²¹⁰ Only those statements that were free of artifacts caused by background conversation or other sounds appear on this graph and the one in figure 30. Of the three measured aspects of the captain's speech, fundamental frequency provided the most measurable data. Missing data precluded similar measurements of the captain's speech rate or amplitude.

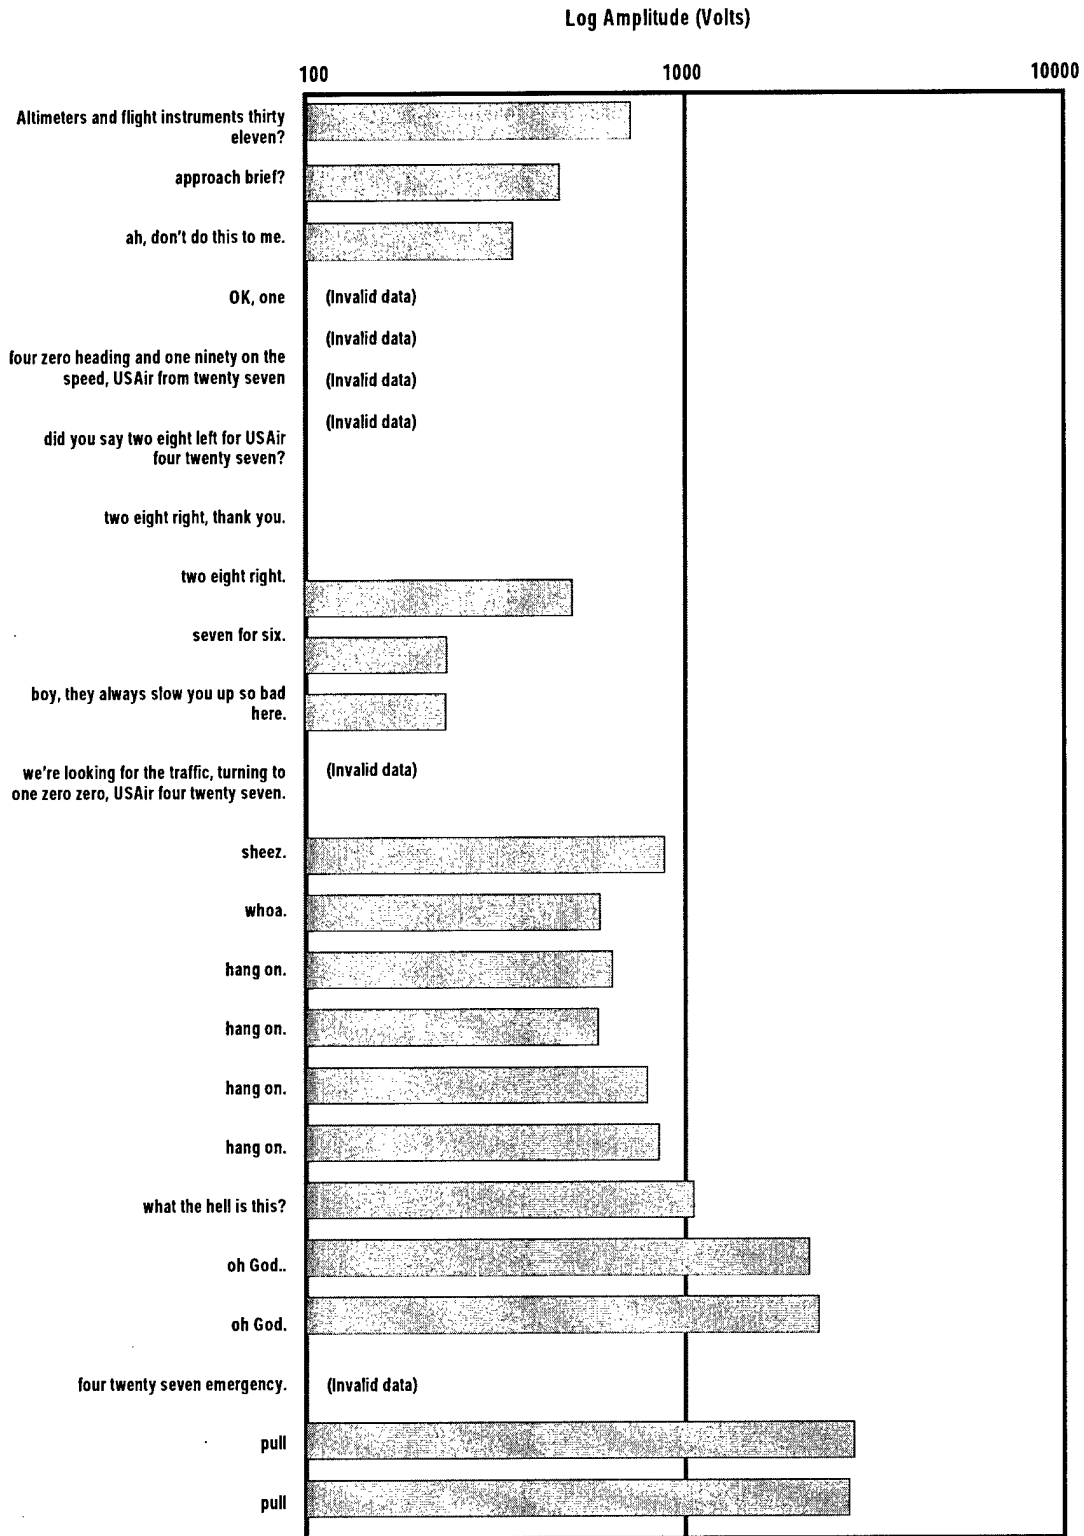
Figure 30. Amplitude measures for the USAir flight 427 captain's speech.

²¹² Amplitude is often measured in decibels, a logarithmic scale determined relative to an internationally accepted calibration standard. Because no calibration standard was available in the CVR recording, amplitude was measured in volts (the direct measure of physical intensity) and plotted on a logarithmic scale for convenience.
