NATIONAL TRANSPORTATION SAFETY BOARD

SAFETY STUDY

Emergency Evacuation
of Commercial Airplanes

**NTSB/SS-00/01
PB2000-917002
Notation 7266
Adopted June 27, 2000**

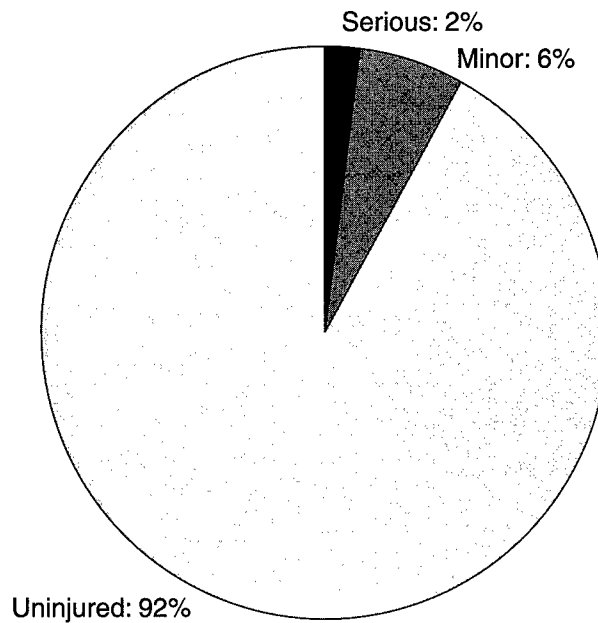
The Safety Board obtained information on passenger injuries from two sources during the study. First, information provided by the air carrier during the basic investigations included injury information. Second, for the detailed investigations, the Safety Board also obtained injury information from passenger questionnaires. In the 46 study cases, 92 percent (2,614) of the 2,846 occupants on board were uninjured, 6 percent (170) sustained minor injuries, and 2 percent (62) sustained serious injuries (figure 3-1).

Figure 3-1. Percent of crew and passengers who sustained serious or minor injuries in the 46 study cases.

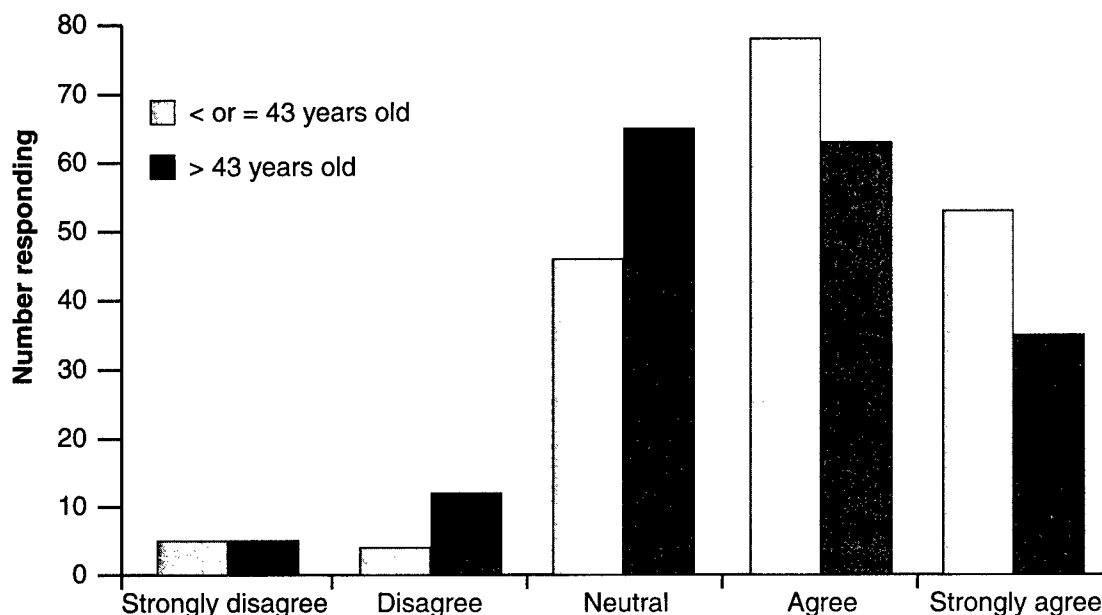
Figure 3–2. Passenger agreement with the statement that their physical condition assisted their evacuation.

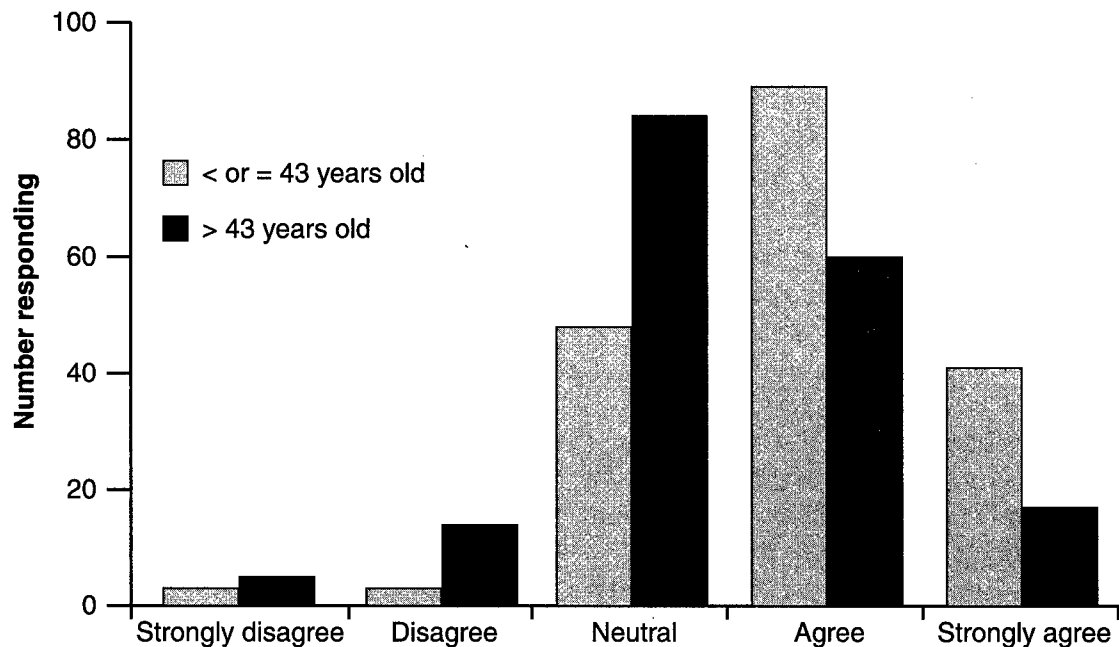
tended to disagree with statements that indicated their age assisted them (figure 3–3). Overall, older passengers were no more likely to sustain an injury, but they perceived their condition and age to hinder their evacuation.

Figure 3-3. Passenger agreement with the statements that their age assisted their evacuation.

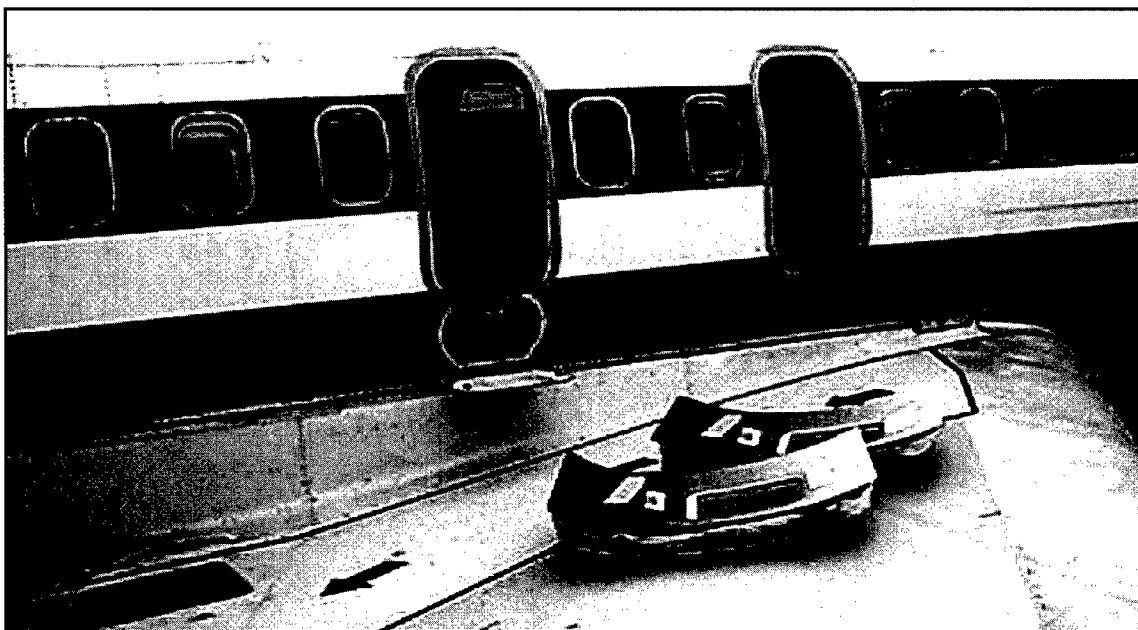
Regulations for emergency exits are contained in 14 CFR 25.807. The exits range from the largest, a “Type A” (a floor level exit door with dimensions of at least 42 inches wide and 72 inches high), to the smallest, a “Type IV” (an overwing exit with dimensions of at least 19 inches wide and 26 inches high). Figure 5–1 shows “Type III” exits (an exit, typically overwing, with dimensions of at least 20 inches wide and 36 inches high). The cases in the evacuation study included a variety of the exit types.⁴⁷

Figure 5–1. Type III exits.

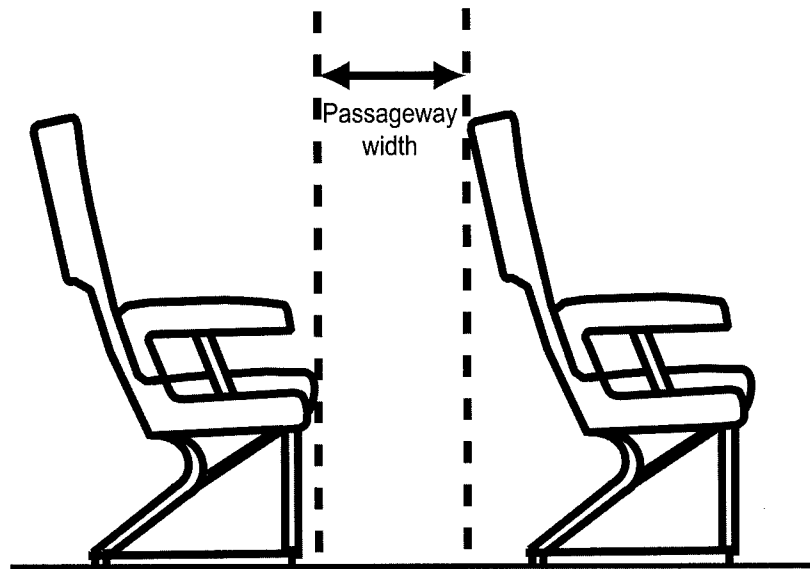
In 1989, CAMI conducted evacuation trials to examine the effects of exit path width—the distance between the forward-most point on an exit row seat and the aft-most point on the seat directly in front of it (figure 5–2)—on the evacuation rate at Type III overwing exits.⁴⁹ Participants were required to evacuate through a Type III exit or open a Type III exit hatch using four different seating conditions: a 6-inch unobstructed passageway, a 10-inch unobstructed passageway, a 20-inch passageway with 5 inches of the seat encroaching on the exit, and a central seat placement with the outboard seat removed. The researchers reported that egress times were quicker for the seating conditions using the 20-inch passageway and the outboard seat removed than were egress times using the 6-inch passageway. However, the various exit widths did not affect exit hatch removal time. As a result of these CAMI trials and the 1991 accident in Los Angeles (described in chapter 1 of this report), the FAA issued a notice of proposed rulemaking (NPRM) that required air carriers to increase the exit path width in exit rows from 6 inches to 20 inches. The Safety Board commented in support of this proposed rule change in a letter dated October 8, 1991.

Figure 5-2. Type III exit row passageway width.

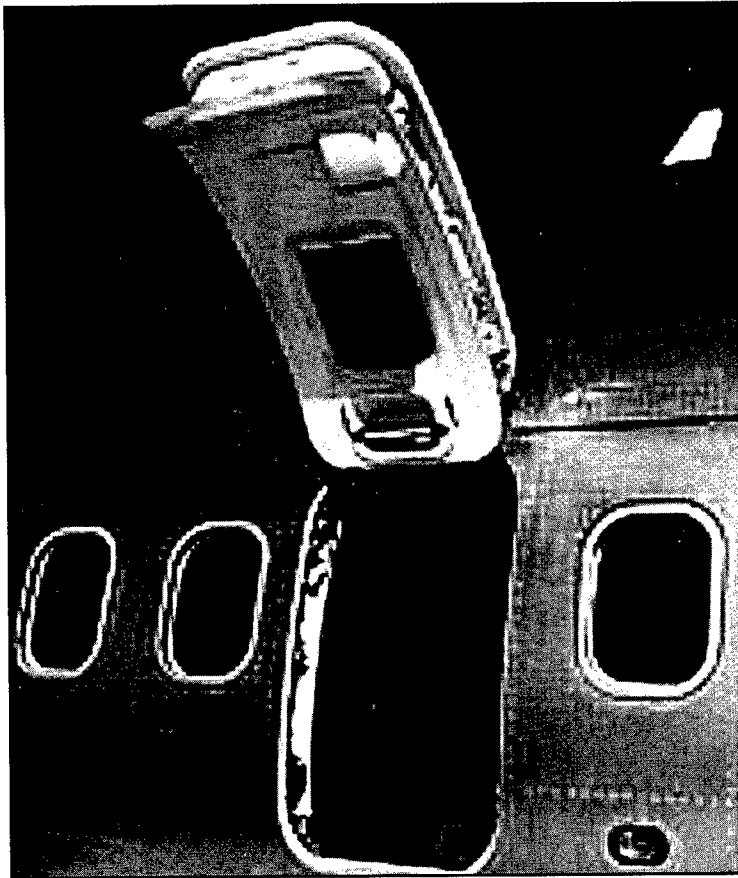
As case 16 (a 727 in Chicago) illustrated, the weight of the overwing exit hatch has also been a problem for some passengers. One air carrier acknowledges on its safety briefing card for an airplane type with Type III overwing exits the weight and awkwardness of this type of exit. The safety briefing card states in the introduction to the exit row seating requirements that "emergency exits are often heavy, awkward to lift, push, pull, and maneuver when opening. Because of this and for the safety of all passengers, Federal law requires that we only seat qualified passengers next to exits." Further, it is not intuitively obvious that after pulling the latch, the hatch is to be turned and either placed on the exit row seats or thrown out the opening. The opening and maneuvering of this exit is also difficult to display graphically. The Safety Board concludes that passengers continue to have problems opening overwing exits and stowing the hatch. The manner in which the exit is opened and the hatch is stowed is not intuitively obvious to passengers nor is it easily depicted graphically. Boeing has designed a new overwing exit for its 737 series airplanes based on human factors principles.⁶¹ The exit is hinged and opens outward as passengers would intuitively expect (figure 5-6). This design also eliminates the problem of where to stow the exit hatch because it moves up and out of the egress route. In short, the design eliminates any guesswork about how the exit operates or what to do with the exit hatch once it is opened. The Safety Board believes the FAA should require Type III overwing exits on newly manufactured aircraft to be easy and intuitive to open and have automatic hatch stowage out of the egress path.

Figure 5-6. View of the newly designed Type III exit for the Boeing 737-600, -700, -800, -900.

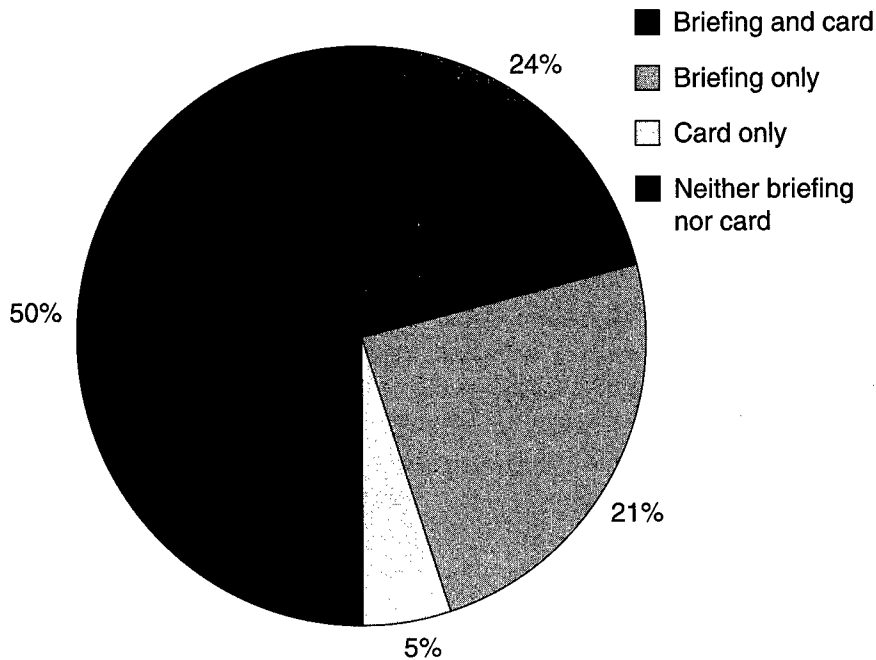
Some of the air carriers make a point to individually brief passengers on the exit row tasks. In the six study cases for which the Safety Board received overwing exit operation information, 9 of the 42 exit row passengers reported receiving such a briefing (figure 5-7). Four of these passengers reported examining their safety card. Twenty-four passengers reported receiving no briefing, and only two of these passengers had examined their briefing card. The two briefed passengers who opened overwing exits reported no difficulties. Four passengers who did not receive a briefing opened overwing exits. Two of these passengers reported no difficulty with the exit whereas the other two reported difficulties with their exit.

Figure 5-7. Percentage of exit row passengers who indicated whether or not they paid attention to safety information.

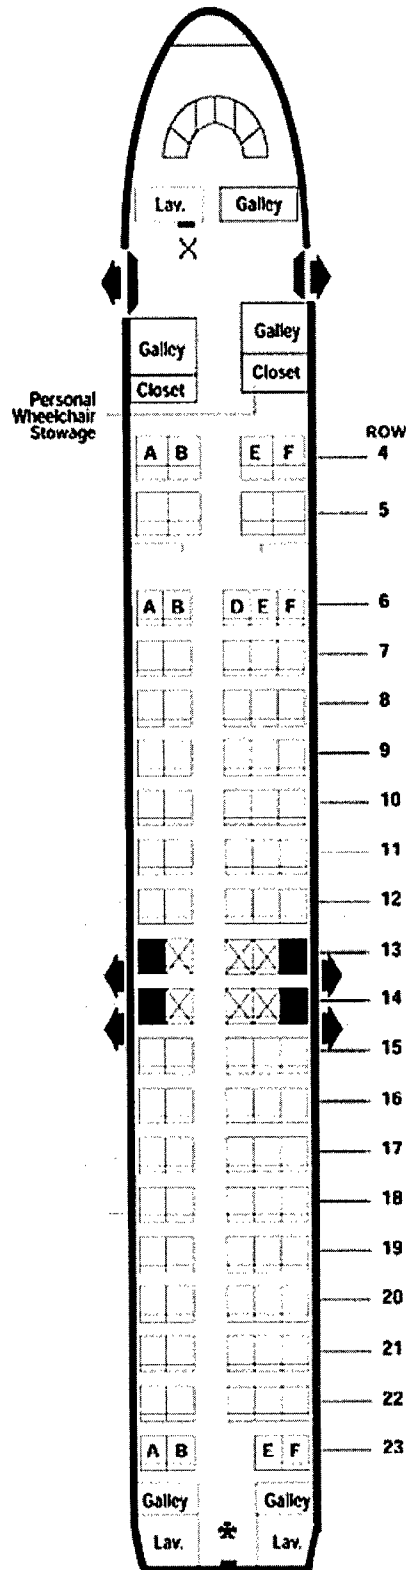
The exit configuration of some Fokker airplanes is unique among jet airplanes in that it does not have any exits in the rear of the airplane. On the Fokker 100 (F100), the forward flight attendant is responsible for the L1 and R1 floor level exits, which are adjacent to the jumpseat where the flight attendant is seated. The aft flight attendant is responsible for opening the forward overwing exits 10 rows and 47 passengers forward of the rear jumpseat where the flight attendant is seated (figure 5–8).⁶² A flight attendant involved in the evacuation of an F100 in Charlotte, North Carolina (case 41) indicated that passenger evacuation in this case would have been helped had there been an emergency exit in the rear of the aircraft. The F100 on which the flight attendant was working was equipped with floor level exits in the forward part of the cabin and four overwing exits. The aft flight attendant's assigned primary exit was a forward overwing exit. The two right overwing exits were blocked by a fire on the right main gear. Passengers from the middle and rear of the airplane were evacuating from the two left overwing exits. The passengers at these exits operated their exits prior to the flight attendant reaching the overwing area.

Figure 5-8. The Fokker 100 exit configuration. The aft flight attendant position is marked by the *. The forward flight attendant position is marked by the X.

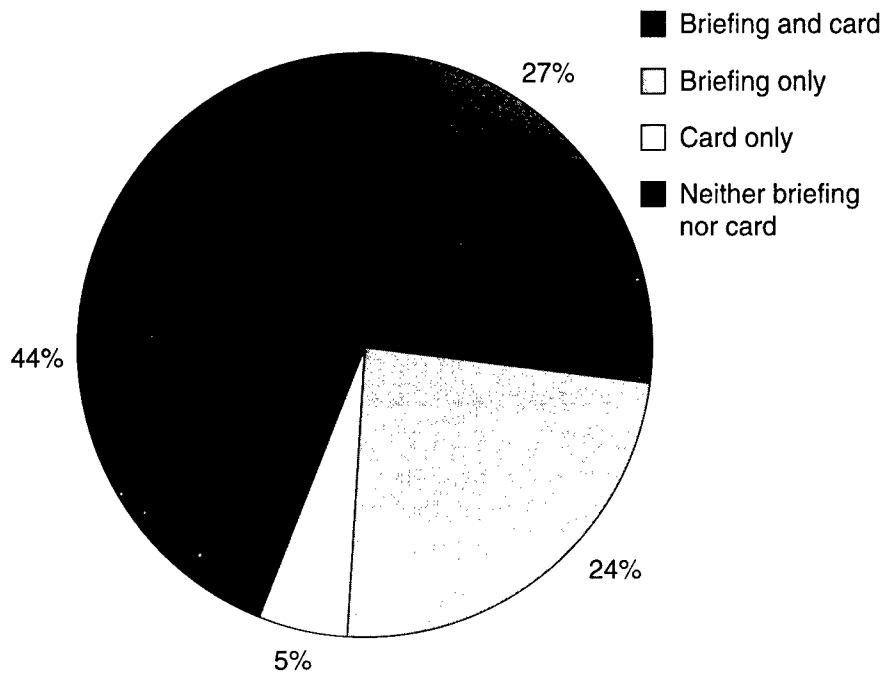
Passenger use of the safety cards on the airplanes in the study cases was consistent with previous findings that passengers tend not to look at the cards.⁷⁹ Of the 431 passengers who reported about reading the safety card, 68 percent (293) indicated that they did not read the safety card. Of those, 89 percent (259) indicated that they had read the card on previous flights. Of particular concern is that 44 percent (175) of 399 responding passengers reported that they neither examined the safety card nor listened to the safety briefing (figure 7-1).

Figure 7-1. Percentage of all passengers who indicated whether or not they paid attention to safety information.
