Considerations for Determining Safe Separation Distances from Mass Fires: a Literature Search

Thomas L. Boggs
Jacobs Naval Systems Group, Ridgecrest, CA 93555

Josephine Covino
*Policy Development Division
Department of Defense Explosives Safety Board, Alexandria, VA*

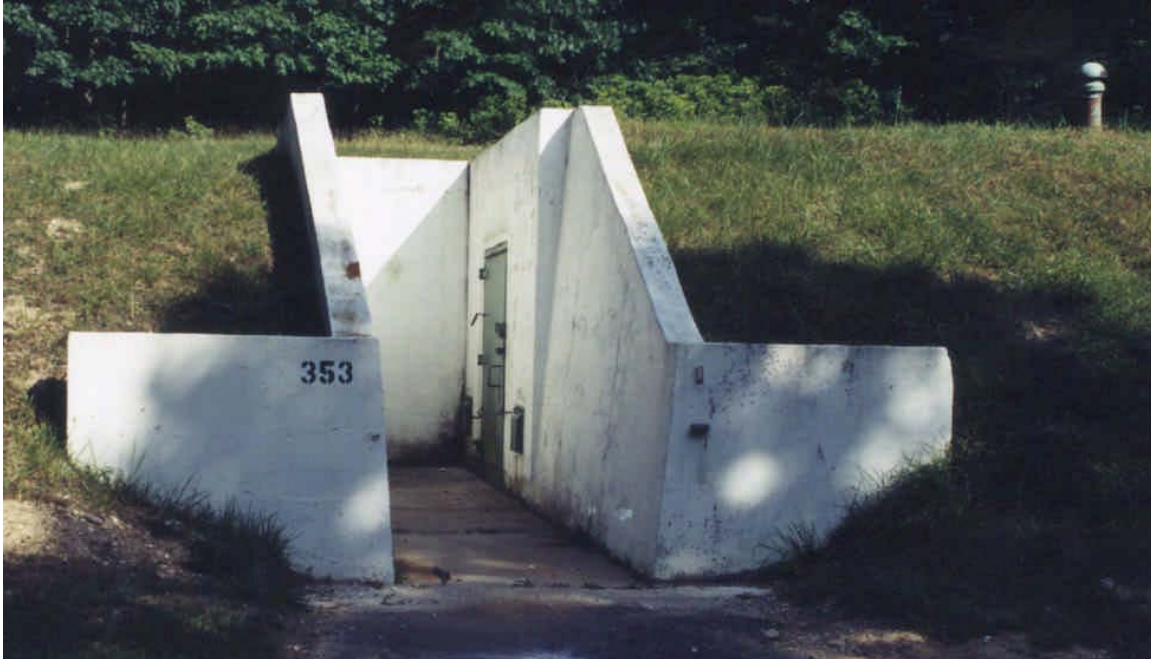
FIGURE 3. Magazine Similar in Design to One Destroyed at White Oak, Maryland, 28 June 1992.

Two explosions destroyed an earth-covered magazine similar to the one shown in Figure 3.

The magazine contained 5,180 pounds of largely HD1.1 materials. Fire was caused by decomposition of experimental energetic material, followed 2 minutes later by detonation of the other energetic materials. The magazine was destroyed. Debris including pieces of concrete 1 to 2 feet in diameter was thrown up to 800 feet. Smaller pieces of debris (concrete pieces up to 4 inches in diameter) were thrown as far as 2,000 feet.

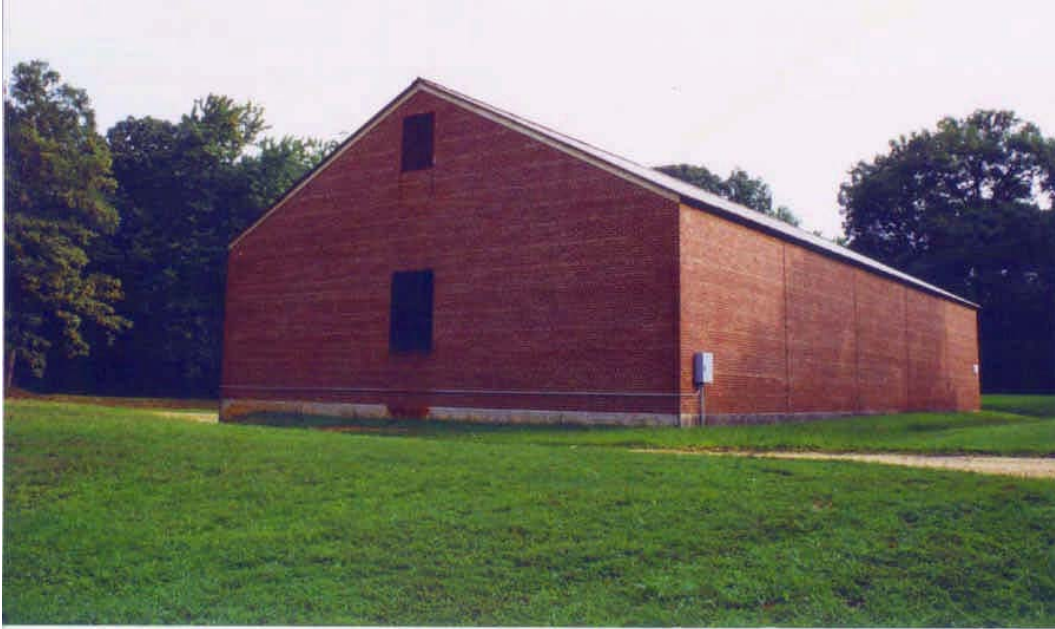
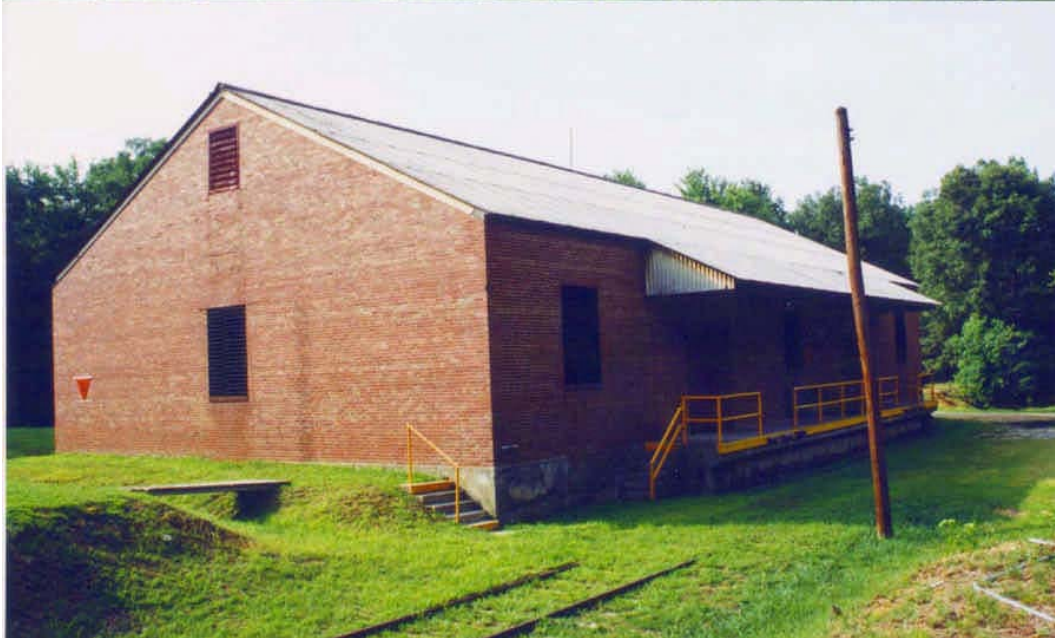
FIGURE 4. Magazines Similar in Construction to Magazine 518, Indian Head, Maryland.

This accident occurred in a non-standard, above ground, non-barricaded structure similar to the ones shown in Figure 4.

The magazine was sited for storage of 500,000 pounds of HD1.3 materials. At the time of the accident, there were 93,522 pounds of HD1.3 material and 4,609 pounds of HD1.1 material. Most of the materials were bulk powders and propellants for cartridge-activated devices or propellant-activated devices (CAD/PAD). The HD1.1 material in the magazine was pyrotechnic/propellant material for which the hazard classification was in question. Later analysis determined it was HD1.1.

The surmised sequence of events started with auto-ignition of nitrocellulose gun propellant. The fire spread and involved a relatively large quantity of magnesium-teflon-viton flare material, which provided an intense boost to the fire. This in turn led to the first and largest detonation followed by a series of smaller detonations.

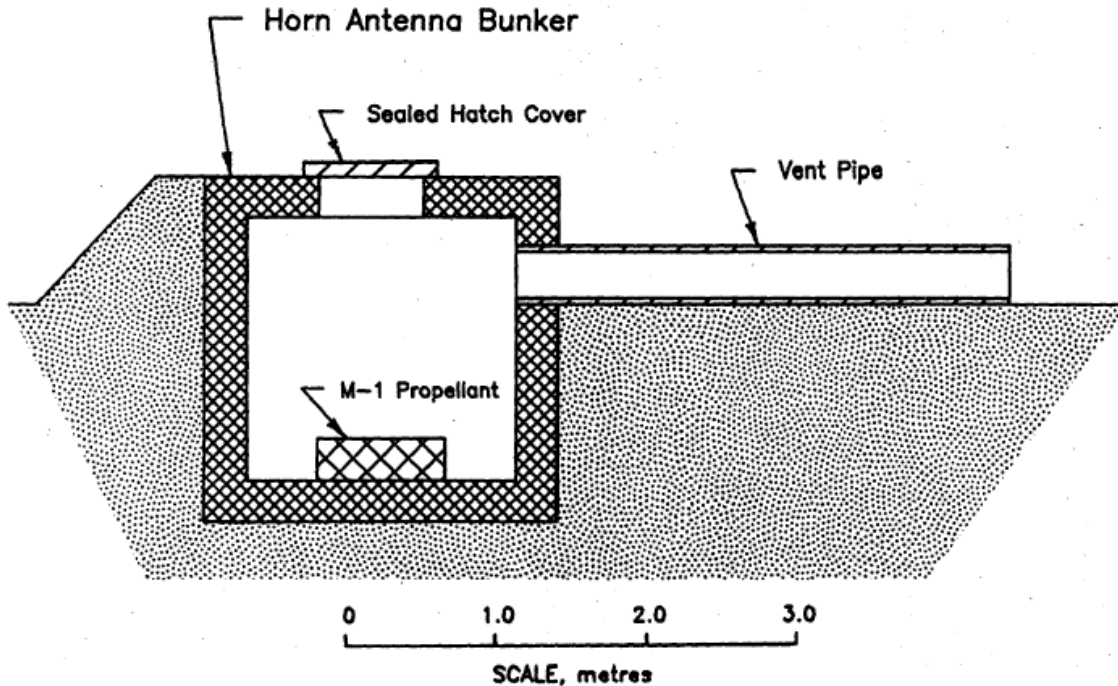
FIGURE 15. Schematic of Bunker, Vent Pipe, and Sample Location.

In the test described by Joachim (Reference 6), the plume distance from subscale tests depended on the loading density of propellant to available volume of chamber, and vent area to chamber volume. Joachim had a single container of 1.4 by 1.9 by 1.9 meters with a 35.6-cm-diameter vent tube. The reinforced concrete walls, roof, and floor were 30 cm thick. Single perf M-1 gun propellant was placed in the container in varying amounts to provide loading densities of 2, 5, 20, 50, and 100 kg/m³. The bunker, vent pipe, and sample location are shown in Figure 15.

Test C-1 was 10 kg of M-1 propellant in the 5 m³ chamber giving a 2 kg/m³ loading density. Initially black smoke was observed coming out the end of the vent pipe. The smoke quickly changed to flame and, by 4 seconds after assumed initiation, the flame extended approximately 5 meters from the end of the pipe. The total duration of the external flame was about 11 seconds. The initial gas flow out the end of the pipe was 3.47 m/sec. The pressures beyond the vent pipe were higher than the chamber pressures indicating that unburned gas and propellant were carried outside the chamber and burning was occurring in the vented gas plume. The video recorded a pulsating flame in the gas plume. Heat flux measured within the tube reached 30 cal/cm² sec (1256 kW/m²) with the average heat flux being about 25 cal/cm² sec (1047 kW/m²).

Test C-4, in the series of tests described by Joachim (Reference 6), had 250 kg of M-1 propellant (50 kg/m^3) in the chamber shown previously in Figure 15. Initially a smoke plume was observed to extend 1.3 meter past the end of the pipe within approximately 0.3 seconds. The plume quickly extended from the vent and filled the entire video field of view (greater than 25 meters) in approximately 5.3 seconds. Shortly after, the structure failed at approximately 6 seconds, releasing all pressure. The remaining propellant then burned rapidly in the air outside. The chamber failed from excessive internal pressure. Post-test observation showed that the concrete bond to the rebar had failed and the rebar pulled out of the concrete. At the time of the failure, the hatch cover and roof section were hurled high into the air at an average velocity of about 33 m/sec (hatch) and 11 m/sec (roof). The peak pressure on the side wall was about 10^3 kPa . This test indicated that over-pressure caused the failure, not a transition to detonation.

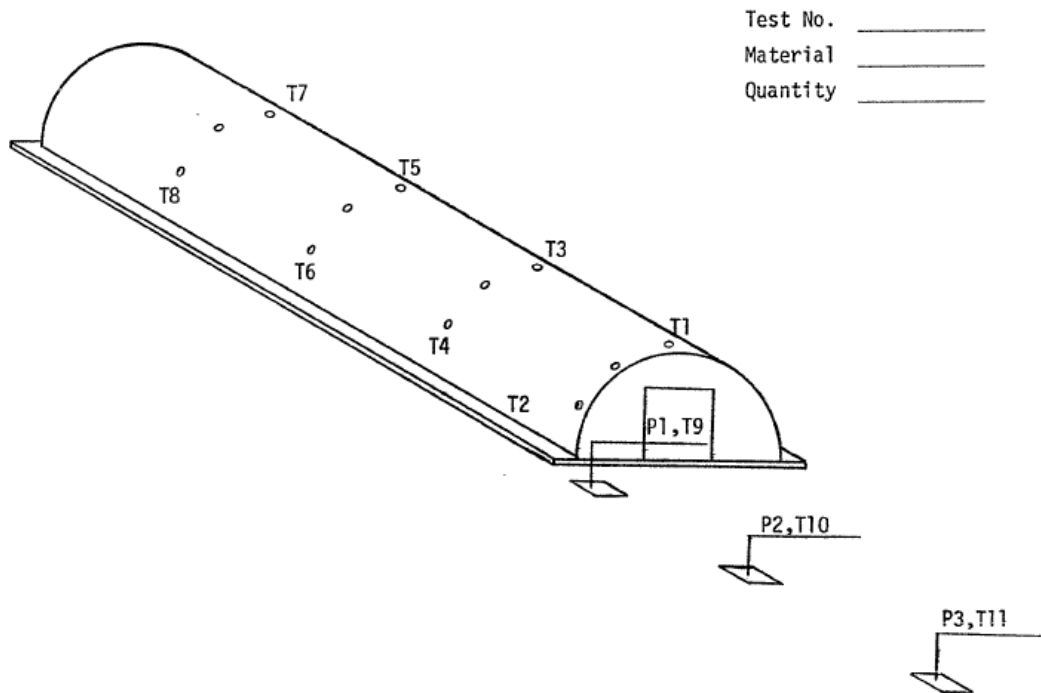
FIGURE 16. Schematic of 1/10th Scale Igloo with Sensor Locations.

Herrera and Vargas continued the testing of various gun propellants and flares in the 1/10th scale igloo with pressure and temperature sensors shown in Figure 16. In the tests, the energetic material type and quantity and the vent size were varied. The vents were square, so a 12-inch vent was 12 inches by 12 inches. A 12-inch vent would correspond to an igloo with double doors and multiple vents (vent area ratio of 0.1234), a 9-inch vent would correspond to an earth-covered magazine with double door (vent area ratio of 0.07), and a 6-inch vent would correspond to an earth-covered igloo with single door (vent area ratio of 0.03).

Temperature data also showed interesting behavior. The data showed that the maximum temperatures outside of the igloo were hotter as compared to the maximum temperatures inside of the igloo. This strongly indicates that unburned propellant is carried outside of the igloo and burns out in the plume.

Reference 3 presented predicted scaling effects in going from 1/10th scale to full scale. They predicted that the 25 foot plume obtained with the 1/10th scale and 10 pounds of propellants would be approximately 250 feet of plume with a velocity of 1500 fps for full scale igloo and 10,000 pounds of propellant.

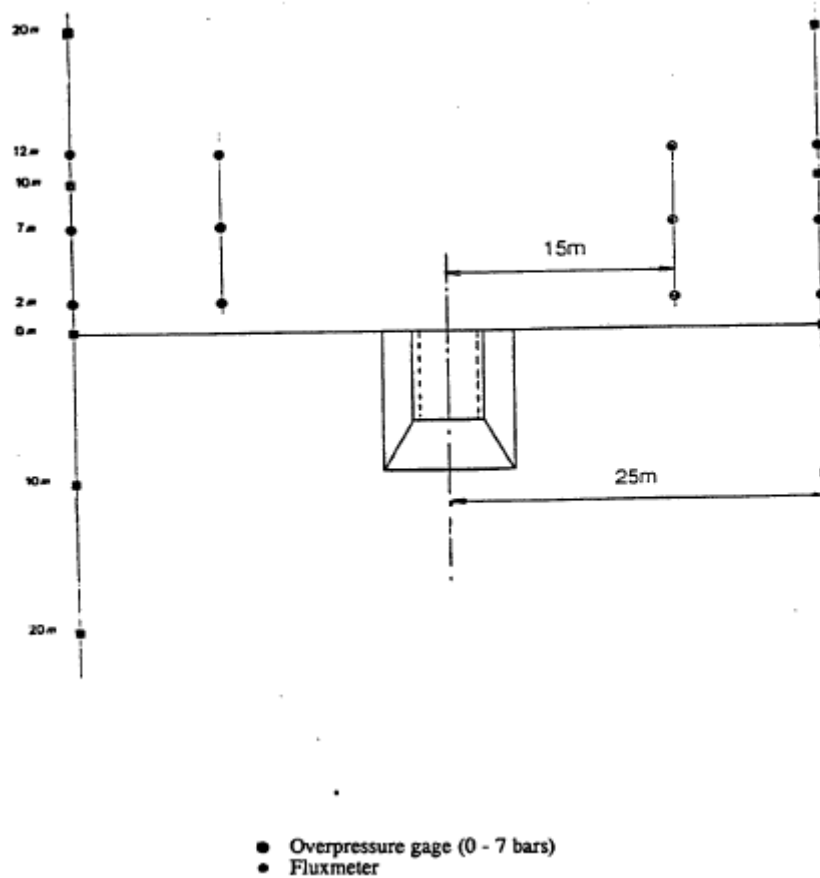
FIGURE 17. Location of Flux Sensors and Overpressure Gauges.

Allain (Reference 5) presents the results of four 1/3rd scale igloo tests. The first three tests used three different structures with approximately 2.22 metric tons of LB 7 T 72 (0,8) propellant. This gun propellant is similar to M-1. In the tests, over-pressure gauges and flux-meters were placed in locations shown in Figure 17.

Unburned propellant was found 45 meters from the igloo.

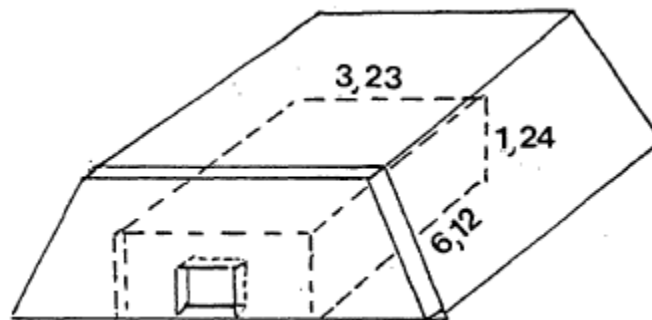
FIGURE 18. Igloo Shape for Test 4.

The fourth test differed from the previous tests in that a different magazine design was used and a different stacking of the cartridge bags. Figure 18 shows the magazine shape for Test 4.

The construction of the igloo consisted of earth covering (0.4 m on top and extending 2 m at the base of the sides and over 4 m at the base of the rear) the concrete box structure that had an internal metal liner, all mounted on a concrete base. The vent opening was 0.33 m^2 .

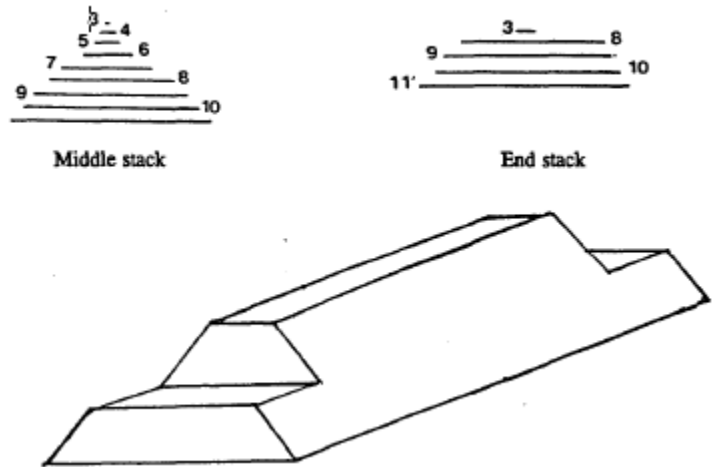
FIGURE 19. Charge Configuration for Test 4.

In order to keep the same loading density as the previous tests, the amount of gun powder and the loading configuration were changed. The new quantity was 2.037 metric tons and 334 cartridge bags, configured as shown in Figure 19.

The volume of the igloo was 24.5 m^3 and the opening area was 0.33 m^2 , giving a volume of charge to volume of chamber of 0.11 and ventilation coefficient of 0.013.

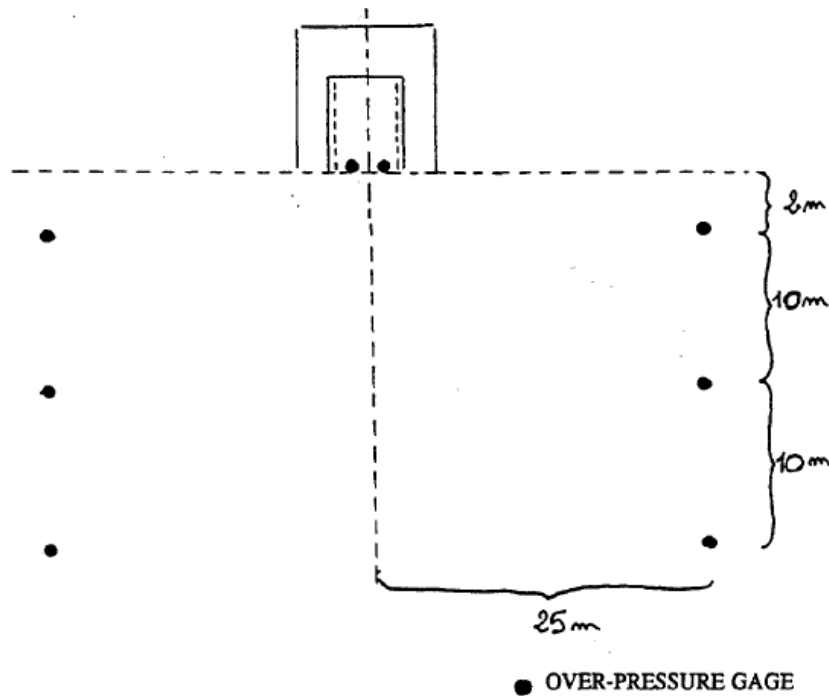
FIGURE 20. Location of Over-pressure Gauges Relative to Magazine in Test 4.

In Test 4, instrumentation was simply two rows of three overpressure gauges at 25 meters on both sides of igloo axis, as indicated in Figure 20.

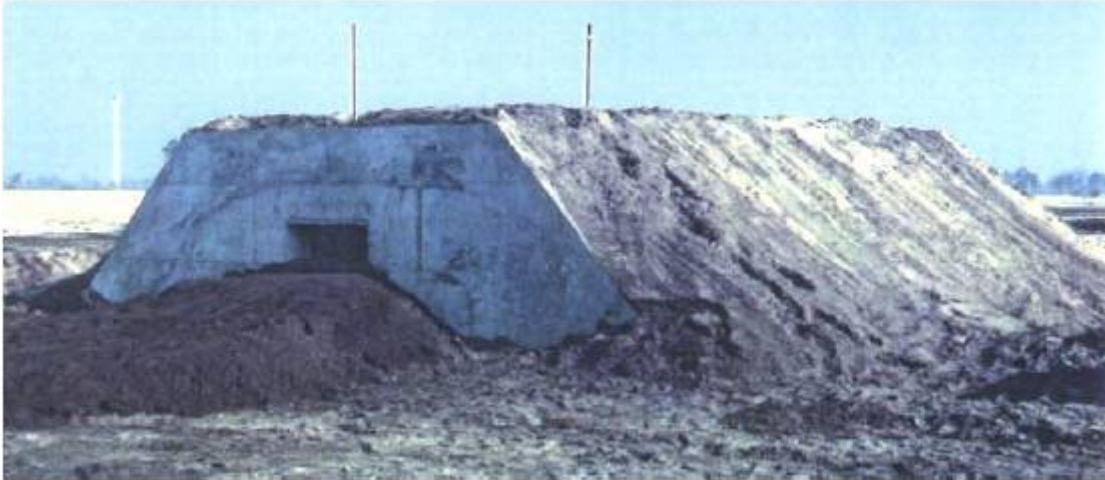
FIGURE 22. Captieux Trial Shot 4 (a) Before and (b) After.

Figure 22 shows the igloo before the tests and the post-event photograph.

Interestingly, none of the overpressure gauges recorded any signal, nor was any crater formed, indicating neither a strong explosion nor a detonation occurred (Figure 22b). One of the internal overpressure gauges recorded an overpressure of 7 bars before saturating. The authors estimated that the maximum internal overpressure before rupture at 10 to 12 bars.

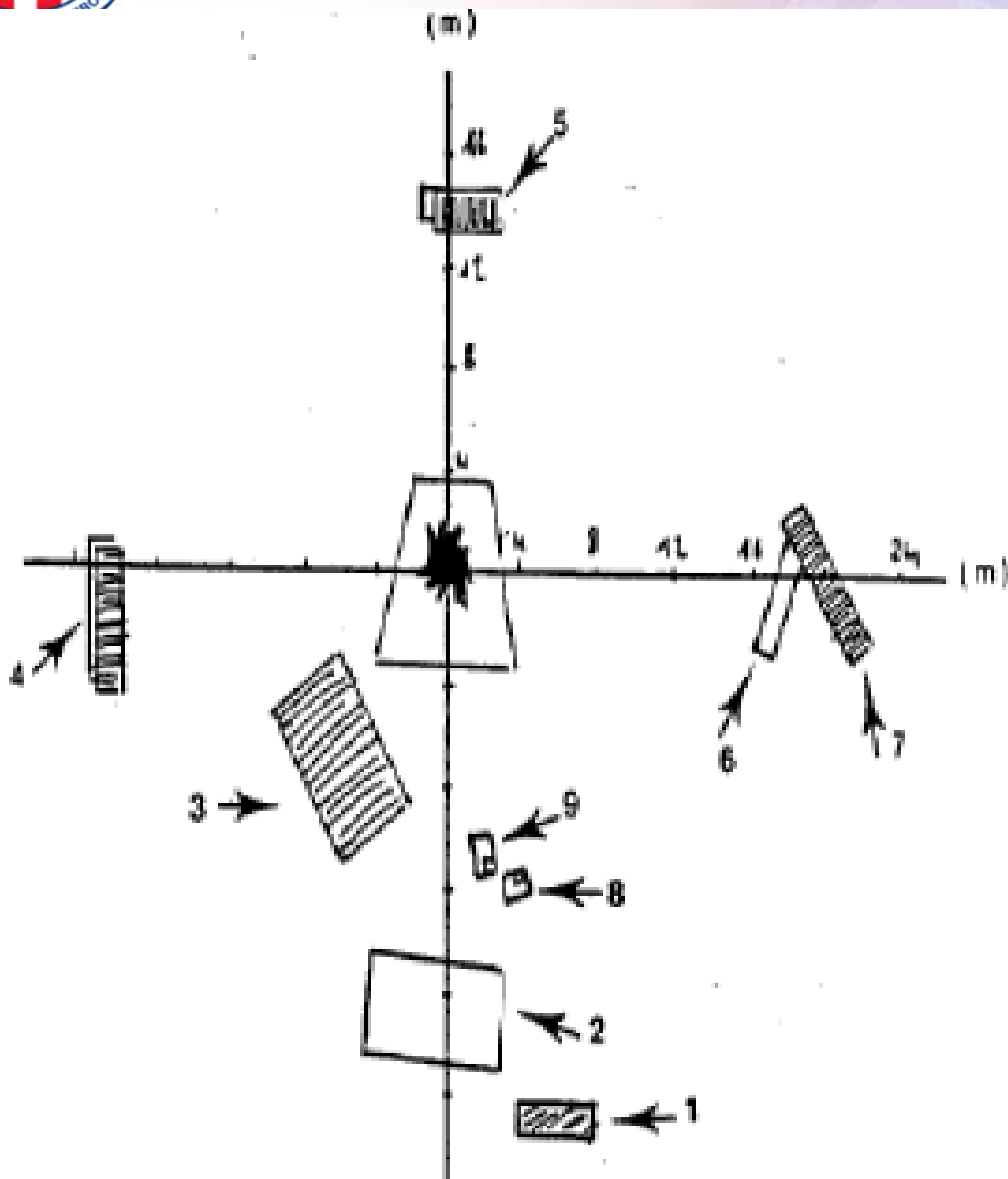
Allain Test 4

Test 4 resulted in the igloo bursting 1 second after ignition, releasing a fireball. At ground level, no trace of a plume was observed. The igloo separated along its structural lines or corners. It separated into five main parts, each comprising two pieces—one concrete and one steel as shown in Figure 21.

- 1 metal front
- 2 concrete roof
- 3 metal roof
- 4 lateral metal + concrete wall
- 5 rear metal + concrete wall
- 6 lateral concrete wall
- 7 lateral metal wall
- 8 1/2 concrete front
- 9 1/2 concrete front
